142 - 152 Plymouth Road, Tavistock, Devon

An Archaeological Watching Brief

COAS reference: COAS/WBF/09/PRD

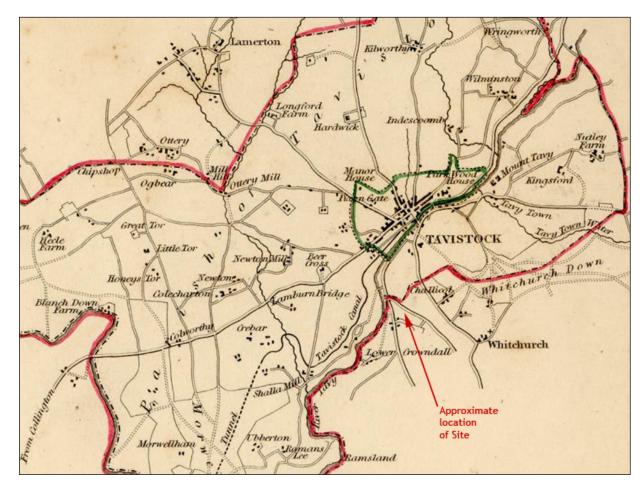
Plate 1. Extract: Tavistock Parish, Robert Creighton, engr. J.& C. Walker for Lewis' Topographical Dictionary, 1835

- Between 1817 and 1820 Plymouth Road was constructed, which forms the eastern boundary of the site;
 - A small-scale survey of the town in 1835 (Plate 1) shows the site as undeveloped open land;

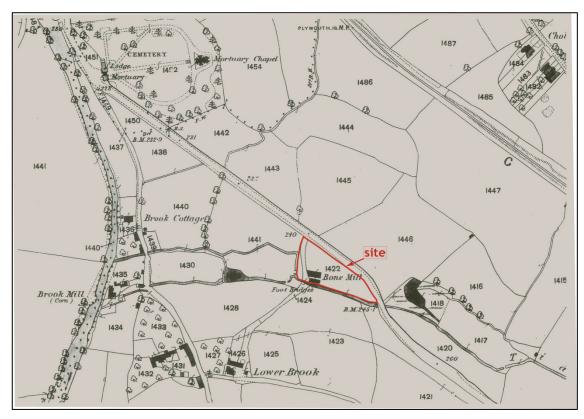
Plate 2. Extract: 25" Ordnance Survey Map, 1885 (site outlined in red)

- The 1st edition OS map of 1885 (Plate 2) shows the south western corner of the site occupied by a Bone Mill (HER 51351) comprising two parallel east to west aligned rectangular structures with a footbridge crossing the Tiddy Brook adjacent to them. The site boundaries were defined by Plymouth Road to the north and Tiddy Brook to the south. As the main Bone Mill structure was located adjacent to the Tiddy Brook, which forms the southern boundary of the Site, the Mill machinery might have been water-powered although the water may only have been utilised for cleaning the bone (see below).

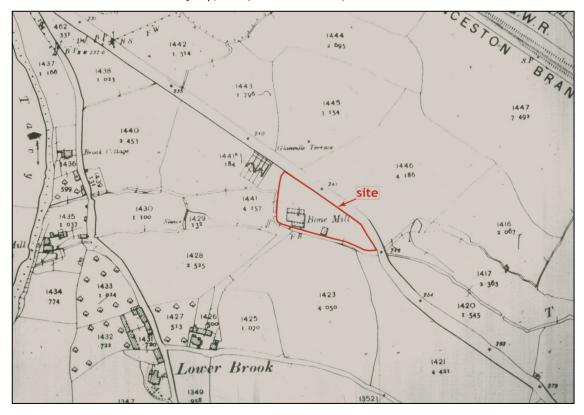
Plate 3. Extract: 25" Ordnance Survey Map, 1904 (site outlined in red)

- The 2nd edition OS map of 1904 (Plate 3) continued to identify the main building on the site (an amalgamation of the two structures shown on the 1885 map) as a Bone Mill. An additional small rectangular structure is also shown to the east of the Bone Mill. The footbridge across the Tiddy Brook continues to be shown and whist the site remains predominantly surrounded by open fields, a small row of houses known as Glanville Terrace had been built along Plymouth Road immediately to the west of the site.

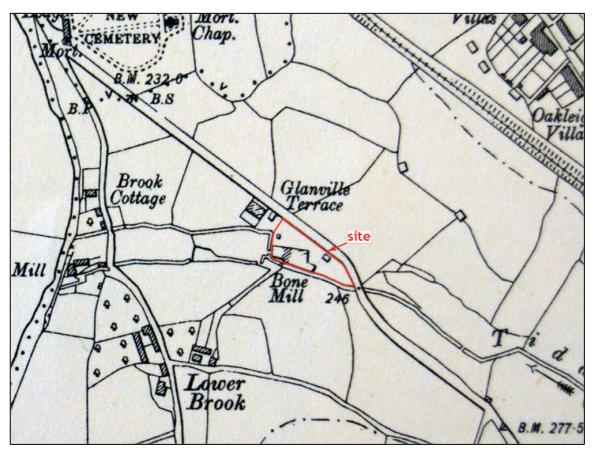
Plate 4. Extract: 25" Ordnance Survey Map, 1938 (site outlined in red)

- The 1938 edition OS map (Plate 4) continued to identify the main building as a Bone Mill.
 This appears to have been surrounded by an enclosure probably defining a yard. A small structure is also shown along the northern boundary of the site with a possible small structure near the western boundary. The site remained predominantly surrounded by open fields.

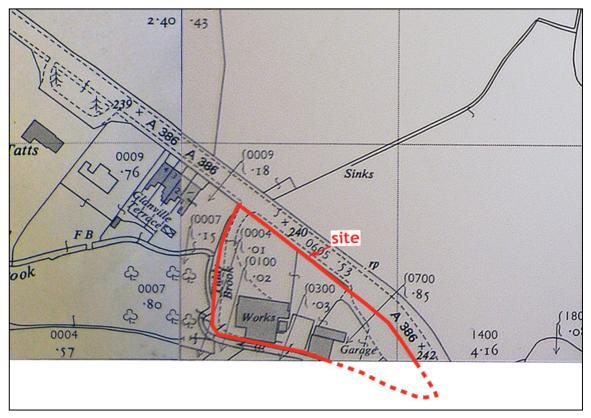
Plate 5. Extract: 25" Ordnance Survey Map, 1962 (site outlined in red)

- The 1962 edition OS map (Plate 5) showed the Site apparently divided into three plots; the western plot contained the Bone Mill building labelled 'works'. The central plot contained two structures, including one first shown on the 1904 map and a further rectangular structure immediately to the north of this. The eastern plot contained a garage. Despite some

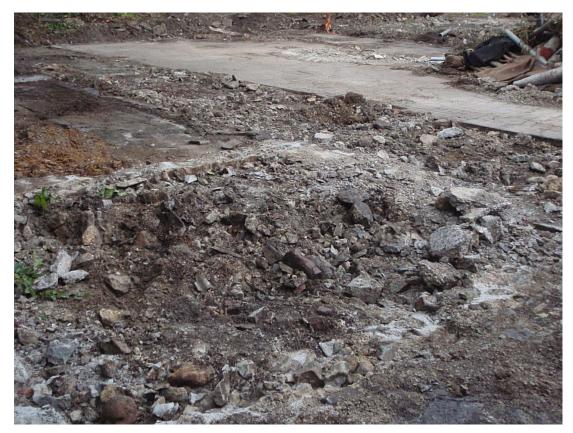
- The most southerly of the buildings, (Plate 6, Figure 3) measuring 11.5m x 4m, was defined by wall (101) (Figure 5) at its eastern end, wall (114) to the west and wall (121) to the north. Walls (101) and (114) were constructed with randomly coursed granite and slate blocks bonded with a soft white lime mortar. Wall (121) was constructed with concrete slab foundations. An upstanding wall (101) up to 2m high defined the east end of the building which originally had a 3m wide entrance; this was later narrowed to a 1m wide doorway which was in turn blocked entirely (Plate 7). These blocking walls were constructed using the same materials and methodology as the original wall. There was no visible evidence of wall (121) having been keyed into wall (101) above ground, suggesting that either wall (121) originally abutted and is later than wall (101), or alternately, an entrance from the alleyway into the building may have existed at the eastern end of wall (121).

Plate 6. Southern Bone Mill building, viewed from the south east across sump (122).

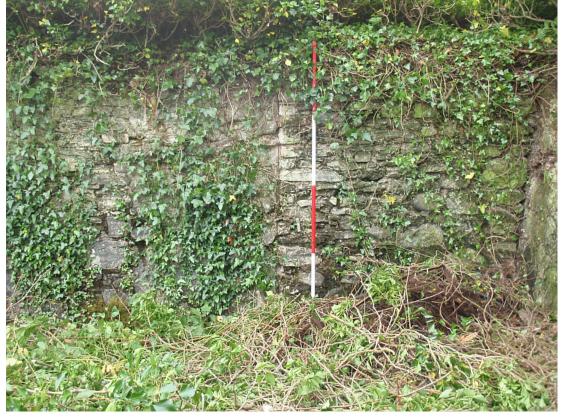
Plate 7. Blocked doorway near southern end of wall (101), viewed from the west.

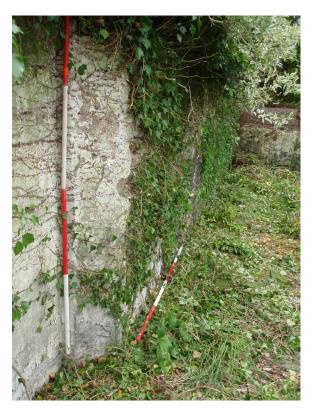
Plate 8. Wall (101) viewed from the north showing chamfered corner of doorway.

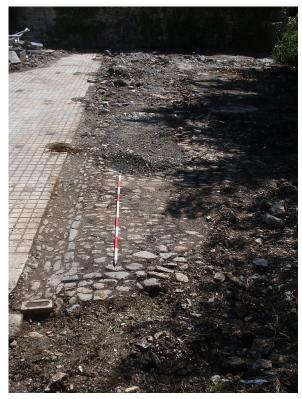
- 6.9 Both the cobbled surfaces (102)/(107) (**Plate 9**) and (104) were constructed with light grey (10YR 7/1) sub-rounded granite setts that directly overlay natural (127). To the north of the Bone Mill complex a concrete slab floor (108) was recorded; this is probably a 20th century addition.

Plate 9. Cobbled alleyway (102)/(107) viewed from the west, with floor (115) and iron column bases (116), (117), (118) and (119) on the left.

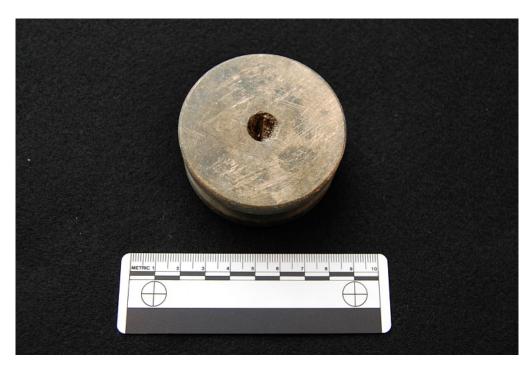
Plate 10. Plan view of copper pulley wheel (sf 1)

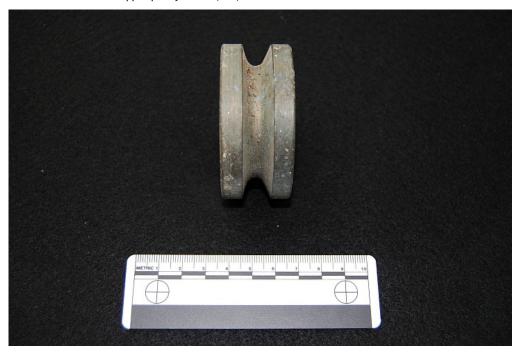
Plate 11. Profile view of copper pulley wheel (sf 1)
