# Hoppins Farm, Southerton, Newton Poppleford, Devon

## An Historic Building Recording Survey

**COAS reference:** COAS/SBR/10/HNP

April 2010

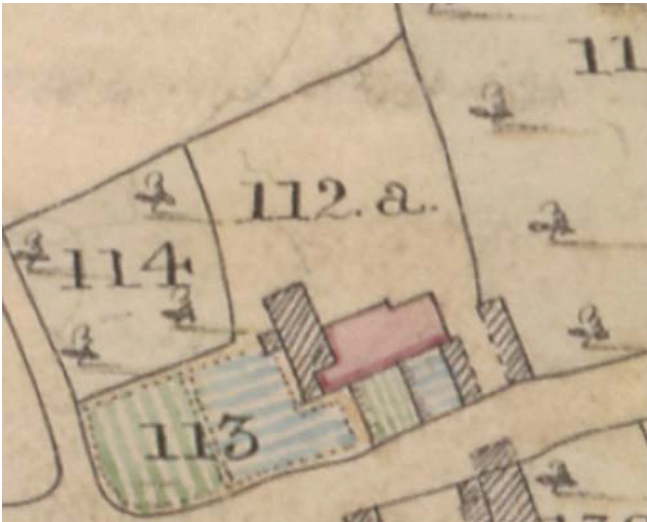
Figure 3. Extract from Venn Ottery Tithe map, 1841

- 4.3 The Tithe map of 1841 (**Figure 3**) appears to be the oldest surviving large scale map for Hoppins Farm and depicts the farmhouse along with four ancillary structures. A narrow building adjoining the front of the house and bordering the drive, and a small square building attached to the western side of a structure adjoining the side of the house are no longer extant and do not appear on any subsequent maps. The building on the opposite side of the drive is now known to be a cart house and the structure extending north from the western side of the farmhouse is a former ?dairy/barn and is, today, mostly subsumed as part of the farmhouse. The accompanying Tithe apportionment states that the farm was owned by the Honourable Mark Rolle and tenanted by William Brice (transcribed incorrectly as ‘Price’).

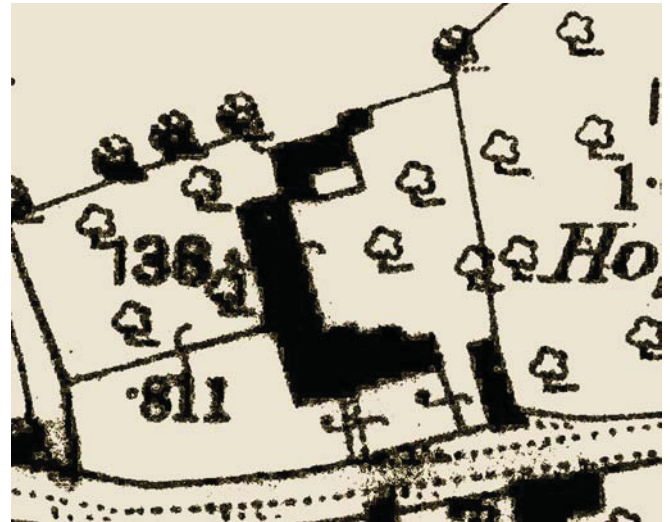
Figure 4. Extract from Ordnance Survey map, 1891

- 4.6 The first edition of the Ordnance Survey (OS) map in 1891 (**Figure 4**) effectively shows Hoppins Farm as it is laid out today; at some point between the Tithe map of 1841 and 1891, both the extension to the main barn and the piggery had been built. A small ‘shed’ or outbuilding is shown attached to the north-east corner of the piggery on both the 1891 and 1905 OS maps (**Figure 5**) but was not shown on the 1957 OS edition (**Figure 6**).

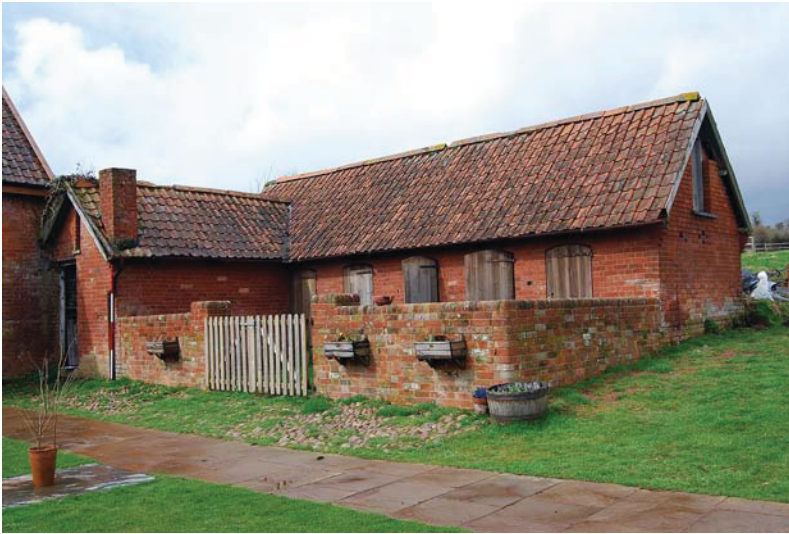
Plate 5. Frame DSC\_0074.jpg, view 2

Element	Observations	Figure no(s)/Plate(s)
General	An 'L-shaped single storey brick building with the main axis (c. 11.00m x 4.00m) roughly aligned WSW-NNE and terraced into a natural slope at the western end up to eaves height. The building adjoins a barn at its south-west corner and the southern and eastern elevations are enclosed by a brick wall with double gates to create a yard area with pebble cobbles. The	Front cover, 5, 6, 7, 8

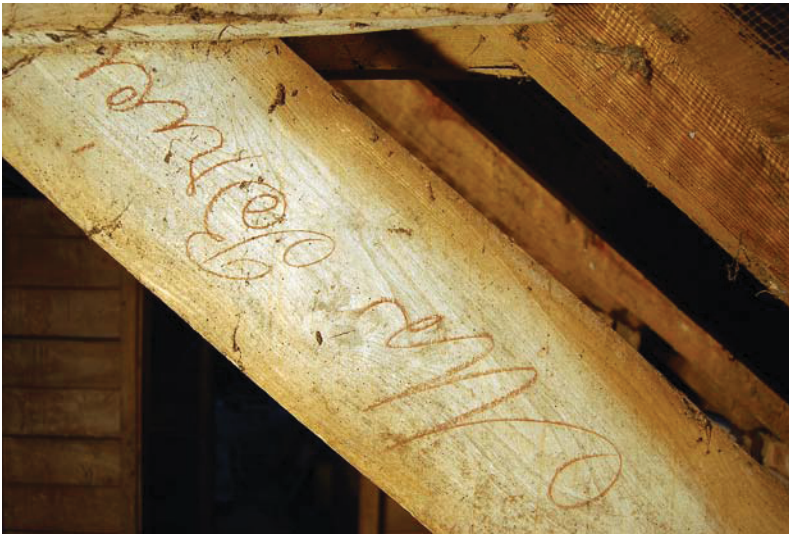
Plate 15. Frame DSC\_0018.jpg, view 34

- 4.4 The Census returns between 1841 and 1871 show that the Brice family lived at Hoppins Farm throughout this period. William Brice was only 24 in 1841 and, given his age, had probably not held the farm for long. In 1851, the census records William as farming 65 acres and employing two labourers although three are noted as living with the family: Charles Holland (23), David ?L (15) and Henry Preston (10). William Brice had a wife, Jane, who was the same age, and they had two children, Sarah (3) and John (2). Emma Wood (20), a ‘house servant’ also resided at the farm. In 1861, a second daughter is recorded, Elizabeth H Brice (5), and Sarah appears as ‘Amelia’, perhaps her middle name. By 1871, William (with a given age of 54) is noted as farming 67 acres and still employing two labourers; Thomas Hellier (30) and John ?Lellick (53). The census shows that a nephew, George Brice (10) was also living at the farm and is recorded as a ‘farm servant in door’. Carpentry marks and notes were observed on several roof timbers during the survey and one of these is believed to refer to William Brice himself. Written in red ?crayon on a principal rafter it reads, “Mr Brice (text broken by tie beam, presumably ‘Venn’) “Ottery” (**Plate 15**).

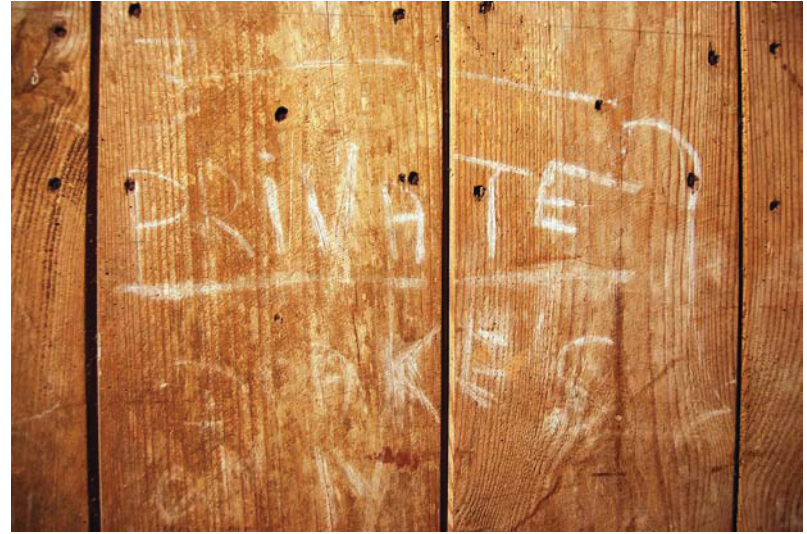
Plate 18. Frame DSC\_0038.jpg, view 41

- 4.8 The Drake family and their descendants are believed to have resided at Hoppings Farm until recent years (D Harwood, pers. comm. 2010). Graffiti referring to the Drakes were found in several parts of the barn during the survey. These include “W Drake” scratched into a brick on the first floor of the barn (Plate 17), perhaps relating to William Drake himself; the initials “A.D 1897” and “L.D 1897” scribed into ground floor window sill of the barn (Plate 26 and 28) probably relating to Albert and Louis or Lily; the name “F Drake” with “D B” underneath carved into a ‘hammer beam’ on the first floor of the barn (Plate 14); and a warning on an internal door, also upstairs in the barn, written in chalk and declaring “PRIVATE DRAKES ONLY” (Plate 18).

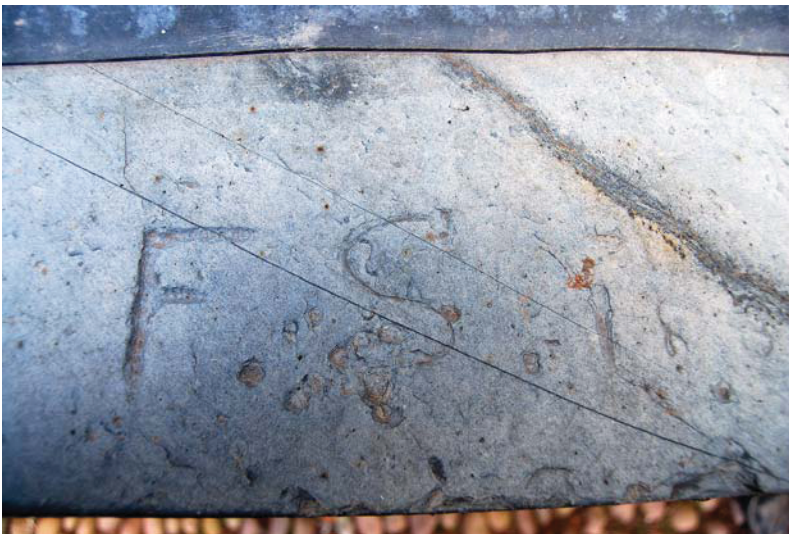
Plate 27. Frame DSC\_0119.jpg, view 11

- 4.5 By 1881, the Brice family were no longer tenants of the farm and the new occupiers were the Smales. William Smale (48) was the head of the family and it is recorded that he took charge of a holding of 160 acres, more than double that of William Brice. He lived with his wife Catherine (47) and their four children, William (22), Mary (20), Frederick (18) and Susannah (16). Sarah Wheaton (12) from the neighbouring Brownings Farm was their ‘general servant’. Graffiti found on a ground floor window sill of the barn during the survey reads “F.S. 18??” (**Plate 27**) and is likely to refer to Frederick Smale.
