Hole Farm, Hockworthy, Tiverton, Devon.

An Archaeological Programme of Works: historic building recording, desk-based appraisal and archaeological monitoring and recording during development groundworks

COAS Project Reference: COAS/WBF/10/HHT

October 2010

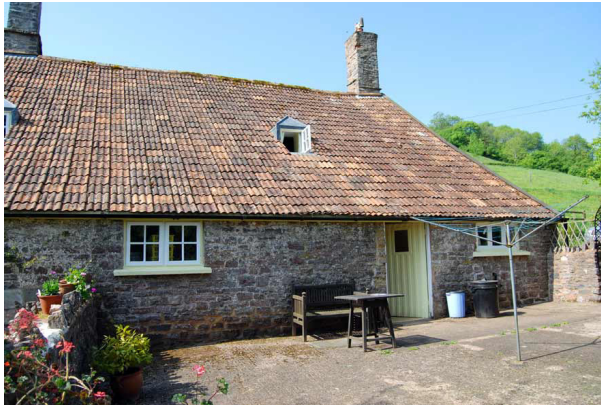
Plate 1. Kitchen and utility room prior to alterations

- 3.6 The present application relates to a single storey extension to the rear (north) of the main house at the western end. Prior to development works the extension was used as a separate kitchen and utility room and it was proposed to create a single kitchen space by removing modern concrete partitions, relocating the outside doorway and raising the floors levels to a common height. This included installing a damp proof membrane under the floor to alleviate long-term damp problems.

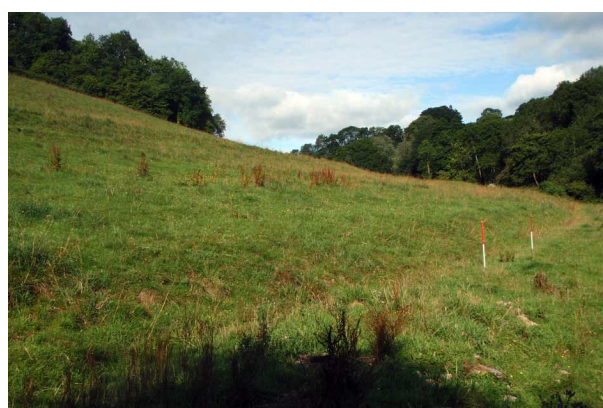
Plate 5. Conjectured route of culvert/drain on western side of farmhouse

- 8.1 As a result of the archaeological monitoring of development groundworks, it has been possible to record a well-preserved stone culvert that may once have formed part of an organised water management system around Hole Farm. The culvert itself was located against the north facing wall of the main house and inside what is believed to be a 17th century extension that, up until recently, served as a kitchen and utility area. The culvert comprised three courses of random stone blocks either side of a central channel that was covered with large limestone slabs. Stratigraphically, the culvert certainly pre-dates the extension and although it is tempting to speculate that it is contemporary with the farmhouse itself, there was no evidence to indicate a date of construction. A ‘spur’ draining into the culvert from the farmhouse in the north-west corner perhaps represents some form of crude ‘waste disposal’ from inside the house; this was later sealed off with a ‘vented’ slate. A large dump of domestic refuse in the channel, presumably designed to infill the culvert, marks the date by which it went out of use. The range of material included pottery, clay tobacco pipe, animal bone, cutlery and glass, the majority of which was dated to the 19th century. The dump may have been a prelude to capping/re-capping the culvert just prior to establishing a new floor over the top. The culvert extended in both directions beyond the extension, a further section of which can be seen under a glass plate in the bathroom of Hole Cottage. Today, this appears to extend underground to the east where it empties out of a modern pipe just north of the farm buildings (plate 4) and disperses across open pasture, although the tithe map of 1842 suggest that it may once have fed a pond on the end of Hole Cottage. To the west, it is conjectured that the line of the culvert may follow a natural contour and fed by one of the many springs in the immediate area (plate 5).
