# BS069: Holt to Semington Water Main Replacement, Wiltshire.

An Archaeological Watching Brief.

**COAS Project Reference:** COAS/WBF/10/HSW

**Wessex Water plc scheme reference:** BS069

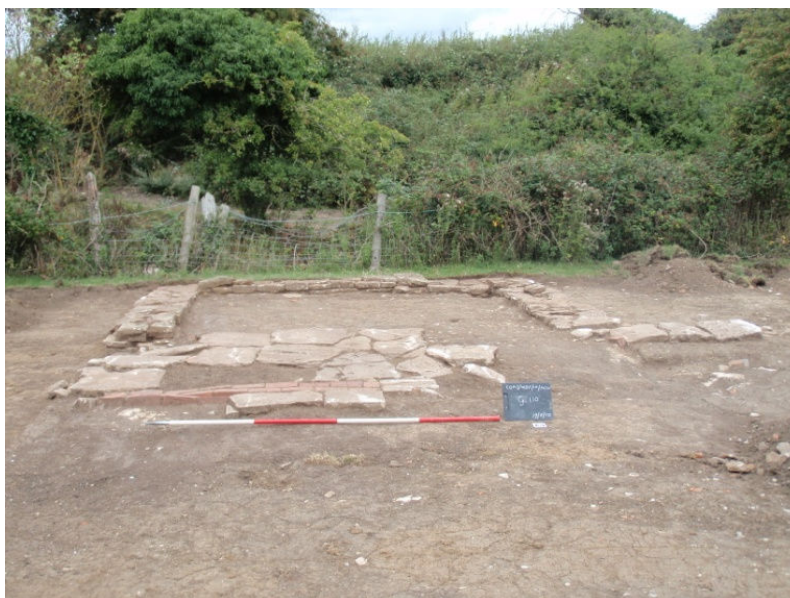
Plate 1. Structure (G115) in Field 12

- 5.2 Within Field 12 the foundation remains of a small stone built structure (**Figure 2, Plate 1**) were revealed directly beneath the topsoil (100). The structure (G110) measured 4.5m x 3.2m with a small paved area (115 & 117) to the south measuring 2.5m x 1.5m. At the southern end of the paved area a line of red bricks (116) was revealed. Two courses of stonework survive with the lower course (111) slightly stepped out from the upper course (112/113).

- 6.1 The watching brief revealed three main areas of archaeological activity along the route of the easement. This included two areas of medieval ridge and furrow in Fields 7 and 12 and a post-medieval/modern foundation of a small 19<sup>th</sup> century agricultural building in Field 12. The building does not appear on any of the historic maps and is therefore likely to have been erected and demolished within the intervening periods of late 19<sup>th</sup>/early 20<sup>th</sup> century mapping. The easement strip across the earthworks was unable to prove or disprove the exact nature of the earthworks. The finds recovered during the watching brief indicate that there has been archaeological activity within the vicinity of the easement from the prehistoric, to modern periods, although the only dateable features were the medieval ridge and furrow and the 19<sup>th</sup> century building.

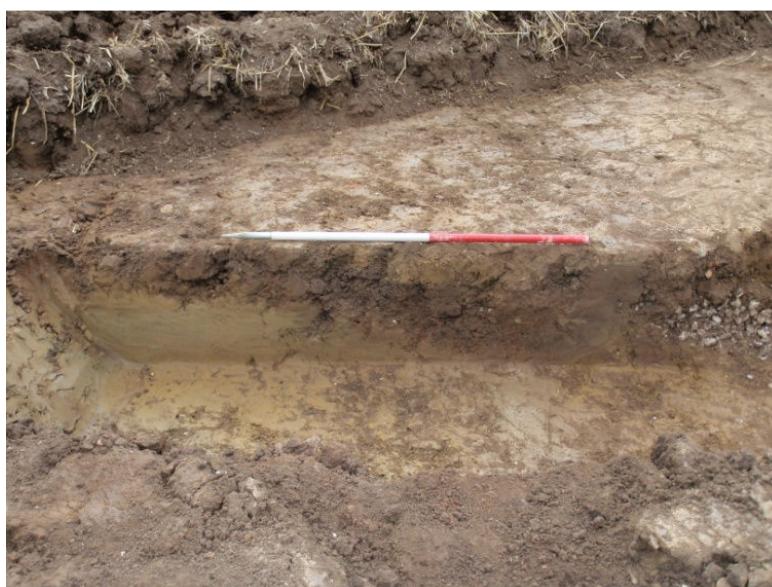
Plate 2. Ridge and Furrow in Field 12

- 5.3 Two areas of medieval ridge and furrow were located directly beneath the topsoil within Fields 7 & 12. Excavation of a section across the ridge a furrow in Field 12 (**Figure 2, Plate 2**) revealed that the furrows were aligned approximately north/south and were between 0.1m deep at their western end and extended to a depth of 0.4m at their eastern end. The furrows were separated by ridges spaced c. 6m apart.

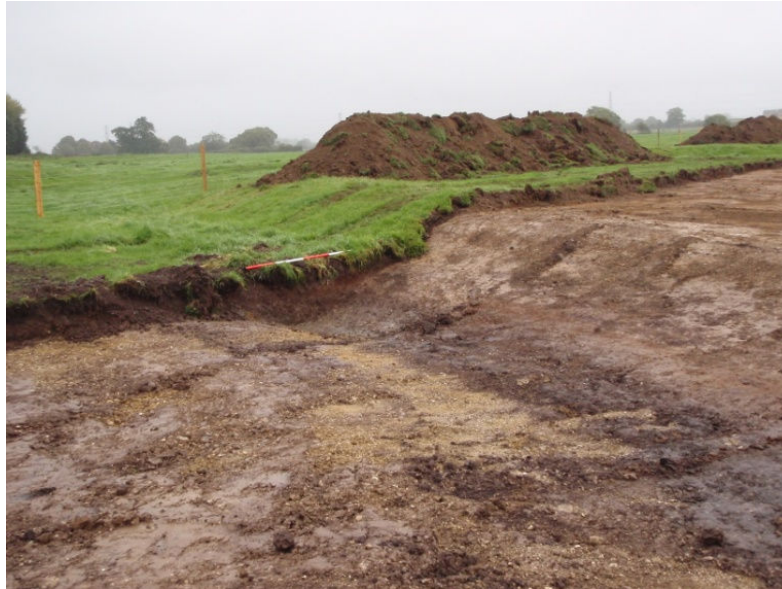
**Plate 3.** Water borne deposit at the base of southernmost earthwork.

- 5.3 As stated above (Section 4.8) a full topographical survey was undertaken of the earthworks (a possible deserted medieval village) in Field 7 prior to the stripping of the easement. The easement strip revealed no direct evidence (features or finds) of medieval activity or any other period within the area of the earthworks. A single modern horse shoe was noted within a water borne deposit (200) at the base of the southernmost earthwork (**Plate 3**).

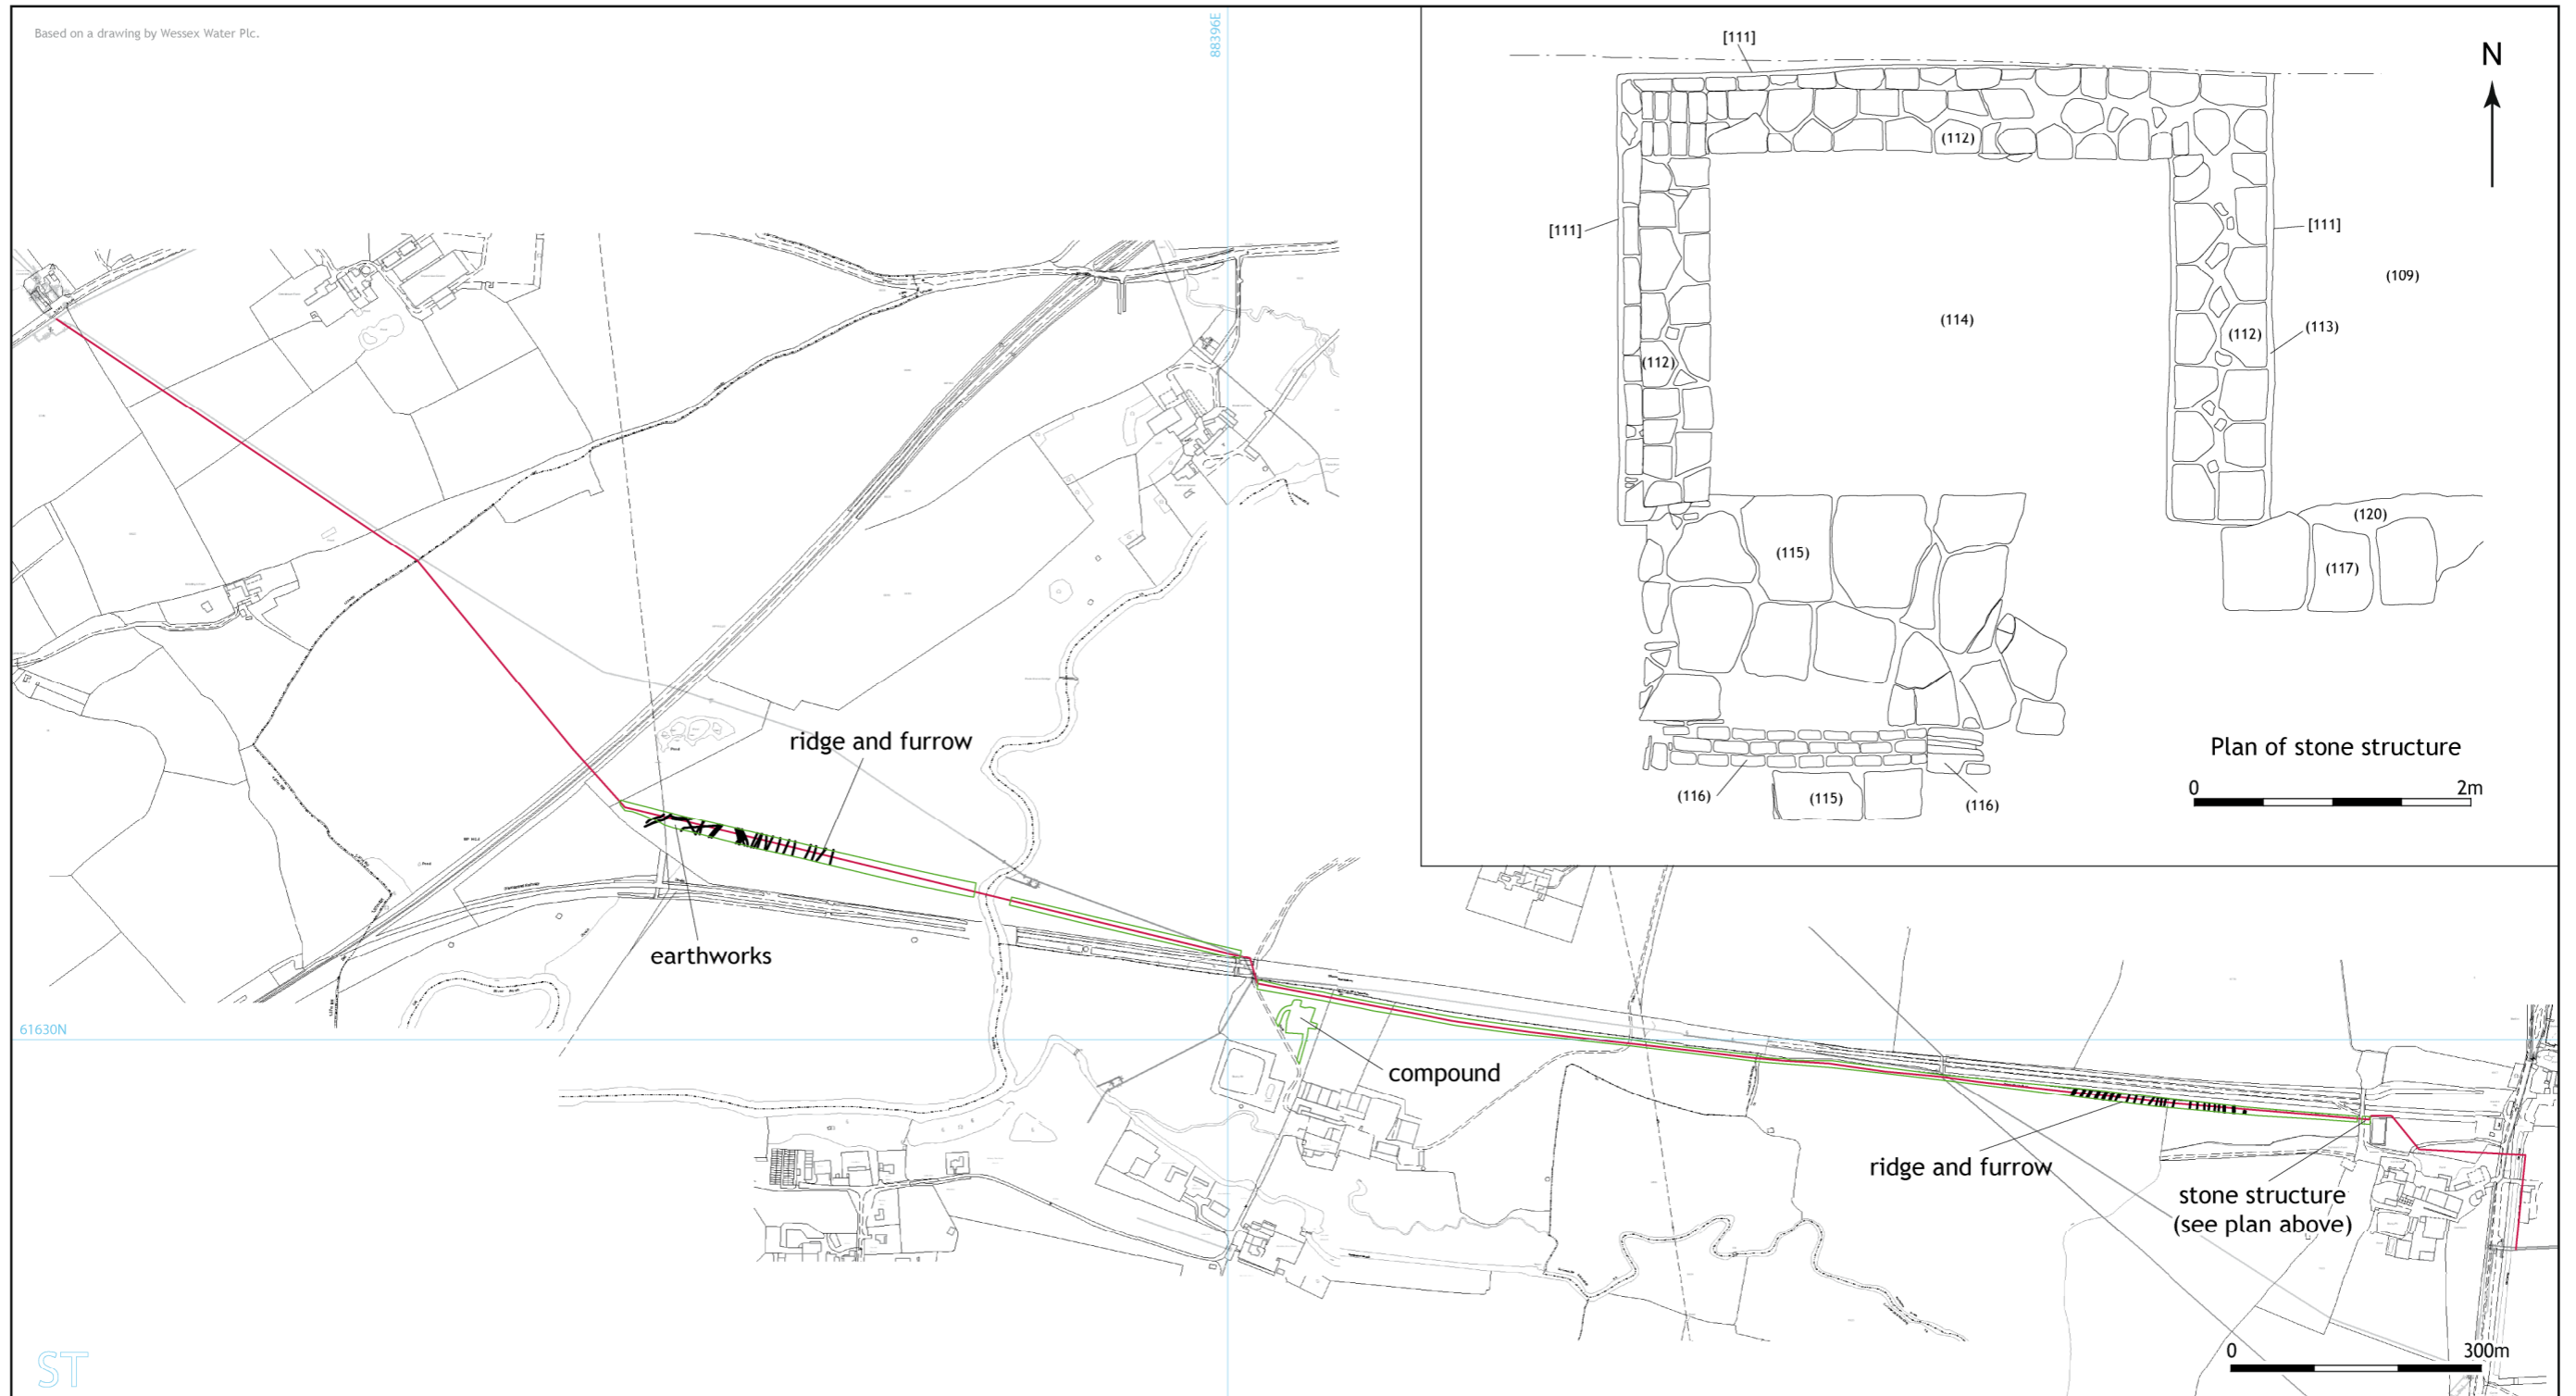
PROJECT TITLE		
Holt to Semington Water Main Replacement, Wiltshire		
FIGURE TITLE		
Detailed site setting		
SCALE	PROJECT CODE	FIGURE NO.
as shown	COAS/WBF/10/HSW	<b>2</b>

- route of easement
- area surveyed
- (000) deposit/layer/structure number
- [000] cut number

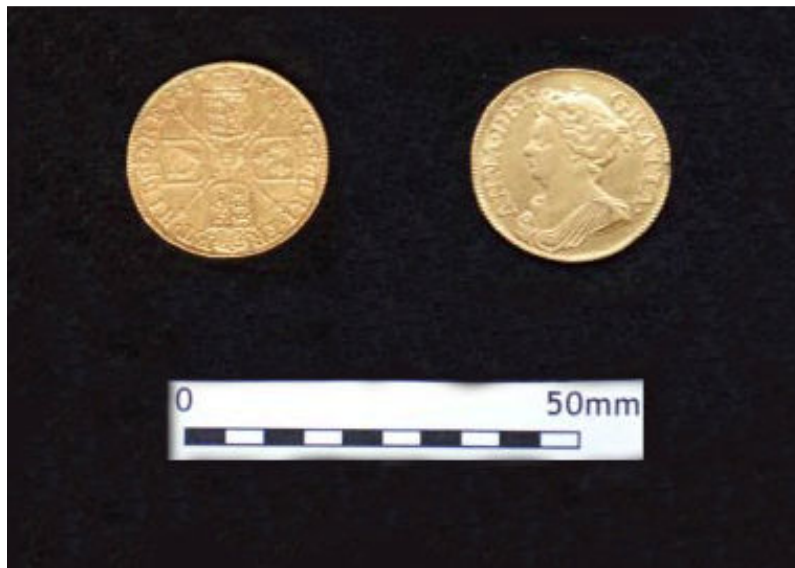
Plate 4. Queen Anne Gold Guinea

- 6.2 From the topsoil (100) in Field 10, a 1714 Queen Anne gold guinea was collected, measuring 25mm in diameter and 8.35g in weight. The coin is in excellent condition other than one slight chip to the rim.

- 6.2 It is very unusual to find a gold coin. The metal detecting survey that followed its discovery did not locate any further coins and it would appear that the coins deposition has resulted from a casual loss and is an isolated find.
