Walled Garden, Rushmore Estate, Tollard Royal, Wiltshire

An archaeological desk-based assessment and photographic Survey

COAS reference: C1/SBR/10/RTW

January 2011

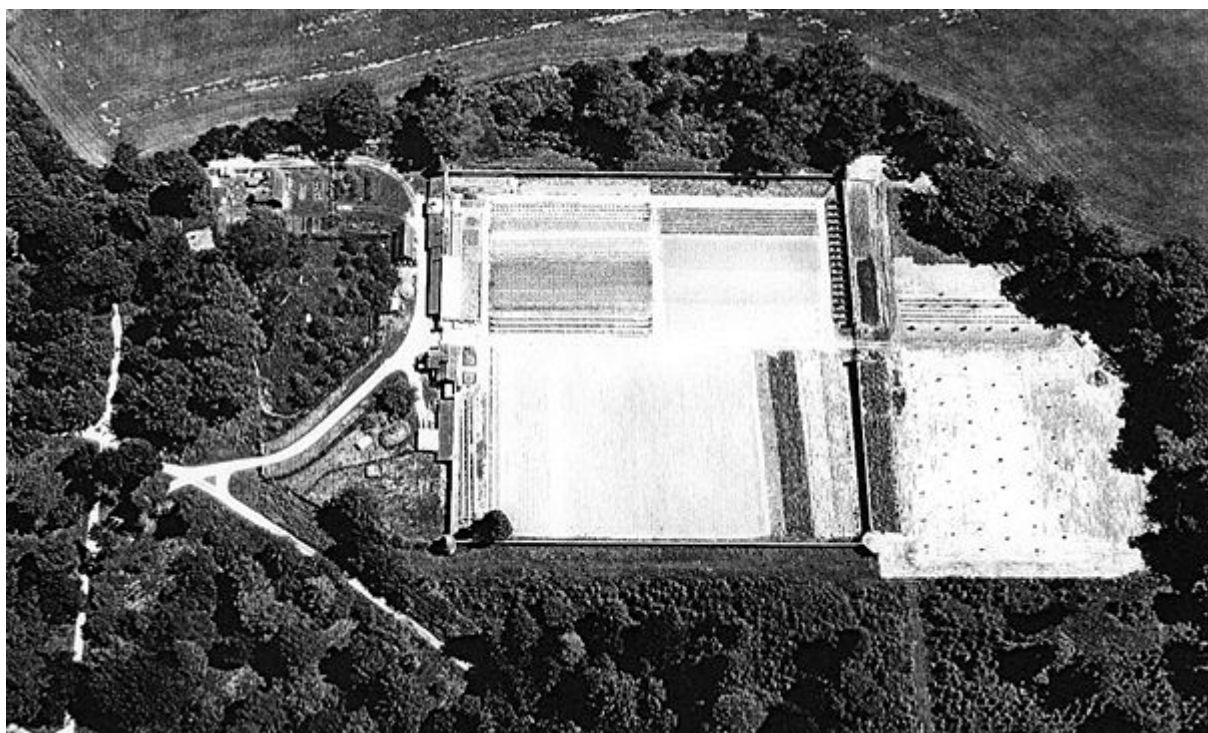
- 3.12 The general layout of the garden prevailed until the early 1970s at least. Photographs from 1973 are taken at low altitude and consequently show the garden in some detail and at a time when it was probably at a post-Victorian high in terms of its organisation (ST 9617/5: 308) (**Plate 1**). The entire garden appears to have been under cultivation with ‘rows’ of crops evident on the eastern half that are orientated north to south. The western half largely appears to be ‘ploughed’ although a number of crops are shown in the south-west corner running from west to east. An orchard outside the southern gate was, at this time, a new plantation.

Plate 1. Aerial photograph from 1973 from the west (ST 9617/5: 308) © National Monuments Records Centre

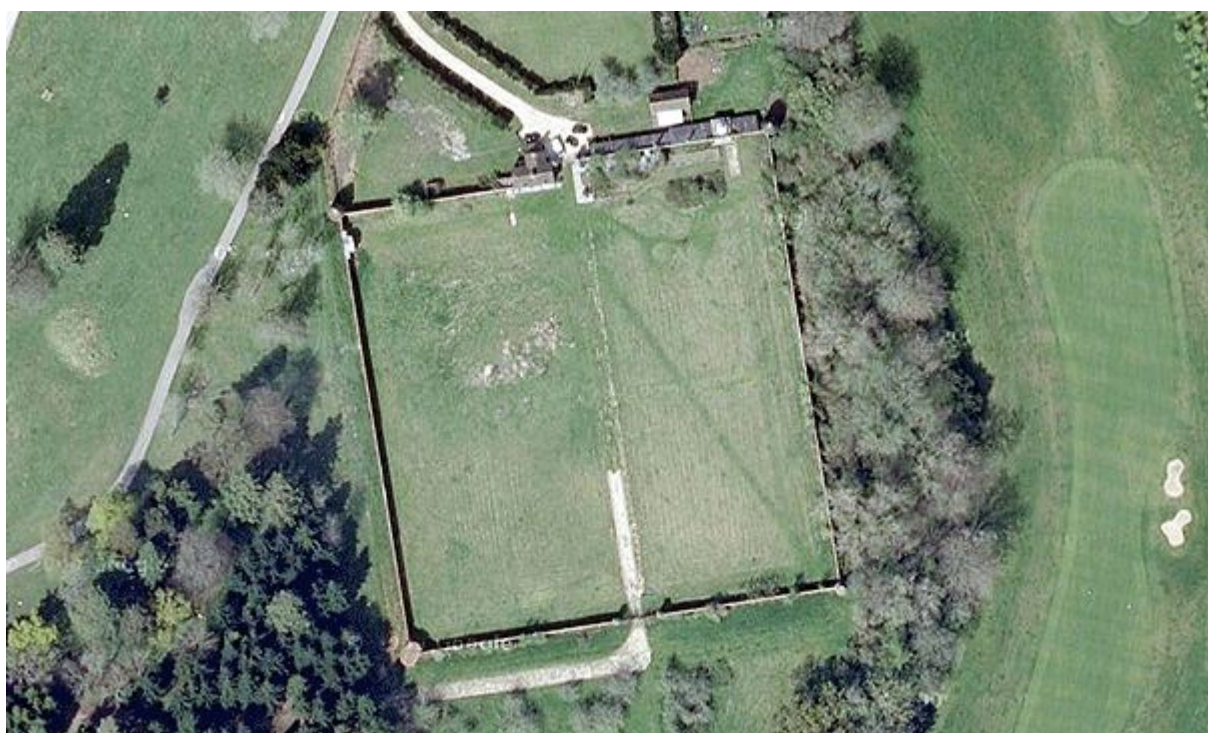
- 3.13 Commercially available aerial photographs from around 2000 show a very different picture (**Plate 2**). The garden was then laid to grass although it is still possible to detect regular striations through the vegetation that once represented cultivation rows. The remains of the dividing path between the two quarters on the western side and the perimeter path are recognisable. A gravel path is clearly defined running alongside the orchard towards the southern entrance gate and continues into the garden heading north towards the northern gate for approximately 35m before becoming just a grassy line. A dark line in the grass running diagonally from the south-east corner of the garden towards the northern entrance suggests the presence of buried services or a former path. A similar dark line in the grass extends from the central path near the northern gate for a short distance in a south-easterly direction before forming a sub-circular patch. An oval-shaped area measuring approximately 15m x 7m comprising small trees/shrubs appears near the north-east corner may represent an in-filled pond. A number of trees/shrubs obscure a view of the glasshouse near the northern entrance and rough vegetation in the northern half of the garden on the western side may represent a dumping area.

Plate 2. Aerial photograph from c. 2000 © Google Maps

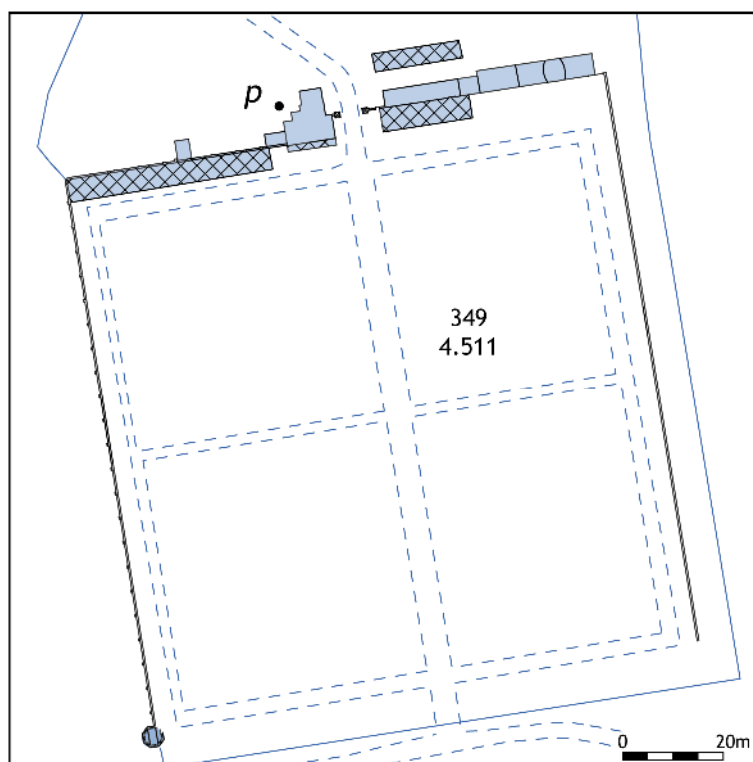
development (**Figure 4**). By this date, the range of buildings adjoining the north wall, the lodge and the observation turret in the south-west corner had been built although the remaining towers and southern wall and gate are absent. This mostly corresponds to the numerous date stones around the Site. The date given for the lodge and north wall is 1883 whilst the western and eastern wall is ascribed to 1884. The tower in the south-east corner, dated 1885 and the southern wall, dated 1886, do not appear on the 1887 map. However, the map date often reflects the release date and not the survey date which is often 1 to 3 years earlier and probably the reason why these elements are not represented. Three glasshouses are also represented; two adjoining the northern wall and one outside of the garden to the north. The garden itself is laid out in equal quarters with paths crossing from west to east and north to south, all connecting to a perimeter path.

Figure 4. Transcription of 1887 25" OS map

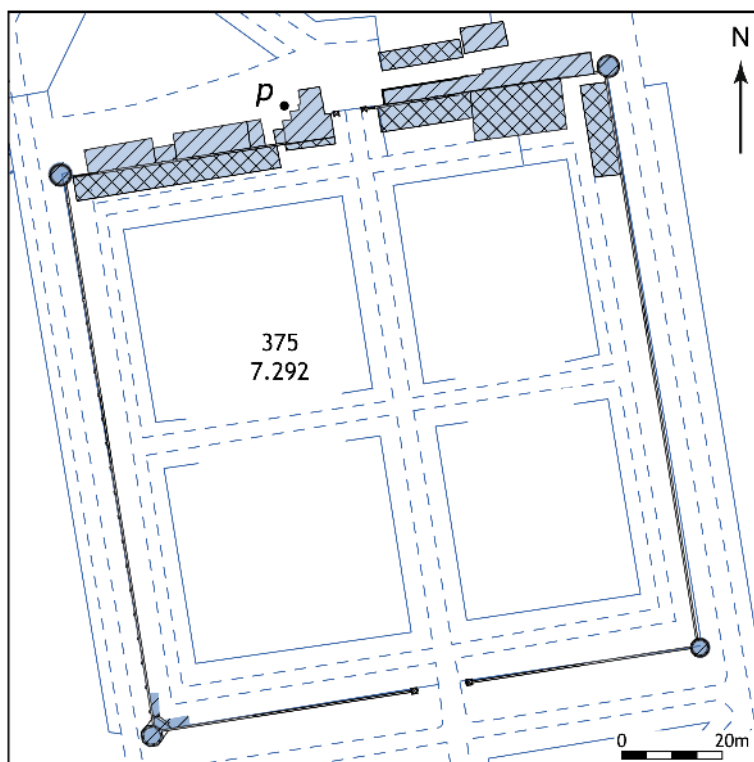
- 3.16 By 1901, and the production of the second edition OS map, much of the Site had been laid out including the remaining three towers and the southern wall. The date stone for the north-western tower is given as 1895. The same date is ascribed to the gate piers on the southern wall which would place their construction some years after the wall itself. Additional glasshouses are shown in the north-east corner of the Site along with a range of 'ancillary' buildings ranged along the northern wall to the west of the lodge and outside of the garden. A separate stable block is shown in the yard outside the northern wall. An 'L'-shaped 'fixture' against the observation turret walls in the south-west corner may represent opposing flights of steps leading up to the observation deck. The garden divisions appear to have become more formalised with perimeter lines that probably represent hedge boundaries. The 'summerhouse' near the north-west corner is notably absent despite being inscribed with a date of 1897. Water pumps marked with the letter 'P' are located on the north-western side of the lodge and adjacent to the north-eastern turret.

Figure 5. Transcription of 1901 25" OS map

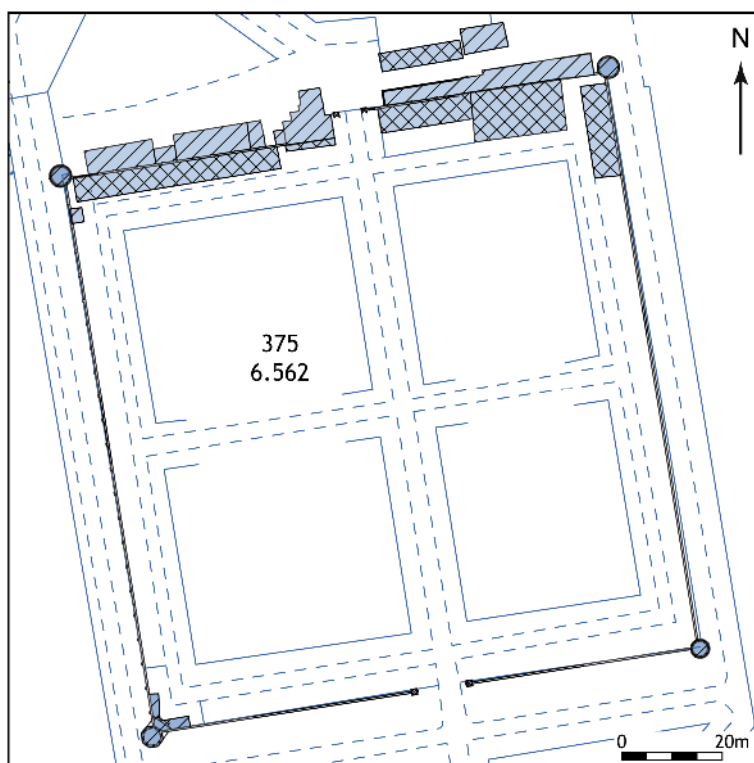
- 3.17 The 1925 map edition shows no significant change to the Site layout although the summerhouse near the north-western corner is now shown.

Figure 6. Transcription of 1925 25" OS map

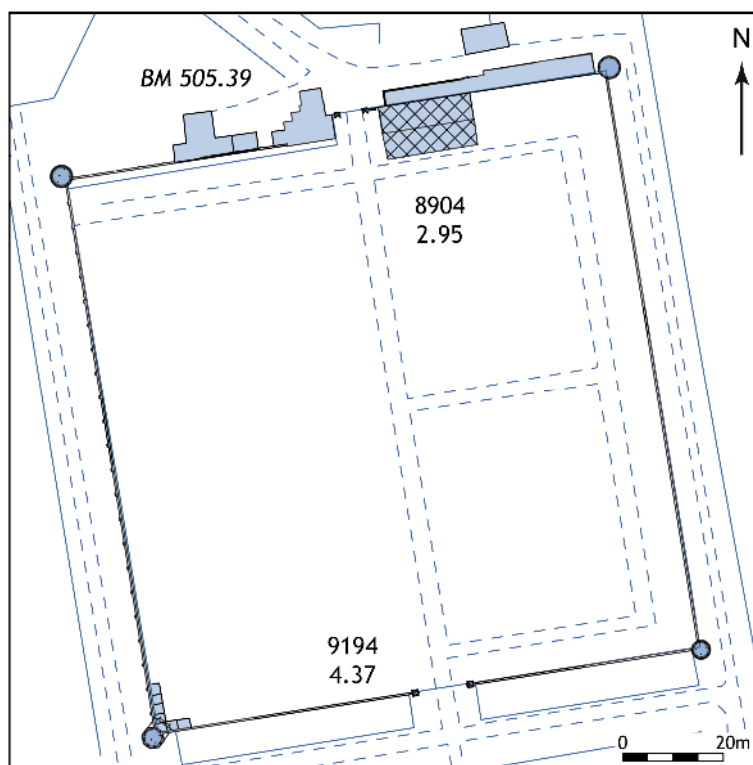
- 3.18 Atypically, there is no map for the 1930s and it is not until the 1955 edition that the Site is represented again. Despite the continuing presence of the main structural elements and features, the intervening years had clearly been a time of change. For example, most of the glasshouses are

no longer shown save for a brief appearance of a 'double' glasshouse near the lodge and the garden appears to have lost the formal appearance that was once exhibited on earlier maps. None of the 'hedge' boundaries are now evident around the divisions and the western 'quarters' have been amalgamated to form a single area. The range of ancillary buildings/outhouses behind the northern wall and to the west of the lodge had clearly contracted to form a smaller run of buildings although there is new adjoining building set perpendicular to them. With the exception of some formal 'borders' behind the southern wall, there appears to be no further change to the Site. Curiously, the summerhouse near the north-west corner is not shown despite its survival to this day.

Figure 7. Transcription of 1955 25" OS map

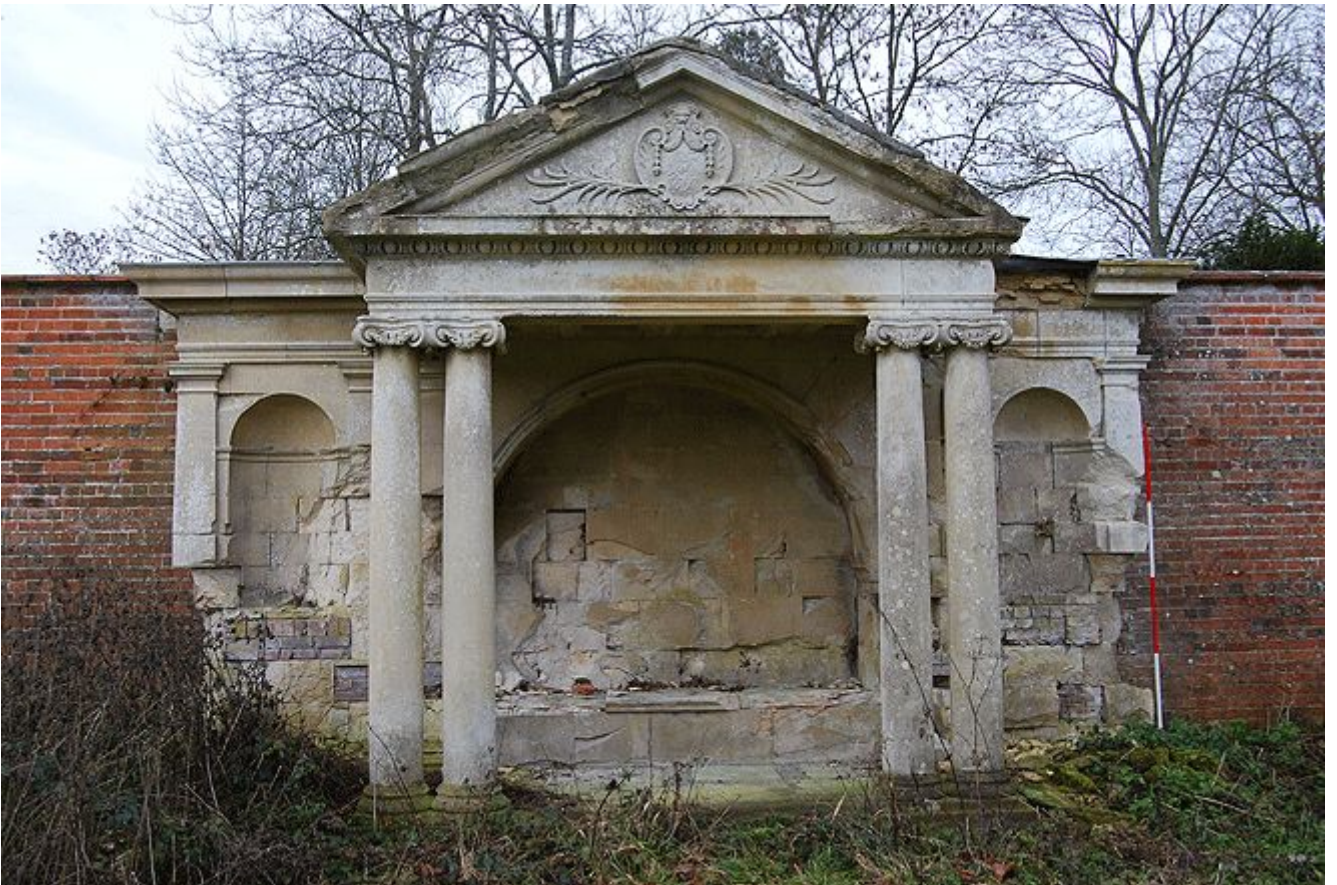
Glasshouse	Only one glasshouse survives and this is located immediately east of the lodge and against the northern wall. The structure comprises a mono-pitch roof supported on a wooden frame over a dwarf brick wall. Most of the glass is absent and the rafters are in a weak condition. The internal space is divided into two bays. Heating pipes run along the southern wall of the glasshouse and the winding mechanism for the roof windows is still in place. Several vines still grow into the building at the western end.	4, 6, 16-17, 19
Summerhouses	Two summerhouses. The summerhouse towards the north-east corner incorporates Ionic columns to portico and flanking niches. A frieze above is inscribed 'APR' and '1897'. The masonry is in poor condition. The temple summerhouse comprises an Ionic stone colonnade of four columns in antis with entablature with strapwork frieze. The interior is constructed of stone with niches, colonnade and coffered dome. Externally, the dome is situated behind the garden wall and is lead covered with a cupola.	8, 10, 14, 22, 35

Plate 8. The summerhouse in 2011

- 6.5 With the exception of the lodge which is currently occupied, the Site is in a dilapidated condition. The garden is laid to rough grass, the superstructure of the observation turret has long since gone and unsafe, the summerhouse masonry on the western wall is suffering badly from years of water ingress, the one remaining glasshouse has lost most of its glass and the rafters are weak, the roofs of the towers and stable block have not been replaced in some years, and the orchard is now largely wild. Despite the survival of some vines and fruit trees variously espaliered against the walls, none of these are managed and much of the shrubbery is overgrown.

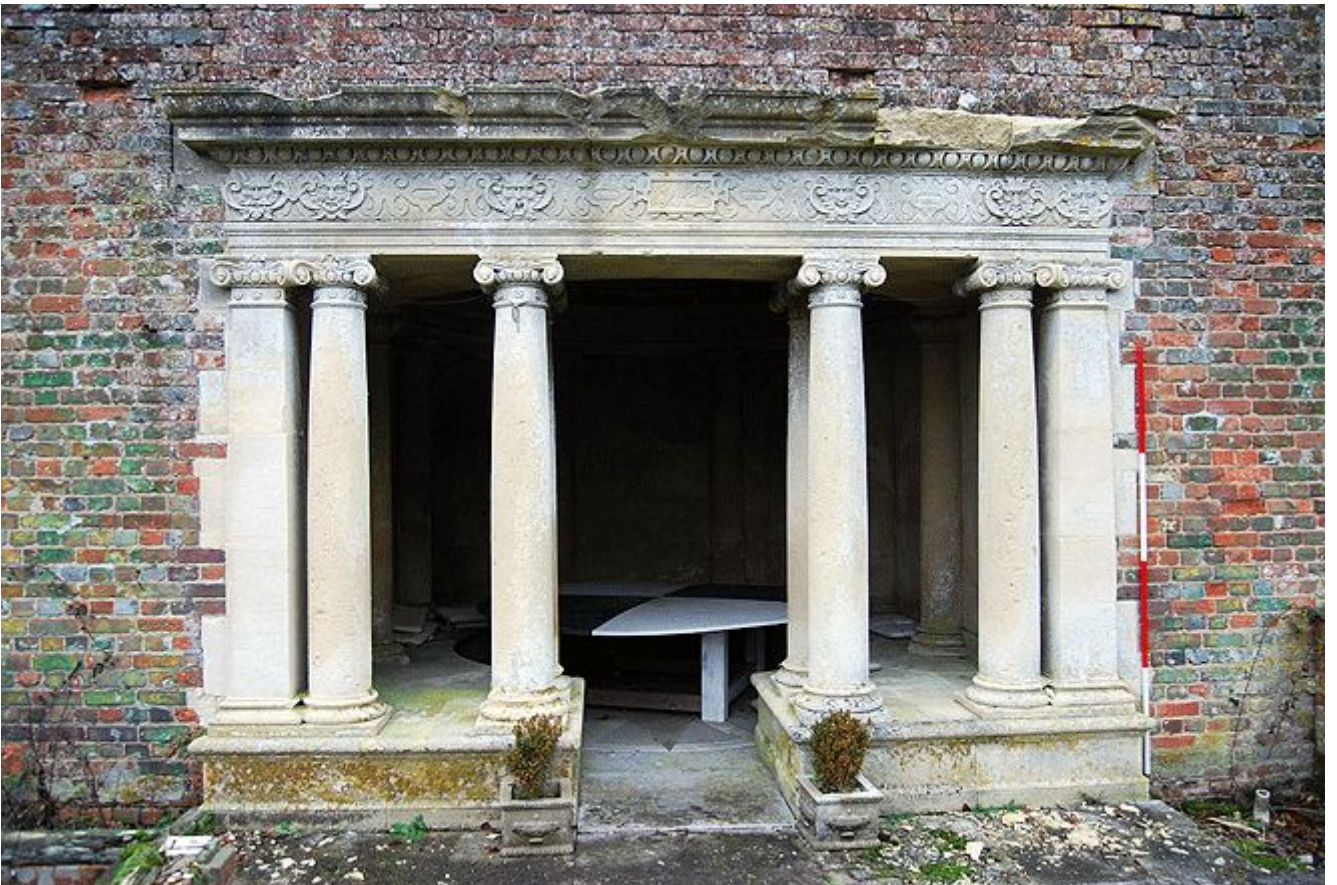
Plate 10. The 'temple' summerhouse in 2011

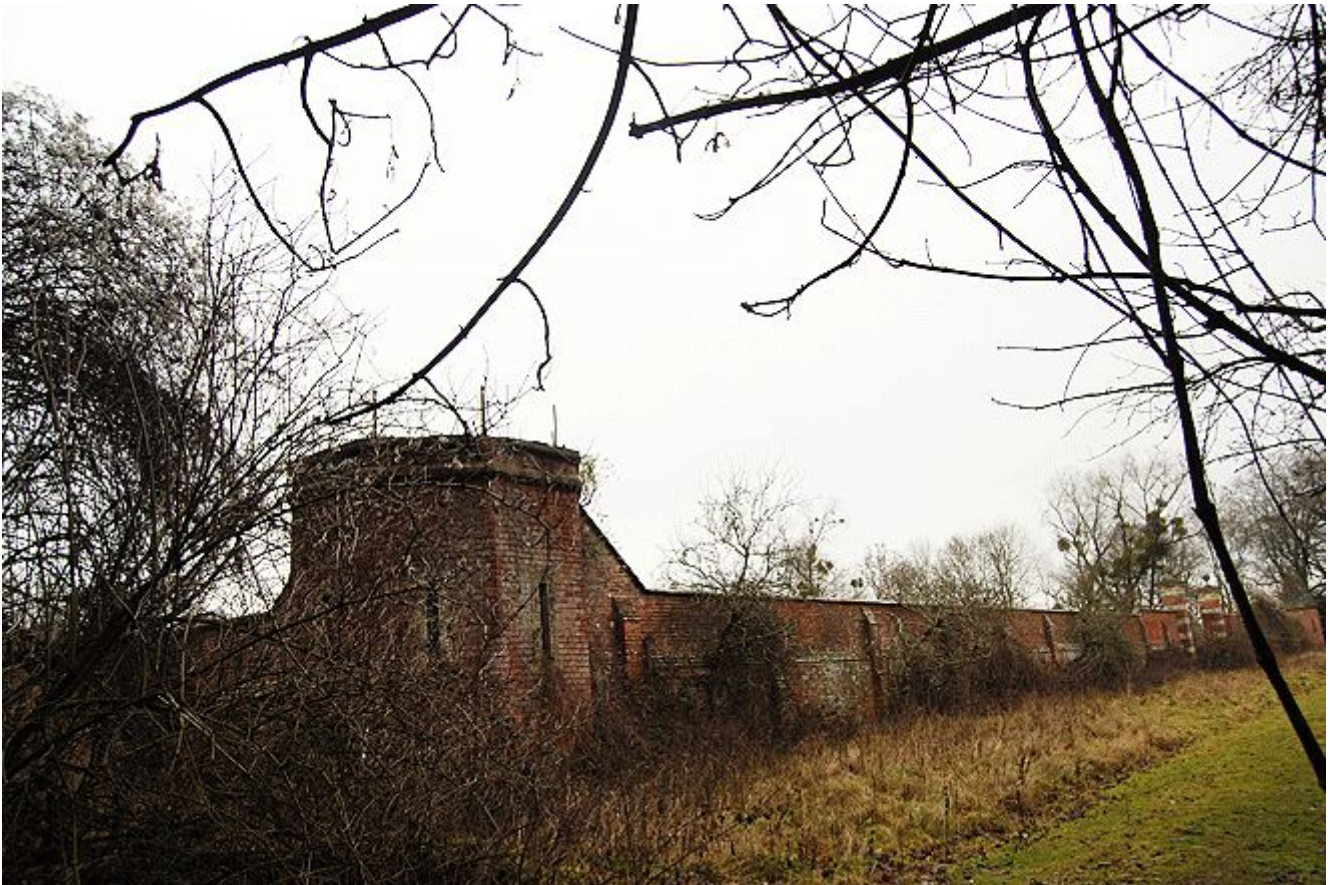
comprising two iron gates supported on large brick piers with masonry bands, decorative stone dressing and topped with ball finials. The piers on the southern gateway have a date stone '1895' and the initials 'A.P.R'.	
Towers	All four towers are still extant although the superstructure of the observation turret in the south-west corner is missing along with both flights of steps. The observation deck is laid with terracotta tiles over a concrete floor which overhangs on the garden side. All the towers are brick built cylindrical structures in header bond with stone dressings. The towers incorporate ventilation slits on the external faces, conical tiled roofs and a single door opening facing the garden. The north-west tower has a date stone inscribed '1895' and internal wooden racking. The north-east tower has a shingle roof and a gothic window looking out over the garden. A date stone showing '1895' is set above the window. The internal space of this tower has been re-modelled in recent years to accommodate a small gymnasium on the ground floor and office space on a modern first floor. The south-east tower has a date stone above the door inscribed '1895'.	12, 20, 22, 29-34

Plate 12. The observation turret in 2011

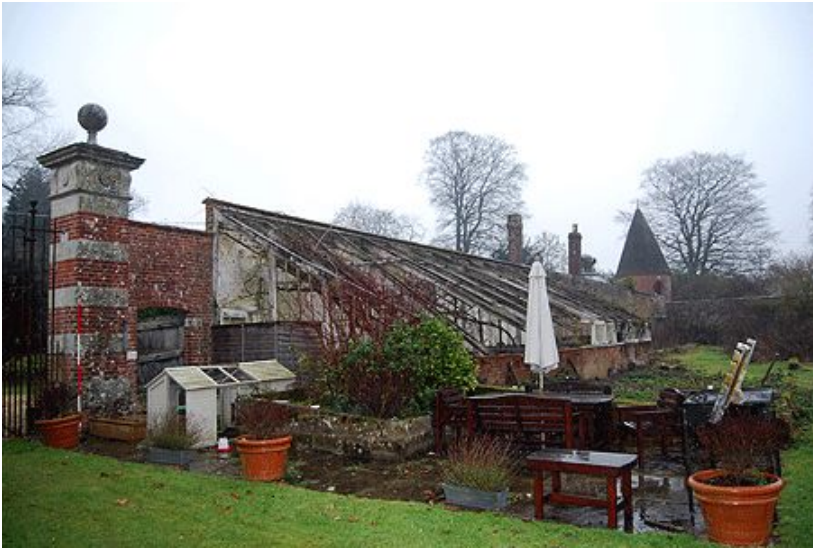
Plate 17. Glasshouse and northern gate pier from the south-west

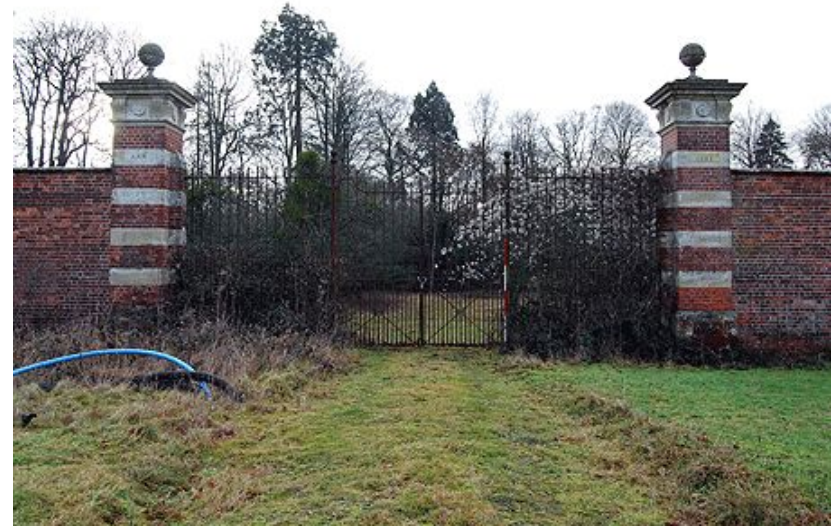
Plate 18. Southern entrance and gate piers from the north

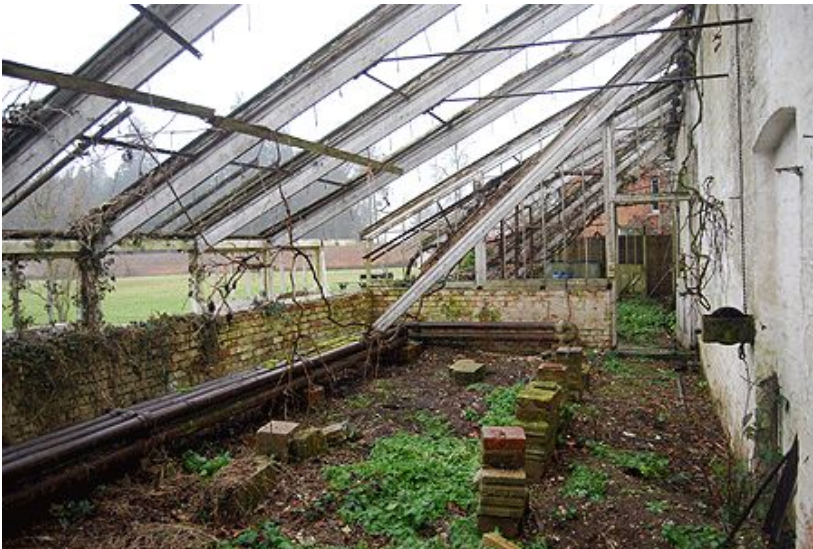
Plate 19. Interior of glasshouse from the east

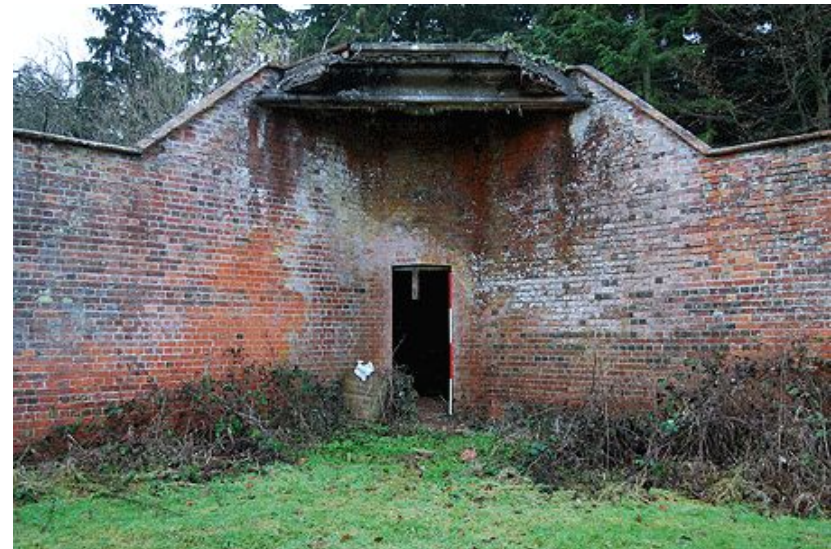
Plate 20. Observation turret from the north-east

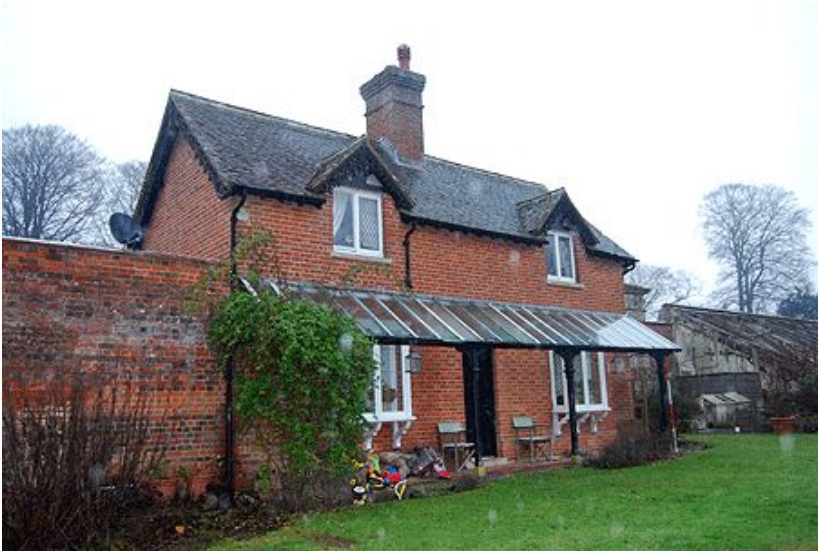
The lodge	The lodge is situated on the north side immediately west of the northern gates and incorporates one storey and attic. Externally, the building has a verandah with iron posts and glass canopy facing the garden. Two half-dormers with ornate pierced bargeboards.	4, 6, 16, 21
Stable	Detached brick built former stable block, largely in Flemish bond, beyond the northern garden wall. Three plank doors and three windows on the south front and timber-framed end gables with ornate pierced bargeboards with finials and pendants. The roof has recently been re-covered with permeable membrane underfelt and re-claimed clay plain tiles.	24, 36
Yard buildings	A series of former stables and outbuildings facing into the yard against the northern garden wall. Separate, single storey, former stable between the north-east tower and summerhouse. Brick built, largely in Flemish bond, with single-hipped roof, slate covering with two roof windows. Three sets of plank doors and two small windows. Two adjoining outbuildings between summerhouse and gates. Brick built, largely in Flemish bond, with mono-pitch slate roofs. Eastern building with one roof window, single chimney stack, two sets of plank doors and three windows. Westernmost building with single chimney stack, two sets of plank doors and three windows. Timber-framed end gables with ornate pierced bargeboards on both buildings.	14, 22-23,

Plate 21. The lodge from the south-west

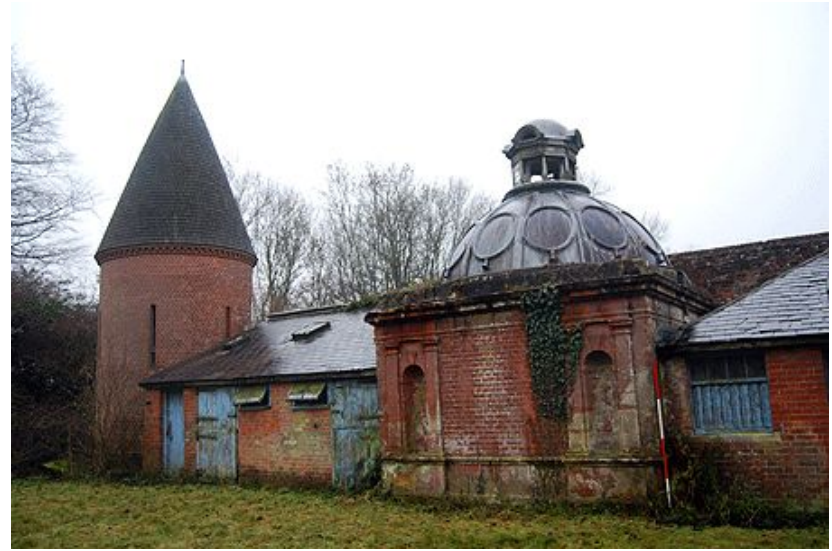
Plate 22. North-east tower, stables and summerhouse from stable yard

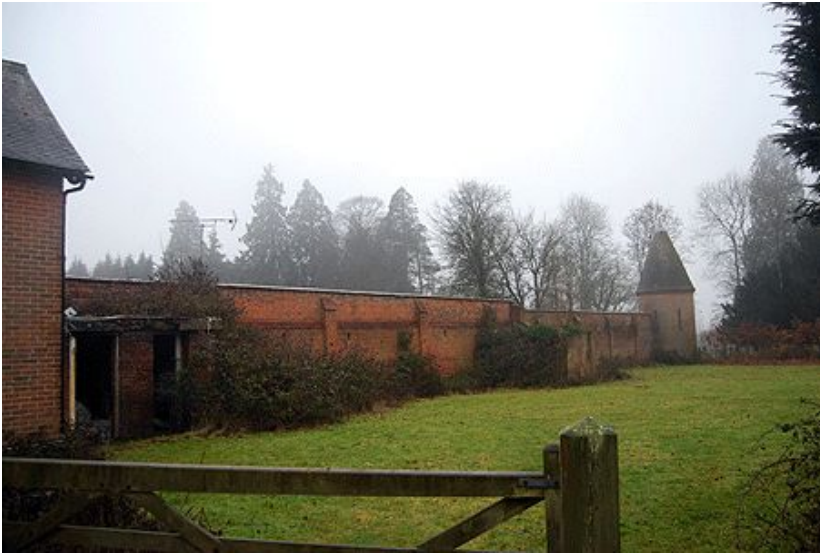
Outbuildings	A small derelict and roofless brick outbuilding is situated against the northern wall outside of the garden mid-way between the north-west tower and the lodge. A brick privy/store with concrete flat roof adjoining the western side of the lodge divided into two equal bays with two door openings.	25
Miscellaneous	The wall remains of two modern concrete brick cold frames survive immediately west and east of the glasshouse. An inspection cover in front of the summerhouse on the northern wall leads to a large underground water reservoir. An old orchard occupying a wedge-shaped area of land is situated outside the southern wall	26, 28

Plate 25. Outbuildings and north-west tower from the north-east

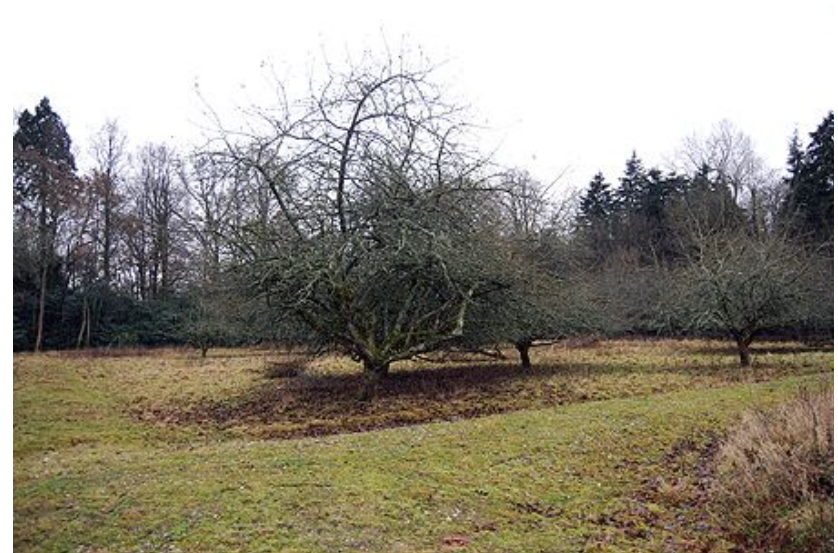
Plate 28. The orchard beyond the southern wall from the north-east

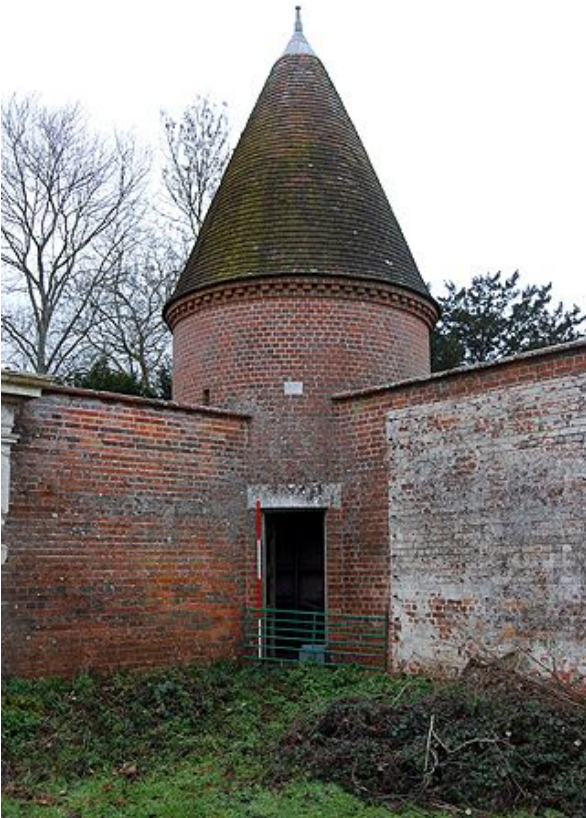
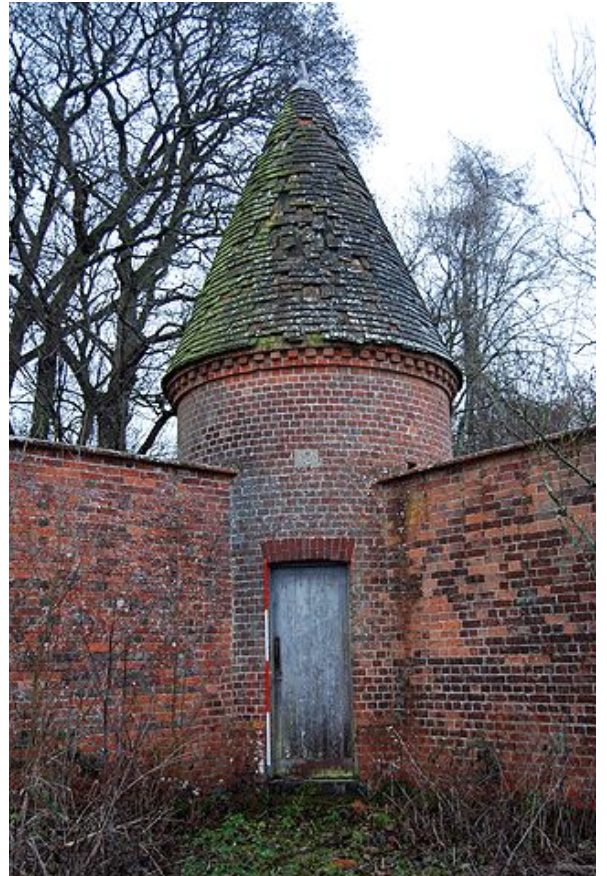
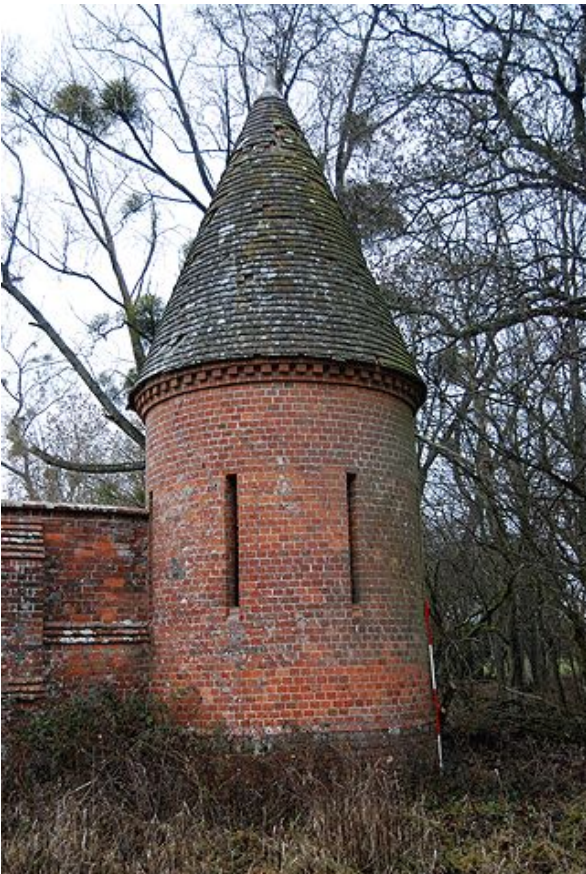
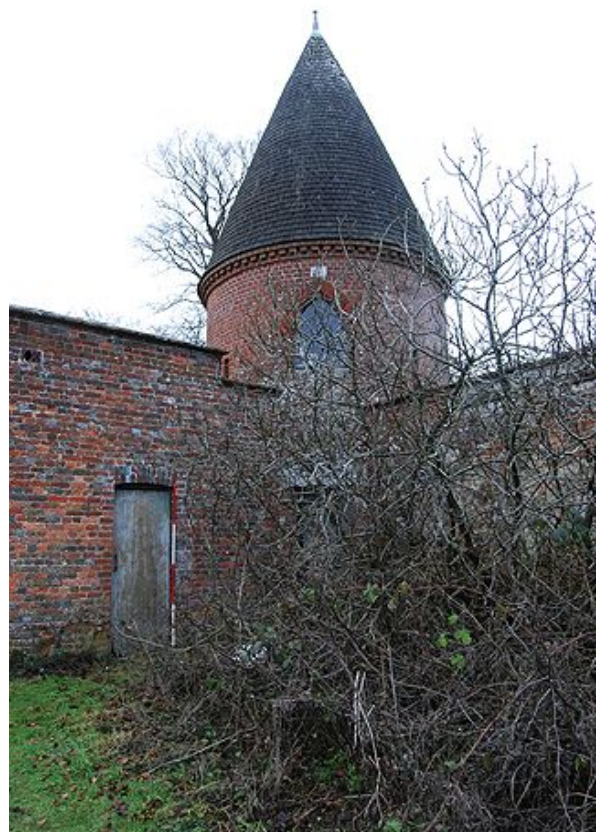
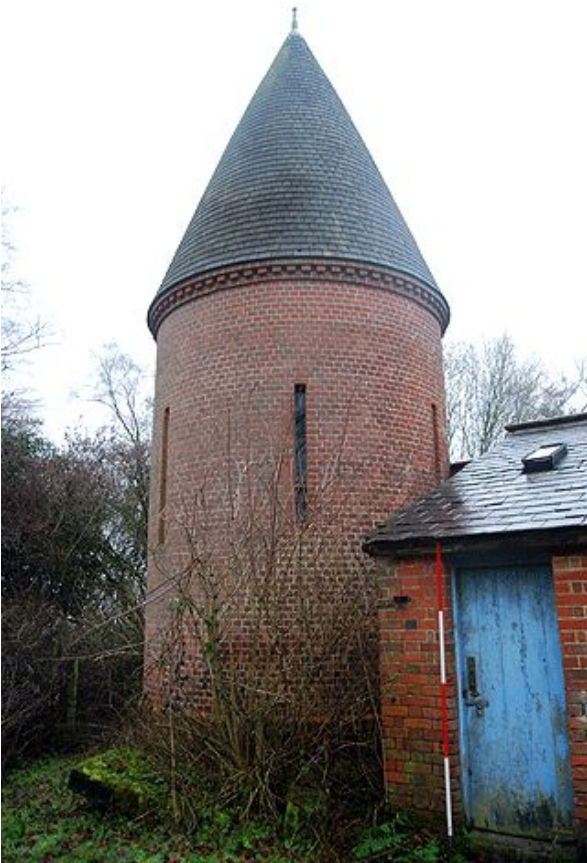
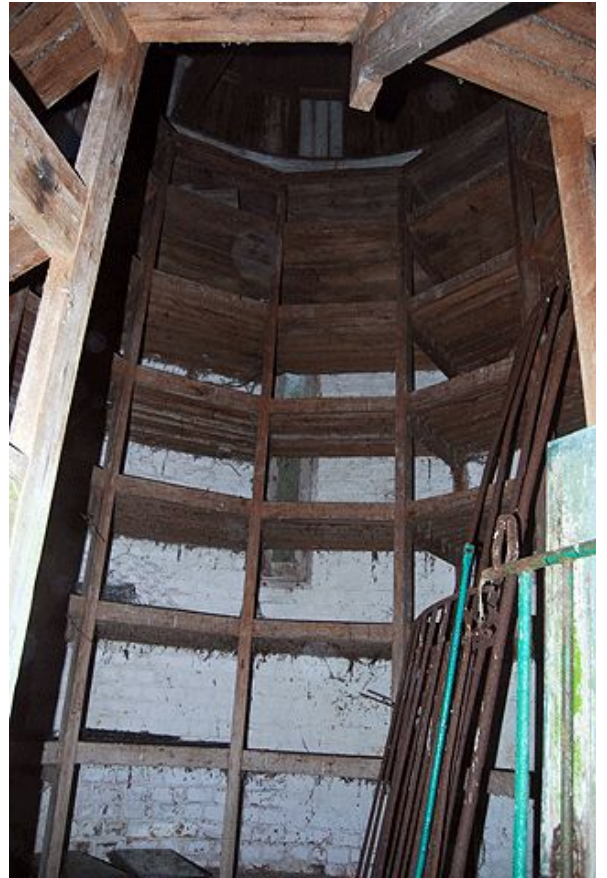
Plate 29. North-west tower from the south-east (garden)

Plate 30. South-east tower from the north-west (garden)

Plate 31. South-east tower from the south-west (orchard)

Plate 32. North-east tower from the south-west (garden)

Plate 33. North-east tower from the north-west (stables)

Plate 34. Racking inside north-east tower

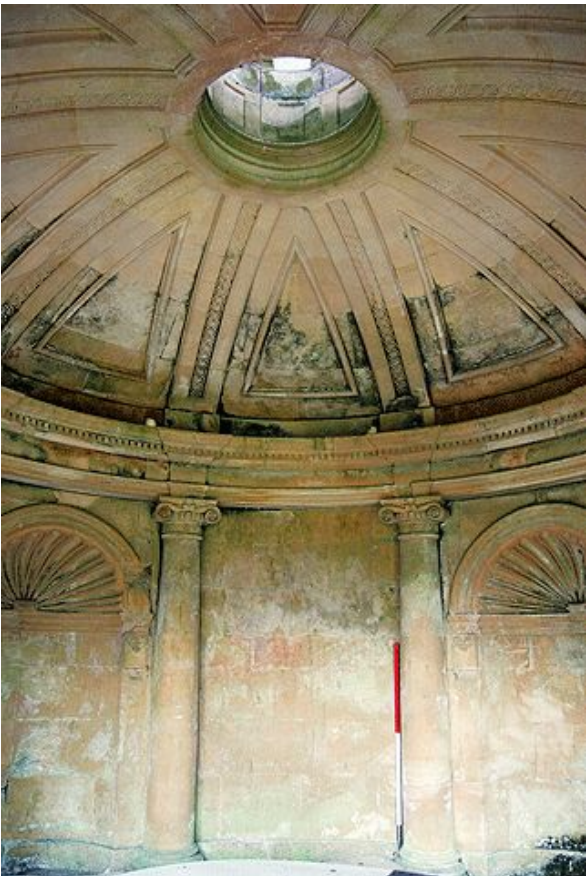
Plate 35. Interior of 'temple' summerhouse
