SLATED LAITHE, OFF PAA LANE,
PAYTHORNE, LANCASHIRE BB7 4JD

HISTORIC BUILDING RECORDING

Report no: 2020/618.R01
Version: Final
Date: July 2020
Author: Shaun Richardson & Ed Dennison

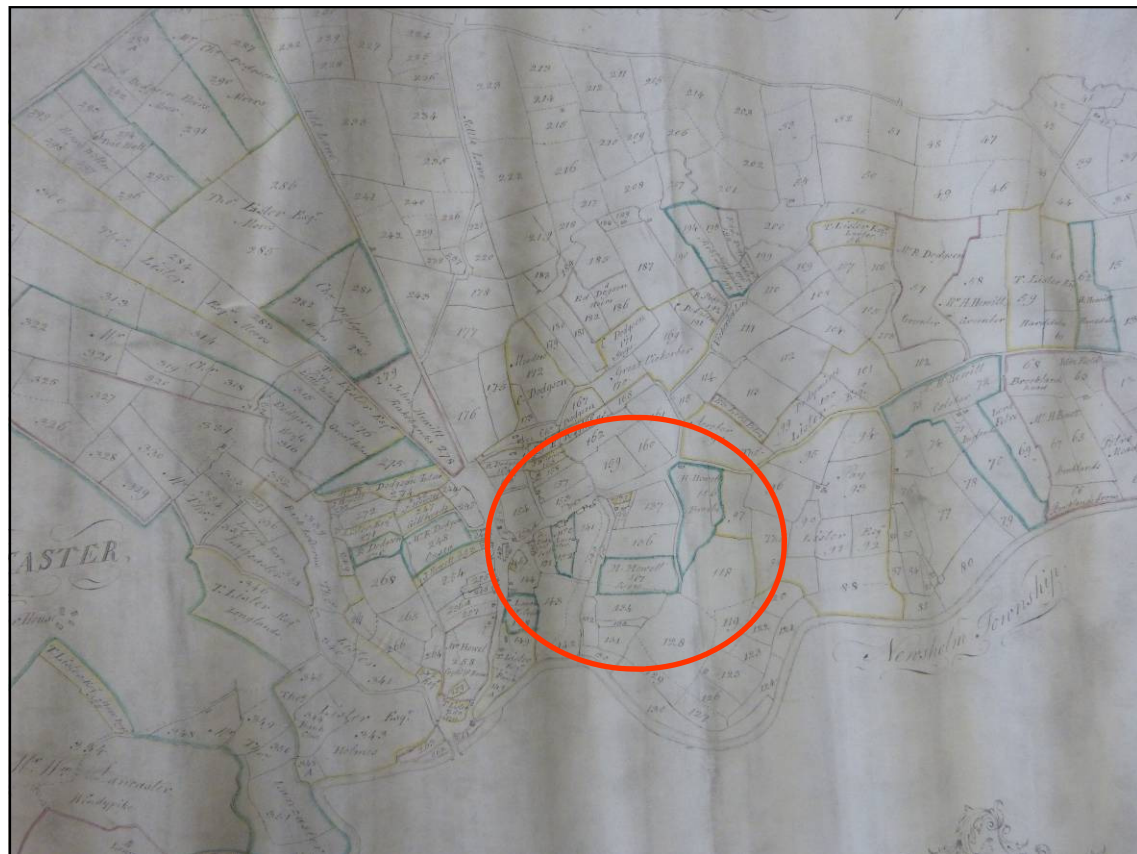
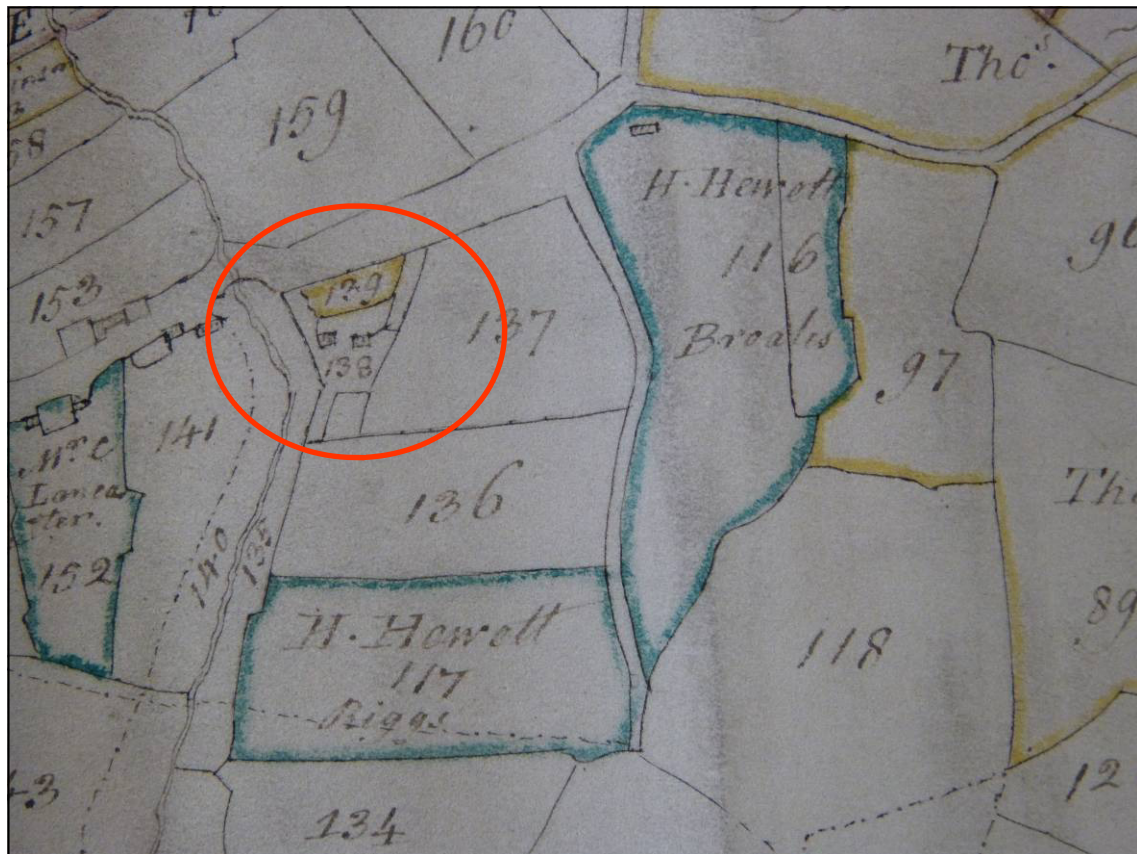
PROJECT		SLATED LAITHE, PAYTHORNE	
TITLE		MAPS OF 1792 AND 1846-7	
SCALE	NTS	DATE	JULY 2020
EDAS		FIGURE	3

Source: 1846-47 Paythorne tithe map and apportionment, map made by Ino Greenwood, Land Surveyor, Gisburn (LA PR 3432/3/4).

- 2.2 The earliest map depiction of the area uncovered during the research undertaken for this report is that provided by a 1792 plan of the township of Paythorne (LA DDHCL/26/13/3) (see figures 3A-3B). A small enclosure, numbered '139', borders Paa Lane. The enclosure is bordered in yellow, and most (although not all) of the other land similarly depicted on the map was owned or tenanted by either 'C Dodgson' or 'Tho Lister Esq'. There is a narrow strip running along the eastern side of the enclosure that might denote a trackway, whilst to the south there is a

- 2.4 The barn is first definitely shown on the 1846-47 Paythorne tithe map (LA PR 3432/3/4) (see figures 3C-3D). There had apparently been a significant number of changes to the area surrounding the building since 1792. The enclosure adjacent to Paa Lane remains and is numbered '468'; it had a small pond adjacent to the external south-west corner. However, the yard or walled area and all other subdivisions shown to the south in 1792 had gone, so that the isolated barn now stood within a larger field, aligned almost east-west and numbered '467'. The barn itself was numbered '469' and labelled as 'Barn'. It is depicted as a rectangular structure, with a small, narrower projection from the west end and a small yard at the east end.

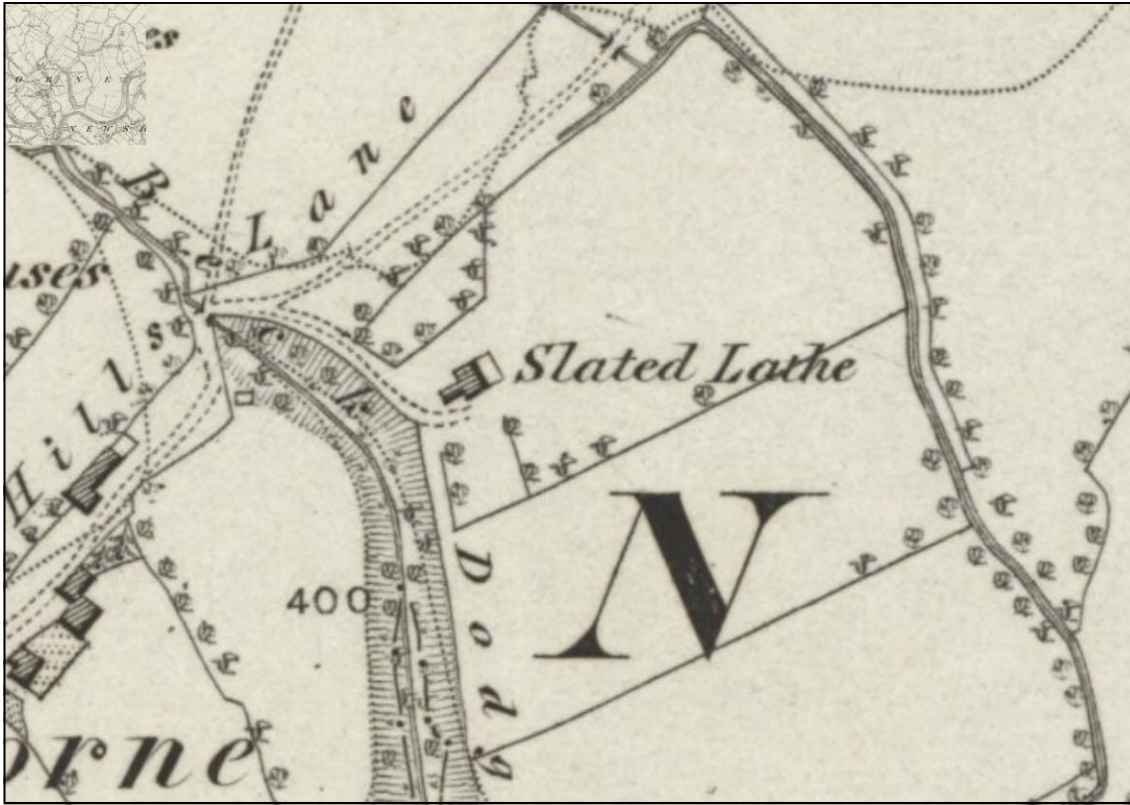
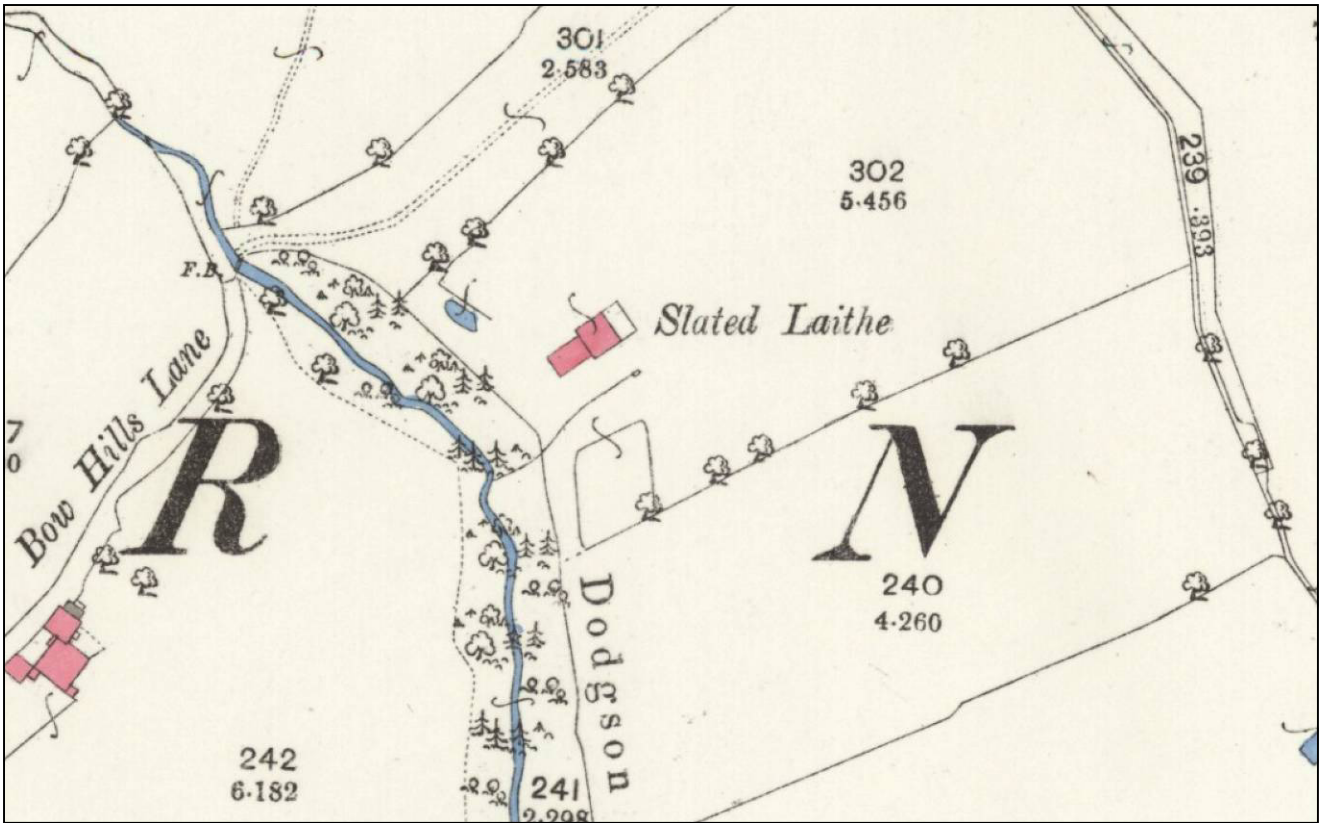
PROJECT		SLATED LAITHE, PAYTHORNE	
TITLE			
		MAPS OF 1853 AND 1894	
SCALE	NTS	DATE	JULY 2020
EDAS		FIGURE	4

Top: 1853 Ordnance Survey 6" to 1 mile map
Yorkshire sheet 166 (surveyed 1849-50).

Bottom: 1894 Ordnance Survey 25" to 1 mile map
sheet 166/6 (surveyed 1892).

- 2.6 On the 1853 Ordnance Survey 6" to 1 mile map, a trackway left the southern side of Paa Lane and ran past the adjacent enclosure along the top of the east side of Dodgson Gill, before curving around to finish opposite the south side of the barn (see figure 4 top). The barn is named 'Slated Lathe' and is shown as a broadly T-

shaped structure, the eastern part being wider than the narrower western part. There is a small yard attached to the eastern end of the barn. Despite not being shown in 1846-47, some of the walls existing to the south of the barn in 1792 are shown in 1853; such discrepancies between the tithe maps and the 1st edition Ordnance Survey maps are not uncommon, as the former are more concerned with 'taxable areas' rather than specific detail (Peter Iles, Archaeology Planning Officer, *pers. comm.*). By 1894, the small enclosure adjacent to Paa Lane, present on historic maps since 1792, had disappeared, although the small pond at the south-west corner and a fragment of wall remained. The barn is named 'Slated Laithe', and is a structure consisting of two parts, a wider eastern part and a narrower western part; the small attached yard remained to the east end. A small spring or watercourse arose to the south of the barn and ran south-west into Dodgson Gill, whilst further south the walls shown in 1792 and 1853 remained. The barn is similarly depicted in 1909, although any remaining walls in the field surrounding it had been removed, with only the small pond remaining.

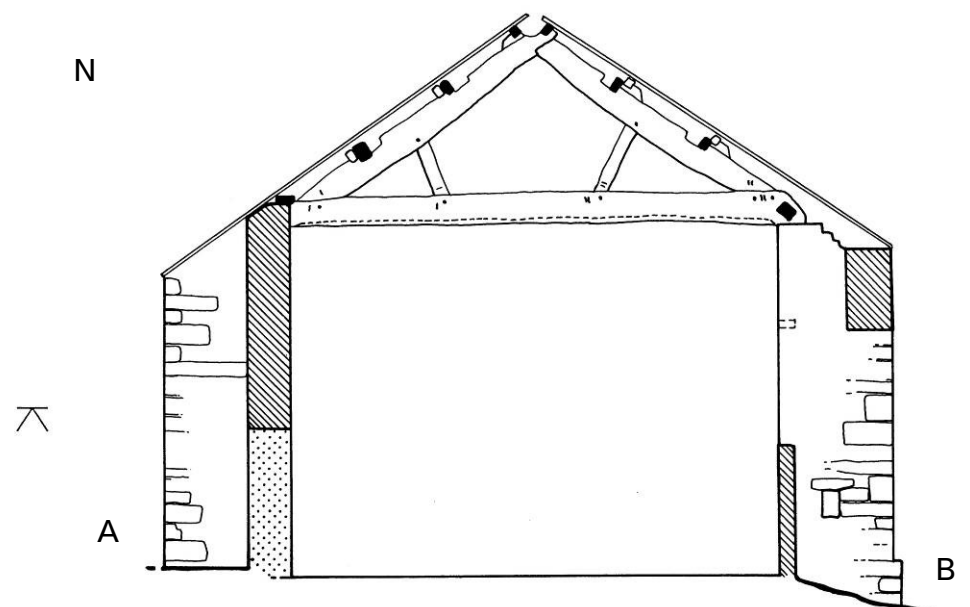
PROJECT		SLATED LAITHE, PAYTHORNE	
TITLE		GROUND PLAN AND SECTION	
SCALE	AS SHOWN	DATE	JULY 2020
EDAS		FIGURE	5

Section

BLOCKING

- 3.5 At ground level, the barn has maximum external dimensions of 14.90m long (east-west) by 8.55m wide (north-south) (see plate 1). It is sub-rectangular in plan, with the eastern two-thirds of the south wall and the eastern half of the north wall breaking forwards from the rest. The external walls have an average width of 0.55m. A stepped plinth is visible to the base of the south elevation [1/203], and also partly to the east gable, although it is then obscured by the rising ground level to the north (see plate 2). At the barn's south-east corner, the stepped plinth rises markedly and is three courses in height [1/200].

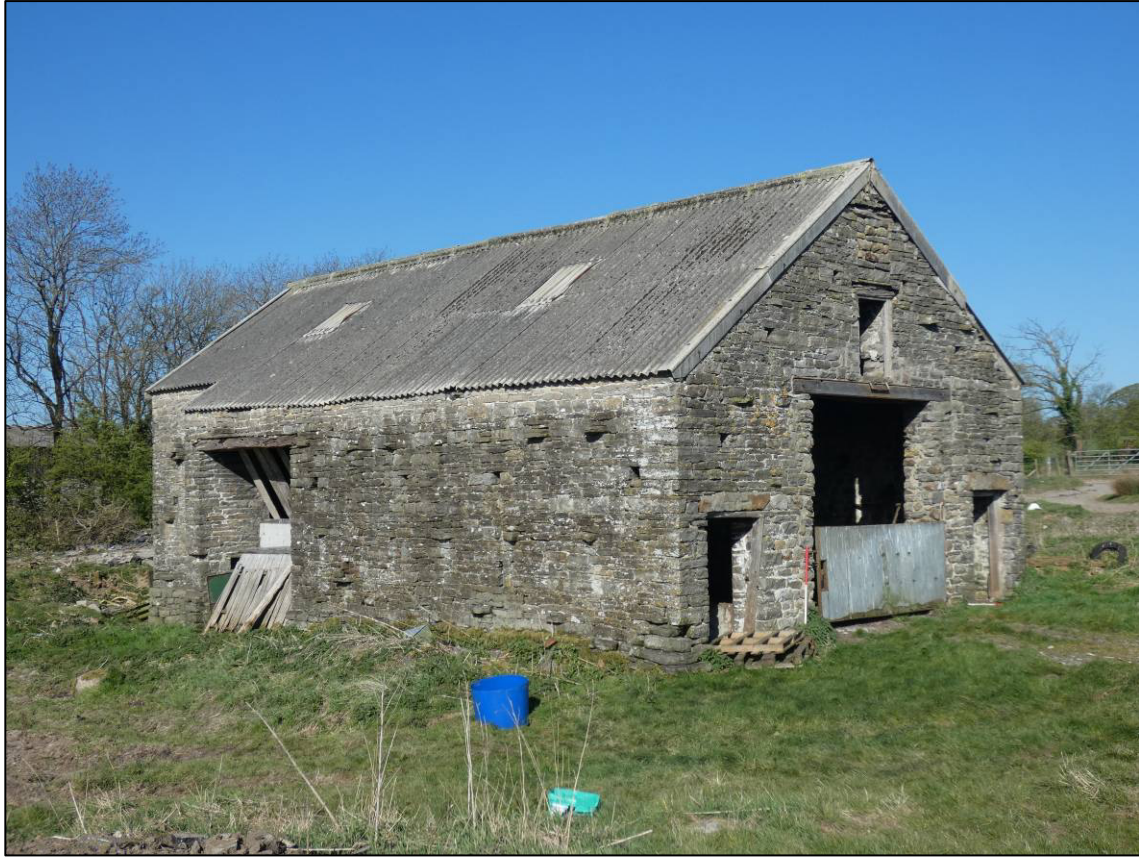
Plate 1: East gable and south elevation, looking NW (photo 1/194).

- 3.6 The barn is of a tall single storey with a pitched roof covered, at the time of the survey, with corrugated metal sheeting [1/194, 1/195]. It is built largely from roughly squared limestone rubble, brought to uneven courses, with some intermittent through stone courses, set with a lime mortar. There is some variety to the size of the rubble used and the depth of the courses in the external elevations; for example, the rubble is generally more thinly coursed to the western part of the barn than to the eastern part. However, there are no major differences in the materials used in the various elevations (apart from perhaps to the lower part of the west gable), and there are similarly no clear butt joints or other structural breaks. Sandstone/gritstone is used mainly for door lintels, and there are also occasional pieces of sandstone incorporated into the limestone rubble. There are quoins to the external corners of the building, and the major openings have quoined jambs; some of the openings make use of sections of re-used timber as lintels.

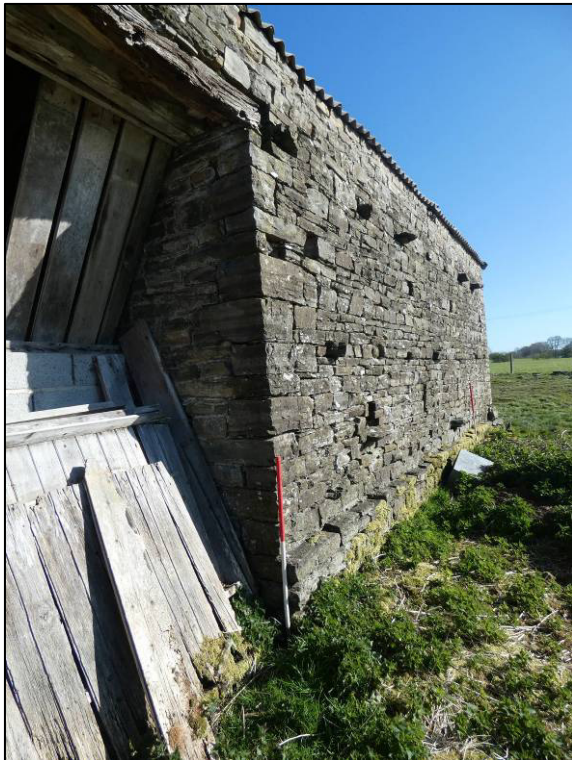
Plate 2: South elevation, east part, detail of plinth, looking E (photo 1/203).

- 3.11 The wider eastern two-thirds of the south elevation break forward from the western part [1/197, 1/211] (see plate 8), but both parts rise from a stepped plinth (see plates 2 and 7); this rises markedly at the barn's south-east corner, where it is three courses high. The walling of the two parts is tied-in well where they meet, with no evidence for butting or any other structural break. The narrower western part has three courses of intermittent through stones and two courses of sub-square ventilators [1/207]. The west end of the eastern part is formed by a flat-headed cart entrance [1/199, 1/201] (see plate 9). The cart entrance is 3.0m wide with quoined jambs, and probably once had a thin flagstone drip course over, although this has mostly now gone. The lintel comprises two pieces of timber re-used from a timber-framed structure [1/202]. The internal side walls of the cart entrance each incorporate a small square recess placed c. 1m above ground level [1/206]. There is a modern breeze-block wall across the inside of the entrance, which has been used as the base for the sloping timber partition which fills the upper part. There was no evidence for any threshold board, although it might have been hidden by the modern blocking. The remainder of the eastern part of the elevation has three courses of intermittent through stones and two rows of ventilators [1/198]. The lower row comprises four slit ventilators, all of which have been blocked; the westernmost example has been partly rebuilt using bricks [1/205]. The upper row comprises four sub-square ventilators.

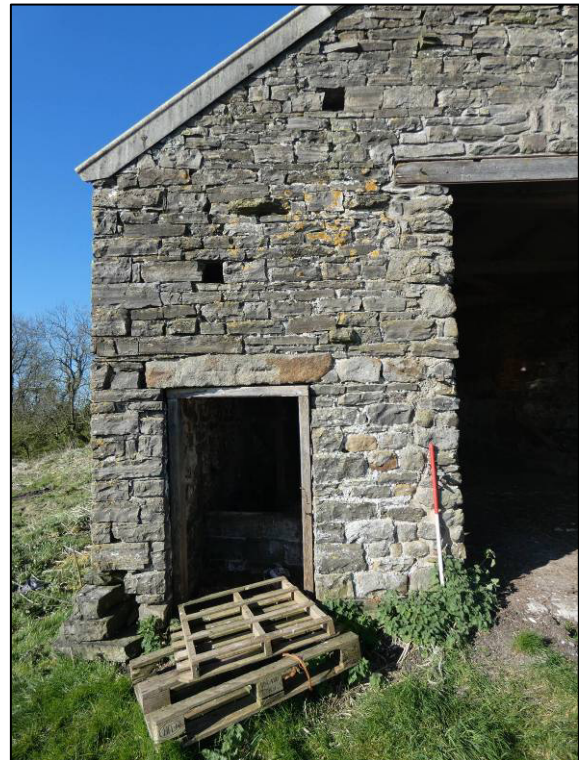
Plate 3: East gable, detail of south end, looking W (photo 1/187).

- 3.8 As noted above, the southern end of the east gable of the barn rises from a stepped plinth. The gable is dominated by a large inserted modern entrance to the centre, with a wooden lintel [1/189, 1/190] (see plate 4). The large modern entrance is flanked by low doorways, each 1.15m wide, with substantial stone lintels. Each doorway was fitted with a simple softwood door frame, with doors hung on cast-iron pintles opening inwards; the north doorway was hung on the south side of the door frame, and the south doorway in the north side of the door frame [1/186, 1/187, 1/191, 1/192] (see plate 3). Above the large modern entrance, there is an opening with a wooden lintel that appears to be earlier, and above this to the apex, a similarly sized opening blocked with stone [1/188]. There are three pairs of sub-square ventilators at different levels, flanking the larger openings; their distribution might suggest that they were once timber sockets for a roofed structure abutting the barn's east gable, but this is almost certainly a result of the pattern left after the insertion of the later openings. There are also a very few through stones.

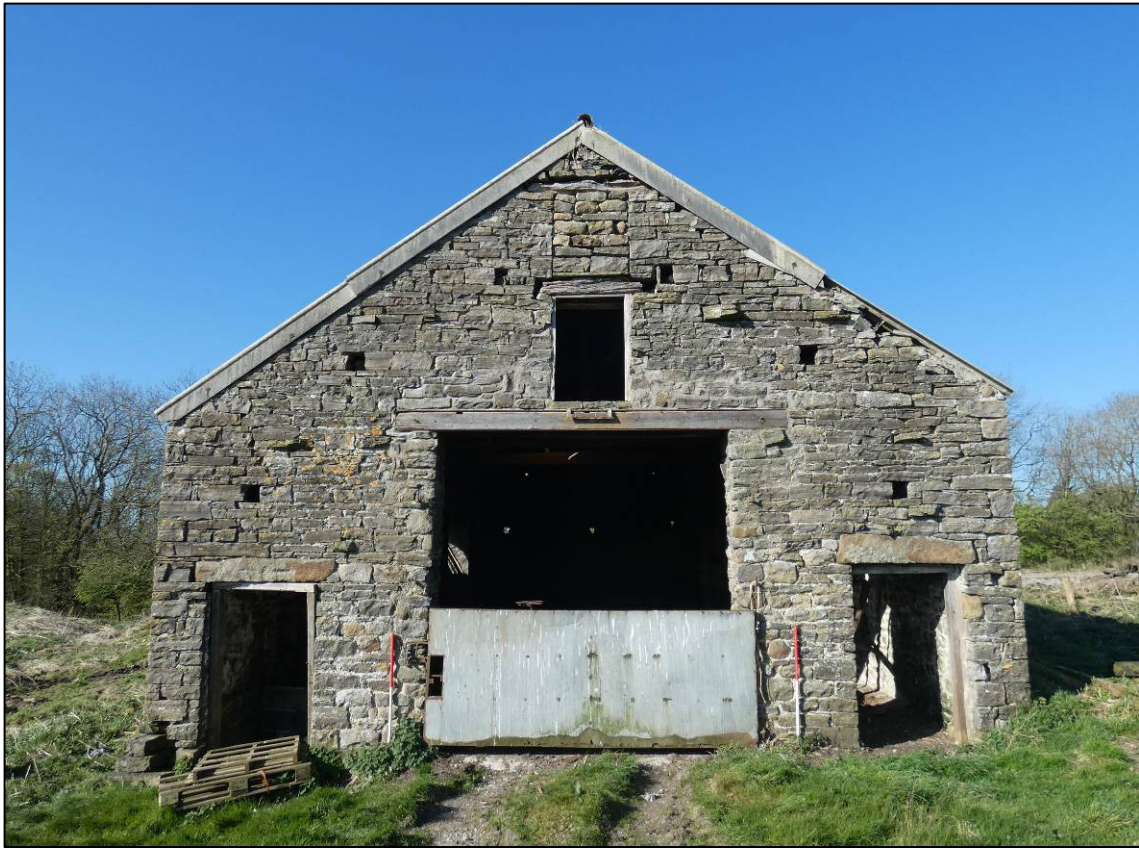
Plate 4: East gable, looking W (photo 1/190).

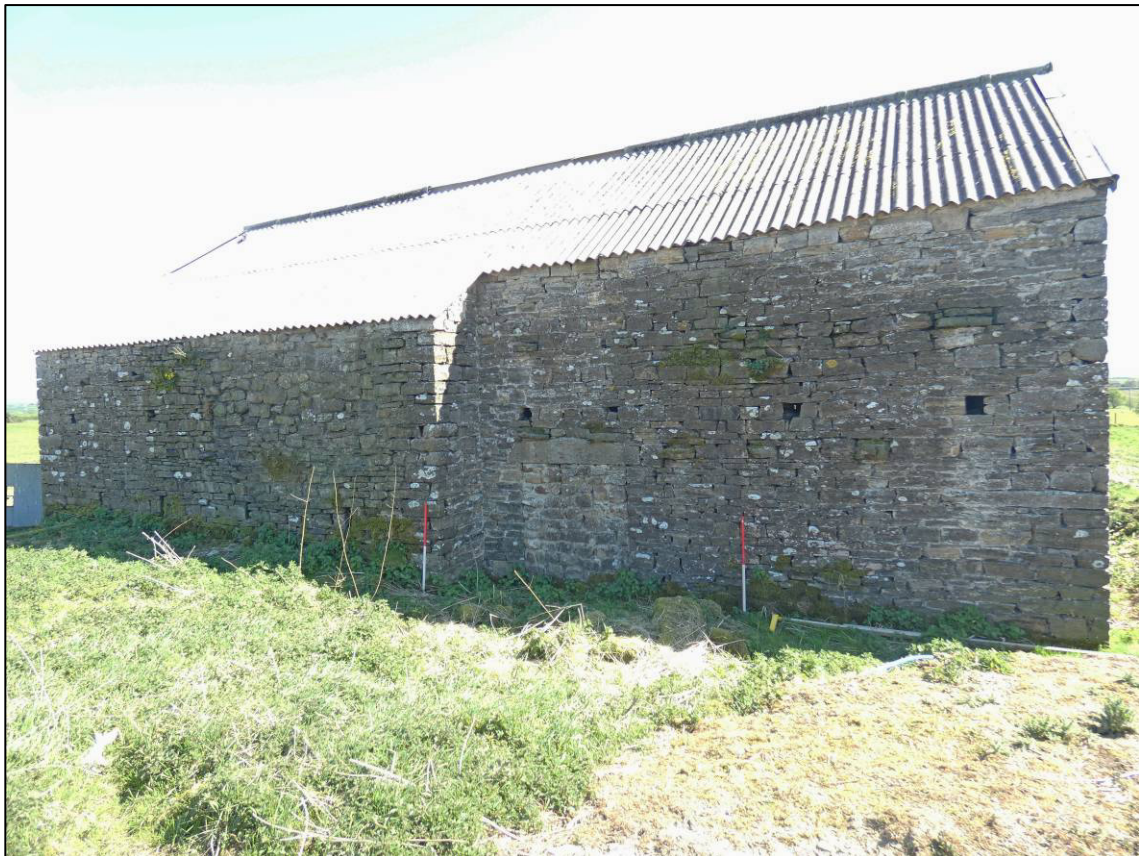
Plate 5: North elevation, looking S (photo 1/213).

- 3.9 The eastern half of the north elevation breaks forward from the western half [1/213, 1/218] (see plate 5), but the walling of the two parts is tied-in well where they meet, with no evidence for butting or any other structural break. The main feature to the narrower western half is a low doorway, 1.45m wide, which has a substantial stone lintel; it has been blocked with stone externally and blockwork internally [1/215] (see plate 6). Above the doorway, this part of the elevation incorporates two deeper and relatively level courses of rubble, with a single row of four sub-square ventilators between them; there are also two very intermittent courses of through stones [1/214]. The wider eastern half of the elevation preserves two rows of ventilators, the lower row comprising four slit ventilators, all now partly or wholly blocked [1/217]. Above, there is an intermittent course of through stones, and then a second row of sub-square ventilators; there were probably once four, but an area of probable modern re-building or repair has removed two. A second course of intermittent through stones is set above the ventilators.

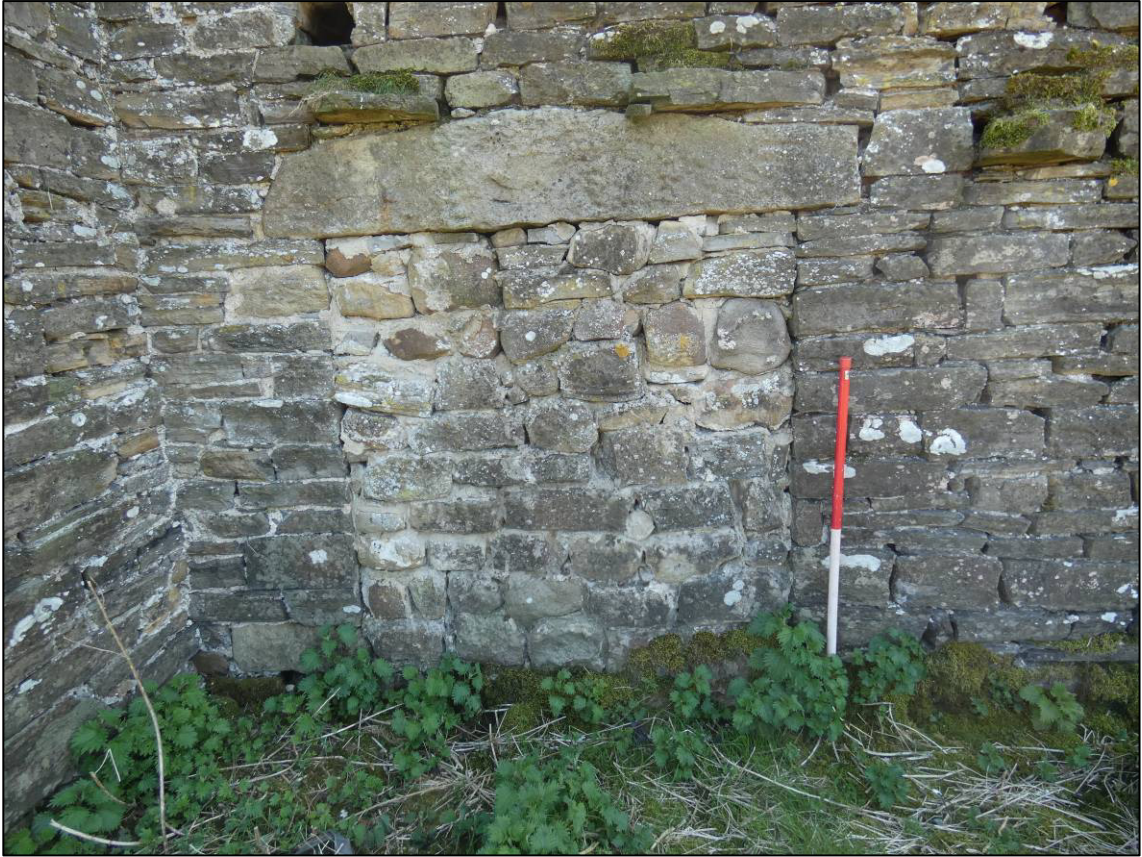
Plate 6: North elevation, west part, blocked doorway, looking S (photo 1/215).

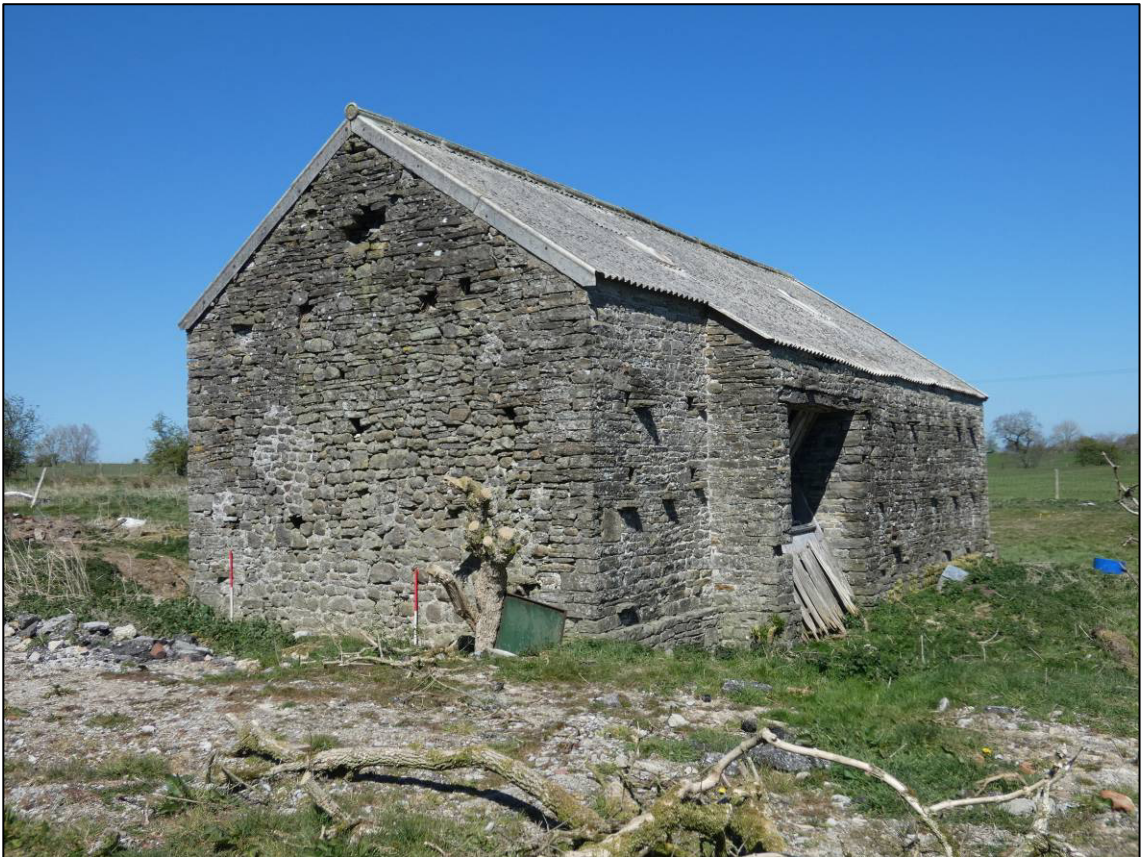
Plate 7: West gable and south elevation, looking NE (photo 1/210).

- 3.10 The west gable of the barn has been subject to several different phases of patching and repair [1/210, 1/212] (see plate 7). However, it is noticeable that the rubble used to a height of c.2m to the central part of the gable is different from that to either side; it is less squared and also less well coursed. There is a what appears to be a straight joint (now obscured by the remains of a tree trunk) at the south end, and perhaps a staggered joint at the north end, but this area of rubble does not form a clearly recognisable shape such as an earlier gable, for example. It incorporates a row of at least three features that resemble the sub-square ventilators seen elsewhere, but they are not visible internally, and it is possible that they are former sockets for timbers relating to a structure that once extended west from the barn. Above, approximately mid-way up the gable, there is a row of three sub-square ventilators, and a second row of similar features to the gable's upper part; all are partly or wholly blocked [1/209].

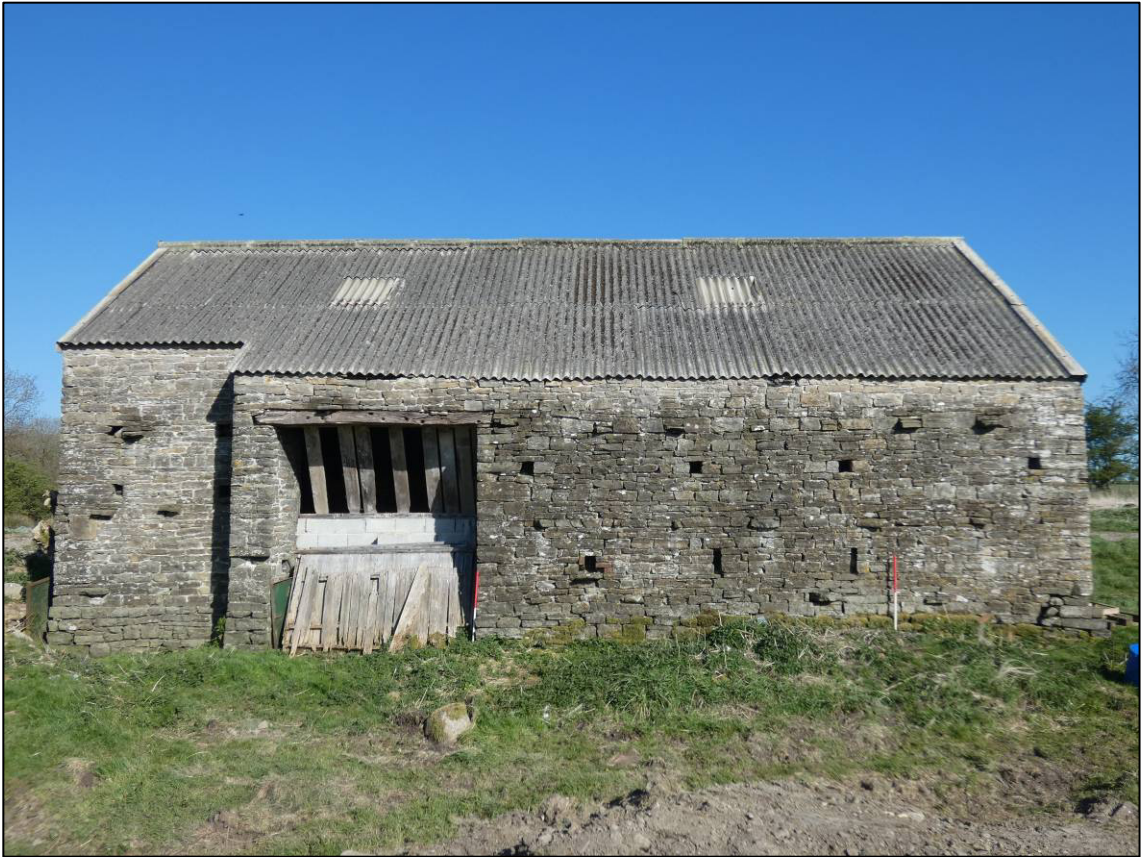
Plate 8: South elevation, looking N (photo 1/197).

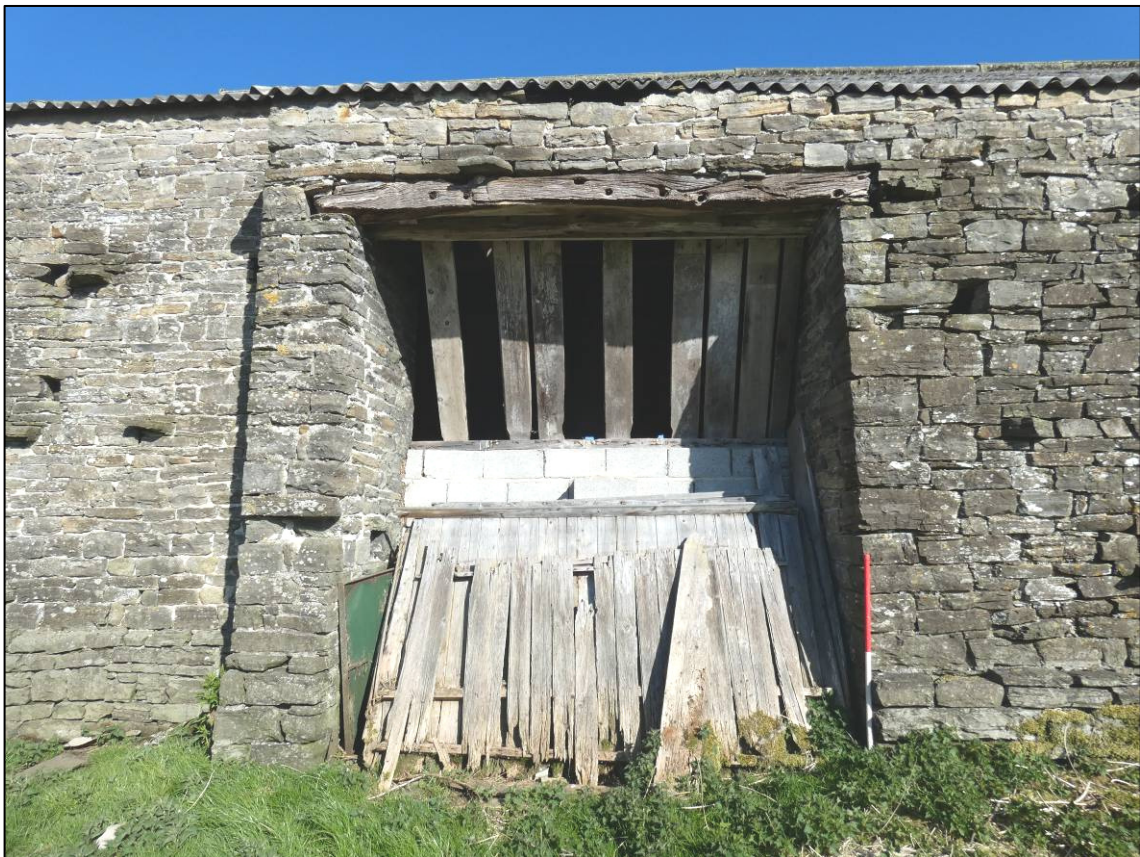
Plate 9: South elevation, cart entrance, looking N (photo 1/201).

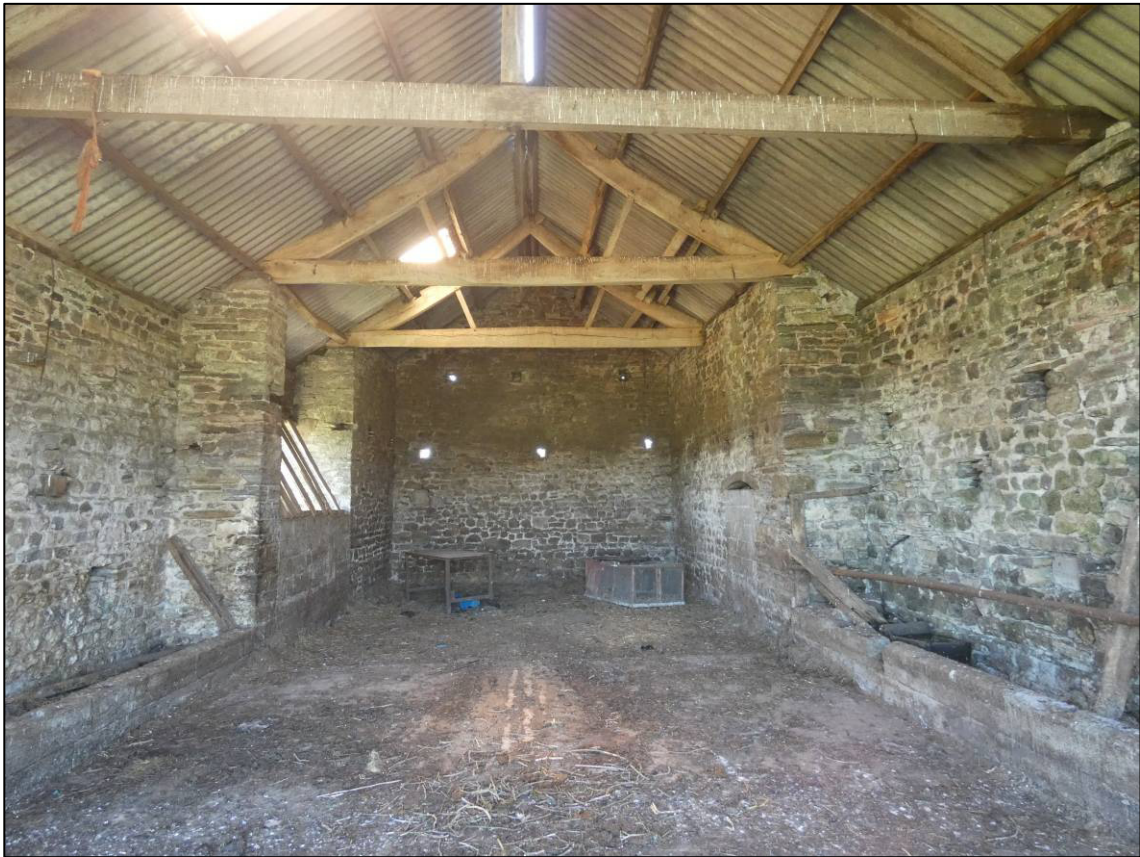
Plate 10: General view of interior, looking W (photo 1/264).

the interior of the barn is floored with concrete, whilst the narrower, western part is floored with earth [1/264] (see plate 10). Modern feeding passages, accessed from the doorways in the east gable, have been created along the north and south sides of the barn's wider, eastern part. Each passage is on average 0.80m wide, and is defined by a low blockwork wall. The north passage retains tubular metal railings along the top and has several water troughs at the west end [1/228] (see plate 11). The south passage has a block work cross-wall to the eastern end, with an adjacent upright timber structure which suggests that the passage itself and perhaps also a wider area of this part of the barn once had a first floor over [1/235, 1/236].

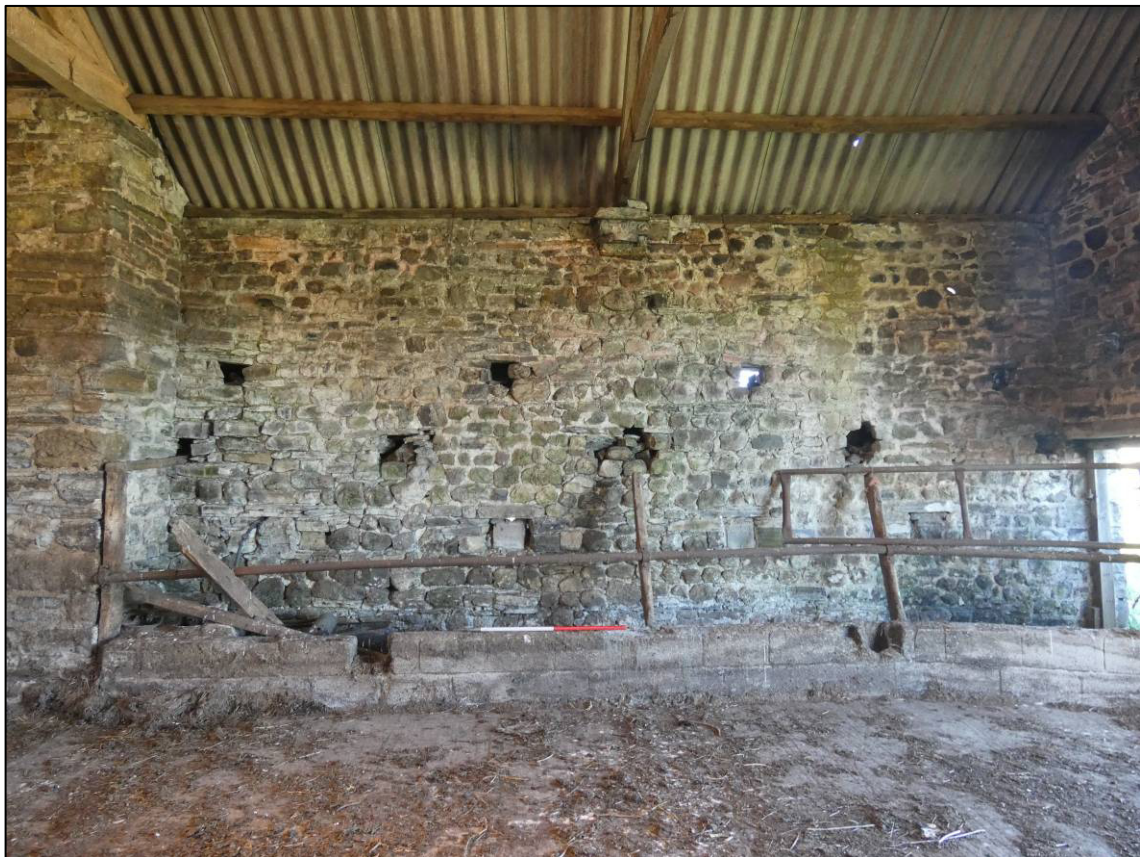
Plate 11: North internal wall, east part, looking N (photo 1/227).

- 3.13 The east wall [1/242, 1/244-1/246] contains no features that are not visible externally, and neither does the west wall [1/223]. In the north wall, the doorway to the western part (i.e. opposite the cart entrance in the south wall) has been blocked with blockwork and has a curving piece or re-used timber as a lintel [1/224-1/226] (see plate 12). A line of damaged recesses to the eastern part again suggest that a wider area of the barn here once had a first floor [1/227] (see plate 11). To the south wall, shallow areas of damage to both sides of the cart entrance, set at the same height, were probably caused by the removal of pintles supporting a two-leaf door here, set flush with the interior wall face [1/231, 1/234]. Further east, a wall recess, possibly for a lamp, with a timber lintel is positioned between the two easternmost blocked slit ventilators [1/237] (see plate 13).

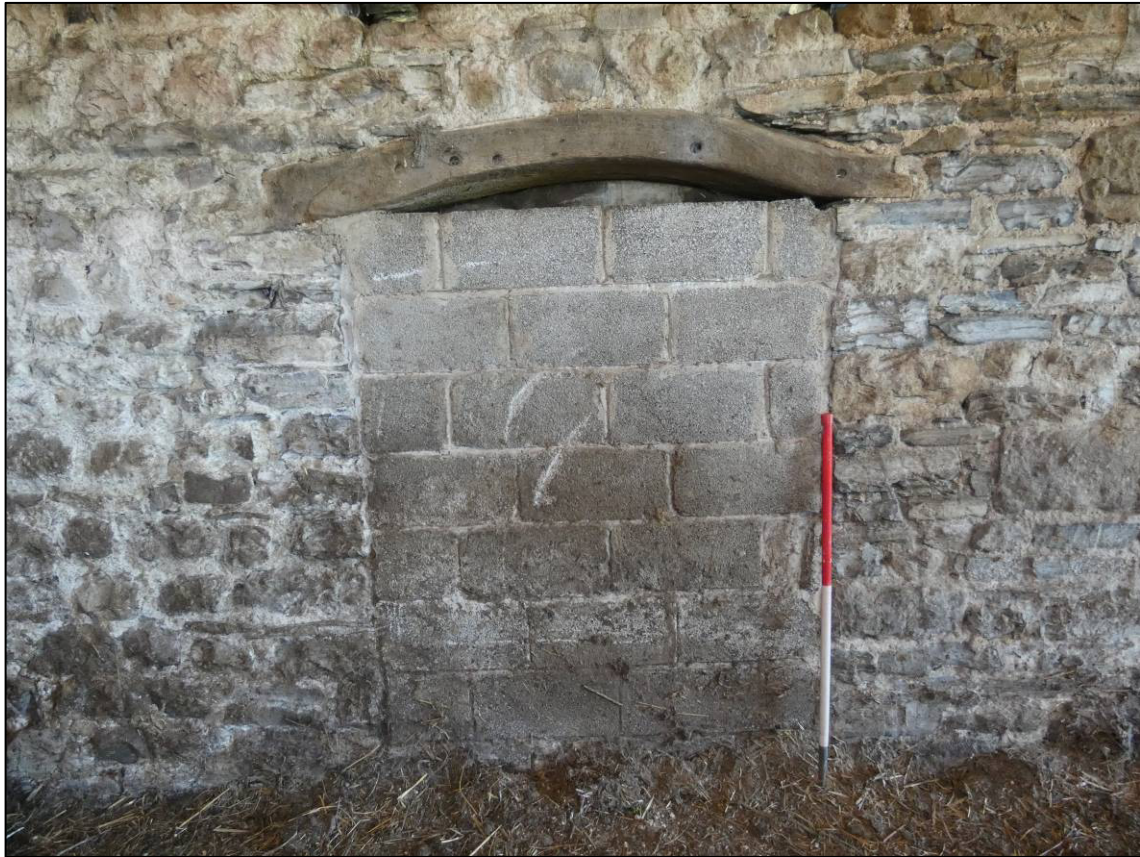
Plate 12: North internal wall, west part, blocked doorway, looking N (photo 1/226).

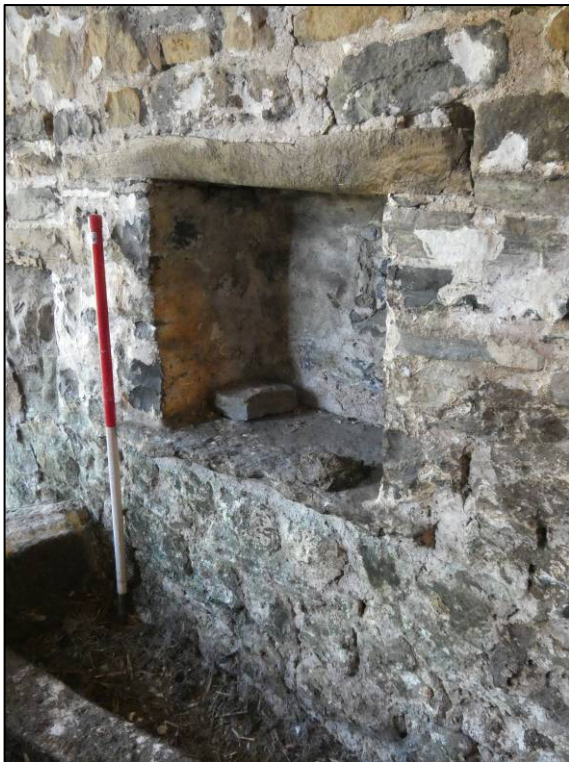
Plate 13: South internal wall, recess to east part, looking SE (photo 1/237).

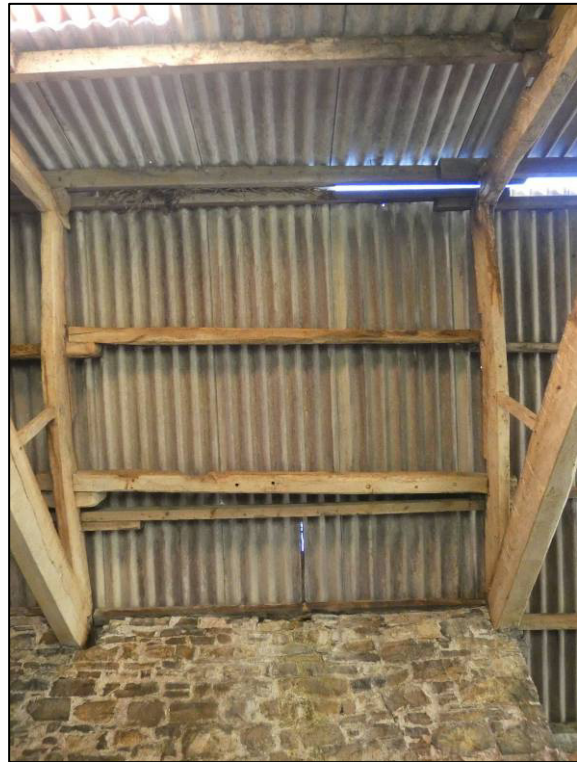
Plate 14: West central roof bay, north slope, looking N (photo 1/253).

- 3.14 The interior of the barn is divided into four bays by three roof trusses [1/263]. The west and central roof trusses are set in line with the side walls of the cart entrance, and are of the same form [1/247, 1/251, 1/255, 1/259] (see plate 15). Each truss is of hardwood, and of pegged construction throughout. The shallowly chamfered tie-beam is slightly tapered in plan, decreasing in width from north to south, with diminished and slightly curved principal rafters; raking struts run between the tie-beam and the principals. The principals are lapped at the apex and there was probably once a diamond set ridge-piece but this has subsequently been removed. Each principal once carried a pair of trenched, staggered purlins, but the majority of these have been either re-set or removed, and replaced by softwood timbers supported by cleats [1/248, 1/249, 1/252] (see plate 16). The common rafters have all been removed, presumably when the roof was renewed with corrugated sheeting. The west faces of both trusses retain incised assembly or carpenters marks. These take the form of a matching 'I' marks to the north half of each truss, and matching 'II' marks to the south half of each truss [1/257] (see plate 17). The north end of each tie-beam is set into the north wall, but the south ends rest on top of the south wall. Although at least one of the surviving original purlins is a re-used timber [1/253] (see plate 14), the remainder of the timber to both trusses is not re-used. The east truss is of much more recent bolted, softwood, king-strut form [1/261] (see plate 18). There are raking struts from the king-strut to the principal rafters, and each principal supports three back purlins with cleats. The ends of the tie-beam are supported on crude stone corbels, and there are again no common rafters.

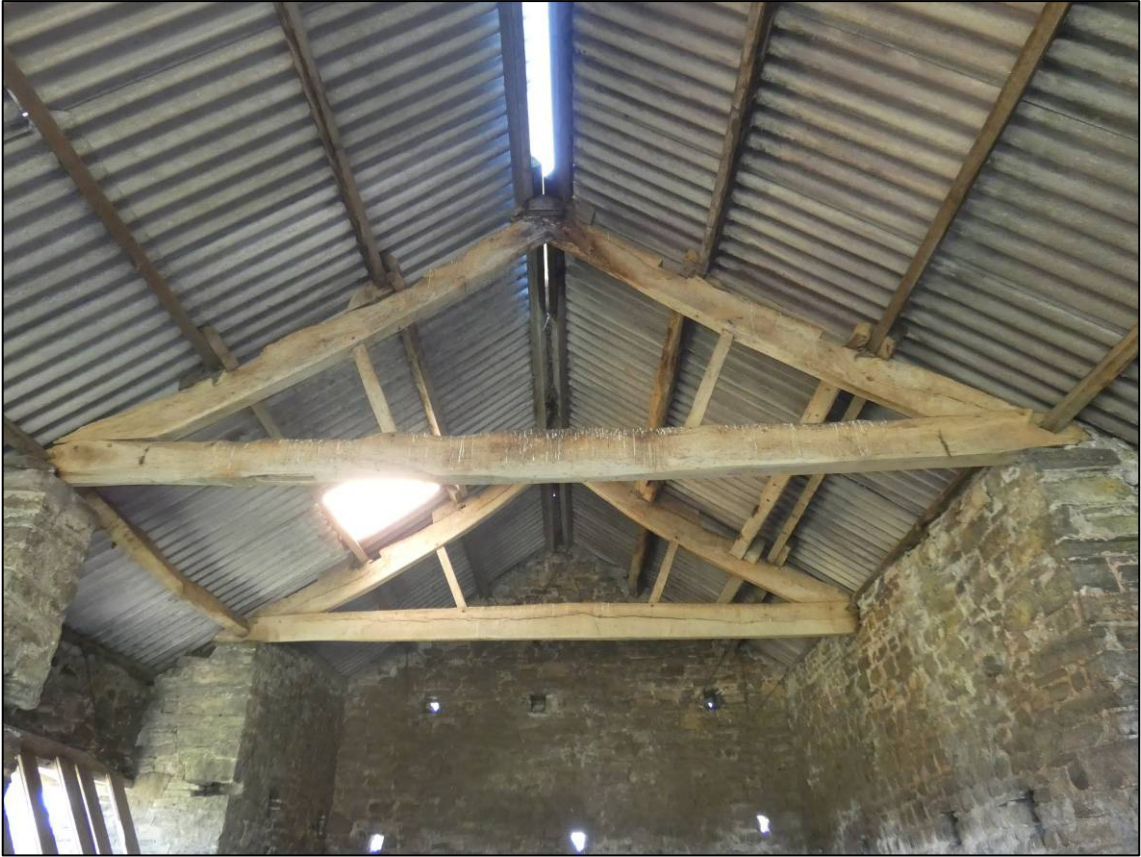
Plate 15: Central roof truss, east face, looking W (photo 1/259).

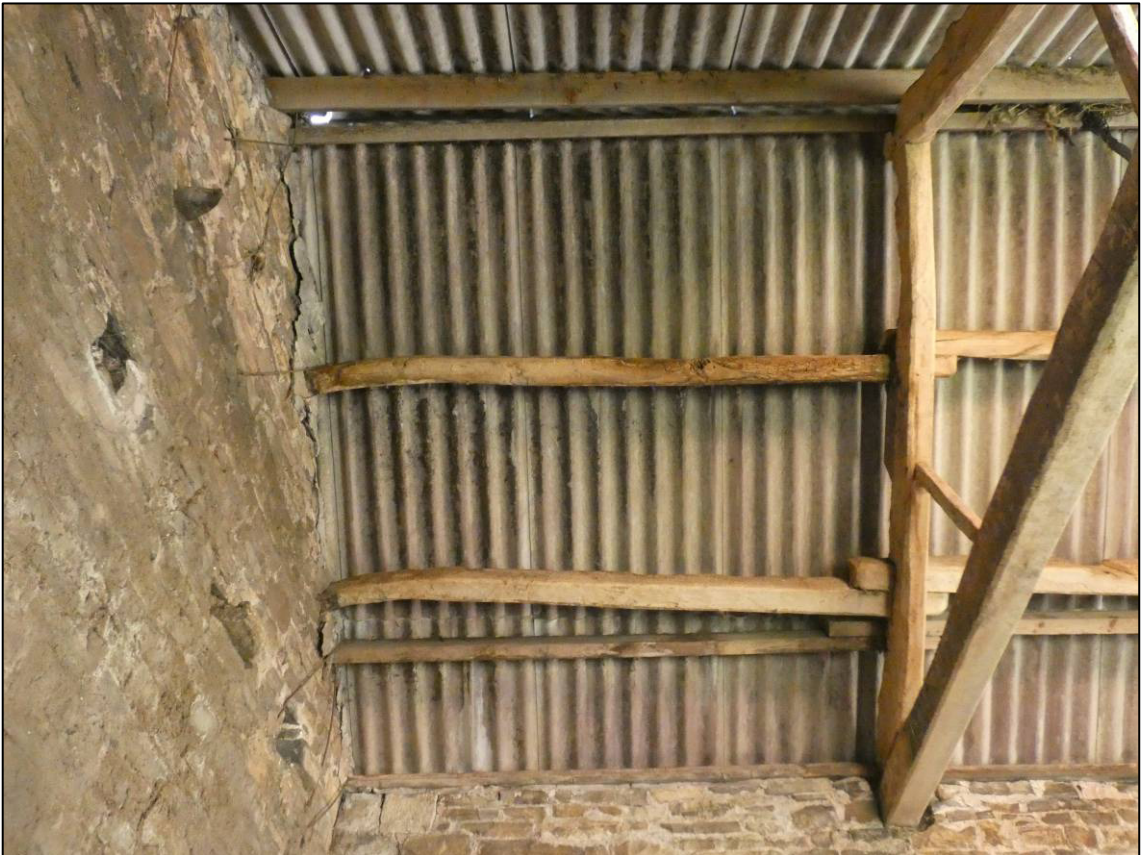
Plate 16: West roof bay, north slope, looking N (photo 1/248).
