SLATED LAITHE, OFF PAA LANE,
PAYTHORNE, LANCASHIRE BB7 4JD

HISTORIC BUILDING RECORDING

Report no: 2020/618.R01
Version: Final
Date: July 2020
Author: Shaun Richardson & Ed Dennison

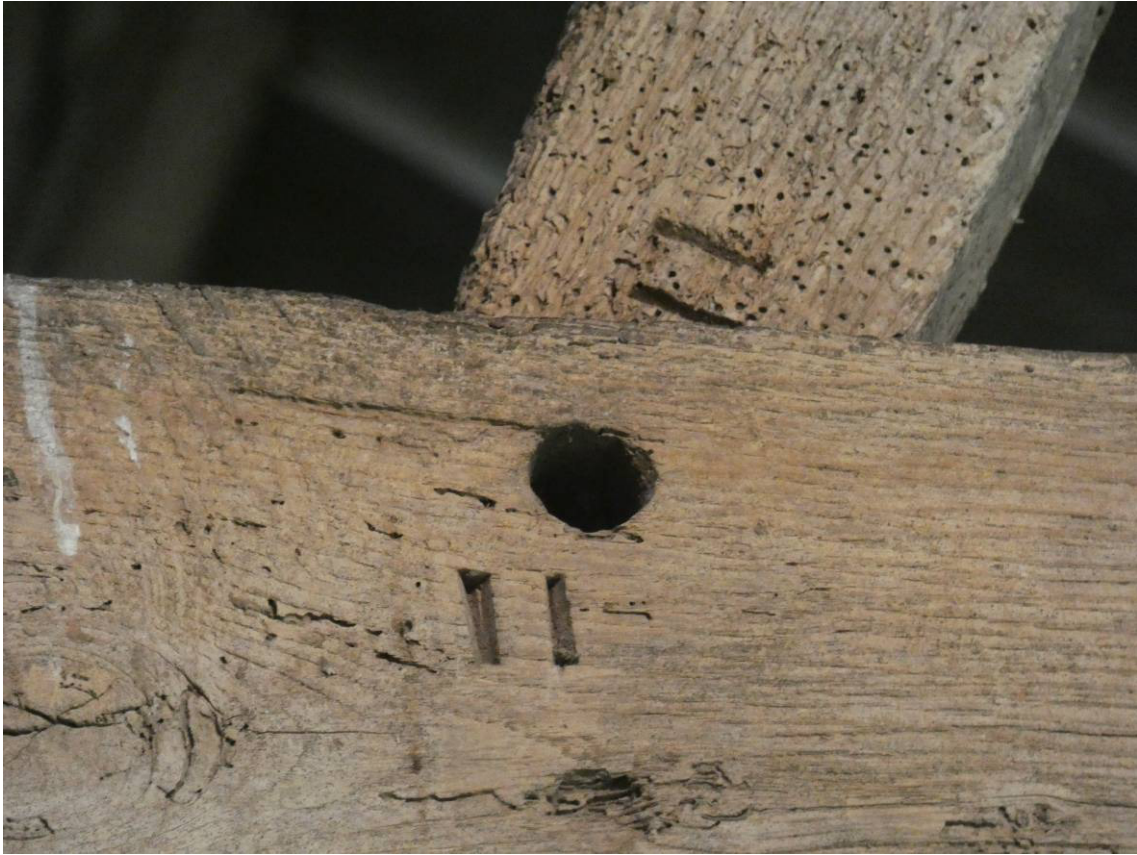
Plate 17: Central roof truss, west face, detail of numbering, looking E (photo 1/257).

- 3.14 The interior of the barn is divided into four bays by three roof trusses [1/263]. The west and central roof trusses are set in line with the side walls of the cart entrance, and are of the same form [1/247, 1/251, 1/255, 1/259] (see plate 15). Each truss is of hardwood, and of pegged construction throughout. The shallowly chamfered tie-beam is slightly tapered in plan, decreasing in width from north to south, with diminished and slightly curved principal rafters; raking struts run between the tie-beam and the principals. The principals are lapped at the apex and there was probably once a diamond set ridge-piece but this has subsequently been removed. Each principal once carried a pair of trenched, staggered purlins, but the majority of these have been either re-set or removed, and replaced by softwood timbers supported by cleats [1/248, 1/249, 1/252] (see plate 16). The common rafters have all been removed, presumably when the roof was renewed with corrugated sheeting. The west faces of both trusses retain incised assembly or carpenters marks. These take the form of a matching 'I' marks to the north half of each truss, and matching 'II' marks to the south half of each truss [1/257] (see plate 17). The north end of each tie-beam is set into the north wall, but the south ends rest on top of the south wall. Although at least one of the surviving original purlins is a re-used timber [1/253] (see plate 14), the remainder of the timber to both trusses is not re-used. The east truss is of much more recent bolted, softwood, king-strut form [1/261] (see plate 18). There are raking struts from the king-strut to the principal rafters, and each principal supports three back purlins with cleats. The ends of the tie-beam are supported on crude stone corbels, and there are again no common rafters.

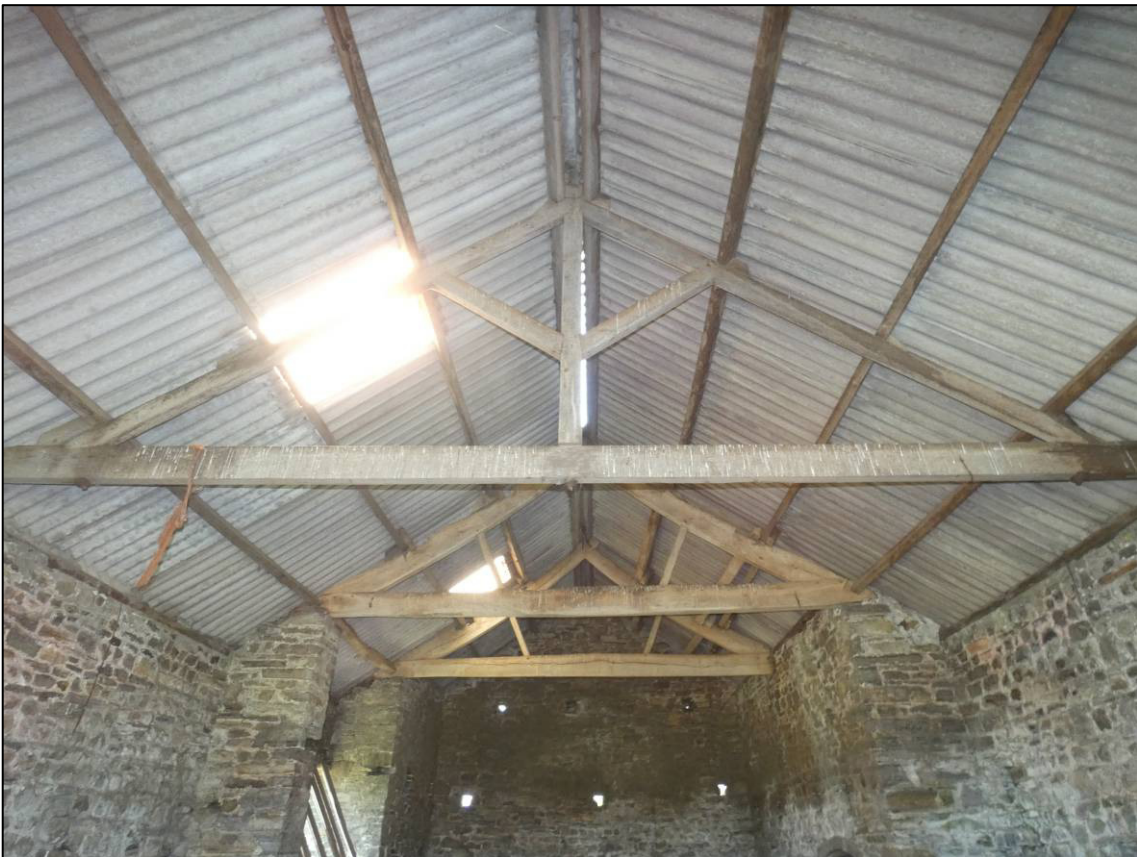
Plate 18: Roof trusses, looking W (photo 1/263).
