GRANGE GILL QUARRY. LIME KILN AND HEN HOUSE,
SKELGILL LANE, LOW ABBOTSDALE,
NORTH YORKSHIRE

ARCHAEOLOGICAL SURVEY

Report no: 2008/322.R01
Version: Final
Date: October 2009
Author: Ed Dennison & Shaun Richardson

Yorkshire Dales National Park Authority
Yoredale
Bainbridge
Leyburn
North Yorkshire DL8 3EL

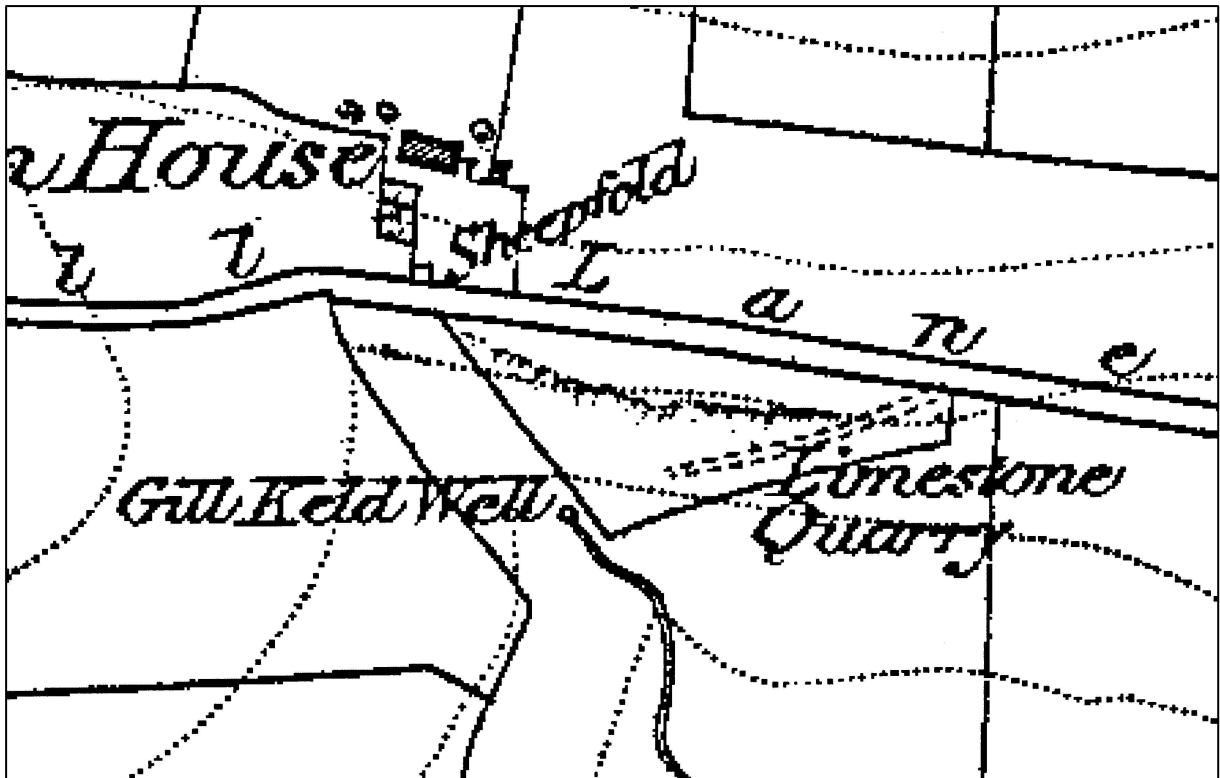
PROJECT		GRANGE GILL QUARRY	
TITLE			
		HISTORIC MAPS	
SCALE	NTS	DATE	OCT 2009
EDAS		FIGURE	3

Top: Ordnance Survey 1856 6" map (sheet 66) (surveyed 1854).

Bottom: Ordnance Survey 1893 25" map (sheet 66/3) (surveyed 1892).

- 3.17 At least part of the limestone extracted from the quarry was burnt in the lime kiln present on site (19). The cartographic evidence suggests that the lime kiln was built between 1856 and 1893 (see figure 3), and it stands to the south of the main quarrying area (10), on the north side of a trackway (7).
- 3.18 The lime kiln has been built into a steep south-facing scarp, and stands up to 3.0m in height (see plate 5). The upper part is formed by the circular mouth of the pot or bowl, c.1.5m in diameter and with walls standing up to 0.8m high; the thinly coursed interior stonework is heavily vitrified, particularly on the north and south sides, while the uppermost two courses of stone are decayed and have partly

- 3.36 On the same wall alignment (31), and immediately to the north of the gateway noted above, is Gill Keld Well (16). This appears on maps from at least 1856 onwards (see figures 3 and 4) and it is now formed by the partly rubble-choked remains of a rectangular trough, c.1.60m long and 1.0m wide, made from several upright stone flags. The flags butt the adjacent field wall (31), although it appears that the trough may once have passed beneath it, as there is an area of collapse above it; there is however no sign of the trough on the opposite (east) side of the field wall. Below the stone flag trough, there is an old metal trough of slightly smaller dimensions, and above it, a short section of drystone wall.

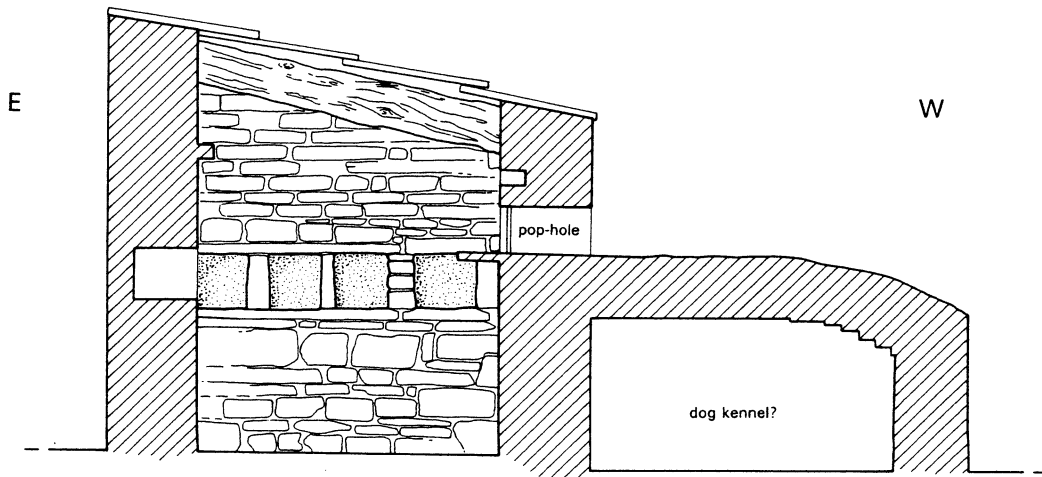
PROJECT		GRANGE GILL QUARRY	
TITLE		HEN HOUSE	
SCALE	AS SHOWN	DATE	OCT 2009
EDAS		FIGURE	7

Plan

East-west section

The hen house is located on the southern edge of the survey area, and set into the steep south-facing scarp which marks the northern extent of another area of quarrying. At the time of the survey, the structure was in good condition, roofed and with part of wooden pallet used to block the doorway; the interior was largely empty, with the exception of a number of dead rabbits and the partial remain of a dead sheep. It was not possible to determine what the original flooring material was.

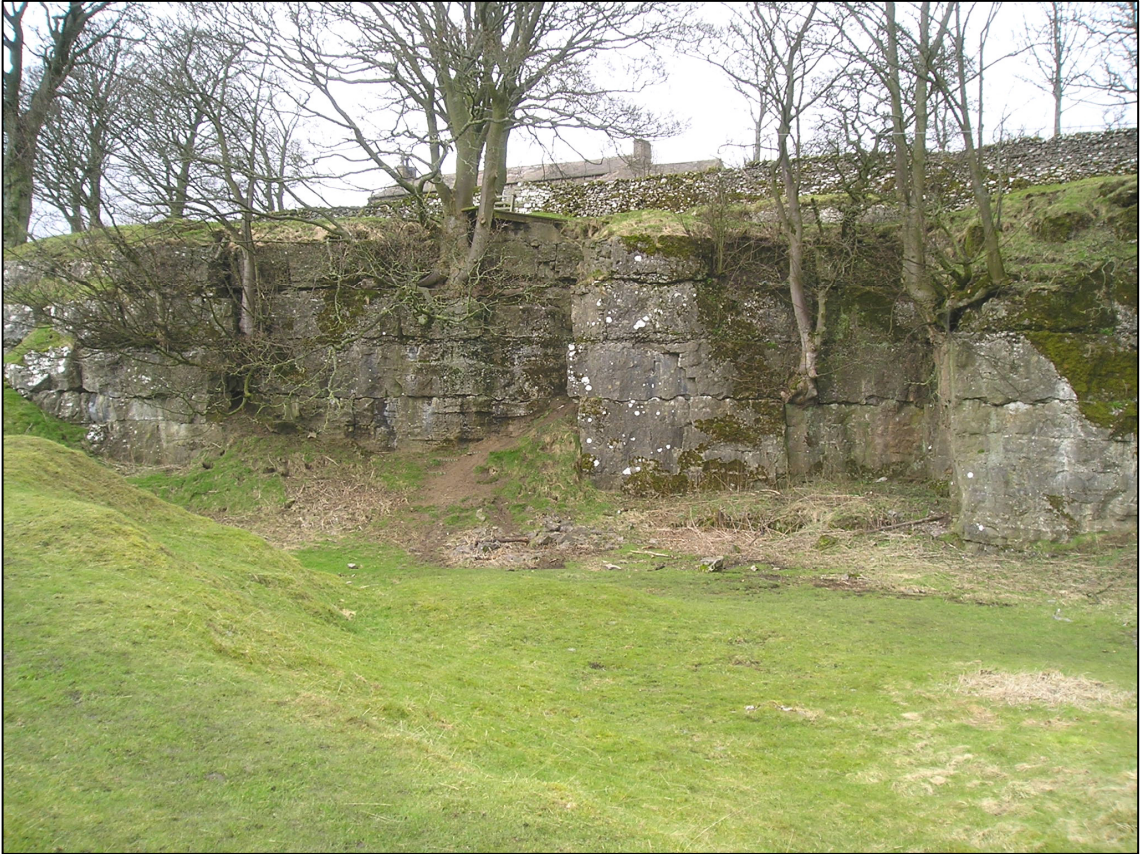
Plate 1: West end of main quarry (Site 10), looking NW.

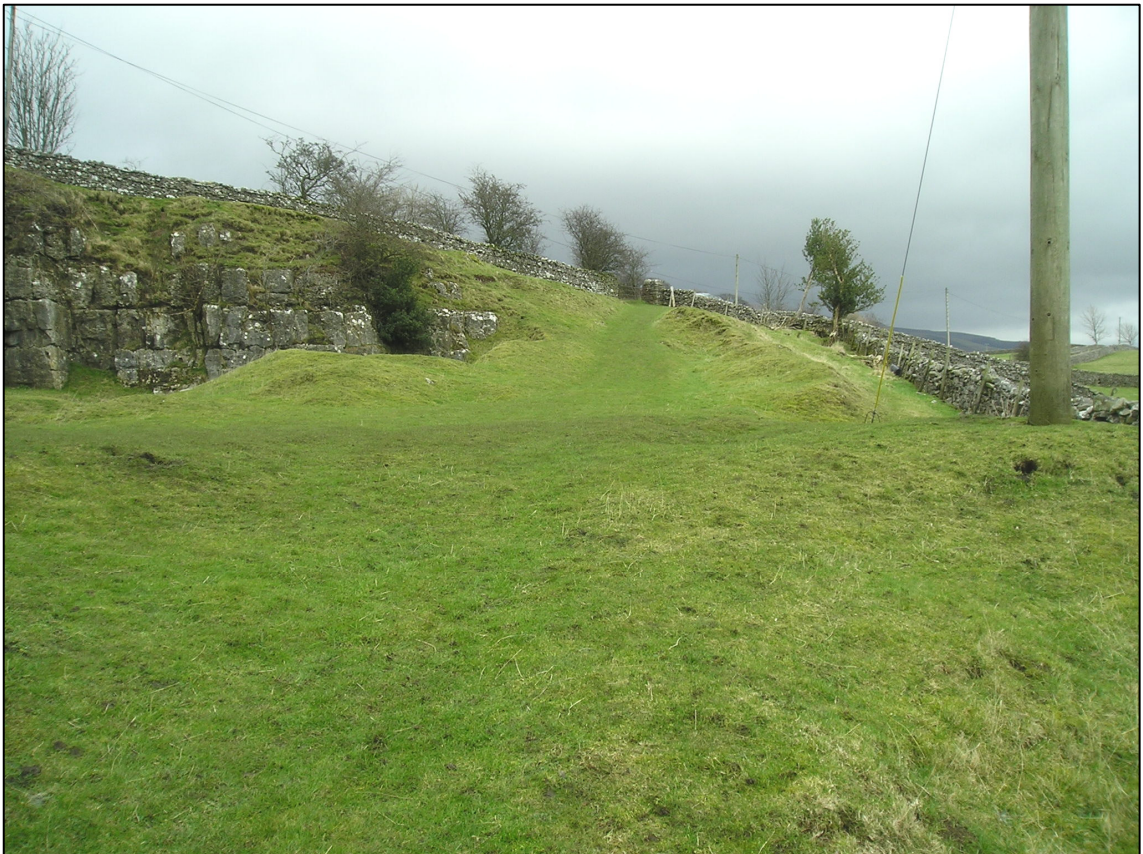
Plate 2: Access track (Site 7), looking NE.

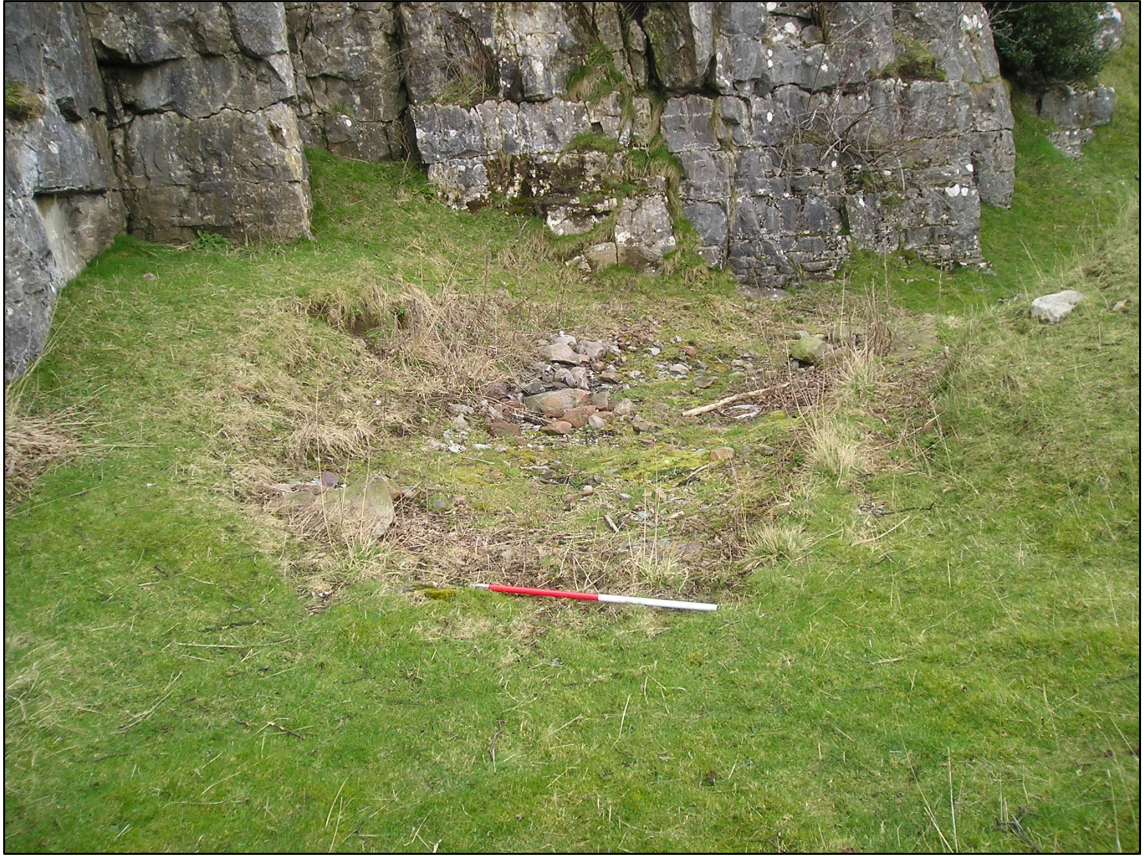
Plate 3: Building platform (Site 9), looking E.

The building is located in the base of the west end of the main quarry (Site 10) within the survey area, at the bottom of the working face and bounded by a steep east-facing scarp to the west. The building has now almost completely disappeared above ground, with only a short length of wall footings visible in plan on the former line of its north wall. Otherwise, it is represented by a shallow sub-rectangular depression, aligned east-west, c.6.0m long and 2.5m wide. As noted above, the ruined building stands a short distance to the west of those shown on the later Ordnance Survey maps, but nothing resembling a building is now visible in the latter area, and so it may perhaps be shown in the wrong location on the map [5].

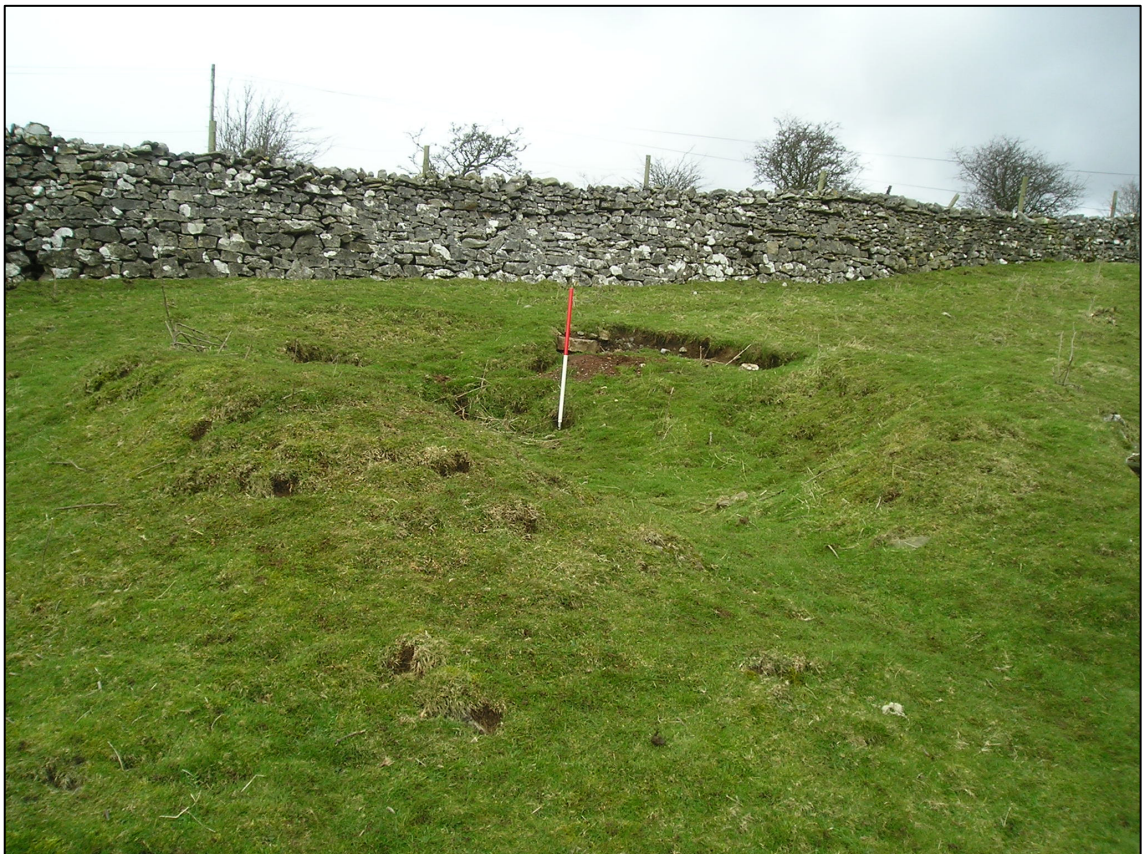
Plate 4: Sow kiln (Site 23), looking NE.

- 3.7 The principal evidence for early lime burning within the survey area is the well preserved remains of a sow kiln (**23**), located on the south side of a field wall (**31**). The kiln is represented a horse-shoe shaped earthwork, open to the south, with maximum dimensions of 8.5m east-west by 6.5m north-south (see figure 6 and plate 4). The earthwork was created by excavating a bowl, now just over 0.5m in depth, into the natural slope. This bowl is sub-oval in plan, measuring 5.0m long (north-south) by 3.5m wide (east-west), and there is a flue/stoke-hole opening on the south side that is c.0.5m wide at the base. The interior base of the bowl slopes down from north to south. The north end of the bowl appears to still be formed by the natural slope, but the east and west sides are flanked by curvilinear banks, at least partly formed by the upcast from the bowl excavation. Both banks are of broadly similar form, with steeply sloping sides and flattened tops, thickest towards the centre but then narrowing again as they curve inwards to their southern ends. However, they are not identical, the west bank having a slight raised linear mound along its top, while the east bank contains a higher proportion of visible stone rubble. There is some erosion and slippage to the northern edge of the bowl, partly caused by rabbit burrowing, with further rabbit activity immediately to the east.

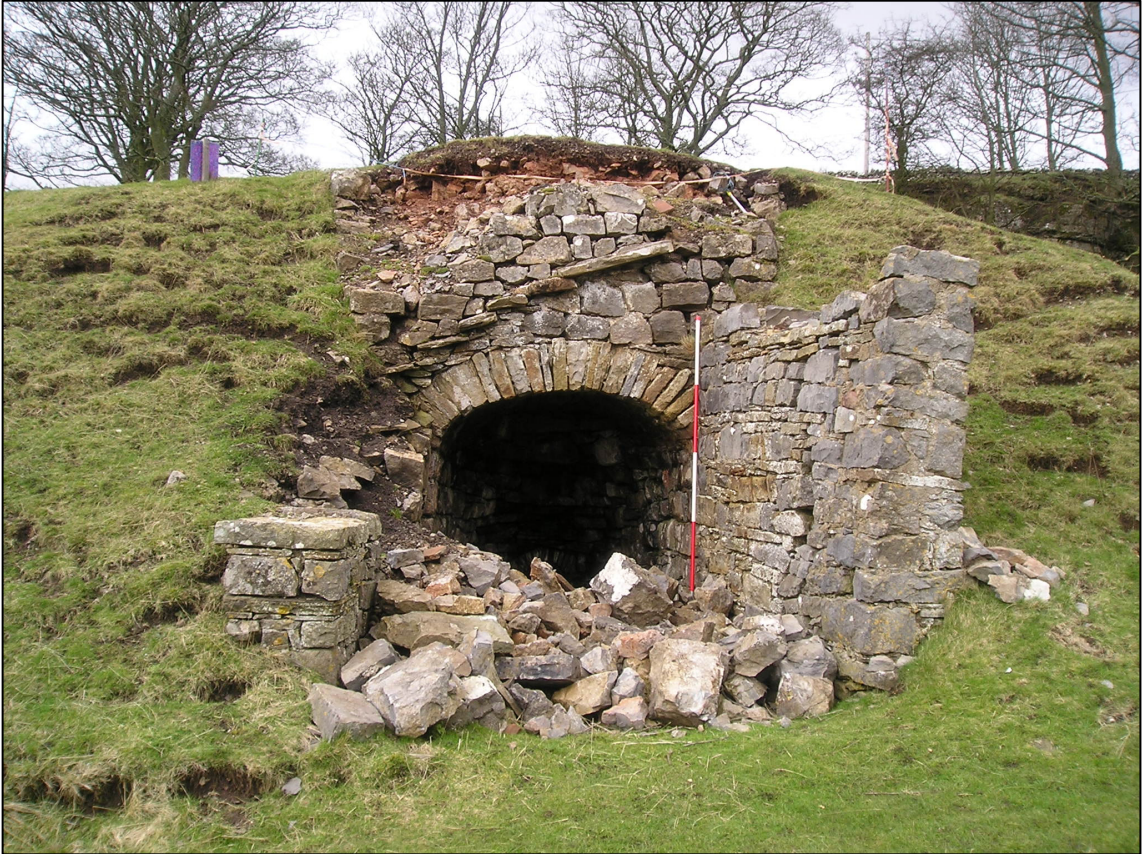
Plate 5: Lime kiln (Site 9), before consolidation, looking N.

The lime kiln stands to the south of the west end of the main quarrying area (Site 10), on the north side of a trackway (Site 7). The lime kiln has been built into a steep south-facing scarp, standing up to 3.0m in height. The upper part is formed by the mouth of the circular pot, c.1.50m in diameter and with walls standing up to 0.80m high; the thinly coursed interior stonework is heavily vitrified, particularly to the north and south sides, while the uppermost two courses of stone are decayed and have partly fallen into the interior. The pot mouth is set within a raised sub-oval mound, c.4.0m long and 3.0m wide, and standing up to 1.0m in height. The south side of the mound is badly eroded, exposing the rubble core of the lime kiln body which is now falling away due to the partial collapse of the kiln's south face.

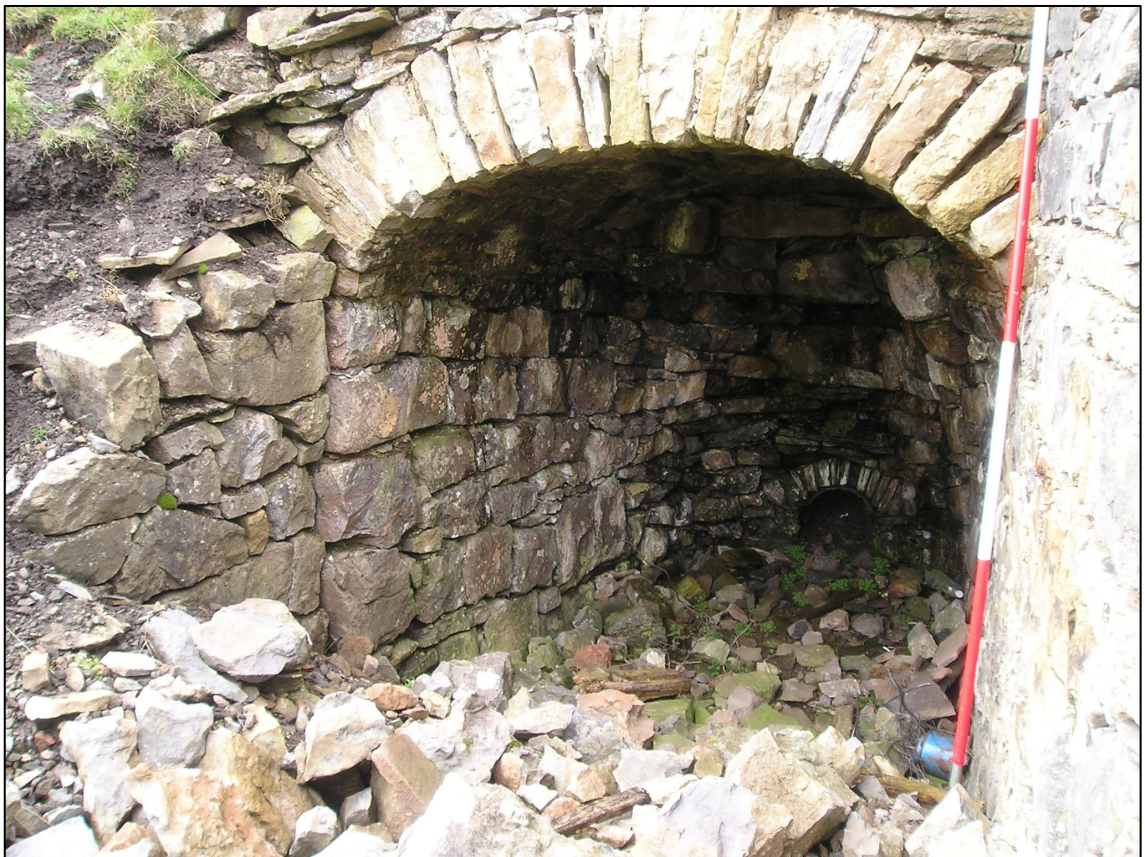
Plate 6: Draw-hole arch and interior of lime kiln (Site 9), before consolidation, looking NW.

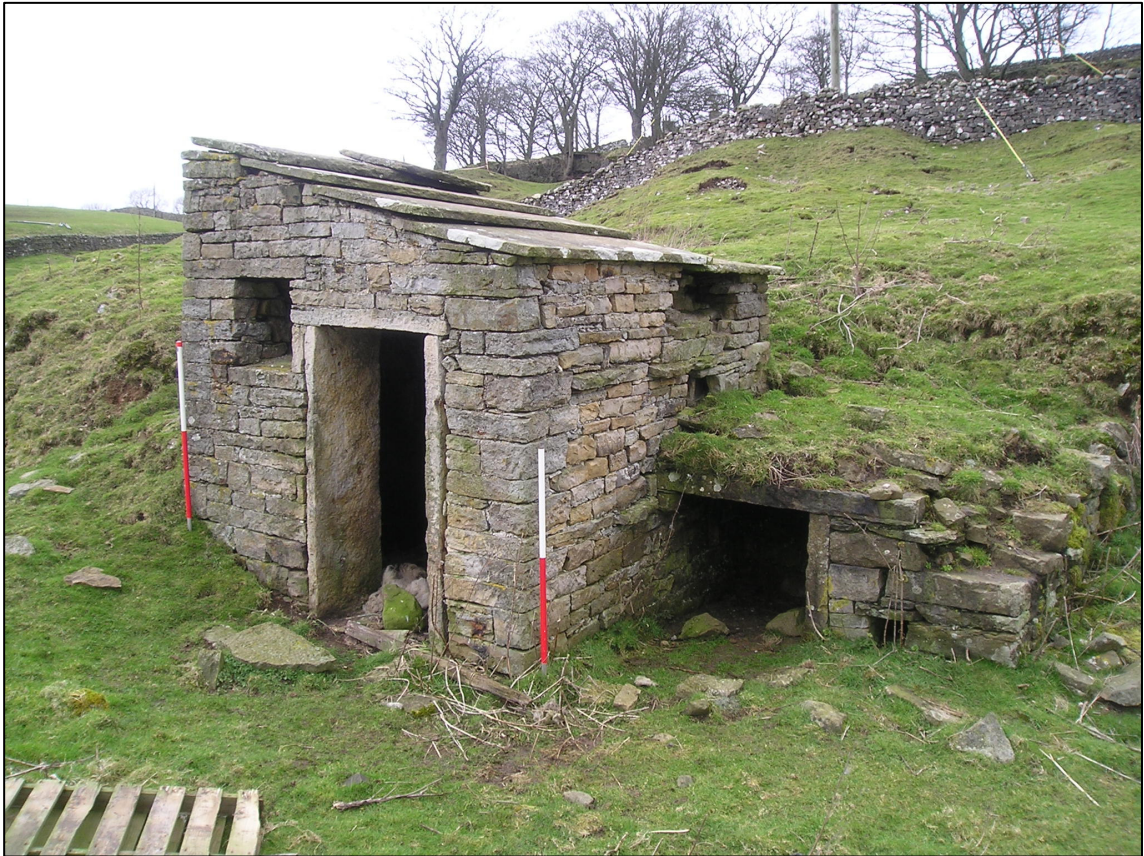
Plate 7: General view of hen house and attached structure (Site 28), looking NW.

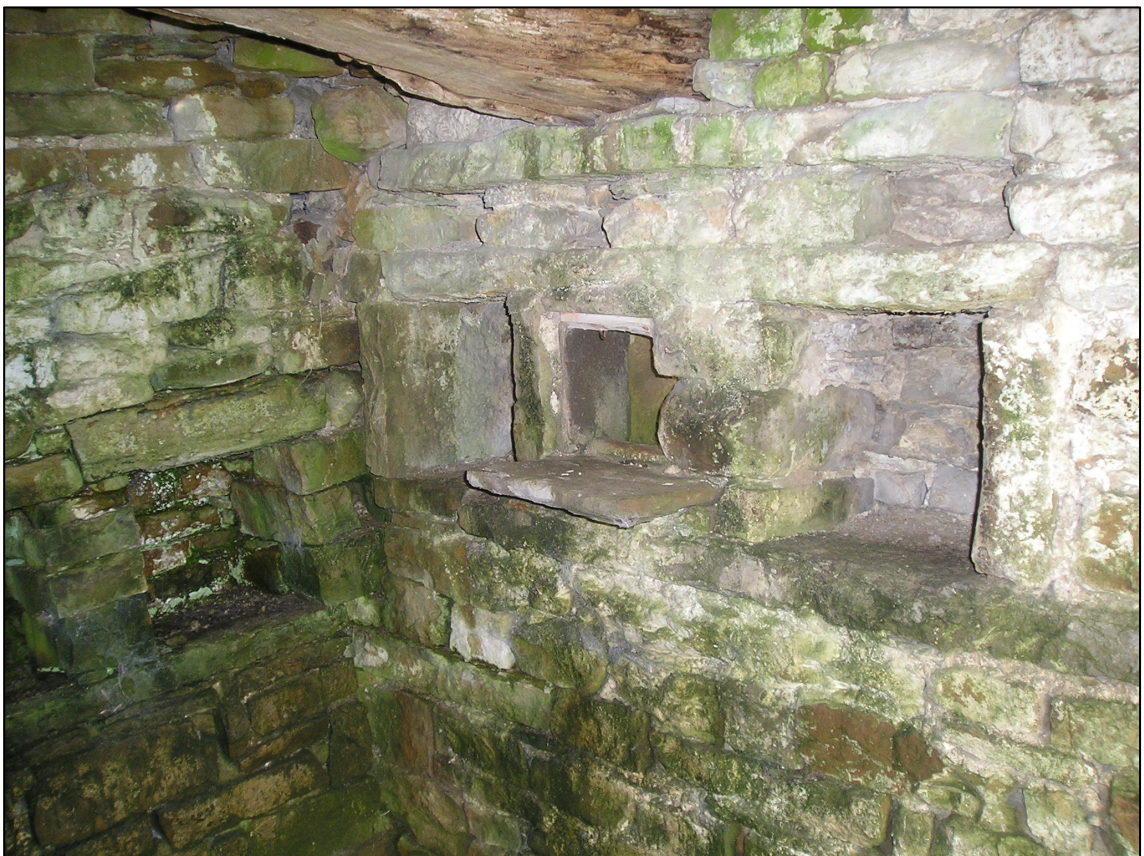
Plate 8: Internal east wall of hen house (Site 28) showing recesses and pop-hole, looking NE.
