HOUSE AT GATE UP, GRIMWITH,
APPLETREEWICK, NORTH YORKSHIRE

ARCHITECTURAL ASSESSMENT

Report no: 2009/357.R01
Version: Final
Date: October 2009
Author: Shaun Richardson & Ed Dennison

Yorkshire Dales National Park Authority
Yoredale
Bainbridge
Leyburn
North Yorkshire DL8 3EL

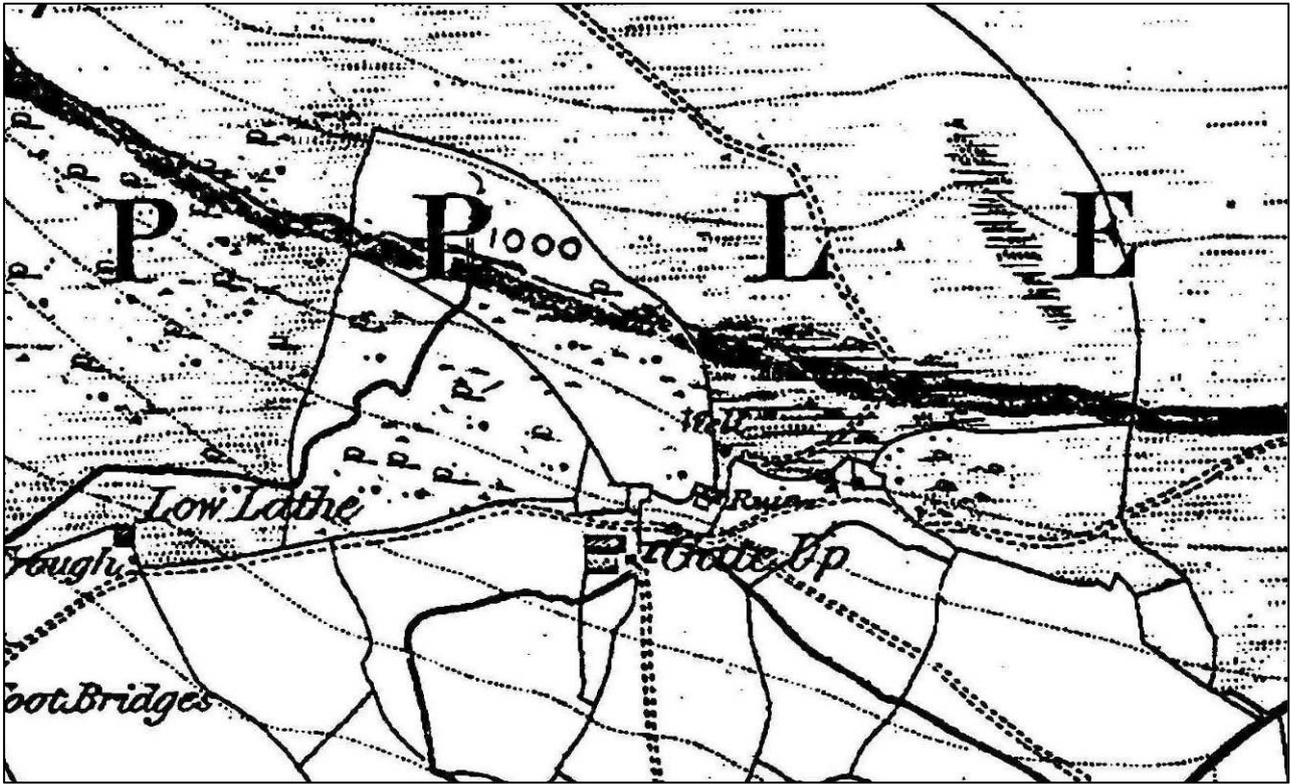
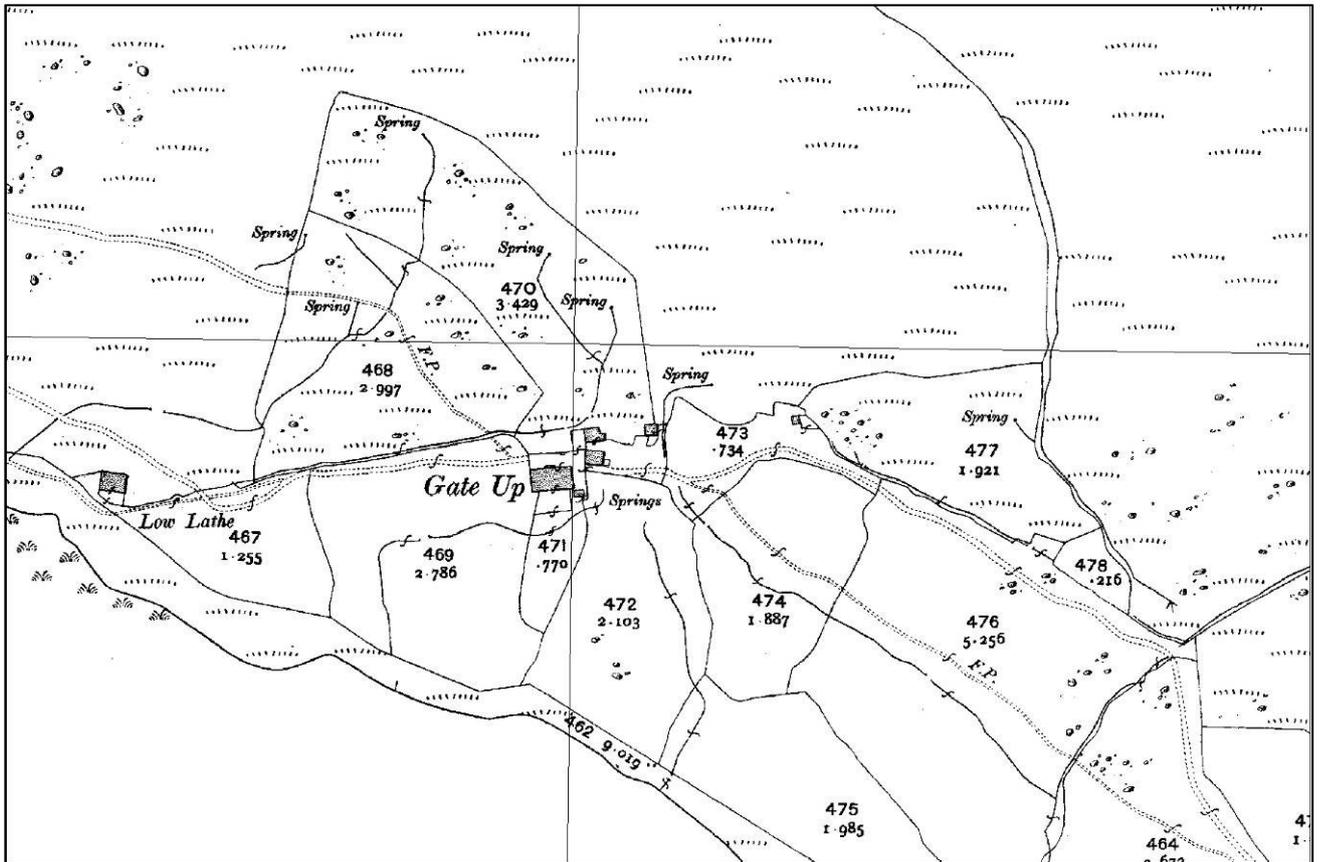
PROJECT		HOUSE AT GATE UP, GRIMWITH	
TITLE			
HISTORIC MAPS			
SCALE	NTS	DATE	OCT 2009
EDAS		FIGURE	3

Top: Ordnance Survey 1853 6" map
(sheet 134) (surveyed 1848-50).

Bottom: Ordnance Survey 1912 25"
map (sheet 134/8).

- 3.7 On the south side of the trackway, located some c.22m to the south of the house, there is a substantial north-west/south-east aligned bank, over 1.5m wide and standing up to 1.0m high [1/39]. The scarp to the north side is wider and more gently sloping than that the south side, which preserves sections of stone facing or revetment up to 0.5m in height [1/40]. The facing comprises pieces of roughly squared stone up to 0.5m across, which can be traced intermittently along the south scarp as far as the east end of the bank, although the individual stones become smaller in size. It is possible that the east end of the bank is in fact formed by a collapsed structure, sub-rectangular in plan, c.7m long and 3.5m wide. The bank does not appear to continue any further east beyond this possible structure, but it can be traced westward for some distance beyond the area which was surveyed. It is likely that this earthwork represents the east-west aligned field wall shown here on the historic maps (see figure 3).

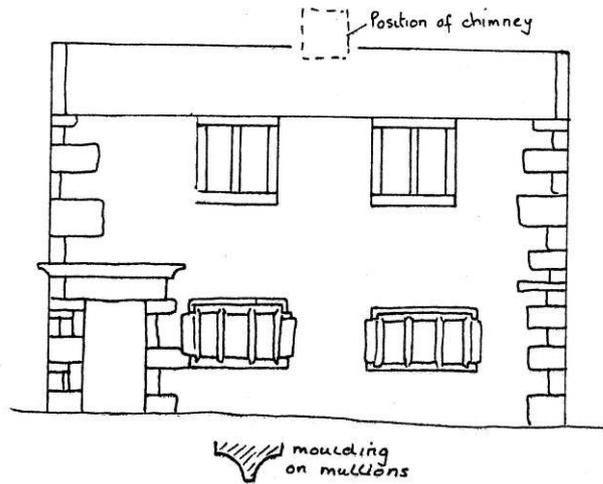
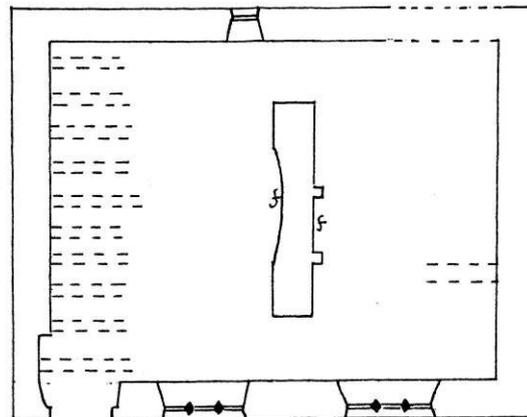
PROJECT		HOUSE AT GATE UP, GRIMWITH	
TITLE		1977 SURVEY	
SCALE	AS SHOWN	DATE	OCT 2009
	EDAS	FIGURE	4

Source: North Yorkshire and
 Cleveland Vernacular Buildings
 Study Group survey report no. 279.

century. The first floor windows recorded in 1977 were of two-lights with ashlar surrounds and rectangular mullions (Barley, Voakes & Harrison 1977a) (see figure 4). However, it is possible that they might have replaced earlier mullioned windows; a fallen jamb, bearing the same moulding as the ground floor windows, is visible adjacent to the house directly beneath the west ground floor window. As all the surviving windows appear complete, the jamb must presumably have come from another window which has since been lost.

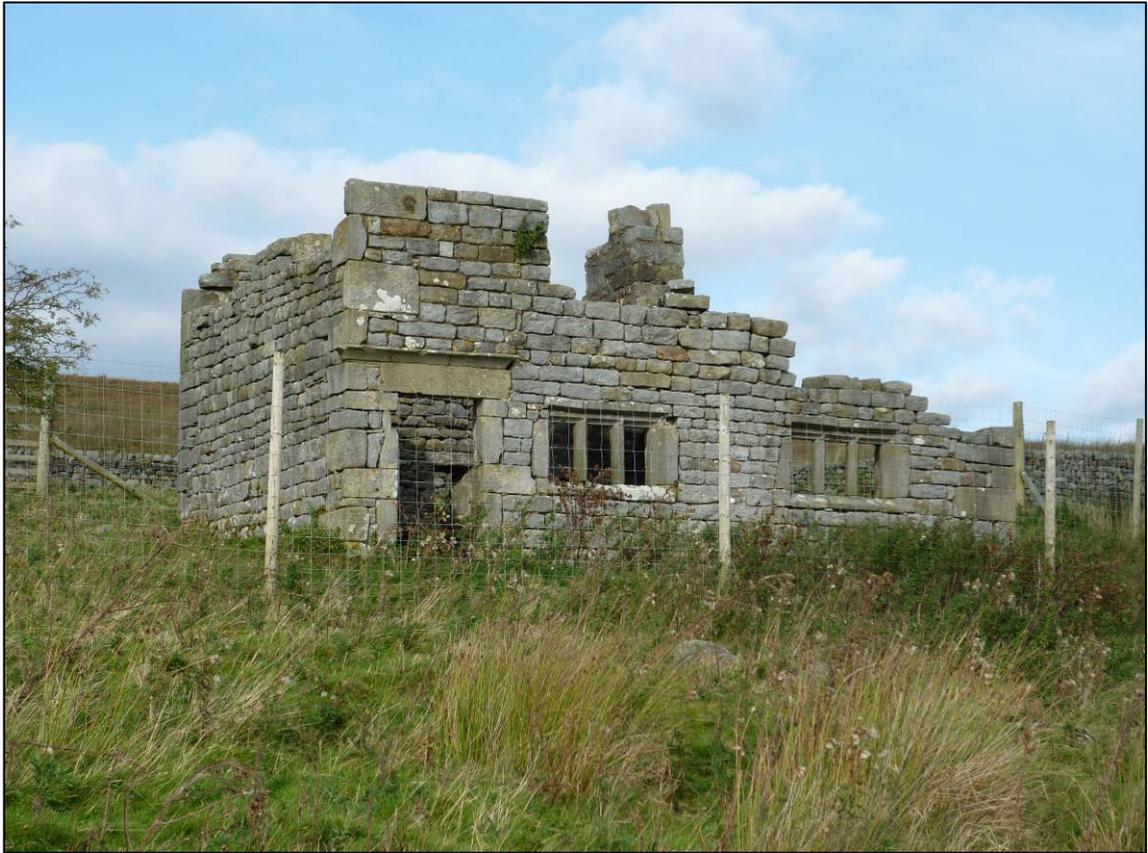
Plate 1: General view of house, looking NE (photo 1/41).

- 3.10 The house is built of coursed and squared millstone grit set with a friable white lime mortar containing frequent ash/charcoal inclusions (see plate 1). The external walls have an average width of 0.54m, although the east gable is somewhat thicker at between 0.60m to 0.64m; it rises from a slightly projecting plinth at the south-east corner, the only part of the structure where such a feature is visible. There are two courses of projecting through stones to the external face of the north wall, set at 1.20m and 2.20m respectively above the external ground surface.

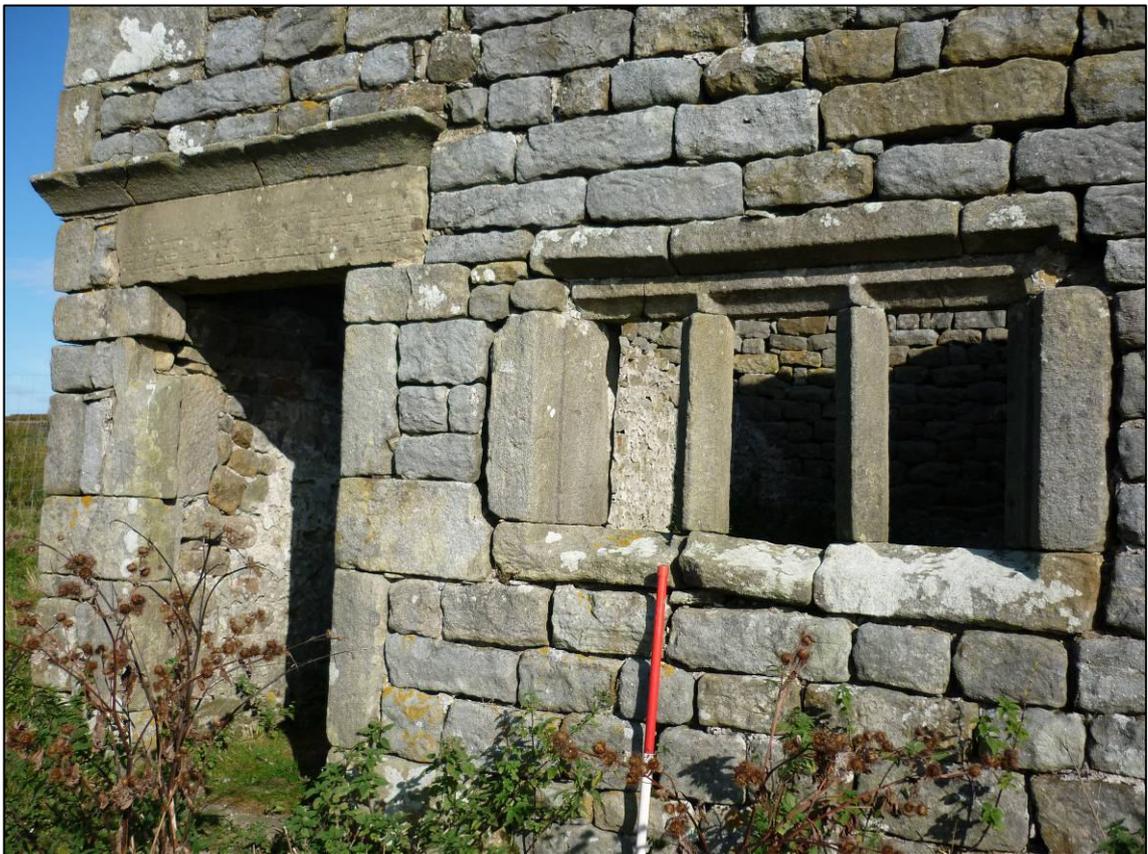
Plate 2: Doorway and west window, south elevation, looking NW (photo 1/03).

- 3.12 The south elevation has a 0.8m wide ground floor doorway at the west end, chamfered to the exterior and rebated to the interior [1/03, 1/05 and 1/08] (see plate 2). The doorway has a substantial stone lintel with horizontal tooling marks, over which there is a projecting dripmould with a shallow hollow chamfered profile [1/09 and 1/26]. To the east of the doorway, there are two recessed three-light mullioned windows to the ground floor [1/02, 1/04, 1/06 and 1/07]. In 1977, it was noted that the higher quoin stones bore herringbone tooling within a border, suggesting that the roof level had been raised by about four feet in the early 19th

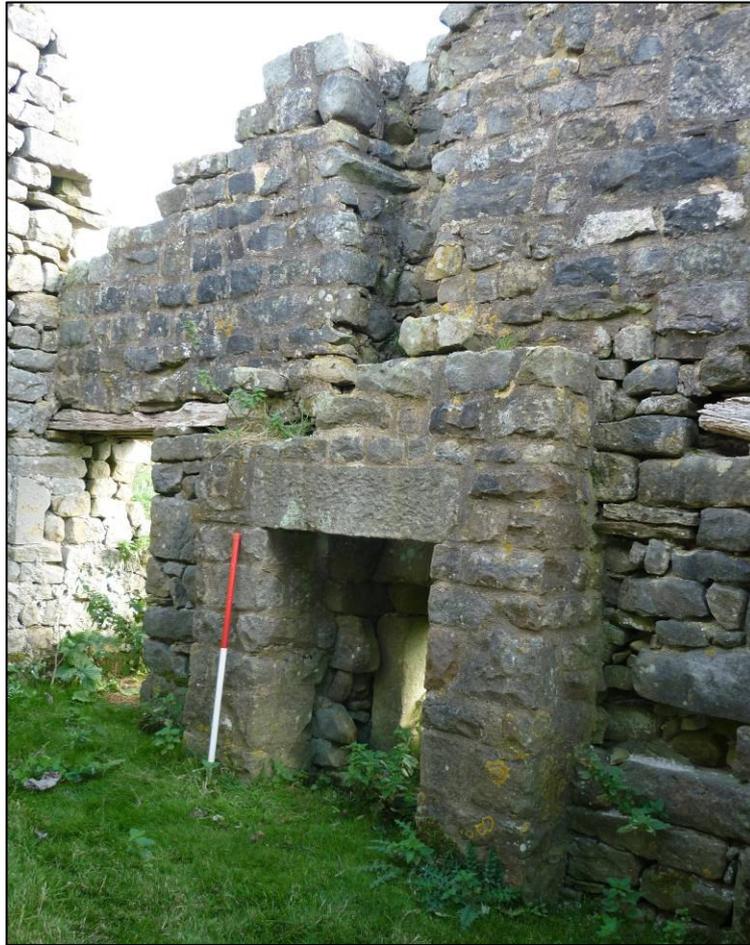
Plate 3: Fireplace, east wall of west cell, looking NE (photo 1/18).

- 3.16 The main feature to the east wall of the west cell is a projecting fireplace, rather blocky and thickly pointed [1/18 and 1/19], and a completely modern construction post-dating 1977 (see plate 3). A possible low horizontal recess is visible to the south. The back of the fireplace has been broken through into that to the east (see below) [1/20]. The flue is well-built [1/28] and can be seen rising up through what remains of the first floor. This flue has also been heavily repointed and perhaps rebuilt to an unknown degree. The remains of a doorway jamb, formerly linking the first floor rooms, can be seen at the south end. The fireplace is flanked by ground floor doorways leading through into the east cell, each positioned at the extreme north or south ends of the cross wall [1/21] (see plate 4). Each of these doorways has a wooden lintel, one of which is made from a re-used timber bearing an empty mortice but, as they have concrete lintels clasped between them, they may also result from modern rebuilding. The inner end of each lintel to the west cell appears to be set within a rectangular recess which is too large for the timber, perhaps an earlier feature which has been re-used.

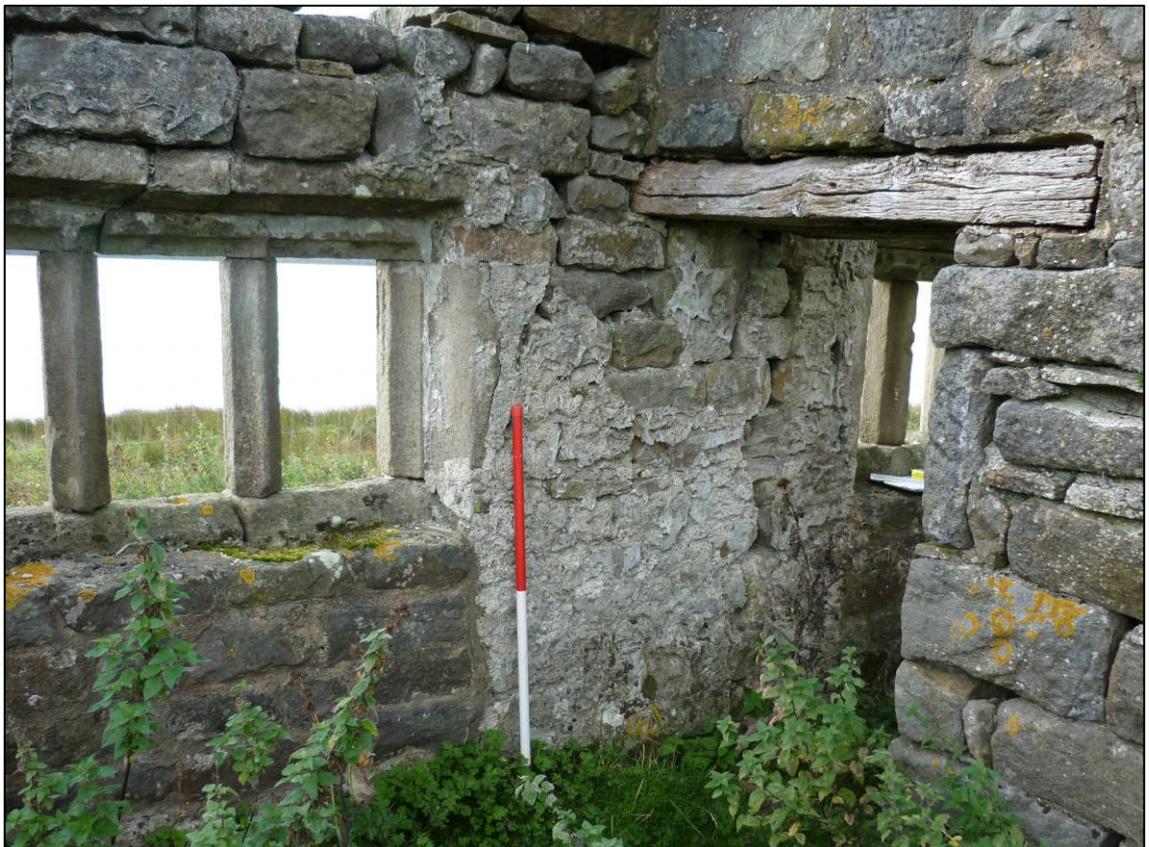
Plate 4: Doorway, south end of west wall in east cell, looking SW (photo 1/21).

- 3.17 The interior of the east cell is even more sparse than the west cell. The mullioned window in the south wall is similarly detailed to that in the west cell, with the same blocked recess beneath (see plate 4), and the west light bears evidence for bolt wear to the east side [1/27]. The projecting fireplace to the west wall has well-tooled monolithic lintels and jambs [1/13 and 1/14]. There is a wooden lintel above the stone lintel and then a low section of wall, heavily repointed. This wall obscures some kind of opening with a larger stone lintel behind, while the flue rising up above the fireplace is rather awkwardly positioned and eventually links into the flue of the fireplace in the west cell. Before it does so, it is crossed by a roughly horizontal wrought-iron bar set c.1.5m above the internal ground level [1/29]. In 1977, the seating of an off-centre spine beam was still visible in the east wall (Barley, Voakes & Harrison 1977a).

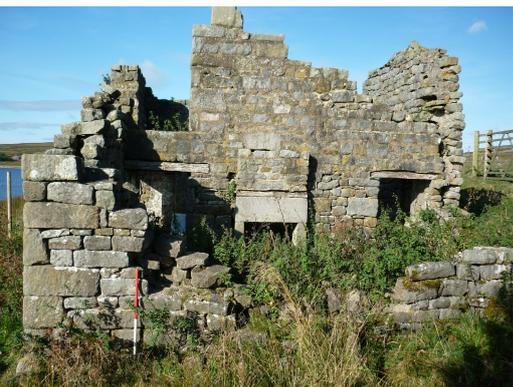
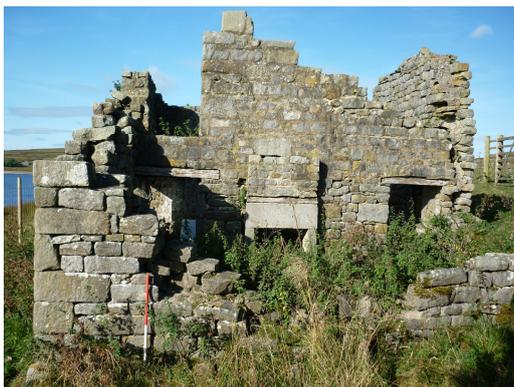
- 3.11 As has already been noted, the east gable has almost completely collapsed [1/10 and 1/11], as has the east end of the north wall. Apart from the through stone courses, the external north elevation is largely blank, with the exception of a small chamfered window positioned at a low level to the west of centre [1/23]. The quoins at the west end of the north elevation are large and rather long [1/25]; one at an upper level bears a sloping diagonal scar or mark, but it does not continue across the main elevation and so does not appear to denote the roofline of a former abutting building. The west gable is completely blank [1/24]. The quoins at the south end are deeper but narrower than those to the north, almost forming an edge-laid pattern; they also bear strong diagonal tooling marks. The upper part of the gable, like much of the rest of the structure, has been repointed/rebuilt since 1977 using a flush sandy mortar, rather thickly applied; there also appears to be the remains of cement capping to the top of the gable. There may be the remains of a first floor window to the south end, but this is more likely to be a result of the conservation works, as no such feature was mentioned or recorded in 1977.

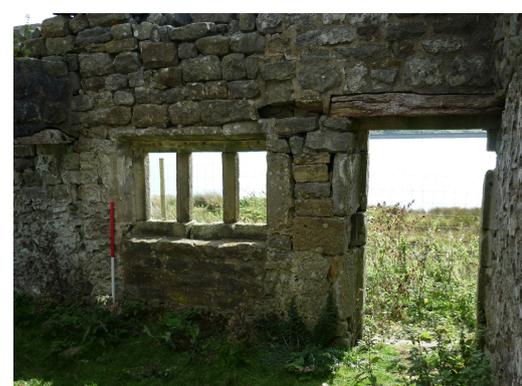
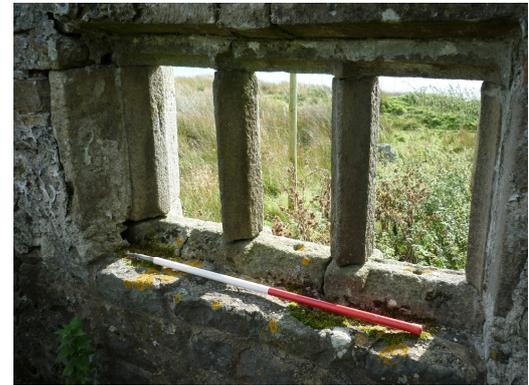
- 3.15 Each light of the three light mullioned window in the south wall [1/30 and 1/36] was also once fitted with a vertical standard, shallowly socketed into the lintel and sill [1/33 and 1/34]; the mullions have a slightly hollow chamfered profile [1/14 and 1/31]. Slight lines or differential weathering around the insides of the lights [1/37] suggest that the standards may once have been used to secure glazing, although the central light has wear to the east side suggestive of a bolt. There is no clear evidence for any former pintles to support shutters, although the window has a 0.57m high blocking beneath it. This was formerly of the same depth and width as the window itself. There is a row of four unevenly spaced dowel holes above the window lights internally, each containing the remains of a dowel [1/35].

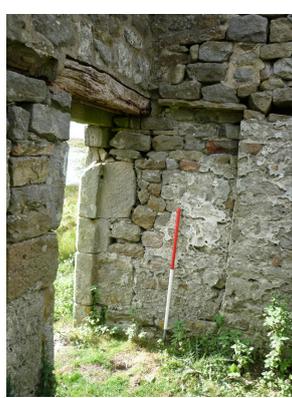
1-32.JPG

- 3.13 The only original access to the interior of the building was through the doorway at the west end of the south elevation. The doorway jambs splay outwards to the interior, and pintle holes show that it was once fitted with a door mounted on the west side. The door opened into a shallow recess in the west wall [1/32].
