POULTRY HOUSE, EAST SIDE OF GRANGE BECK,  
SKELLGILL LANE, LOW ABBOTSDALE,  
NORTH YORKSHIRE

ARCHAEOLOGICAL SURVEY

Report no: 2008/322.R02  
Version: Final  
Date: October 2009  
Author: Shaun Richardson & Ed Dennison

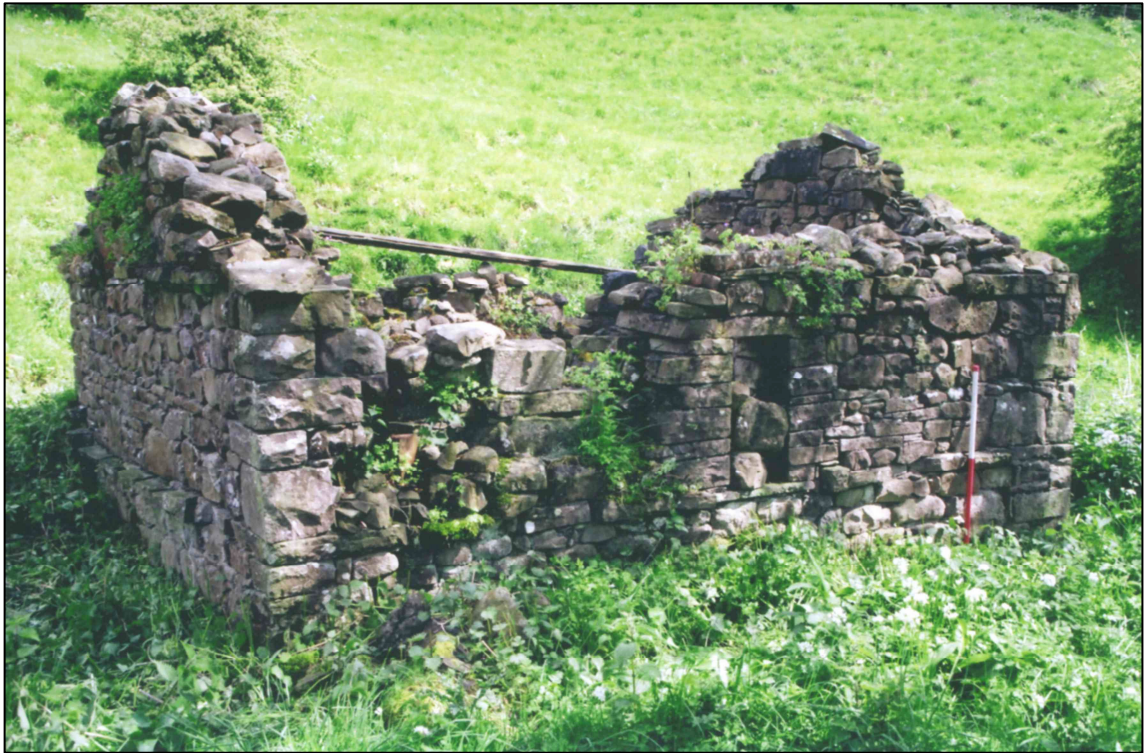
Plate 1: West elevation of hen house, looking E.

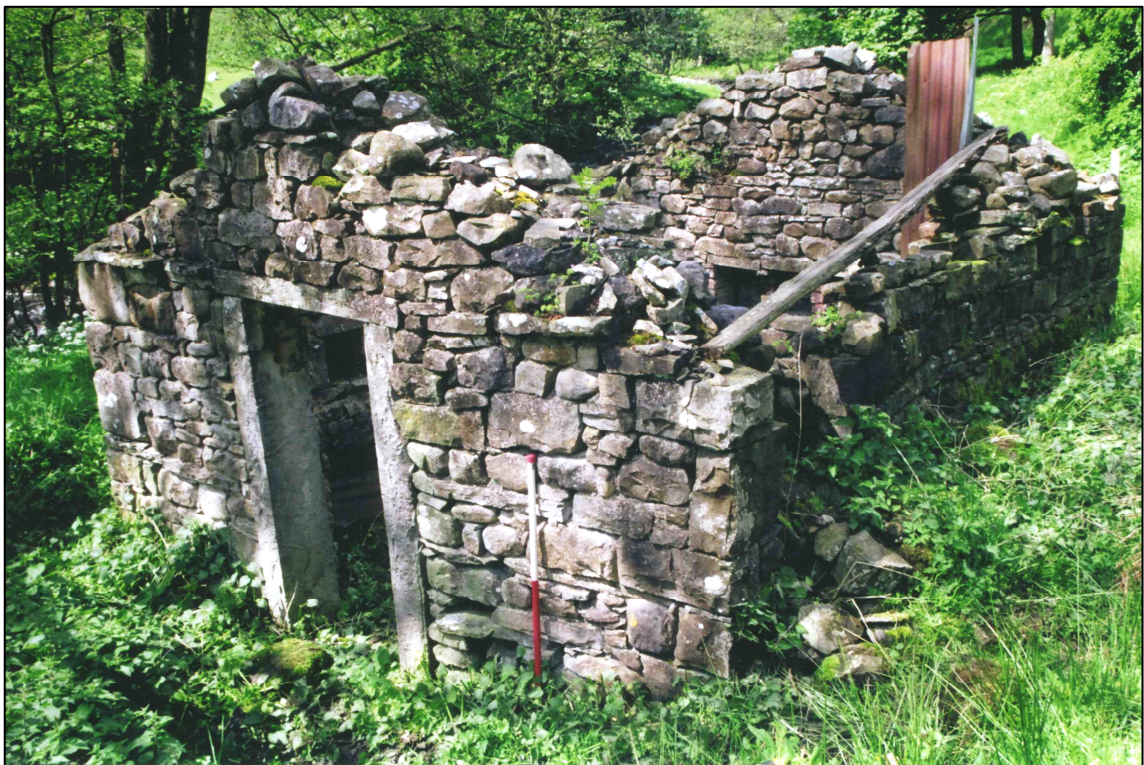
- 3.9 The only access into the interior of the building is through a doorway in the south gable (see plate 2). The doorway has monolithic limestone jambs and a flat limestone lintel. It is rebated to the interior, and preserves the remains of a stable-type door. The upper and lower leaves of the door were each supported on wrought-iron spearhead strap hinges set on iron pintles to the east jamb, and secured to latch fasteners to the west jamb. The upper leaf of the door was formed by softwood uprights nailed to softwood battens secured to the hinges; narrow gaps between the uprights provided ventilation. The lower leaf had completely gone at the time of the survey, but was presumably solid. To the east of the doorway, there is a possible opening placed just above ground level. This is unlikely to be a former "pop-hole" for hens, as it lacks any evidence for a shutter and is also at a level that provides easy access for vermin, and so is perhaps just the result of collapse rather than an actual structural feature.

Plate 2: South elevation of hen house, looking NW.

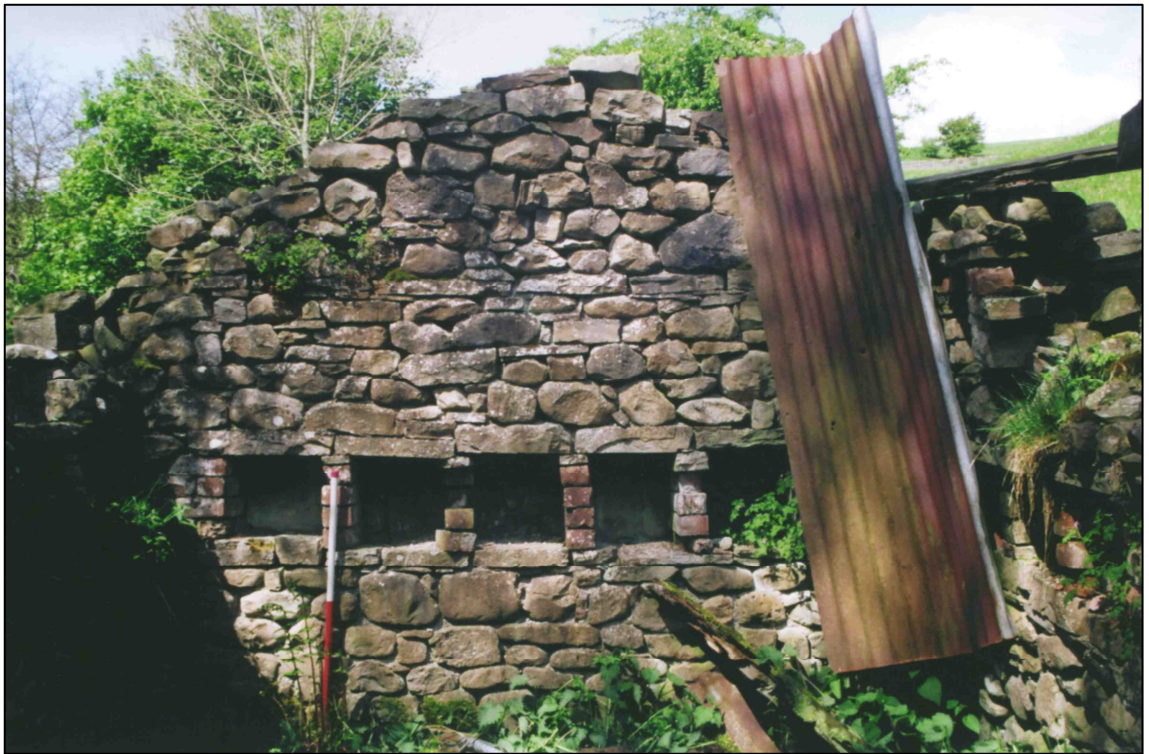
Plate 3: Internal north wall of hen house, looking N.

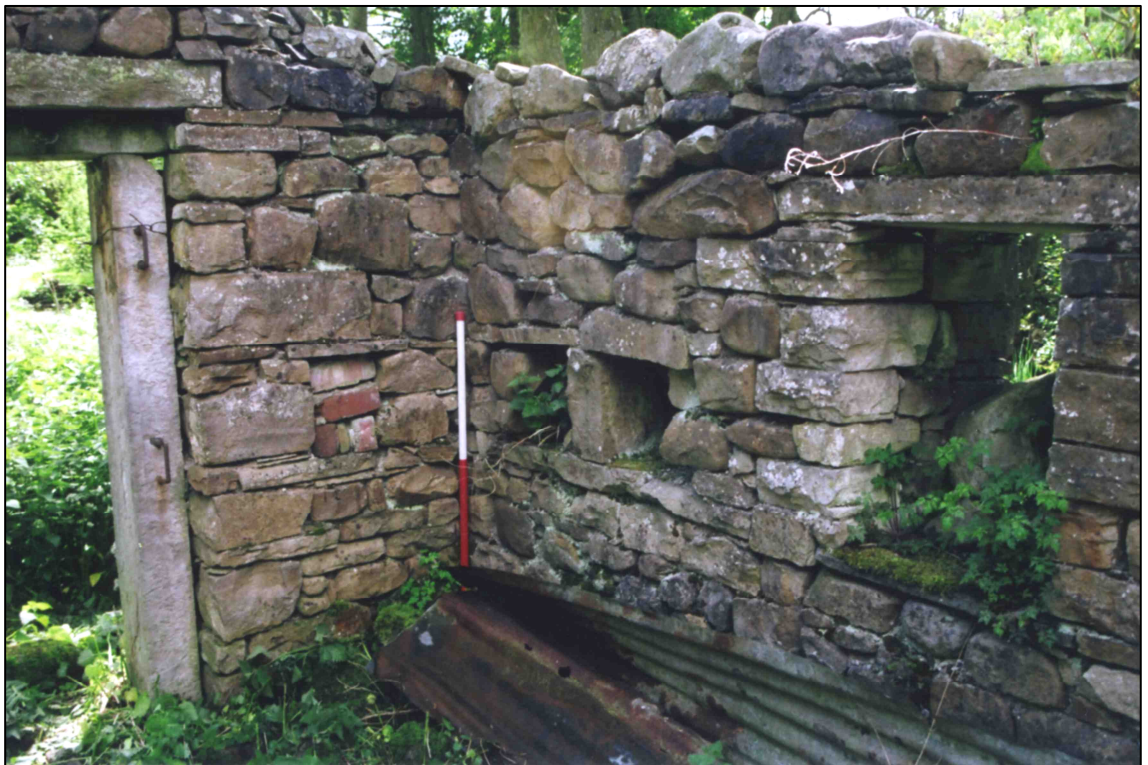
- 3.10 The poultry house was lit by a relatively narrow window, splayed to the interior, in the centre of the west elevation (see plate 4). The head and sill of this window are formed by smooth sandstone flags, and preserve no evidence for a frame, dowel holes or any other fittings. There was once another window at a high level towards the north end of the east elevation but this had largely collapsed by the time of the survey; it may once have had a counterpart at the south end of the same elevation. Apart from the projecting stones, the north gable is completely blank, while the lower part of the east elevation is hidden by the adjacent slope.

Plate 4: Internal south-west corner of hen house, looking SW.
