REAR OF 25-27 MARKET PLACE,  
PONTEFRACT, WEST YORKSHIRE

BUILDING RECORDING

Report no: 2008/329.R01  
Version: Final  
Date: February 2010  
Author: Shaun Richardson & Ed Dennison

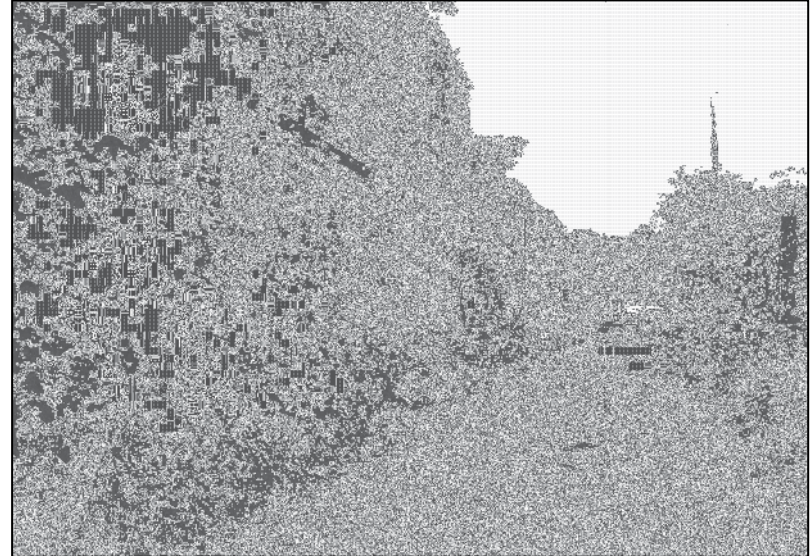
Plate 1: W side of range, Building D in foreground, looking NW (photo 1/4).

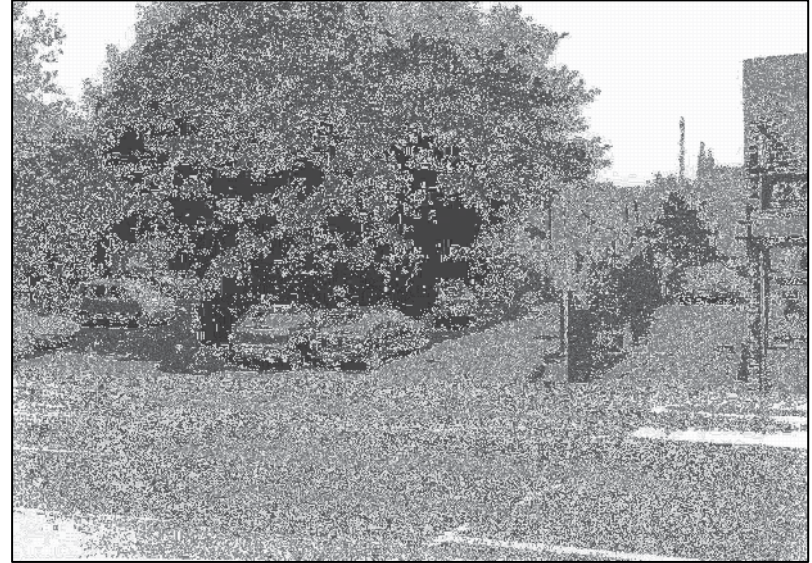
Plate 5: S gable of Building D and E side of range showing conditions at start of survey, looking NW (photo 1/1) (top to left).

- 4.19 The structures forming the range of outbuildings would have been subject to piecemeal alteration throughout the late 20th century. The insertion of large doorways in the ground floor east elevations of several of the buildings suggest that they could have been turned over to the repair of cars, or used as temporary garages. Their condition at the time of the survey suggests that they had been unoccupied for a significant period of time before the survey work began.

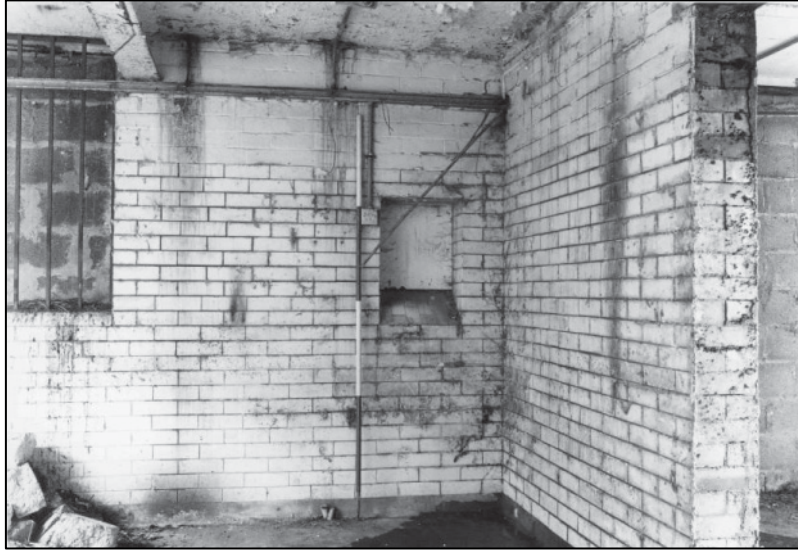
a former function, but the large window to the east wall is fitted with an internal grille of vertical round-section steel bars (plate 21).

Plate 21: Building A, N part of GF, looking E (photo 10/4).

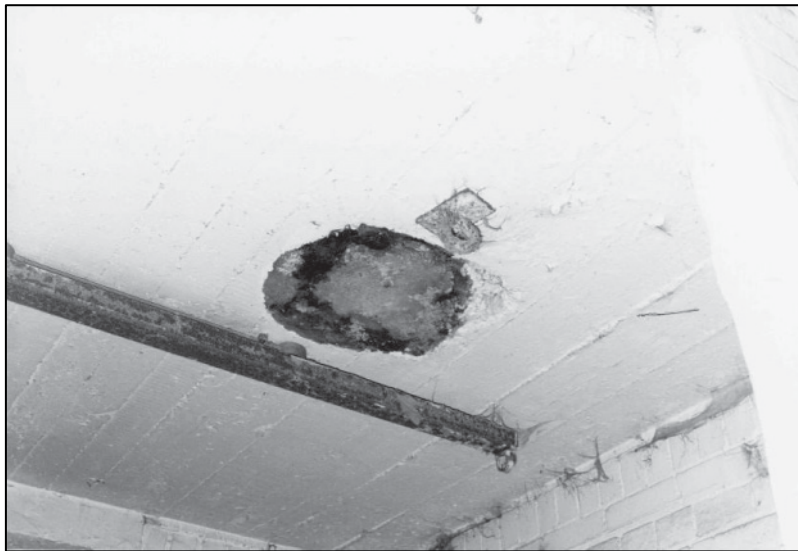
Plate 23: Building A, blocked hole and ring to ceiling, GF SE corner room, looking E (photo 9/2).

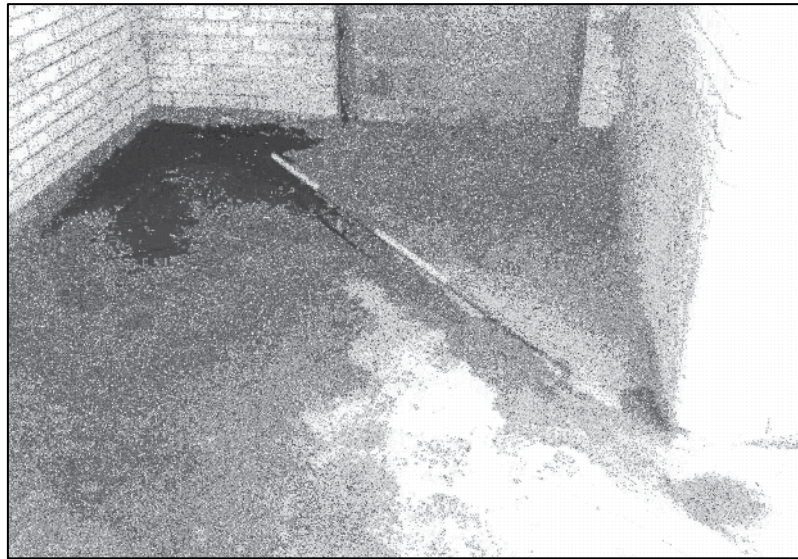
Plate 27: Building A, S part of GF, drain crossing floor, looking N (photo 9/10).

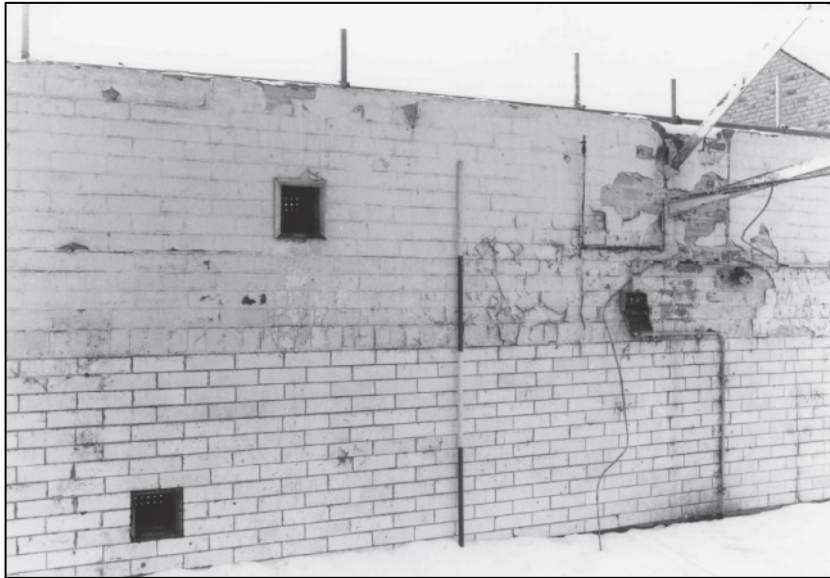
- 3.23 The first floor was formerly accessed via the timber stair rising from the ground floor (plate 30). The concrete first floor is supported on the steel beams crossing the ground floor and, at 0.22m thick, is relatively substantial. The first floor is split into two parts, with a large single space occupying most of the area, and a much smaller separate space at the south-east corner; to the west of the latter is the double height space rising from the ground floor. In both the large and small spaces, the walls of the first floor have white glazed brick to 1.0m above floor level, again with sealed joints between the brick and the concrete floors (plate 31).

Plate 31: Building A, 1F, showing typical glazed brick height, looking W (photo 8/17).

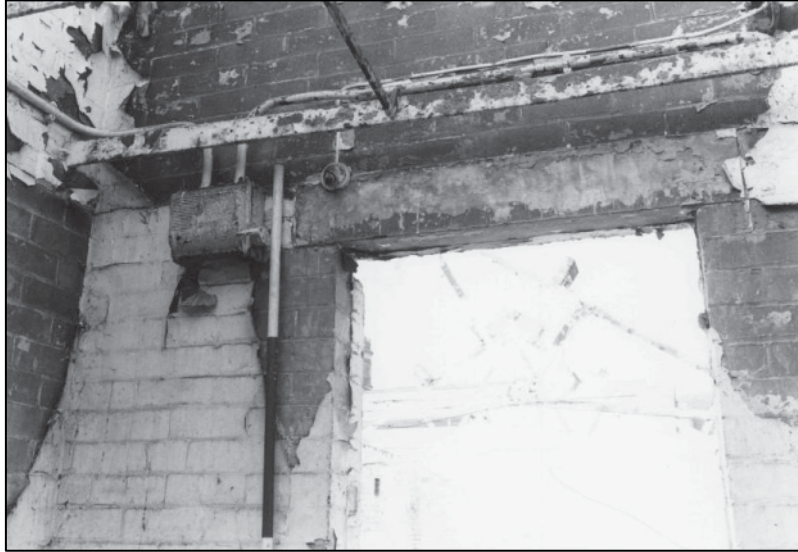
- 3.24 The small space at the south-east corner is entered via a doorway in the north wall, and is lit by a window in the east wall flanked by vents (plate 32). The doorway itself has a wall-mounted switch/fuse box to its west (plate 33). It is crossed by a number of east-west aligned slim steel joists, linked by some square-section cross pieces. An extraction hood with associated vent is mounted on the south wall (plates 34 and 35). This may have been served by the louvered ridge vent visible on the roof; the short stack adjacent to the vent appears to have served the same space, although quite why is not clear. The double-height space to the west can be viewed from the first floor through a small opening in its north side, above which rises a short corbelled out chimney stack or flue (plate 36) noted above. Again, it

Plate 33: Building A, 1F SE corner room, detail of rail over door, looking N (photo 8/6).

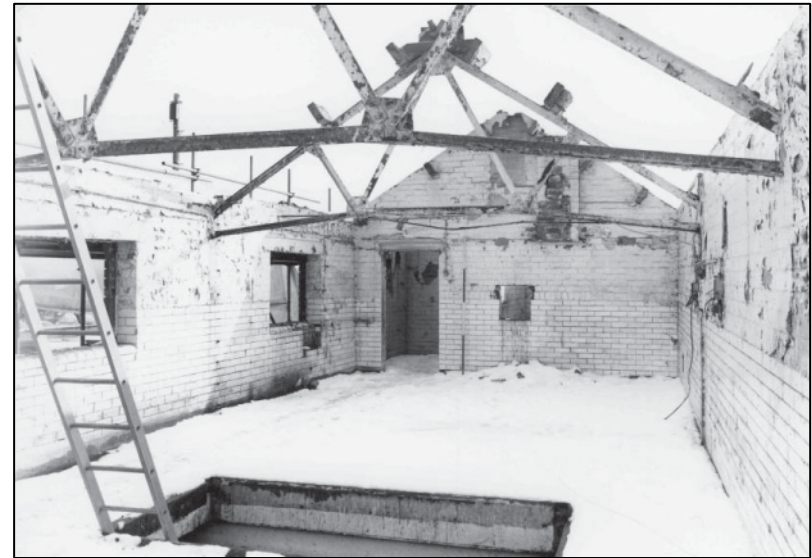
is difficult to see what this flue serves, as there is no fireplace on the ground floor in this position, nor apparently on the first floor. The quantity of electrical ducting surviving along the east and west walls of the main space at this level, and the large windows to the east wall (plate 37), indicate that there must have been some machinery formerly operating here, although it seems to have all been mounted on tables or benches, as there are no indications in the concrete floor of former machine positions.

Plate 36: Building A, 1F, looking S (photo 8/16).

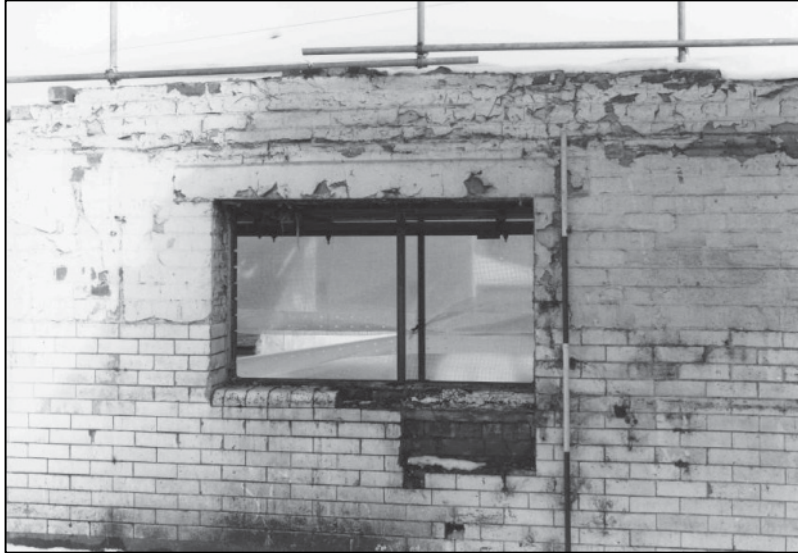
Plate 37: Building A, 1F, showing typical window, looking E (photo 8/18).

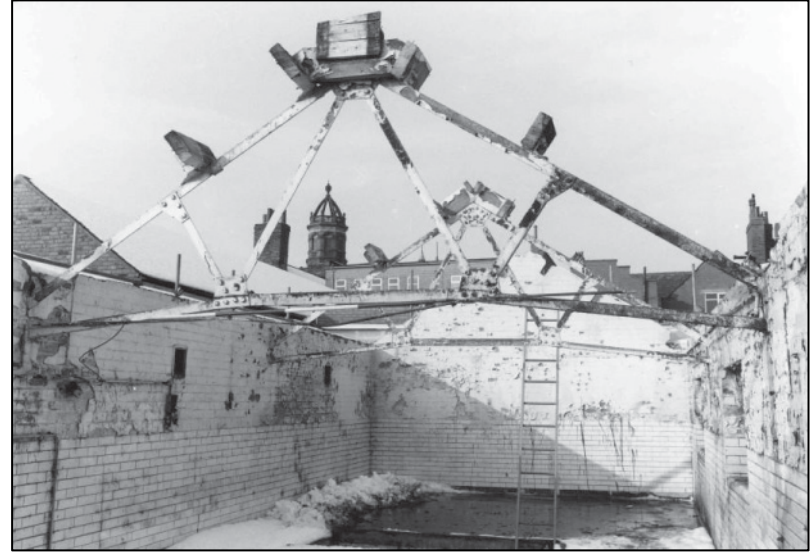
- 3.25 The main space is crossed by three roof trusses, all of bolted angle-steel sectional construction and all of the same form (plates 38 to 40); the ends of the trusses are set directly into the wall, with no wall-plate. The “tie-beam” of each truss is formed by three separate pieces of angle-steel, joined so that the central piece is horizontal but raised further up over the floor to ease circulation. The principals are formed by single pieces of angle-steel, with angle struts running from the “tie-beam” to the centre of principals and a second set from the “tie-beam” to the apex of the truss; flat plates are used to secure the joints of the different elements of the truss (plate 41), and there are triangular plates between the smaller of the angle struts and the principals. Each principal formerly supported three softwood purlins, with small pieces of angle-iron set at their downslope sides. There is no ridge piece but at the apex of each truss, an upright softwood board is placed across the top with wedges supporting a valley arrangement of softwood planks, which formerly ran the length of the roof.

Plate 38: Building A, 1F showing typical roof truss, looking N (photo 8/7).

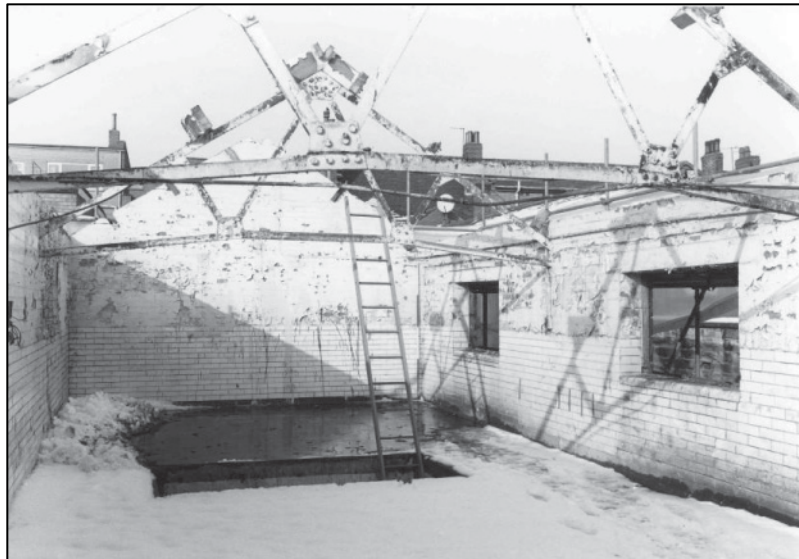
Plate 39: Building A, 1F, looking NE (photo 8/10).

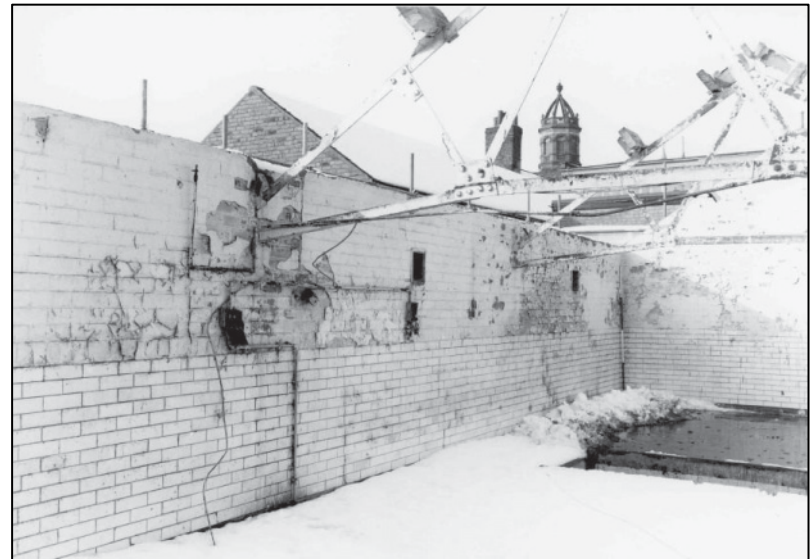
Plate 40: Building A, 1F, looking NW (photo 8/12).

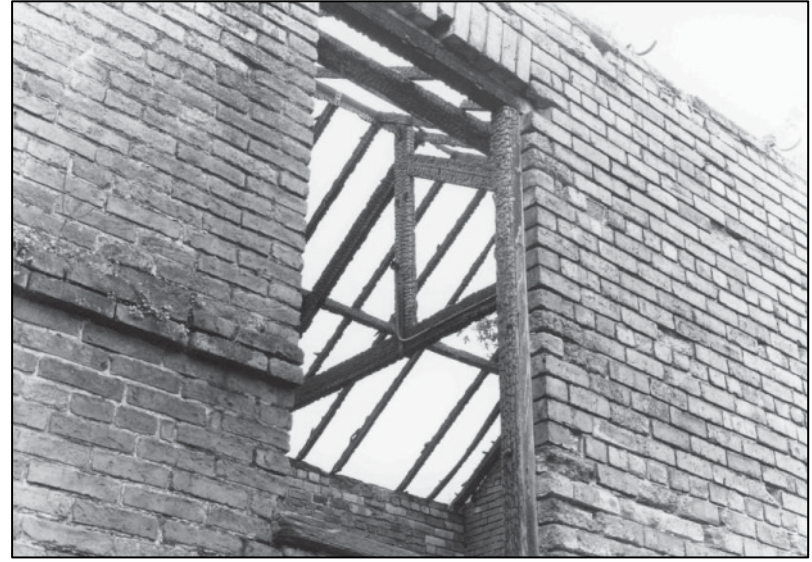
Plate 46: Building B, 1F truss viewed through 1F window in E elevation, looking S (photo 2/10).

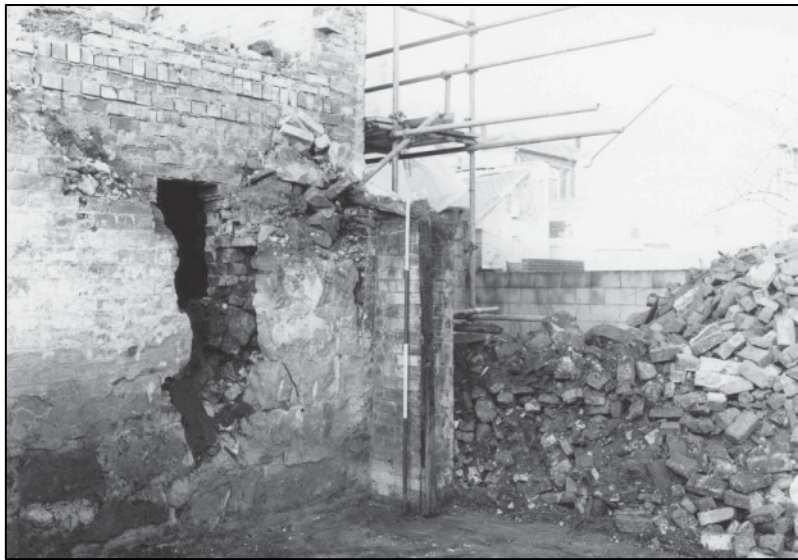
- 3.30 At the time of the survey, the only access to the interior of the building was via a doorway cut through the south wall of Building A (plate 47). An examination of the resulting section through the walls demonstrated that the north wall of Building B, which has a total thickness of 0.35m, is made of more than one skin of brickwork, thus explaining the disturbance/ragged joints visible externally at the north ends of the east and west elevations. To the interior ground floor of the building, the north wall is built of coursed and squared sandstone to 1.30m above ground level (plates 48 and 49). Over this, the wall is built of reddish-orange handmade bricks (average dimensions 220mm by 110mm by 80mm) set with a cream lime mortar but not laid to any particular bonding pattern. This brickwork incorporates a blocked window with a cambered head, crossed by the existing first floor and so predating its construction; it also clearly predates Building A to the north, which obscures it (plate 50).

Plate 47: Building B, GF after partial demolition, looking N (photo 10/11).

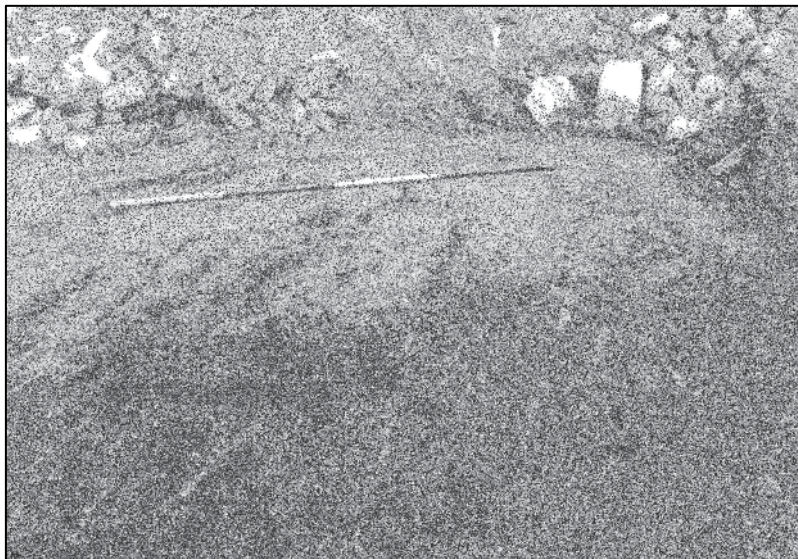
- 3.31 The ground floor is floored throughout with concrete, with metal tracking curving around the north-east and south-east corners indicates the former position of a sliding / folding door. A drain is positioned to the south-east of the centre of the floor (plate 51). The west wall (plates 52 and 53) is of brick and contains a number of blocked recesses and areas of render patching. The south wall is also of brick, with a blocked doorway at the east end formerly leading through into Building C (plates 54 and 55). The ground floor was crossed by east-west aligned joists, badly charred (plate 56). No structural or documentary evidence was uncovered to suggest the presence of a cellar beneath the building.

Plate 51: Building B, concrete floor of GF after partial demolition, looking E (photo 10/16).

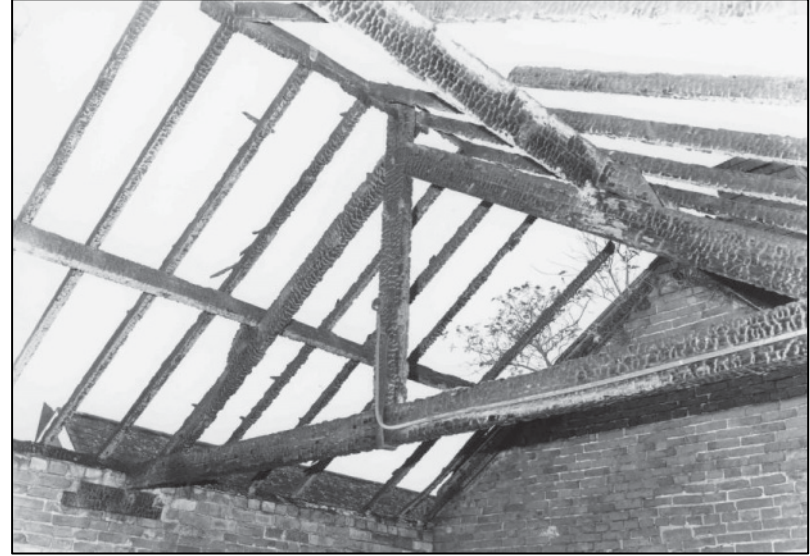
- 3.33 The remainder of the internal walls are largely blank, with a doorway in the south wall leading through to Building C. The first floor is crossed by a single badly charred softwood roof truss, of simple bolted tie-beam, king strut and principal rafter form. Each principal supports a single purlin with a wooden wedge to the downslope side, and there is a plank ridge piece (plate 58).

Plate 58: Building B, roof truss over 1F room, looking NW (photo 4/2).

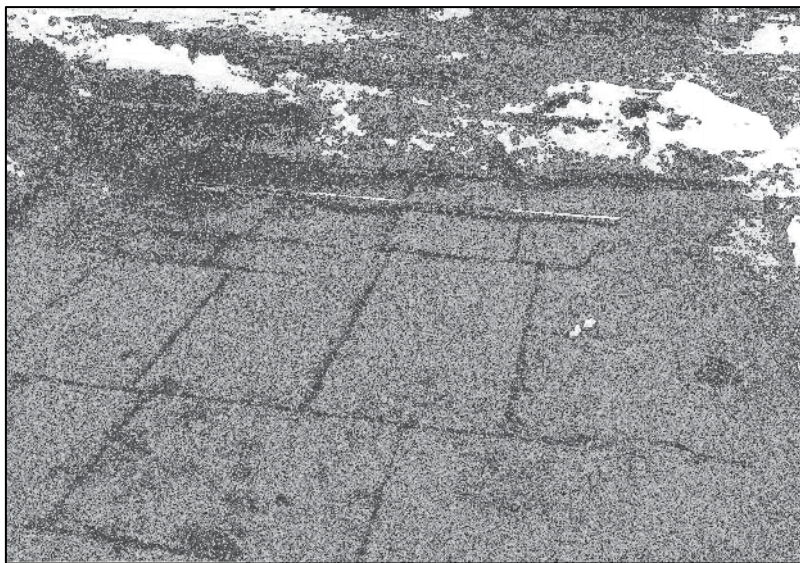
Plate 80: Building C, tethering ring? in flagstone floor, S GF room, looking SE (photo 6/8).

- 3.40 The southern, smaller, cell is floored with well-cut sandstone flags (plate 79), within which a number of features are visible. There is a large cast-iron tethering ring (plate 80) attached to the south side of the floor, while to the north, a small cast-iron drain cover is set into it; the shape of the flags adjacent to the cover suggests that the floor was draining into the drain from the south (plate 81). Towards the west side, a curving line of wear may suggest an opening gate or door here. A shadow or mark left by a fitting attached to the floor runs along the west edge of the cell, terminating in a concrete socket (plate 82), similar to that used for the stall partition in the north cell. A number of features are also visible in the west wall

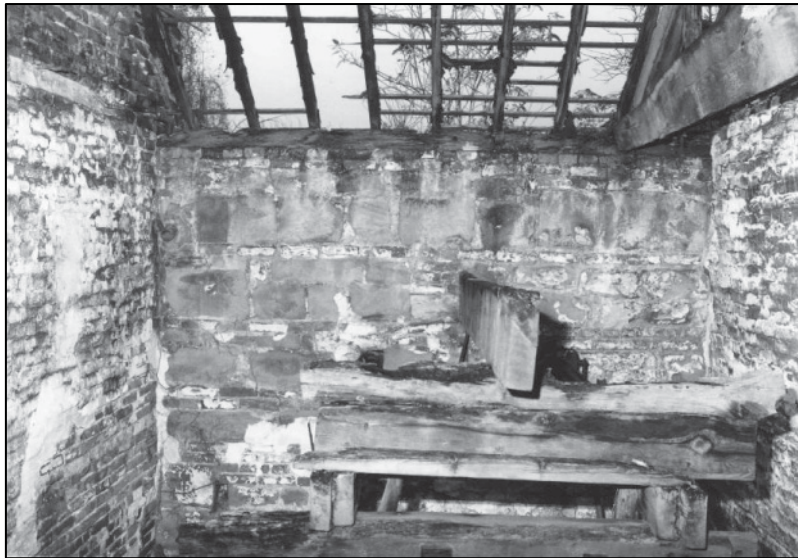
Plate 87: Building C, S 1F room, looking W (photo 4/16).

- 3.42 The smaller, southern, cell has the same mixture of stone and brickwork to the west wall (plate 87). A doorway was crudely inserted into the centre of the south wall through an earlier flue within Building D to the south, linking the first floor of the two structures (plate 88). To the east of the doorway, a single brick width skin has been added to the wall face, whereas at the west end the south wall can be seen to be built over the west wall; there may also be a slightly lower roof line visible here. A large pile of timbers has been made at first floor level (plate 89), lodged principally on the north-south beam. Although it was initially considered that these timbers may have served some historic purpose, the more detailed view gained from the scissor-lift and scaffolding during demolition shows that they were in fact a relatively recent creation; white spray paint rising up the north and south walls here suggests that spray painting was undertaken on the ground floor, with the timbers forming a crude hoisting frame to lift heavy parts. The southern cell is crossed by a single roof truss, set very close to the north wall. It is clearly re-used from a timber-framed building, and is constructed of pegged oak throughout (plate 90 and 91). The slightly cambered tie-beam supports tapered principal rafters, with angled struts between the two; the east principal bears the numeral "III" at the foot of its south face. Empty mortices in the soffit of the tie-beam once housed braces to posts.

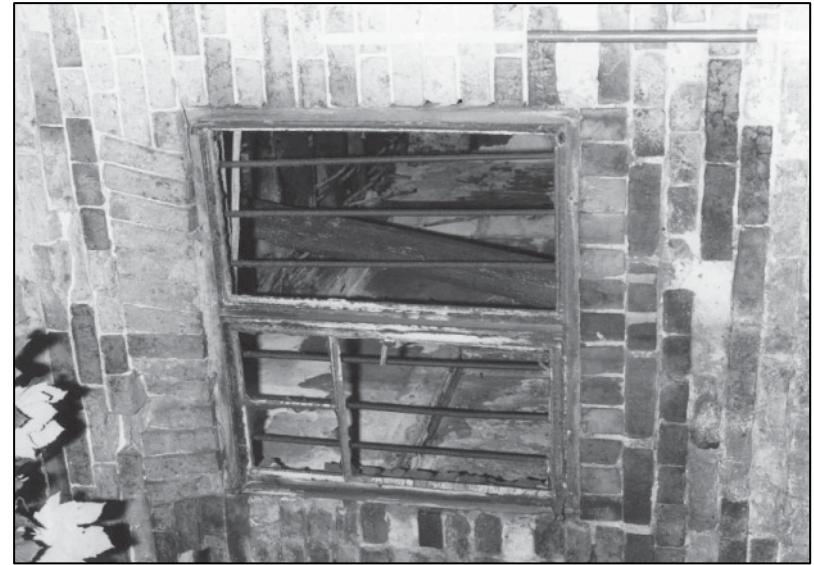
Plate 94: Building D, detail of GF window at W end of S gable, looking NW (photo 2/18) (top to left).

- 3.45 The south gable was partly obscured by a large tree at the time of the survey. A window at the west end of the ground floor has a two-light metal opening casement placed to the front of an earlier timber casement fitted with seven circular section vertical wrought-iron bars socketed into the frame (plates 93 and 94). Above, to the first floor, there is a window of similar size in the same position (plate 95). The south gable and east elevation of the building are built of the same brickwork as the west elevation, although the three bay east elevation has been subject to considerably more alteration. A wide doorway with a steel lintel has been inserted at the south end of the ground floor, but the tall original central doorway survives, as does the window to the north with its projecting stone sill (plates 96 and 97). To the first floor, there are windows with projecting stone lintels to the outer bays (plate 98). The north end of this elevation (i.e. the north-east corner of the building) is butted by the south end of Building C to the north, which is slightly narrower in width (plates 99 and 100).

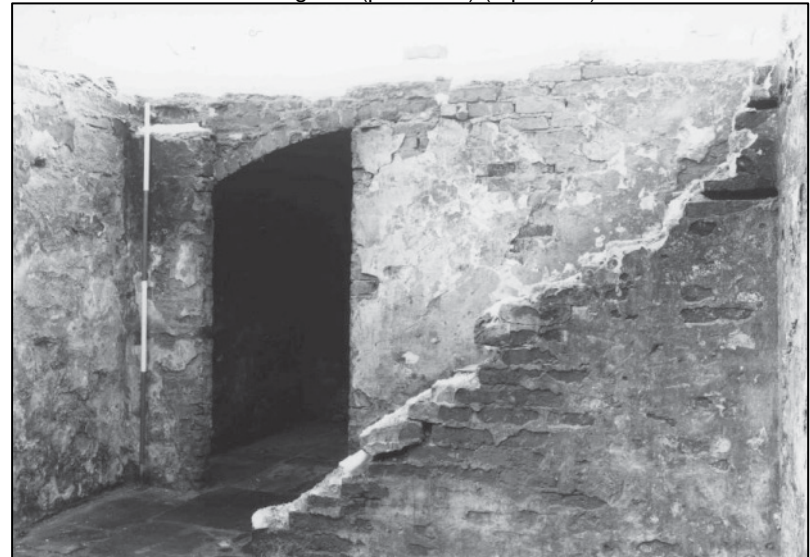
Plate 104: Building D, S wall of N cellar space, looking SE (photo 7/8).

- 3.46 At the time of the survey, the only access to the interior of Building D was via the doorway cut through the south wall of Building A and then by working one's way internally through the rest of the range. The ground floor once had a single-pile domestic plan, with single cells of equal size flanking the central staircase. A doorway at the west end of the north wall of the south cell opened into a small lobby, once fitted with shelving to the west wall (plate 101), from which the stairs descended to the cellars. The stairs are formed by a single flight and are built of brick with flagstone treads (plate 102). They descend to a small flagstone paved lobby, which formerly had doorways to either side, leading into the two parts of the cellar (plates 103 and 104).

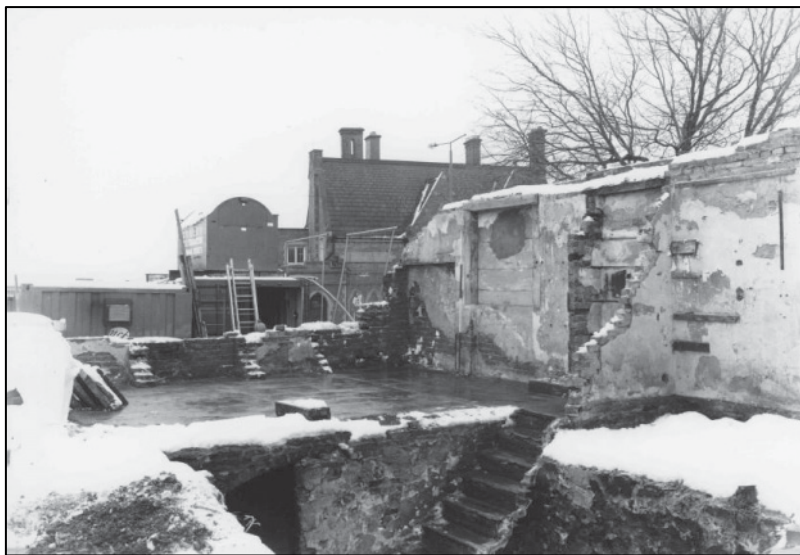
Plate 113: Building D, GF after partial demolition, looking S (photo 6/1).

- 3.49 As has already been noted above, the ground floor once had a single-pile domestic plan, with single cells of equal size flanking the central staircase, which was accessed externally by the central doorway in the east elevation (plates 113 and 114). The doorway opened into a small lobby or hall; ahead, the wooden staircase rose to the first floor, whereas to either side doorways gave access to the two ground floor cells.

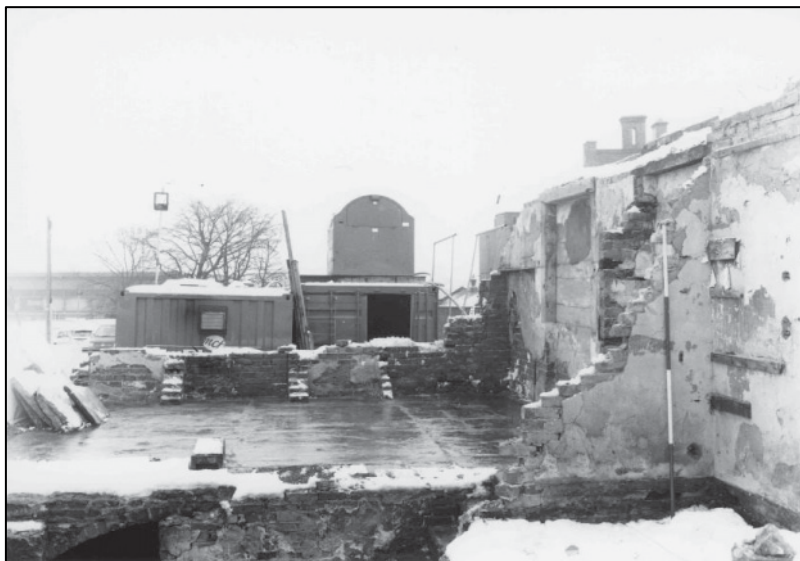
Plate 115: Building D, S GF room after partial demolition, looking SE (photo 6/13).

- 3.50 The majority of the south cell is floored with concrete, although there are narrow bands of neatly cut sandstone flags to the west and south sides (plate 115). The room was formerly lit by the small window in the west end of the south wall; there was probably once also a window in the east wall, but this has been removed by later alterations. Low stub walls to the south side of the room define a fireplace flanked by cupboards, once fitted with internal shelving (plate 116), with sandstone flags beneath. There are two shallow recesses to the west wall, retaining the remains of plaster beaded surrounds. The south recess is c.1.50m tall and probably housed a piece of furniture (plate 117), whereas the north recess is over 2.0m in height, and was once fitted with shelving (plate 118); its overall form suggests that it may once have formed a window, although there is no indication of such in the external elevation.

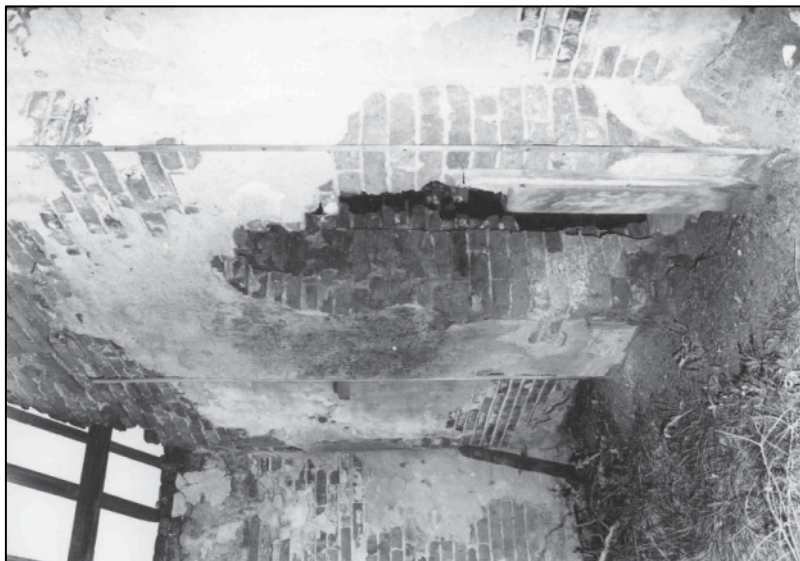
Plate 123: Building D, N 1F room, looking NW (photo 5/2) (top to left).

- 3.53 The doorway from the landing into the north cell retains a plain 19th century softwood architrave (plate 122), and there is a projecting chimney breast to the north wall (plate 123), once housing a fireplace but crudely cut through later to form a doorway. The brick walls of the cell are covered in decaying plasterwork, and there may be a blocked window visible in the west wall. Above the chimney breast in the north wall, a slightly lower roof line can be seen in the brickwork. The room is crossed by a single roof truss, placed towards its south side, although it was originally ceiled and so the truss would have been hidden. The bolted softwood roof truss is of simple tie-beam, king strut and principal rafter form (plate 124). Each principal supports a pair of staggered purlins with through-tenons secured by pegs.

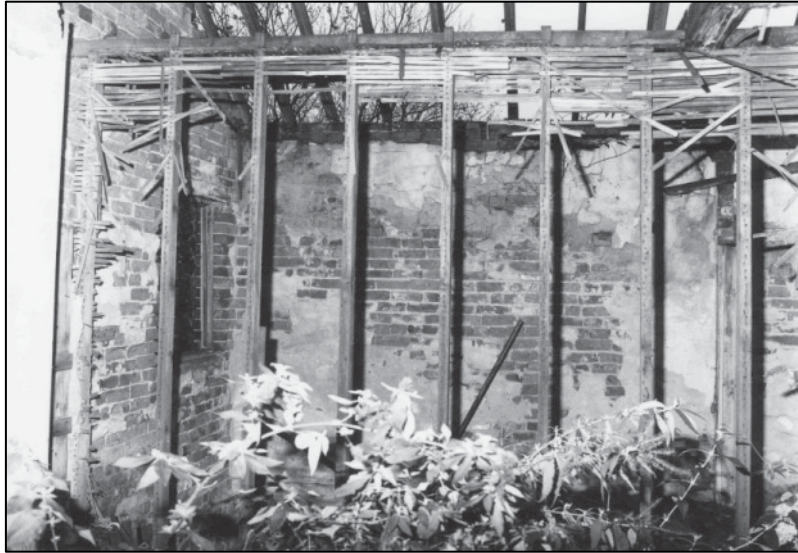
Plate 125: Building D, former partition, S wall of S 1F room, looking W (photo 5/7).

- 3.54 The south cell is sub-divided into two smaller rooms, formerly separated by a lath and plaster partition. The west room opened directly off the landing, and was lit by a window in the south wall (plates 125 and 126). The east room could only be reached through the west room and was lit by a window in the south wall. It was heated by a small fireplace at the east end of the south wall (plates 127 and 128), which retains a plain moulded 19th century timber surround. Both rooms were originally ceiled, but the lath and plaster has collapsed, revealing a roof truss of the same form as that described over the north cell (plate 129).

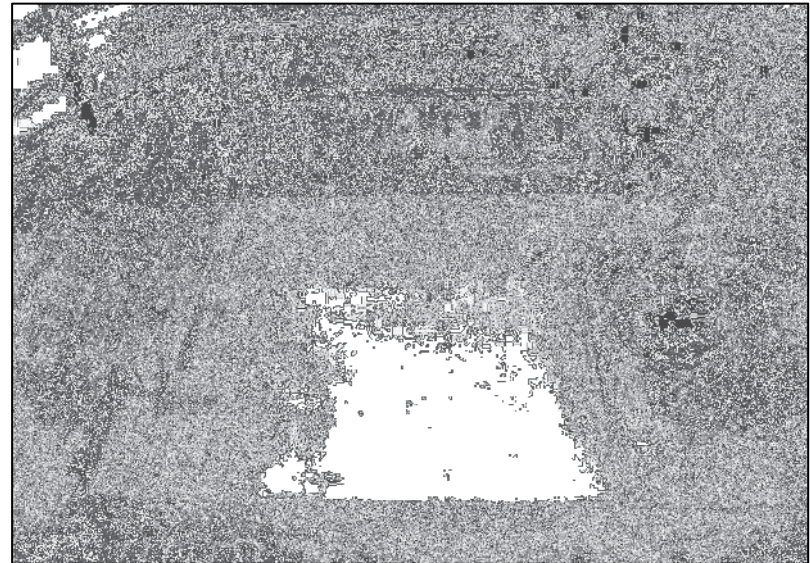
Plate 128: Building D, fireplace in S wall of S 1F room, looking S (photo 5/11)  
(top to left).

- 4.10 Surviving remains recorded during the survey work, and those observed during the initial site visit, demonstrate a modest degree of internal decoration to Building D, including plaster ceiling cornices, moulded fireplace surrounds and door architraves. The principal entrance was through the central doorway in the east
