ST MARY'S CHURCH,
WHARRAM LE STREET, NORTH YORKSHIRE

ARCHAEOLOGICAL WATCHING BRIEF

Report no: 2010/375.R01
Version: Final
Date: April 2010
Author: Shaun Richardson & Ed Dennison

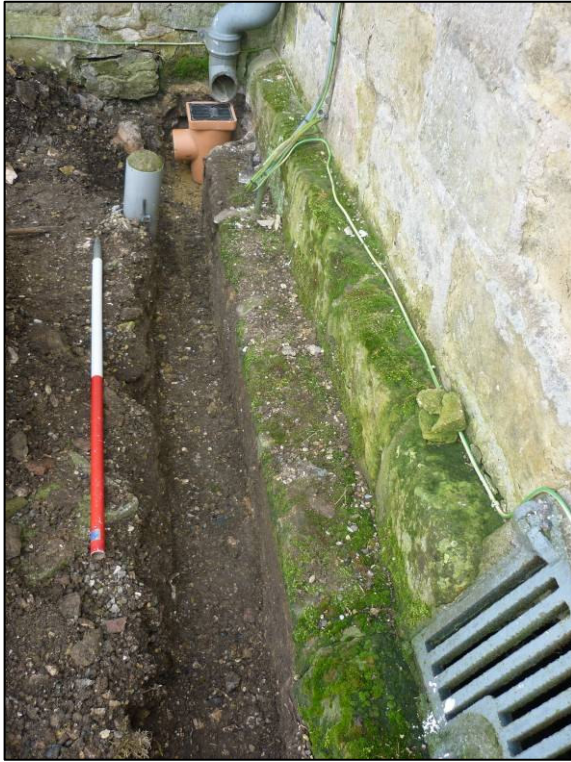
- 4.2 The pit for Gully 1 was located at the junction of the tower and the north aisle. The excavation of the pit allowed the stepped plinth of the tower to be more closely examined. The plinth comprised two stages, an upper step projecting 0.11m out from the wall face and a lower step projecting 0.20m beyond the lower step (see plate 1); the former may have been the 'foundation set-off' described by Bilson (1923, 58). The exposed section of the plinth stood c.0.50m in height and continued below the base of the adjacent drain (137.56m AOD). Both parts of the stepped plinth had been disturbed by the construction of the earlier downpipe gully, and so their relationship to the west wall of the north aisle is uncertain. However, the upper step can be traced around the west face of the tower, where it is broken by the doorway, and then around the south face, where it eventually fades beneath the rising ground surface here.

Plate 1: Gully 1 adjacent to church showing stepped plinth, looking E.

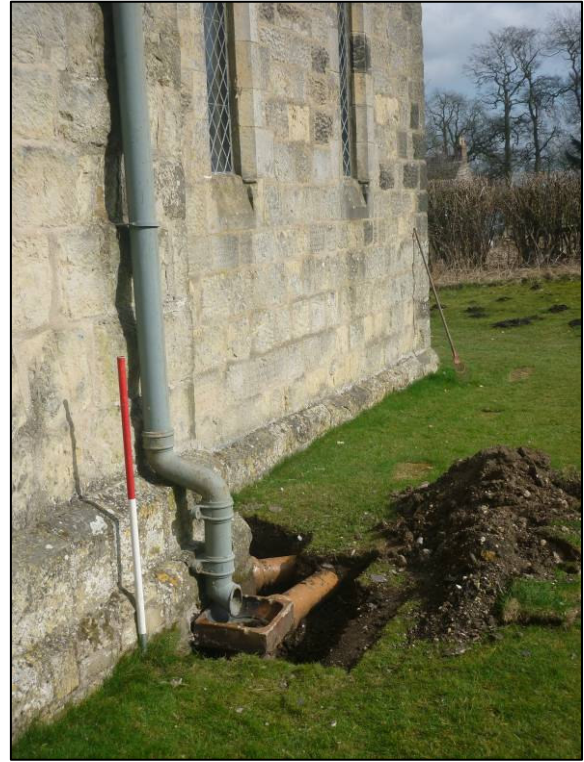
- 4.11 The pits for Gullies 4 and 5 were formed by a single conjoined excavation, located at the junction of the south sides of the chancel and the nave (see plate 2). The excavation of this pit allowed the plinths of both these parts of the church to be more closely examined. The plinth to the south side of the chancel is of the same form, and set at the same height, as that described for the north side of the chancel above under Gully 3. However, below the chamfered course, the wall face dropped vertically to the base of the pit (137.59m AOD), with no sign of the possible stepped plinth noted in Gully 3. The chamfered course of the chancel plinth continues unbroken around to the south side of the nave, where it forms the lower part of a double chamfered plinth. This double chamfered plinth runs the full length of the south side of the nave as far as the south porch, but is not present to the west of the porch.

Plate 2: General view of Gullies 4/5, looking E.

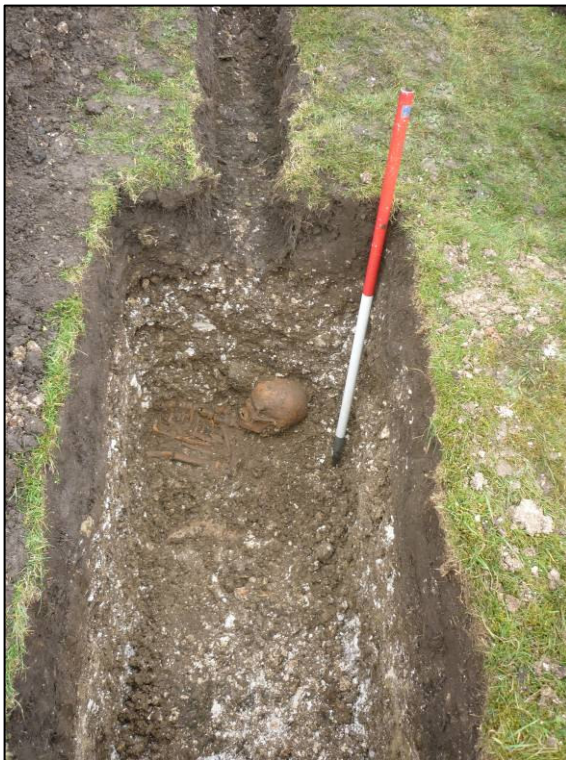
- 4.5 Within this layer [003], an *in situ* articulated burial [004] was partly exposed beneath the south section of the soakaway pit at 0.60m BGL (136.74m AOD) (see figure 4 and plate 3) - there was no clear cut associated with the burial. The skull, upper thoracic area and part of one arm were excavated; in accordance with best practice, the burial was not 'chased' beyond the limits of the excavation (EH/CoE 2005, 33) (see plate 4). The skeleton, which was extended with the head to the west, was probably that of an older child or young adult, and the bone appeared to be in a good state of preservation. Unusually, rather than lying prone, with the face looking upwards, the skull was placed upright, so that the face looked east, although there was no indication that the head had been detached from the body prior to burial. No nails or other coffin fittings were noted in association with the burial, and there was no dating evidence, but its relatively shallow depth might suggest that it is of medieval date.

Plate 3: General view of burial 004 in soakaway pit, looking S.

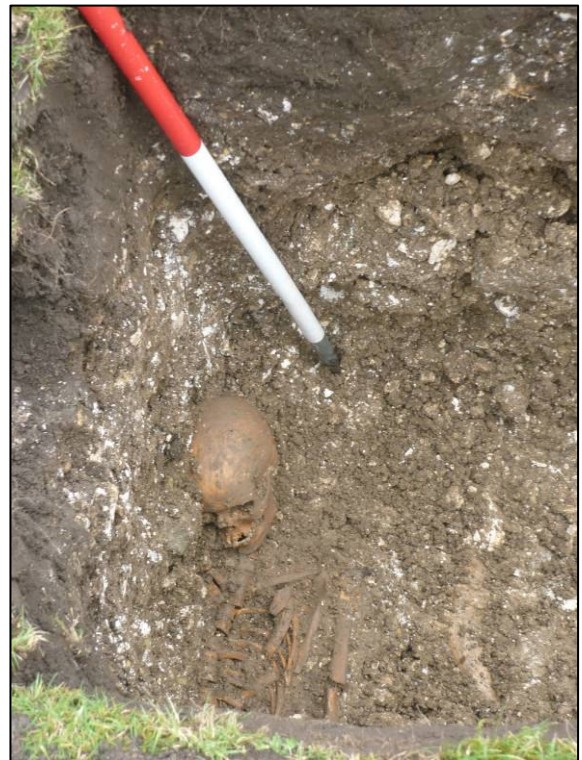
Plate 4: Burial 004 in soakaway pit, looking W.
