FOOTPATH REPAIRS, SHERIFF HUTTON CASTLE,
SHERIFF HUTTON, NORTH YORKSHIRE
ARCHAEOLOGICAL RECORDING BRIEF

Report no: 2009/355.R01
Version: Final
Date: January 2010
Author: Ed Dennison & Shaun Richardson

North Yorkshire County Council
Public Rights of Way Section
Economic and Rural Services
County Hall
Northallerton
North Yorkshire DL7 8AH

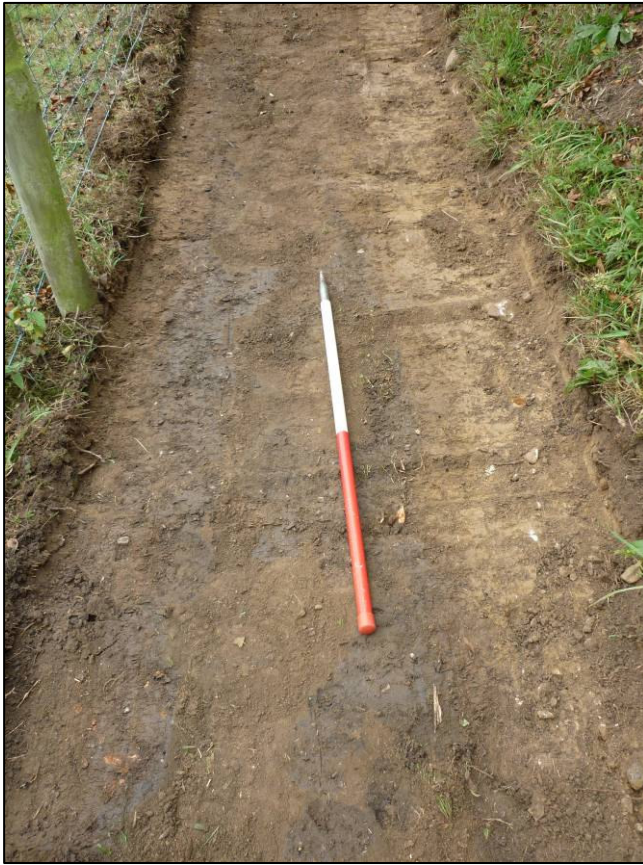
- 4.2 Three contexts were exposed within this part of the footpath alignment. Beneath the 0.05m thick dark brown/black silt topsoil (001), a friable mid-brown sandy silt subsoil (002) was revealed. This subsoil was only visible on the southern side of the footpath, where it extended beyond the base of the reduced area. On the northern side of the footpath, it overlay a hard/compacted orange-brown clayey sandy silt (003) which contained frequent inclusions of both angular and rounded stones; the former were up to 0.03m across, while the latter were somewhat larger at 0.10m (see plate 1). The clayey sandy silt (003) formed the make-up of the bank running parallel to the canal and it extended for a maximum of 1.50m to the south of the post and wire fence forming the north side of the footpath.

Plate 1: East section of footpath after ground reduction, showing contexts 002 (left) and 003 (right), looking W.

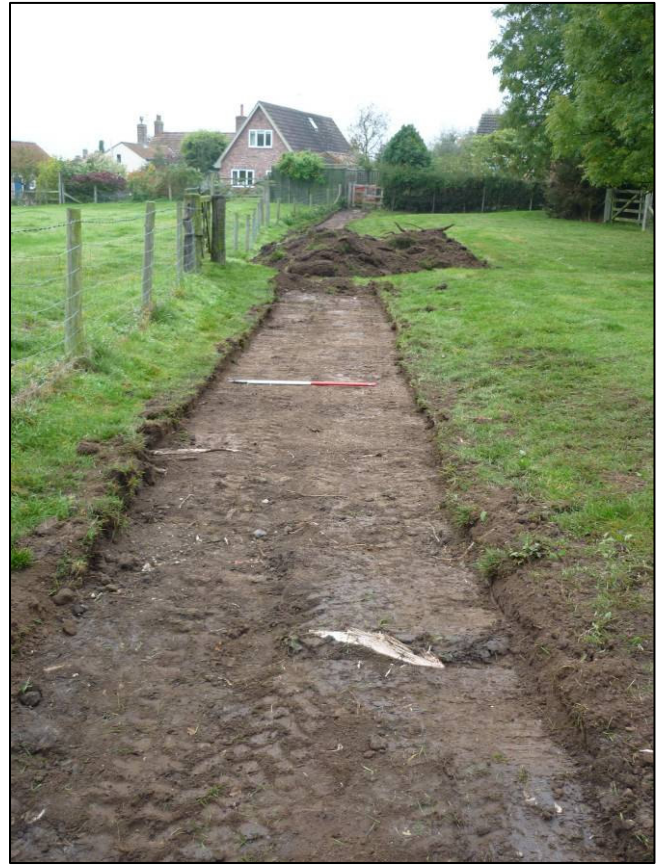
- 4.8 The whole of the western section was very clean, with only topsoil (001) and subsoil (002) encountered (see plate 2). The excavation through the central part of the western section (c.14m in length) was not monitored, as this area was already disturbed, having been used to dump spoil prior to it being removed from site. However, the c.11.50m length to the east and the c.17.50m length to the west were monitored, and these were found to contain no deposits of archaeological significance. It was therefore decided to curtail the archaeological recording at this point.

Plate 2: East end of west section of footpath after ground reduction, looking W.

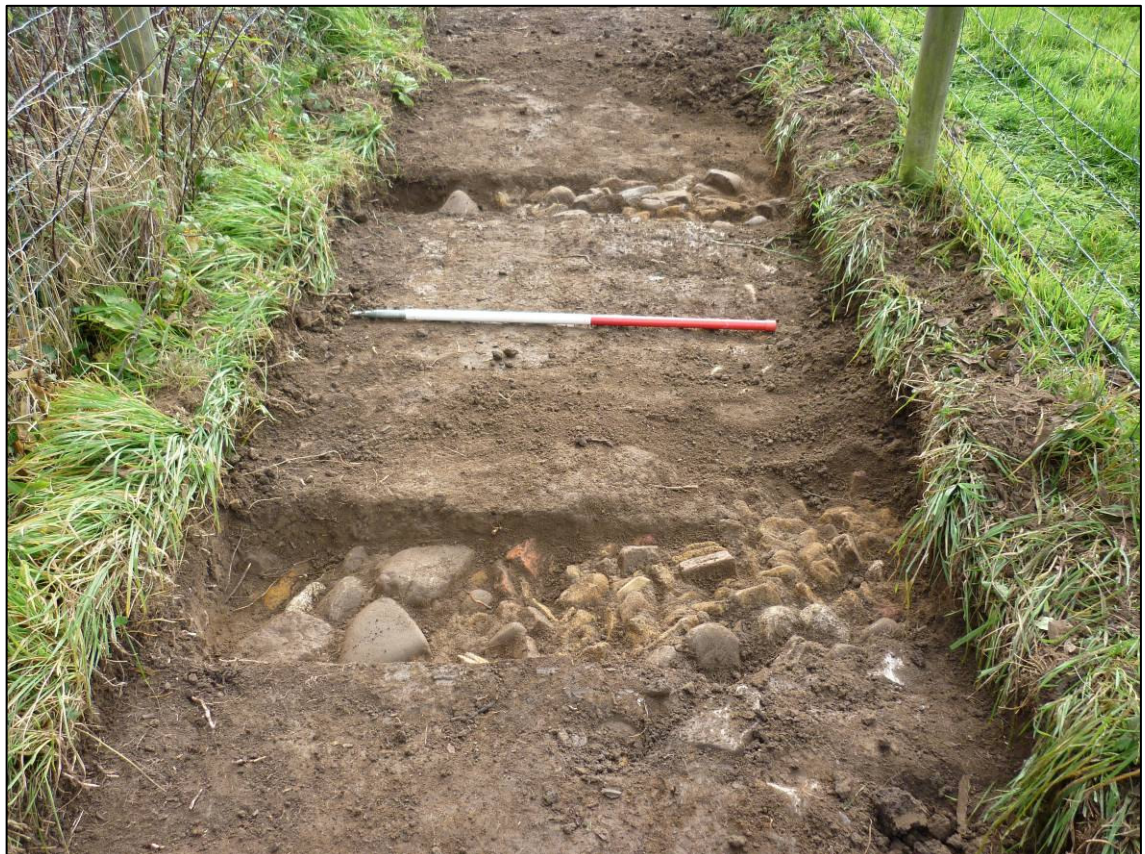
- 4.4 At a point 6.50m north of the return, the top of the remains of a structure (004) was partially exposed beneath the subsoil (002), and so the reduced ground level was slightly deepened by hand in two places to more fully expose the structure, in order to gain further information about its form and possible function. The southernmost visible part of the structure was located just to the north of the centre line of the north canal, which now terminates as an earthwork immediately to the east. The

Plate 3: Structure 004 in central section of footpath, looking S.
