THE CHURCH OF THE ASCENSION,
WHIXLEY, NORTH YORKSHIRE

ARCHAEOLOGICAL WATCHING BRIEF

Report no: 2009/350.R01
Version: Final
Date: January 2010
Author: Shaun Richardson & Ed Dennison

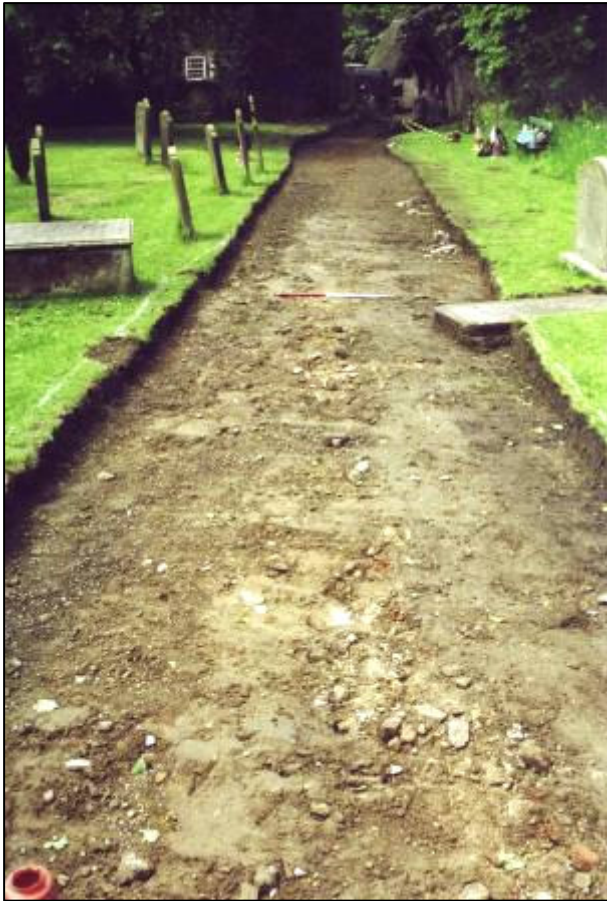
- 4.1 The ground works undertaken for the replacement of the footpath comprised the excavation of a shallow trench, aligned north-east/south-west and measuring 2.75m wide and 47.50m long (see plates 1 and 2). The northernmost 21.70m of the trench ran approximately straight, but the southern part followed a slightly sinuous course. The trench was excavated to a maximum depth of 0.25m below ground level (BGL) (44.81m AOD). Approximately half way along the west side of the trench, the associated vehicle turning point was excavated. This was aligned north-west/south-east, measured a maximum of 5.10m long by 6.50m wide, and was excavated to a maximum depth of 0.30m BGL (46.76m AOD).

Plate 1: Path trench after excavation, looking S.

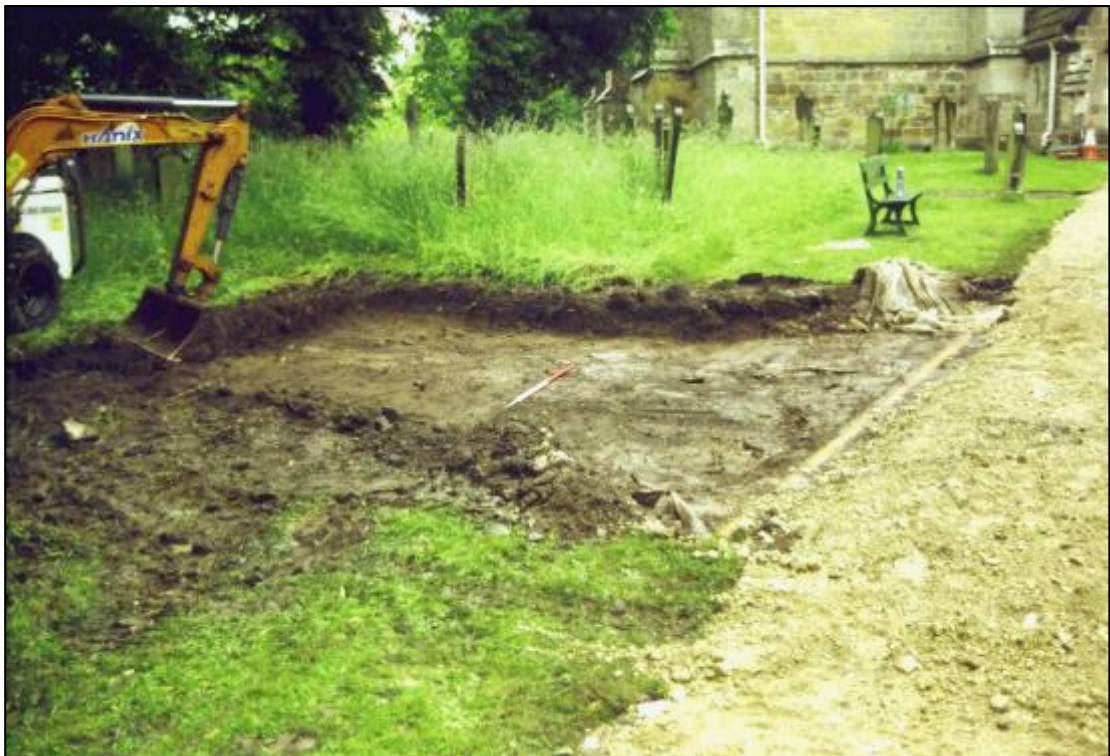
- 4.5 Within the area of the vehicle turning area, the same depths of topsoil (001) and sub-soil (002) were noted as in the main footpath trench (see plate 3). The sub-soil (002) overlay a reddish brown silty sand (011) with frequent flecks of sandstone and rounded pebbles, only visible in the base of the excavated area, i.e. at 0.30m BGL.

Plate 3: Vehicle turning area after excavation, looking N.
