ROMAN ROAD, BLUECASTER SIDE,  
NEAR SEDBERGH, CUMBRIA

ARCHAEOLOGICAL SURVEY AND  
WATCHING BRIEF

Report no: 2010/383.R01  
Version: Final  
Date: December 2010  
Author: Shaun Richardson & Ed Dennison

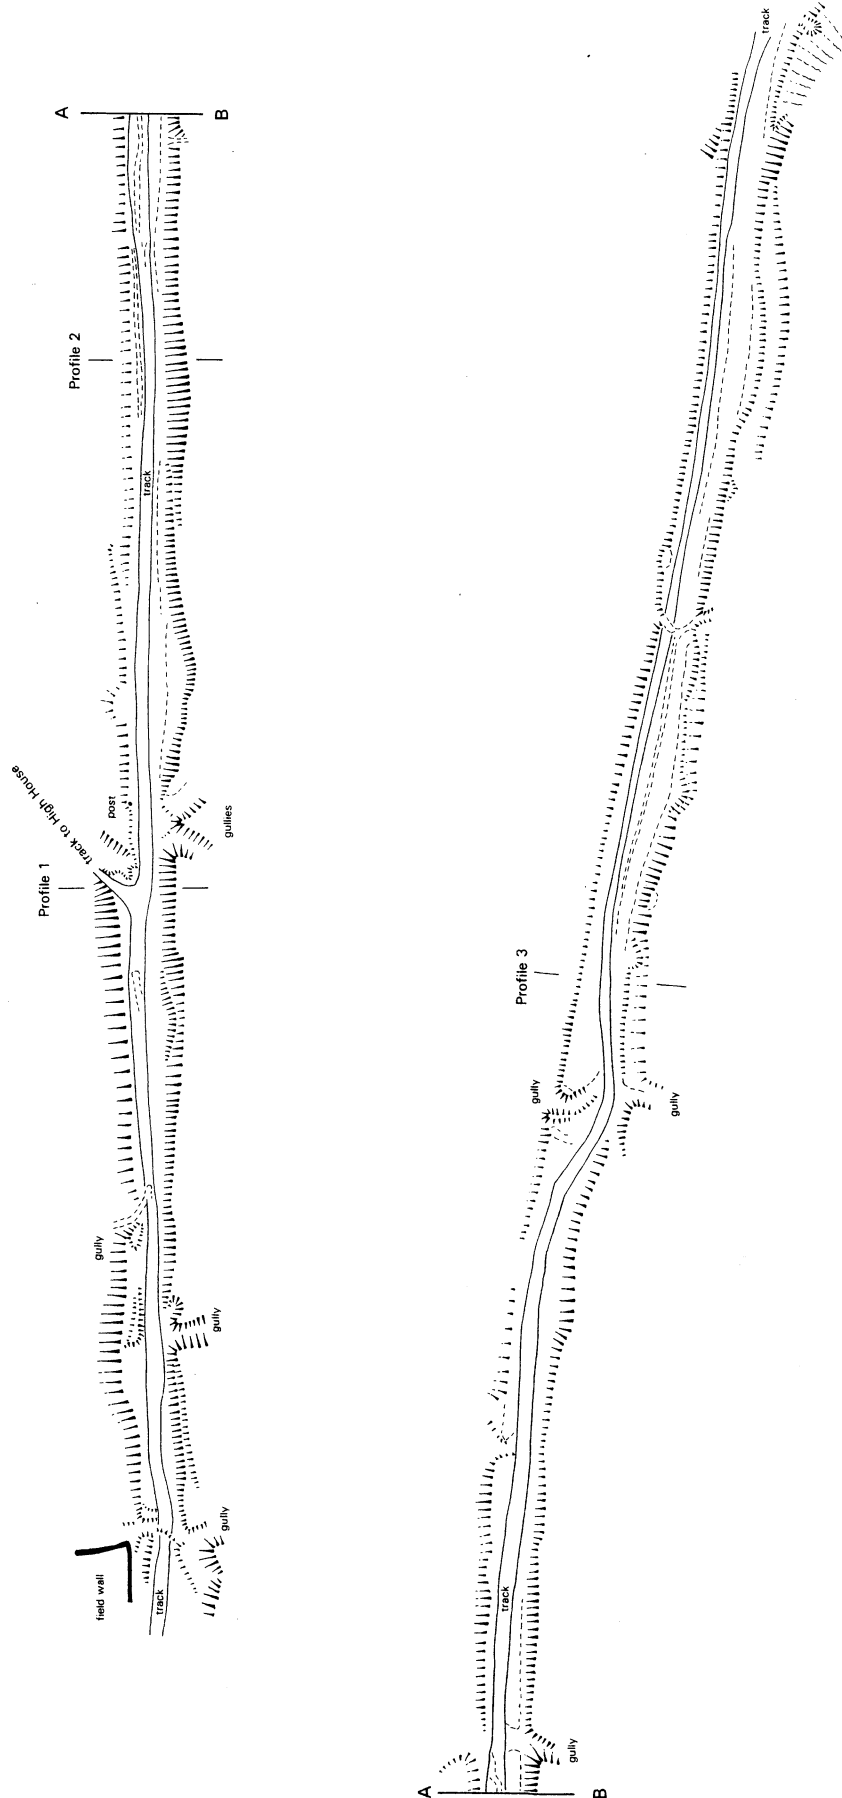
PROJECT	BLUECASTER ROMAN ROAD		
TITLE	TOPOGRAPHICAL SURVEY		
SCALE	AS SHOWN	DATE	DEC 2010
	EDAS	FIGURE	3

### **The Road Alignment** (see figure 3)

- 4.2 For the majority of its length, the road broadly follows the contour of the hillside. It is terraced slightly into the hillside, and for the southernmost 250m of the surveyed section, it rises gently from south to north. It then runs approximately level for a distance, before sloping downwards again into Near Gill. For most of its length in the surveyed section, the road is grassed, but some metalling, represented by both angular and rounded stones up to 0.10m across, shows through (see plates 1 and 2). In a few places, particularly where natural run-off has gouged deep gullies in the road surface, there are larger angular stones up to 0.25m across, presumably placed here relatively recently to try to stop further erosion.

- 4.3 The southern end of the survey area coincides with the north-east corner of a drystone field wall defining an enclosure formerly associated with Bluecaster Side house. At this point, the line of the road has been somewhat disturbed by a natural gully draining the moorland to the east. However, it is noticeable that to the south

of here, beyond the survey area, an earlier line of the road is clearly visible as an earthwork running parallel to the east side of the existing trackway. To the north of the gully, the road survives as a flattened linear terrace 6.5m in width, with a central rutted strip 3.0m wide forming the existing trackway used by vehicles [1/909] (see plate 1). The surface of the road is hard, but uneven. Along the west side, there is a prominent west-facing sloping scarp, up to 4.0m wide and 2.0m high. On the east side, there is second single, sometimes double, west-facing scarp, narrower but more steeply sloping, and up to 1.4m in height. Taken together, the terrace and scarps have a total width of 12.0m.

- 4.4 As the road rises to the north-east, another natural gully disturbs the east scarp, and there is a low curvilinear mound on the west side, overgrown with nettles at the time of the survey. At c.60m north of the southern end of the survey (where culvert 2 was excavated – see below), the natural water run-off had caused the surface of the road to become very uneven, including a curvilinear steep-sided gully over 1.0m deep which cuts through the west side. Beyond this gully, the road continues in approximately the same scarp-terrace-scarp form as before [2/924], although the total width of the earthworks increases markedly, reaching almost 15.0m wide where a trackway diverges from the west side towards High House. The first profile (Profile 1, see figure 4) was made across the alignment here, and it shows a total fall of c.3m from the top of the eastern scarp to the bottom of the western scarp. The profile also shows a slight gully or drain on the east side of the road here, although this was difficult to discern in plan at the time of the survey due to thick grass.

- 4.5 The road narrows immediately to the north of the trackway junction, where its east side is disturbed by a number of natural gullies. There may then be evidence for re-alignment or re-cutting, as a 50m long section adopts a slightly curvilinear plan, diverging from the general north-eastern alignment to a more northerly trend. Within this section, the scarp on the east side stands over 2.0m in height, while that on the west side is much lower and more spread at only 0.7m high. There is also a second, very faint scarp at the base of the east scarp which may mark the line of the ditch which become more clearly visible to the north. After a distance of 50m, the road resumes its north-eastern alignment and shallow ditches, set 5.0m apart from centre to centre, can be seen [2/925] (see plate 3). The second profile (Profile 2 - see figure 4) taken across the alignment here shows the road to have a width of 2.4m while the terrace is 6.8m wide, and there is a total fall of c.2.20m from the top of the eastern scarp to the bottom of the western scarp.

- 4.6 After the point where the second profile was taken, the road continues north-eastwards with the same scarp-terrace-scarp form of approximately the same dimensions, although the east scarp gradually becomes less prominent, falling to less than 0.5m in height [1/910] (see plate 2). Between the points where profiles 2 and 3 were taken, there are numerous ruts and gullies in the moorland slope immediately above the east scarp. The stepped profile of the east scarp is still apparent where the third profile was taken (Profile 3 - see figure 4). By this point, the road has almost stopped rising, and has levelled out somewhat. The stepped east scarp has a total height of c.1.4m, with a shallow ditch visible at the base. The terrace that supports the road is 7.5m wide here, with the west scarp becoming increasingly spread and shallow, barely more than 0.3m high. The earthworks forming the road alignment here have a total width of 13.0m, with a total fall of c.1.2m from the top of the scarp on the east side to the bottom of the scarp to the west.

- 4.7 Beyond profile 3, the terrace widens to 10.0m, and is able to support the existing trackway and a pair of ditches set c.4.0m apart to the east; however, at least some of the ditches are almost certainly the result of late 20th century rutting by large farm vehicles. This arrangement is visible for a distance of c.60m, after which point the ditches become intermittent at best, although the road terrace maintains a similar width. Indeed, as the road begins to descend towards Near Gill, it increases to almost 11.0m wide in places, although the scarps on either side remain low. At the northern end of the survey area, c.20m short of where the road crosses Near Gill, a shallow linear depression, diverging towards the northern end, becomes visible on the east side of the terrace. Its east scarp has a steep-sided U-shaped depression, 1.40m deep and open to the west, set into its northern end.

- 4.8 The ground surface dips quite markedly into Near Gill, and it may be that the road was once carried over it on a bridge, although if so, it was presumably a timber structure, as no footings, earthworks or accumulations of rubble that might indicate stone abutments can be seen. To the north of Near Gill, beyond the survey area, the road is visible again, although here it is of a different form and much better defined than within the survey area itself. It comprises a flattened linear strip, slightly raised and c.7m across, flanked by shallow ditches, and set within a low 'cutting' formed by c.1m high scarps [2/921 to 2/923]. In some places, particularly along the western side of the 'cutting', the road is flanked by a substantial bank.

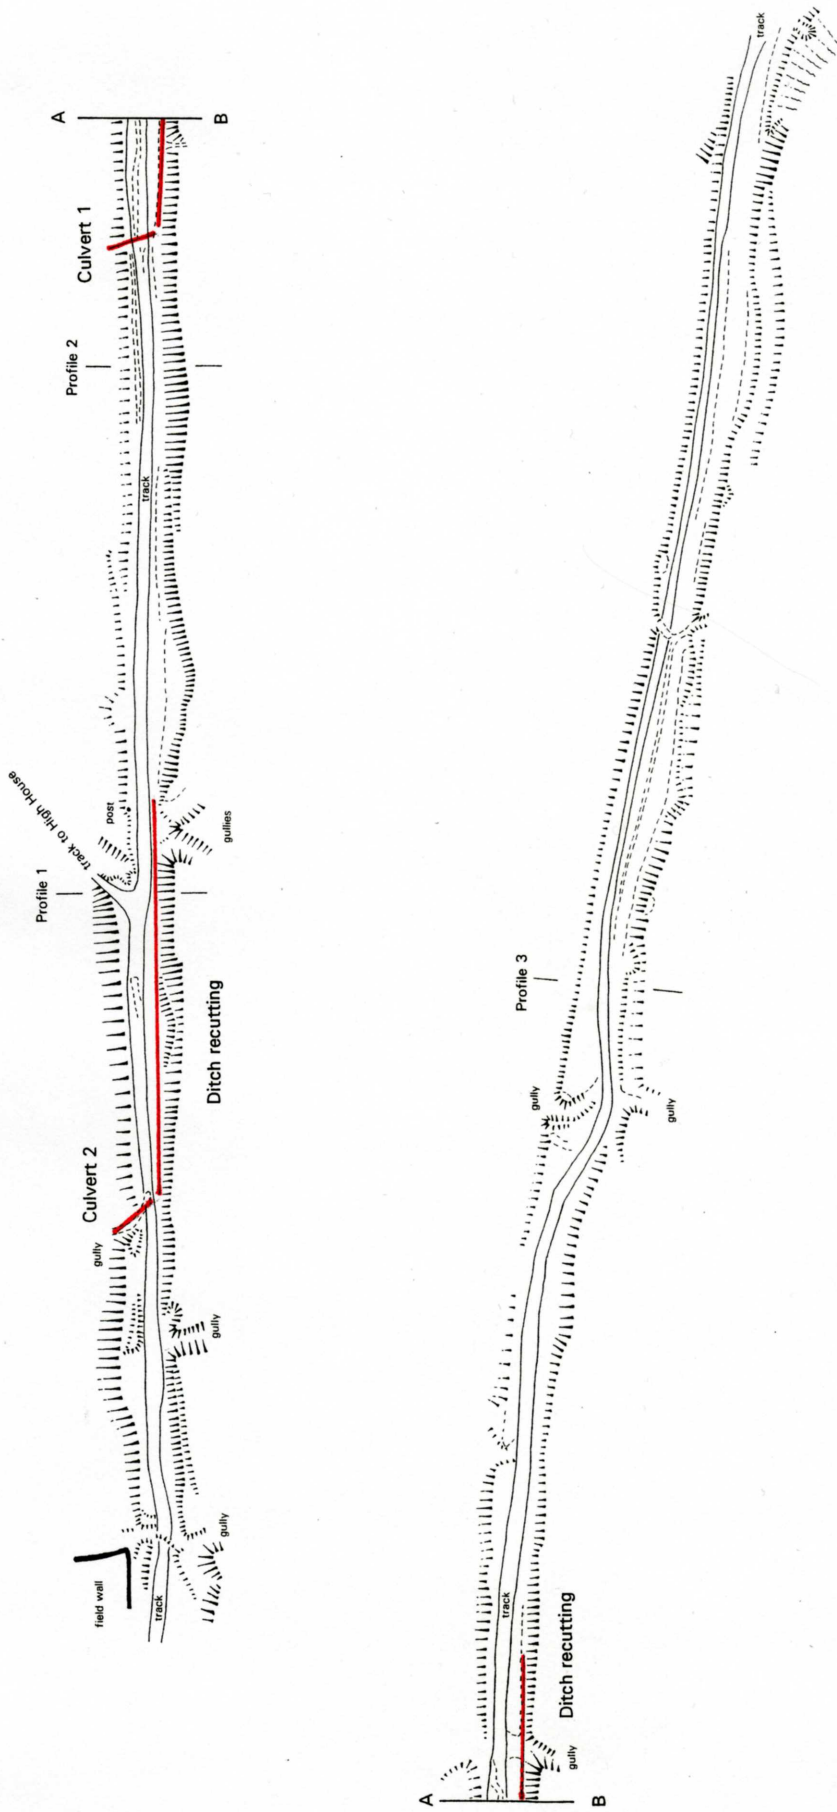
PROJECT	BLUECASTER ROMAN ROAD
TITLE	AREAS OF WATCHING BRIEF
SCALE	AS SHOWN
DATE	DEC 2010
FIGURE	5

#### **The Watching Brief** (see figure 5)

- 4.10 The groundworks involved with the excavation of two culverts across the Roman road alignment, as well as the re-cutting of the drainage ditch on the east side of the road, were subject to archaeological monitoring.

- 4.11 The trench for culvert 2 was set 60m to the north of the south end of the survey area. The trench was aligned almost east-west, and was c.8.0m long, 0.55m wide and up to 0.5m deep. To reduce the amount of ground disturbance, the trench was placed partly within a deep natural gully created by water run-off. As a result, the sections revealed in the trench [2/929 to 2/931] were partly cut through ground that had previously been disturbed by natural erosion and, although the sequence of deposits appeared broadly similar to that seen in culvert 1 (see below), they were not as clear, and so were not recorded in detail.

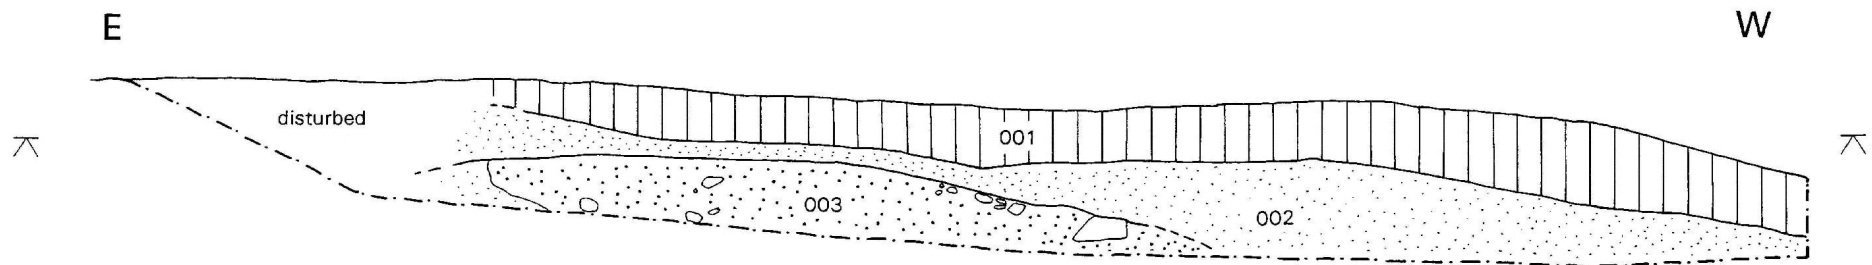
Culvert 1, north-facing section

- 4.12 However, within the trench for culvert 1, excavated 245m north from the south end of the survey area, a sequence of deposits was clearly visible. The north-facing section was recorded at a scale of 1:10 [2/914 to 2/917]; this has been reduced to a scale of 1:20 for publication (see figure 6). Like the trench for culvert 2, this was also c.8.0m long, 0.50m wide and 0.60m deep (see plate 4). The uppermost deposit encountered (001) was a hard-packed layer of angular stones up to 0.10m across forming the metalling of the road; it had an average depth of 0.20m but became shallower towards the east before petering out. This metalling appears to relate at least in part to the existing trackway, but may also partly belong to a pre-modern route. Beneath the layer of stones, there was a layer of compacted clean

mid-brown silty sand (002), only 0.04m thick in the centre of the section, but becoming substantially deeper at either end. This silty sand overlay a deposit of orange-brown silty sand (003), containing frequent inclusions of angular stone up to 0.25m long but mostly smaller; towards the western side of the top of the deposit, the stones may form the remains of a surface. The top of the central part of the deposit runs approximately level for 1.80m, where it is set at 0.28m below ground level, but it slopes away gently at either end, continuing beneath the base of the trench.

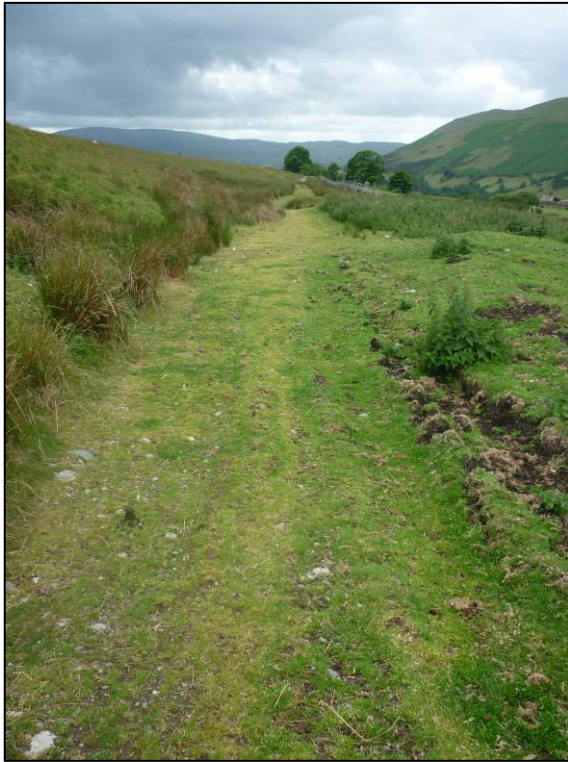
Plate 1: Southern end of surveyed section, looking SW.

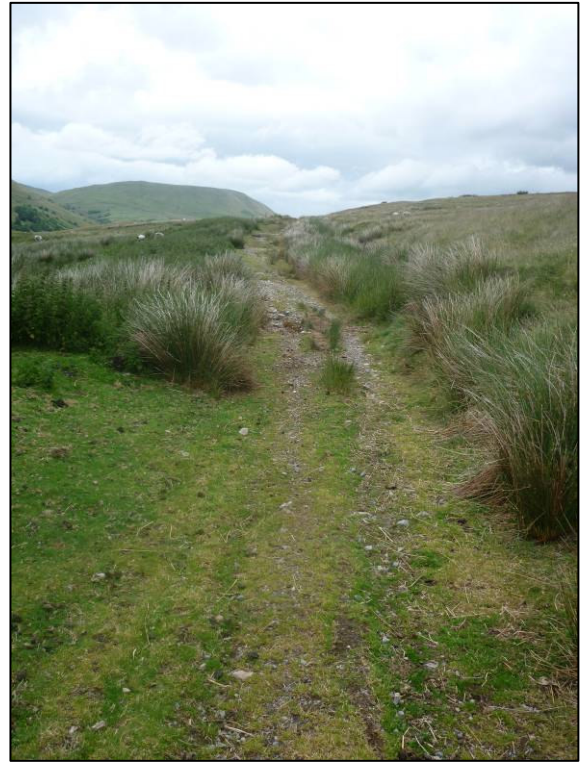
Plate 2: Central part of surveyed section, looking NE.

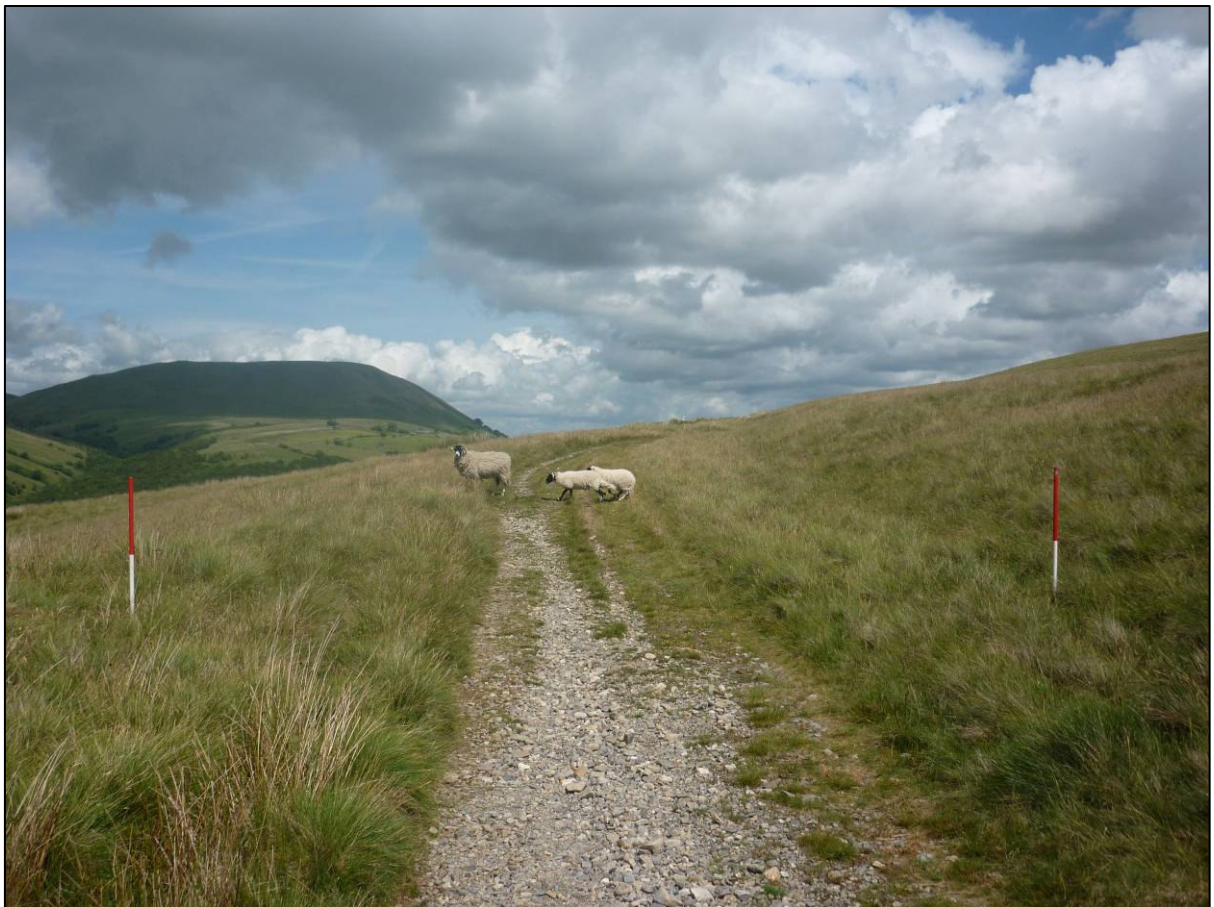
Plate 3: Central part of surveyed section, showing side ditches, looking NE.

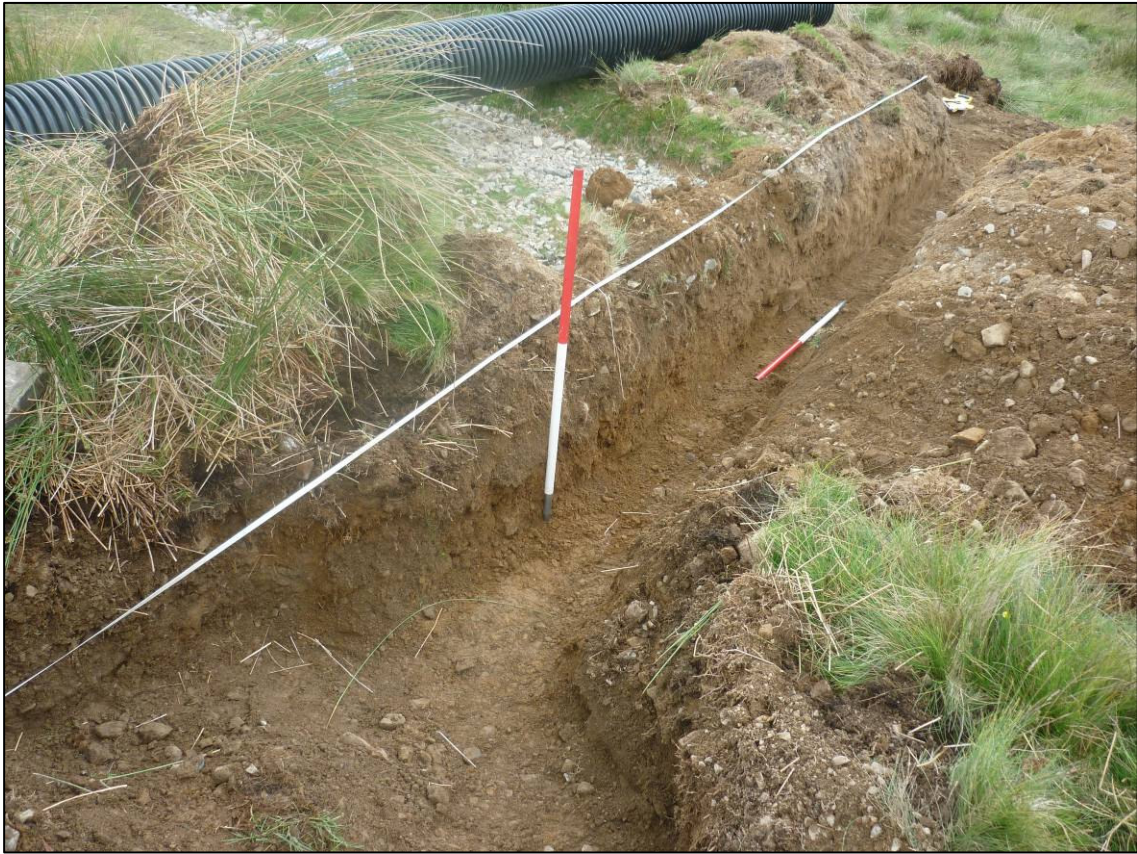
Plate 4: Trench for culvert 1, looking SE.

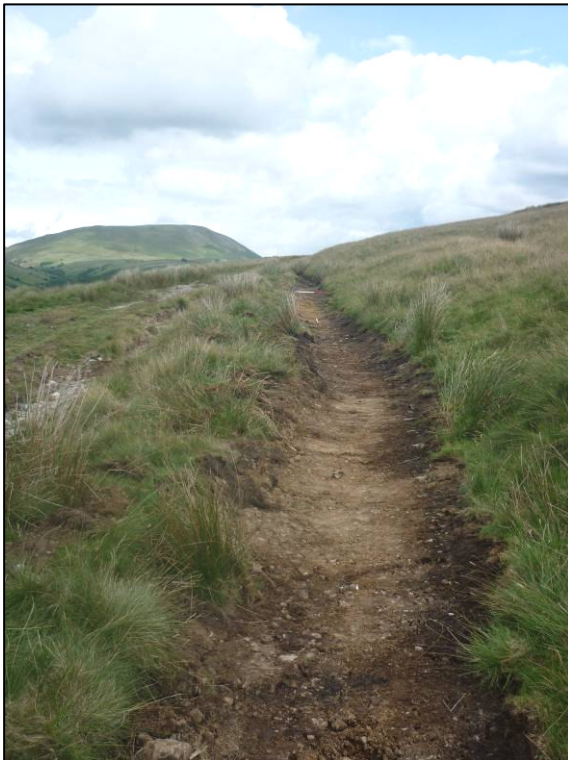
- 4.13 The shallow nature of the ditch re-cutting on the east side of the road alignment meant that little more than turf and a thin layer of topsoil (004) was revealed (see plates 5 and 6). However, within the re-cut sections, some patches of metalling (005) were noted, represented largely by hard-packed angular stones, generally less than 0.05m across but with some occasionally up to 0.10m long [2/917 to 2/920 and 2/926 to 2/928]. Significantly, this metalling appeared to extend right to the base of the east scarp, well beyond that part of the road which is still used by vehicles today.

Plate 5: Re-cut ditch to north of culvert 1, looking NE.

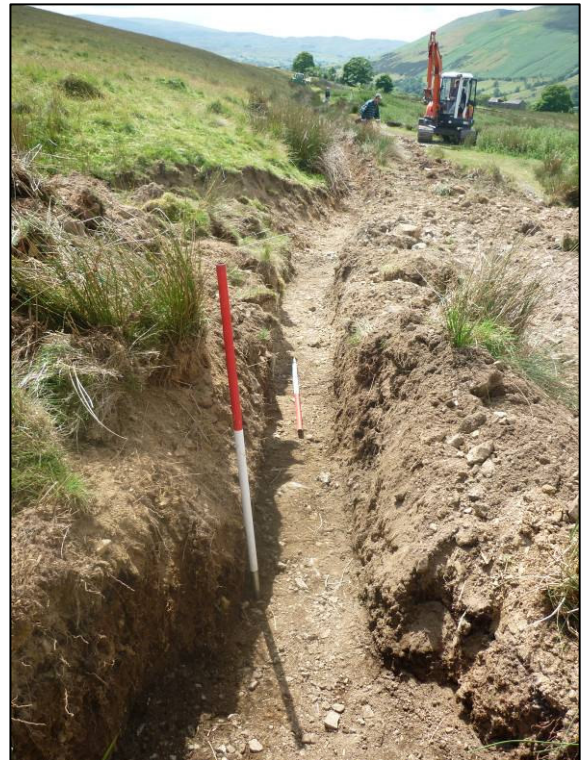
Plate 6: Re-cut ditch to north of culvert 2, looking SW.
