HAMBLETON ROAD,
MURTON COMMON, NEAR COLD KIRBY,
NORTH YORKSHIRE

ARCHAEOLOGICAL WATCHING BRIEF

Report no: 2010/370.R01
Version: Final
Date: June 2010
Author: Ed Dennison & Shaun Richardson

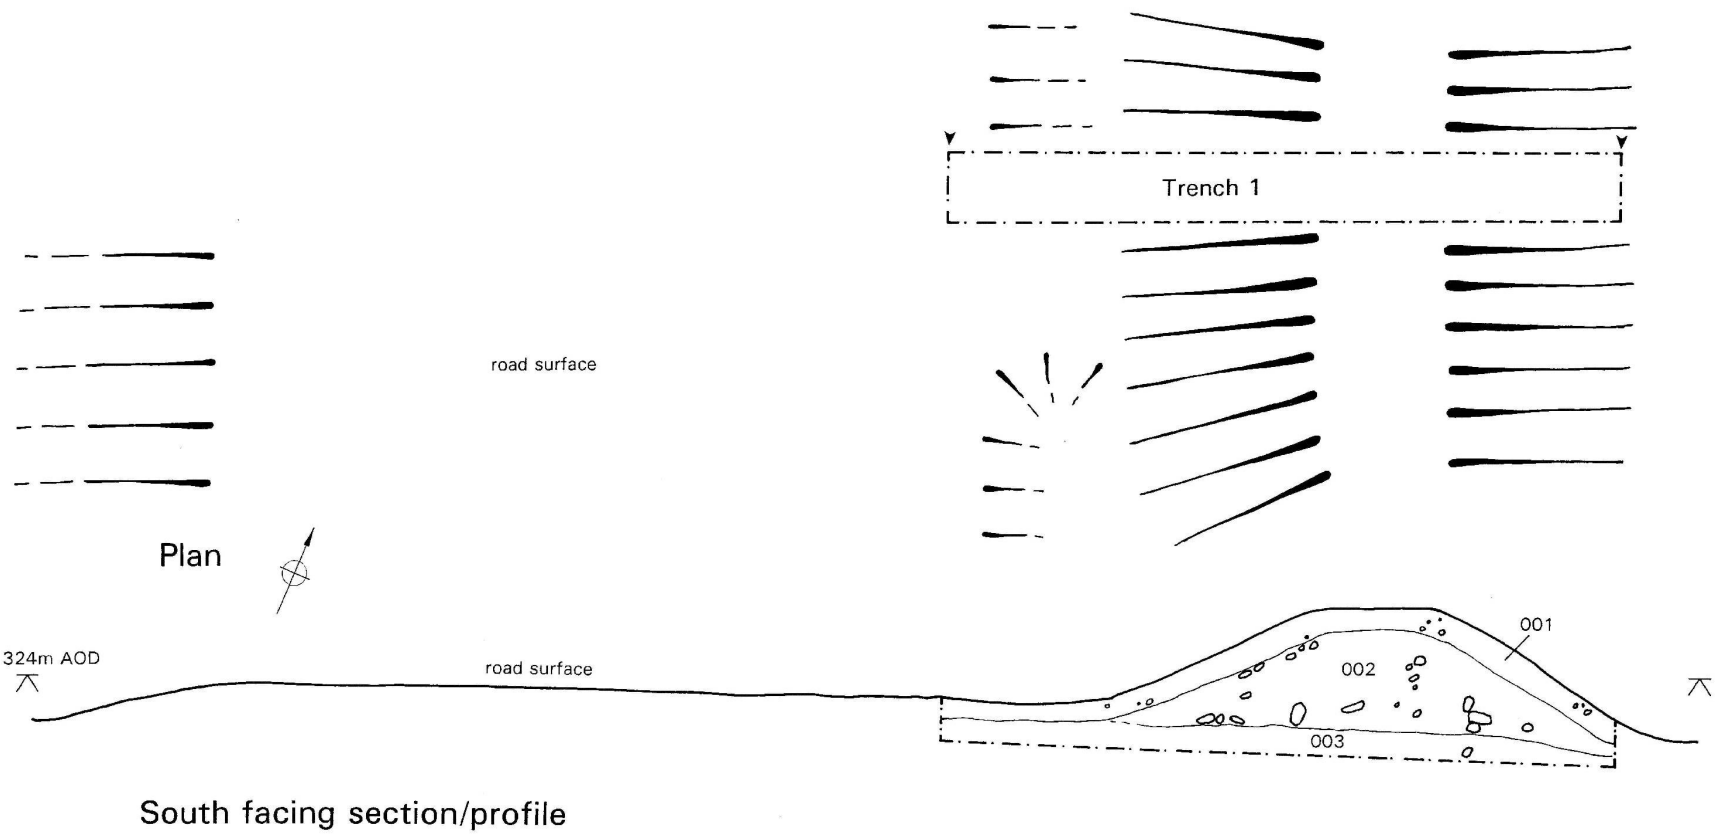
PROJECT HAMBLETON ROAD, MURTON COMMON	
TITLE TRENCH 1 PLAN AND SECTION	
SCALE AS SHOWN	DATE JUNE 2010
EDAS	FIGURE 4

- 5.2 Trench 1 was the northernmost of the three drainage trenches to be excavated, and was located c.1.10km north of the Sneck Yate car park, to the east of the farm known as High Paradise (at NGR SE 5056 8880). The trench was aligned east-west, and was excavated from the east side of Hambleton Road. Adjacent to the trench, the road was roughly metalled with stone, measuring 3.80m in width, with a slight west-facing scarp to the west side and a very slight ditch or depression to the east side; the surface was set at c.324m AOD. The extant dyke here, on the east side of the road, was formed by a single earthwork bank, flat-topped and with sloping sides set at an angle of c.45 degrees. The bank had a total width of 2.40m and a maximum height of 0.55m; the ground surface to the east of the bank was set slightly lower than that to the west.

- 5.3 The excavated trench measured 3.08m long and 0.30m wide, and exposed a section through the dyke with a maximum height of 0.72m. Beneath the 0.12m thick layer of turf and dark brown friable sandy silt topsoil (001), the majority of the bank was seen to be formed by a deposit of compacted mid to dark brown sandy silt (002), containing frequent inclusions of angular limestone rubble but also modern material including decayed metal parts (perhaps from agricultural machinery) and a rotten wooden fence post. The upper surface of the deposit followed the same profile as the dyke bank, but the lower surface was level. It overlay a layer of clean, moist, compacted mid-brown sandy silt (003), at least 0.14m in depth, which continued below the base of the trench.

- 6.3 The visual appearance of the Hambleton Road dyke in the area of Trench 1 suggests that it has been heavily modified in the recent past, or is perhaps even a wholly modern creation. This was confirmed by the excavation of the trench, and the recent material found within the main deposit (002) making up the bank which suggested a 20th century date. It may be that this is one of the parts of the dyke that were affected by the Forestry Commission work in 1960 noted by Hayes, and Spratt suggested that the western side of the bank was partly bulldozed away in this area (Hayes 1963a, 61; Spratt 1982, 38).

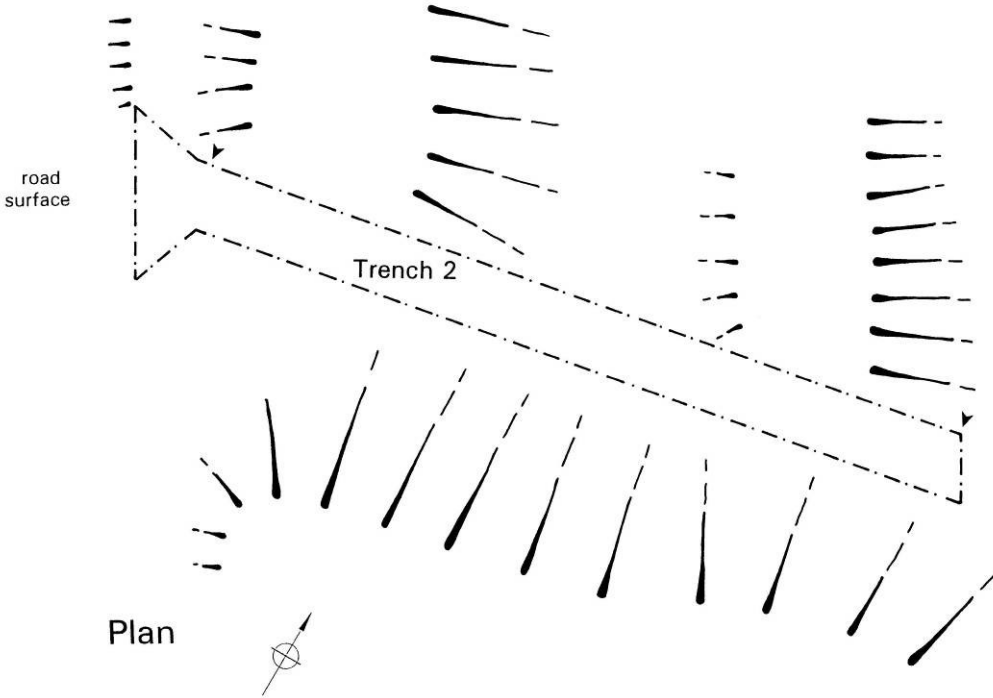
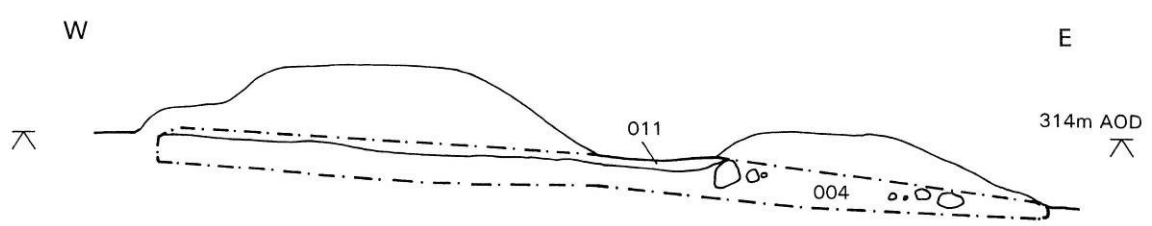
PROJECT HAMBLETON ROAD, MURTON COMMON	
TITLE TRENCH 2 PLAN AND SECTION	
SCALE AS SHOWN	DATE JUNE 2010
EDAS	FIGURE 5

- 5.5 The dyke here was formed by two parallel earthwork banks. The larger, western, bank was flat-topped; the west side was formed by two stepped west-facing scarps, while the east side was formed by a single slope set at an angle of c.45 degrees. The bank had a total width of 2.00m and a maximum height of 0.35m; the ground surface to the east of the bank was set c.0.15m lower than that to the west. The banks were separated by a narrow strip of level ground, 0.55m wide. The smaller, eastern, bank was also flat-topped, with sloping sides set at an angle of c.45 degrees, and set lower than the western bank; the eastern scarp was significantly wider than the west scarp. This bank had a total width of 1.50m and a maximum height of 0.35m; the ground surface to the east of the bank was set 0.25m lower than that to the west. In total, the dyke had an overall width of 4.00m, with the base of the east bank set 0.40m lower than the surface of Hambleton Road.

- 5.6 The excavated trench measured 3.90m long and 0.30m wide. It was positioned in a slight east-west gully, perhaps an earlier cut through the dyke, with the result that the section of the trench was no more than 0.18m deep, and the exposed deposits may not be representative of the dyke construction. Beneath the 0.06m deep layer of turf and dark brown friable sandy silt topsoil (011), a deposit of compacted mid to dark brown sandy silt (004), containing frequent inclusions of angular limestone rubble, was exposed. The angular limestone rubble appeared to be concentrated beneath the eastern bank, and the mid to dark brown sandy silt continued beneath the base of the trench.

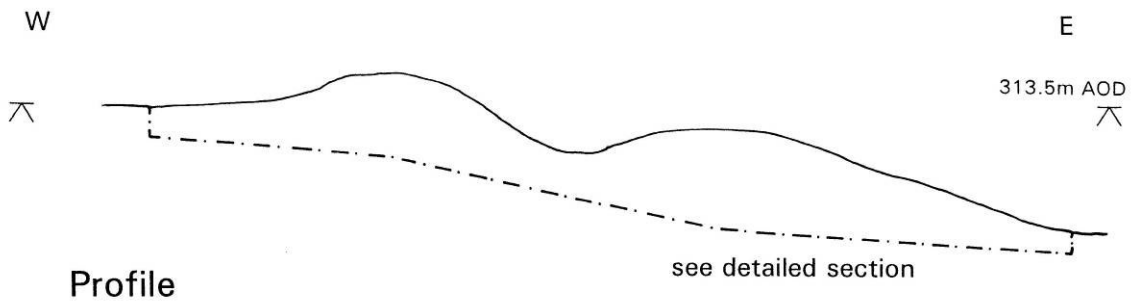
PROJECT HAMBLETON ROAD, MURTON COMMON	
TITLE TRENCH 3 PLAN AND PROFILE	
SCALE AS SHOWN	DATE JUNE 2010
EDAS	FIGURE 6

- 5.8 The dyke here was formed by two parallel earthwork banks. The higher, western, bank had a very slightly rounded top; the east side was markedly steeper and taller than the west side. This bank had a total width of 1.20m and a maximum height of 0.40m; the ground surface to the east of the bank was set c.0.30m lower than that to the west. The banks were separated by a very shallow depression, essentially created by the two banks meeting one another. The lower, eastern, bank was flat-topped, with gently sloping sides. As with the western bank, the eastern scarp was significantly wider than the west scarp. The east bank had a total width of 2.10m and a maximum height of 0.45m; the ground surface to the east of the bank was set 0.35m lower than that to the west. In total, the earthwork had an overall width of 3.30m, with the base of the east bank set 0.65m lower than the surface of Hambleton Road.

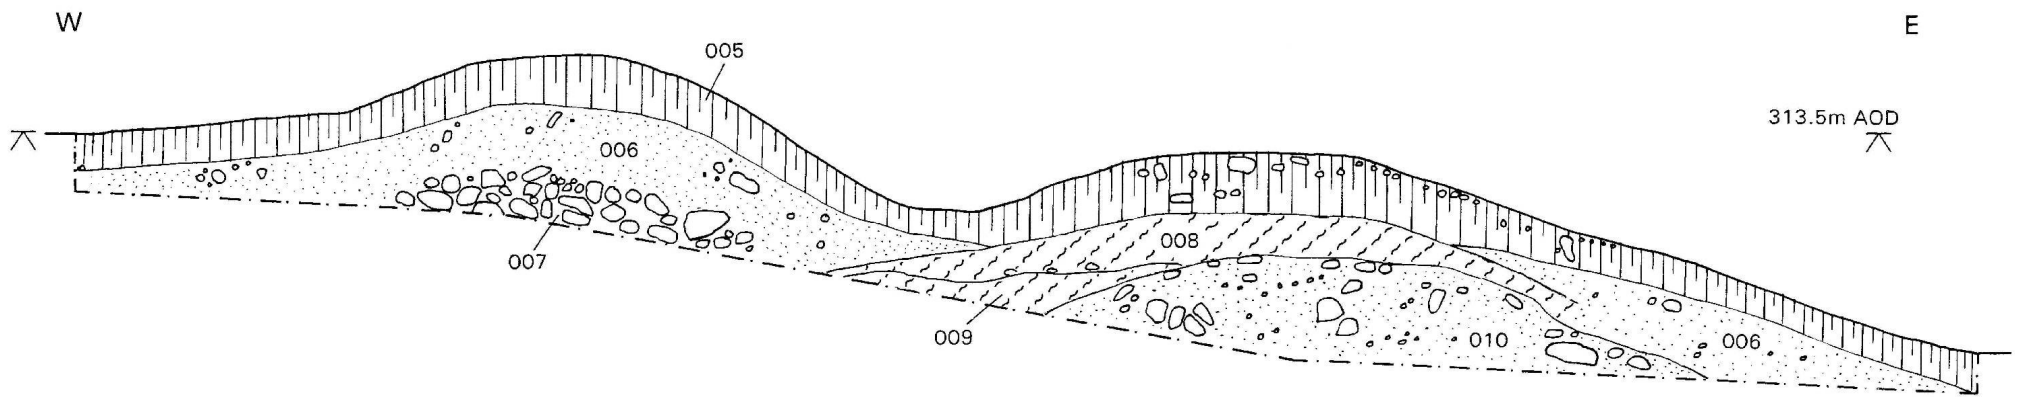
PROJECT HAMBLETON ROAD, MURTON COMMON	
TITLE TRENCH 3 SECTION/PROFILE	
SCALE AS SHOWN	DATE JUNE 2010
EDAS	FIGURE 7

- 5.9 The trench measured 3.50m long and 0.35m wide, and exposed a section through the dyke with a maximum height of 0.40m. Beneath the 0.12m deep layer of turf and dark brown friable sandy silt topsoil (005) (which contained a high proportion of small rounded stones within the east bank), a deposit of compacted mid to dark brown sandy silt (006), containing frequent inclusions of angular limestone rubble, was exposed. In the western bank, the brown sandy silt overlay a 0.60m wide spread of very hard packed angular limestone rubble (007), which appeared to form the core of the bank itself; this rubble continued beneath the base of the trench. To the eastern bank, the brown sandy silt (006) overlay a 0.10m deep layer of rich brown clean silty clay (008), which in turn overlay a compacted clean dark brown silty clay (009). The latter butted up against the west side of the 1.25m wide deposit appearing to form the core of the bank, a friable mid brown clayey silt (010) with very frequent inclusions of small angular pieces of limestone. This deposit continued below the base of the trench.

- 6.5 The watching brief recorded two roughly parallel banks in Trenches 2 and 3, the western banks being larger and set at a slightly higher level than the eastern banks. There was also no trace of a ditch; one might interpret the gap between the two banks as being such a feature or it could lie to the east, just beyond the extent of the drainage trenches and on the very eastern edge of the adjacent arable fields, although this does not appear to be the case as shown on the early Ordnance Survey maps. Trench 3 provided the best section across the earthwork, and this appears to show the Hambleton Road dyke as being the eastern and wider of the two recorded banks; it was flat-topped with gently sloping sides and measured 2.10m wide and a maximum of 0.45m high, with the ground surface to the east of the bank set 0.35m lower than that to the west. The core of the bank was represented by a mid-brown clayey silt (010) with frequent inclusions of stone, with silty clays (008 and 009) on the west side probably being part of the construction. The western bank appeared to have been constructed by creating a core of hard packed angular limestone rubble (007), and this may relate to the use, development and repair of the Hambleton Road itself. Unfortunately, no dating evidence was found in either Trenches 2 or 3.

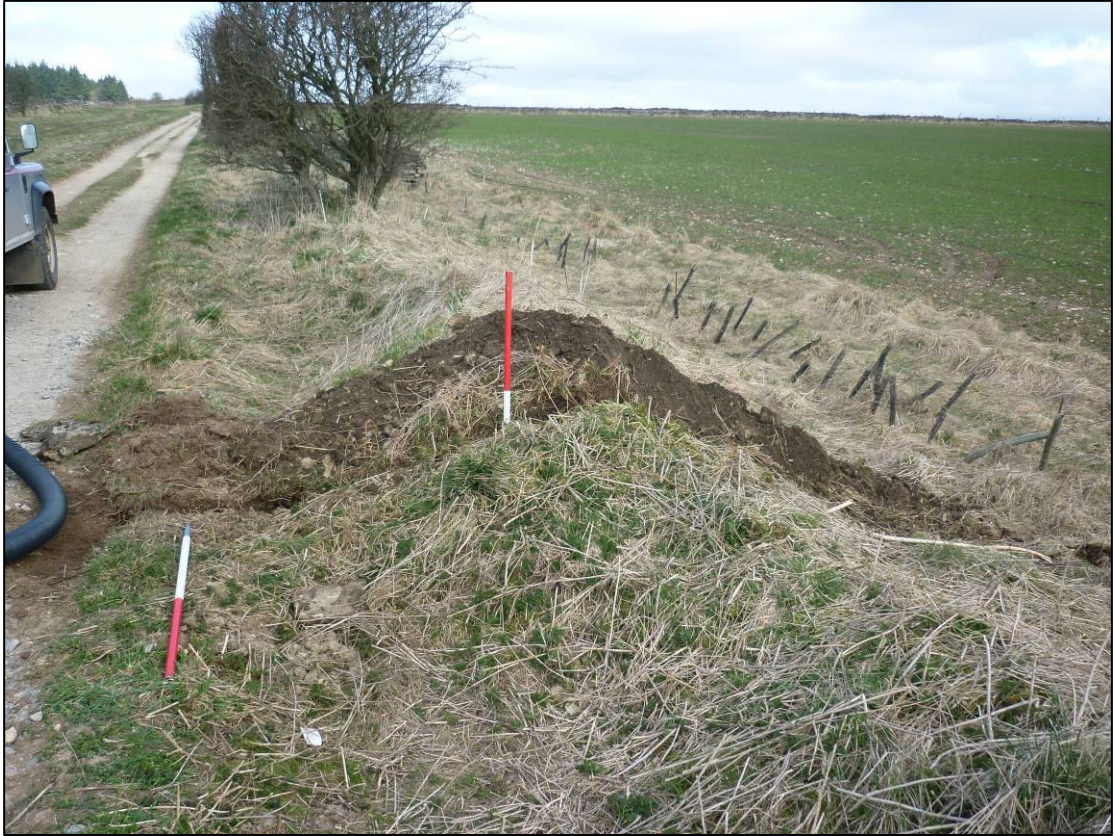
Plate 1: Excavated Trench 1, looking N.

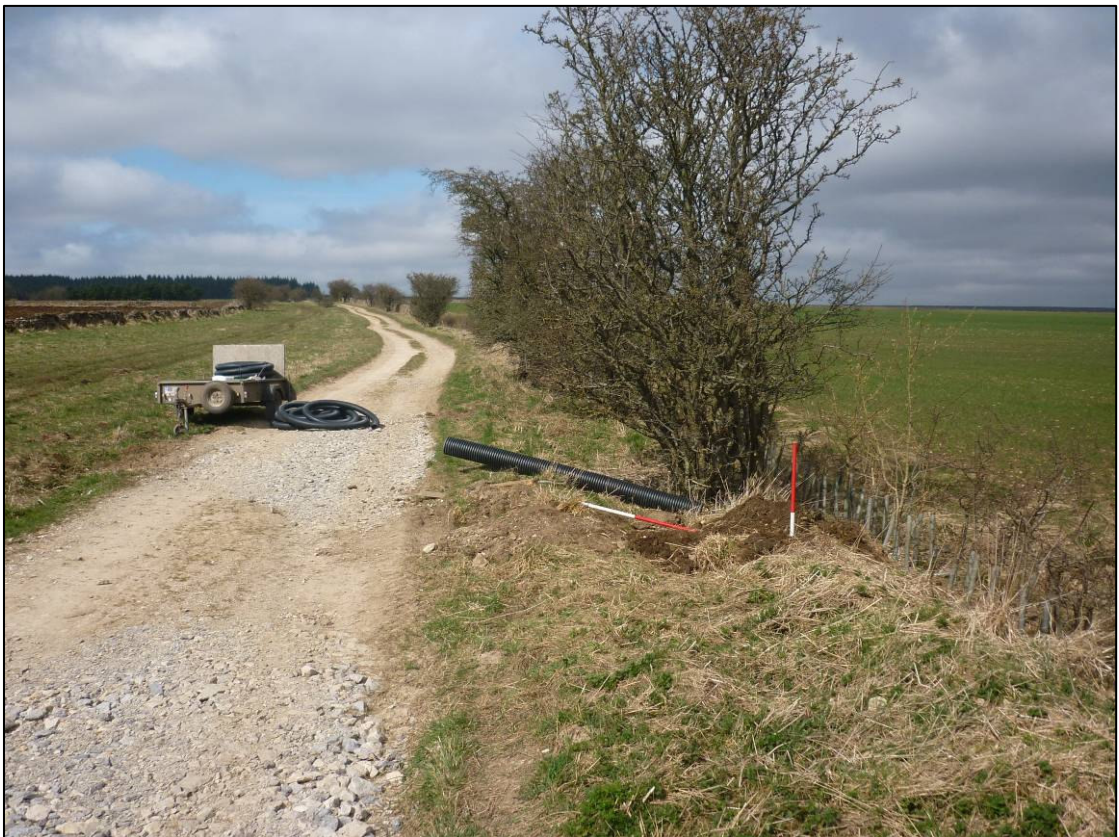
Plate 2: Trench 2 and Hambleton Road, looking N.

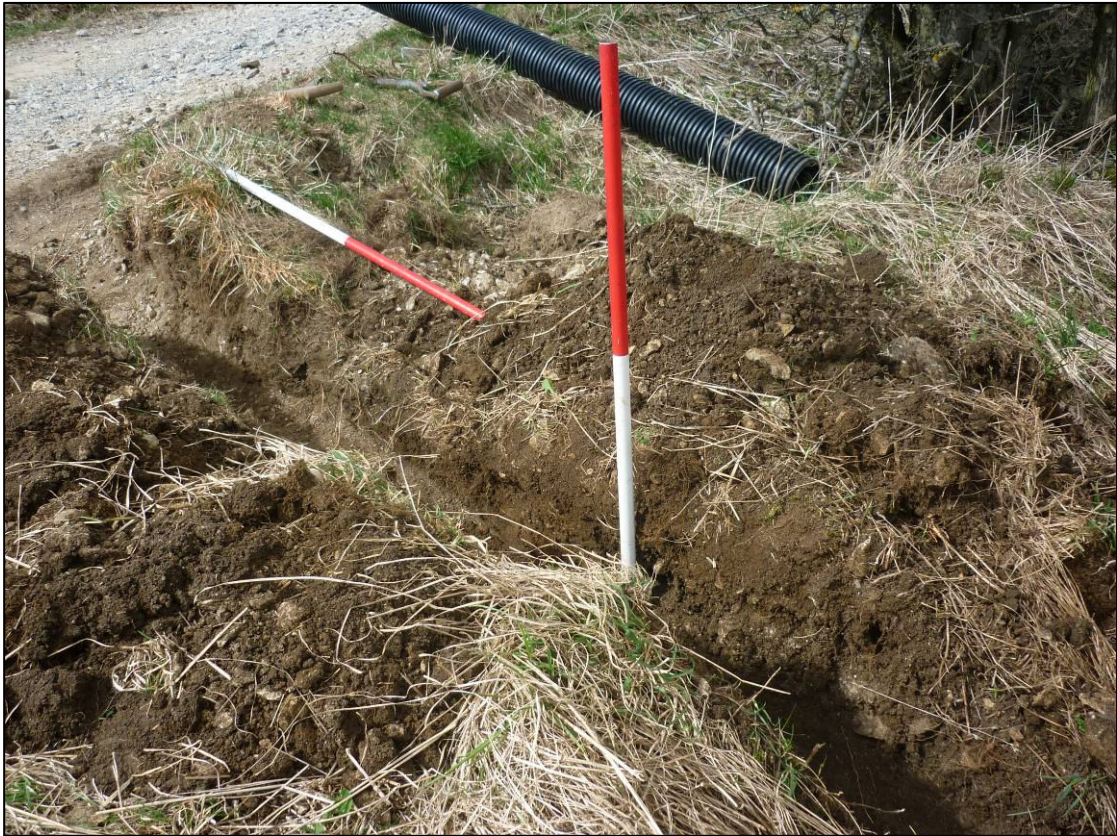
Plate 3: Excavated Trench 3, looking N.

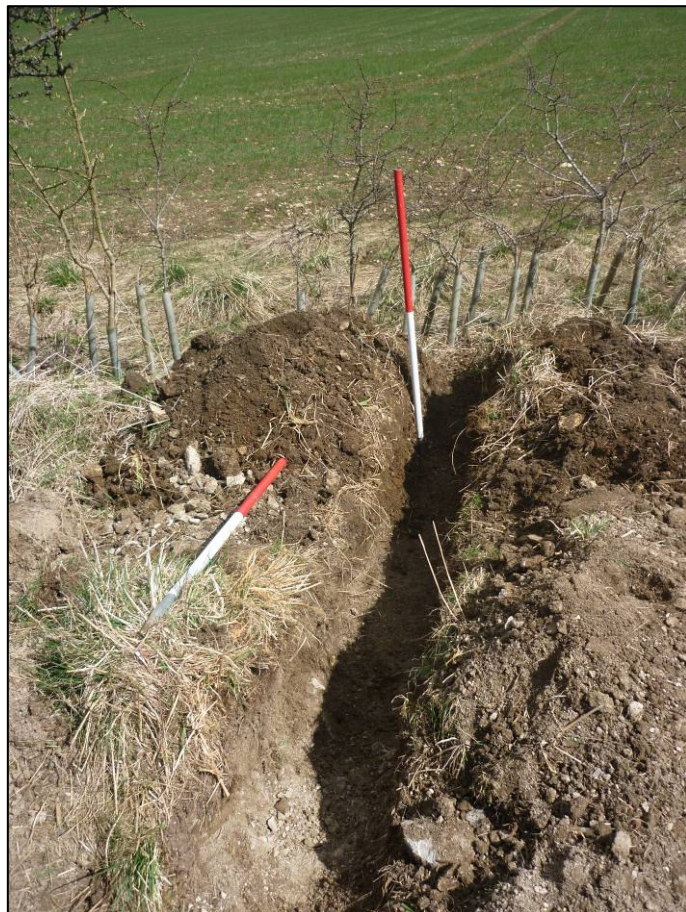
Plate 4: Excavated Trench 3, looking E.
