CHANGE OF USE AND EXTENSION OF SUNDAY
SCHOOL ANNEXE TO FORM 1 NO. DWELLING
AND NEW DOMESTIC CURTILAGE, AND
ERECTION OF SINGLE STOREY EXTENSION
TO CHAPEL AT REAR AND PORCH TO FRONT,
MELBOURNE METHODIST CHURCH,
MAIN STREET, MELBOURNE, EAST YORKSHIRE

ARCHAEOLOGICAL OBSERVATION,
INVESTIGATION AND RECORDING

Report no: 2011/394.R01
Version: Final
Date: March 2011
Author: Ed Dennison

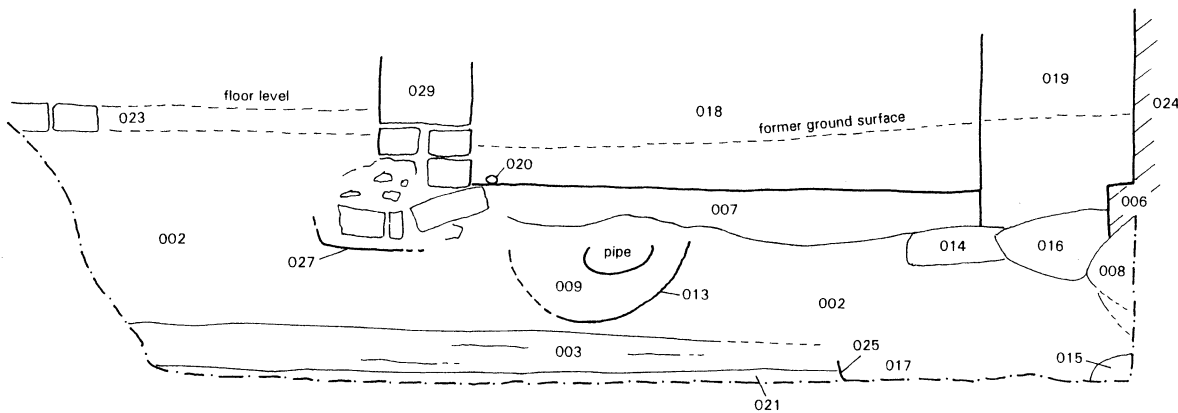
| EDAS | FIGURE 3 |

Section: west side of Trench 2

| TITLE WATCHING BRIEF RESULTS | |

- 5.1 Four courses of the brick foundation (006) for the south wall of the cottage were exposed at the north ends of Trenches 1 and 2, stepping out 0.07m from the wall face above (see plates 3 and 4). What appeared to be the construction trench (026) for the foundation was also visible; in Trench 1 this was filled with a firm grey-brown clayey soil (012) while in Trench 2 it was a ginger-brown sand (028). The trench (026) was cut into the clean yellow-brown natural sand (021) which was exposed in the base of all the trenches. Also clearly exposed in the north-west corner of the base of Trench 2 was what appeared to be the linear construction cut (025) for the east wall (019) of the adjacent house (East Lynne), or possibly for the wall of its predecessor.

- 5.2 The drainage system was a little unclear with several disused pipes exposed by the groundworks. A disused unglazed ceramic drain (008) was visible at the north end of Trench 2 beneath the foundation of the south wall of the cottage, emerging at an oblique angle from the north-west. It had possibly been inserted at a later date, as the wall's foundations (019) appeared to have been cut or adapted to accommodate the pipe. A small deposit of a blue-grey clay (015) below some modern concrete (016), also seen in the north-west corner of Trench 2, may be associated with the insertion of the drain (008) and its subsequent consolidation. A small patch of a yellow-grey lime mortar (014) lay adjacent to this clay. A further modern drain (005) in a linear cut (004) was seen on the east side of Trench 1.

- 5.3 A glazed ceramic drain pipe surrounded by a loose yellow-brown sand (009) within a trench cut (013) was exposed in the west side of Trench 2, visible beneath the 0.15m thick concrete raft foundation (007) of the modern boiler house (018) belonging to the adjacent property (East Lynne). This pipe was also seen in the east side of the trench, and it may have been linked to a drain junction (011) adjacent to the south wall of the cottage, although this was not established. A small bore lead water pipe (020) also crossed the trench above the concrete foundation (007).

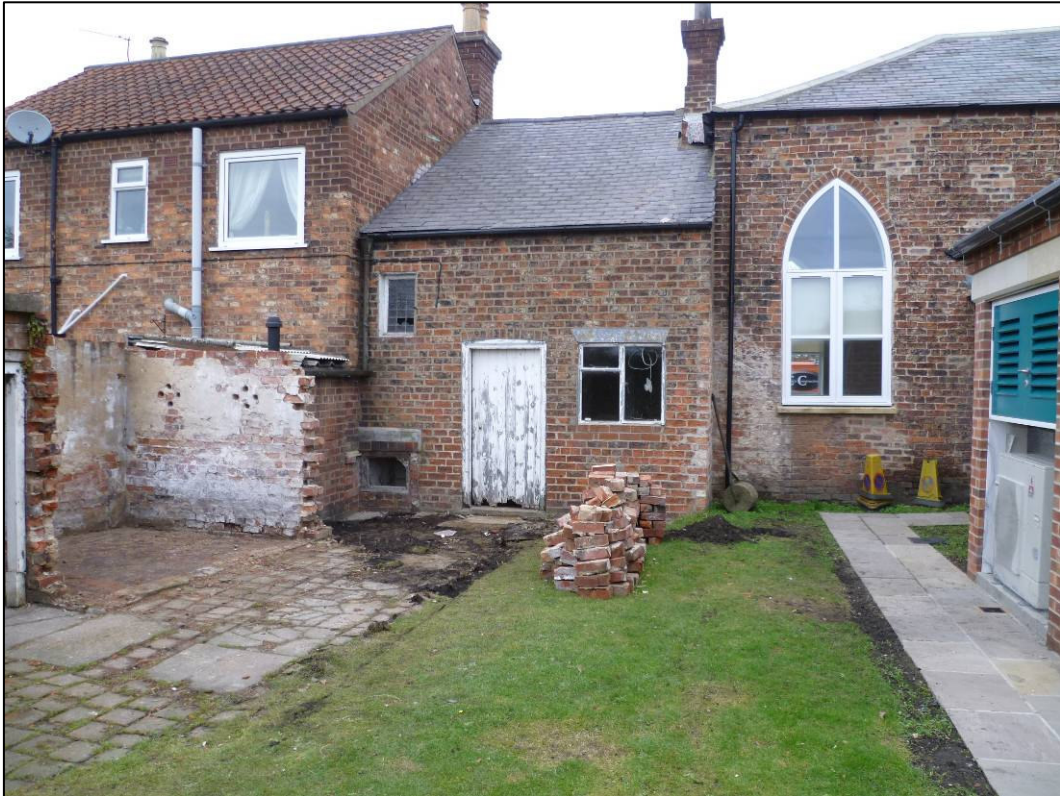
Plate 1: Rear of cottage prior to start of works, looking NW.

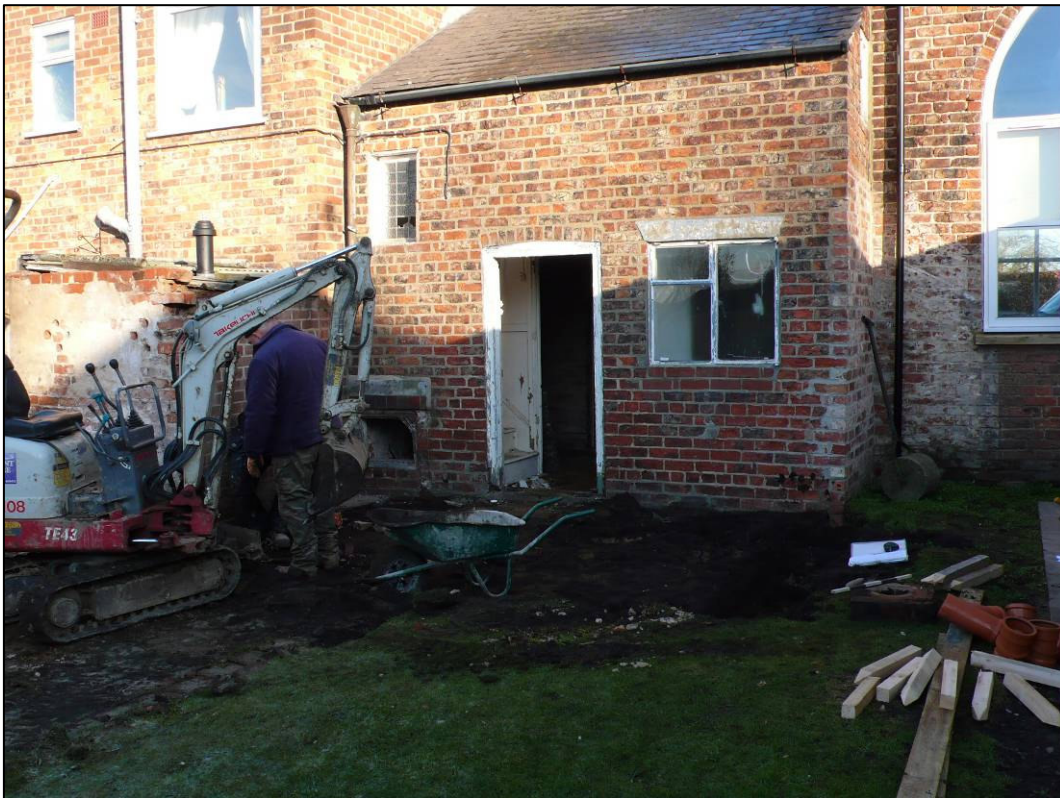
Plate 2: Excavations in progress, looking NW.

- 3.4 The foundation trenches were dug by the contractor, to a depth of up to 0.8m and a width of less than 0.8m using a mechanical excavator with a toothed bucket; a spade was used in areas immediately adjacent to the building (see plate 2). Part of a concrete raft foundation (007) jutting out into Trench 2 on the west side of the building was reduced in width from 0.8m to 0.18m using an electric hand tool with circular saw.

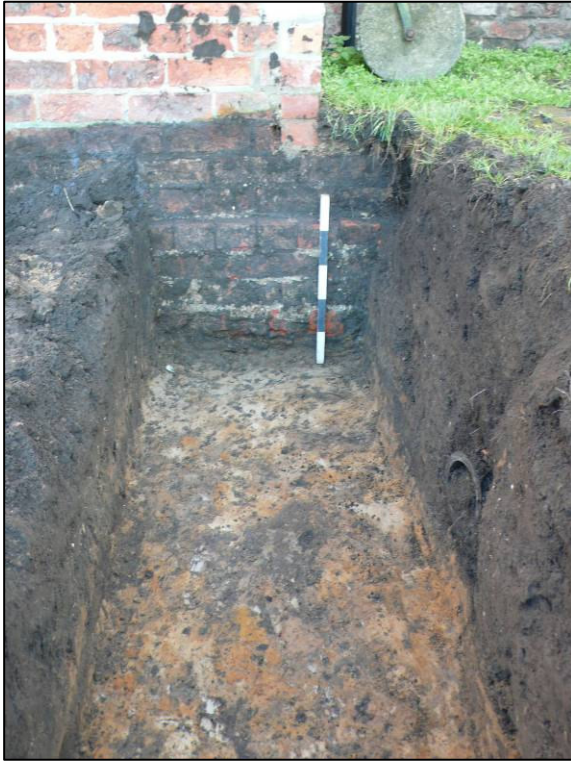
Plate 3: North end of Trench 1 showing stepped foundations to cottage, looking N.

- 5.5 In Trenches 1 and 2, a layer of firm orange/brown sand (003) averaging 0.12m thick, was noted beneath the loam subsoil (002) (see plate 3). This was streaked with darker sand and contained small lumps of solid clay, indicating some disturbance, but this deposit was barely present in Trench 3, furthest away from the building.

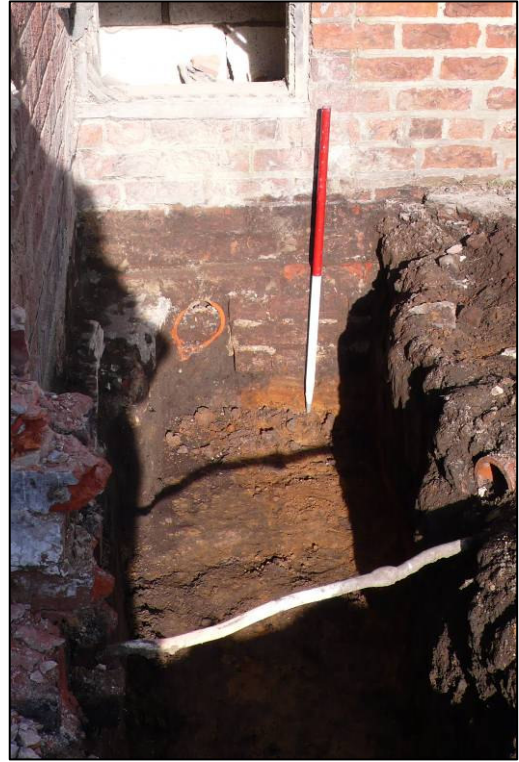
Plate 4: North end of Trench 2, showing foundations, drains etc, looking N.

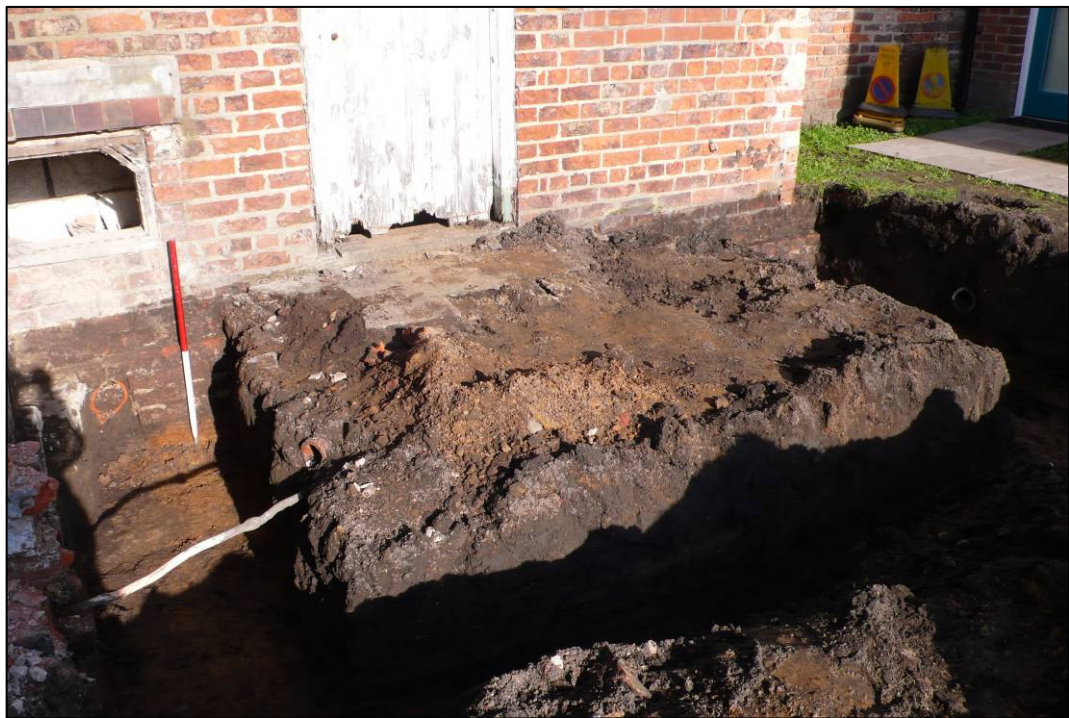
Plate 5: Excavations complete, looking NE.
