ALL SAINTS CHURCH,  
SKIPSEA, EAST YORKSHIRE  
ARCHAEOLOGICAL WATCHING BRIEF

ARCHAEOLOGICAL WATCHING BRIEF

Report no: 2010/390.R01  
Version: Final  
Date: April 2011  
Author: Ed Dennison & Doug Jobling

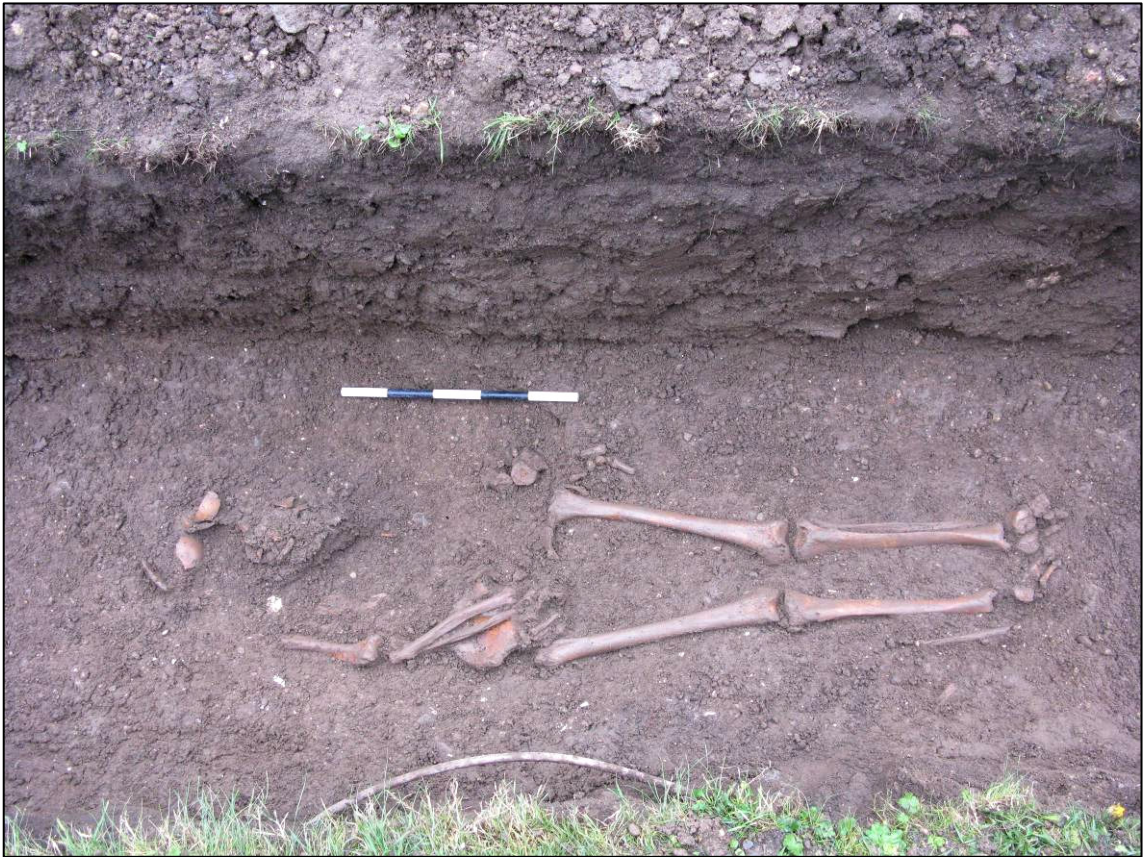
Plate 1: Skeletons 120 and 123 in Trench 1, looking N.

- 5.4 The earliest feature encountered in the trench was a rectangular east-west aligned cut (118); it had rounded corners, and measured 2.05m long by 0.70m wide, and was 0.20m deep (base at 8.15m OD). The break of the slope at the top of the cut was sharp with vertical sides with a sharp turn towards the flat base. The extended, supine and articulated skeleton (120) within, which was truncated by a later burial cut (121) (see below), was fairly well preserved and in good condition (see plate 1). The skeleton lay at an average of 8.32m OD, the disturbed skull area at 8.34m OD, the hips at 8.31m OD, and the feet at 8.35m OD (see figure 4). The right hand was extended and placed on the right side of the pelvis, the extended left hand was placed on the ground to the left of the pelvis, the right leg was extended with the foot fallen inwards, and the left leg was also extended with the foot turned or fallen outwards. The skeleton (120) was that of an extremely robust male, about 6ft 1ins high, and the wear on the teeth suggests he was a 45+

- 5.5 Cutting into the chest cavity and head area of skeleton 120 was a sub-circular cut (121) containing an infant burial (123) (see figure 4). The cut measured 0.35m long (east-west) by 0.25m wide (north-south) and it was 0.15m deep with sharp vertical edges and an indeterminate base (see plate 1). The height of the remains of the skull lay at 8.34m OD. The orientation of the body was east-west, and the skeleton was in good condition and probably extended. A significant number of associated bones were present, although they were disturbed by the excavation works, and so no further details could be recovered. The skeleton suggests a very small child in 'Early Childhood', which equates to between one and six years of age, although the probable age is between 1½ and two years (see Appendix 3). The stature and sex of the child is unknown. The fill of the grave was a loose dark brown silt (122).

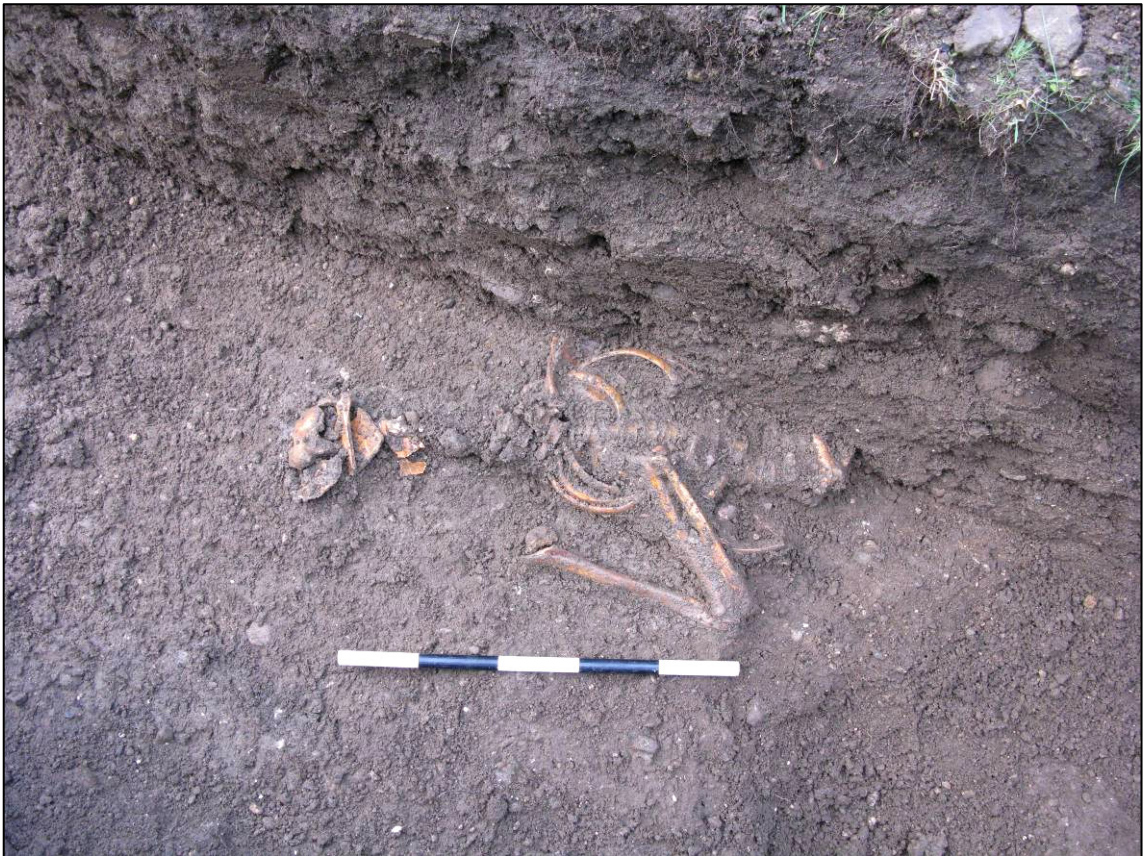
Plate 2: Skeleton 113 in Trench 1, looking NE.

- 5.6 A second grave cut (114) was noted in the centre of the trench, which also cut into the mid grey-brown subsoil (103). This cut was a maximum of 0.40m wide and 0.35m deep, the base at 8.22m OD, and it was oriented south-west/north-east over a distance of 0.80m; it cut slightly into the underlying burial (118), extended beyond the north side of the trench, and the east end was truncated by a later pit (111) (see below). The cut was slightly concave at the top with a vertical edge with a gradual turn to the flat base. Set within the cut were the truncated remains of a crouched and supine female skeleton (113) in good condition (see plate 2); the orientation of the body was the same as the cut. There was complete articulation of the skeleton apart from the skull which was unfortunately broken into pieces during excavation by the contractors. The right arm was flexed with the hand on the breast/chest area, the left arm was in an extended flexed position pointing towards the truncated pelvis, and both legs were missing (see figure 4). The top of the disturbed skull area lay at 8.42m OD and the chest area at 8.48m OD. The pathology suggests that this adult had reached 18 years of age, as demonstrated by the presence of all three molars, although the very limited wear indicated that survival did not occur for much longer, perhaps up to 25 years. Although only limited unwashed material was available, the skull remains suggest that it was a 'possible female', around 5ft 3ins tall (see Appendix 3). The fill of the grave (112) was a very soft, friable and loose very dark charcoal-brown grey fine grained sandy silt with occasional small gravel inclusions.

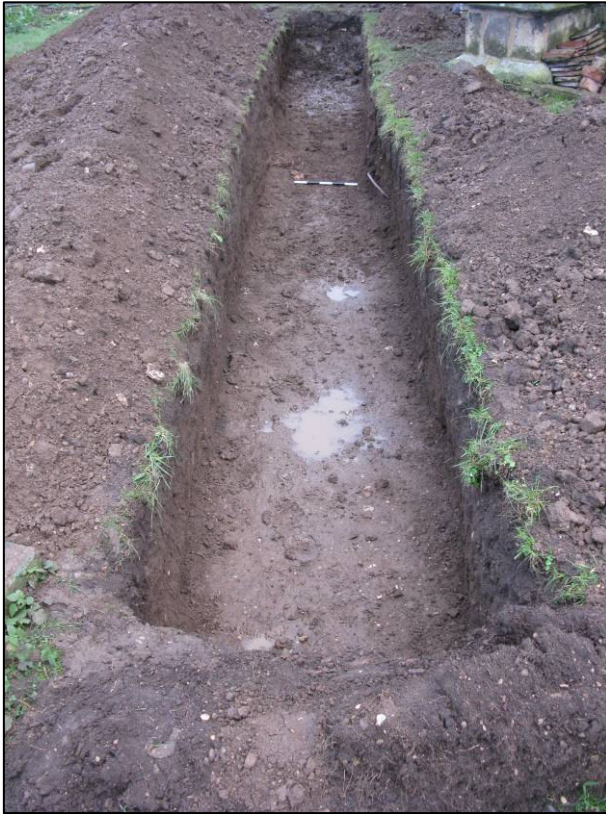
Plate 3: General view of completed drainage trench, looking W.

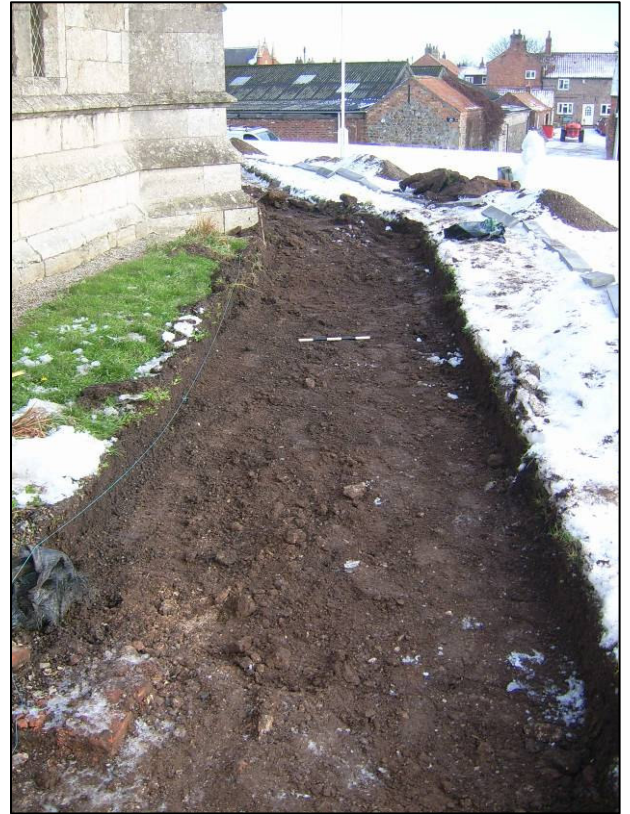
Plate 4: Excavations for new path, looking NE.

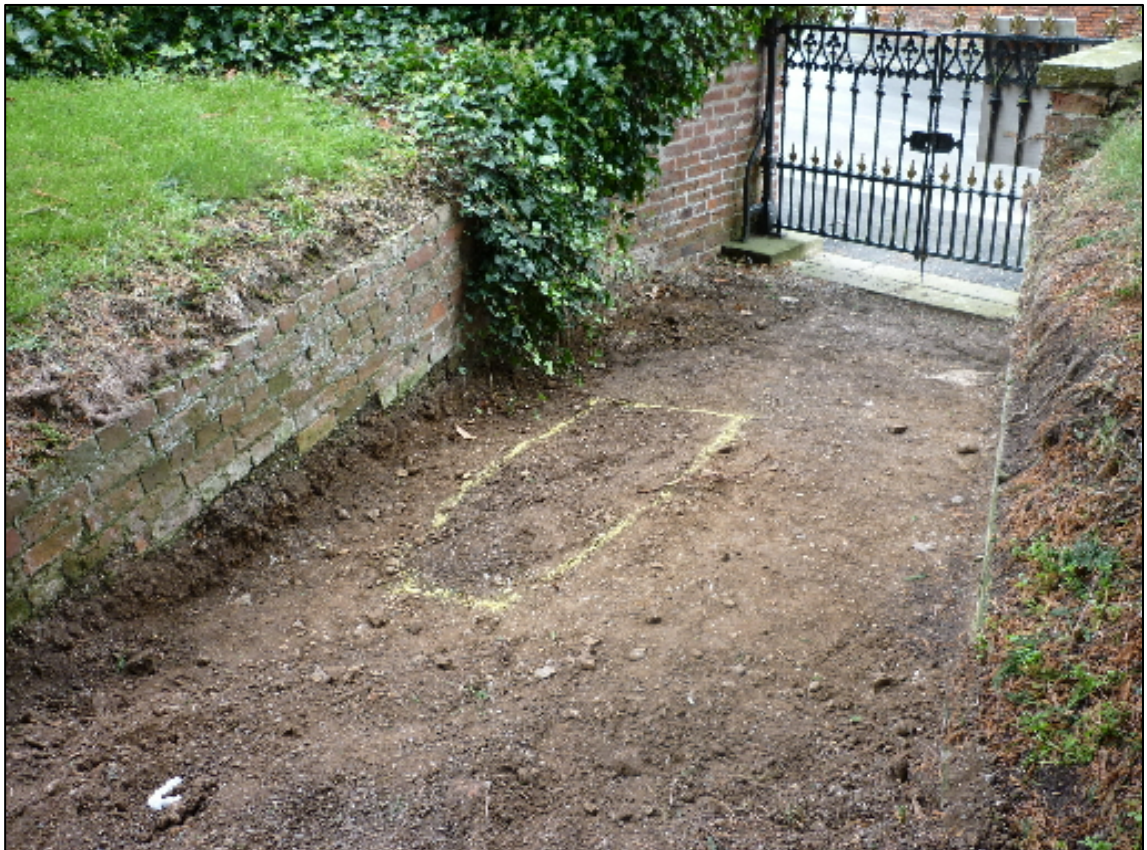
Plate 5: View of burial 203 prior to excavation, looking NE.

- 5.17 A grave cut was uncovered in the path, 2.15m to the west of the churchyard gate; the path here was in a cutting, c.1.2m below the surrounding ground surface, with the slope previously broken by steps which had since been removed (see plate 5). The grave cut (201) was sub-rectangular in plan, oriented east-west, with slightly rounded corners and measuring 1.95m long, 0.60m wide and 0.15m deep (base at 7.42m OD) (see figure 5). The break of slope at the top of the cut was sharp with angled sides and a graded slope to the flat base. Set within this cut were the truncated remains of adult inhumation (203) (see plate 6). The skeleton was oriented west to east and in fair condition, but there had been some prior damage due to the unauthorised and unsupervised start of excavations - the head and lower legs had been exposed and were removed for safekeeping to the church vestry. The remaining *in situ* skeleton was articulated and in an extended supine position. The right arm was extended with the hand behind the right buttock and the left hand was also extended with the hand centred on top of the pelvis. The lower legs were missing but, for the appearance of one knee (patella), the legs were probably extended. The pathology suggests that this is a robust right-handed male, 5ft 7ins in height, and aged around 45 (see Appendix 3). The considerable wear on the teeth indicates a coarse diet, which suggests a possible medieval date; this is also suggested by the depth of the burial when compared to the surrounding ground surface (c.1.2m deep).

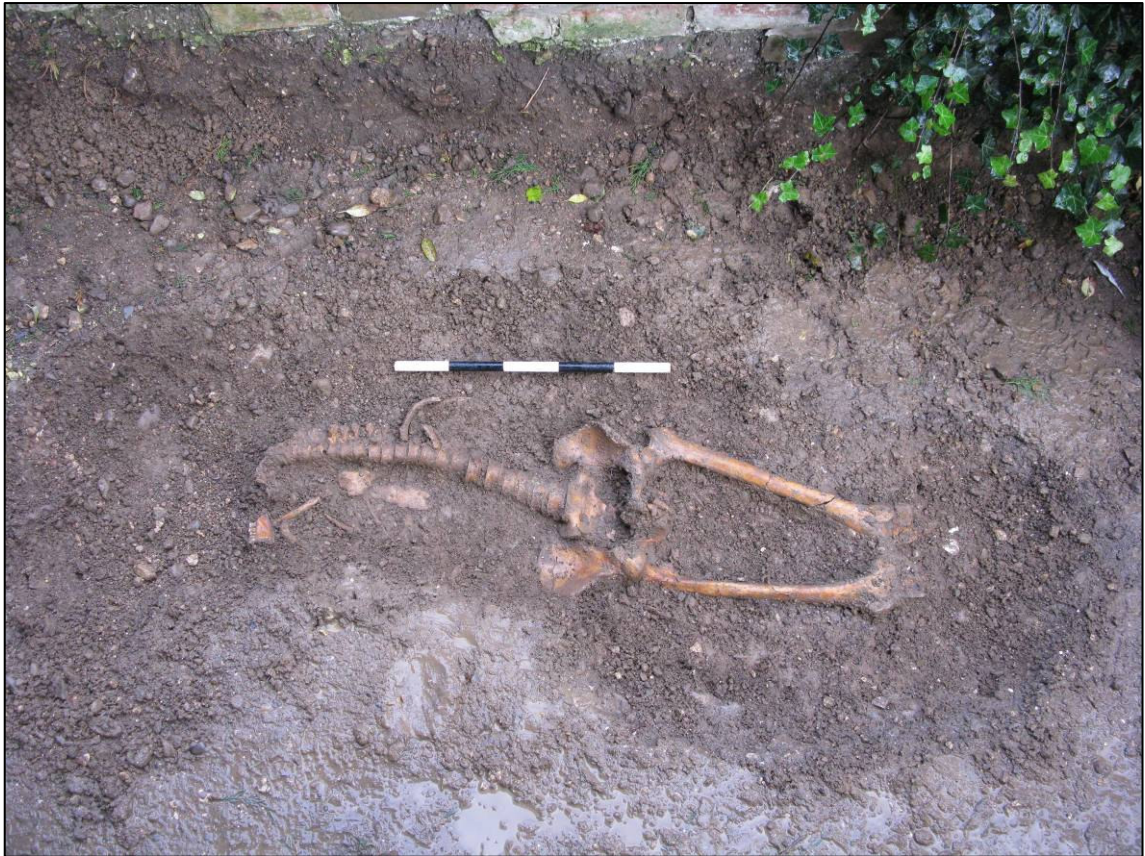
Plate 6: Skeleton 203 in path adjacent to gate, looking N.

- 203 Skeleton - extended and supine, articulated in fair condition. Upper body mostly intact, but skull removed and legs and feet truncated. Robust male, considerable wear on teeth, 45+ years.

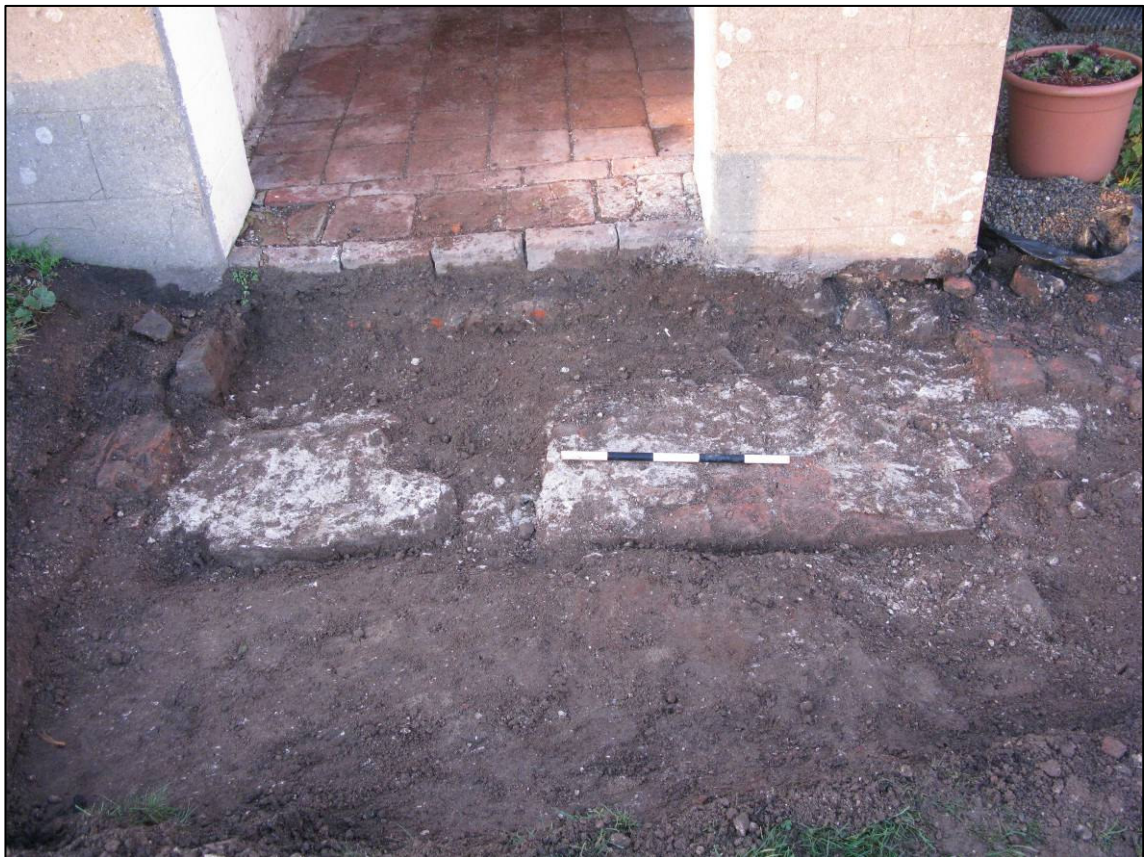
Plate 7: Foundations of earlier south porch, looking N.

- 5.20 Set within the cut were the foundation remains of an earlier south porch (208) (see plates 7 and 8), which had presumably been dismantled and demolished to make way for the existing early 18th century structure (see figure 6). The foundations were of brick with a thick lime mortar bonding, up to 30-40mm thick in places. The bricks were handmade and of various sizes ranging between 300mm x 150mm x 40mm and 260mm x 180mm x 50mm; the lime mortar also held blue grey and black grits. The bricks were laid as header courses along the south face and as a stretcher course to the east and west. The structure was more than 2.58m east-west and extended for a distance of 0.80-0.82m to the south of the existing porch. The general surviving height of the foundations was 8.50m OD, however a higher course to the east was 8.59m OD high while one to the west was 8.63m OD.

- 206 Cut for path foundation - broad S shape.
- 207 Soft friable very dark brown-grey sandy silt, at least 0.20m thick - topsoil.
- 208 Foundation remains of former S porch - composed of handmade bricks of various sizes ranging between 300mm x 150mm x 40mm and 260mm x 180mm x 50mm with lime mortar bonding. Bricks laid as header courses along the south face and stretcher course on the east and west. The structure was more than 2.58m E-W and 0.80-0.82m N-S.

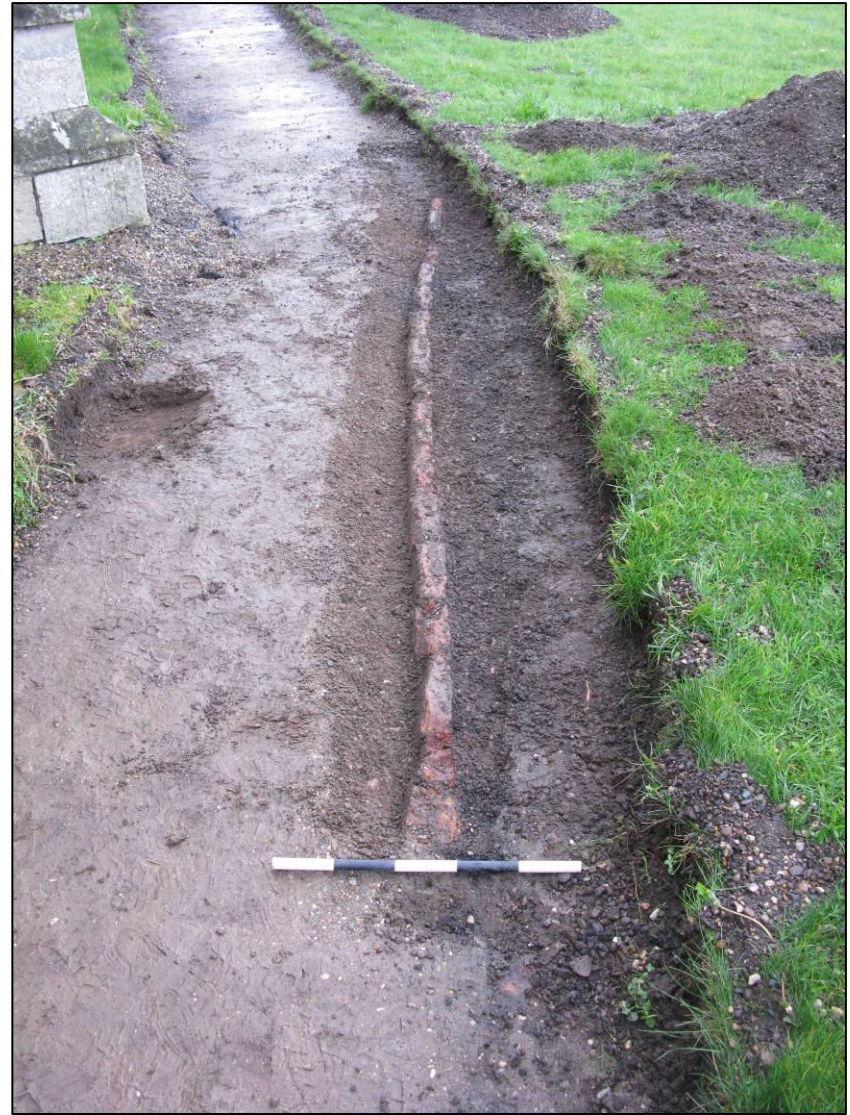
Plate 9: Brick kerbing in path, looking NE.

- 6.5 Little was revealed along the rest of the length of the path, apart from two sections of brick kerbing (213 and 214) which probably represent the east edge of the earlier path alignment shown in 1855. However, limited excavations around the front of the south porch did reveal an earlier brick foundation (208), which extended 0.8m to the south beyond the existing structure. This brick foundation pre-dates the existing early 18th century structure, and so is presumably of early post-medieval date, although no dating evidence was recovered.
