44 EASTGATE, BEVERLEY,
EAST YORKSHIRE

ARCHAEOLOGICAL OBSERVATION,
INVESTIGATION AND RECORDING

Report no: 2011/405.R01
Version: Final
Date: December 2011
Author: Ed Dennison & Kate Dennett

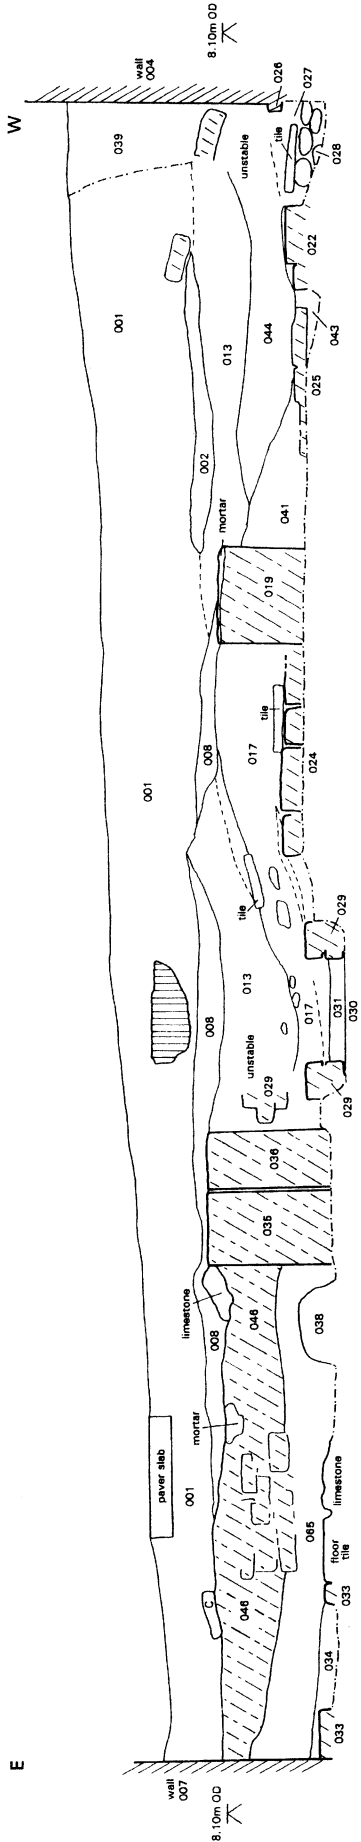
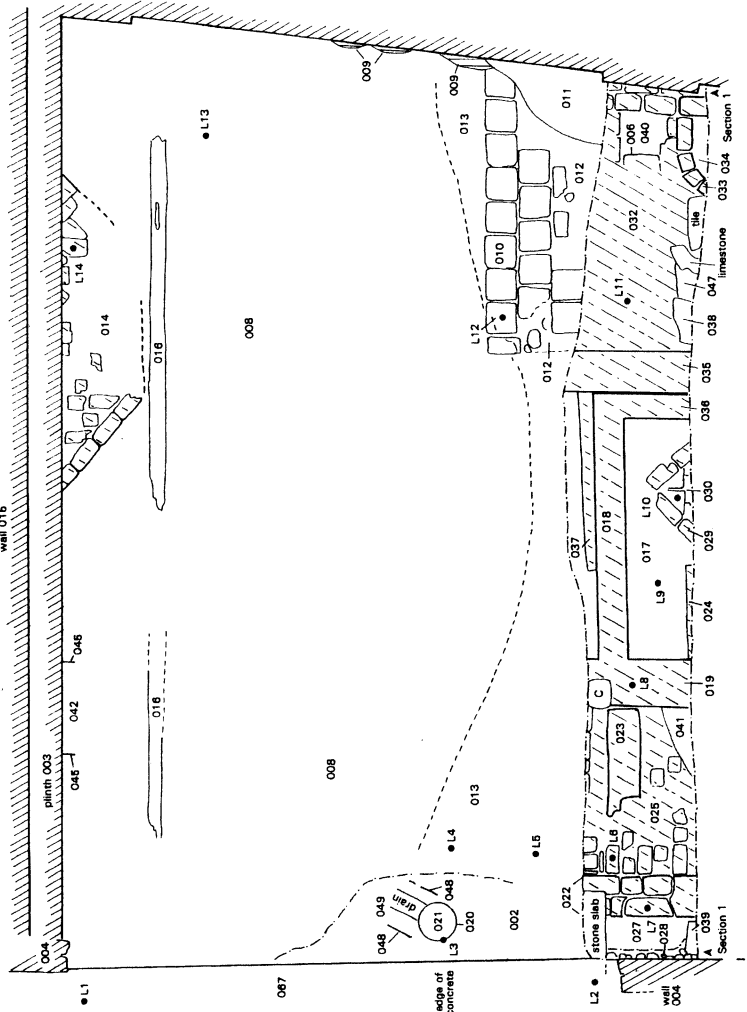
PROJECT	44 EASTGATE, BEVERLEY		
TITLE	MAIN AREA AND WALL TRENCH		
SCALE	AS SHOWN	DATE	DEC 2011
	EDAS	FIGURE	6

Section 1: South side of trench

Plan

- 5.14 A further phase of building, earlier than that represented by the features already mentioned, was apparent in the east end of the trench. At a depth of 7.71m OD, a well-worn brick floor (032) mortared with a fine whitish material was exposed in the base of the trench. Within this floor was a square recess (006), measuring almost 0.3m square and c.0.09m deep. This was filled with a compacted black coal dust or ash deposit (040), c.0.22m thick which also extended over the brick floor itself. Adjacent to the recess (006), part of what appeared to be a brick hearth or fireplace (033) defined by a curved brick kerb was exposed. The sooty black floor deposit (040) did not extend over or into the fireplace, which was overlain by a soft very fine gritty and unburnt deposit (034), possibly mortar or plaster.

- 5.15 Partly exposed in the base of the south face of the trench and pressed into a softer grey-brown gritty deposit (047) just off the south edge of the brick floor (032), were two pieces of yellowish limestone. One piece was amorphous and much decayed, but the other (038) was a partly dressed fragment, semi-circular in cross section and with a flat base, possibly part of a half-column, 0.3m in diameter and of unknown length (see plate 9). It was not possible to remove the stone without collapsing the face of the section, although a piece was broken off by the mechanical excavator.

5.17 At the extreme west end of the trench, and partially underlying the single brick plinth (026) of the now demolished north-south boundary wall (004), the edge of what was probably a small cobbled yard (028) was evident. The top of the deposit, which was at least two cobbles (0.10m) deep, lay at 7.80m OD, and it was overlain by a loose black gritty-ashy moist deposit (027). Although only exposed in a very limited area, to prevent undercutting of the wall, this deposit produced pottery sherds from a number of vessels ranging from a brown-glazed vessel of possible residual medieval date, the rim and handle of a large 'Humber 5' green glazed red earthenware vessel dating to the 17th to 18th century, 18th century Staffordshire slipware and a 19th century brown-glazed factory-made teapot (see Appendix 2). This could suggest that this was part of a midden, but the possibility of this deposit having been disturbed by the building of the recently demolished north-south wall (004) cannot be discounted.

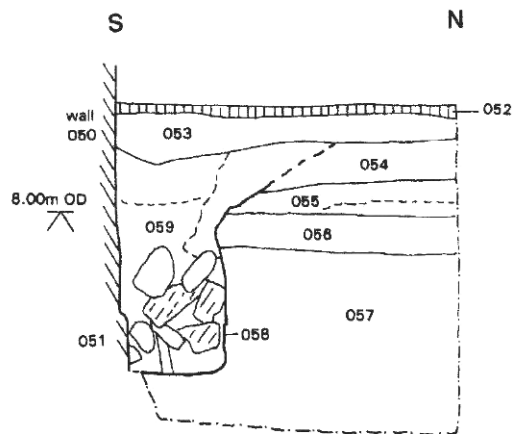
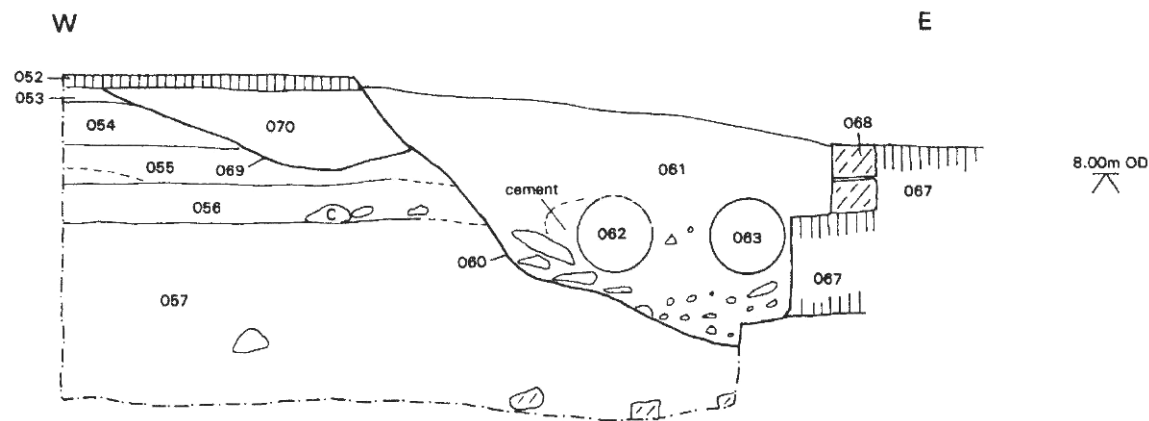
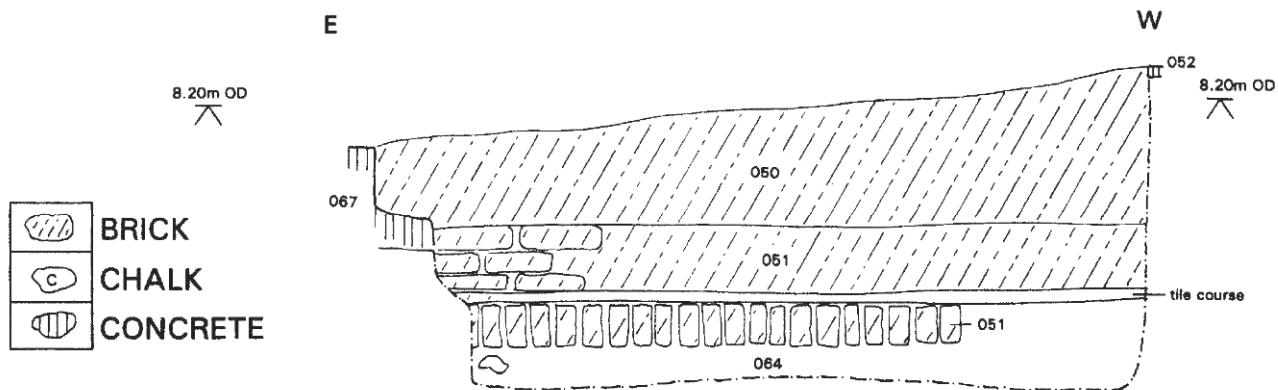
PROJECT		44 EASTGATE, BEVERLEY	
TITLE		DRAINAGE TRENCH	
SCALE	AS SHOWN	DATE	DEC 2011
EDAS		FIGURE	7

5.19 The 2.0m long drainage trench dug at the west end of the concrete pad (067) at the far west end of the site exposed the foundations of the north wall (050) of The Carriage House property, which formed the southern boundary of the development site. Below ground level, there were seven courses of bricks flush with the rest of the elevation, and then a plinth of three courses which projected out 0.3m from the face (051) (see plate 10); the below ground bricks were generally thinner (228mm by 112mm by 42mm-52mm) than those above. There was then a levelling course of heavily mortared tile fragments, over a single course of unmortared upright headers, which did not extend the full length of the tile levelling course in the section revealed by the excavation. Below the foundation was a firm dark brown moist gritty soil (064) containing occasional chalk, brick and tile fragments.

5.20 The drainage trench revealed a series of well stratified deposits. Below a thin layer of damaged concrete (052), 0.4m thick, was a c.0.18m thick firm grey-brown dirty mixed loam (053), the top of which lay at 8.25m OD. This overlay a firm black coal dust (054) up to 0.12m thick, then a c.0.1m thick layer of friable but firm grey-brown mixed soil (055). Below this was a clean uniform deposit, c.0.11m thick, of creamy grey crushed stone/mortar (056) containing occasional small fragments of coal, brick, stone and chalk; the top of this deposit was at 7.98m OD, and it probably corresponds to the compact cream/light brown lime mortar (016) seen just north of here in the January 2007 watching brief (Dennison & Richardson 2011, figure 6). Below this, and extending beyond the base of the trench (i.e. more than 0.52m thick), was a blanket layer of firm dark brown gritty soil (057) containing occasional fragments of chalk, pottery, shell, glass and coal - this deposit is probably the same as that (064) seen under the foundation of the north wall of The Carriage House (see above). Pottery sherds were confined to the lowest deposit (057), and they included five clay pipe stem fragments, including one of 17th century date, one sherd of Staffordshire slipware (18th century), and five sherds of post-medieval red earthenware with brown glaze, including a dish or bowl of 17th/18th century form (see Appendix 2).

5.21 The above stratigraphy was disturbed by several pits. Towards the west end of the north side of the trench was a shallow cut (069), 0.85m wide and 0.2m deep, filled with a loose very dark black-brown silty soil (070) containing metal, rubber, wire, coal, coal dust etc. Along the east side of the trench, adjacent to the brick curb

Section 2: West side of pit

Section 3: North side of pit

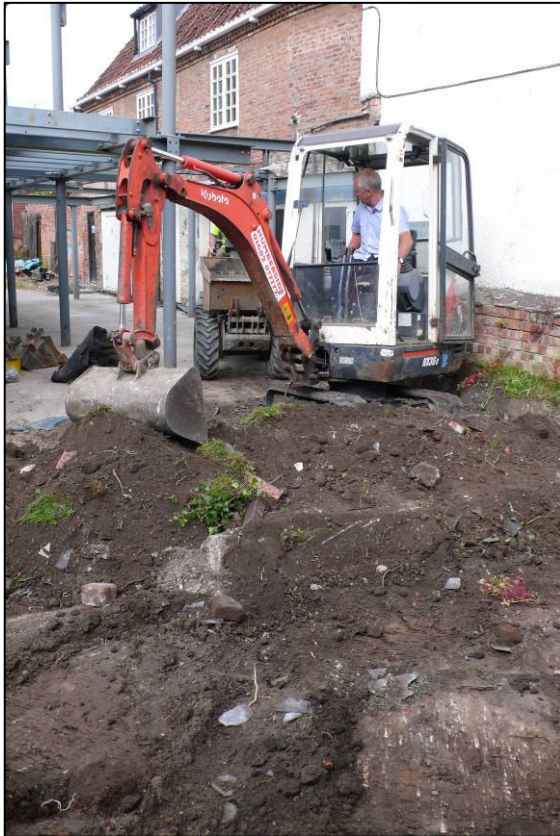
Plate 3: Topsoil strip in progress, looking W.

- 5.3 The ground reducing works revealed a relatively clean, firm but friable fine brown loam garden soil (001), generally 0.37m deep but extending up to 0.62m in some areas, containing some brick, tile, slate and chalk fragments (see plate 3). Below this, over most of the site, was a blanket layer of a loose grey/yellowish-brown sandy deposit (008), c.011m thick, containing moderate amounts of small brick, mortar, stone, tile, glass, coke and coal fragments; the top of this deposit lay at 8.24m OD. Beneath this was a firm grey-brown silty soil (013), extending across large parts of the southern half of the site. In the south-western part of the site, where seen in section, the grey/brown silty soil (013) lay directly under the garden loam (001) which also contained a lens of firm light brown clay (002), between 0.09m-0.11m thick.

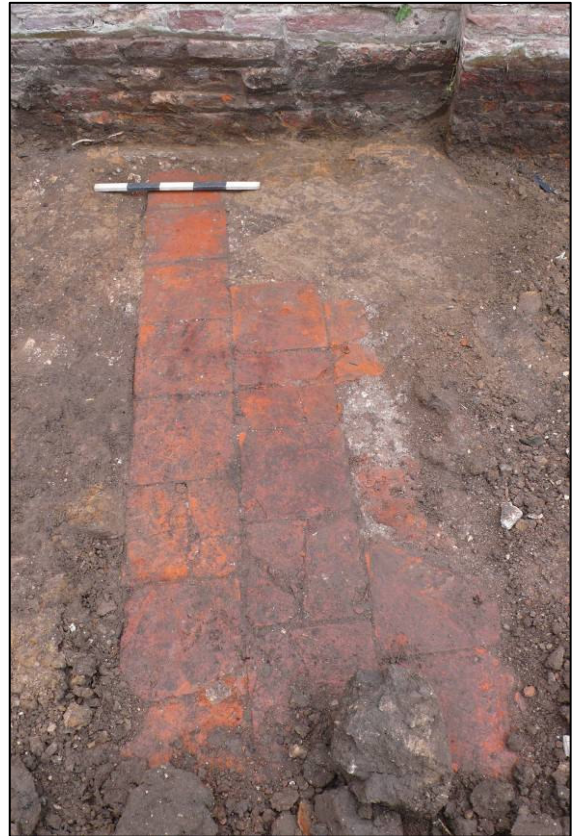
Plate 4: Tiled area (010) forming passage inside No. 46, looking E.

- 5.7 The inside of the boundary wall fronting onto Eastgate (007) was partly rendered with a cement plaster. A further five courses of brickwork were revealed by the topsoil strip but the base was not exposed; this wall was rebuilt in the early 1960s after road widening, incorporating a late 16th century gateway from the Priory and using reused bricks and stone fragments. A very thin gravely concrete deposit (009) butted up to the wall towards the south-east corner of the site. This lay partially under the yellow-grey sandy deposit (008) noted above, and it was overlain by a solid but thin layer of a ginger-brown fine mortar (011), 0.05m thick, which also partially covered the 'quarry' tiles (010) and its bedding layer (012).

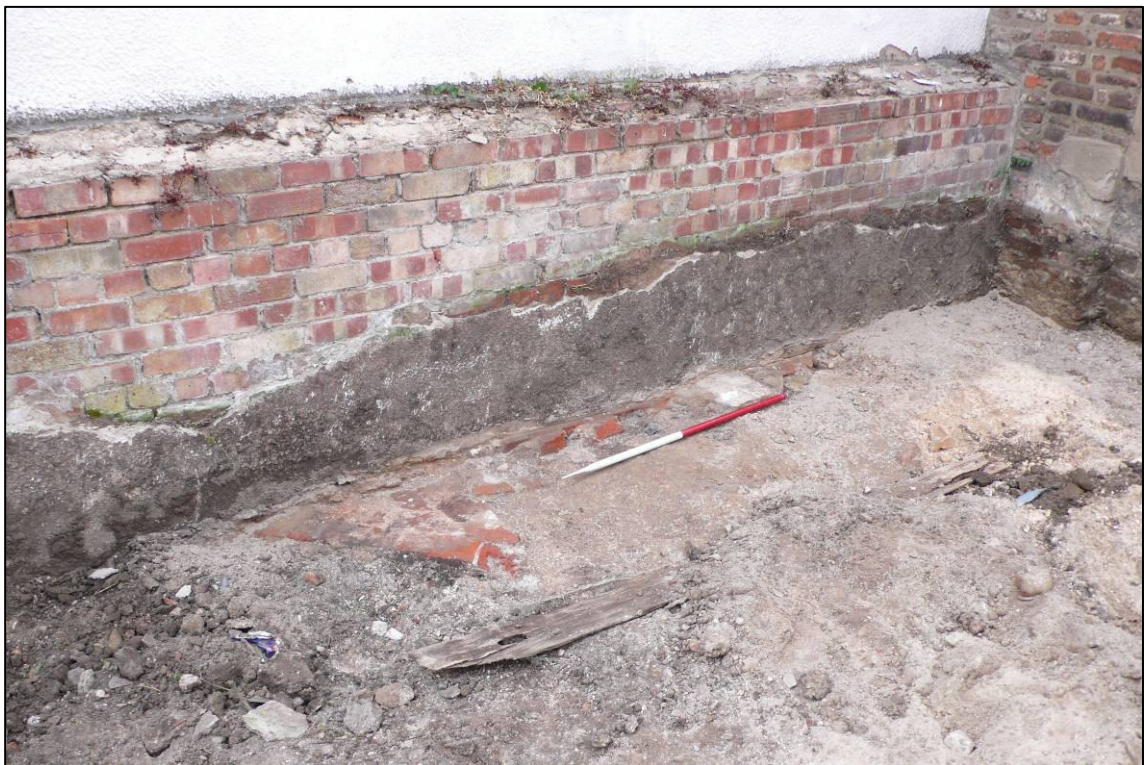
Plate 5: Remains of fireplace (014) and wooden plank (016), north side of site, looking N.

- 5.4 Both the yellow-grey sandy deposit (008) and the brick plinth (003) of the south gable of no. 44 lay on top of the remains of what appears to be a brick and tile fireplace (014), 0.42m below the variable ground level (BGL) (8.24m OD) (see plate 5); this is presumably associated with the northernmost terraced cottage (no. 46) which was demolished in the early 1960s. This fireplace was approximately aligned with the centre of no. 44, and appeared to be two bricks deep; it was 2.38m long and projected out 0.6m from the plinth adjoining no. 44 with splayed sides, and was covered with loose mortar. A piece of slightly decayed timber (016), 0.14m wide and more than 2.8m long, lay adjacent to the fireplace in the grey/yellow-brown sandy deposit (008), and there was another similar piece to the west; it was assumed to be one or two sections of either a scaffolding plank or a floor-board.

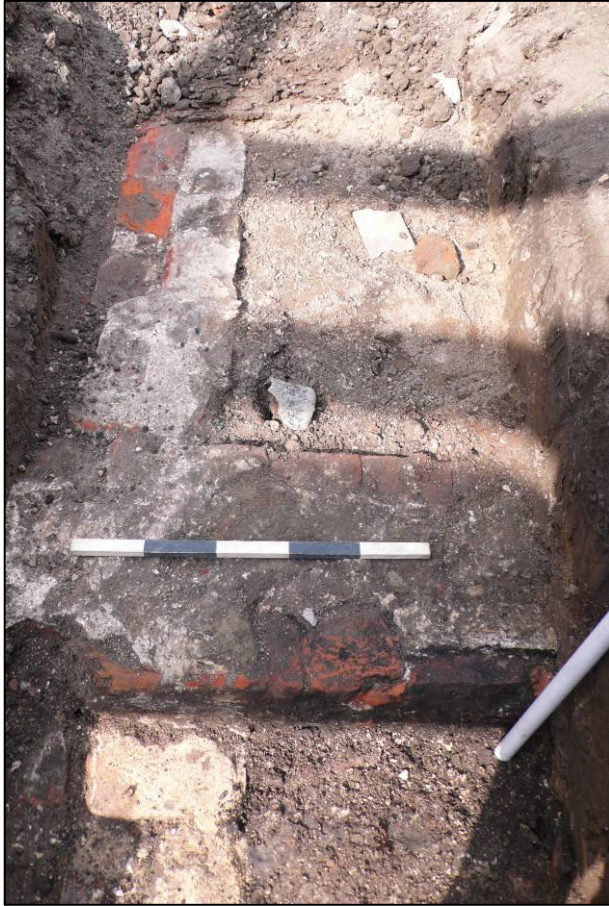
Plate 6: North-south aligned wall 019 with wall 018 to north and wall 023 to south, looking E.

- 5.12 Parts of two less substantial brick wall foundations (024) and (037) were also visible in this central part of the trench, beneath the walls defining the 'small space' (036, 018 and 019); these walls were on a slightly different alignment to the walls above. Very little of these foundations was exposed, but they appeared to be associated with each other and clearly belong to an earlier phase of building. This earlier phase may be represented by a floor (032) and hearth (033) seen to the east (see below), although this could not be determined precisely, and they could equally be associated in some way with the small square brick structure (029). The structures and features within the 'small space' were overlain by a pale gritty grey-brown plaster/mortar deposit (017) of varying depth, which contained pottery sherds dating to no later than the 18th century, with some residual pieces of possible medieval date. This deposit is likely to represent a demolition layer, although its limited extent as revealed by the excavated trench makes it difficult to be more specific.

- 6.2 Assuming that the above widths of the plot are correct, the east-west aligned brick wall (018) and its less substantial continuation to the west (023) represent the division between no. 46 to the north and no. 48 to the south. It is curious that no eastern extension was revealed but it is possible that some or all of the extensive *in situ* brickwork (046) seen in both sides of the excavated foundation trench to the east of wall 035 may be associated with this division. The two parallel north-south brick walls (035 and 036) uncovered in the centre of the trench represent the internal division between the front and rear rooms of nos 46 and 48, while the rear wall of the terrace is represented by the other north-south aligned wall (019); the front wall of the terrace is now lying beneath the now re-aligned Eastgate pavement. The fact that the two central walls (035 and 036) are butted against each other is curious, but it might simply reflect a staged approach to construction. The topsoil stripping in the north of the site also revealed the large fireplace (014) in the north wall of no. 46, and the extent of its foundation suggests that this house had a single large front room; the position of the fireplace accords almost exactly with another now blocked example seen in no. 44 (Dennison & Richardson 2011, figure 5). It is also likely that the area of square ceramic tiles (010) to the south represents the hallway of no. 46, as evidenced by the external door step on the 1892 Ordnance Survey map.

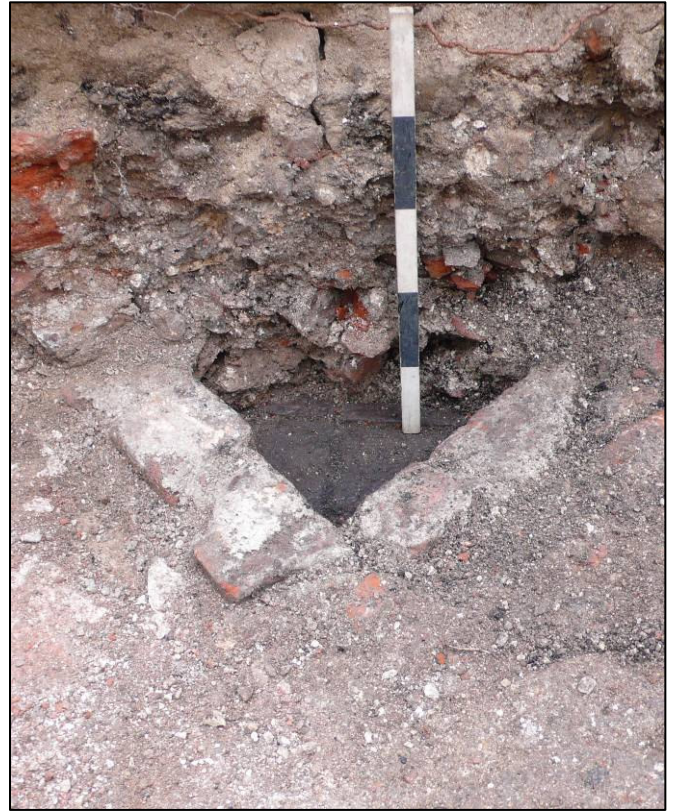
Plate 7: Square brick structure 029 - possible ash pit, looking N.

surface of ceramic tiles (030) which may have extended into the adjacent space. No evidence of burning was visible, either on the brick structure itself or on the underlying tiles, and it is possible that it was a pit for the temporary storage of household ash. These pits, common in the Georgian period, were cleaned out periodically and would sometimes also have a latrine placed over the top (Trevor Brigham, Humber Field Archaeology, *pers. comm.*). However, the precise relationship between the structure (029) and the small room in which it was located (represented by walls 036, 018 and 019) is unclear, and it may in fact relate to an earlier phase of building (see below).

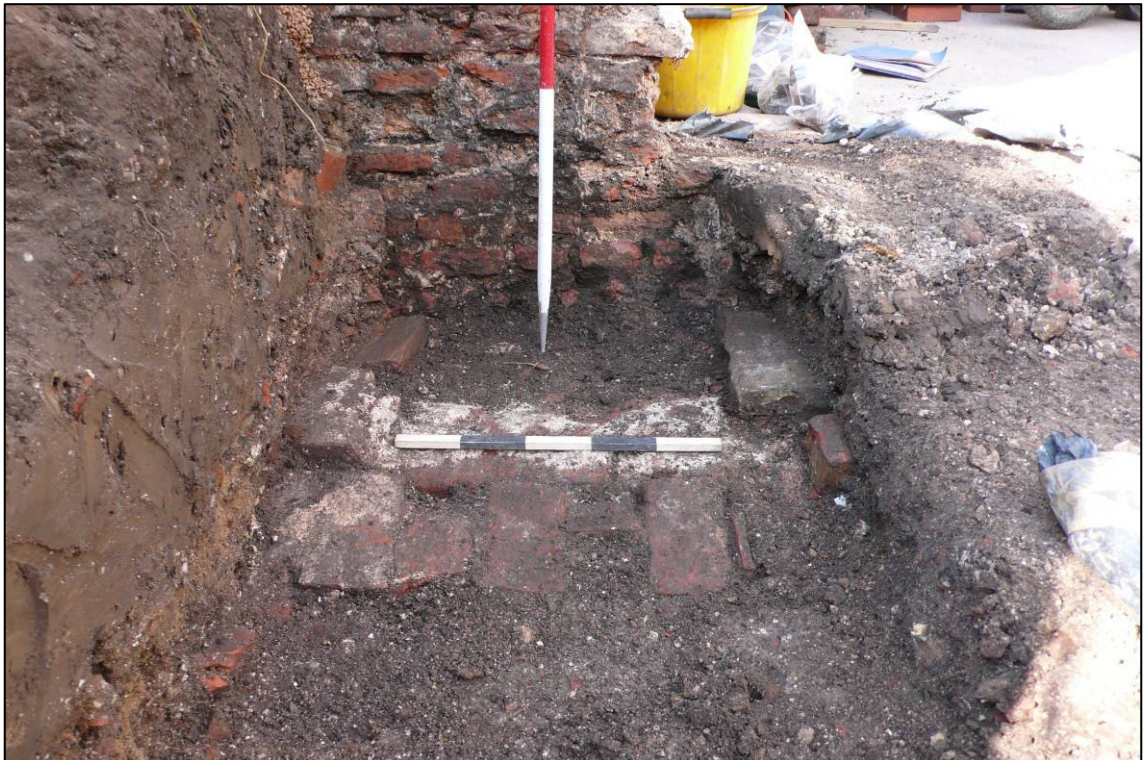
Plate 8: North-south aligned rear wall (022) with brick floor (025) of former privy in front, looking W.

- 6.4 The detailed 1892 Ordnance Survey map also allows the various wall lines and floor surfaces to the rear of the terrace, as revealed in the excavated trench, to be interpreted. The east-west aligned wall 023 represents the south side of the small structure attached to the south-west corner of no. 46, probably a privy, while the thinner north end of wall 022 forms part of its west side. The thicker south end of this wall (022) represents the wall line shown to the south, enclosing a very small open space which had a loose black gritty ash deposit (027) as a floor; this deposit contained various 18th and 19th century pottery sherds. Beneath this, and extending under the adjacent wall to the west, was a cobbled surface (028) which may represent a former yard. The floor of the probable privy and the larger space to the south was of brick (025). A clay pipe bowl, dating to around 1820, was found in the dark grey-brown gritty soil (043) beneath this brick floor.

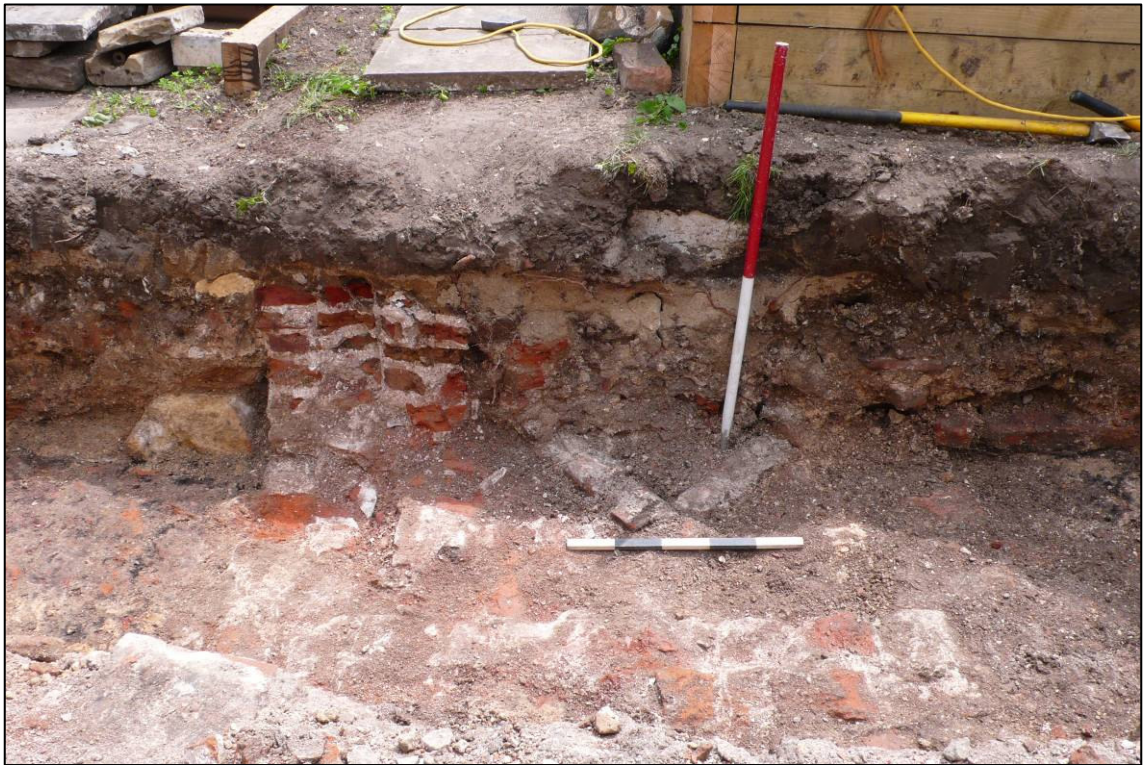
Plate 9: South side of wall foundation trench, showing walls 035/036 with possible square ash pit (029) to right and limestone fragment (038) to left, and wall 018 in front, looking S.

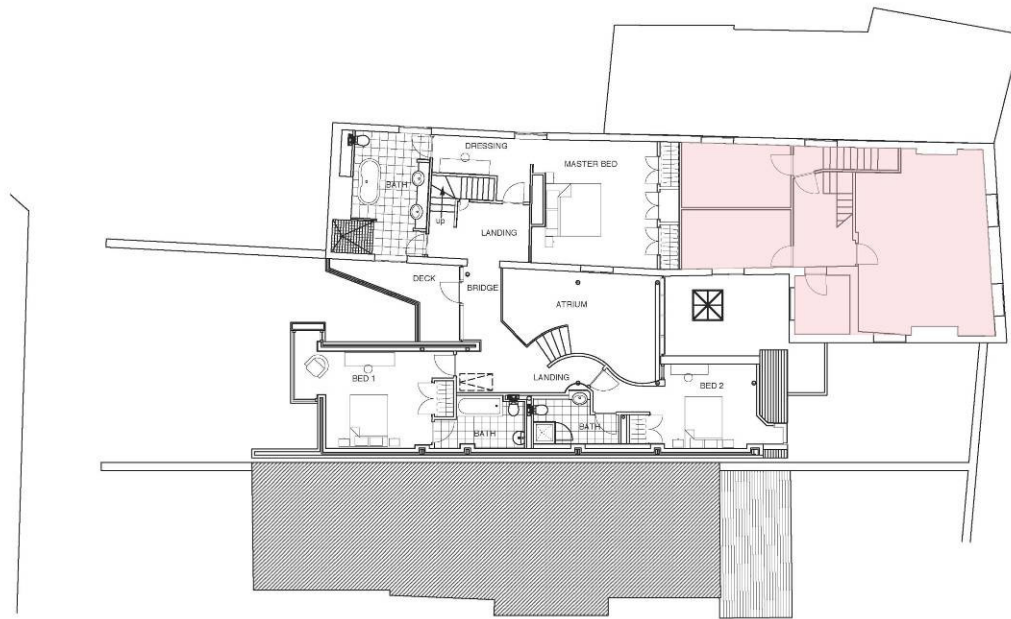
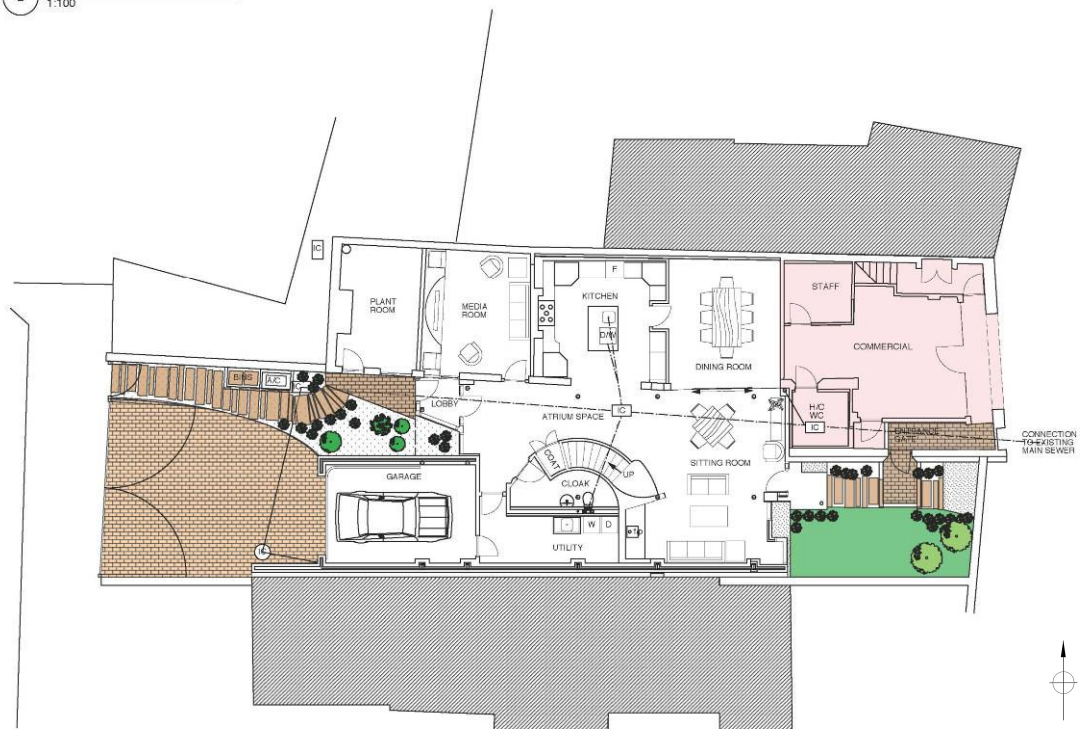
FIGURE 1: GROUND AND FIRST FLOOR AS PROPOSED
(not to scale - plans supplied by Steve Burland Architecture)

2 FIRST FLOOR AS PROPOSED
1:100

1 GROUND AS PROPOSED
1:100

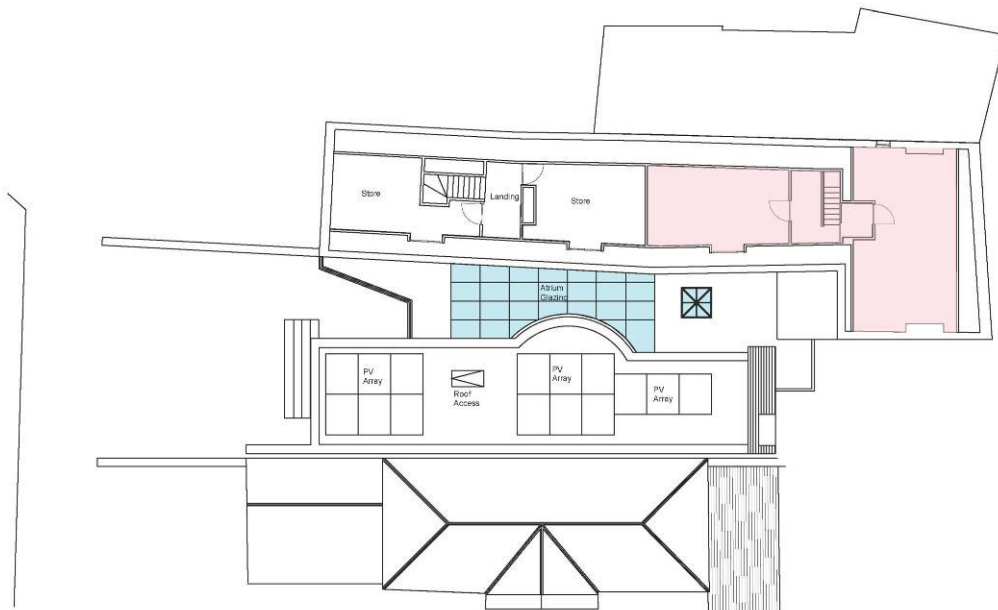
FIGURE 2: SECOND FLOOR AND ROOF SURVEY
(not to scale - plans supplied by Steve Burland Architecture)

2 ROOF SURVEY
1:100

1 SECOND FLOOR SURVEY
1:100
