CONVERSION OF AND ALTERATIONS TO
EXISTING BUILDING TO FORM SEVEN APARTMENTS
AND RETENTION OF RETAIL UNIT TO GROUND FLOOR,
SUITE AND CARPET WAREHOUSE,
MORLEY'S YARD, BEVERLEY,
EAST YORKSHIRE

ARCHAEOLOGICAL OBSERVATION,
INVESTIGATION AND RECORDING

Report no: 2007/320.R01
Version: Final
Date: June 2011
Author: Shaun Richardson & Ed Dennison

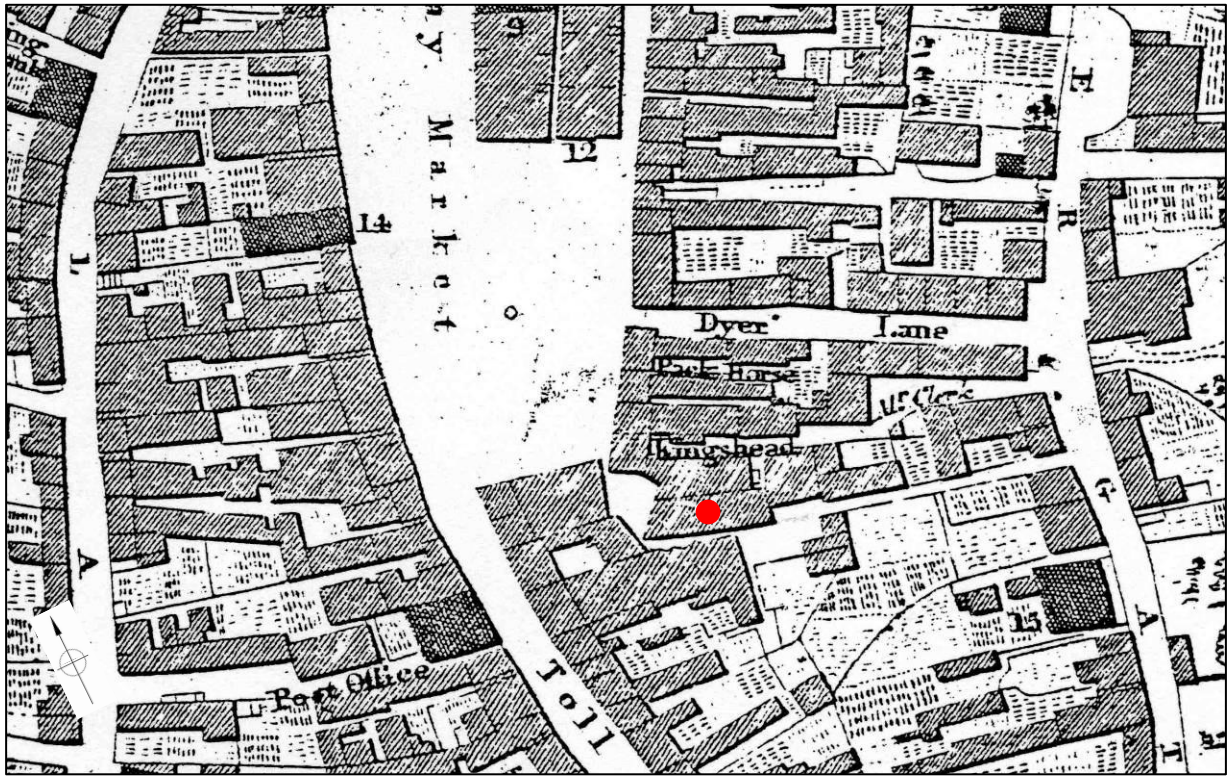
PROJECT	MORLEY'S YARD, BEVERLEY	
TITLE	HISTORIC MAPS	
SCALE	NTS	DATE JUNE 2011
	EDAS	FIGURE 3

Top: Section of Wood's 1828 map of Beverley.
 Bottom: Section of OS 1853 map sheet 3.

- 4.7 The building is similarly depicted in 1853, when it is shown to be divided into three parts internally, the western and central parts being approximately the same length, with the eastern part approximately half their size (see figure 3). The west

end is set at a less acute angle than was shown in 1828, although this may be merely a result of exaggeration in the earlier depiction. There appears to be a flight of steps set against the west gable. As in 1828, the building stands on the north side of a yard, by this date named as 'Morley's Yard'. The structures shown attached to the north side and north-east corner in 1828 are still present.

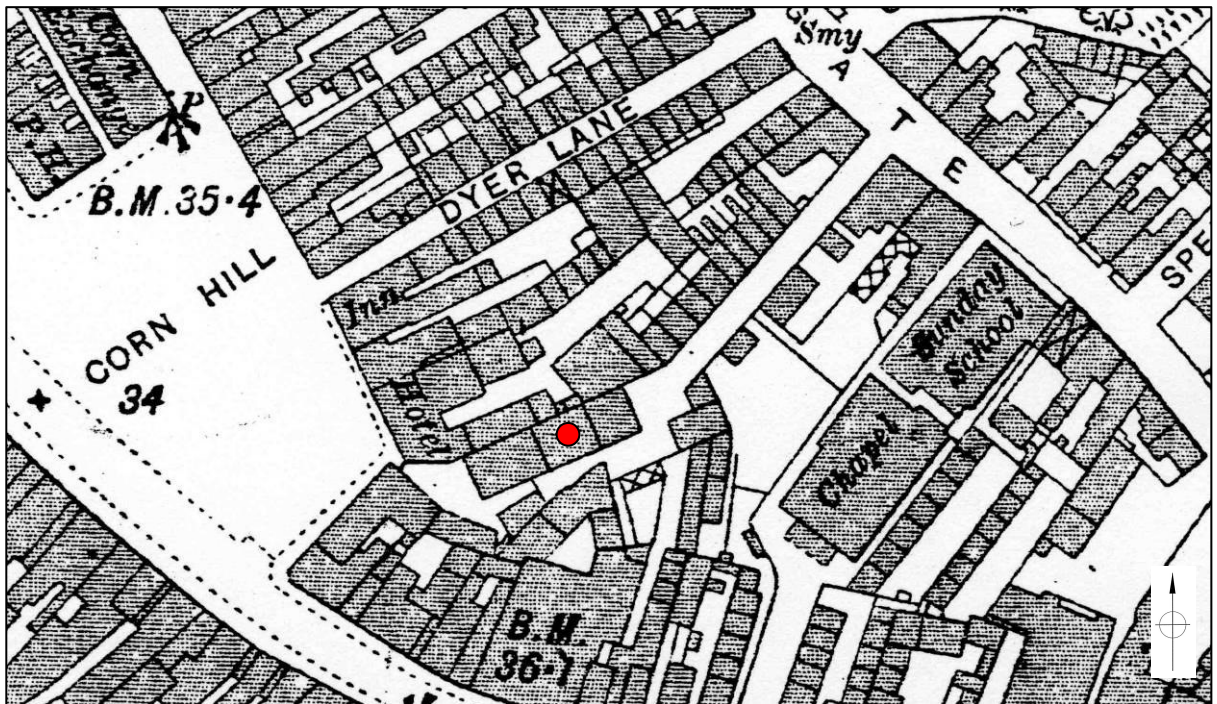
PROJECT		MORLEY'S YARD, BEVERLEY	
TITLE		HISTORIC MAPS	
SCALE	NTS	DATE	JUNE 2011
EDAS		FIGURE	4

Top: Section of OS 1892 map sheets 210/8/18 and 210/8/23.
 Bottom: Section of OS 1910 map sheet 210/8.

- 4.8 The more detailed 1892 1:500 scale Ordnance Survey maps show a similar tripartite division of the building, although no steps are depicted against the west gable; the west end measures c.11.5m long, the central cell c.8.5m long and the east cell c.7.5m long (see figure 4). The building is again very similarly depicted in 1910 (see figure 4). The structures shown attached to the north side and north-east corner in 1828 are still present. However, by 1985 that to the north-east (forming part of the King's Head) had been completely demolished and a new structure (forming an extension to the Yorkshire Bank) had been erected against the west end of the building.

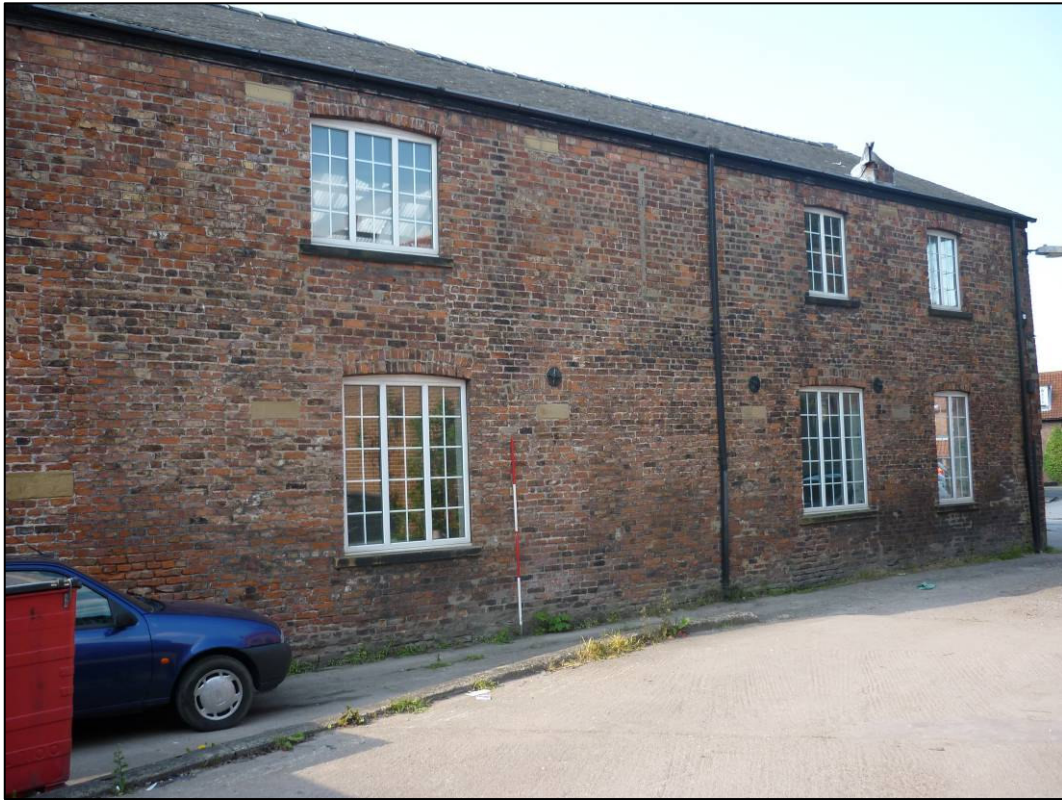
Plate 1: East end of south elevation of standing building, prior to conversion, looking N.

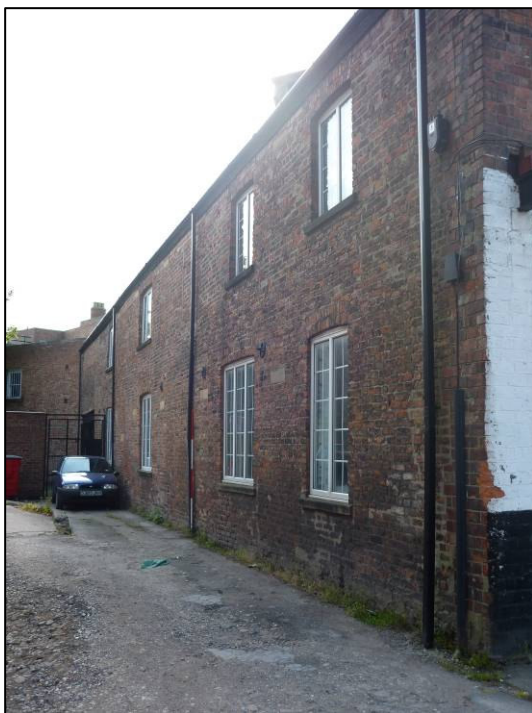
Plate 2: South elevation of standing building, prior to conversion, looking SW.

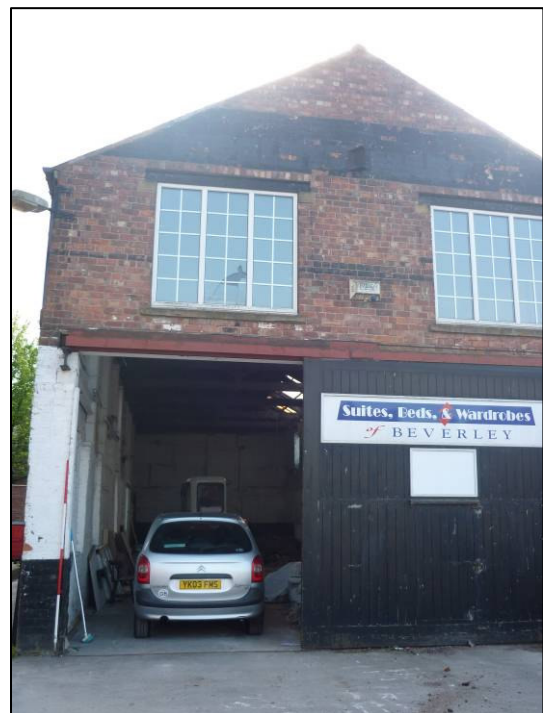
Plate 3: East gable of standing building, prior to conversion, looking W.

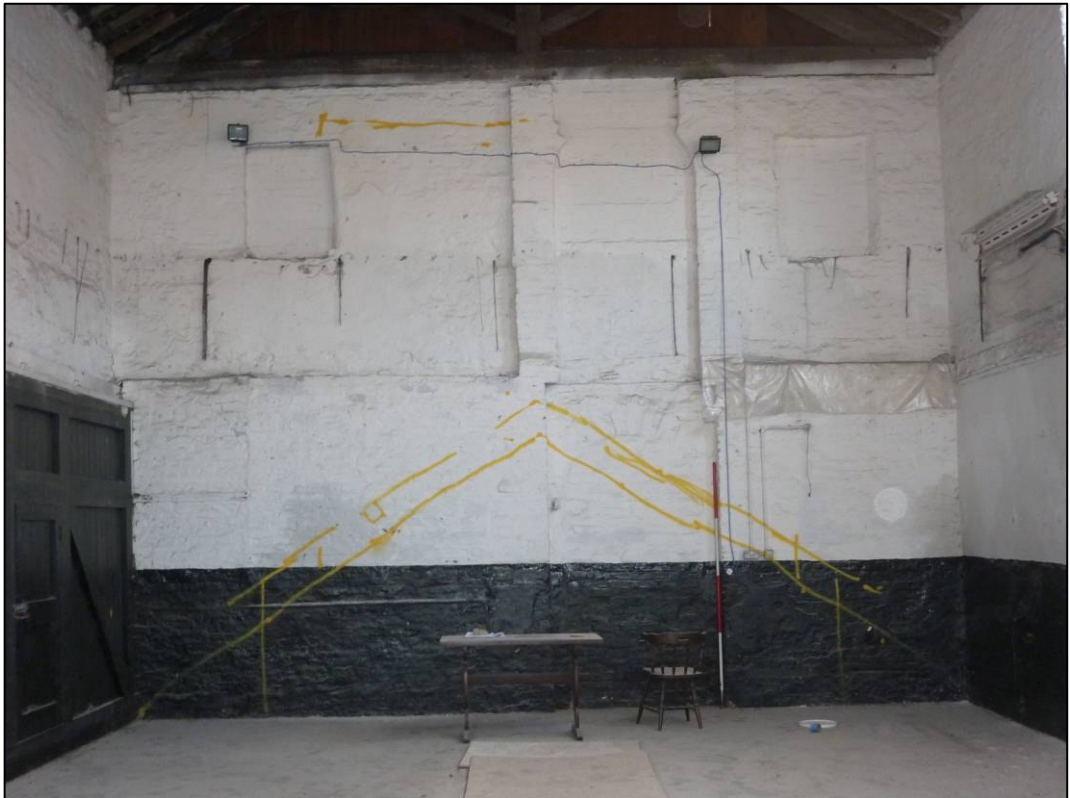
Plate 5: Internal west wall of standing building, looking SW.

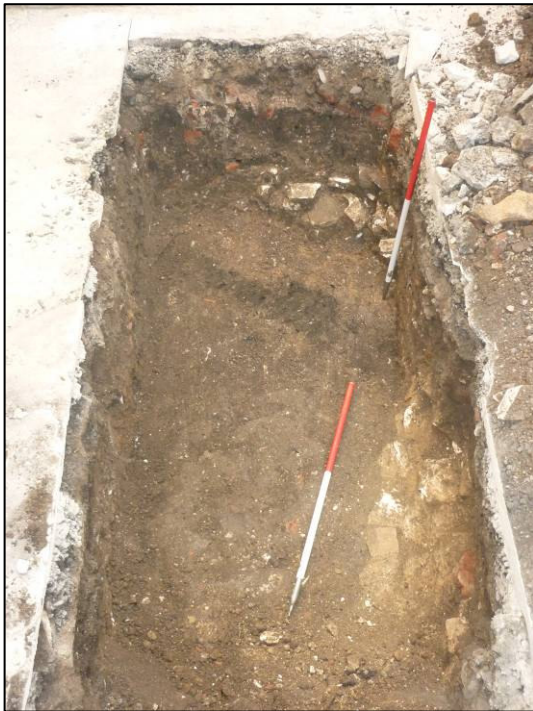
Plate 6: North end of Trench C, showing slot [018] and brick/chalk footing [005 and 008/009], looking NW.

- 6.10 At the north end of the trench, the mid-brown clay [007] was cut by a linear east-west aligned slot [018] (see plate 6). It measured 0.30m wide at its east end, but the north side stepped in at a point 0.45m from the east side of the trench to continue across the full width of the base of the trench with a reduced width of 0.15m. The slot was filled with a firm mid-brown clay, very heavily stained with flecks of charcoal [019].

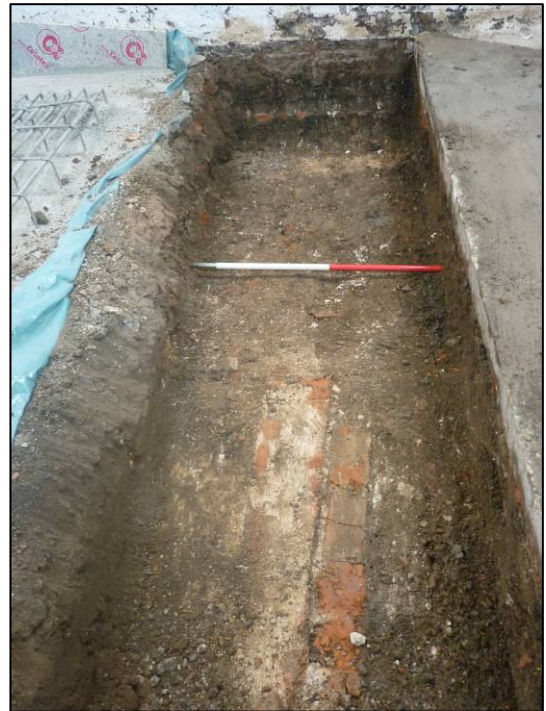
Plate 7: Trench E, showing brick foundation [038/039], looking NW.

- 7.8 Earlier brick/chalk structures (i.e. pre-dating the late 18th century) are represented by contexts 005, 008/009 and 012 in Trench C, and context 038/039 in Trench E. Although these structures may not all be contemporary, it is interesting that they lie within the western half of the site, but there could, of course, be other structures in Trenches F to I at greater depths. It is difficult to see what these structures might represent. The north-south aligned foundation [038/039] in the base of Trench E might be a structural wall of a small building of unknown dimensions. It is also noticeable that other foundations seen in Trench C [012] and Trench D [027 and 030] all have the same broad north-east/south-west alignment; the two parallel walls of 027 may well represent a small 1.8m wide structure, the ground surface within being formed by crushed brick fragments [028].

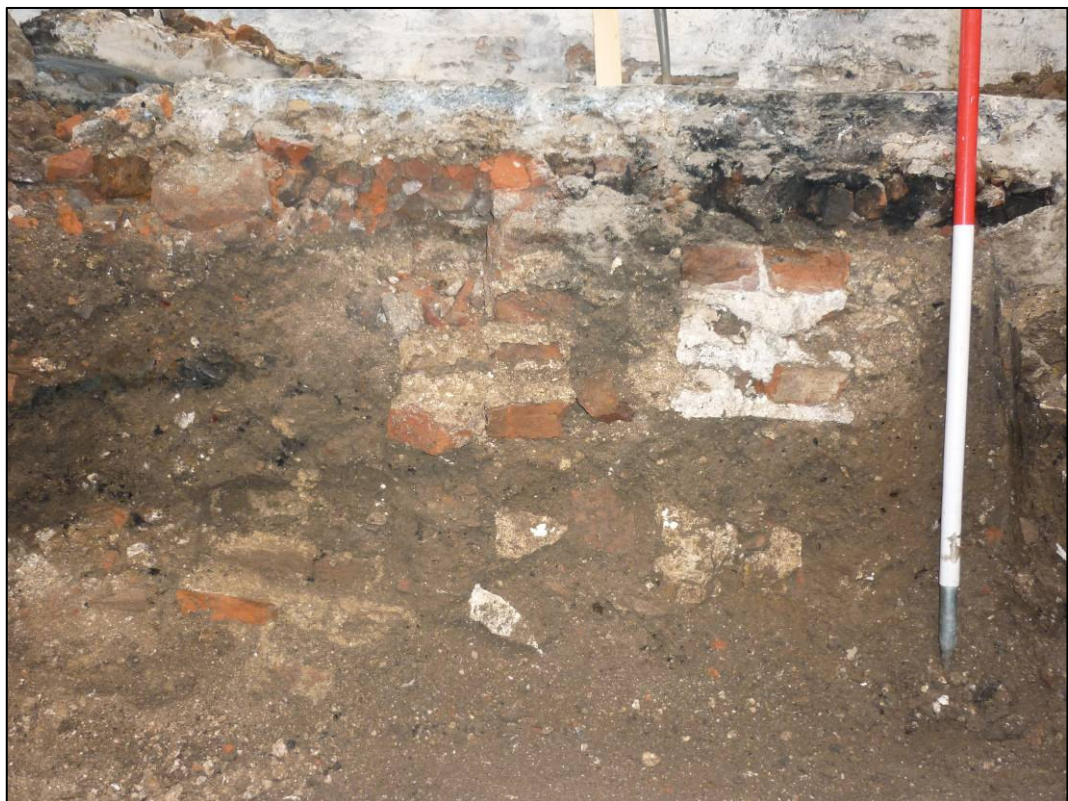
Plate 8: South side of Trench C (section 4), showing brick/chalk foundations [023 and 014], looking S.
