FOLLY AT PARK FARM,  
RISBY, EAST YORKSHIRE

Bat Report

**FOLLY AT PARK FARM, RISBY, EAST YORKSHIRE**

**Project Brief for a Management Plan for the Restoration of the  
Folly at Park Farm, Risby, East Yorkshire**

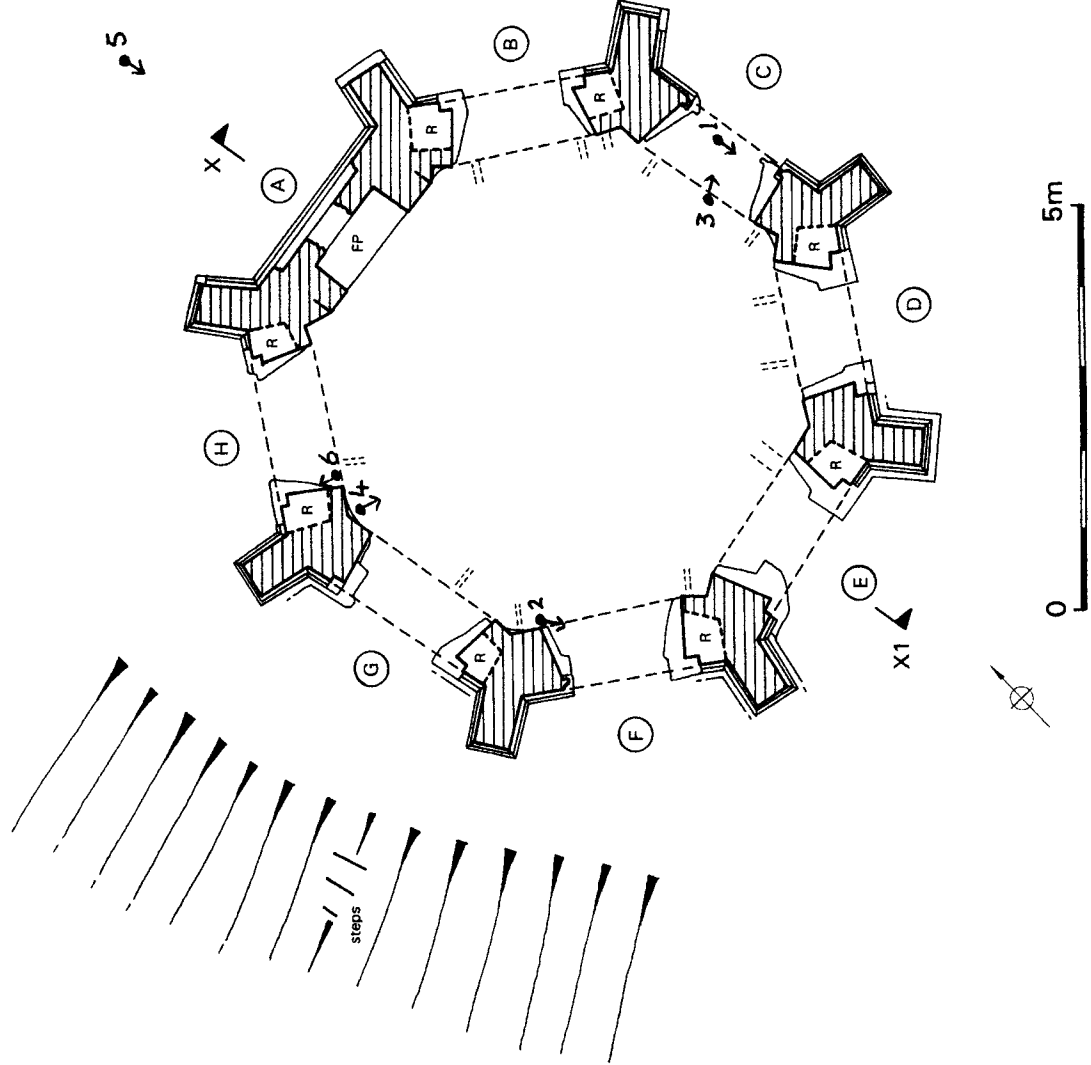
**SKETCH 1**  
 Plan of the folly at  
 Park Farm, Risby,  
 East Yorkshire

(A)	IDENTIFIERS
FP	FIREPLACE
R	RECESS
	PHOTO LOCATION

2.3.4 An evening emergence survey was conducted on 27<sup>th</sup> June 2011. Two recorders were stationed at opposite ends of the building: one had clear views of the northern external elevations (A, B and H) and the other had clear views of the southern external elevations (D and E) - refer to Sketch 1.

3.1.1 The general location of the folly at Park Farm, Risby, East Yorkshire, is shown in the aerial photo of Figure 1. A sketch plan of the structure is shown in Sketch 1 and the locations for each photo are shown on this plan.

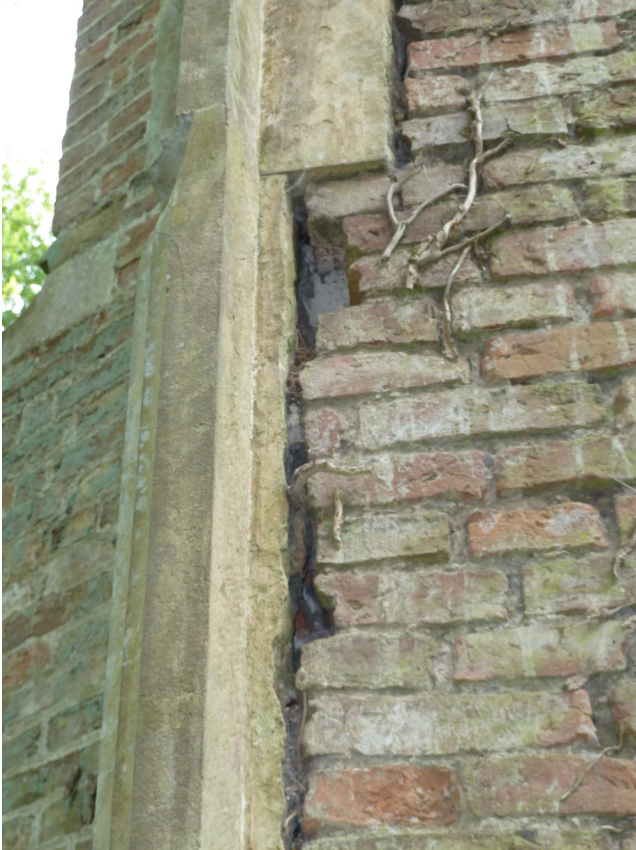
**Plate 1**

3.1.2 Many crevices suitable for bat entrances into potential bat roosts were recorded between some of the brick columns and the adjacent stone dressings of this structure (Plate 1). Occasional crevices suitable for bat entrances into potential bat roosts were also recorded within the red brick walls and columns (Plate 2) and also between the stonework at the apex of some of the arches (Plate 3). Finally, further gaps in the brickwork that were suitable for bat entry into potential roost(s) were recorded in the upper levels

Example of bat entrances into potential bat roosts that were recorded between some of the brick columns and the adjacent stone dressings

3. An assurance that the contractor is made aware of the possibility of bats roosting in small crevices within the folly. Caution should therefore be applied to dismantling procedures with any cavities between the brickwork and/or stonework checked for bats as restoration work proceeds. Any bat found during operations should have the cavity covered or protected, all work should cease and a Licensed Bat Worker should be immediately notified. Should bats be discovered then it is likely that they would be able to fly away at the recommended time of year (April/May or September/October) and find an alternative roost nearby, perhaps in one of the nearby bat boxes. However, should bats be torpid then a Licensed Bat Worker should gently remove them by hand (with appropriate glove protection) and transfer them into one of the nearby bat boxes, preferably without causing them to fly out in daylight.

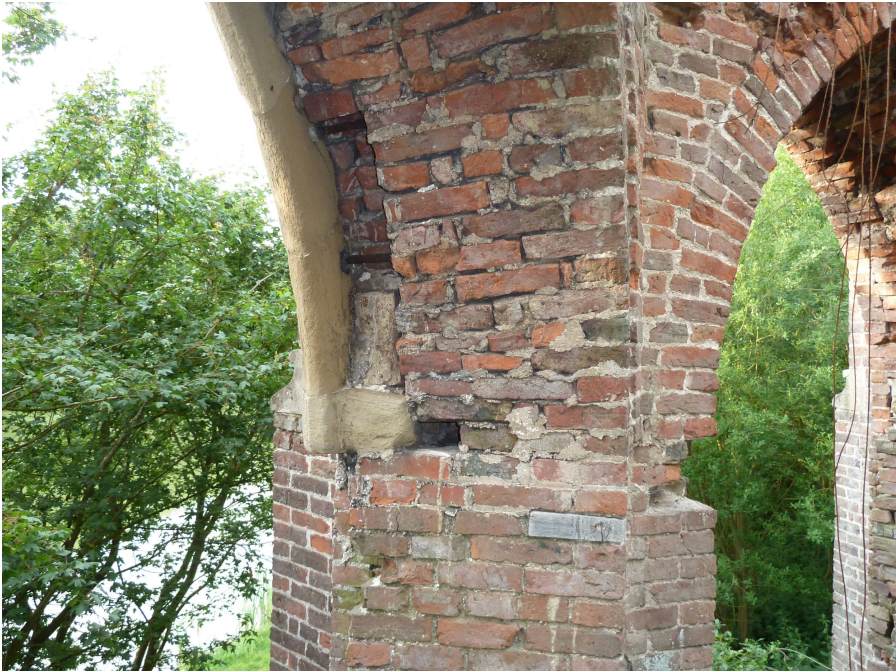
**Plate 2** Occasional crevices suitable for bat entrances into potential bat roosts were also recorded within the red brick walls and columns

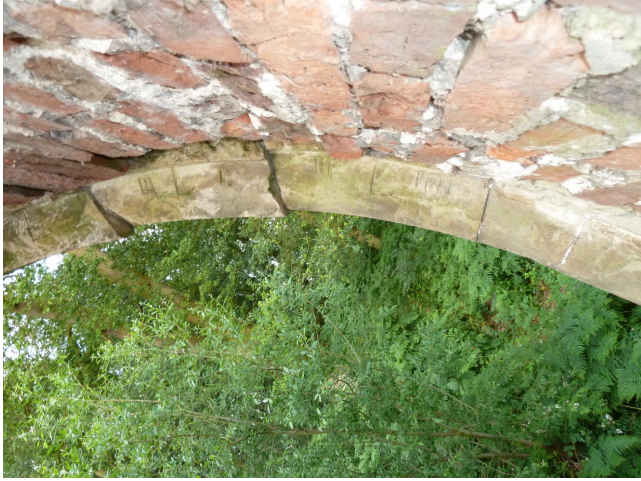
**Plate 3** Occasional crevices suitable for bat entrances into potential bat roosts were also recorded between the stonework at the apex of some of the arches

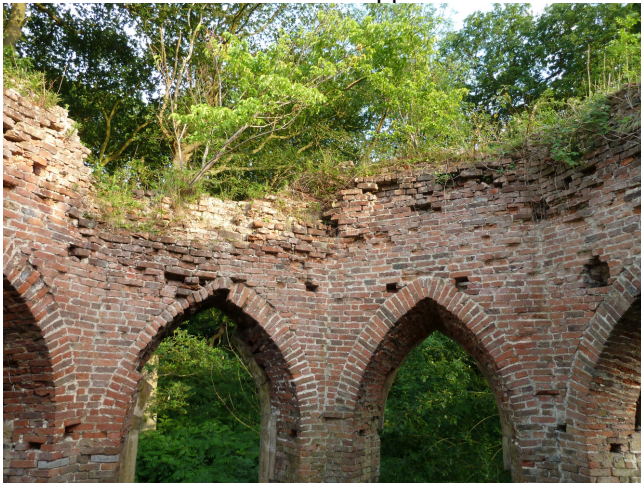
of the building as illustrated in Plate 4. No signs of bats, however, were recorded in any of the accessible crevices.

**Plate 4** Occasional crevices suitable for bat entrances into potential bat roosts were also recorded in the upper levels of the building

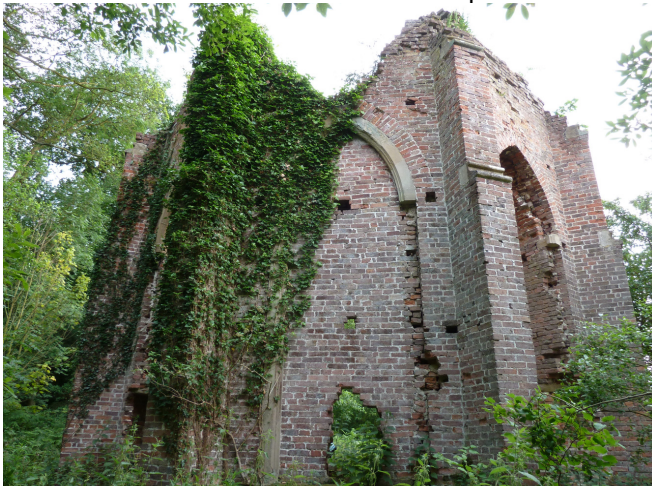
- 3.1.3 Dense ivy covered parts of the external elevations of the fireplace as shown in Plate 5, which made this wall and the adjacent arches difficult to search for signs of bats. In addition, scrub growth was particularly close to the external elevations adjacent to the path and the fishing lake (refer to Sketch 1), also making these parts of the structure difficult to comprehensively survey. Finally, dense vegetation covered the ground within the roofless, octagonal, structure effectively obscuring any bat droppings that may have otherwise been recorded at these locations. The tops of the walls were covered by a range of pioneer vegetation. This included common ragwort *Senecio jacobea*, male fern *Dryopteris felix-mas*, rosebay willowherb *Chamerion angustifolium* and young woody vegetation such as elder *Sambucus nigra*, oak *Quercus spp.* and cherry *Prunus spp.*

**Plate 5** Dense ivy covered parts of the external elevations of the fireplace making the brickwork inaccessible for inspection

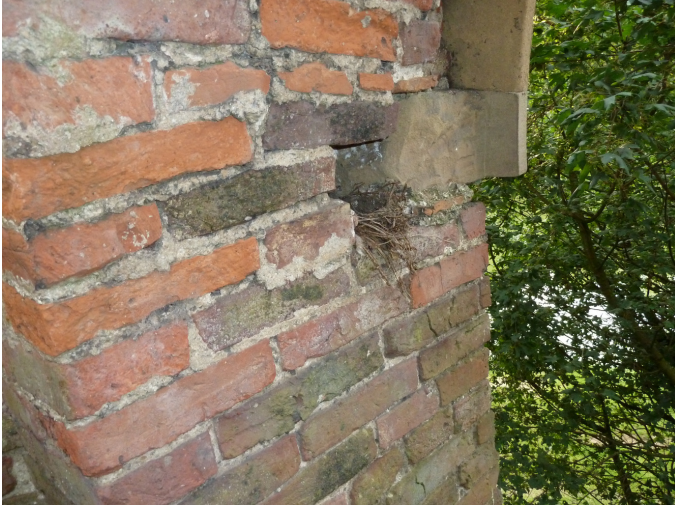
- 3.1.4 A single bird nest was located in the gap left by a missing brick in one of the arches (Plate 6).

**Plate 6** A single bird nest was located in the gap left by a missing brick in one of the arches
