ST PAUL'S CHURCH (HORBURY METHODIST CHURCH)
AND FORMER SUNDAY SCHOOL,
HIGH STREET, HORBURY,
WEST YORKSHIRE

BUILDING RECORDING

Report no: 2010/386.R01
Version: Final
Date: May 2011
Author: Shaun Richardson & Ed Dennison

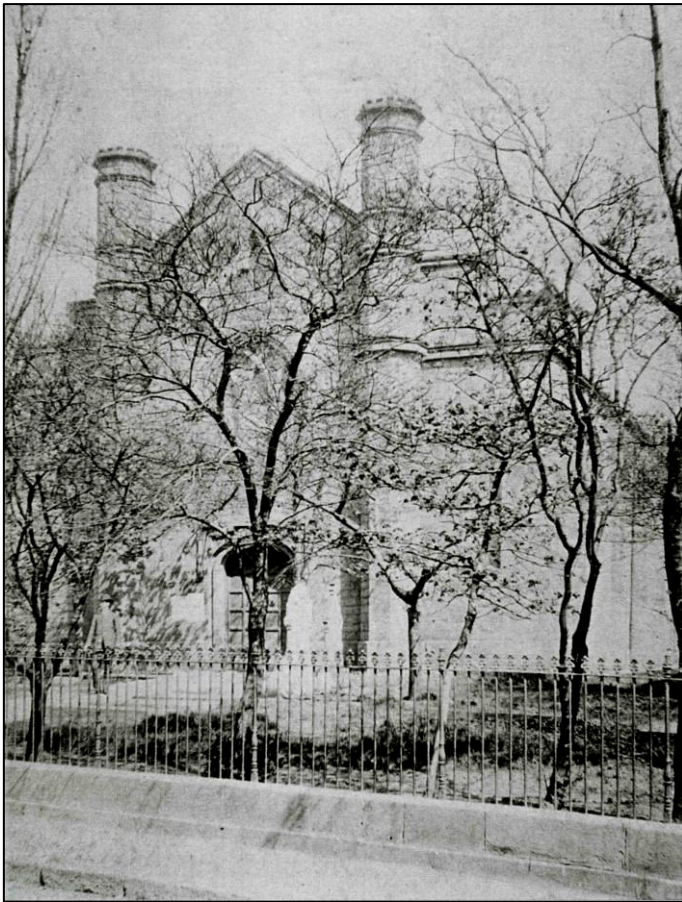
PROJECT		ST PAUL'S CHURCH, HORBURY	
TITLE		HISTORIC PHOTOGRAPHS	
SCALE	NTS	DATE	MAY 2011
EDAS		FIGURE	3

Left: Wesleyan chapel built 1845-46 and demolished c.1883 to make way for existing St Paul's church.

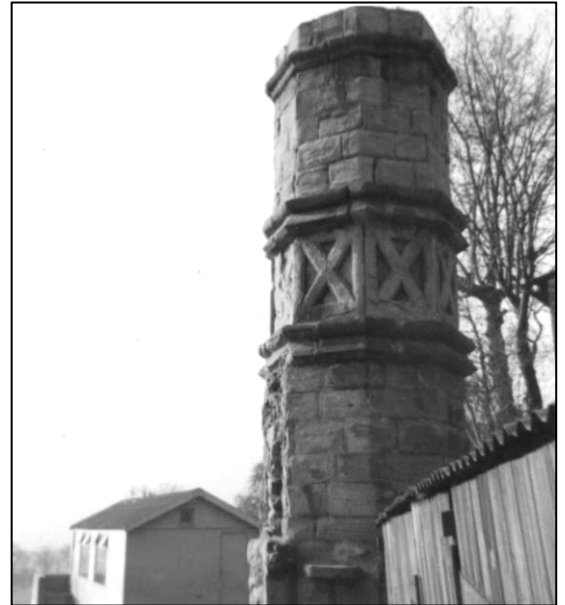
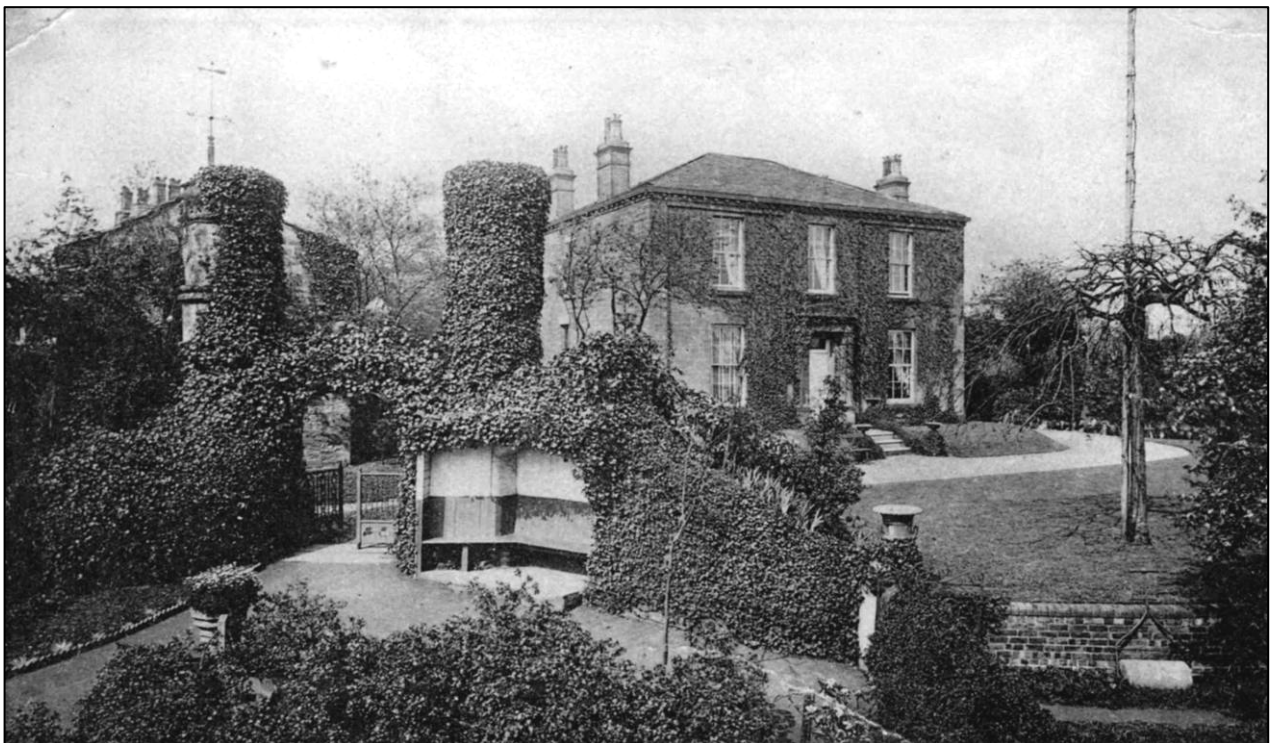
Below: Surviving tower from demolished Wesleyan church in c.1969.

Above: Early 20th century postcard of High Fields showing towers from demolished Wesleyan chapel in grounds.

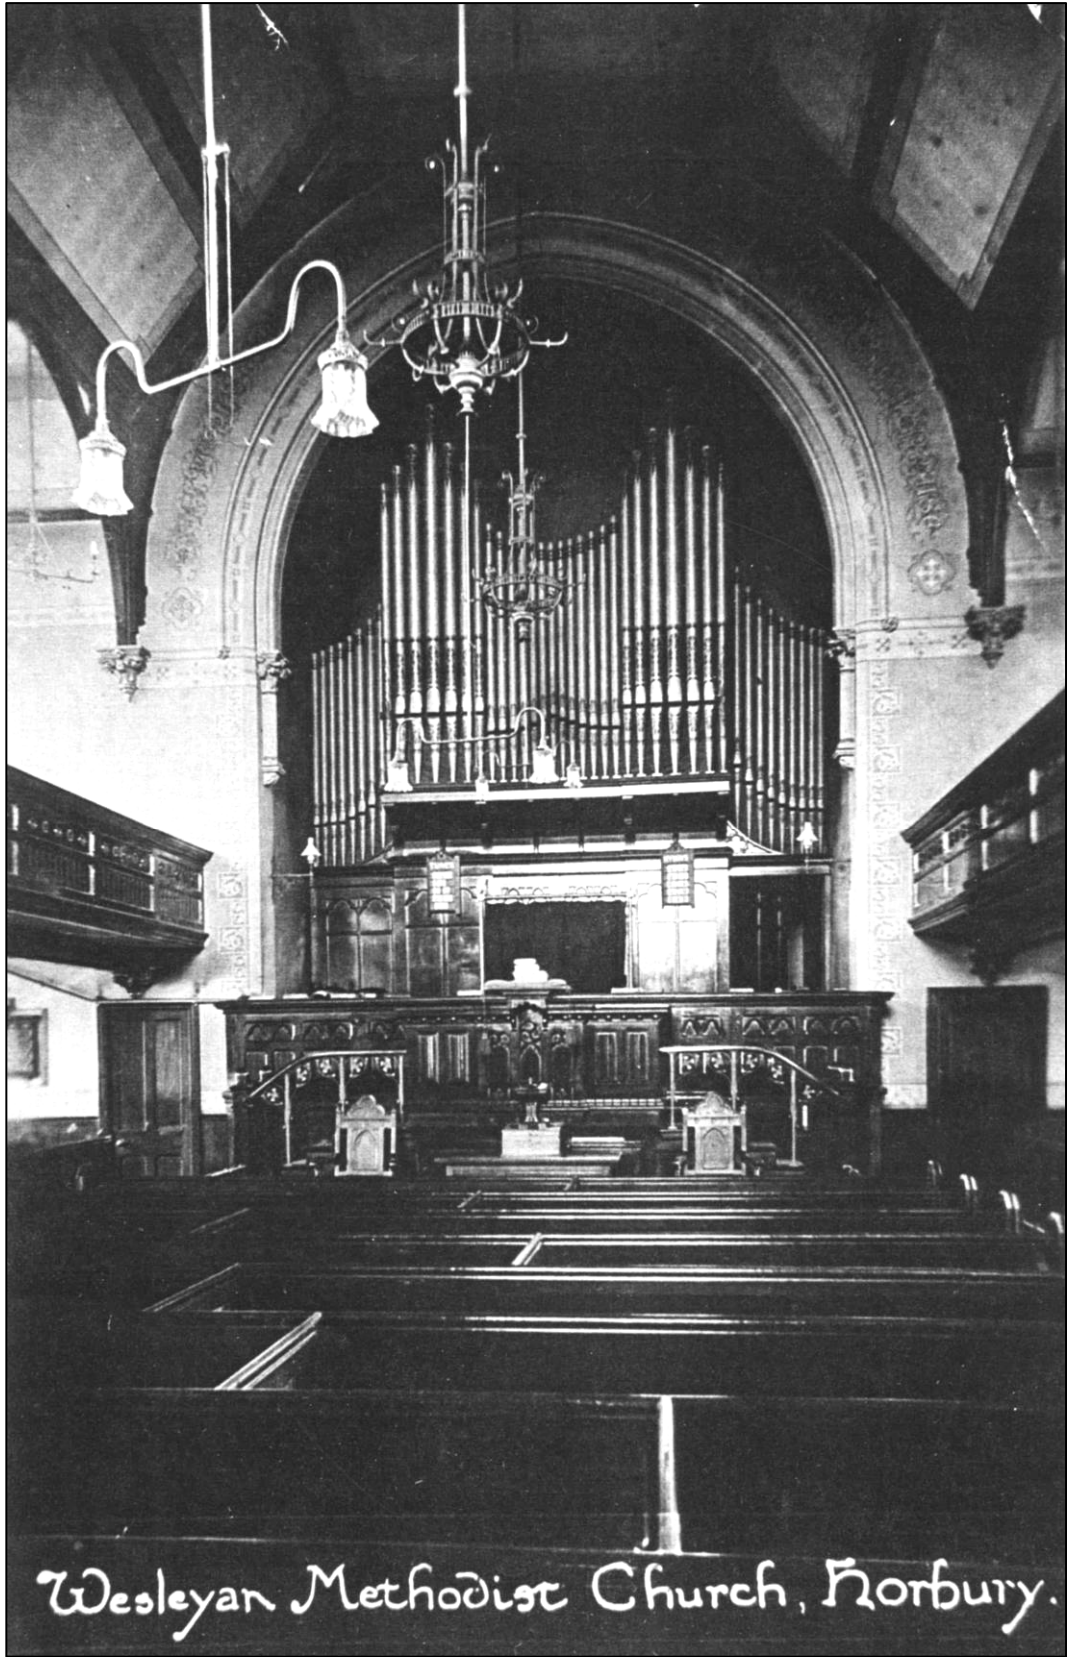
PROJECT	
ST PAUL'S CHURCH, HORBURY	
TITLE	
EARLY 20TH CENTURY PHOTOGRAPH	
SCALE	DATE
NTS	MAY 2011
EDAS	FIGURE
	6

Wesleyan Methodist Church, Horbury.

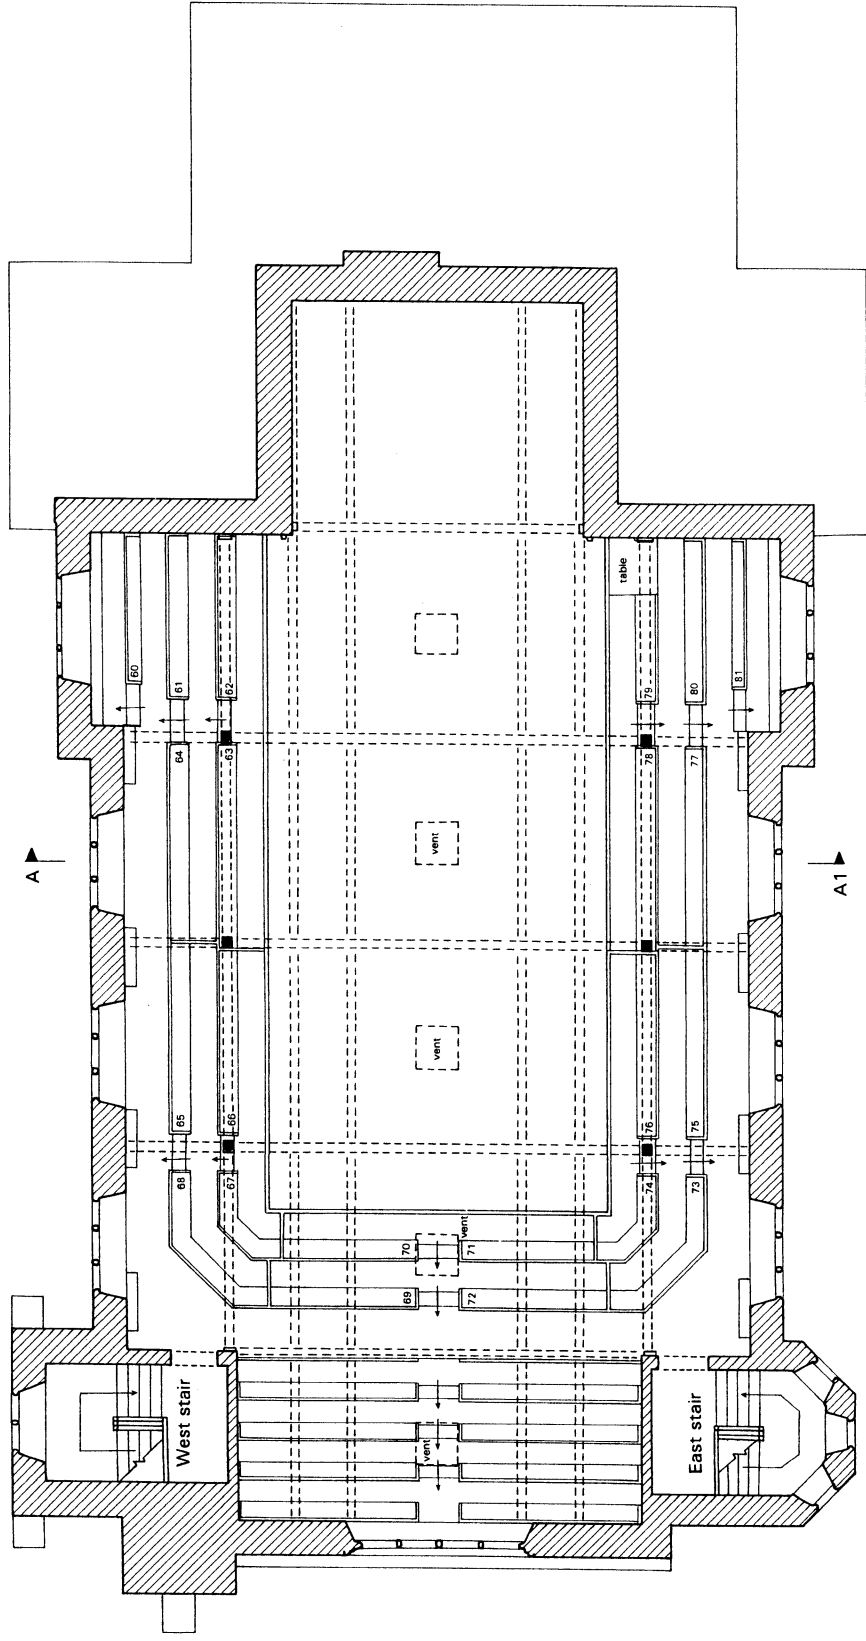
PROJECT	ST PAUL'S CHURCH, HORBURY		
TITLE	FIRST FLOOR / GALLERY PLAN		
SCALE	AS SHOWN	DATE	MAY 2011
	EDAS	FIGURE	8

81 PEW NUMBERS

- 1.10 The drawn record comprised ground and first floor plans of the church at a scale of 1:50, using plans prepared by Potts Parry Ives and Young as a base. These were checked in the field for accuracy and then detail added, so that the EDAS plans show all significant details such as inserted or blocked openings, original fixtures and fittings, and details of items relating to original and subsequent uses. Where stored material was present that could not be moved, detailed inspections were undertaken behind and around any stored material to ensure that all relevant features were noted. In addition to the floor plans, a section at a scale of 1:50 was constructed through the church, again based on a survey by Potts Parry Ives and Young.

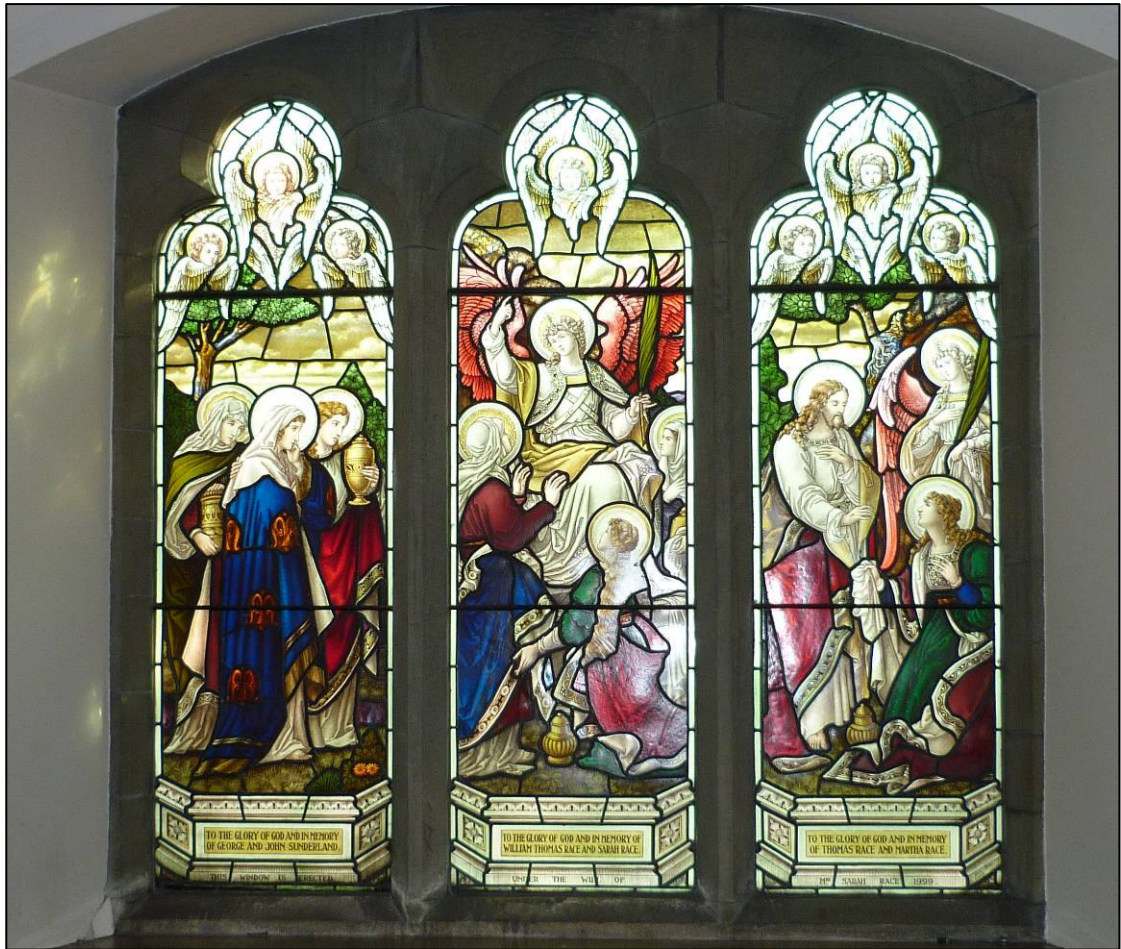
Above: Window at north end of east aisle, 'erected under the will of Mrs Sarah Rice 1929' (photo S1).

- 2.30 In January 1929, the Trustees granted permission for the 'placing of a stained glass window behind the pew that Mrs Race had occupied' (WYAS C8/12/3/1/3 - 29/1/1929); this still exists (see figure 12), and is described in Chapter 3 below. In 1932, a major redecoration of the chapel took place. This was first discussed on April 7th, and in May, estimates of £10 from R H Lockwood of Horbury for plasterwork and £88 from Mr L Jagger for redecoration of the interior were accepted. The details of the latter were discussed by the Trustees using a

3.19 Looking north, towards the former organ recess (plates 61 and 62), the appearance of the church is now largely as it was immediately following the 1968 refurbishment, the steps, pulpit, metal and wood communion rail, cross and panelling from this refurbishment all still being in place (plate 63). The windows lighting the aisles are generally fitted with plain geometric leaded glazing, although there is some stained glass of a simple foliate design to the trefoiled heads of the window lights (plates 64 and 65). The exception is the stained glass window at the north end of the east aisle (plate 66), referred to in the Trustees' Minutes of January 1929. The three-lights of the window depict Mary Magdalene, Salome and Mary (mother of James) carrying ointments to the tomb of Christ, the Angel appearing to the three women at the empty tomb and the resurrected Christ appearing to Mary Magdalene (see figure 12). The gazing of the three lights also includes the inscriptions 'To the glory of God and in Memory of George and John Sunderland' (left-hand light), 'To the glory of God and in Memory of Thomas Race and Sarah Race' (central light), and 'To the glory of God and in Memory of Thomas Race and Martha Race (right-hand light)'; at the base runs 'This window is erected under the will of Mrs Sarah Race 1929'.

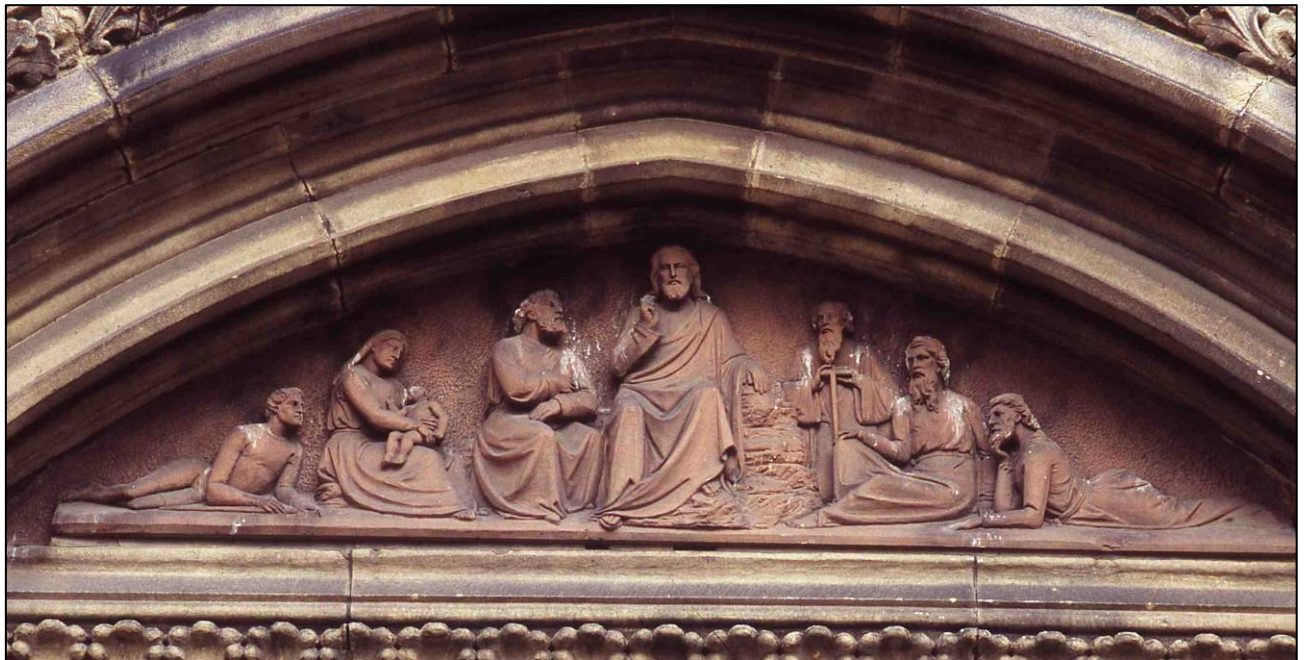
Below: Frieze depicting the sermon on the mount over south door (photo S23).

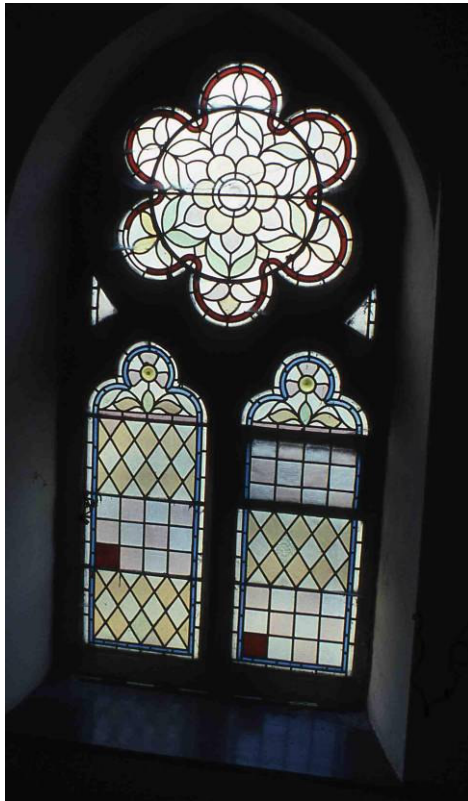
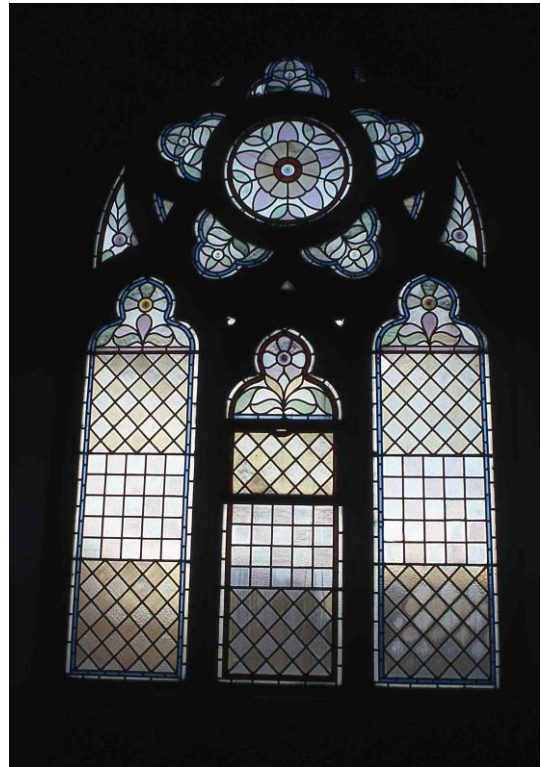
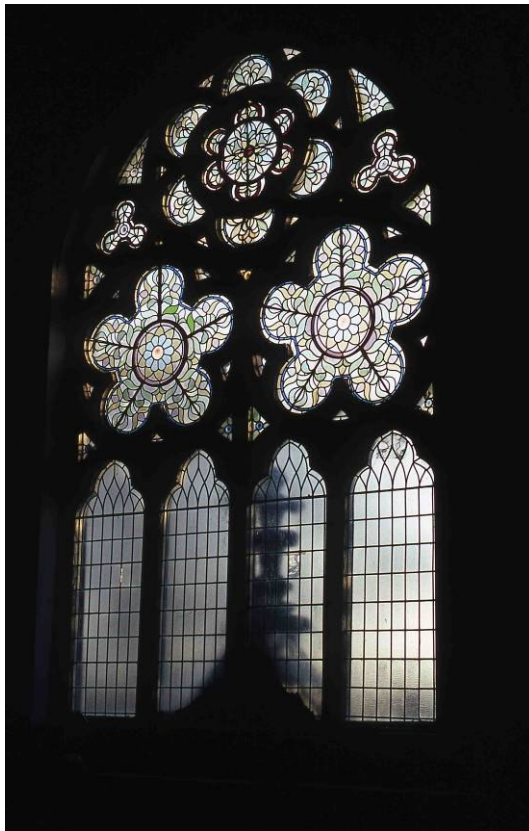
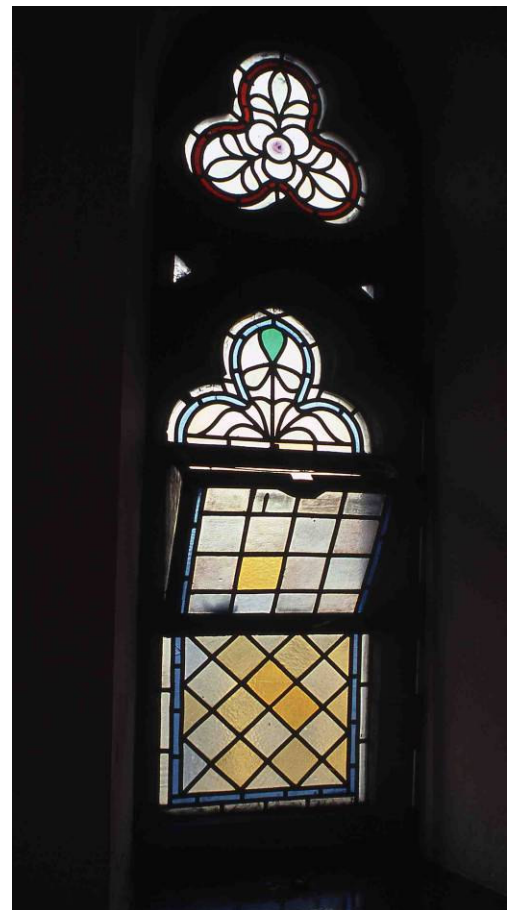
PROJECT		ST PAUL'S CHURCH, HORBURY	
TITLE		STAINED GLASS WINDOWS	
SCALE	NTS	DATE	MAY 2011
EDAS		FIGURE	13

Top left: Window in west stair (photo S5).
 Top right: Window to north bay in gallery (photo S7).
 Bottom left: Window at south end of gallery (photo S10).
 Bottom right: Window in east stair (photo S15).

- 3.16 The doorways at the east and west ends of the entrance lobby lead through into small circulation spaces at the base of the east and west stairs leading to the first floor gallery; both circulation spaces are provided with a settle-type seat to the three-light window in the south wall (plate 36); the windows have simple stained glass (plate 37). Although the east gallery stair is housed within a canted projection, and the west within a sub-rectangular one, both are furnished in the same manner. Each pitched pine dog-leg staircase has a square newel post with a conical ribbed finial, stick balusters and a moulded handrail (plate 38). To one side of the stair, there is a short passage leading to a door with a coat rack above, which opens into a below-stair cupboard (plate 39). Both staircases rise steeply to a small half-space landing, lit by a window of two trefoil-headed lights and a sexfoil over (plate 40) (see figure 13). The window glazing is of the same, simple foliate pattern, as seen elsewhere within the church, but most is plain-glass and not coloured (plates 41 and 42) (see figure 13). The stairs then rise again to the first floor gallery.
