THE OLD MILL, THE GHYLL, GUNNERSIDE,
MELBECKS, NORTH YORKSHIRE

ARCHAEOLOGICAL RECORDING

Report no: 1999/100.R03
Version: Final
Date: November 2011
Author: Shaun Richardson & Ed Dennison

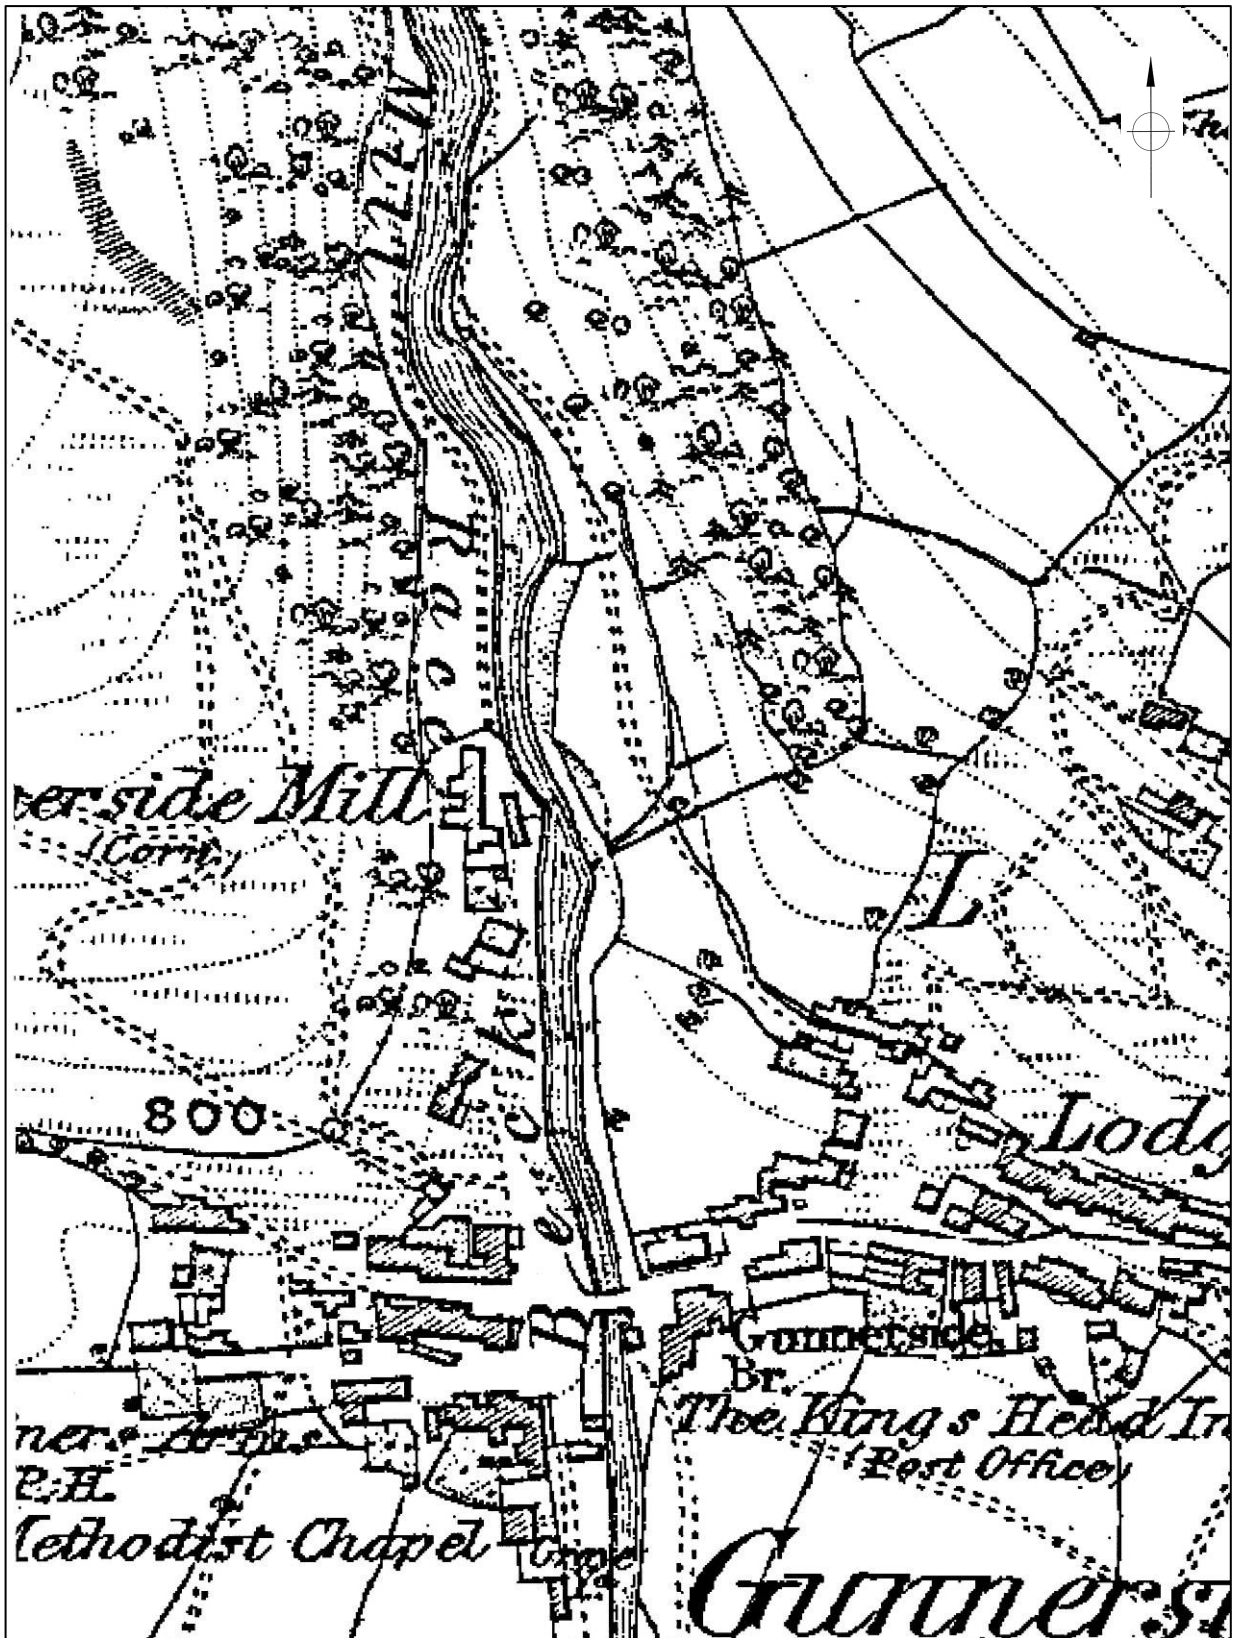
PROJECT		GUNNERSIDE MILL	
TITLE			
1857 ORDNANCE SURVEY MAP			
SCALE		DATE	
NTS		NOV 2011	
EDAS		FIGURE	
		4

Source: Ordnance Survey 1857 6" map sheet 51

- 2.9 The site next appears on the 1857 Ordnance Survey 6" map, which names it as 'Gunnerside Mill (Corn)' (see figure 4). A head race (marked as 'Mill Race') is clearly shown, leaving the Gunnerside Beck several hundred metres north of the mill and then running south, following the contours on the west side of the beck. At its south end, it curves around to the east to enter the complex between two extensions on the west side of the west range. The west range also appears to

- 3.24 The 'Mill Race' supplying the mill complex is clearly marked on the Ordnance Survey 1857 6" map, leaving the Gunnerside Beck several hundred metres to the

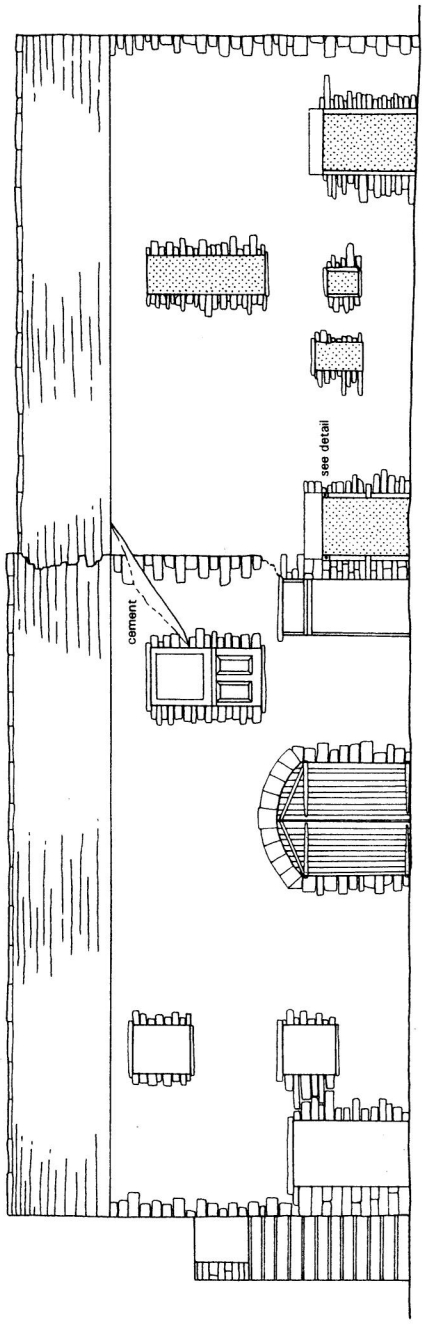
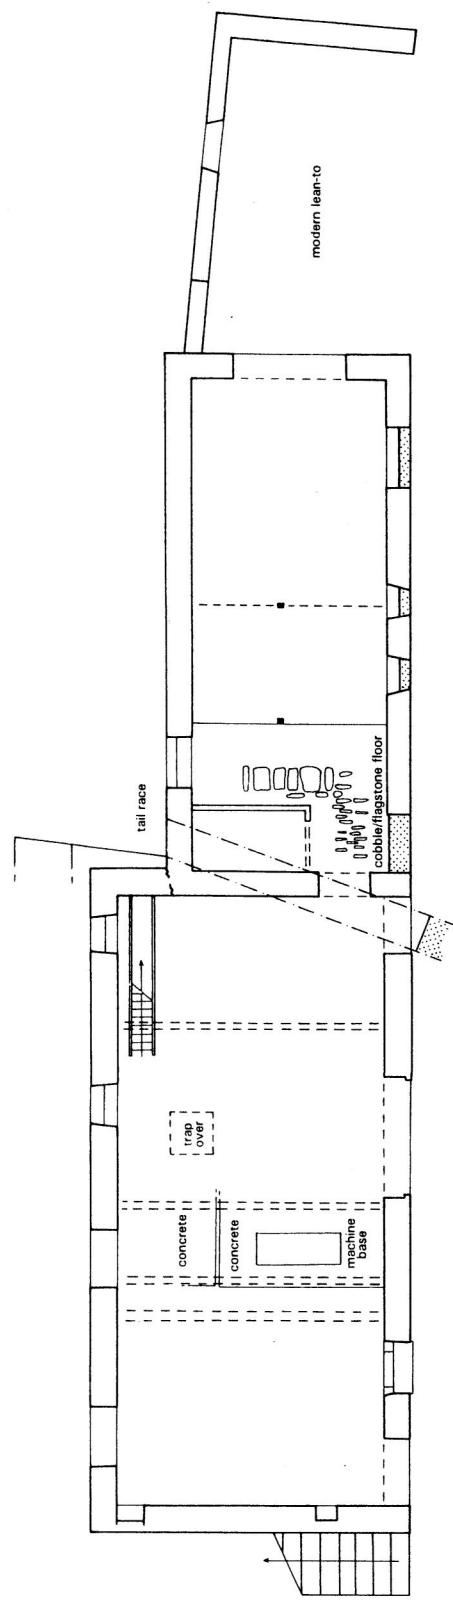
PROJECT	GUNNERSIDE MILL		
TITLE	EAST RANGE		
SCALE	AS SHOWN	DATE	NOV 2011
	EDAS	FIGURE	8

East range: west elevation

Detail of decoration on door frame
(not to scale)

East range: plan

The East Range (see figure 8)

- 3.21 The larger, northern building of the east range is also rectangular in plan and of two storeys with a pitched roof. It is built of coursed squared local stone, roofed with diminishing courses of stone slates and clearly post-dates the south part of the range. In the west elevation, there is a large doorway to the south of centre with a broad arched head of dressed voussoirs with a central keystone (see plate 7). The doorway retains a pair of plank and batten doors with long wrought-iron strap hinges supported on cast-iron pintles. At ground floor level, the central doorway is flanked by a window and narrower doorway to the north, and a further doorway to the south. At first floor level, there is another window at the north end of the elevation, with a loading door at the south end. To the south of the loading door, quoins are visible above first floor level, marking a straight joint between this part of the east range and that to the south. The upper part of the straight joint is obscured by a sloping line of cement, indicating the roof line of a lean-to structure formerly present here. The quoins at first floor level can only be explained by the south gable of the building originally being free standing i.e. built to two storeys whilst the adjacent southern building remained a single storey only, and then a first floor being added to the latter at a later date.

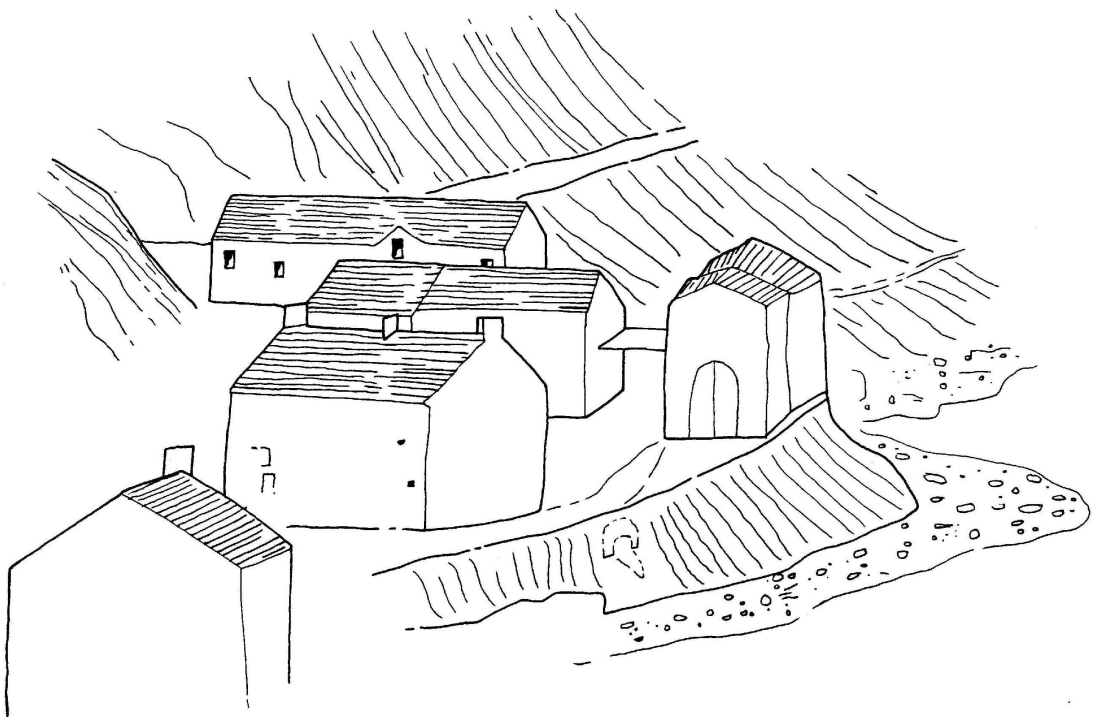
PROJECT		GUNNERSIDE MILL	
TITLE		PART OF LATE 19TH CENTURY PHOTO	
SCALE	NTS	DATE	NOV 2011
EDAS		FIGURE	9

Source: Sketch from photograph held
by Mr G Staines, The Old Mill,
Gunnerside

- 2.11 The mill complex appears on an enlarged portion of a late 19th century photograph (Mr G Staines, *pers. comm.*); the photograph must date from after 1877, as the Literary Institute appears in the foreground, but is unlikely to be much later than c.1900. The scale of enlargement has made some of the mill buildings difficult to pick out (see figure 9). However, the east range is clearly visible, with a large pair of doors in an arched opening at the south gable. The west range cannot be seen, although the building set at a right angle to its south end can be made out, and is apparently of two parts. Above, and to the north, there is another long east-west orientated building, with a dormer opening in the south elevation and set at a higher level than the surrounding parts of the complex. The Calvert family of Gunnerside apparently also hold a photograph of the interior of the mill, showing some of the machinery *in situ* (Mr G Staines, *pers. comm.*), but this could not be consulted for the present survey. The Ordnance Survey 1895 6" map shows the mill complex much as it was in 1857, although the northernmost of the western extensions to the west range has now gone.

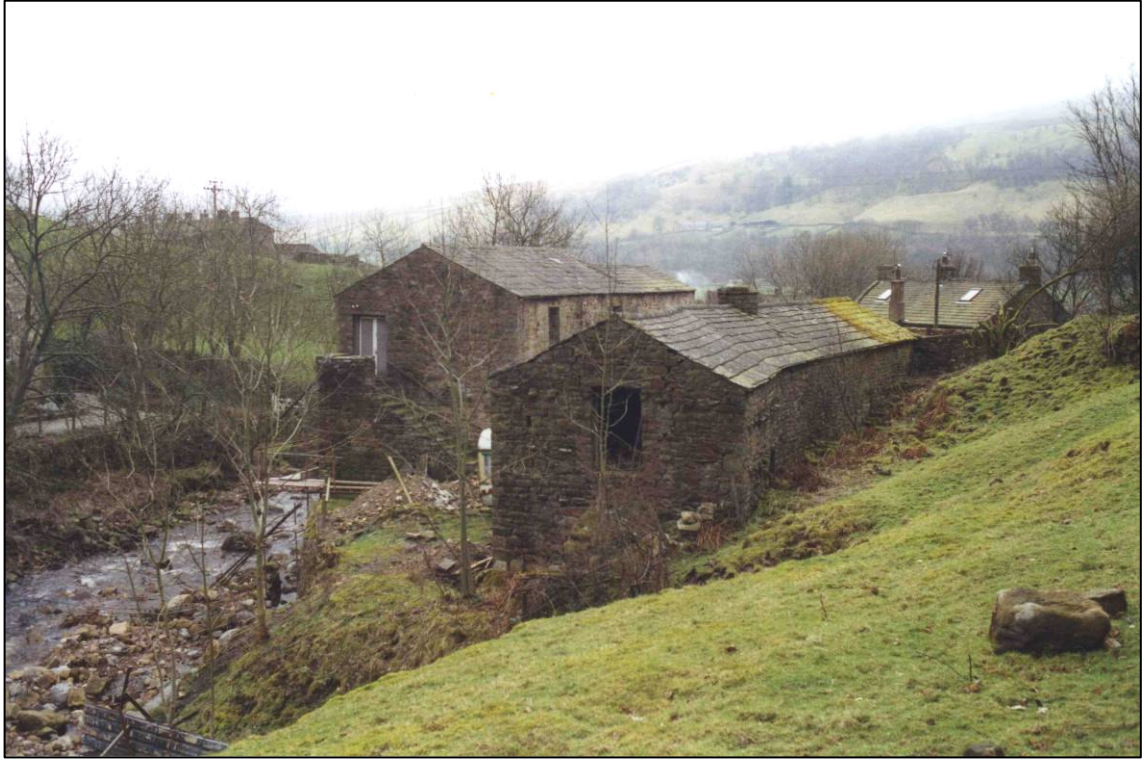
Plate 1: General view of mill complex, looking SE.

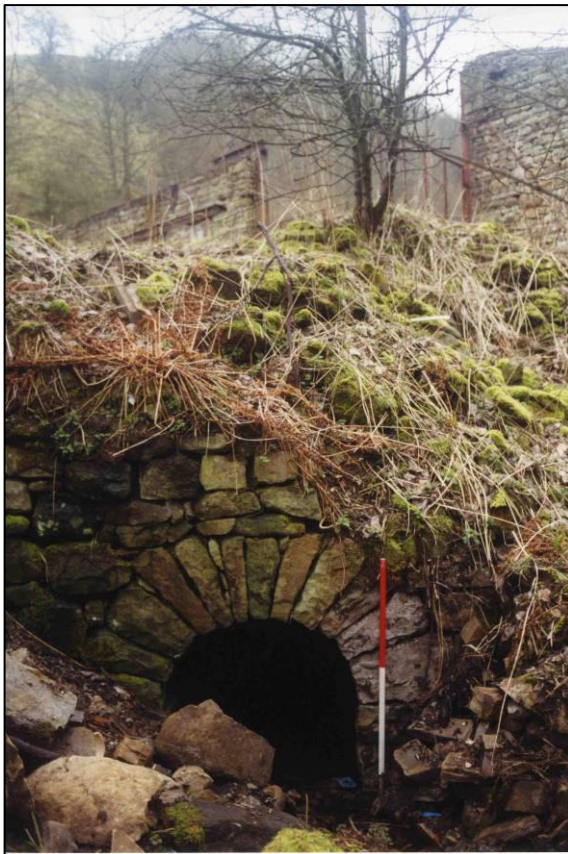
Plate 2: Culvert on east side of access track, looking NW.

- 3.3 In contrast to the pinfold, the culvert on the east side of the track does not appear on any of the historic maps consulted for this report. It is set within a short section of retaining wall and is built of substantial rubble voussoirs, c.1m wide and 0.75m high. The culvert, which takes the form of a broad barrel vault, curves around quite sharply to the north-west and can be traced for at least 5.5m from the entrance (see plate 2). It is almost certainly associated with the operation of the mill complex and may well be a bypass culvert.

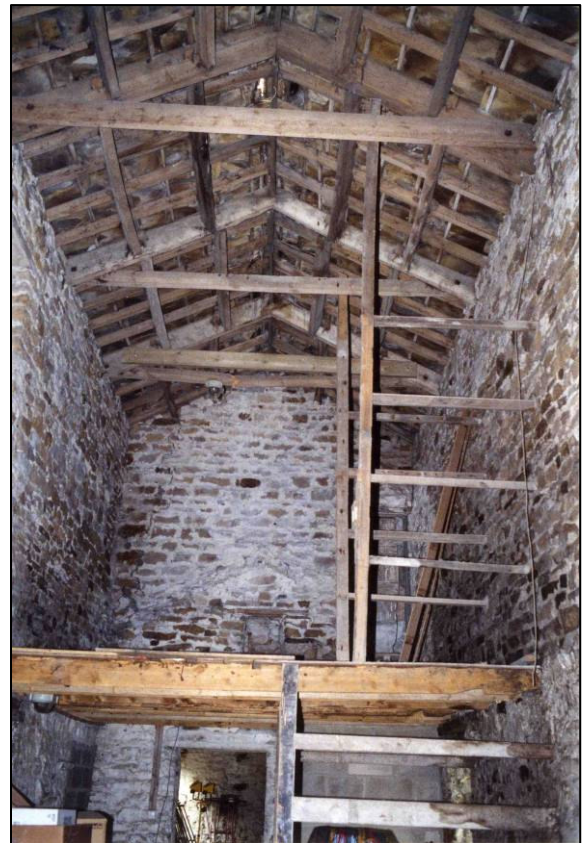
Plate 3: Interior of south end of east range, looking N.

- 3.20 The interior of the building is now accessed either from inside the building to the north or through the arched opening in the south gable. It is floored with concrete, although a small area of cobble and flagstone flooring survives at the north end,

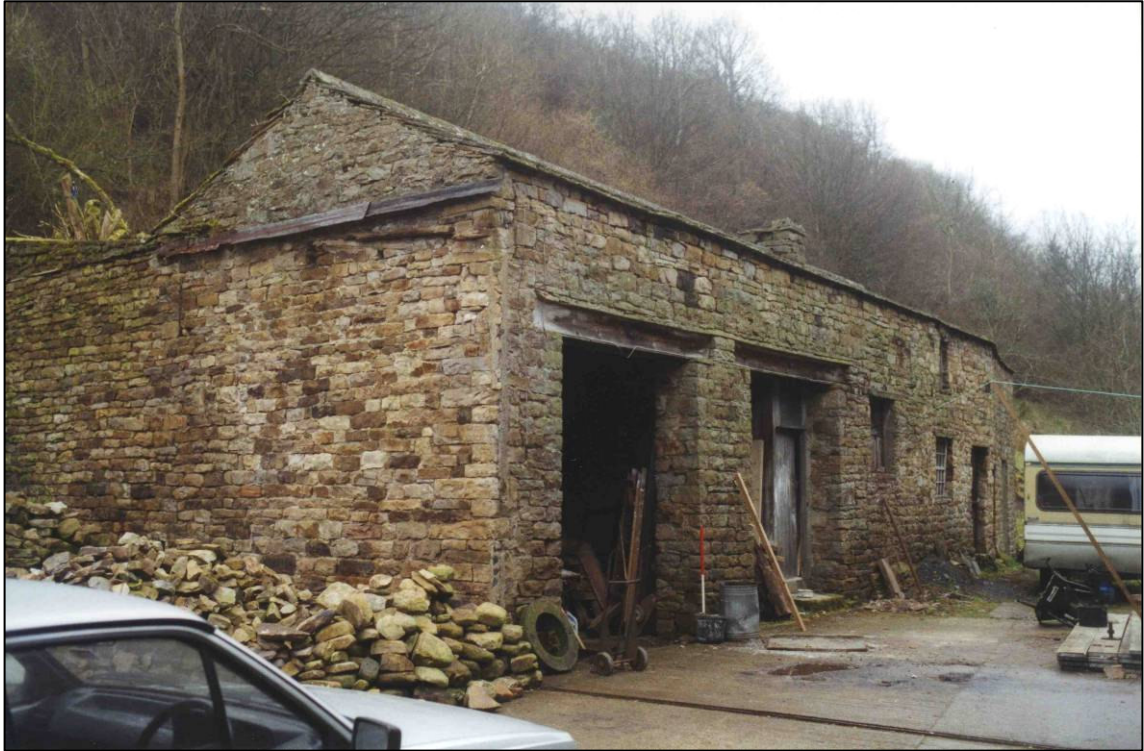
Plate 4: General view of west range, looking NW.

- 3.11 The existing structure is rectangular in plan, of two storeys with a pitched roof and a short central ridge stack. It is built of coursed squared local stone and is roofed with diminishing courses of stone slates. A shallow stone plinth or step is visible at the base of the northern half of the east elevation, terminating at a doorway at its north end. The doorway is of plain appearance with a flat stone lintel. To the south, there is a small ground floor window retaining a 16-pane timber casement, with a smaller opening over, also retaining parts of a timber window frame. Further to the south, there is another ground floor window with a concrete lintel and part of a metal frame, flanked by straight joints of differing heights; above, and slightly offset to the north, there is a blocked rectangular opening of the same size as the window retaining the 16-pane frame. The south end of the central elevation is dominated by two tall openings, both with massive wooden lintels (see plate 4).

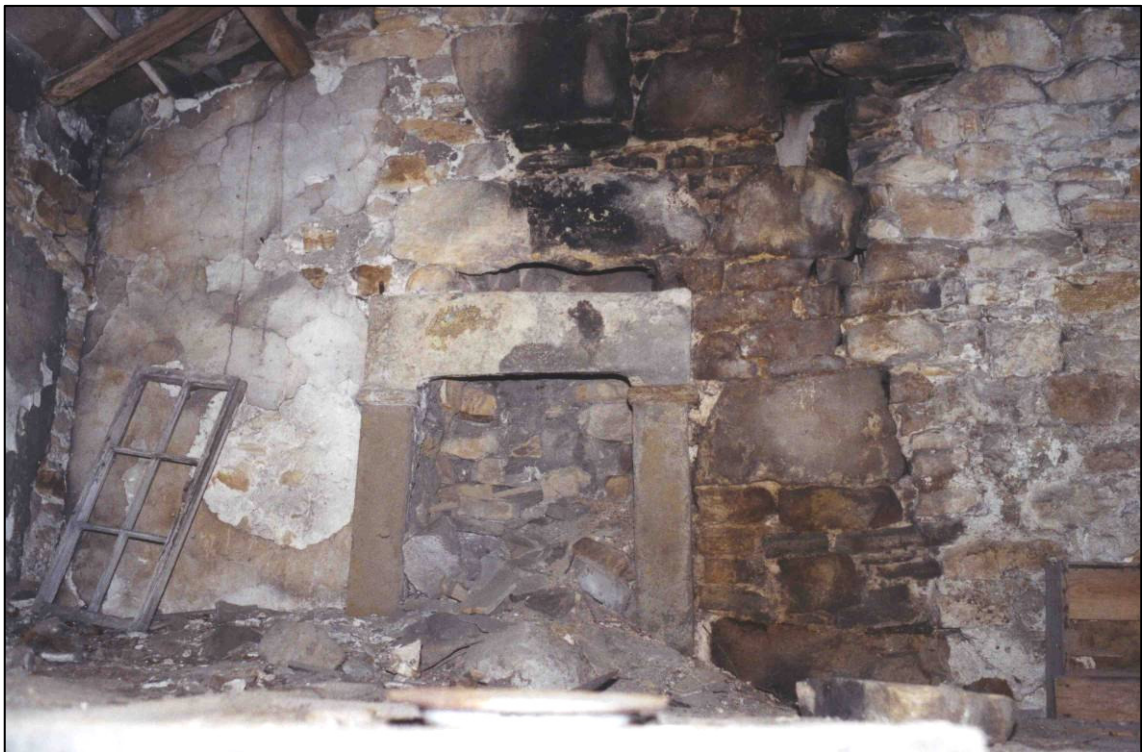
Plate 5: Fireplace in north end of central part of west range (first floor), looking S.

- 3.16 Although the stairs have been removed, the first floor of this part of the west range could be viewed by standing on a piece of furniture. It is floored with north-south aligned boards (average width 0.25m) and is crossed by a single roof truss of principal rafter construction with a raised collar jointed to the principals using halved lap joints. Each principal supports a pair of staggered butt purlins. The south wall retains a plain but well proportioned chimney-piece, with well-dressed jambs with moulded impostes supporting the lintel (see plate 5). The chimneypiece is built onto the front of a larger, cruder opening, with much soot staining above. To the west, there is a staggered joint running from floor to roof level, sloping upwards from west to east. On the east side of the joint, there are a number of very large pieces of stone; these, together with the batter of the staggered joint, are suggestive of an earlier structure here that was incorporated into the later building.

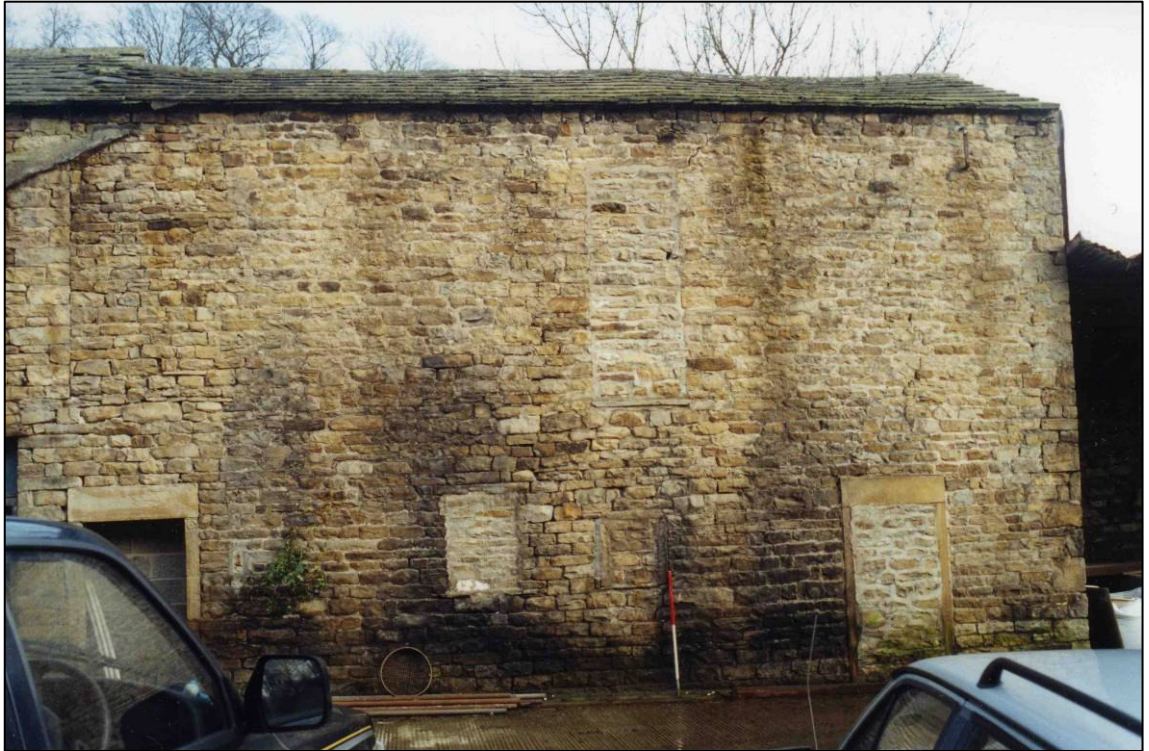
Plate 6: West elevation of east range (south end), looking E.

- 3.18 The smaller south building is rectangular in plan (slightly narrower than the adjacent north part) and is of two storeys with a pitched roof; it was originally of a single storey only (see below). It is built of coursed squared local stone with larger stones used as quoins at the corners and roofed with diminishing courses of stone slates. There are blocked ground floor doorways at either end of the west elevation, flanking a pair of blocked window openings (see plate 6). The northern of the two doorways, which is blocked with recessed breeze blocks rather than flush stone, has interrupted jambs and a substantial lintel of well dressed milled stone. The heads of the jambs are decorated with four petalled flowers in shallow relief set within a square panel (see figure 8), whilst the thin stones interrupting the jambs are partly vermiculated. The southern doorway is of similar construction but without any decoration. There is a single blocked loading door at first floor level in the west elevation. The south gable retains a tall central opening, with an arched head of roughly dressed voussoirs (now partly obscured by a later lean-to, but visible on a late 19th century photograph of the site).

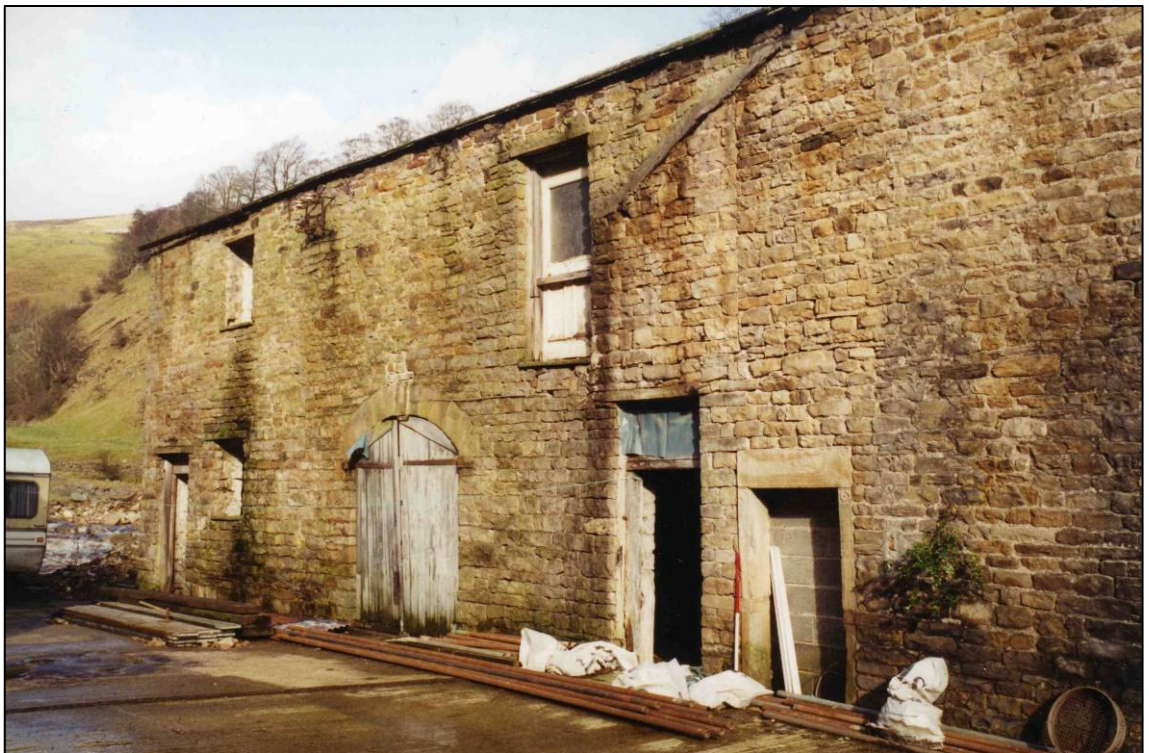
Plate 7: West elevation of east range (north end), looking E.

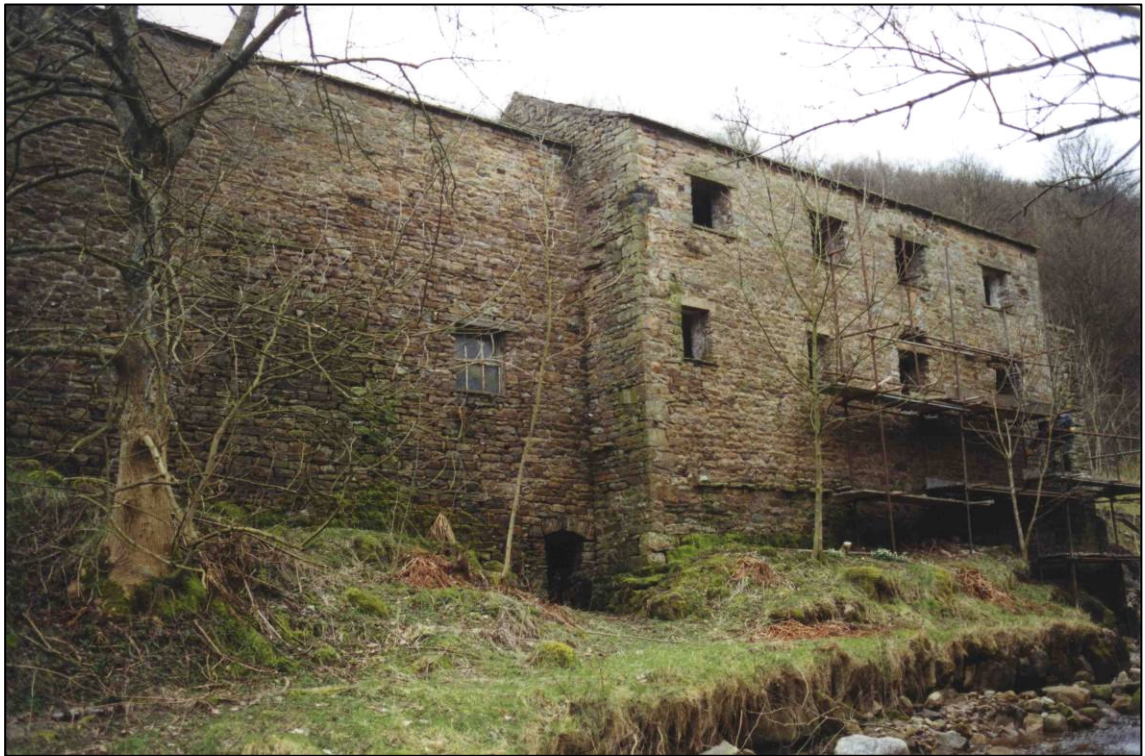
Plate 8: East elevation of east range, looking W.

- 3.22 A flight of stone steps against the north gable lead up to a first floor doorway. In addition, a high stone retaining wall fronting the beck curves around to the north-west from the north-east corner of the building. The east elevation of the building is very regular in appearance, being divided into four bays, each containing a window at ground and first floor levels (see plate 8).

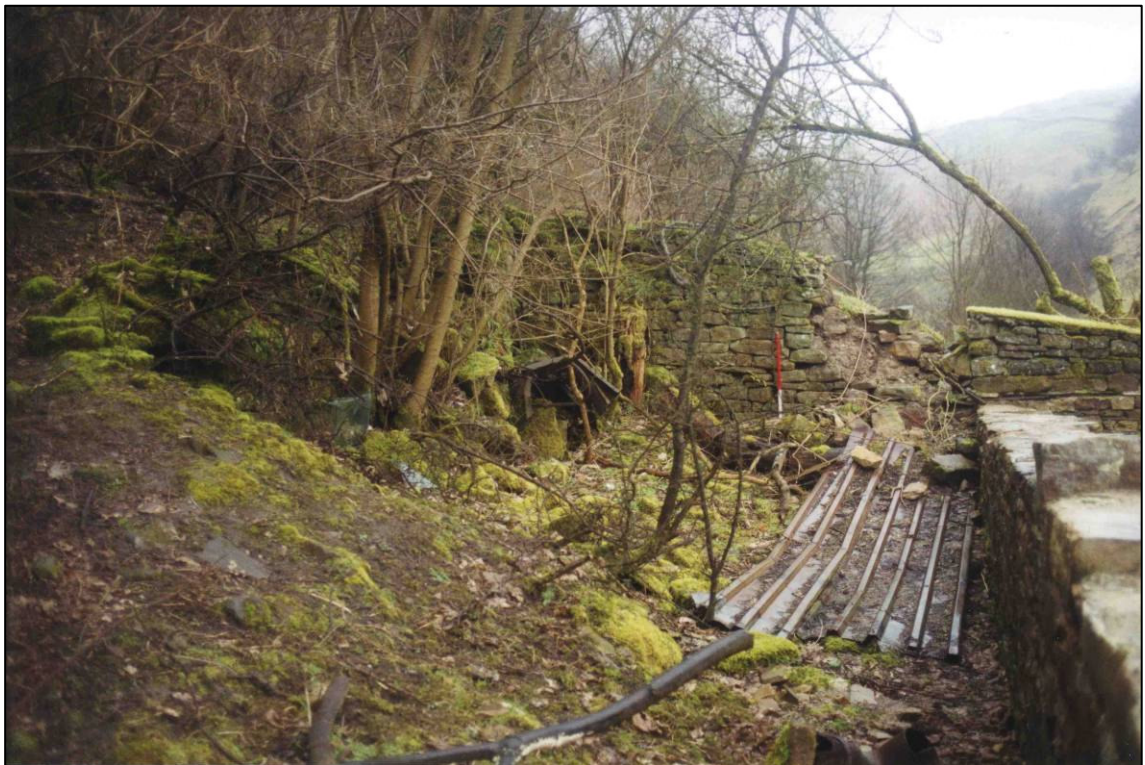
Plate 9: Ruined structure beyond west side of yard, looking N.
