BONFIELD GILL AQUEDUCT,
POCKLEY MOOR, NORTH YORK MOORS

ARCHAEOLOGICAL SURVEY

Report no: 2012/426.R02
Version: Final
Date: September 2012
Authors: Ed Dennison & Shaun Richardson

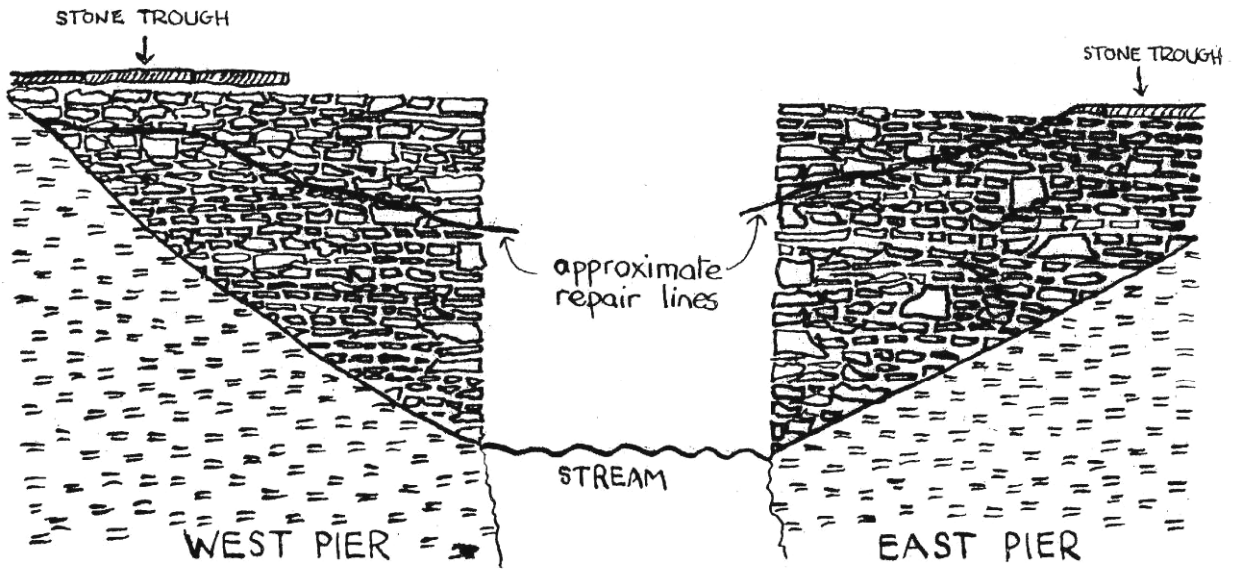
Side view of the restored aqueduct in Bonfield Gill. The piers stand 10' above the beck, and the water flowed over it from west to east.

- 3.2 The aqueduct was repaired again in the summer and autumn of 1964 by several members of the Ryedale Archaeological Society (Grayson 1965). It was reported that the damage had been caused by vandalism rather than erosion, that the east pier was less damaged than the west, and that the structure consisted of a stone casing with an earth and rubble fill. The top 4ft of the east pier needed to be completely rebuilt, using large stones recovered from the beck, the centre was re-filled with small stones and earth, the topmost course of stone was cemented into place, and a thin layer of soil was scattered on the top and seeded with grass. A similar procedure was followed for the west pier although, as much of the stone had washed away, new stone was brought from a nearby quarry, probably used by the original builders. The remaining stone trough sections which were found during the reconstruction were placed on the top of the final grassed-down soil fill. Wooden notice boards were also erected on either side. It is fortunate that some records of the repairs were kept, including photographs and a drawing (see figures 3 and 4).

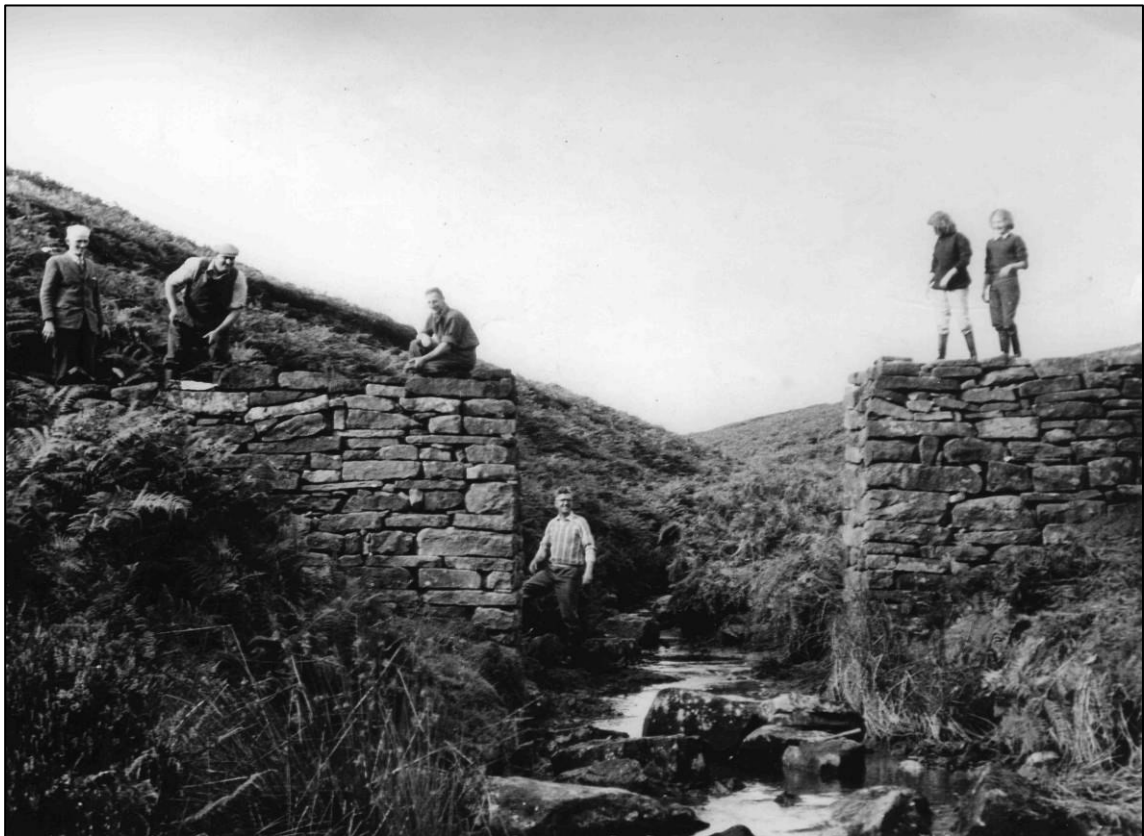
PROJECT		BONFIELD GILL AQUEDUCT	
TITLE		1964 REPAIR WORK	
SCALE	NTS	DATE	SEPT 2012
EDAS		FIGURE	3

Top: Drawing by Grayson (1965).

Bottom: Photograph of repairs in progress (courtesy Helmsley Archive, HA 02461).

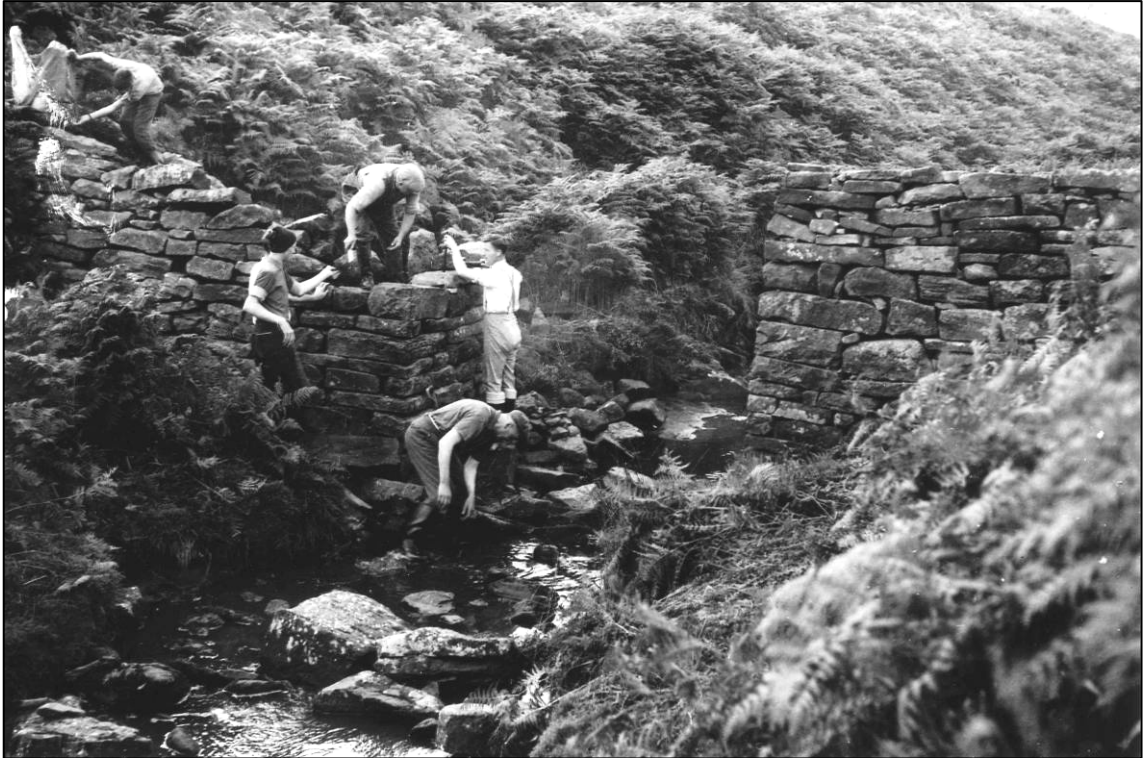
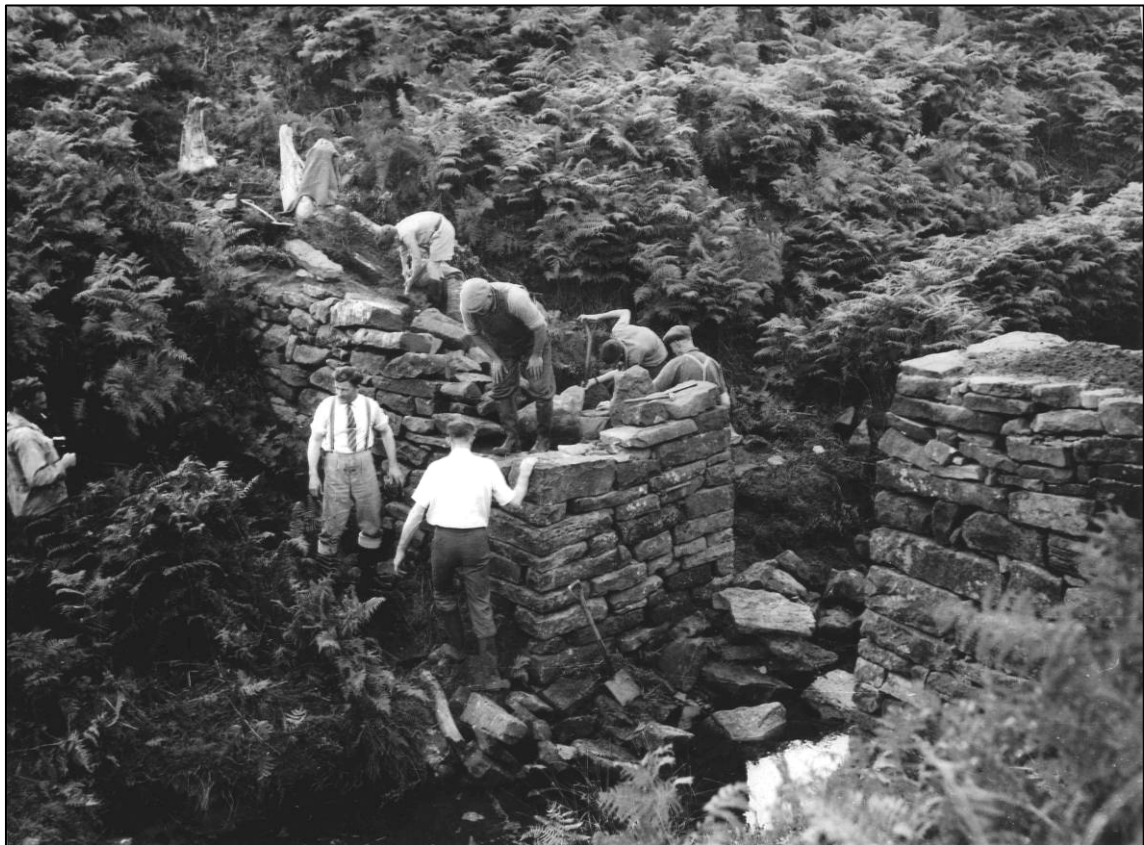
PROJECT		BONFIELD GILL AQUEDUCT	
TITLE		1964 REPAIR WORK	
SCALE	NTS	DATE	SEPT 2012
EDAS		FIGURE	4

Photographs of repairs in progress
 (courtesy Helmsley Archive, HA 02455 &
 HA 02462).

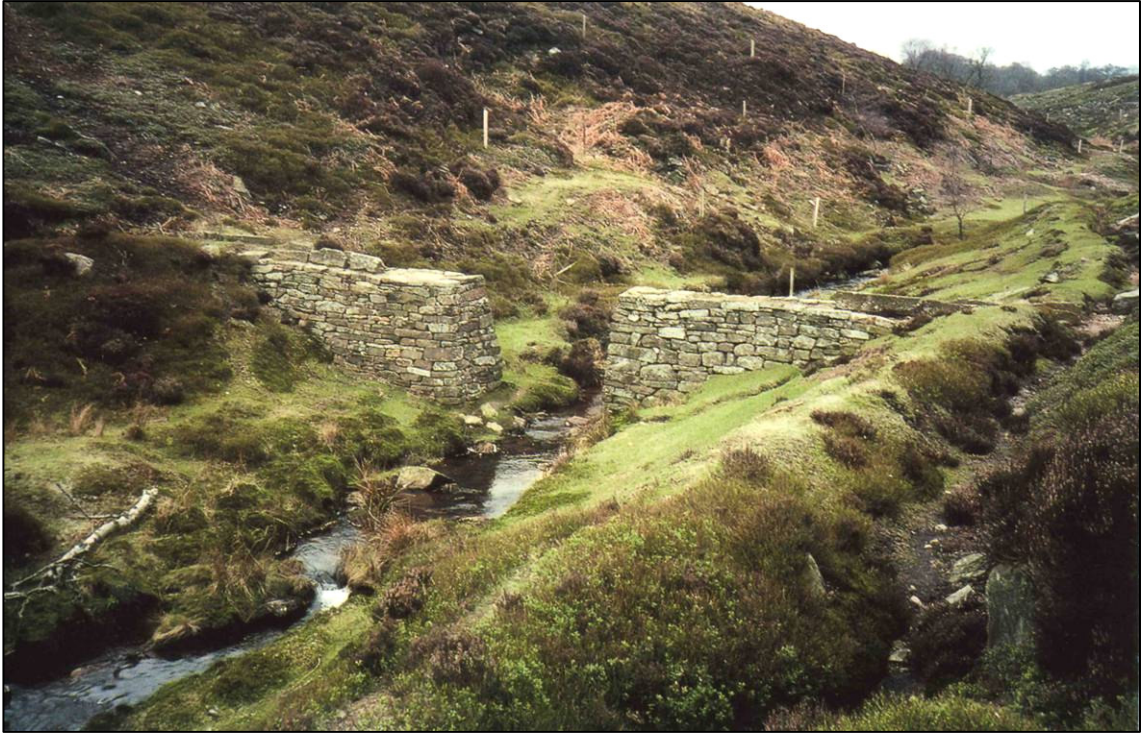
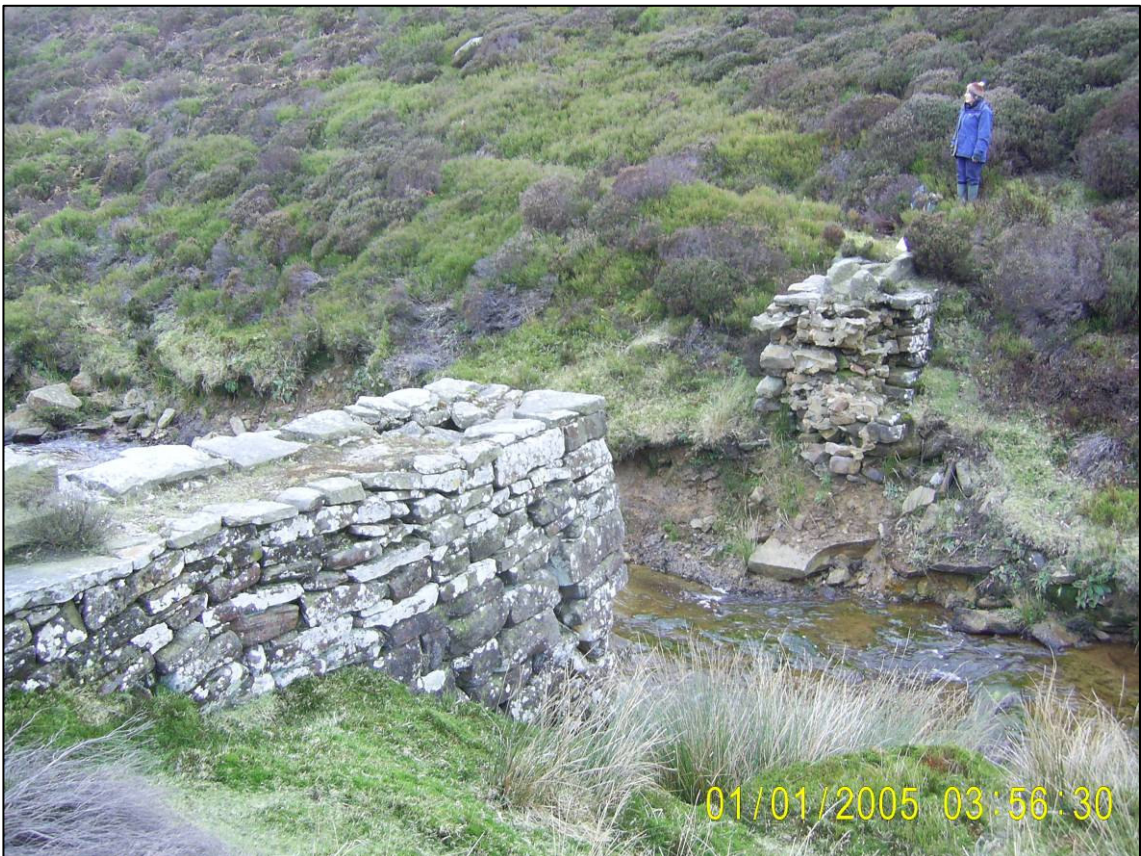
PROJECT		BONFIELD GILL AQUEDUCT	
TITLE			
PHOTOGRAPHS			
SCALE	NTS	DATE	SEPT 2012
EDAS		FIGURE	5

Top: McLean photograph, looking NW (undated but taken between 1995 and June 2005).

Bottom: Tony Wright photograph, looking NE (February 2008) (2008_02_24B, 48).

- 3.3 McLean also notes that the aqueduct was restored again in 1982, by the North York Moors National Park and volunteers from the British Trust for Conservation (McLean 2005, 147). It is assumed that some of the stone trough sections were positioned on the tops of the piers then, although it is not known precisely how much work was done. At a public lecture in 1997 one of the volunteers said that a section of the eastern race was also cleared out, and a plaque that was erected unfortunately misdated the race and underestimated its length. McLean publishes a photograph of the repaired aqueduct (McLean 2005, 91 colour figure 10) (see figure 5), which was probably taken between 1995 and June 2005 (Graham Lee, NYMNP archaeologist, *pers. comm.*).

- 3.4 The aqueduct was recorded by the Helmsley Archaeological and Historical Society (Barbara Hickman and Tony Wright) on 24th February 2008. They note that the "*west pier [is] severely damaged - much missing (and carried tens of metres down the gill) and erosion is removing its base. The east pier is almost intact but is collapsing inwards, as it has been eroded beneath, and is being supported by a large fallen, wedged stone. The next flood could remove the structure entirely*". A number of photographs were taken (2008_02_24B nos 41-59) as part of the recording exercise (see figure 5). This damage was largely caused by a severe flood in June 2005.

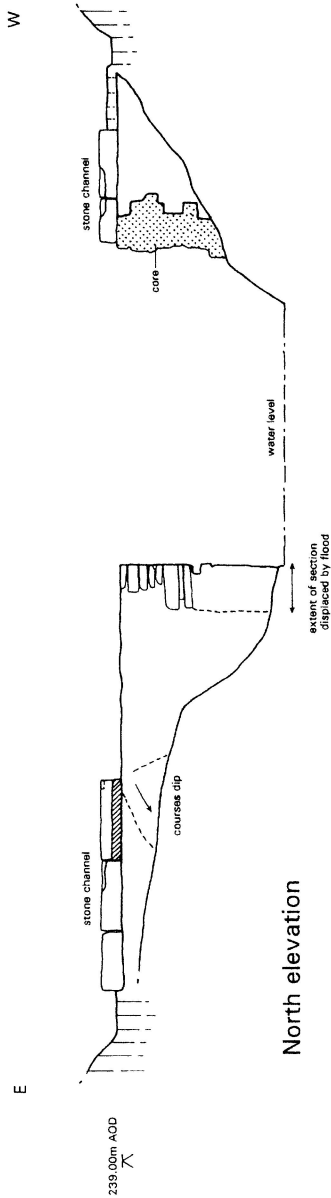
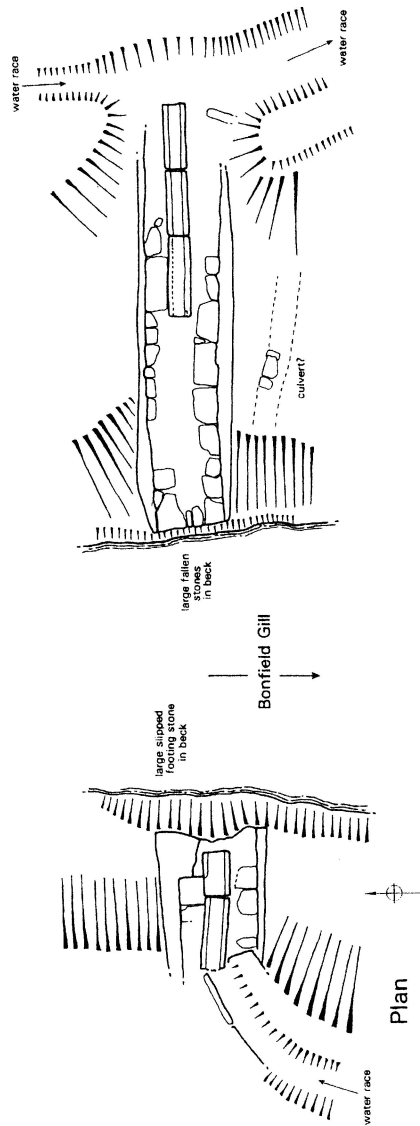
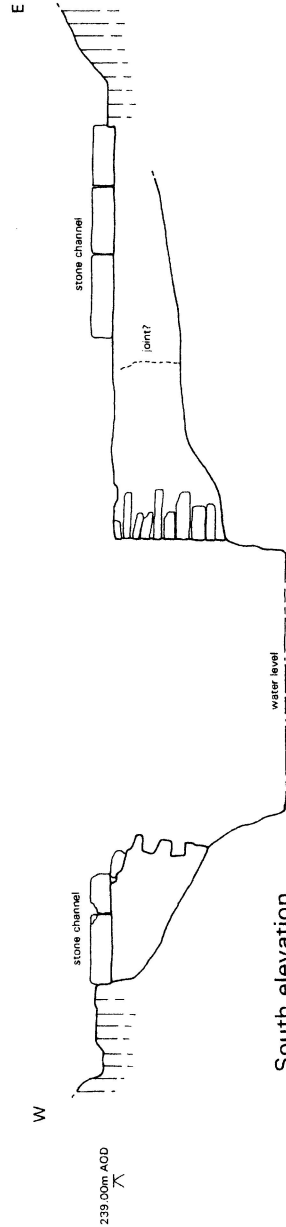
PROJECT	BONFIELD GILL AQUEDUCT		
TITLE	SURVEY RESULTS		
SCALE	AS SHOWN	DATE	SEPT 2012
	EDAS	FIGURE	6

North elevation

Plan

South elevation

- 4.1 In the following description, reference should be made to the plan and sections (see figure 6) and the illustrative plates. The photographic record appears as Appendix 1; photographs are referenced in the following text in bold type and square brackets, the numbers before the stroke representing the film number and the number after indicating the frame e.g. [1/32].

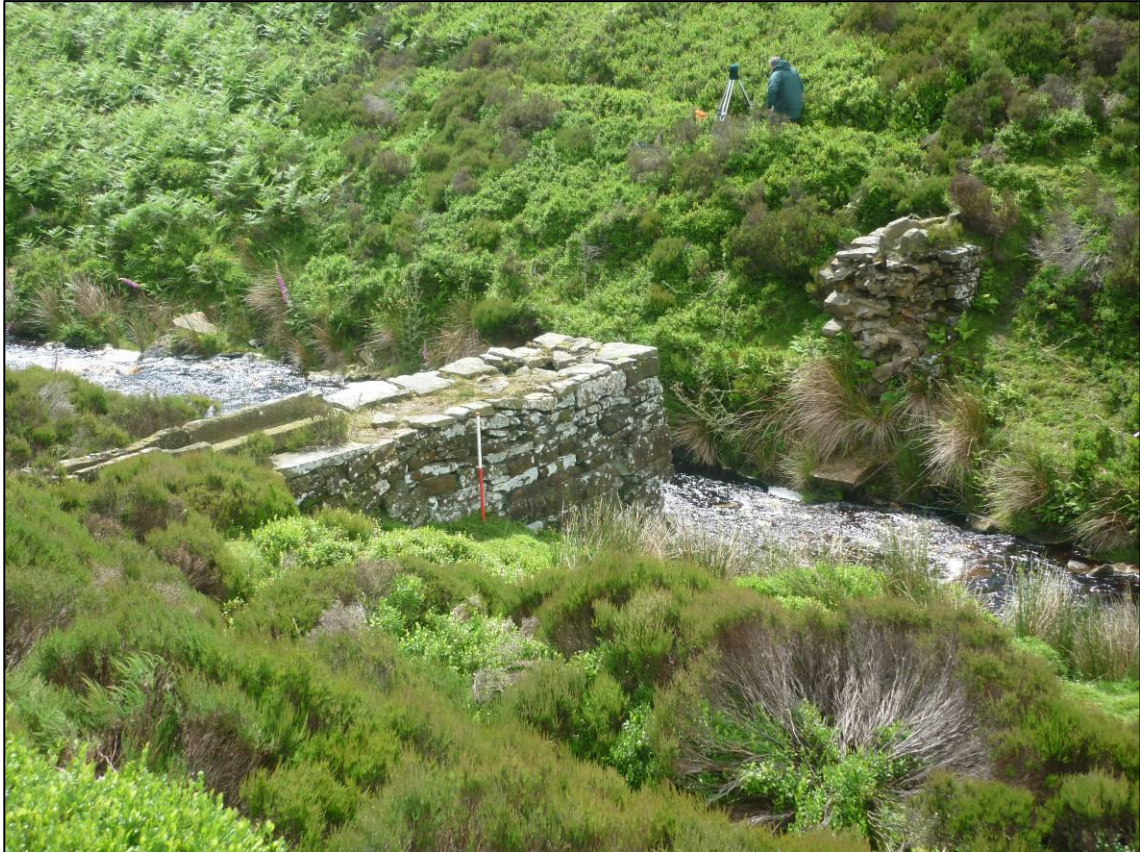
- 4.2 The aqueduct is located in the narrow base of Bonfield Gill, a steep sided natural valley [1/627, 1/628 and 1/640] (see plate 1). The Piethorn branch of the Nawton water race [2/247] formerly ran up the west side of the valley to the west pier of the aqueduct. Water was then taken across the beck via stone channels on top of the piers and a wooden launder spanning the gap, to join with the main Nawton race running south along the east side of the valley [1/653].

Plate 1: General view of aqueduct, looking SW (photo 1/628).

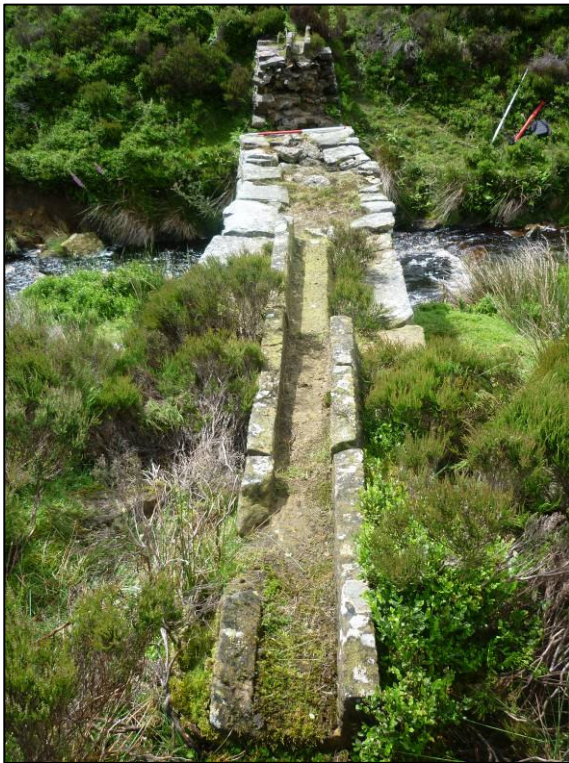
- 4.12 The stone channel [1/630, 1/631, 1/634, 1/635 and 1/641] surmounting the east pier has a total length of 3.90m and comprises three sections, decreasing slightly in length individually from west to east, but of the same overall dimensions as described to the west pier above (see plate 2); the westernmost section has lost its north side, which has fractured off leaving a regular break, while there is a small shallow recess cut into the top of the south side that might be an original feature. The western section does not appear on the post-1982 photograph. All three sections have prominent diagonal tooling marks to their external and internal faces, and the stone channel is located approximately centrally on the pier below. The post-1982 colour photograph appears to show the pier extending east beyond the stone channel into the adjacent water race, but this feature is no longer visible due to greatly increased vegetation cover.

Plate 2: Stone channel to east pier, looking W (photo 1/634).

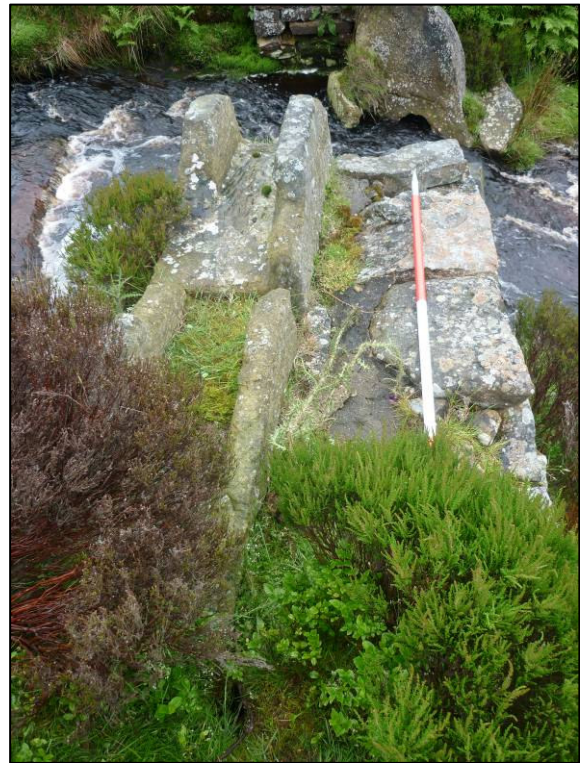
- 4.5 The stone channel on the west pier is constructed in sections [1/648 to 1/650]. There are currently two surviving sections (see plate 3), but the colour photograph taken after the 1982 restoration works shows a third section, now lost; all parts of the channel were positioned here during the 1964 works (see below). Of the surviving sections, both are on average 0.45m to 0.50m wide, and stand 0.35m in height. The base of each section is 0.20m deep, leaving a channel 0.15m deep with sides 0.10m wide. The longest of the surviving sections measures 1.30m in length, and both have prominent diagonal tooling marks to their external and internal faces. The stone channel is not located centrally on the pier below.

Plate 3: Stone channel to west pier, looking E (photo 1/648).

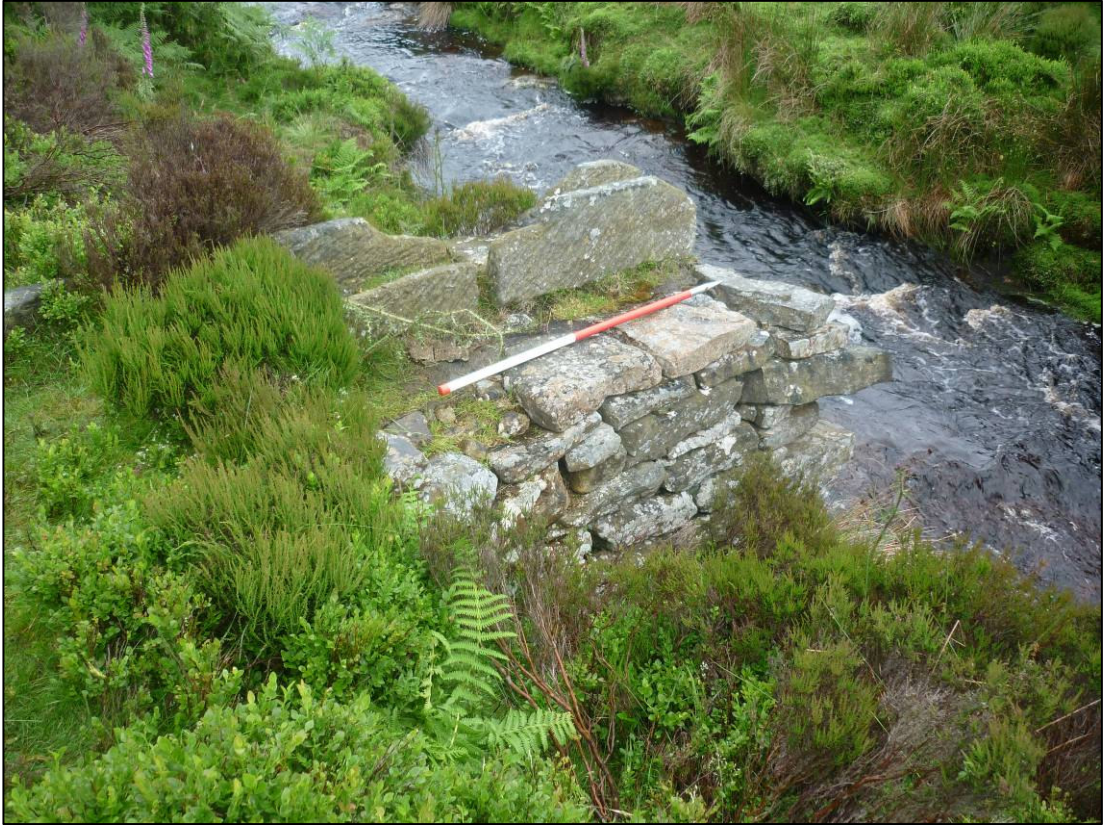
- 4.6 The surviving section of the western pier has a maximum visible length of 2.80m and a maximum width of 2.0m across the base, and it stands up to 2.0m in height (excluding the stone channels), both the north [1/643, 1/644, 2/248 and 2/249] and south [1/651] faces being much reduced (see plate 4). A report accompanying the 1964 works notes that: "*On the western pier, a similar procedure was followed, but here, as most of the original stone had been washed downstream and was*

Plate 4: Collapsing west pier, looking NE (photo 1/650).

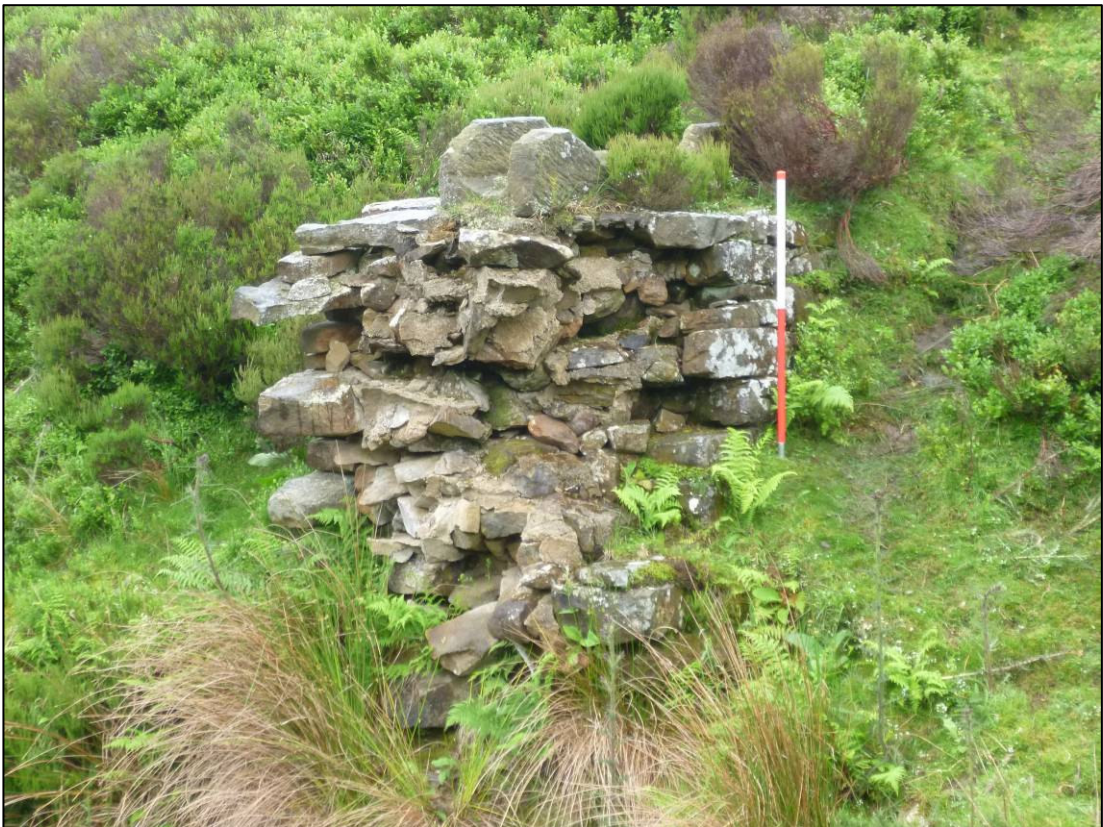
- 4.7 The construction technique used during the 1964 restoration works (roughly coursed and squared facing stones with an infill of stone rubble set with sandy mortar, rather than the earth suggested in the 1964 account), visible on the photographs taken at that time, is clearly evident in the collapsed beck face of the pier [2/250 and 2/251] (see plate 5). Comparison with photographs taken in 1964 and the subsequent post 1982 colour photograph referred to above suggest that a length of up to 2m has been lost from the west pier in the intervening years (see figures 3 to 5); this would make the gap between the piers after the 1964 works something in the order of 3.50m. A large sub-rectangular tilted stone in the west bank of the beck presumably represents a former foundation from 1964.

Plate 5: Exposed core in west end of west pier, looking W (photo 2/248).

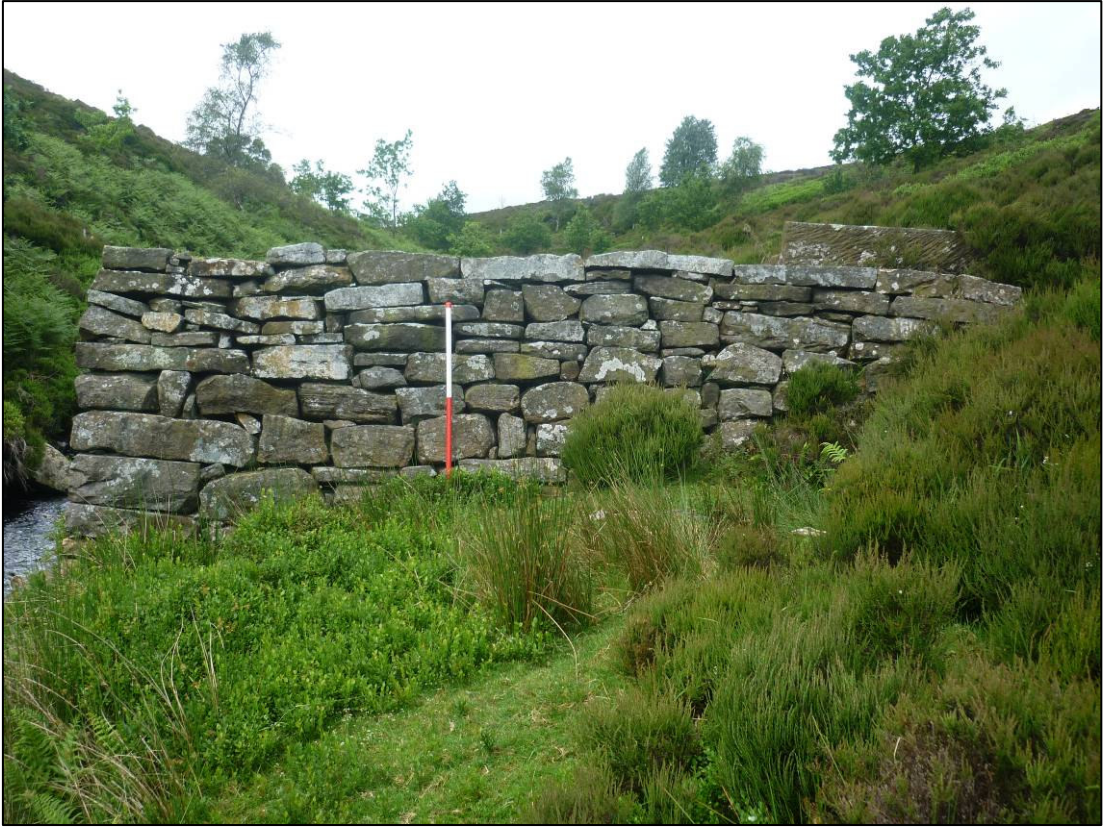
- 4.10 On the north face [1/622 to 1/624, 1/626, 2/236 and 2/239], the western 0.90m end of the pier has been pushed south as a result of pressure from floodwaters, opening a ragged vertical crack in the pier face (see plate 7). It is possible that this crack reflects a weakness resulting from a joint between two different phases of repair or reconstruction. Further to the east, there is a short section of the north face where the courses dip markedly downwards from west to east, and may be overlain by the wall immediately to the east [1/625]. To the south face [1/636 to 1/639, 2/244 and 2/245], c.3m to the east of the west end, there may be one or more relatively straight vertical joints, again perhaps resulting from a joint between two different phases of repair work or reconstruction (see plate 6).

Plate 6: South face of east pier, looking N (photo 1/638).

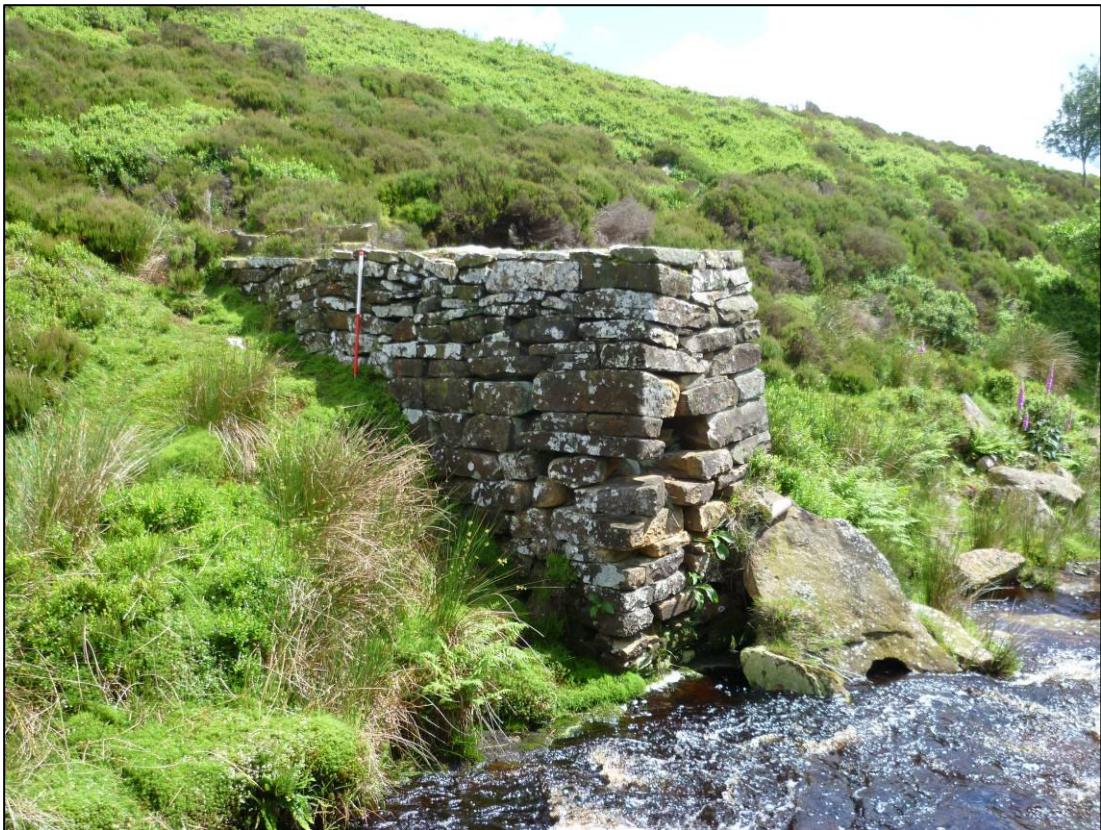
Plate 7: East pier, looking SE (photo 2/239).
