WALTERCLOUGH PIT BUILDINGS,
SOUTHOWRAM, HALIFAX,
WEST YORKSHIRE

BUILDING RECORDING

Report no: 2012/412.R01
Version: Final
Date: August 2012
Author: Shaun Richardson & Ed Dennison

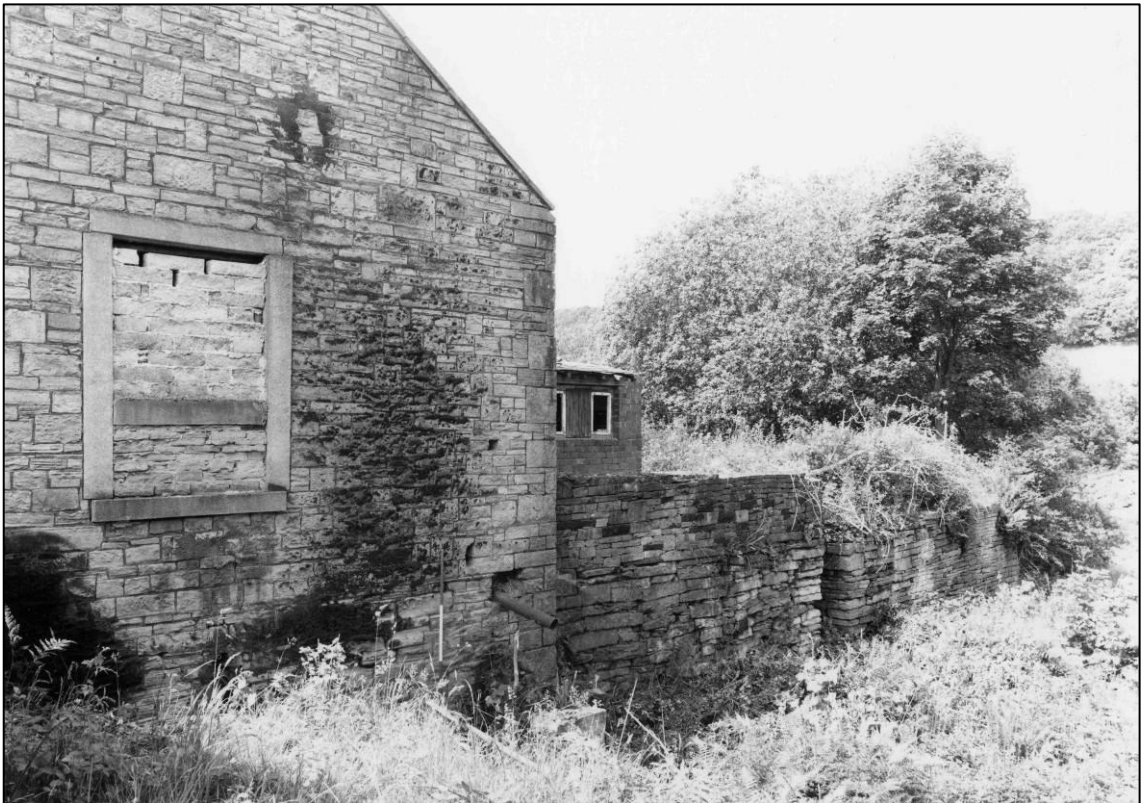
Plate 4: Building N2, revetment wall to north, looking NW (photo 6/5).

- 3.6 A drystone revetment wall runs north from the north-east corner of the winding house (Building N2) (see plate 4). This wall stands up to 2.50m in height and was clearly either built or modified in several different phases; it is possible that sections remain from those shown on the 1893 25" map and the late 19th century photograph (see figure 3, bottom and figure 4, top). Commencing at the winding shed, the lower part of the wall is built of large roughly squared and coursed stone, while the upper part has the same 'snecked' appearance as noted to the winding house itself (see Building N2 below). There is then a break in the revetment wall, probably once housing a flight of steps leading up to the level ground above where

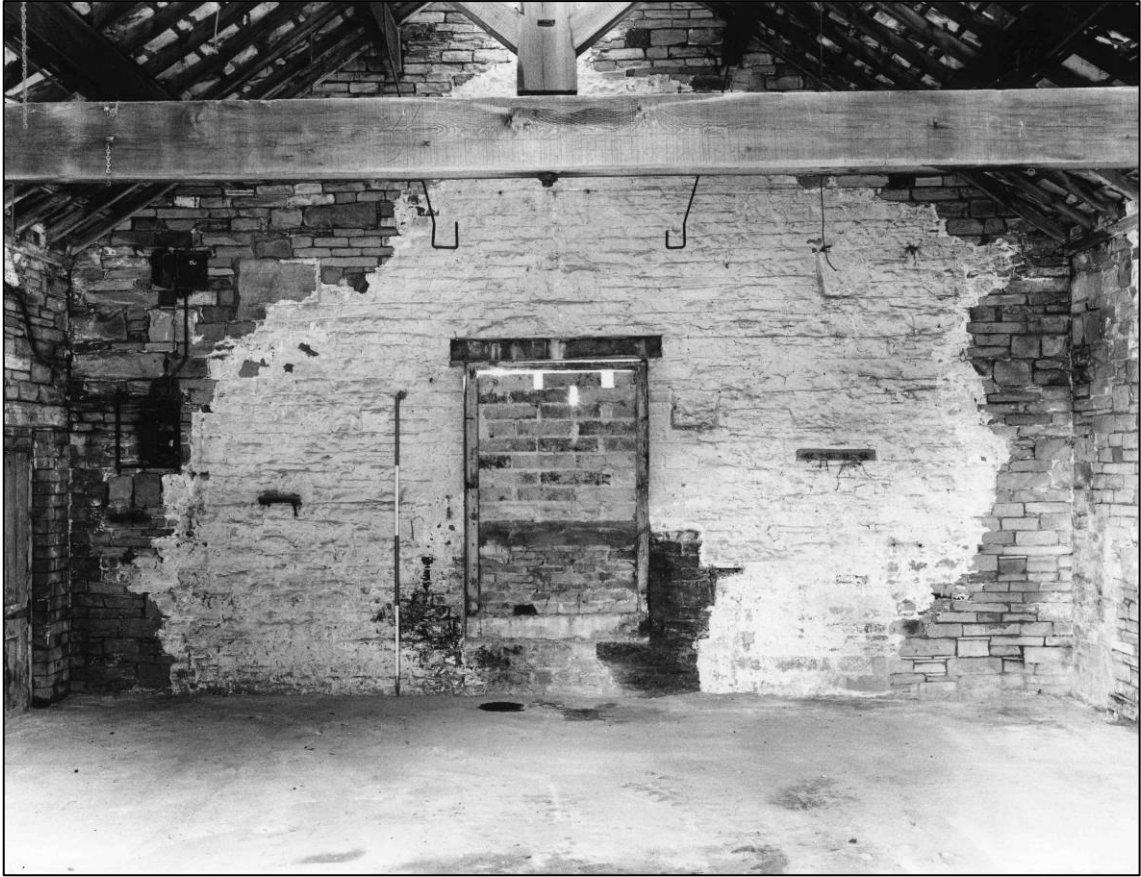
Plate 31: Building N2, interior east wall, looking E (photo 2/2).

- 3.32 The majority of the east wall is whitewashed (see plate 31). Set slightly to the north of centre, there is the blocked opening, visible externally. The base of the opening is set 0.35m above the internal concrete floor level, and it has brickwork jambs, with a steel joist lintel; there is a prominent grease or oil stain on the lower brickwork to the south jamb. The base steps inwards to meet the concrete sill visible externally, and above sill level, retains the remains of the jambs and lintel of a wooden frame, in two parts. The inner frame is moulded and was apparently unglazed, and is fixed to a slightly wider outer frame with small metal brackets. To the north of the main opening, a small U-shaped wooden base, set 1.50m above floor level, is supported on metal brackets; the upper surface of the wooden base has a shallow U-shaped recess set into it. There is a second projecting wooden fitting to the north, set at a slightly lower level, comprising a holder for two cables. Above this, there are the remains of two fittings relating to a former three phase and neutral 'ac' electricity supply (see plate 32). The lower fitting is probably a fuse box. It is mounted vertically on a metal frame attached to the wall but occupies only one third of the frame's length. The box has an opening cover bearing the cast mark "Made in England U Patent" to the interior. Inside, the box was once divided into four levels, and one of these retains part of a ceramic fitting. At the base of the interior, there are a number of cloth-bound cables. A metal pipe rises

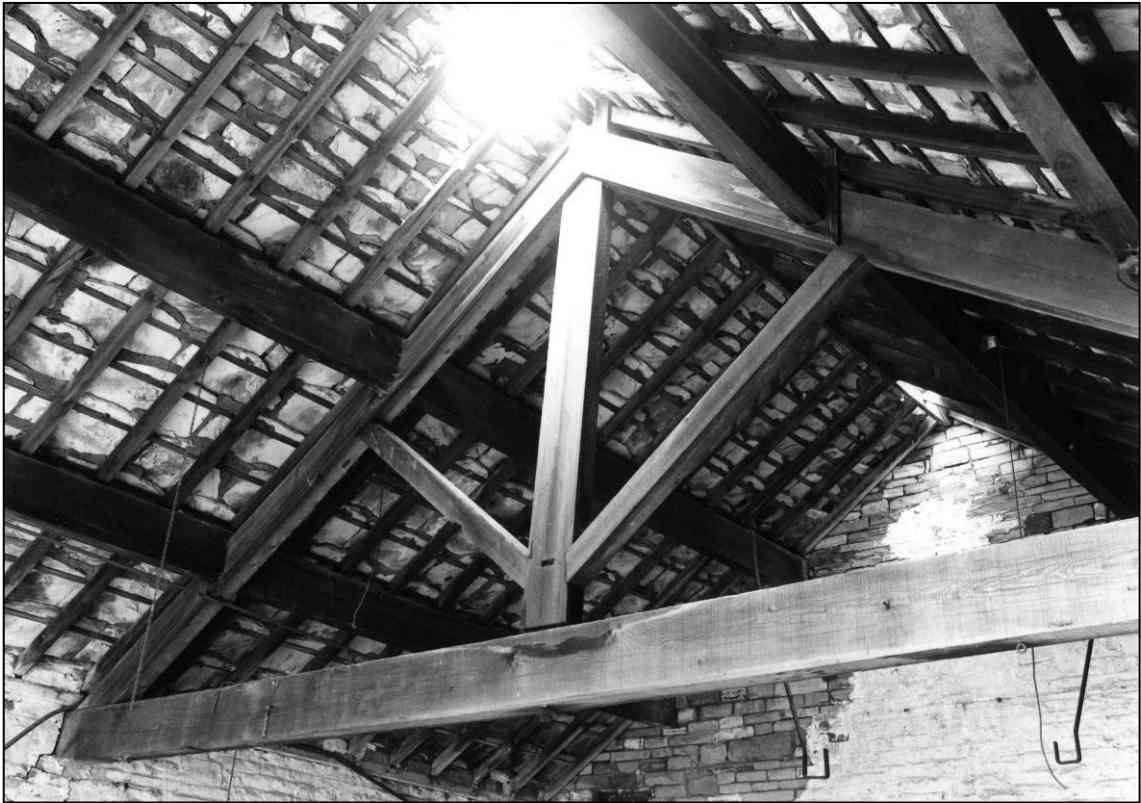
Plate 35: Building N2, truss, looking NE (photo 1/11).

- 3.35 As has already been noted, the interior of the winding house is crossed by a single, centrally placed, north-south aligned truss. The truss is of kingpost form, and of sawn bolted softwood construction throughout (see plate 35). There are raking struts to the principal rafters, a pair of upright purlins to each principal, and a plank ridge piece. At either end of the truss, the face of the wall steps outwards above the top of the tie-beam and is carried on a separate timber, which also appears to support the feet of the common rafters after they pass into the wall. Midway between the king post and the north wall, the top of the tie-beam has two shallow parallel grooves cut into it, while two metal eyes are fixed to the soffit towards the south end. At its northern end, the west face of the tie-beam retains a series of incised marks. These appear to comprise 'F2"9 X1 2"' and their style suggests that they relate to the importation of Baltic pine (Patrick Greene 1995, 119-123). On the same face of the truss, beading has been nailed to the base of the principals above the level of the upper purlins, and this appears to be associated with the remains of the wooden vent that can be seen projecting from the roof ridge. The purlins carry a number of other fittings. To the north roof slope, the lower purlin has a metal pipe fixed to it, probably formerly housing electrical cabling, and there is a similar pipe here fixed to the timber carrying the outward step at the top of the wall. To the south roof slope, the upper purlin retains two bell-profile ceramic light fittings mounted on wooden discs. The lower purlin carries another metal cable pipe as far as a circular metal junction. The lower purlin also once had brackets fixed to the inner face at equal distances from the tie-beam, but that to the west

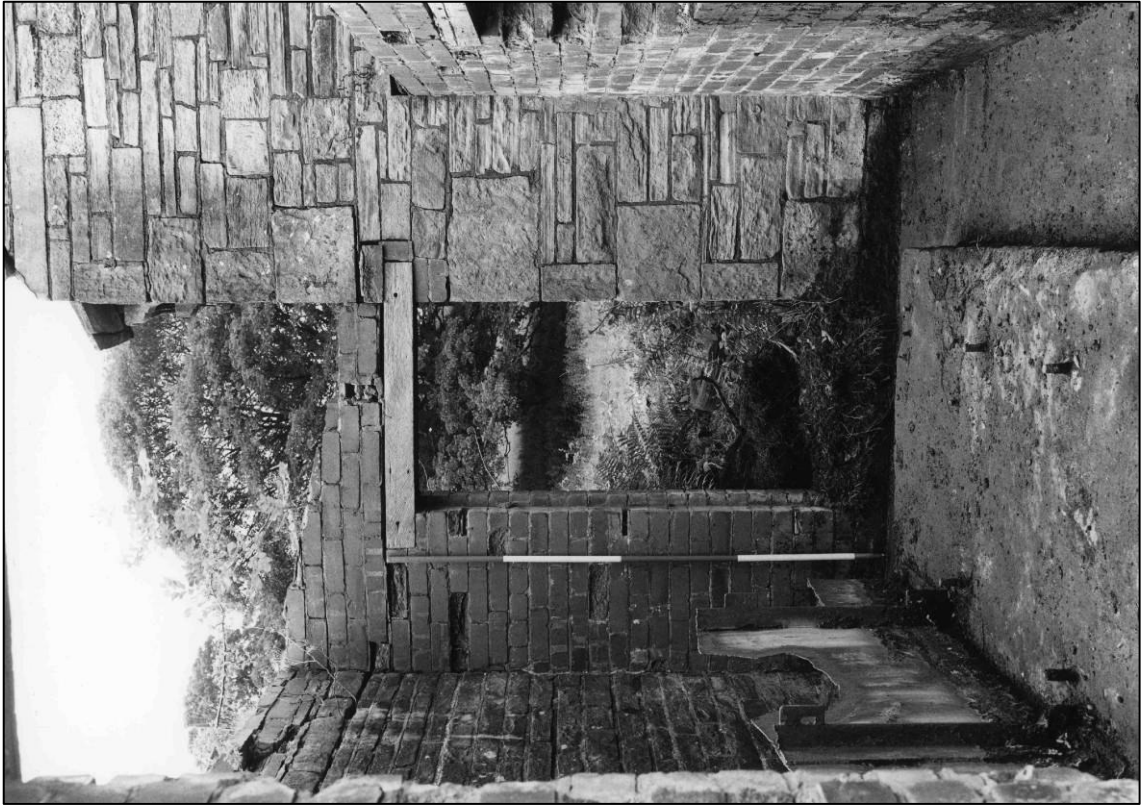
Plate 39: Building N3, interior, looking W (photo 3/11) (top to left).

- 3.40 The external elevations of the building are, as might expected, very plain and functional. There are doorways in the east and west walls, but both doors are now missing, retaining only parts of the wooden door frame (see plate 39). The west doorway has a steel joist lintel (see plate 40), and the east doorway a concrete one. A window opening in the centre of the north wall has a concrete lintel but the wooden frame has been removed.
