ERECTION OF PUBLIC CONVENIENCES
ON EXISTING CAR PARK,
CHARLES BRIGGS AVENUE,
HOWDEN, EAST YORKSHIRE

ARCHAEOLOGICAL OBSERVATION,
INVESTIGATION AND RECORDING

Report no: 2012/434.R01
Version: Final
Date: December 2012
Author: Ed Dennison & Karen Adams

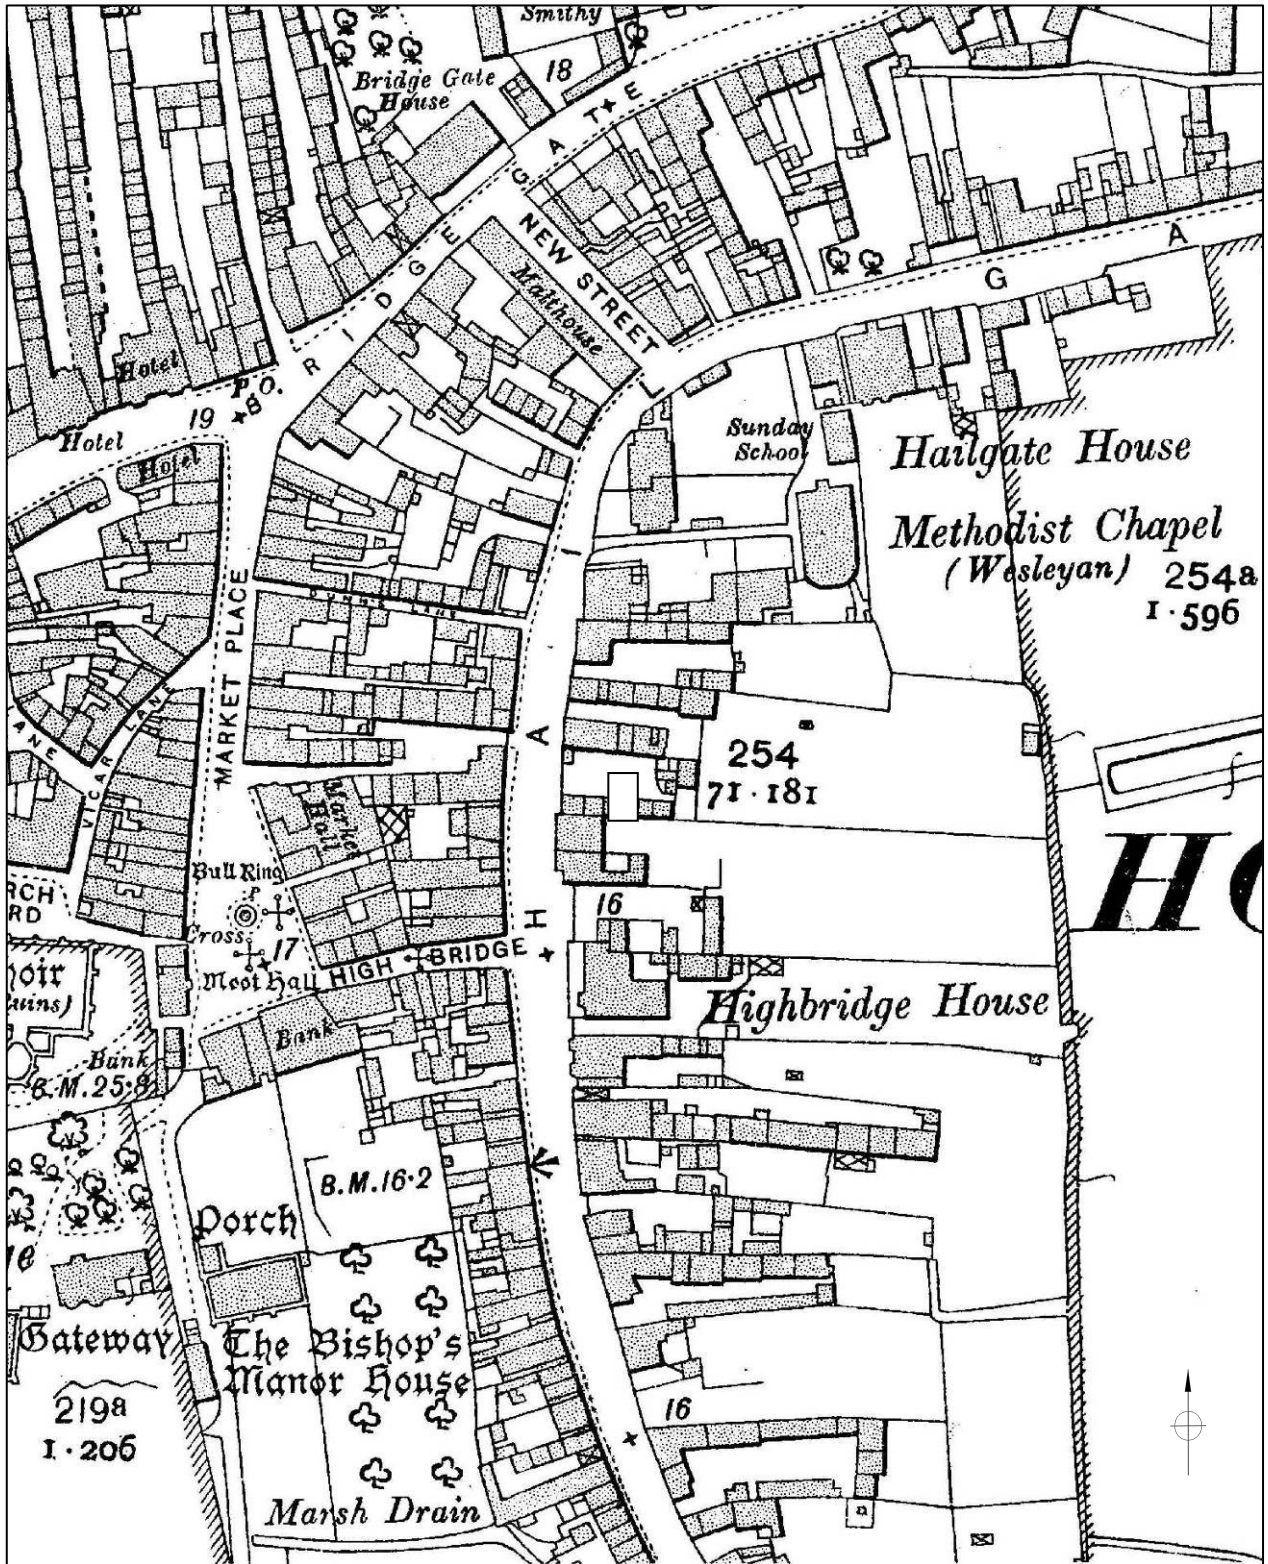
PROJECT CHARLES BRIGGS AVENUE, HOWDEN	
TITLE ORDNANCE SURVEY 1907 MAP	
SCALE NTS	DATE DEC 2012
EDAS	FIGURE 4

Ordnance Survey 1907 1:2500 scale map (sheet 237/4).

adjacent fields. The house and gardens are similarly shown on Ordnance Survey maps of 1890 and 1907 (see figure 4).

- 6.2 A number of brick walls were noted in the foundation and drainage trenches, although their full lengths could not be seen as they extended beyond the limits of excavation. In the southern part of the site, a modern right-angled concrete-floored c.0.80m wide passage wide was noted, defined by walls 116 and 130. The fact that the walls were lined with white-glazed tiles suggests that it may have been a toilet area, presumably associated with the former 20th century Majestic Cinema or later offices which lay on the site, to the east of the street frontage building. Other brick walls in the centre of the west side of the site appear slightly older, defining an east-west aligned 2.50m wide brick and quarry-tiled floored cellar space (walls 106/127 and 113/128) which was subdivided by a north-south wall (107/118). The bricks of this cellar date to the late 17th-late 18th century, and it is presumably associated with the rear arm of Highbridge House which is shown on the 1851 Ordnance Survey map; the northern side of the cellar space (walls 106/127) seems to correspond to the north side of this rear arm (see figure 3). The division between a backfill material (120) and the natural clay deposit (114) seen in the eastern foundation trench also lines up with the north side of the former arm. Other brick walls (123 and 103) in the north-east corner of the site are presumably associated with former outbuildings to Highbridge House shown in 1851, or more likely in 1907 (see figure 4).

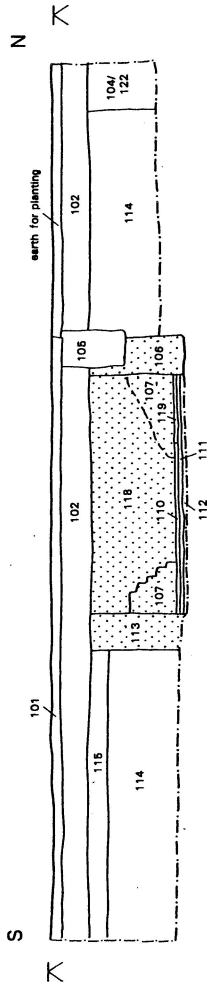
PROJECT	CHARLES BRIGGS AVENUE, HOWDEN		
TITLE	RESULTS OF WATCHING BRIEF		
SCALE	AS SHOWN	DATE	DEC 2012
	EDAS	FIGURE	5

Plan

Section 1: West side of west foundation trench

5 RESULTS FROM THE WATCHING BRIEF (see figure 5)

- 5.4 Along the western arm of the foundation, four further lengths of similar brick walls were encountered. Two (106 and 113) had an east-west alignment, each being three bricks (0.38m) wide with at least nine courses (up to 1.00m high) surviving; the space between the two alignments measured 2.50m and the tops of the walls lay at 0.40m BGL (see plate 2). The bricks measured 230mm by 113mm-115mm by 56mm-60mm and were set with a pale brown-cream-grey mortar, and there was a lime wash/render to one stretcher course on the inner (southern) face of the northern wall (106); these bricks are likely to date to the late 17th-late 18th century (see Appendix 1). A further two brick walls (107 and 118), seen in section on the west side of the trench, were constructed on a north-south alignment between the two east-west walls (106) and (113) - wall 107 was two courses wide and formed an inner skin with wall 118 being an outer skin to the west; they seemed to represent two separate walls butted together rather than one thick wall.

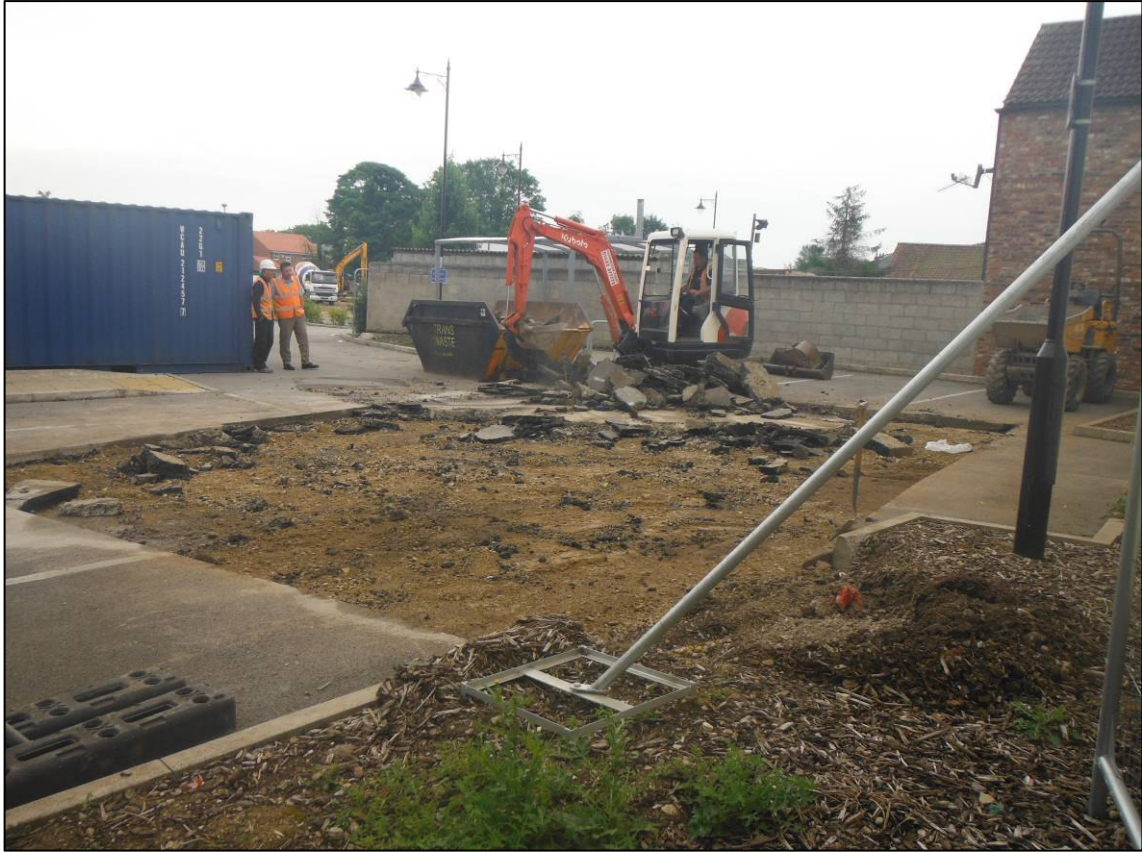
Plate 1: General view of development area after removal of tarmac surface (101), looking SE.

- 5.2 The existing tarmac (101) of the car park, up to 0.10m thick, was removed within the limits of the footprint of the new building (see plate 1). Below this, over the whole site, was a compacted layer of cream-grey chalk gravel (102) up to 0.30m thick, which provided a hardcore foundation for the tarmac. This gravel deposit had been truncated in parts by a north-west/south-east aligned 0.25m wide plastic-sleeved electricity cable (105) which served the car park lighting. Below the chalk gravel (102), in the southern half of the site, there was a hard consolidation/levelling layer of brick rubble (115) up to 0.20m thick, material which presumably is associated with the demolition of the former buildings on the site. A sherd of late 19th/early 20th century factory-produced white earthenware was recovered from within this rubble (115). The natural brown-orange clay (114) was encountered at a general depth of 0.60m BGL.

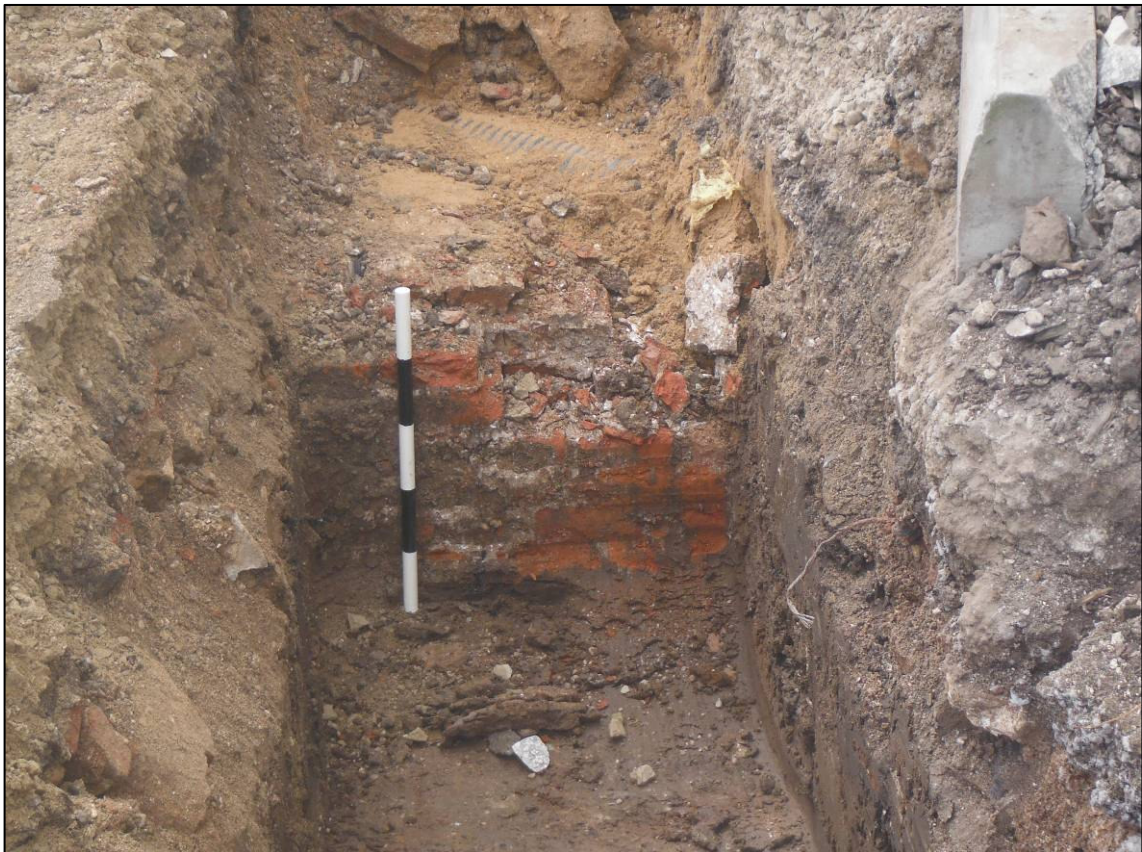
Plate 2: North side of brick wall (106) with cable (105), in west foundation trench, looking S.

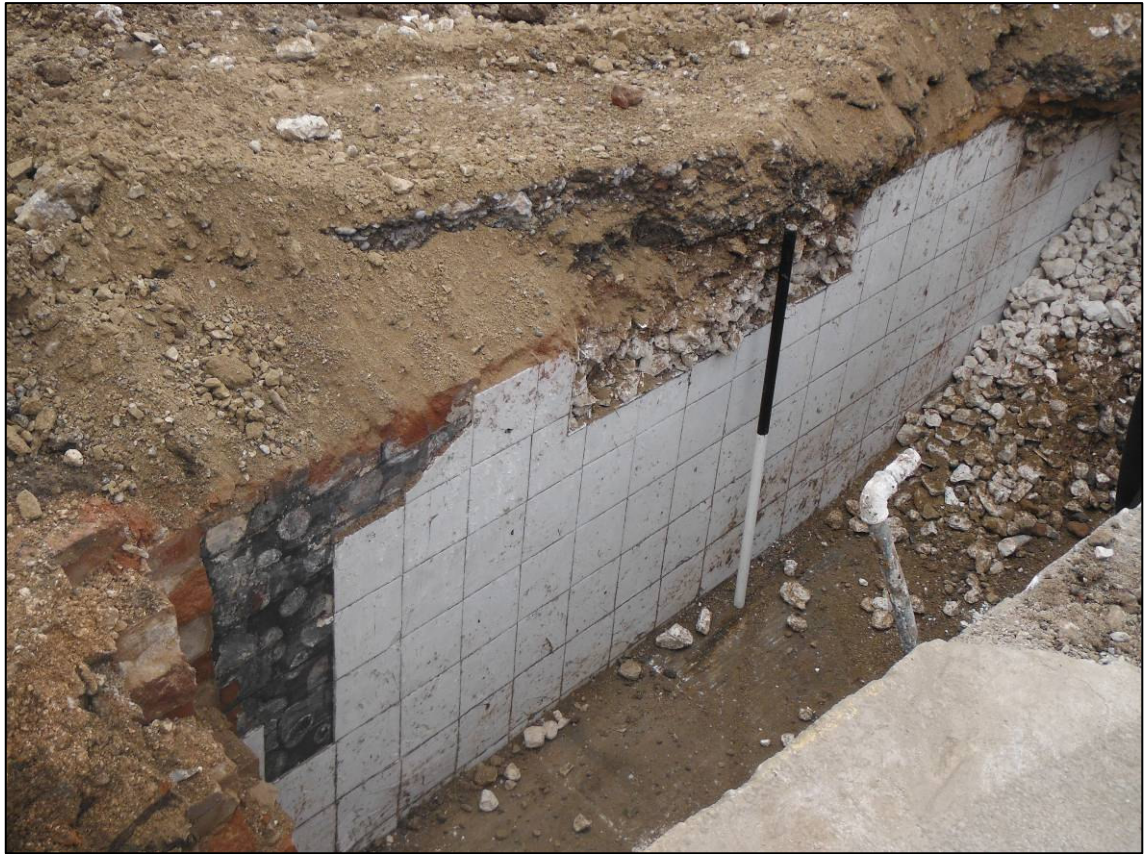
Plate 3: White tiled brick wall (116) of concrete-floored passage, in north side of south foundation trench, looking NE.

- 5.8 At the southern end of the foundations, a modern L-shaped structure was encountered. A brick wall (116), two bricks (0.25m) wide and 2.30m long, was observed on a north-south alignment, which then turned and continued east for c.4.00m along the north side of the southern arm of the trench; this part of the foundation trench collapsed back to this wall alignment, which explains why the trench was wider here. Parallel to these walls, and c.0.80m to the south, another 0.25m wide brick wall (130) was seen in the south side of the trench; the east-west part was 3.20m long and continued to beyond the limit of excavation, while the north-south part was 1.50m long and continued south beyond the limit of excavation. The walls, which were bonded with a grey sandy cement mortar, survived to over eleven courses high with the tops at 0.40m BGL. The bricks were frogged (indented on the bed surfaces during manufacture) but contained no manufacturer's details, and measured 222mm-225mm by 105mm by 70mm. The south and east (i.e. internal) faces of wall 116 were faced with white-glazed square tiles while the west face of wall 130 was painted black and the longer north face had white-glazed tiles and a white limewash (see plate 3). The floor (125) of the passage created by the two wall alignments, exposed in the base of the trench, was of concrete of undetermined thickness. Following disuse, the passage between the walls had been backfilled with a clean chalk rubble (117), presumably laid down in the fairly recent past.

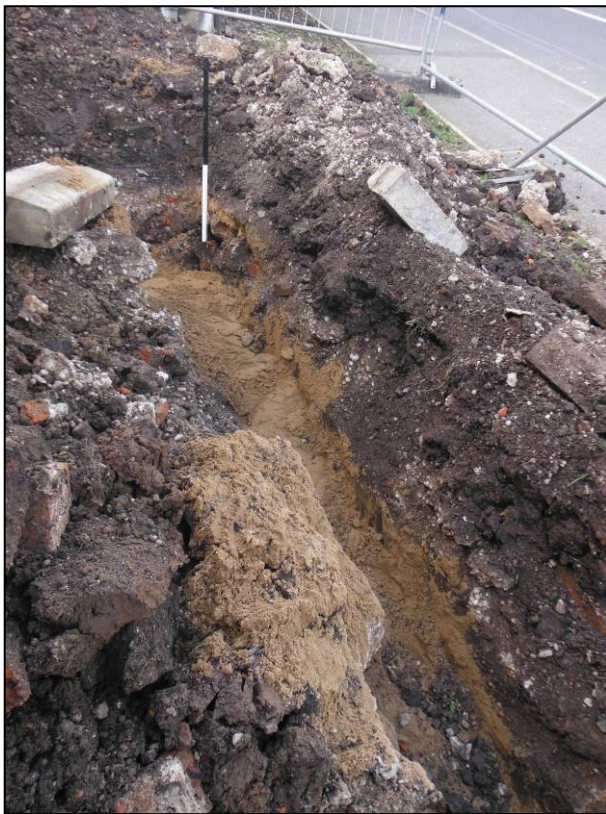
Plate 4: West end of north drainage trench, looking W.

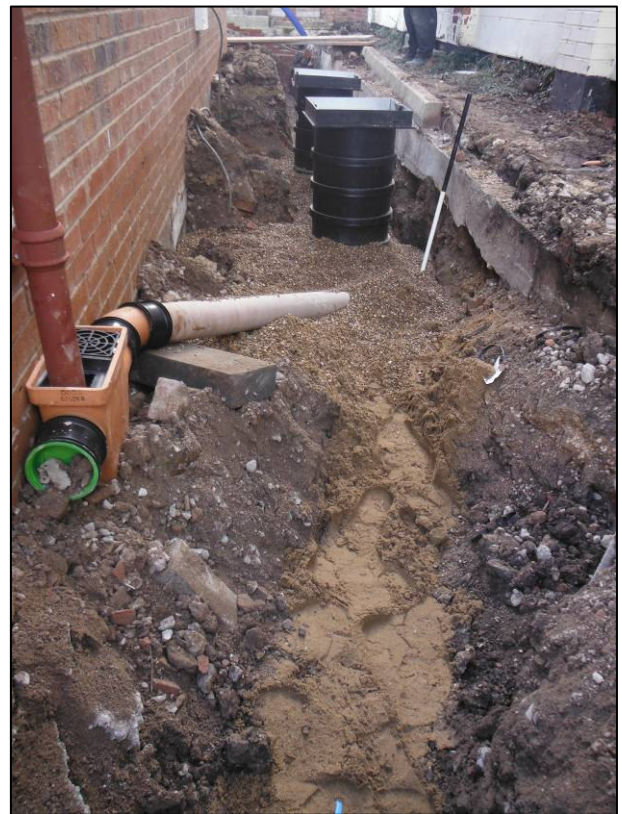
Plate 5: West drainage trench, looking S.

- 5.10 Two east-west aligned 0.38m wide brick cellar walls (127) and (128) were observed in the western side of the west drainage trench dug around the perimeter of the new building. These correspond exactly to the walls seen within the adjacent foundation trench, 106 and 113 respectively, although their full extent, and any other associated deposits, could not be seen as pipes, inspection chambers and gravel were laid before inspection could take place (see plate 4); the same was the case for the northern length of drainage trench (see plate 5). A continuation of brick wall 103 was seen towards the north end of the eastern drainage trench, and it continued on an east-west alignment for 0.50m before turning north and continuing beyond the edge of the excavation. A course of modern bricks (129) was also observed below the cream-grey hardcore (102) along the northern east side of this part of the eastern drainage trench. Although recording was difficult, no other archaeological features were seen in this eastern trench.
