ERECTION OF SINGLE STOREY EXTENSION TO REAR,
INTERNAL ALTERATIONS AND REPLACEMENT
OF GROUND FLOOR WINDOW,
8 ST JOHN STREET, BEVERLEY,
EAST YORKSHIRE

ARCHAEOLOGICAL OBSERVATION,
INVESTIGATION AND RECORDING

Report no: 2011/402.R01
Version: Final
Date: December 2012
Author: Ed Dennison & Kate Dennett

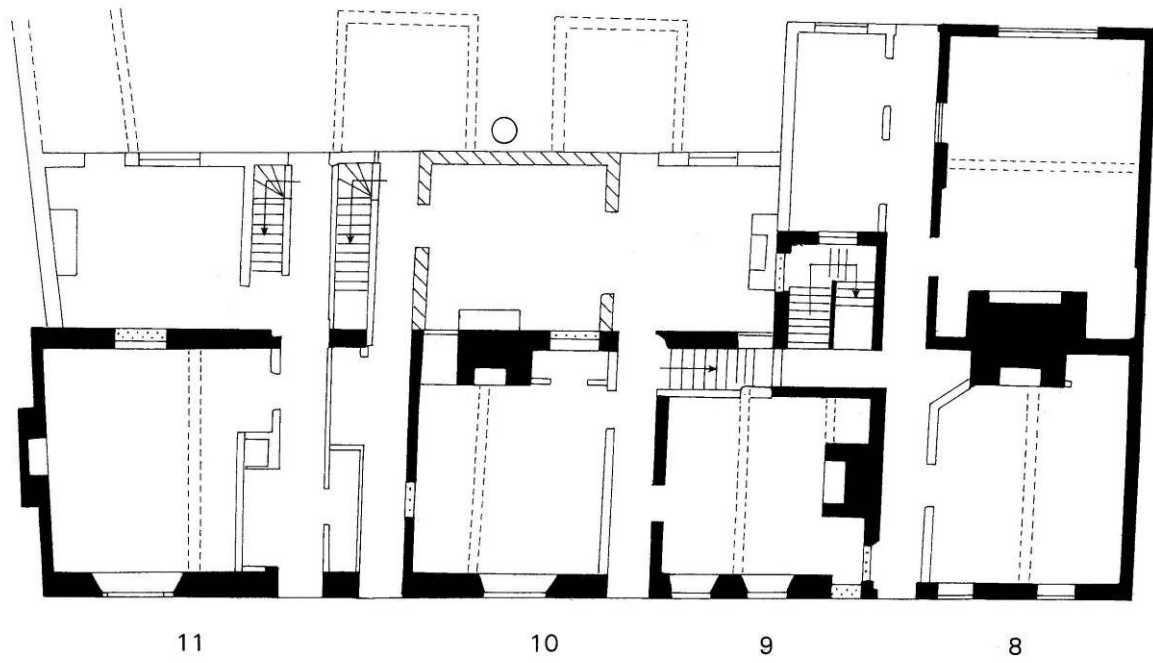
PROJECT		8 ST JOHN STREET, BEVERLEY	
TITLE		NOS 8 TO 11 GROUND PLAN	
SCALE	NTS	DATE	DEC 2012
EDAS		FIGURE	3

- 1695-1705 house
- Possible main staircase wing of 1695-1705
- Late 18th-early 19th century additions
- Later extensions
- Blocked opening

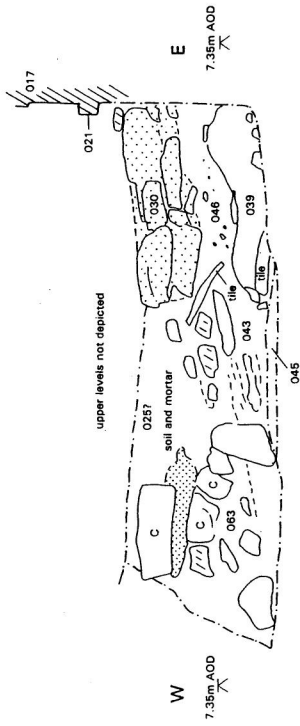
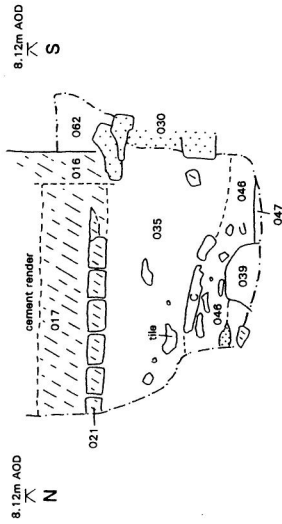
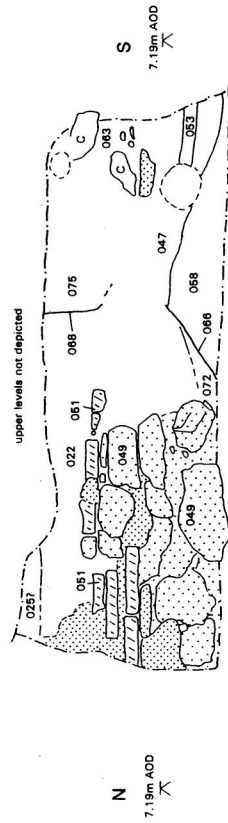
PROJECT	8 ST JOHN STREET, BEVERLEY		
TITLE	SECTIONS		
SCALE	AS SHOWN	DATE	DEC 2012
	EDAS		FIGURE
			8

Section 2: north side of north foundation trench

Section 1A: east end of north foundation trench

Section 1B: east end of south foundation trench

Section 3: east side of central area

Section 4: south side of south foundation trench

- 5.10 The excavations for the north foundation trench exposed the foundations of the west gable of Lambert's c.1700 rear wing (001) (see Section 1A on figure 8). These foundations (023) consisted of a single course of dressed limestone less than 0.34m wide by 0.20m deep, very tightly laid, over a single course of bricks laid on edge measuring 140mm wide by 41-50mm thick, which was in turn placed on a firm brown gritty soil (033) less than 0.18m deep (see plate 9); this deposit contained some CBM, shell and animal bone. In places, the dressed stones were very heavily plastered with a lime mortar and just above this, the lowest courses of the brick wall (001) had been covered by a row of slates (054), possibly in an attempt to provide a damp course.

- 5.12 The chalk foundation (030) appeared to continue beneath the south-west corner of the presumed mid 18th century extension (017) and beneath the brick wall (016) forming the southern boundary of the site (see Section 1B on figure 8) (see plate 10). It also probably continued beneath (and was damaged by) the 20th century extension to no. 9 further to the south. As noted above, the foundation (028) of the east end of the southern boundary wall (016) was built directly onto, and utilised, the chalk foundation (030).

- 5.19 A bowl-shaped pit (055) was recorded in the south side of the south foundation trench (see Section 4 on figure 8) towards the west end of the trench, although it was not seen in plan. It may be associated with the demolition of whatever structure was represented by chalk foundation 048 or a feature associated with it, as the demolition layer (044) appears to form the primary fill, down to a level of 7.13m AOD. Above the primary fill (044) were successive layers of darker soil and mortar (056) together with small fragments of CBM, indicating a more gradual infill. Overall, the pit was c.0.65m wide and less than 0.35m deep.

- 5.30 The general background soil (058) at the lowest level of excavation on the south side of the site, at 6.96m AOD, was a very dark brown, moist, peaty deposit of unknown depth, containing small pieces of wood, charcoal, oyster shell, bone and tile fragments. It also included Humberware pottery sherds with a date range of 14th-16th century, and one sherd of possibly Beverley 2 ware (prior to 1350). This moist deposit did not appear to be present on the north side of the site, but it may well underlie the lowest deposit excavated here, which was a firm but friable dry dark brown soil (037) streaked with clay and containing tile and oyster shell fragments - this deposit lay beneath and to the side of foundation 036 (see Section 1A on figure 8).

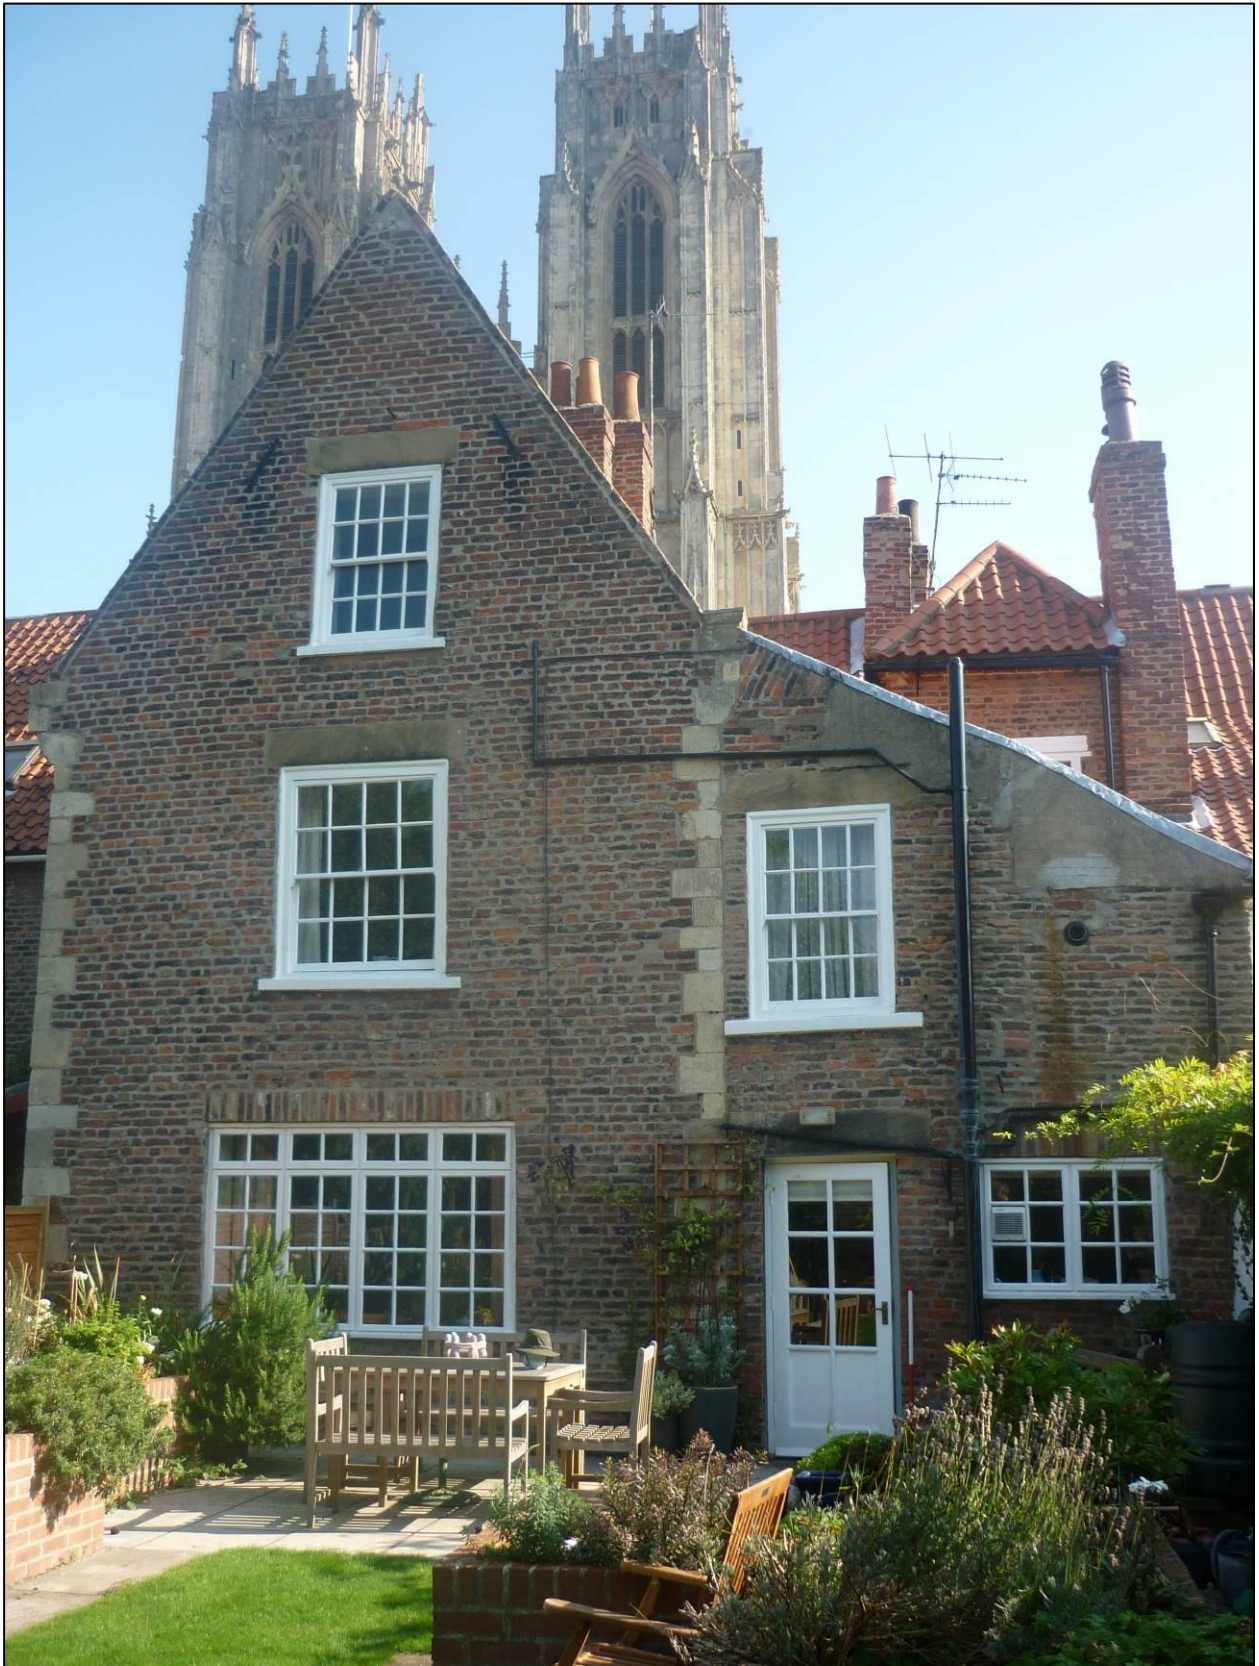
Plate 3: Rear of no. 8 showing west gable of Lambert's c.1700 rear wing to left, and later kitchen extension to right, prior to development, looking W.

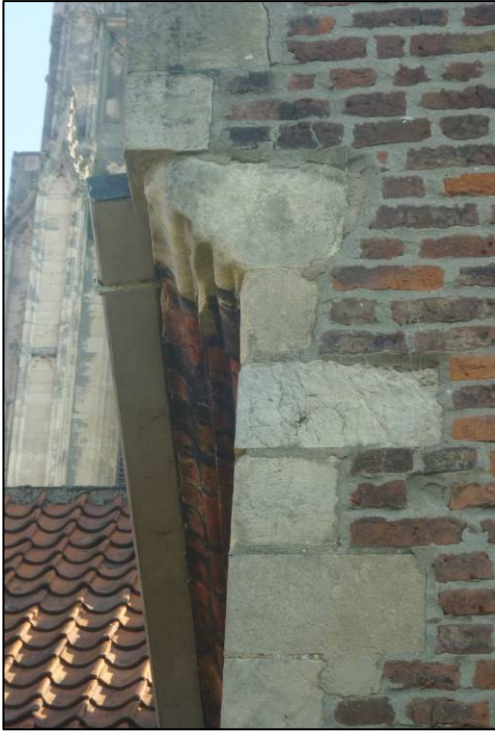
Plate 4: Moulded kneeler and eaves cornice to north side of rear gable, looking E.

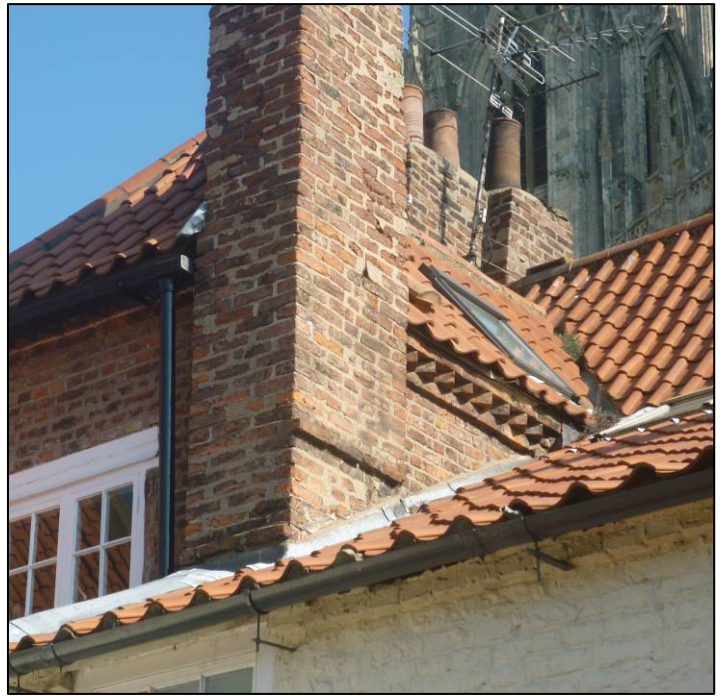
Plate 5: Top of small c.1700 staircase showing cogged brickwork, looking NE.

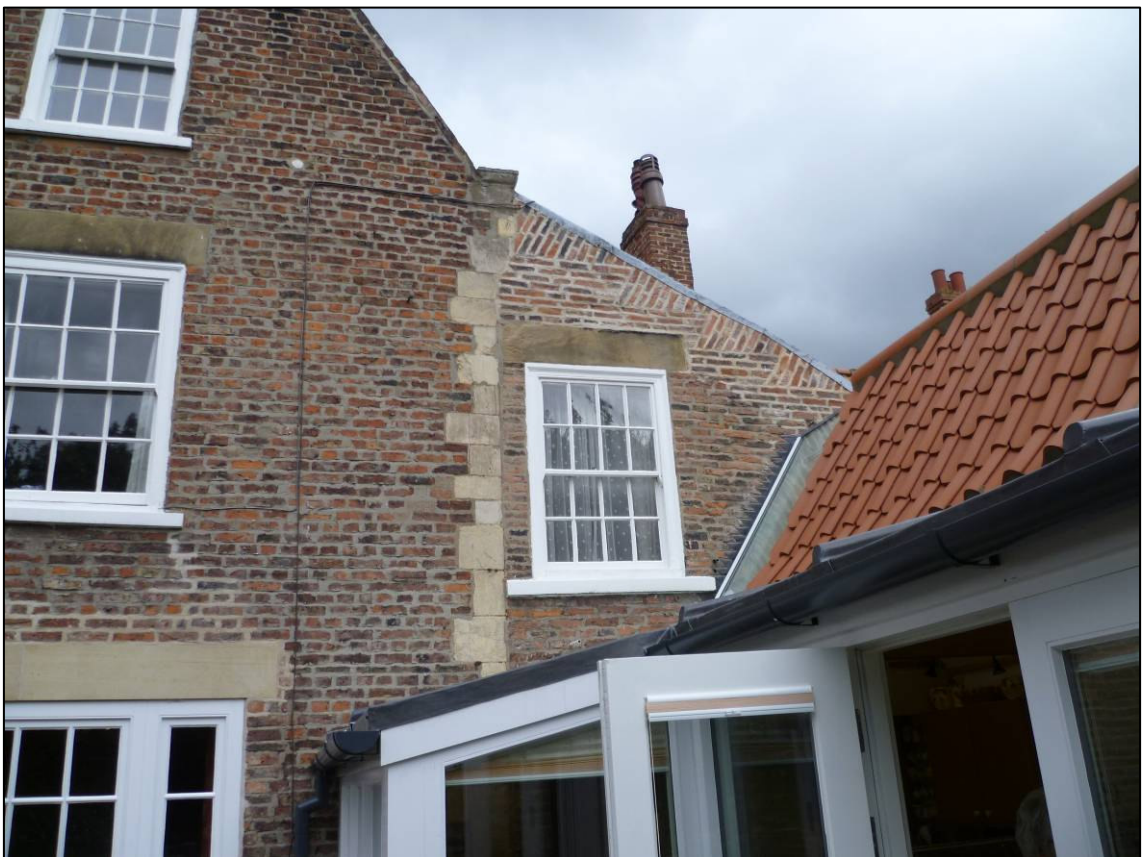
Plate 6: Restored tumbled brickwork of later kitchen extension, after development, looking E.

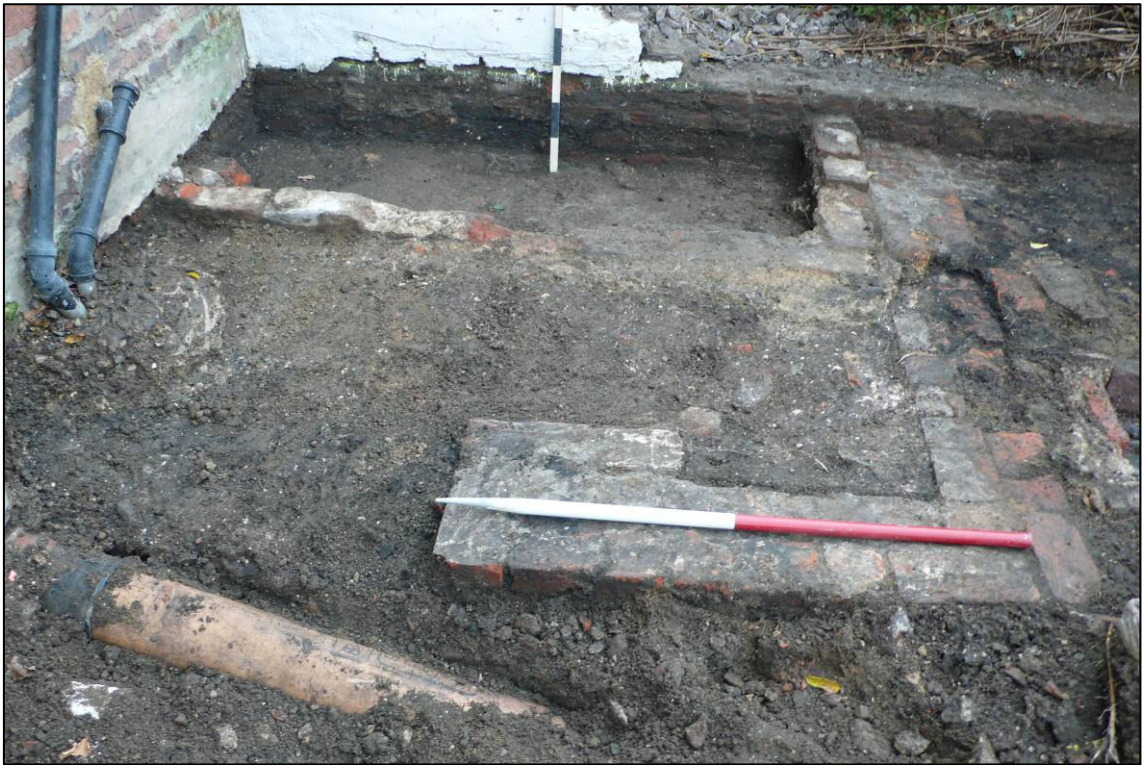
Plate 7: Brick foundation (014) of outhouse enclosing privy (006), looking S.

The Phase 3 elements are fairly representative of Beverley sites. One interesting feature was a brick-lined gully or drain (019) which extended under a later 18th century extension built on the south side of Lambert's c.1701 rear wing. This drain probably connected with a cistern or well located in the garden or yard of the house. Other Phase 3 features included the brick foundations for a privy/outhouse (014/006) and a small coal bunker (018).

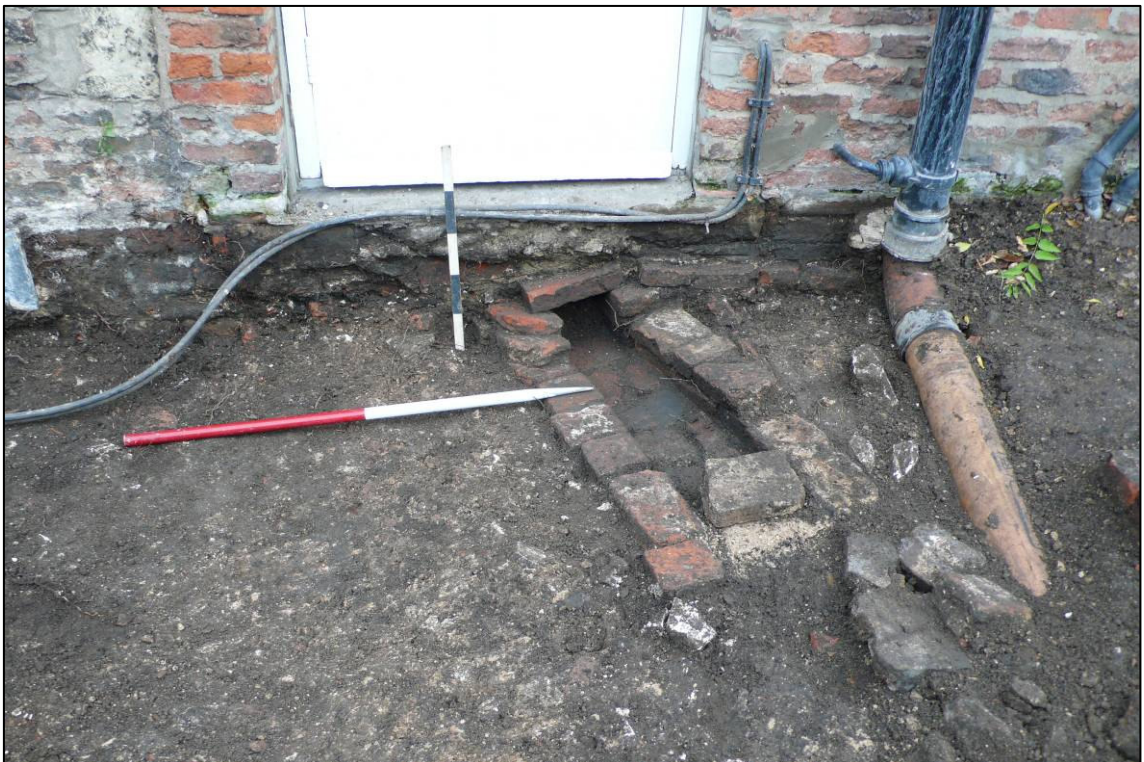
Plate 8: Brick gully (019) passing under wall of presumed mid 18th century kitchen extension (017), looking E.

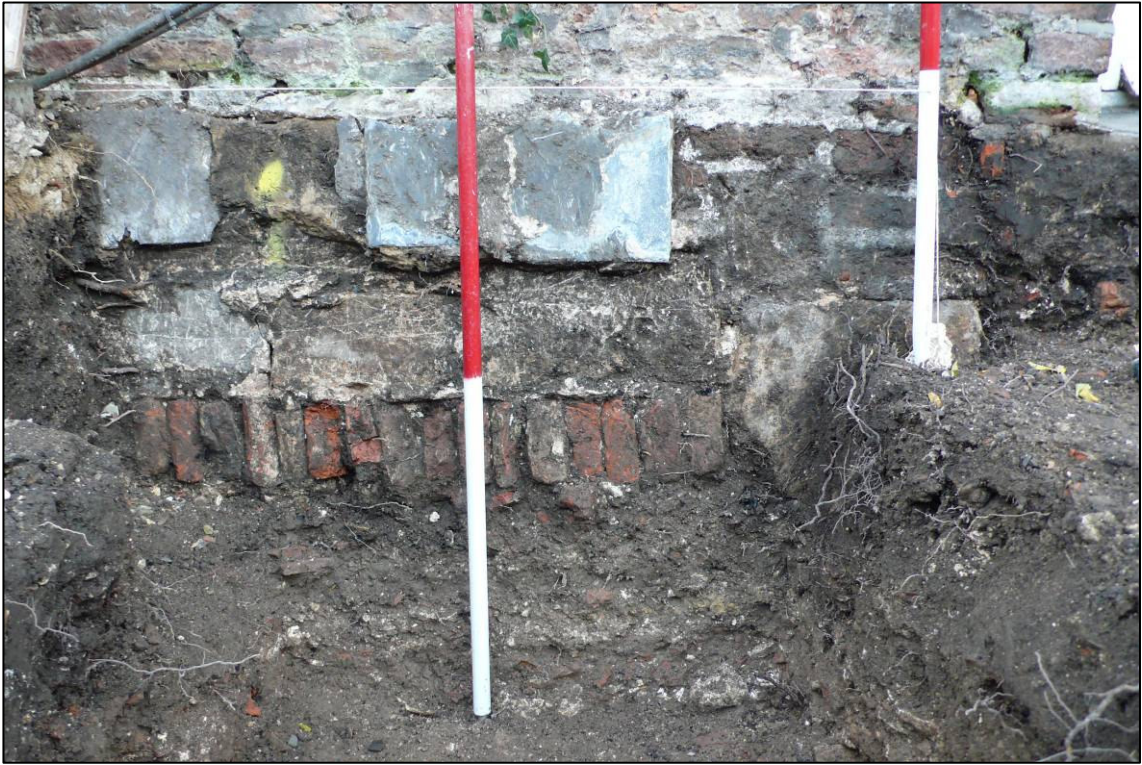
Plate 9: Foundations for gable of Lambert's c.1700 rear wing comprising dressed stone and brick on edge (023) on brown soil (033), looking E.

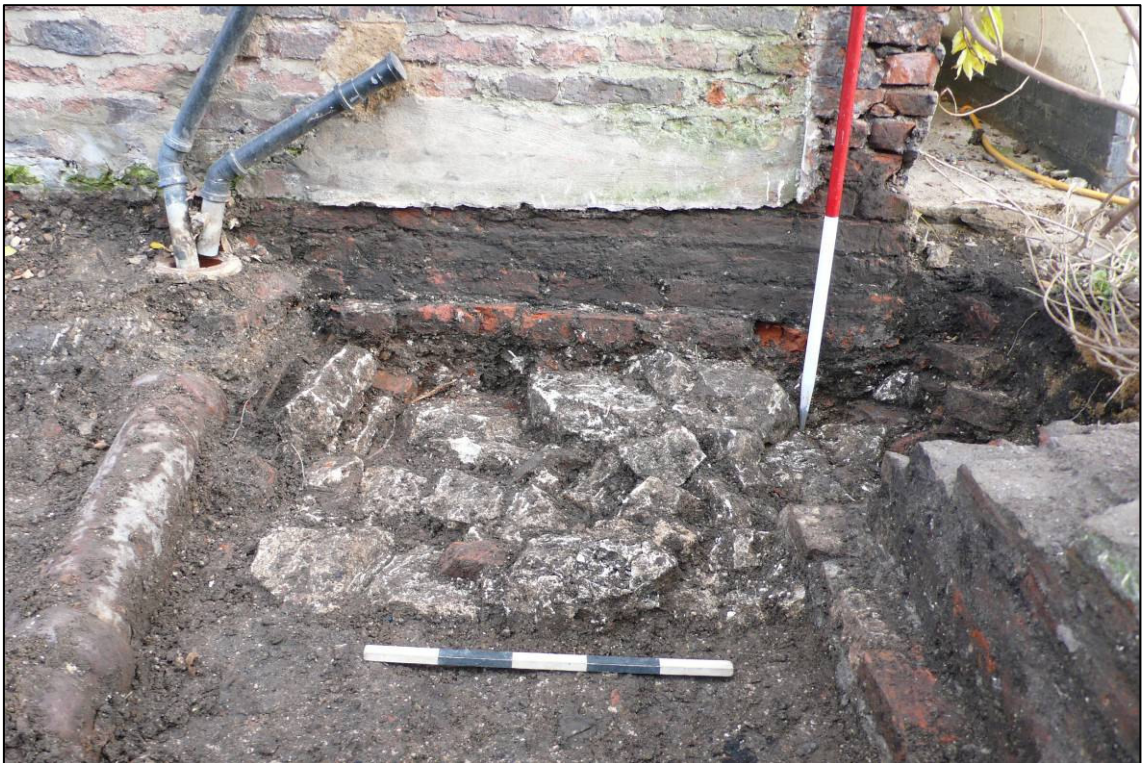
Plate 10: Chalk foundation (030) running beneath SW corner of mid 18th century extension (017) and brick wall (016) forming the southern boundary of the site, looking E.

- 5.11 The south-west corner of the presumed mid 18th century extension to no. 8 partially overlay a 1.80m length of chalk rubble foundation (030) for an earlier building on a slightly different alignment, i.e. running NNW/SSE (see plate 10). Initially exposed by the stripping of the area adjacent to the house, the substantial foundation was c.0.71m wide and up to 0.34m deep, with the top at 7.60m-7.72m AOD. The base, exposed in the south foundation trench, was at a level of 7.38m-7.42m AOD (see Section 4 on figure 8). A single, much abraded, sherd from the base of a medieval vessel of Humberware 1 or Beverley 2 ware was embedded in the lower part of the chalk, and is likely to be residual, rather than contemporary. The trench cut for the foundation (030) could not be distinguished, but the wall appeared to be built on a firm brown fine gritty soil (046) rather than the solid clay (039/045) just below this (see Section 4). The firm brown fine gritty soil (046) included oyster shell, fragments of brick and tile and a sherd of medieval pottery from a Beverley 2 ware vessel (dating prior to 1350), as well as a sherd from a Humberware vessel (14th-16th century). The firm brown fine gritty soil (046) included oyster shell, fragments of brick and tile and a sherd of medieval pottery from a Beverley 2 ware vessel (dating prior to 1350), as well as a sherd from a Humberware vessel (14th-16th century).

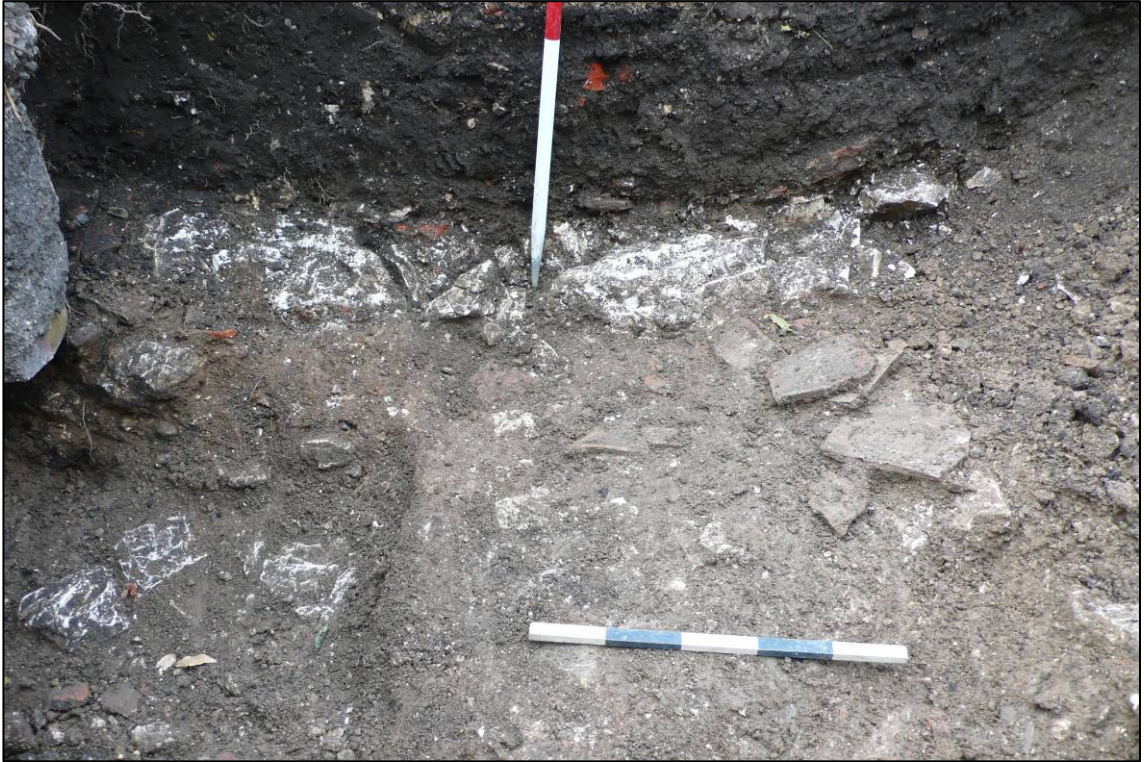
Plate 11: Chalk foundation (048) in south-west corner of excavation, looking W.

- 5.18 At the very west end of the excavated area, a single surviving course of another chalk foundation (048) running approximately NNW/SSE was seen at a level of 7.48m AOD (see plate 11). It comprised roughly dressed chalk blocks forming a section of wall more than 1.52m long, more than 0.23m wide and at least 0.25m deep, and was seen to continue into the adjacent property (no. 9) to the south (see Section 4 on figure 8). At its north end, the wall appears to respect the major boundary wall (049/051 - see Phase 1 below) and it also possibly had a return to the west, although this could not be firmly established. Loose chalk rubble visible at the north end of the wall, may be part of the return of the wall. Immediately to the east of this chalk foundation, was a scatter of smaller chalk rubble (050), at a slightly lower level within deposit 042 (see Phase 1 below).

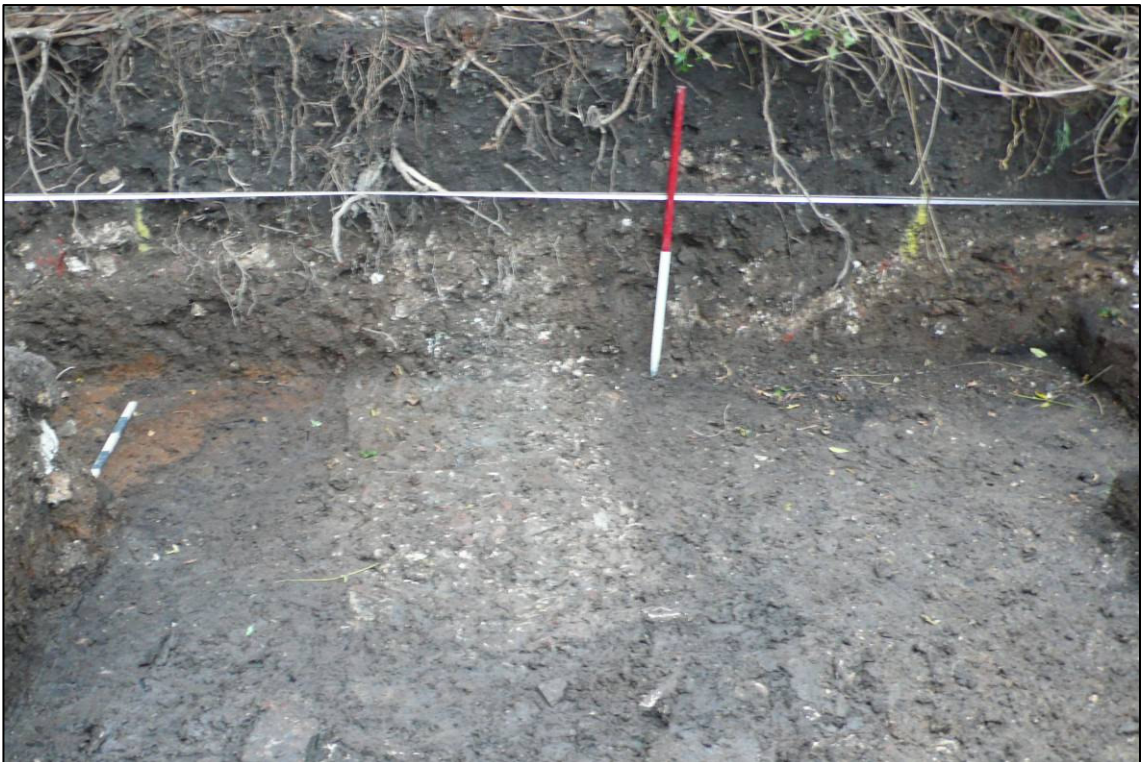
Plate 12: Base of robber trench (004) with fill (041), looking S.

- 5.22 As the south foundation trench and the exercise pool area were excavated, a substantial robber trench (004) 0.57m wide and running approximately NNW/SSE became apparent, both in plan and section, c.0.3m west of foundation 040, but on the same alignment (see Phase 2 above) (see plate 12). It was backfilled with a fairly uniform firm greyish gritty soil (041) containing crushed mortar, fine chalk, and small brick and tile fragments. The robbed-out wall represented by the backfill (041) was clearly seen in the south side of the trench (see Section 4 on figure 8), and it must have survived to a height of at least 0.50m, but its full depth was not exposed and the land surface from which it was built is unknown. Seen in section, the profile of the robber trench appears to widen slightly towards the base of the excavation at a depth of 6.99m AOD, and this might indicate a wider or foundation course having been removed. It is likely to have been backfilled immediately. It appears that the original wall, probably a boundary, respected the major WSW/ENE boundary (049/051) or more likely, a ditch (072) or fence preceding the wall (see below).

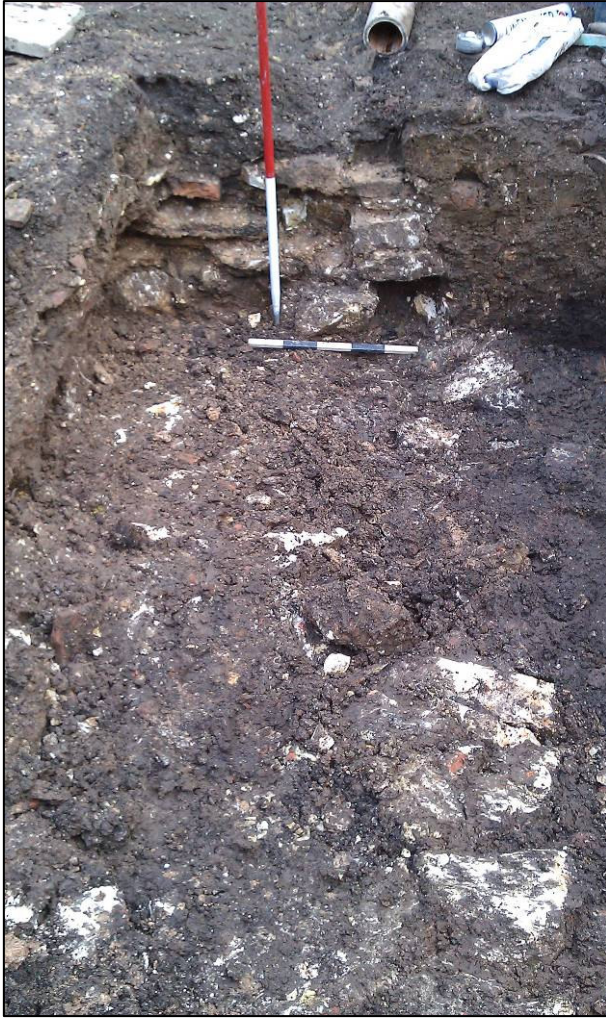
Plate 13: Brick wall (051) over chalk foundation (049), looking E.

The major feature of Phase 1 was an east-west aligned boundary represented by a substantial chalk and brick wall (049/051). The chalk foundation (049) appeared to be more than 1.18m wide, and the brick wall (051) survived to a surprisingly high level until the insertion of a sewer in the recent past. The alignment may have been following an earlier ditch (066). It is thought that this boundary represents the north side of the plot of land granted to the Minster parsons in 1399, when their street frontage house was built. The brick wall (051) presumably remained as a boundary until the start of the 18th century, when Lambert created a unified yard and garden to the rear of nos 8 to 11. Other Phase 1 features included a series of floor deposits (053), a clay deposit (045), a possible slot for a wall partition (076) and a robbed out wall (004/041). One notable find was a complete iron rowel spur dating to the 15th-16th century, found at a level of 7.13m AOD. Several lengths of other wall foundations (030, 040 and 048), tentatively identified as belonging to Phase 2, may represent outhouses or ancillary buildings to the rear of nos 9 to 11, either associated with the medieval parson's house or more likely its post-Dissolution but pre-1701 owners. Nearly all the pre-18th century structural features were noted to be on the same alignment, which is slightly skewed to the existing range of street frontage buildings.

- 6.3 The major feature of Phase 1 (14th to mid 15th century) activity was the substantial approximately east-west aligned medieval boundary as represented by a chalk and brick wall (049/051). The full extent of the base of the chalk foundation (049) was not exposed, but it appeared to be more than 1.18m wide. The brick wall (051) built on top of the chalk was slightly narrower, and it appears to have survived to a surprisingly high level until the insertion of a sewer in the recent past. The alignment of the chalk and brick wall, which may have been following an earlier ditch (066), suggests that it ran towards the south-west corner of Lambert's c.1700 rear wing. It is known that the Minster Parsons were granted a piece of land in the Bedern Close in 1399, for a house which can be identified with the site of nos 9 to 11 St John Street. Although there was no specific dating evidence for this wall, its relationship with other adjacent features on the site suggests that it is medieval in origin, and it seems likely that it (and/or the ditch which preceded it) represent the northern boundary of the parsons' plot of land which measured 62 feet (18.9m) on the east side (St John Street), 96 feet (29.3m) wide on the west side and 177 feet (54m) long. The brick wall (051) presumably remained as a boundary until the first few years of the 18th century, when Lambert rebuilt nos 9 to 11 and added a two bay extension and rear wing to form no. 8 to create a single dwelling with presumably a unified yard and garden to the rear.

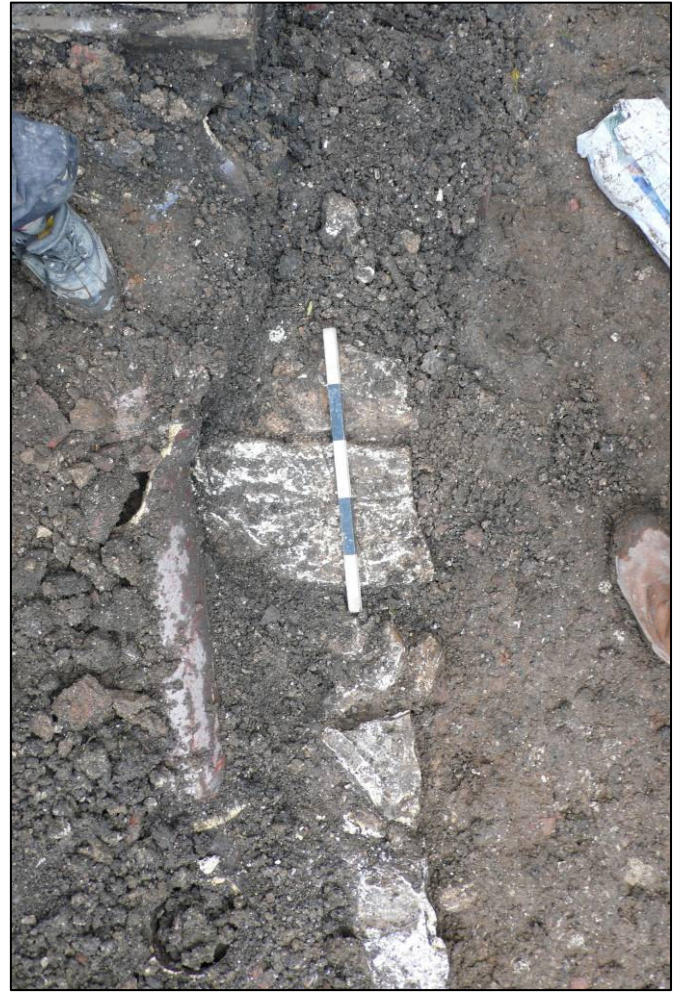
Plate 14: South side of wall foundation (049) and sewer pipe (052), from above.

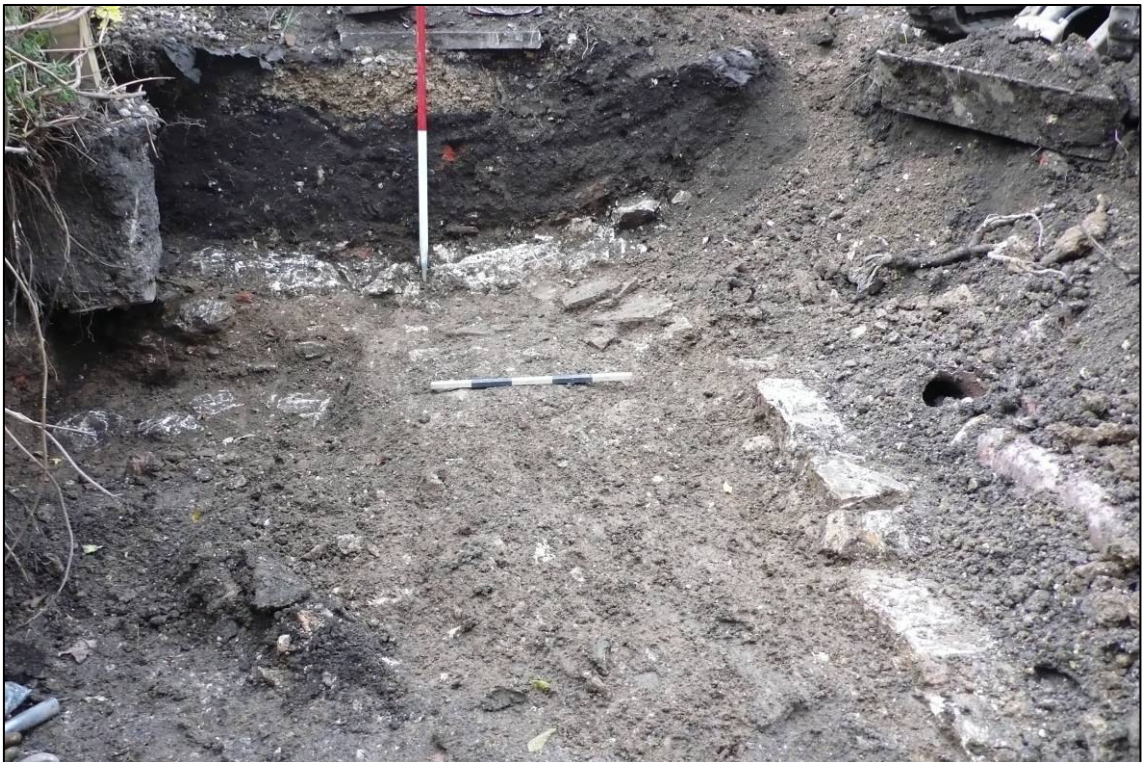
Plate 15: South side of chalk foundation (049) with central sewer pipe (052), with chalk foundation (048) to rear, looking W.

- 5.24 In the central part of the site, the machine excavation of demolition layer 044 meant that its relationship with a major chalk foundation (049), first exposed at a level of 7.38m AOD, could not be clearly established (see plate 15). This chalk foundation, running approximately east-west, was of rubble and roughly shaped blocks measuring on average c.0.35m wide and 0.22m thick (see plates 13 and 14). The full extent of the base of the wall was not able to be exposed, but it appeared to be more than 1.18m wide. Due to a combination of time constraints and the mechanical excavation, the north edge of the foundation was not seen or recorded, although an estimation of its alignment suggests that it ran towards the south-west corner of Lambert's c.1700 rear wing. Towards the east of the site, i.e. beneath and immediately east of manhole 013, the lowest four courses of a medieval brick wall (051) overlay the chalk foundation (049), although it was not apparent in the central area. However, at the western side of the site, the outer skins of this brick wall (051) survived in excellent condition to at least 13 courses and to a surprisingly high level of 7.87m AOD, i.e. only 0.2m below the existing ground level (see plate 13). The bricks measured 250mm by 126mm by 35mm thick, and were bonded with a distinctive, relatively hard, and thickly applied lime mortar; the brick wall was 0.76m wide at the west end and 1.00m wide at the east. This brick and chalk boundary was obviously long-lived, and it presumably represents a property boundary (see 'Conclusions' below).

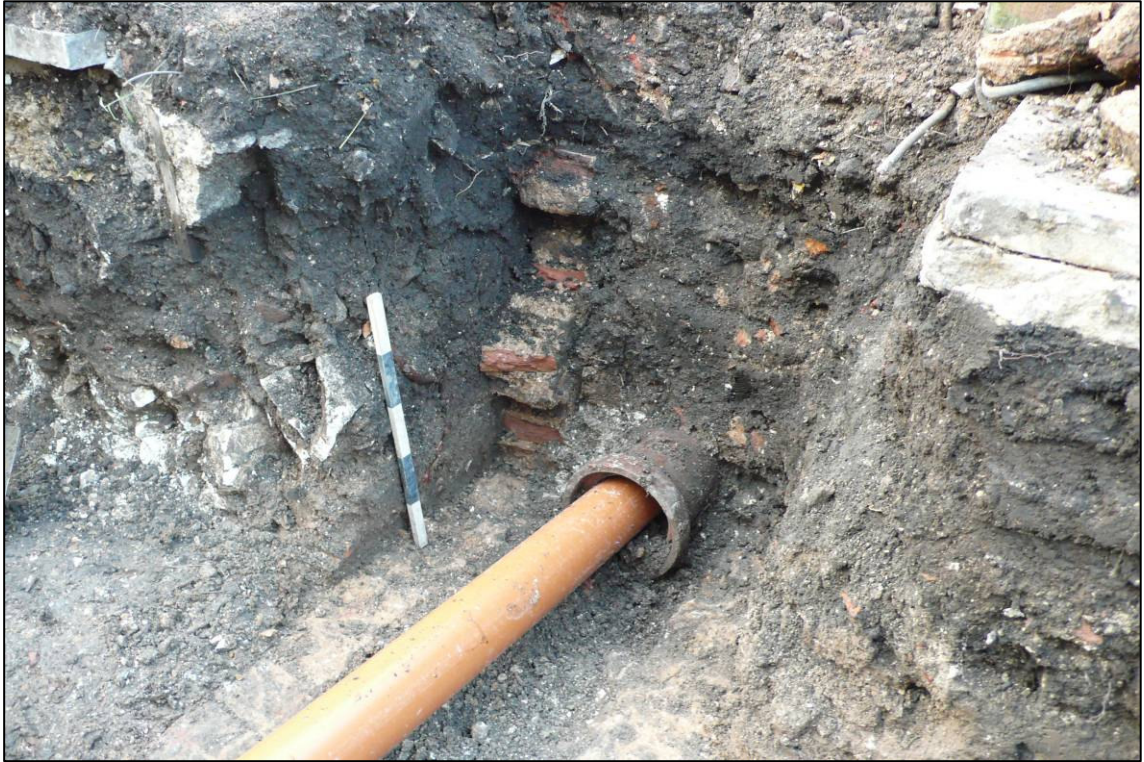
Plate 16: Sewer pipe (052) cut through centre of brick wall (051) leaving outer skins intact, looking SW.

- 5.26 The necessity of replacing the broken sewer pipe (052 - see Phase 1) exiting from the west side of manhole 013 meant that the course of the drain had to be traced. On excavation at the west end of the site, it was seen that the pipe had been inserted neatly into a cut (060) made through the centre of the surviving courses of the brick wall (051), to a level of 7.26m AOD (see plate 16) - as noted above, the cut was backfilled with a friable mid-brown fine gritty soil (057) containing mortar, fragments of CBM and slate, and small stones. It was not clear at what point the central length of the brick wall had been demolished, but it is likely to have been when the drain/sewer (052) had been connected. It was noted during machine excavation that the brick manhole (013) had been built on top of earlier brickwork, i.e. part of wall 051. It is interesting to note that the bricks of wall 051 were mainly laid east-west where visible at the west end of the site, but mainly laid north-south where the wall survived adjacent to the manhole at the east end. It is possible that there was a buttress or pillar at this point, and although not photographed or recorded in detail, the bricks were seen during rapid machine excavation to be battered or stepped on the north side at this point.

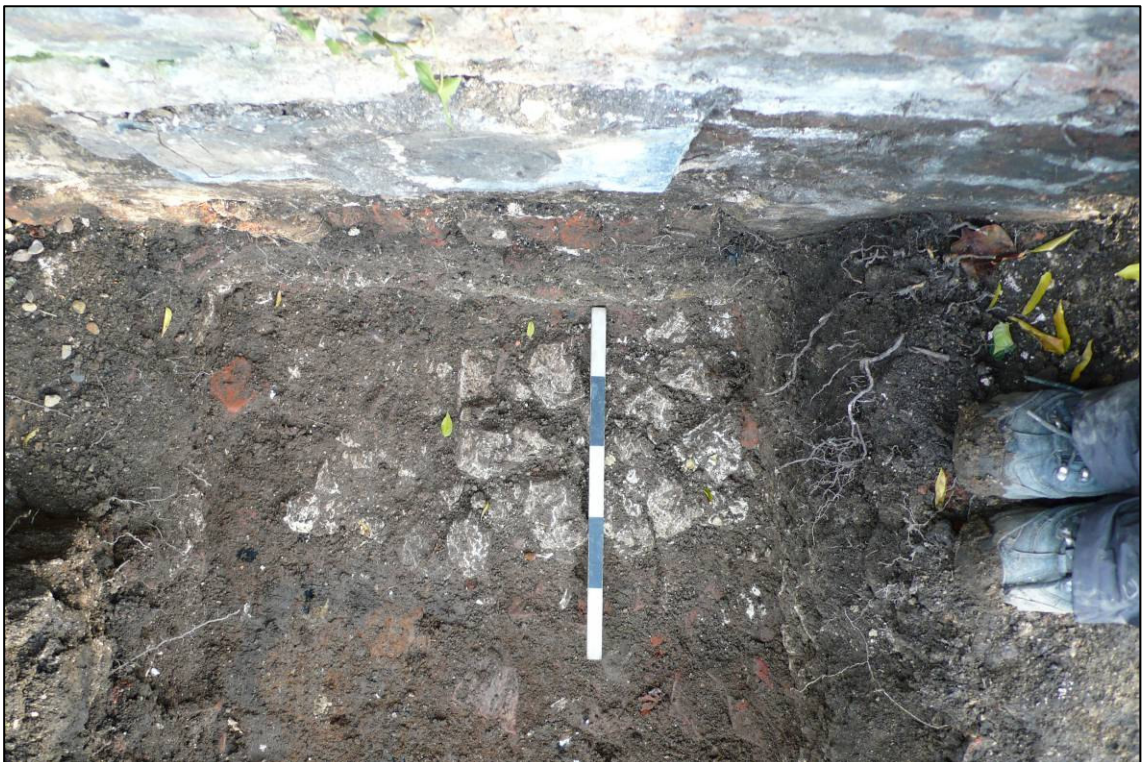
Plate 17: Chalk wall foundation (036) under gable of Lambert's c.1700 rear wing, from above.

- 5.28 At the east end of the north foundation trench, the edge of a trampled surface of mortar and crushed chalk (032) c.0.12m thick, with oyster shell, bone and tile fragments, and a sherd of Humberware pottery (14th-16th century) was exposed at a level of 7.37m AOD, running approximately NNW/SSE (see Section 1A on figure 8). Also in the same context, a fragment of a thin copper (copper alloy?) strap measuring 10mm by 35mm was found. This deposit (032) overlay the north end of a chalk rubble wall foundation (036), c.0.36m wide with the top at 7.29m AOD, running on the same alignment and disappearing beneath the present house (see plate 17). Not enough of these two contexts was exposed to make any useful interpretation, except that they ran on a slightly different alignment from the 18th-20th century buildings, but were on the same alignment as most of the other earlier features on the site.

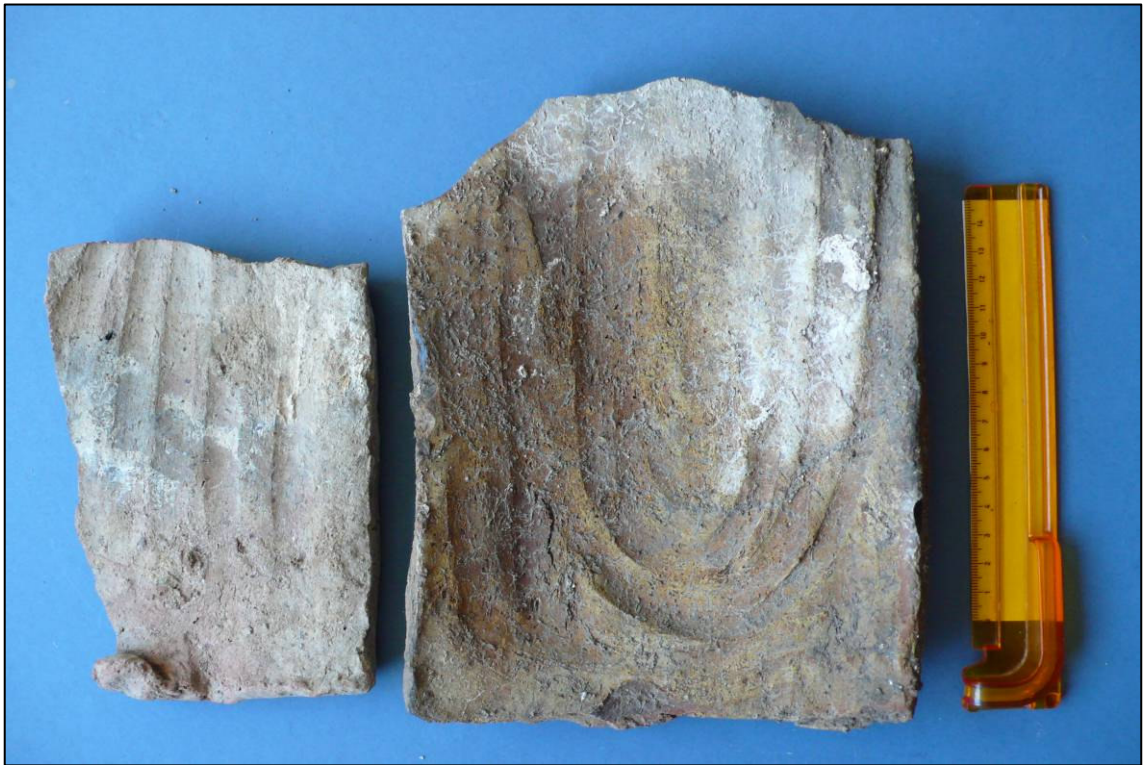
Plate 18: Handmade ceramic roofing tiles with finger marks on top (left) and bottom (right).

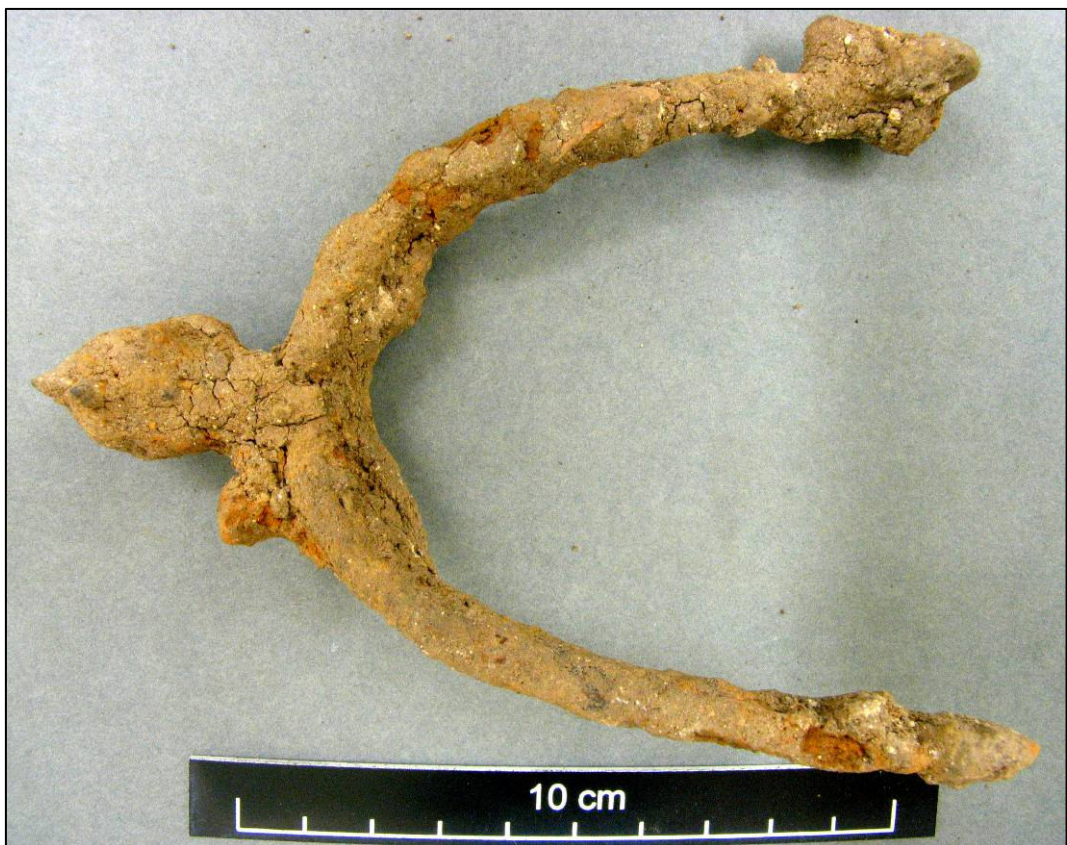
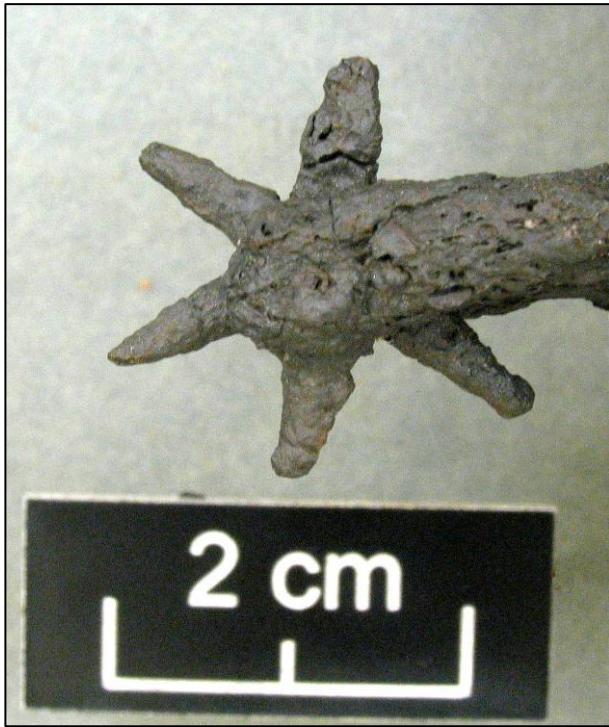
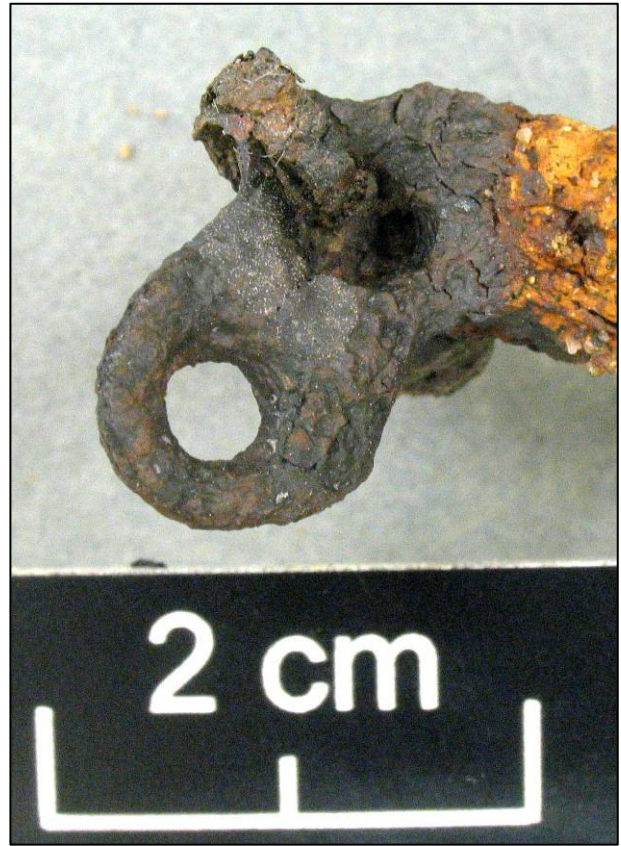
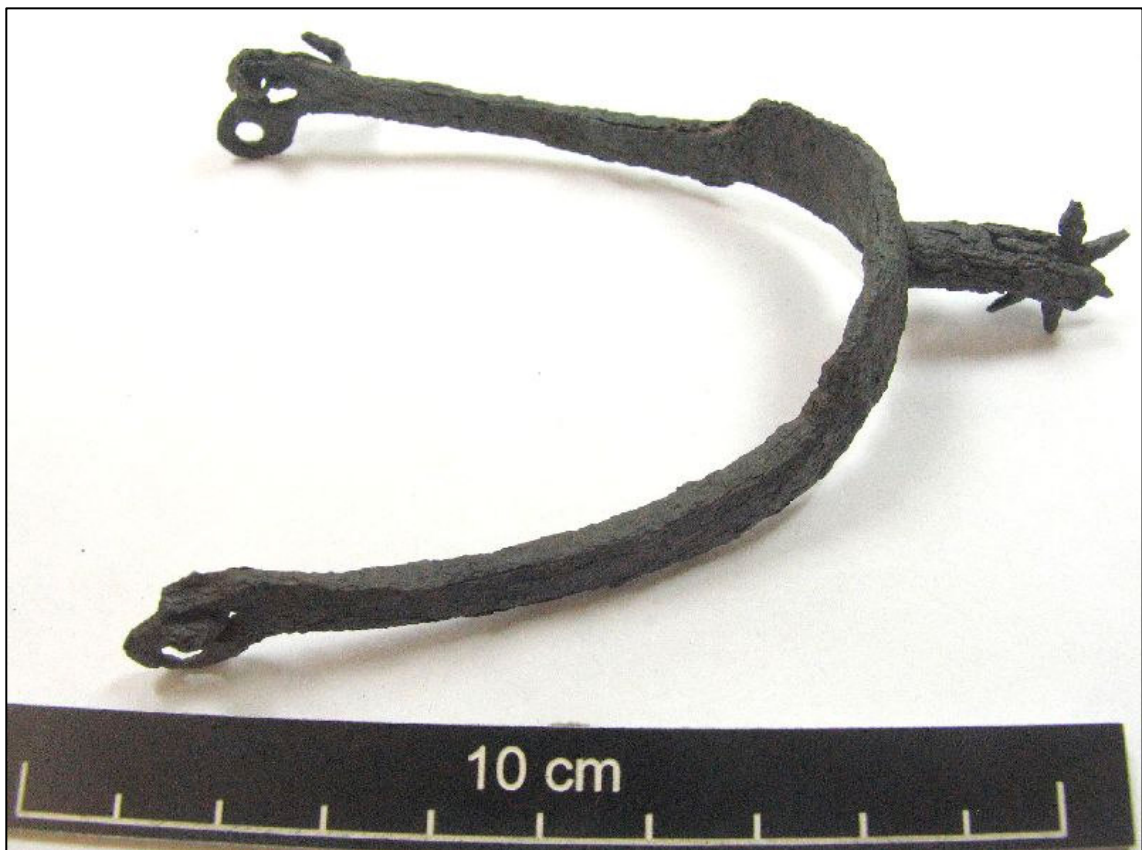
Plate 19: Iron rowel spur of 15th-16th century date (SF047A), prior to conservation.

Plate 20: Six pointed rowel of spur (SF047A), after conservation.

Plate 21: Attachment hook of spur (SF047A), after conservation.

Plate 22: Rowel spur (SF047A), after full conservation.

Investigation: The spur was found to have a 6 point star rowel. The terminals have two circular holes with the remains of a hook attachment present in the rear hole on each side. One of these is more complete than the other and has a rectangular body with a possible ring loop attaching it to the terminal and a hook to attach it to the leather. The presence of surface plating was suggested by the X-ray and traces of a white metal (either silver or tin alloy) were observed on the flat plate of the attachment during cleaning. Similar possible traces were noticed between the spokes of the rowel. These traces were minimal and poorly preserved.
