ERECTION OF SINGLE STOREY EXTENSION TO REAR,
INTERNAL ALTERATIONS AND REPLACEMENT
OF GROUND FLOOR WINDOW,
8 ST JOHN STREET, BEVERLEY,
EAST YORKSHIRE

ARCHAEOLOGICAL OBSERVATION,
INVESTIGATION AND RECORDING

Report no: 2011/402.R01
Version: Final
Date: December 2012
Author: Ed Dennison & Kate Dennett

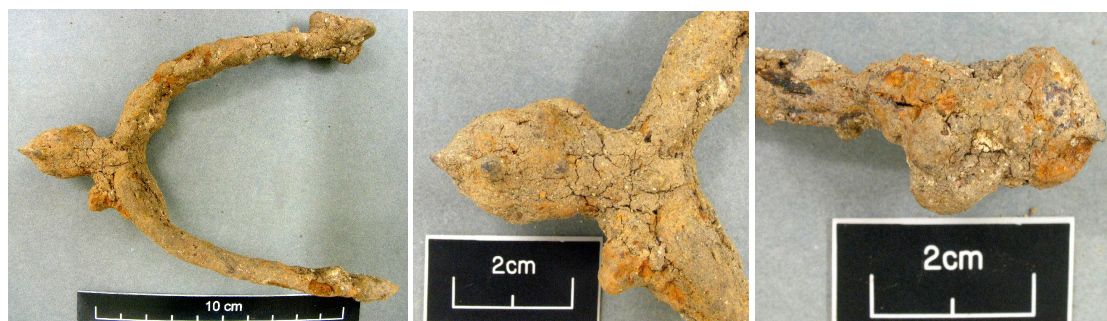
Assessment/Description: The spur was first X-rayed using standard YAT procedures and equipment. Two views of the spur were made on one sheet of film which was given a reference number in the YAT conservation laboratory series (X7906). Visual examination showed the spur to be in a good overall condition, although all detail was obscured by a thick crust of soil and bulky brown corrosion products. This crust was cracked in places especially along the arms but there was no sign of active corrosion occurring. Examination of the X-ray showed a fairly even, partially mineralised, metallic core to be present within corrosion layers, with heavier mineralisation towards the ends of the arms and at the terminals. A brighter outline within the corrosion on one of the terminals suggested the possible presence of plating.

Spur before investigation

Rowel before investigation

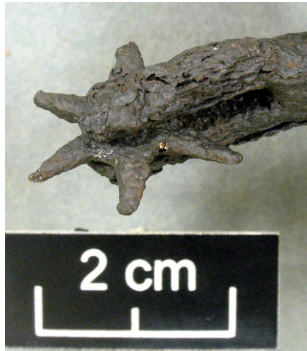
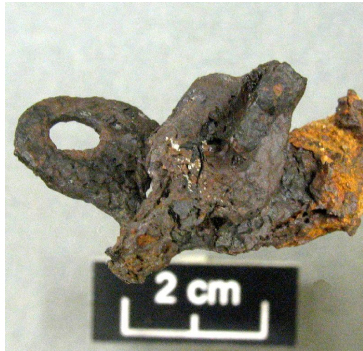
Investigation: The spur was found to have a 6 point star rowel. The terminals have two circular holes with the remains of a hook attachment present in the rear hole on each side. One of these is more complete than the other and has a rectangular body with a possible ring loop attaching it to the terminal and a hook to attach it to the leather. The presence of surface plating was suggested by the X-ray and traces of a white metal (either silver or tin alloy) were observed on the flat plate of the attachment during cleaning. Similar possible traces were noticed between the spokes of the rowel. These traces were minimal and poorly preserved.

Rowel after investigation

Terminal with attachment

Treatment: The overlying corrosion was removed from the terminals using air abrasive equipment with aluminium oxide powder. The fragile attached fitting was consolidated with 5% Paraloid B72.

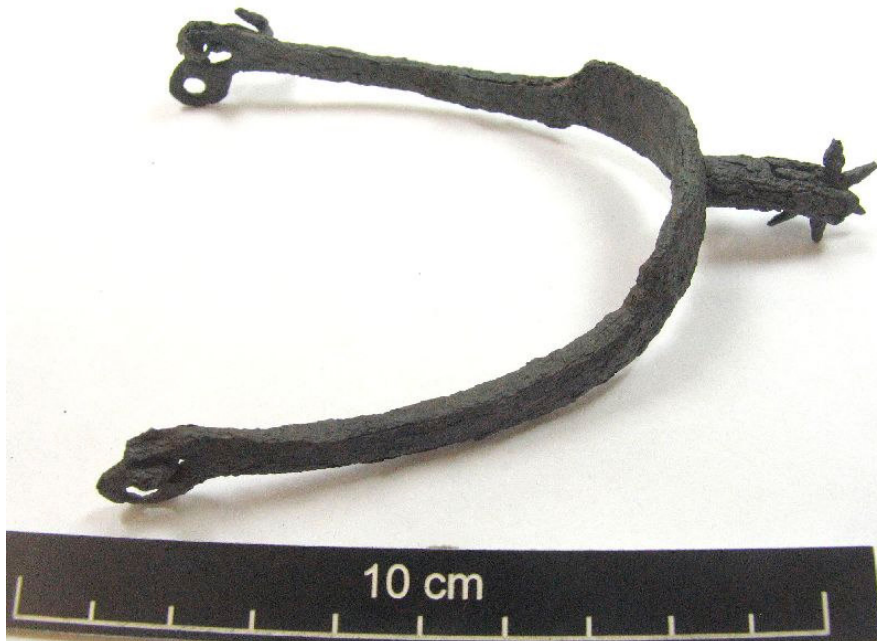
Following on from the previous investigation, total corrosion removal was requested for publication. This was carried out using air abrasion with aluminium oxide powder. 5% Paraloid B72 in acetone was pipetted into cracks and splits as a consolidant during cleaning, as required. Although a suggestion of plating was occasionally noticed within the corrosion crust, a coherent layer was not present.

After full corrosion removal
