FORMER GROSMONT IRONWORKS,
GROSMONT, NORTH YORKSHIRE

ARCHAEOLOGICAL OBSERVATION,
INVESTIGATION AND RECORDING

Report no: 2012/438.R01
Version: Final
Date: November 2012
Author: Ed Dennison

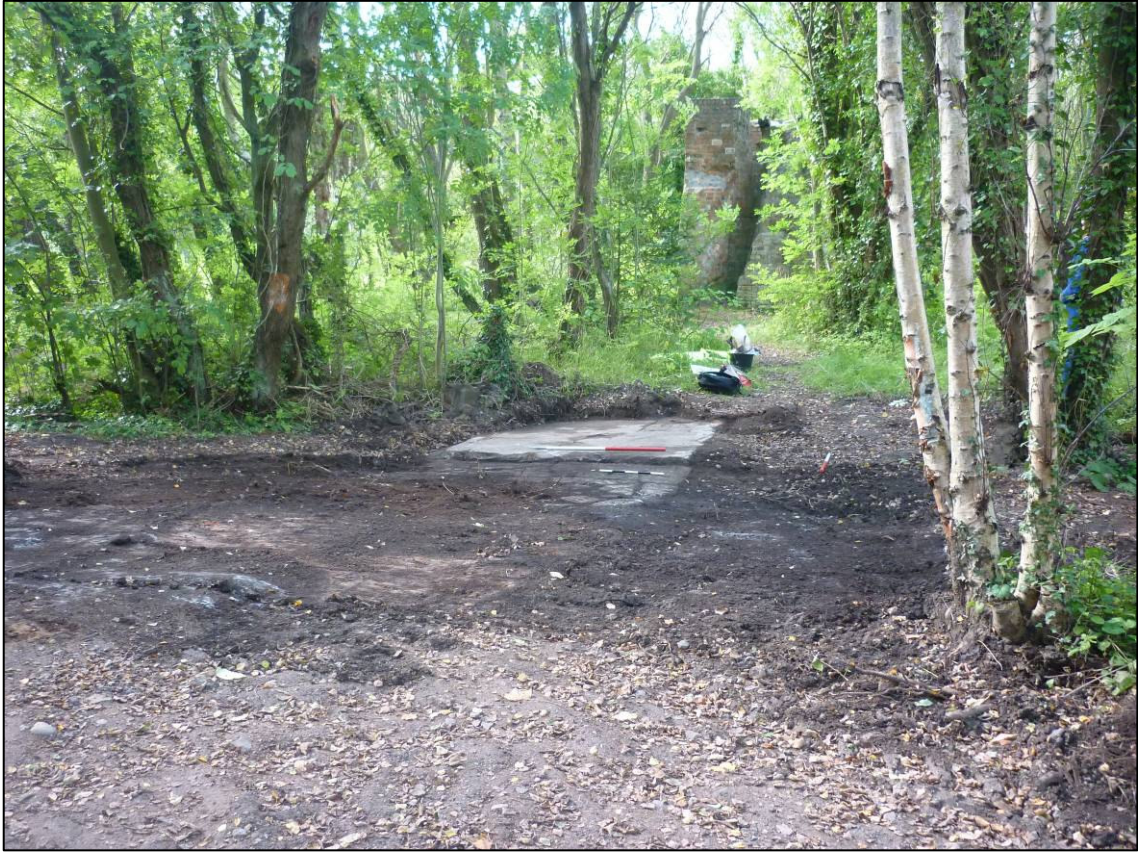
Plate 1: Re-excavated area and concrete base, looking SW.

- 4.1 The principal structure exposed within the re-excavated area was a concrete base or bed (see plate 1). This base was set c.2.50m to the north-east of another rectangular concrete base or bed, which measured c.1.50m long by 0.90m wide and had the remains of bolts to the corners, noted during the previous 2007 survey (see figure 3 and Appendix 1). This base was set on a north-east/south-west alignment, and the newly-exposed concrete base recorded during the current survey shared the same alignment, although it was of somewhat larger size.

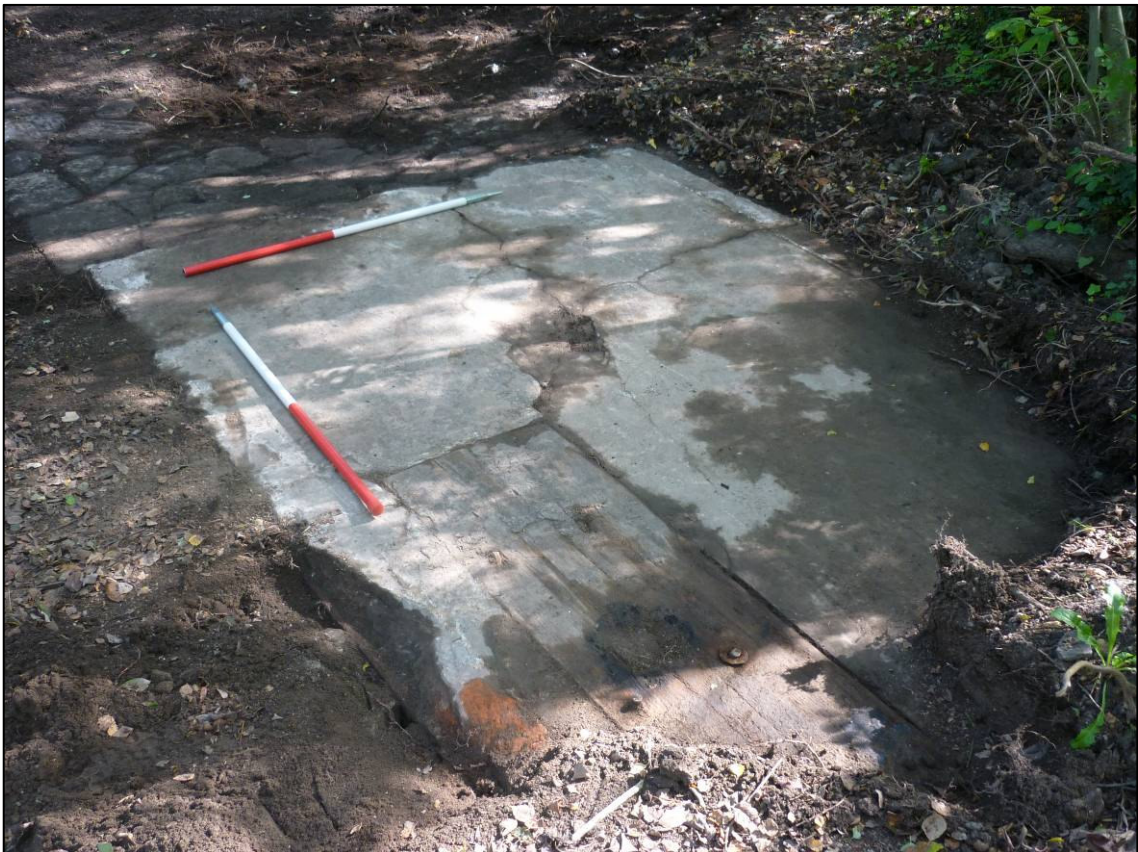
Plate 2: Exposed concrete base, looking E.

- 4.2 The new base was not fully exposed, but it had a maximum length of 2.90m and was 2.12m wide (see plate 2 and figure 4). A short section towards the western end of the northern edge had been damaged in the past, necessitating a repair using a flat wrought-iron bar presumably bolted to it. Probing between the bar and the edge of the concrete base indicated that there was a void below, c.1m in depth, but is not known whether this represents the depth of the base itself (i.e. the tape sliding down against the side of the base through a void in rubble heaped against it) or merely the depth of adjacent loose rubble.

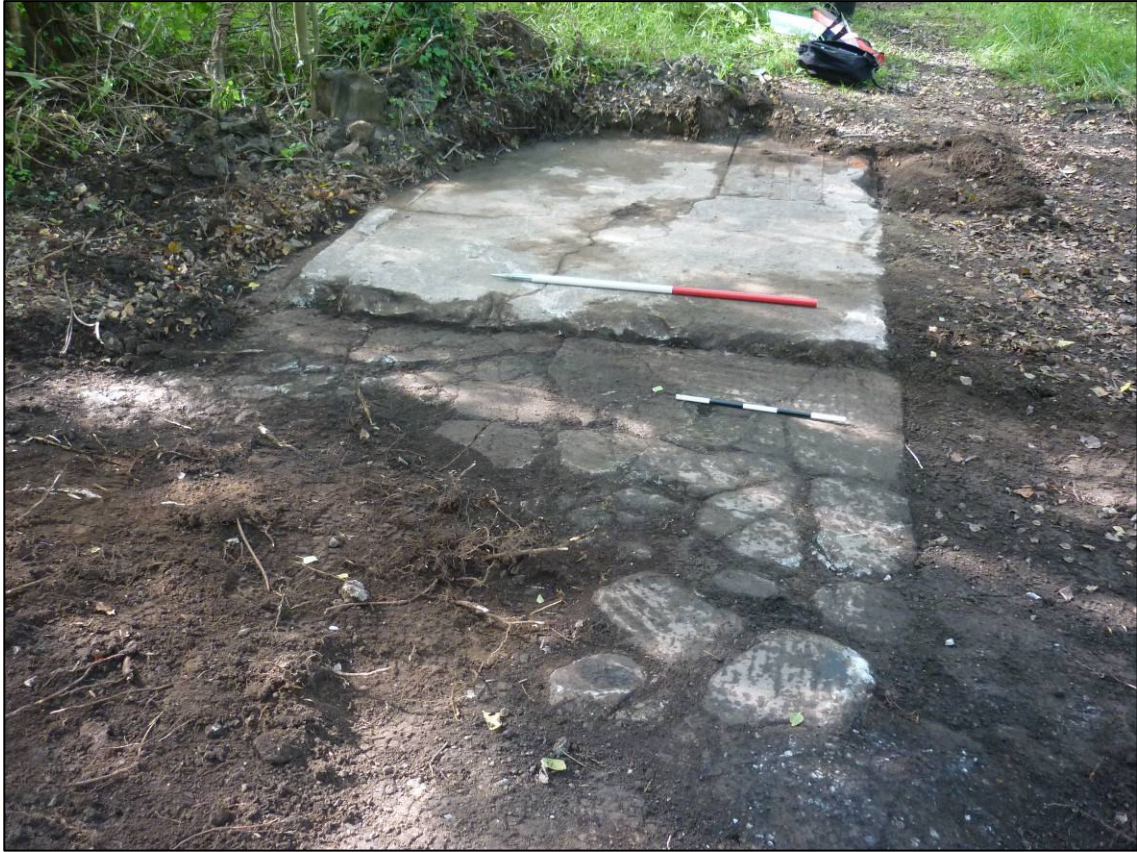
Plate 3: Exposed concrete base and fractured concrete surface, looking SW.

- 4.4 Around the concrete base, in the base of the re-excavated area, the exposed ground surface was generally a compacted dark-brown silt soil, with inclusions of brick rubble and mortar, much disturbed by tree roots. To the immediate east of the base, there was a small area of fractured concrete, formerly a surface (see plate 3). Beyond this, there were two small areas of modern tarmac, the remnants of surfacing for the adjacent track which passed through this area.
- 4.5 No other archaeological remains were noted within the area where the surface had been 'bladed off', but here the ground reduction had generally been much shallower than in the re-excavated area.

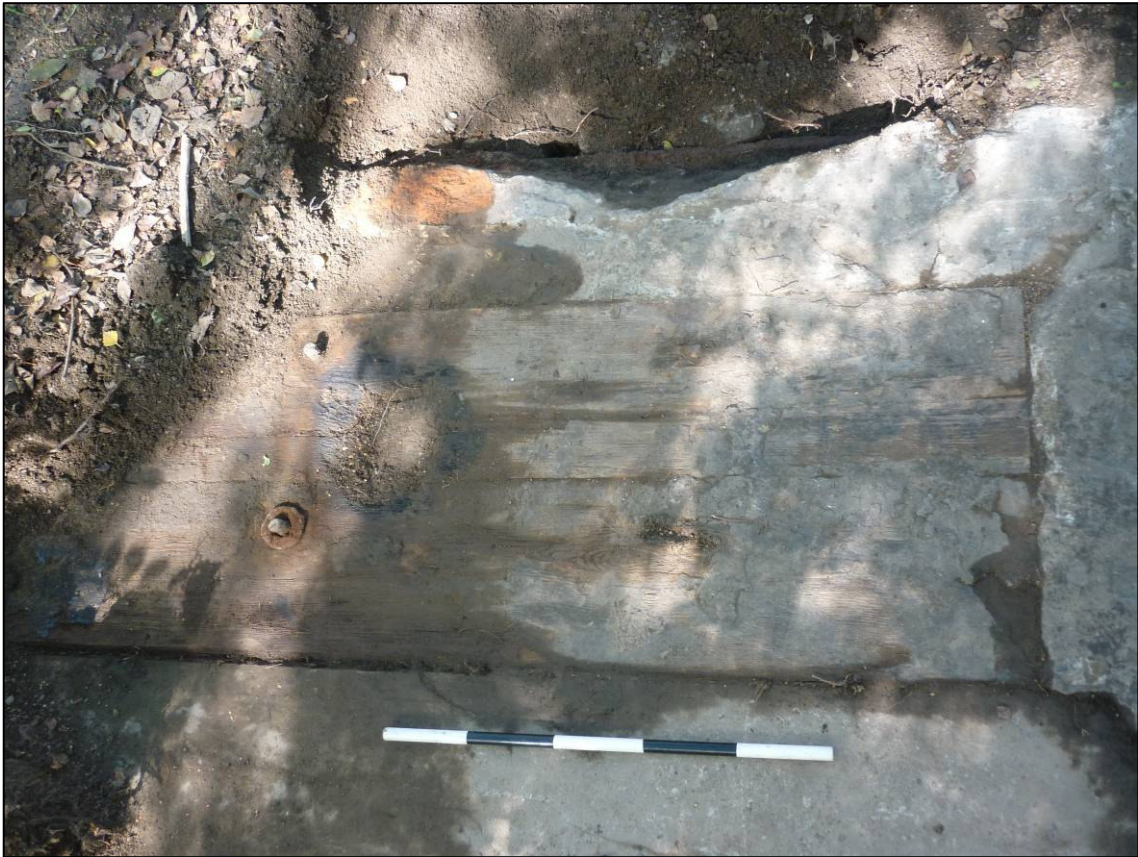
Plate 4: Timber in concrete base.

width (c.0.15m). The bricks had almost all been removed, but the mortar that had once fixed them to the base remained. Adjacent to the area of damage noted above, a large timber resembling a railway sleeper was set into the base, flush with its surface. This timber retained traces of four circular bolts arranged in a rectangular pattern (see plate 4). Each bolt was originally 0.025m in diameter, and each projected the same distance above the surface of the base; several retained traces of a washer 0.055m in diameter, and all were presumably once threaded. Close to the western pair, there was a sub-circular area of bitumen staining to the timber, with a similar, sub-oval area of staining to the west of the bolts. Away from the timber, the remains of a fifth bolt were visible in the approximate centre of the eastern side of the base, with a small rectangular impression to the south.
