EXTERNAL DRAINAGE WORKS,
ALL SAINTS' CHURCH, HELMSLEY,
NORTH YORKSHIRE

ARCHAEOLOGICAL OBSERVATION,
INVESTIGATION AND RECORDING

Report no: 2012/420.R01
Version: Final
Date: December 2012
Author: Ed Dennison & Katie Keefe

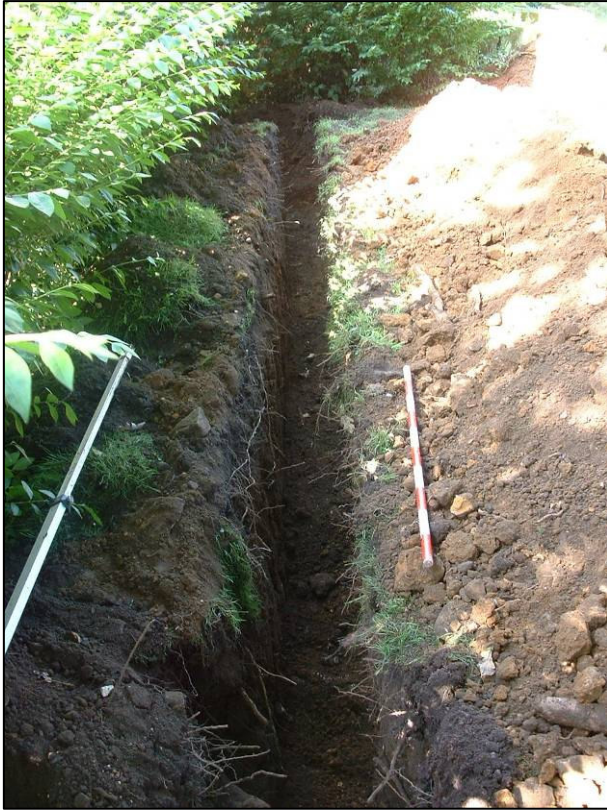
Plate 1: Trench 1 running north from vestry, looking north.

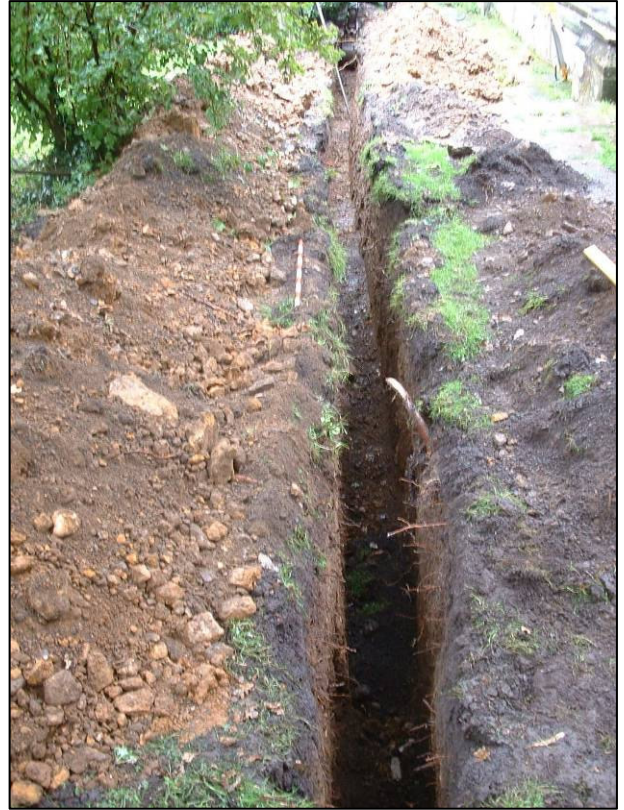
Plate 2: Trench 1 running south on east side of vestry, looking south.

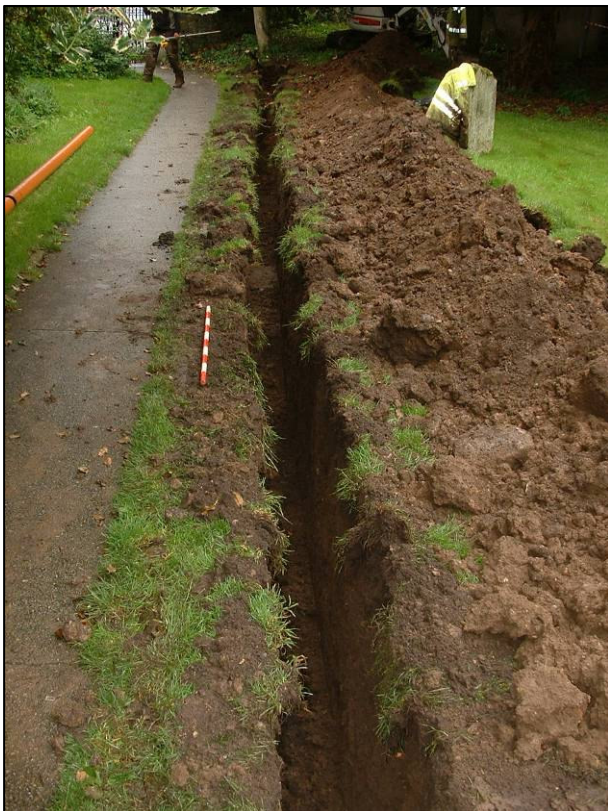
Plate 3: Trench 1 running south on west side of path, looking south.
