ERECTION OF SINGLE STOREY EXTENSION TO REAR  
FOLLOWING DEMOLITION OF EXISTING,  
9-10 ST JOHN STREET, BEVERLEY,  
EAST YORKSHIRE

ARCHAEOLOGICAL OBSERVATION,  
INVESTIGATION AND RECORDING

Report no: 2011/403.R01  
Version: Final  
Date: May 2012  
Author: Ed Dennison & Kate Dennett

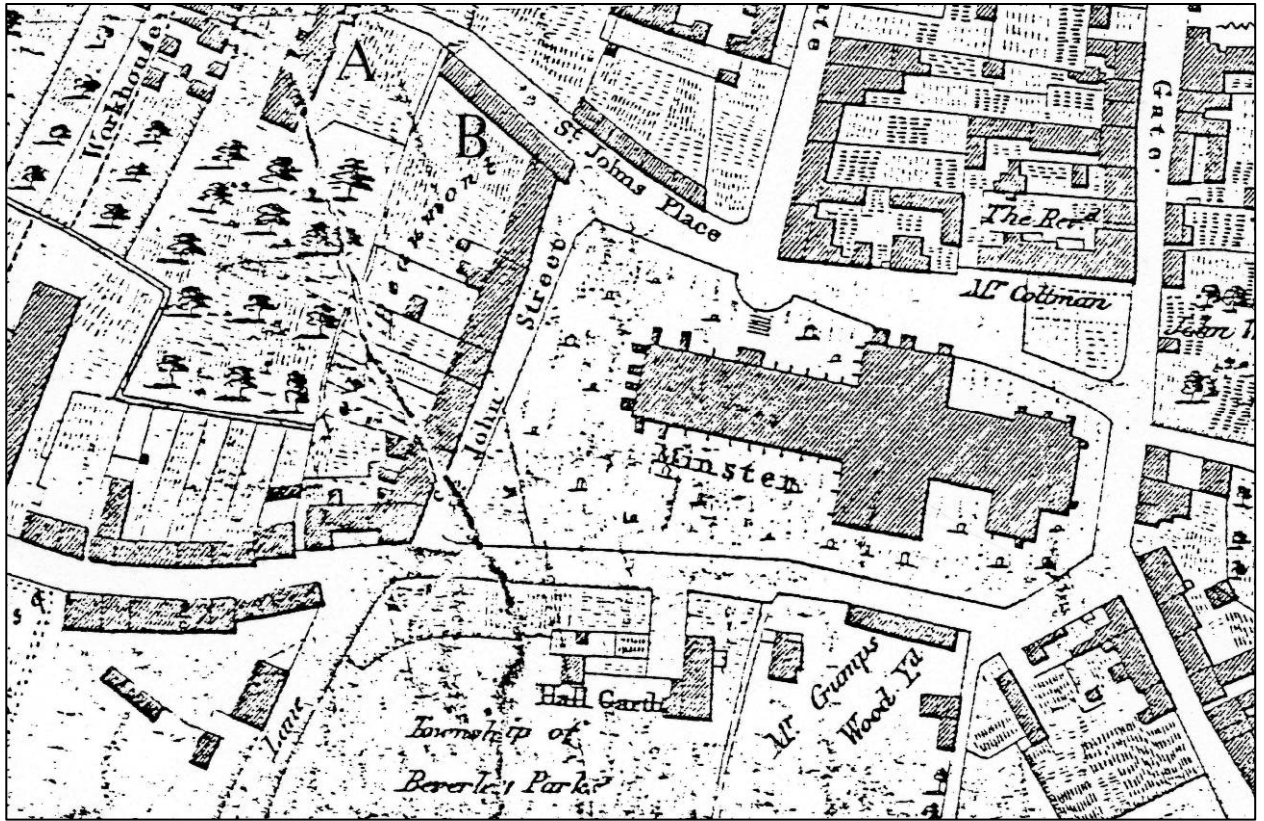
PROJECT 9-10 ST JOHN STREET, BEVERLEY	
TITLE HISTORIC MAPS	
SCALE NTS	DATE MAY 2012
EDAS	FIGURE 5

Top: John Wood's plan of Beverley, 1828.  
 A = Croft's tannery (early 18th century).  
 B = Acklam's tannery (c.1770).  
 Source: Neave 1996.

Bottom: Ordnance Survey 1853 map, sheet 4,  
 5 feet to 1 mile.

- 4.7 The 1st edition Ordnance Survey plan of 1853 shows all the houses in St John Street (then named as St John's Street), together with the gardens and orchards to the rear of the street frontage properties (see figure 5). There are what appear to be two extensions to the rear of no. 10, but the more detailed 1890 Ordnance Survey plan shows that they are actually extensions to the rear of both nos 9 and 10 (see figure 6). The back walls of these extensions line up with the rear of no. 8, which means that the wider part of the former outbuildings demolished in the early 1980s was built at this time.

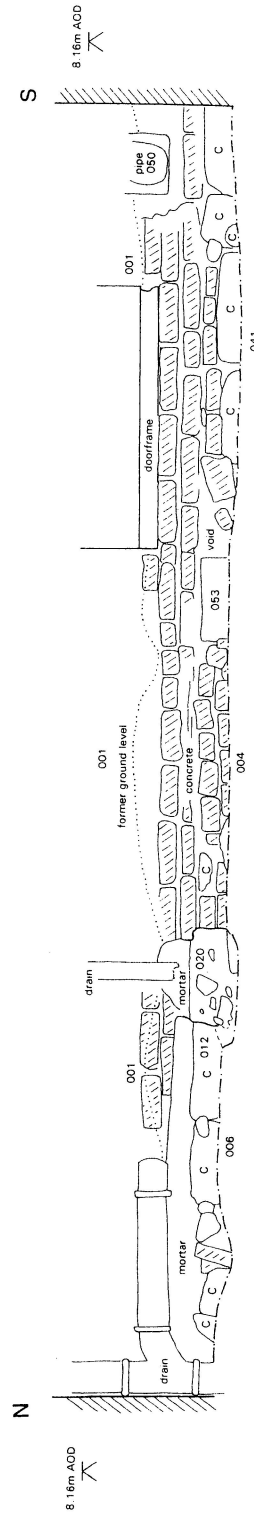
PROJECT	9-10 ST JOHN STREET, BEVERLEY		
TITLE	WATCHING BRIEF RESULTS		
SCALE	AS SHOWN	DATE	MAY 2012
	EDAS	FIGURE	7

- L1 = 8.05m AOD
- L2 = 8.20m AOD
- L3 = 7.43m AOD
- L4 = 7.80m AOD
- L5 = 7.51m AOD
- L6 = 7.95m AOD
- L7 = 7.75m AOD
- L8 = 7.69m AOD
- L9 = 7.77m AOD
- L10 = 7.62m AOD
- L11 = 7.87m AOD
- L12 = 7.68m AOD
- L13 = 7.41m AOD
- L14 = 7.81m AOD
- L15 = 7.97m AOD
- L16 = 7.46m AOD
- L17 = 7.65m AOD
- L18 = 7.51m AOD
- L19 = 7.65m AOD
- L20 = 7.71m AOD
- L21 = 7.58m AOD
- L22 = 7.64m AOD
- L23 = 7.62m AOD
- L24 = 7.72m AOD
- L25 = 7.46m AOD

Plan

Section 1: Back wall of No. 10

## 5 RESULTS FROM THE WATCHING BRIEF (see figure 7)

- 5.13 The north-south aligned back wall of no. 10 (001), measuring 4.82m long, is of brick construction, laid in an English Garden wall bond (one course of headers and three or four courses of stretchers). The excavations showed that the lower part of

the south end of the wall (2.66m long) rested on a heavy chalk foundation (041), projecting forwards (west) of the brickwork above by about 0.08m. The chalk blocks were roughly dressed, less than 0.82m long and up to 0.14m thick; the top of the chalk lay at 7.72m AOD, which was the same level as the brick-on-edge foundation (033) to the adjacent east-west boundary wall (048). A similar chalk foundation (006) was seen at the north end of the back wall of no. 10 which, although it was difficult to see due to the various modern drainage works, appeared to project less far forwards, perhaps only c.0.04m. Both lengths of chalk foundations (041 and 006) seemed to be contemporary, but the central 1.05m long section of the wall was composed of two courses of brick (004) which projected out (west) from the wall face above by 0.1m. The north side of the brickwork was disturbed by a vertical cut (012) for a drain pipe (007); the cut was filled with a firm yellow-brown sand (020) containing moderate amounts of small rounded gravel. The south side of the brickwork was marked by a single well-cut rectangular limestone block (053) 0.31m long; the top of the block lay at 7.73m AOD but it was not clear whether it was part of the original foundation or later infill. Adjacent to the brickwork (004) was a small patch of very firm yellow-brown clay (021).

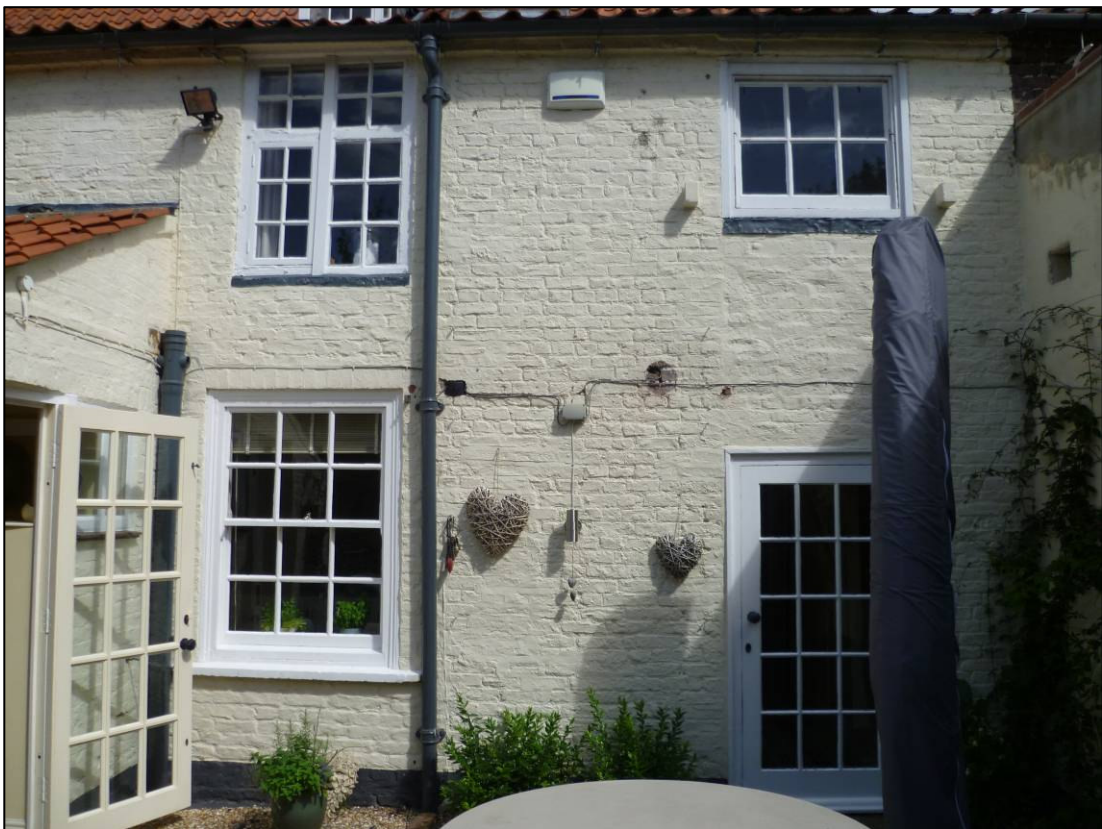
Plate 2: Rear wall of nos 9-10 prior to development, looking E.

- 2.4 The majority of the rear elevation appears to be built of handmade bricks (average dimensions 235mm by 110mm by 70mm), laid in a rough English garden wall bond

(three or four stretcher courses to each header course); the original bonding material is largely obscured by the whitewash (see plate 2). A small single storey addition to the north end probably dates to the early 20th century. To the south of this, to the ground floor, is a 12-pane (6 over 6) horned sash, and then an inserted modern doorway. To the first floor, there are smaller 9-pane and 6-pane windows to the north and south ends respectively. The north window has a blocking to its north side. Between these two is a wooden casement window of c.1700. If this is *in situ*, it may mark the position of the former main staircase to the c.1700 house, although there is little obvious surviving evidence in the rear (west) elevation of nos 9-10 to suggest that an earlier structure was incorporated here.

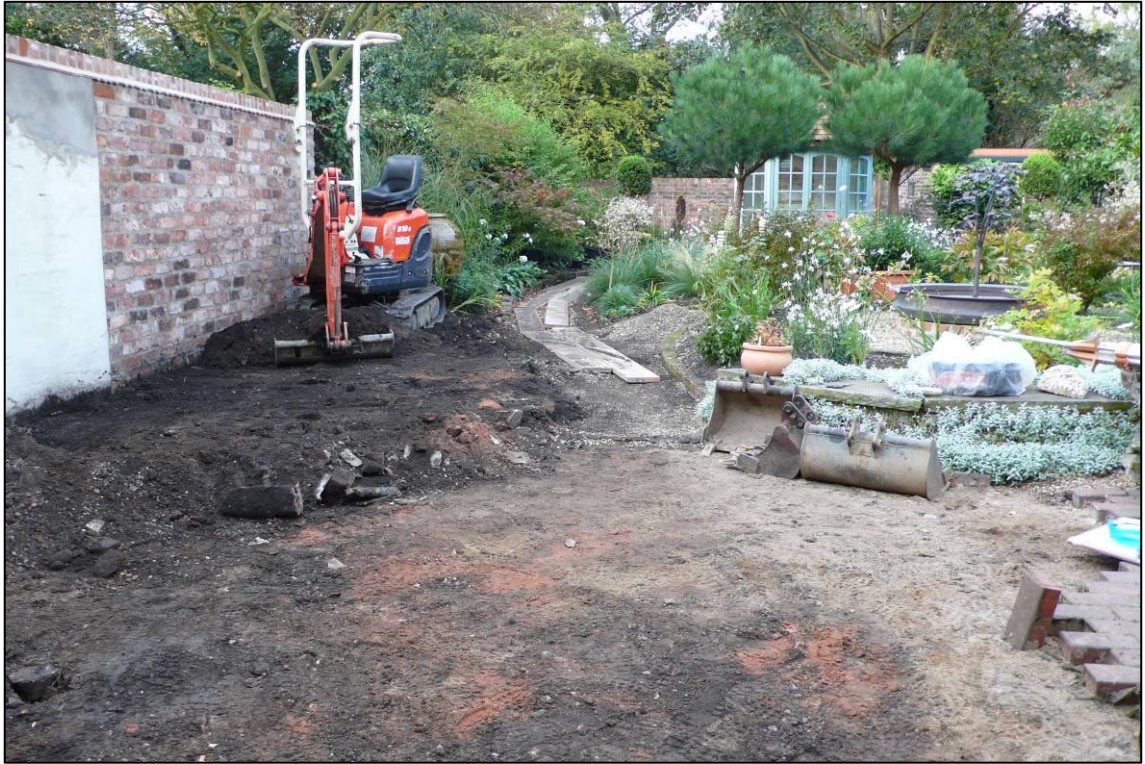
Plate 3: Topsoil strip in progress, looking W.

- 5.1 As noted in Chapter 3 above, the modern brick-paved patio (043) extending into the south corner of the development area, where the southern boundary wall (048) meets the rear wall (001) of the house, had been removed together with deposits beneath it, to a depth of between 0.3m and 0.4m, prior to the start of the watching brief (see plate 3).

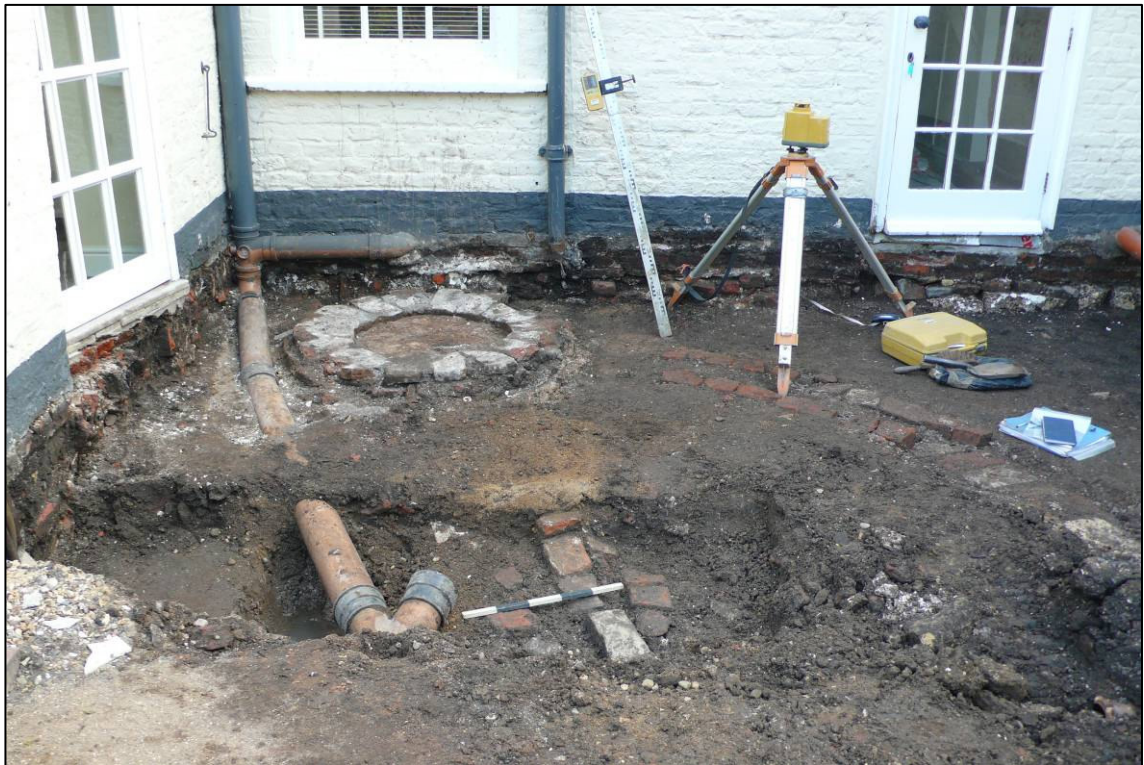
Plate 4: General view of site, looking E.

- 5.8 The top of a circular well or cistern (008) was exposed by the topsoil strip immediately adjacent to the back wall of no. 10 (see plate 4). The circular collar was c.1.20m in diameter and no more than 0.40m thick overall, composed of at least two courses of brick laid as stretchers pointing inwards; the upper course slightly overlapped the lower course to create a slightly corbelled effect (see plate 7). The apparently handmade bricks were wide and thin, measuring 240mm long by 132mm wide and 44mm-50mm thick, and may have been reused. They were set in a lime mortar although the upper parts had a more modern cement mortar on top. A third outer course of bricks appeared to have been present originally but it had been damaged by the insertion of the modern drainage pipe trenches (005 and 007) on either side. The top of the brickwork lay at 7.73m AOD, and it was not possible to determine if the collar had originally risen any higher. The opening was infilled to within c.0.30m of the top of the bricks, the infill being covered by a deposit of the distinctive firm orange/brown sand (009) with occasional gravel also seen over the brick footings (019) further to the west. Two small voids or holes (051 and 052) were noticeable on opposite sides of the well/cistern, passing through the surrounding soil (014), and the immediate surrounding area sounded very hollow when the surface was trowelled. These holes, more than 0.27m deep and at an approximate 45° angle, might simply be rat holes, but it is perhaps more likely that they represent localised collapse of the corbelled roof of a cistern; the holes were not investigated further as they lay beneath the required excavation depth for the development.

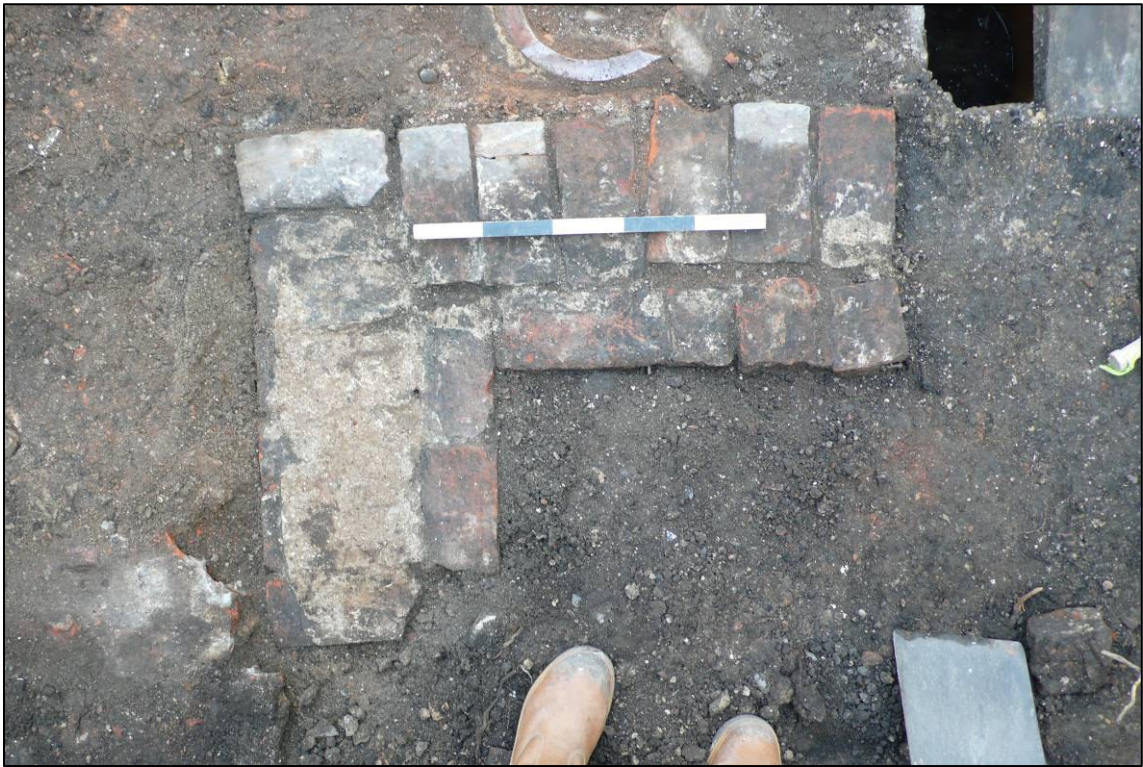
Plate 5: L-shaped brick foundation (019) from above.

- 6.2 A number of the structural elements, for example a small area of concrete (038) and an L-shaped brick wall foundation (019) and another short length of north-south aligned chalk and brick foundation (013/022), remain from the former outbuildings to the rear of no. 10, demolished in the 1980s. The various historic maps show that these outbuildings were built in two phases - the wider eastern end had been built by 1853, but the narrower western two cell range is post-1890 in date. The L-shaped foundation (019) is part of the later range while the north-south aligned foundation is earlier. It might be that this wall is actually of two phases, with the chalk blocks (013) forming part of the early 19th century extension and the brick (022) being part of a later post-1890 rebuild.

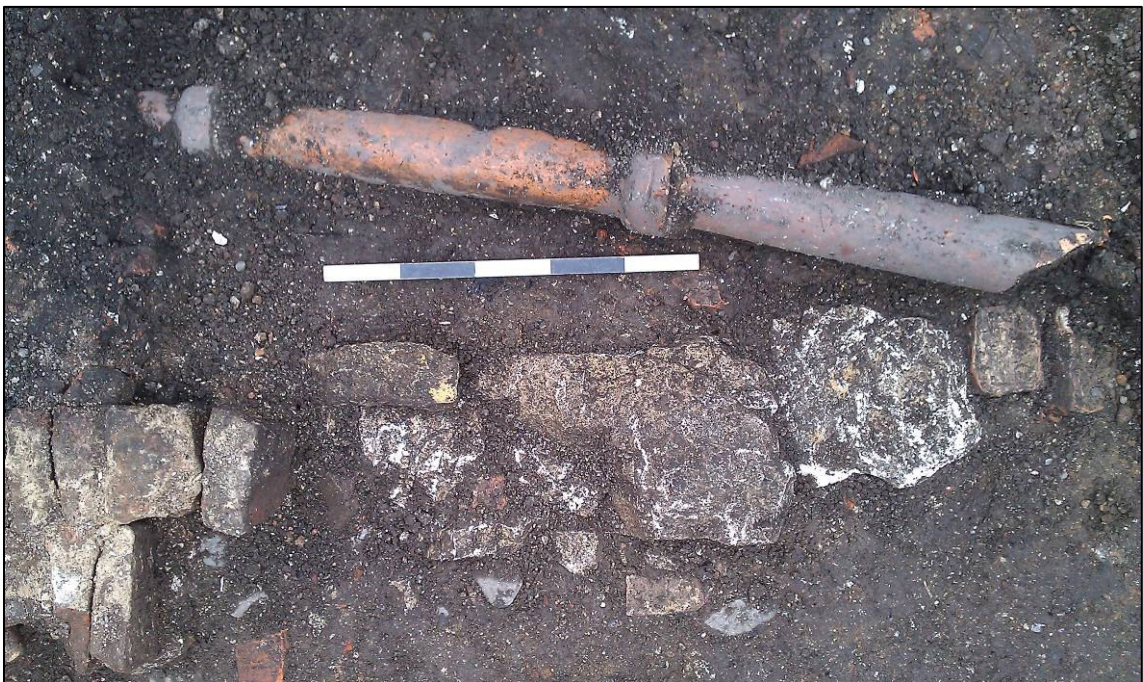
Plate 6: Chalk foundation (013) and brick foundation (022) from above.

- 5.7 The remains of a wall foundation (013), 0.90m long and up to 0.30m wide comprising one course of roughly shaped chalk blocks c.0.22m thick and the occasional brick and limestone fragment, were exposed in the easternmost part of the new foundation trench (see plate 6); the top of the foundation lay at 7.68m AOD and its north end had probably been truncated by the modern pipe trench (005). Partly overlying the south end of the chalk foundation was a c.1.0m long alignment of handmade brick and half bricks set on edge (measuring 260mm long, 48mm wide and 60mm thick) (022) set with a lime mortar; the top of the bricks lay at 7.87m AOD. Below this was a small area of firm brown gritty soil (027), which was probably the same as the grey-brown gritty background soil (014) seen elsewhere on the site. It appeared that the bricks (022) and chalk blocks (013) were part of the same foundation, although the mechanical method of excavation meant this could not be precisely determined. This north-south wall foundation was in the correct position and had the right alignment to be part of the end wall of the wider part of the former outbuildings demolished in the 1980s; however, the wall could actually be of two phases, with the chalk blocks perhaps forming part of an earlier structure.

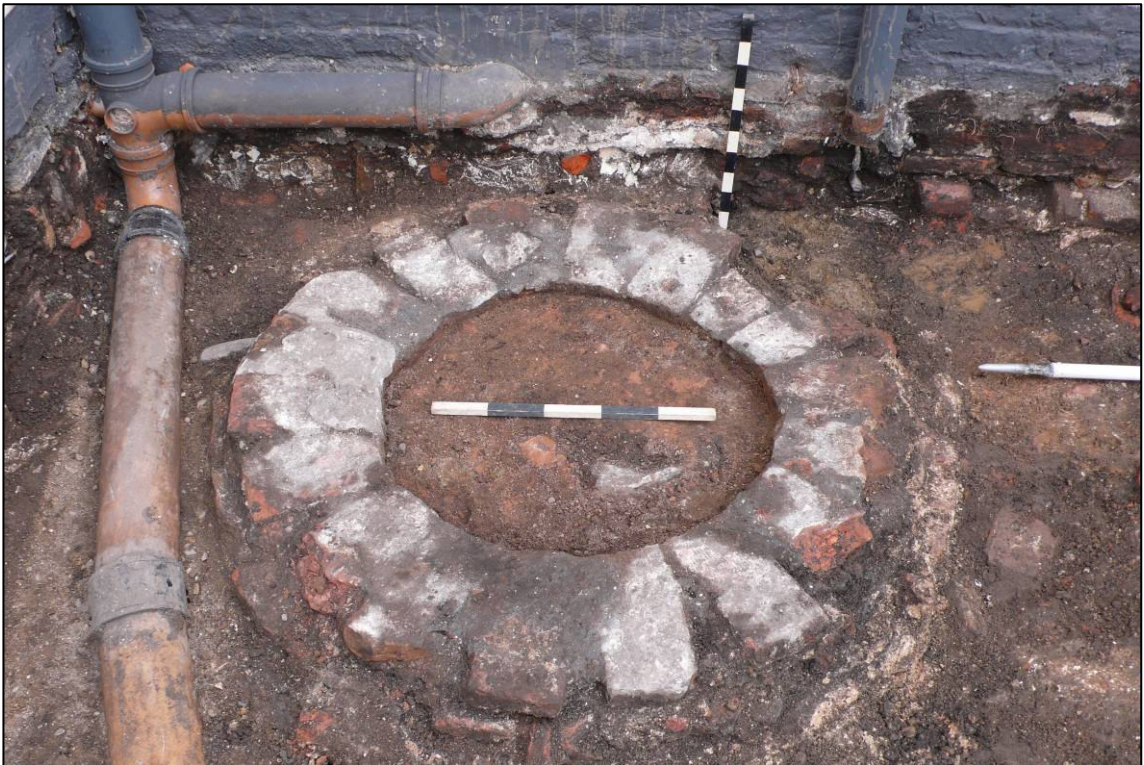
Plate 7: Well or cistern (008), looking E.

- 6.4 The fact that the collar of the well or cistern (008) was slightly corbelled, that there were two small voids (051 and 052) adjacent to it, and that the whole area sounded very hollow when trowelled, all suggest that this structure is a 19th century cistern or water tank rather than a straight-sided well. These water tanks are commonly found behind houses or in rear yards in Beverley (Rod Mackey, *pers. comm.*; e.g. Dennison 2006), as well as in agricultural and ecclesiastical contexts (e.g. Dennison & Dennett 2006; Richardson & Dennison 2007). They were used to store rainwater gathered through guttering and downpipes to ensure a constant supply of 'softwater' for domestic or day-to-day use. The position of the water tank means that it would have laid in the small open yard between the later extensions to the rear of nos 10 and 9, while the curving culvert (010) was within the extension to no. 10; the presence of the water tank may well be the reason that the rear extensions were not continuous. It is possible that the water tank was constructed in 1853, when there are records of the well to the rear of no. 10 being 'opened out and cleansed' (see Chapter 4 above). However, the apparently handmade bricks forming the collar of the tank were wide and thin, and so they may have been reused from an earlier, perhaps even late medieval, well lying in the same position but further to the rear of the narrower 17th century and earlier house represented by nos 9 to 11.

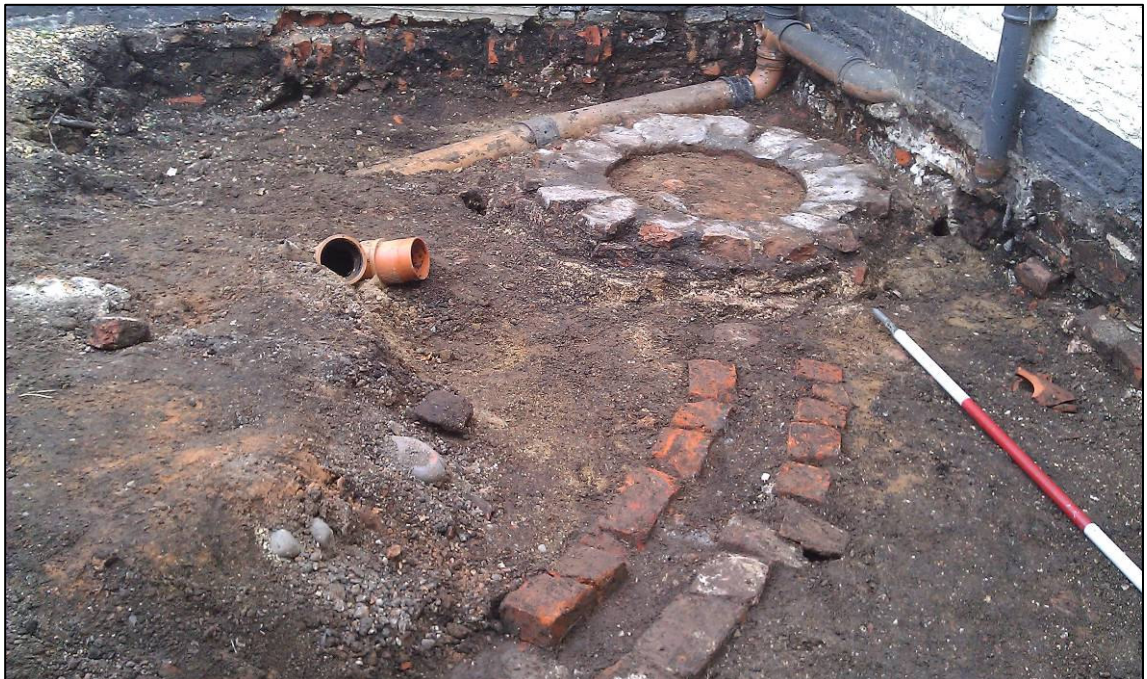
Plate 8: View of well or cistern (008) and brick drainage channel (010), looking N.

- 5.9 Also exposed by the topsoil strip within the area of the proposed new extension was a brick drainage gully (010), 0.42m wide and 3.10m long, running on a curving alignment south-west from the well/cistern (008) (see plate 8); the bricks measured 232mm by 111mm by 62mm. According to the levels taken, it sloped from 7.77m

AOD at the south-west end to 7.64m AOD at the north-east end, i.e. it was draining towards the well/cistern. The gully was formed by two lines of parallel bricks set on a single brick base, which itself was bedded on lime mortar. The base was cut into the general grey-brown gritty background soil (014), the vertical sided cut (049) appearing to continue right up to the southern edge of the well/cistern (008), although the bricks immediately adjacent to it were not present and they may have been removed by the insertion of the modern drainpipe (007). The gully was covered at its south-west, higher, end by a 0.52m wide sloping stone slab (026) and it had probably been truncated beyond that point by the insertion of a modern ceramic drain (015/016) and the settling drain (023) noted above. It is assumed that the brick drainage gully (010) was originally capped along its whole length with slabs, and that it channelled rain water into the well/cistern although the entry point was not evident within the depth of excavation required for the new extension. The gully was filled with a firm brown fine silt (011), less than 0.65m deep, which contained a relatively large quantity of small animal bones (mostly avian, together with some sheep and pig teeth, and butchered cow and sheep bone fragments), probably representing domestic waste, as well as small fragments of CBM, window glass, fragments of iron nails and a small brass reinforcing ring.
