ERECTION OF ONE DWELLING, DETACHED GARAGE  
AND ASSOCIATED ACCESS,  
LAND SOUTH OF EASTFIELD, 33 NETHERGATE,  
NAFFERTON, EAST YORKSHIRE

ARCHAEOLOGICAL OBSERVATION,  
INVESTIGATION AND RECORDING

Report no: 2010/378.R01  
Version: Final  
Date: December 2012  
Author: Ed Dennison

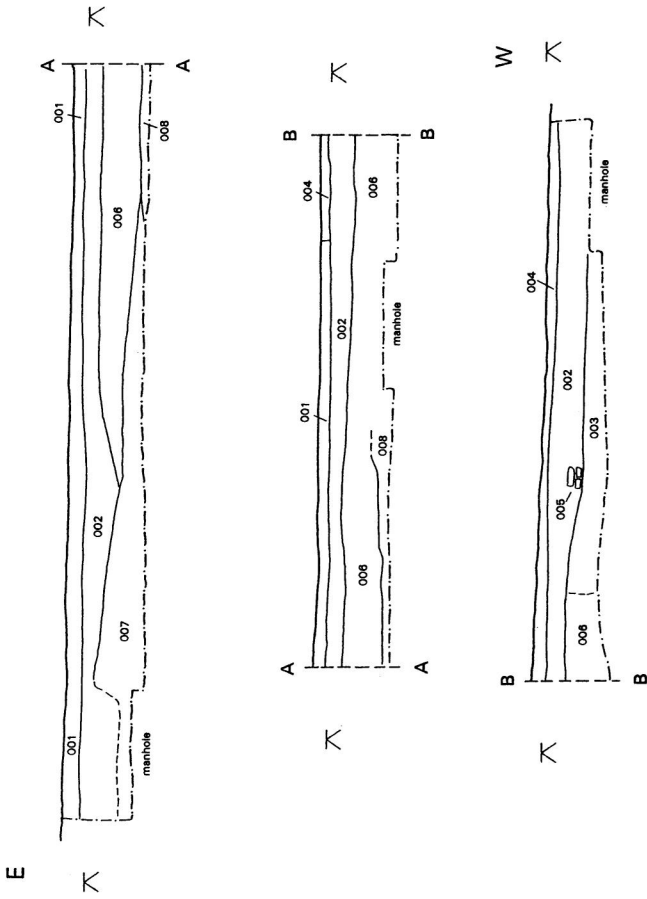
Section 1: south side of drainage trenches

- 5.5 The existing modern brick manhole chamber on the edge of the road was exposed, and a trench was excavated through the roadside verge in a north-east direction (Trench 1) (see plate 1). The trench was 4.50m long and 0.45m wide, and it was excavated to a maximum depth of 1.20m BGL. The same sequence of deposits as seen in the adjacent topsoil strip was observed throughout the trench. Beneath the 0.20m deep turf and topsoil (001), the same dark brown compacted clayey silt with chalk inclusions (002) was observed to a depth of 0.65m BGL. This overlay a clean, stiff reddish-brown clay (003), which continued below the base of the trench. Where the trench was scraped slightly deeper, the clay started to become rather gritty and contained fragments of chalk. The trench was discontinued after a distance of 4.50m from the manhole chamber due to the number of north-south aligned services which were encountered during its excavation, which made the positioning of the sewer pipe at the planned depth very difficult. At the west end of the trench, a modern plastic gas pipe (without overlying safety tape) was encountered at 0.90m BGL. To the east, there was a 0.15m diameter ceramic clay drain, the top of which was set 0.60m BGL. Finally, at the eastern end of the observed section, there was a modern electricity cable set at 0.60m BGL.

- 5.7 A similar sequence of deposits was observed throughout the whole of the new sewer trench alignment. Within the western manhole chamber pit, the uppermost deposit was a 0.15m deep layer of modern compacted gritty dark brown sand (004), used as the base for the hardstanding here; this was replaced by the turf and topsoil (001) beyond the hardstanding to the east. The sand/turf and topsoil (001/004) overlay a band of the same dark brown clay silt (002) as described above. This deposit was present throughout the whole of the trench, but its depth became shallower as it moved east, from over 0.60m deep at the west end to less than 0.20m towards the east end. Between the western and central manhole pits (Trench 2), the clayey silt (002) overlay a 0.40m wide concentration of chalk rubble (005). This rubble was aligned on the south-east corner of the adjacent house (no. 33), but was visible only in the south side of the trench; it may represent part of a structure of unknown dimensions and origin. The base of the rubble was set on the surface of the same stiff reddish-brown clay (003) observed above. This clay continued beneath the base of the trench at its western end, but in Trench 2 it merged imperceptibly into a mid-brown gravelly silty sand (006). This had an average depth of 0.70m, and could be traced east for much of the length of the trench, eventually becoming shallower and fading out close to the eastern manhole pit. Between the central and eastern manhole pits (Trench 3), the silty sand (006) was observed to overlay a clean light brown/orange sand (007). The surface of this deposit rose in height further to the east, but it had been badly disturbed within the eastern manhole pit due to the construction of the earlier brick chamber. In Trench 3, the silty sand (006) was seen to overlie a hard reddish-brown clay (008)

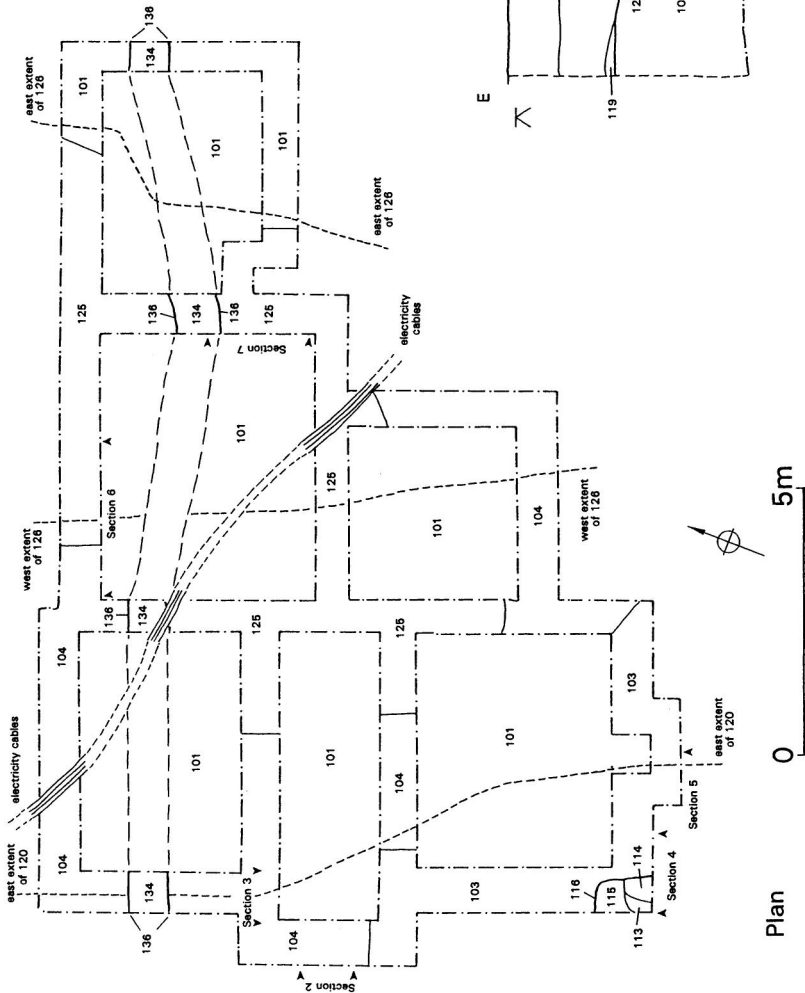
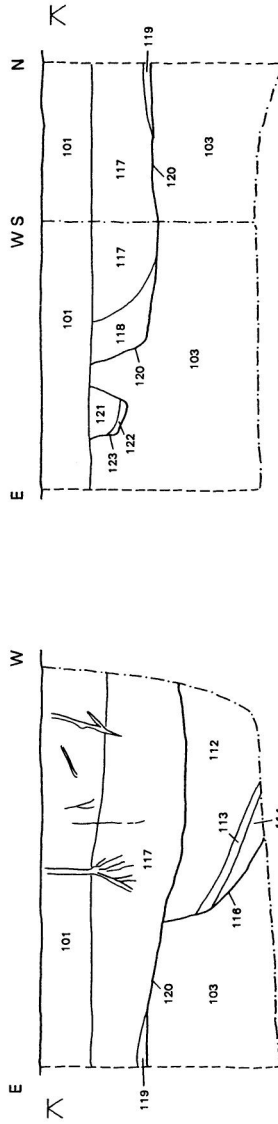
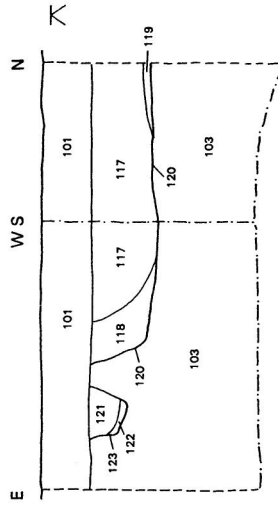
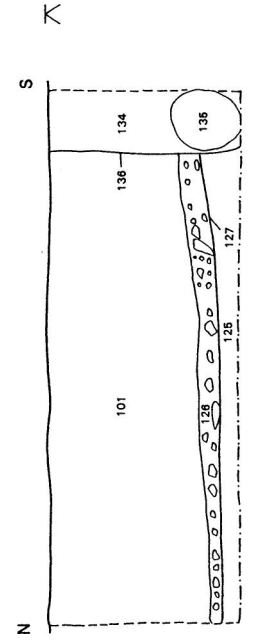
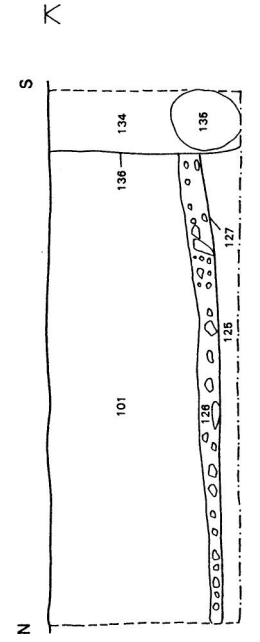
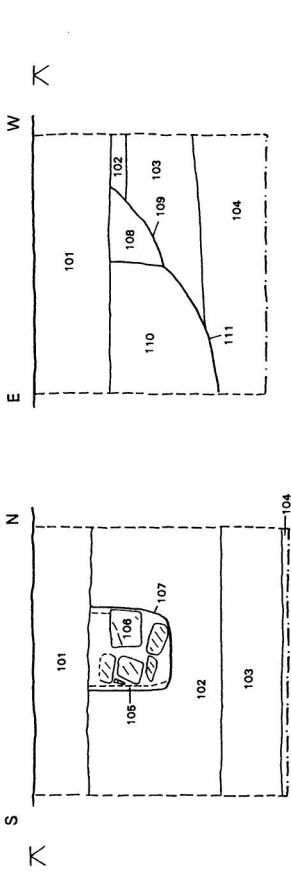
PROJECT	NETHERGATE, NAFFERTON		
TITLE	HOUSE FOUNDATIONS		
SCALE	AS SHOWN	DATE	DEC 2012
	EDAS	FIGURE	5

- 5.9 As noted above, the L-shaped area covered by the new house foundations measured 17.50m east-west by 12.00m north-south, and the trenches were typically 0.70m wide and up to 0.85m deep (see plate 3).

- 5.13 In the centre-north of the site, along the northernmost foundation trench, a chalk-lined pit or more likely a culvert (133) was identified (see Section 6 and plate 4). Although only seen in section, it was presumed to be a linear feature, and it measured 1.52m wide (east-west) and 0.42m deep. The west side was sharply defined but the east side was perhaps initially overcut as there was a thin layer of a soft mid-light green/blue grey clay (131) 0.04m thick in the flat base, over which an amount of dark grey-brown silty clay and chalk rubble (132) had been deposited. Chalk slabs were then laid against the rubble to form a solid central channel or culvert within which an alternating series of soft silts (130 and 128) was formed, separated by a 0.05m thick band of gravel (129). The lower deposit (130) and the gravel (129) appeared to be waterlain, with the uppermost deposit (128) possibly representing a deliberate dump. It seems that the 0.40m wide concentration of chalk rubble seen in the south side of the surface water sewer trench (005, see above) represents the northern continuation of this culvert.

- 5.16 A sub-rectangular pit (116) was recorded cutting into the natural gravels (103; see below) in the south-west corner of the foundations (see Section 4 and plate 5). Only a partial profile in plan and section of this feature was recorded as it extended to the west and south beyond the limit of excavation; the visible part measured 1.05m north-south by 0.60m east-west and at least 0.40m deep, and it lay 0.55m BRGL. The pit contained several fills - the basal fill was a soft dark grey/brown very silty sand with occasional charcoal flecks (115) while the secondary fill was mid-yellow/brown slightly silty sand containing small amounts of gravel and chalk (114); both appeared to be deliberately deposited. Overlying these deposits was a thin off-white/grey-brown gravel band (113), 0.03m thick, which could have resulted from flooding or waterlogging. The main overlying dark silt fill, a very dark grey sandy silt (112) more than 0.28m thick, contained a rim sherd in a fine sandy fabric with sparkling refractive sand (not mica); it had an upright rim with external bevel, and was from a handmade jar, and could either be Iron Age or early Anglo-Saxon in date (see Appendix 2). This deposit also contained one fragment of animal bone and a fragment of daub which may have been used in an oven or hearth (see Appendix 2). Overlying the pit (120) and its various fills was the compacted mixed yellow/off-white and mid-grey/brown gravel-based deposit (117), representing the fill of the wide linear depression (120) noted above.

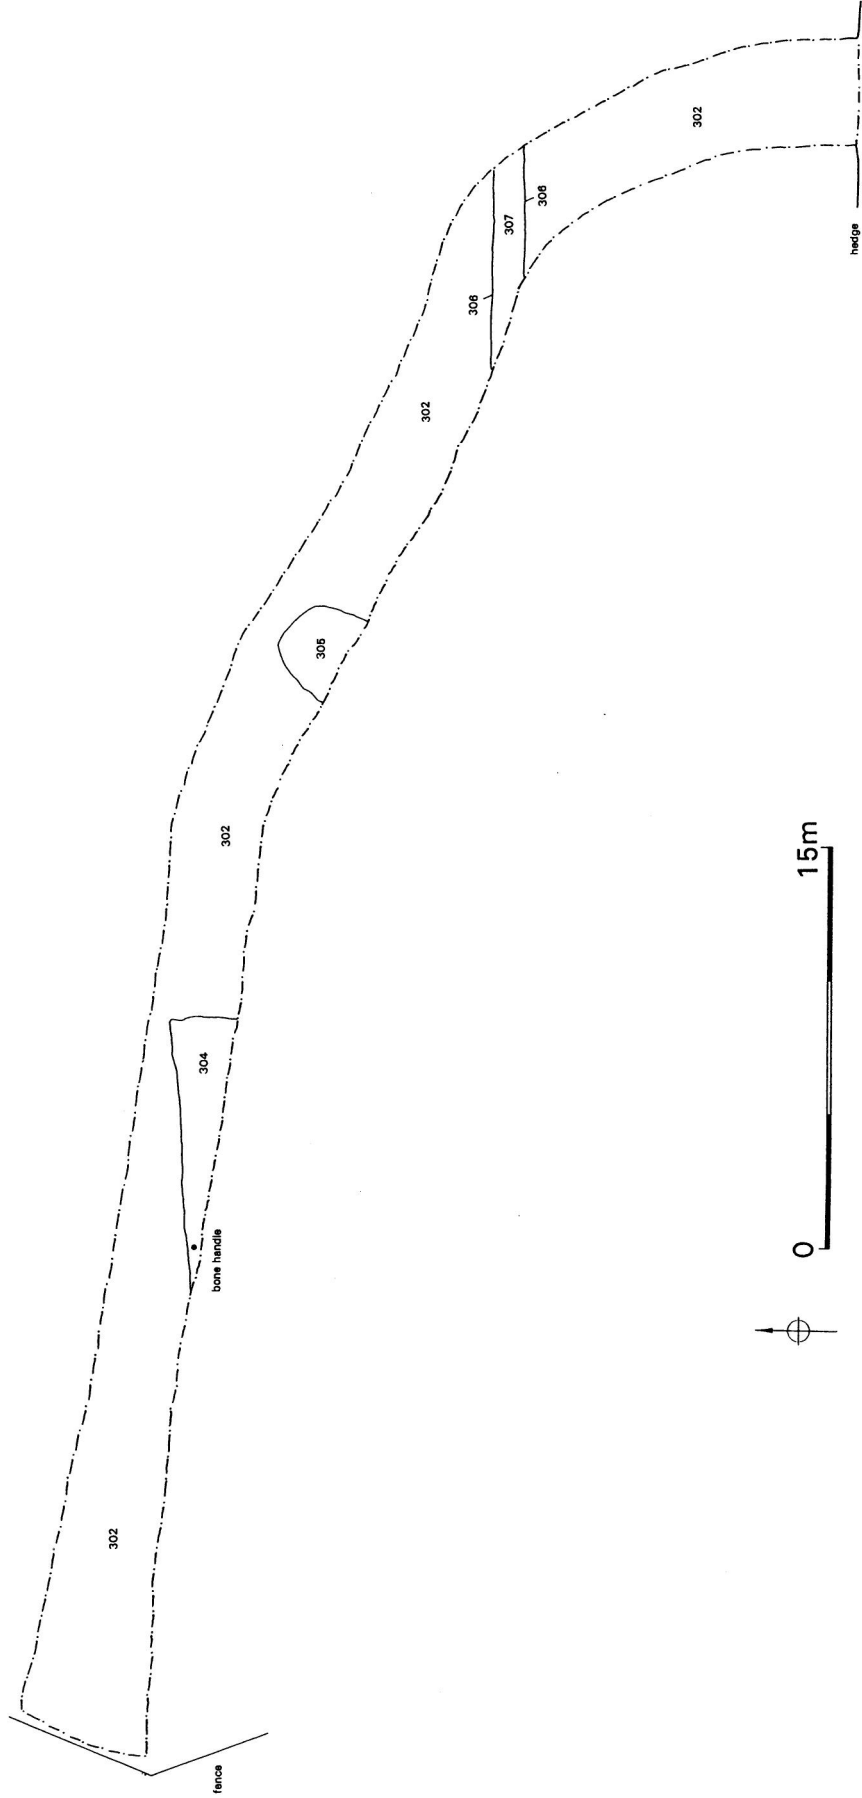
PROJECT	NETHERGATE, NAFFERTON		
TITLE	ACCESS ROAD		
SCALE	AS SHOWN	DATE	DEC 2012
	EDAS	FIGURE	6

### **Phase 3 Access Road** (see figure 6)

- 5.20 The area subject to the topsoil strip for the new access road running east from the north-east corner of the development plot measured 70m long by on average 3.20m wide (although it was up to 4.00m wide at either end), and the depth of excavation reached 0.25m (see plate 7).

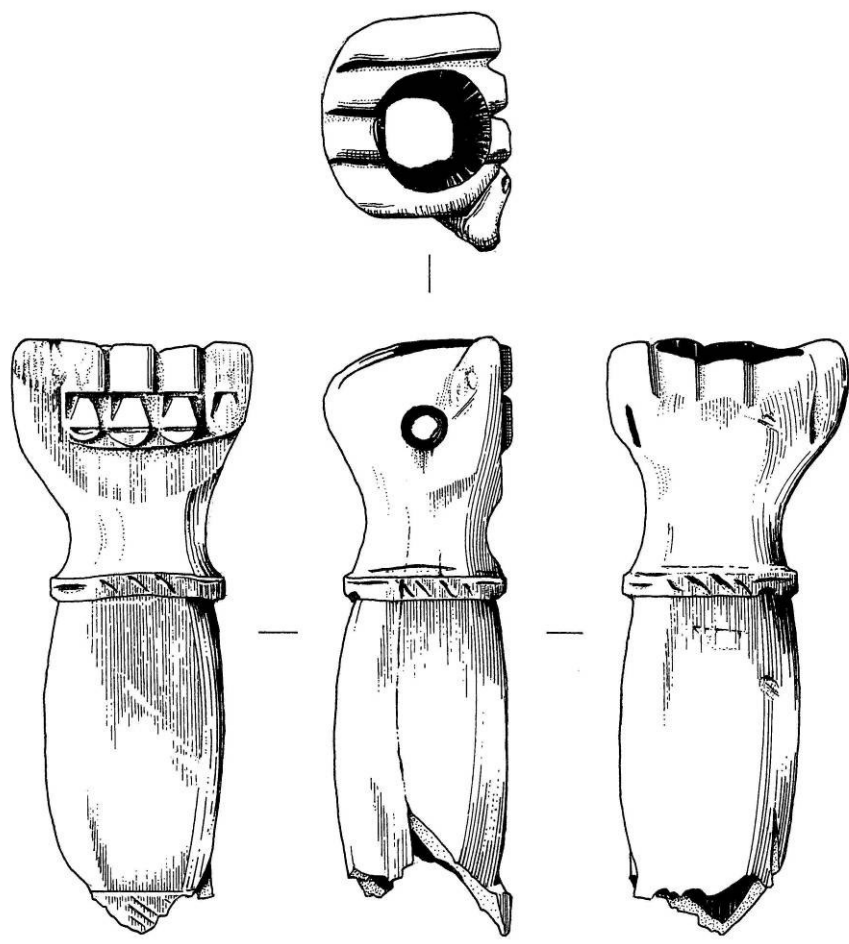
PROJECT		NETHERGATE, NAFFERTON	
TITLE		BONE HANDLE	
SCALE	AS SHOWN	DATE	DEC 2012
EDAS		FIGURE	7

There were no significant archaeological deposits observed in the surface water sewer trench. The only possible man-made feature that was recorded, a concentration of chalk rubble (005), probably represents a continuation of a chalk-lined culvert (133) that was seen further to the south in the house foundations. Little of significance was identified in the groundworks for the Phase 2 garage foundations and Phase 3 access road, probably due to the limited depth of excavation, although a mid 18th-mid 19th century bone walking cane handle found during the topsoil strip is of passing interest.

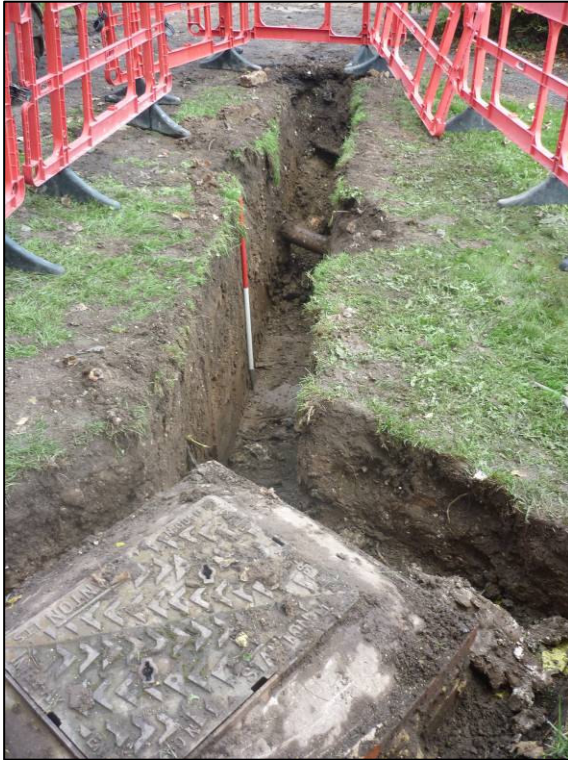
Plate 1: Trench 1, looking NE.

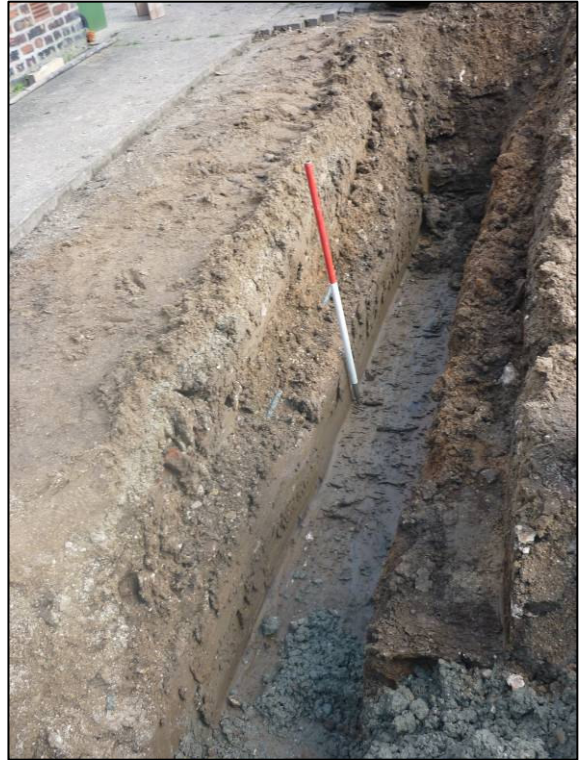
Plate 2: Trench 3, looking E

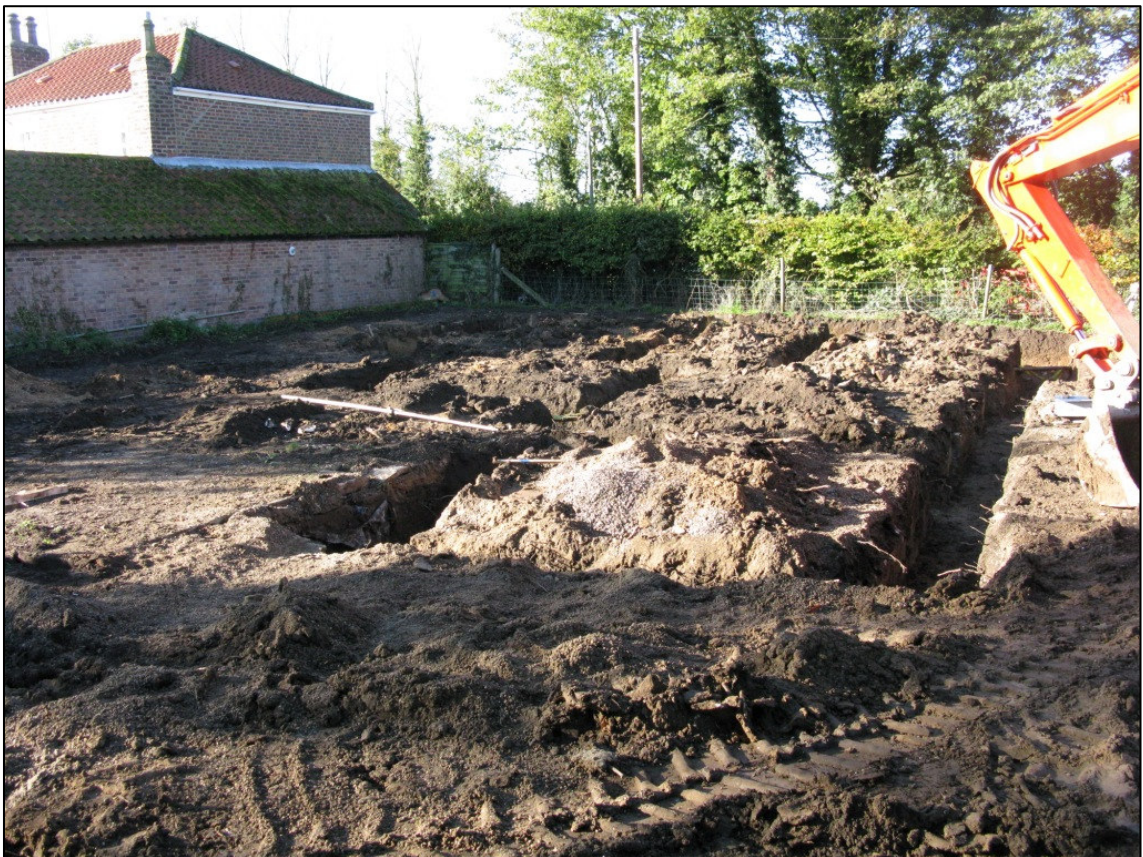
Plate 3: General view of Phase 2 house foundations under excavation, looking SW.

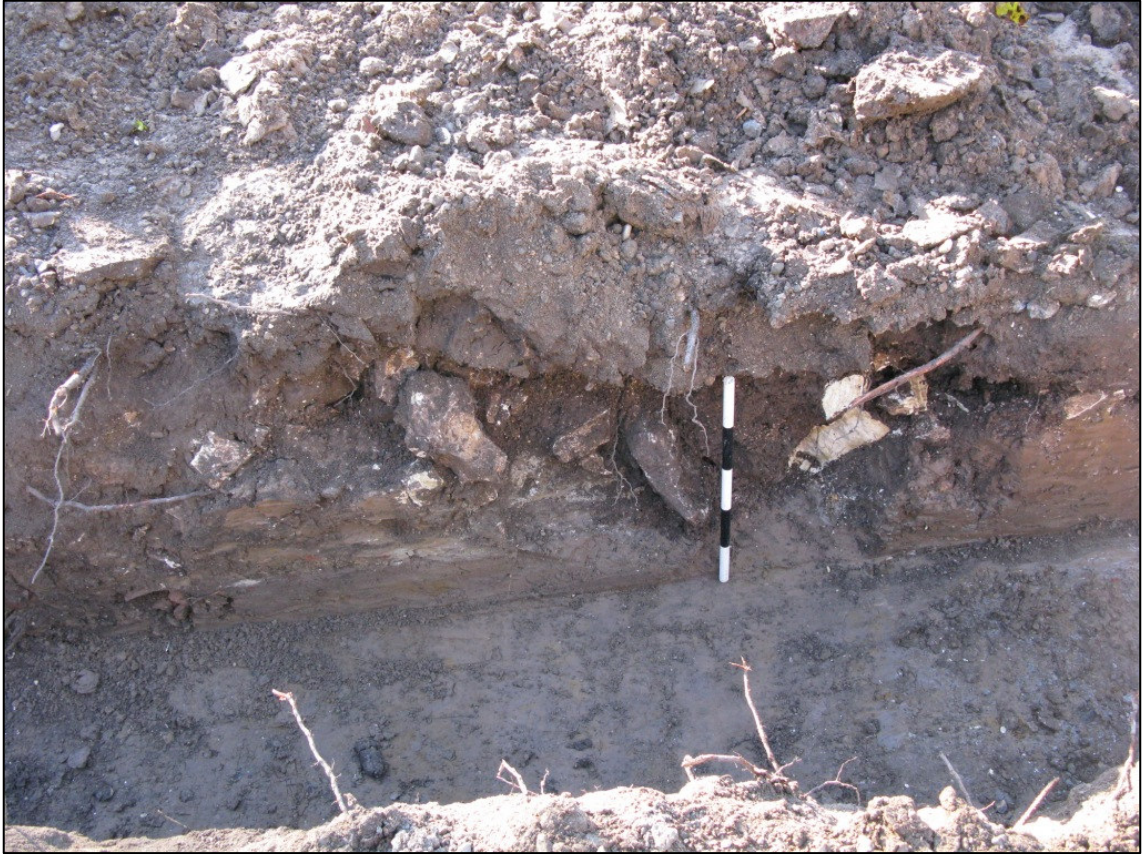
Plate 4: Chalk-lined culvert (133), looking S.

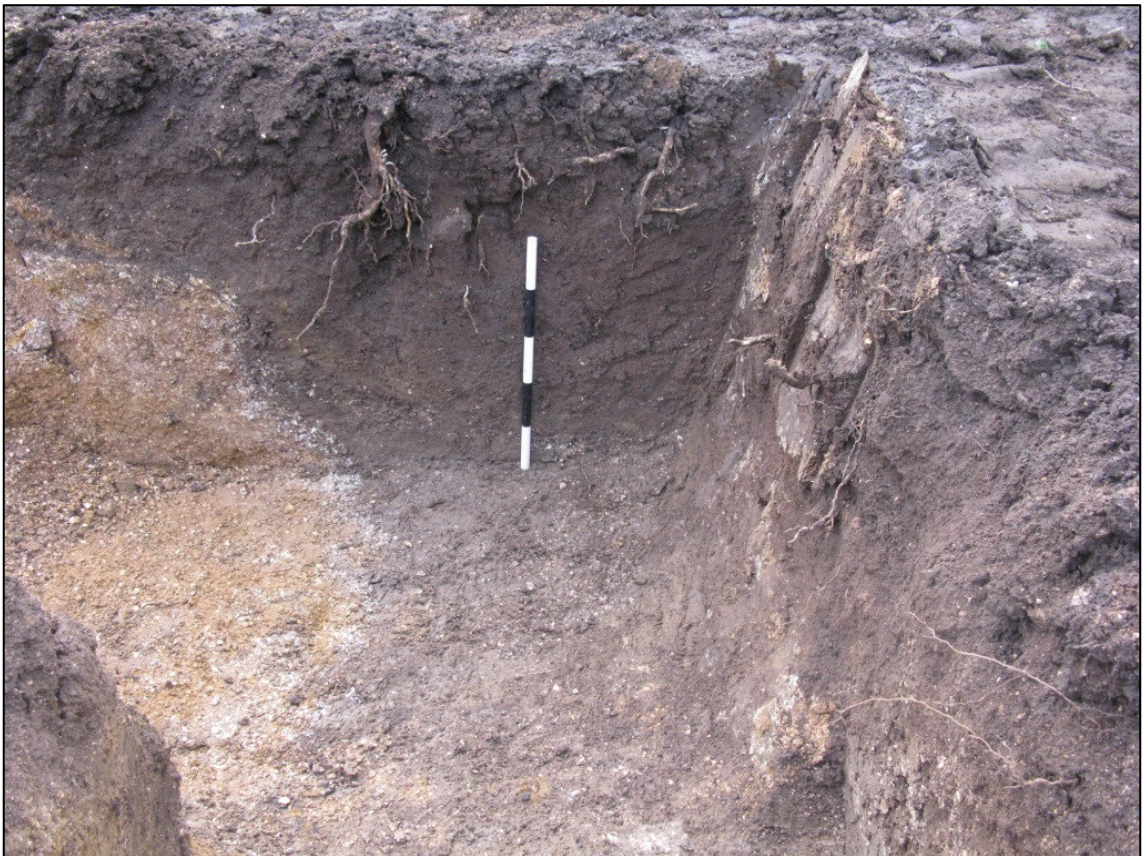
- 6.3 A piece of either Iron Age or more likely early Anglo-Saxon pottery was recovered from the upper fill (112) of a sub-rectangular pit (116) cut into the natural gravels (103) in the south-west corner of the foundations. This deposit also contained one fragment of animal bone and a piece of daub which may have been used in an oven or hearth, and the nature of the basal and secondary silt-based fills (115 and 114) of the pit implied a deliberate construction. There is evidence of Anglo-Saxon

Plate 5: Pit 116, looking S.

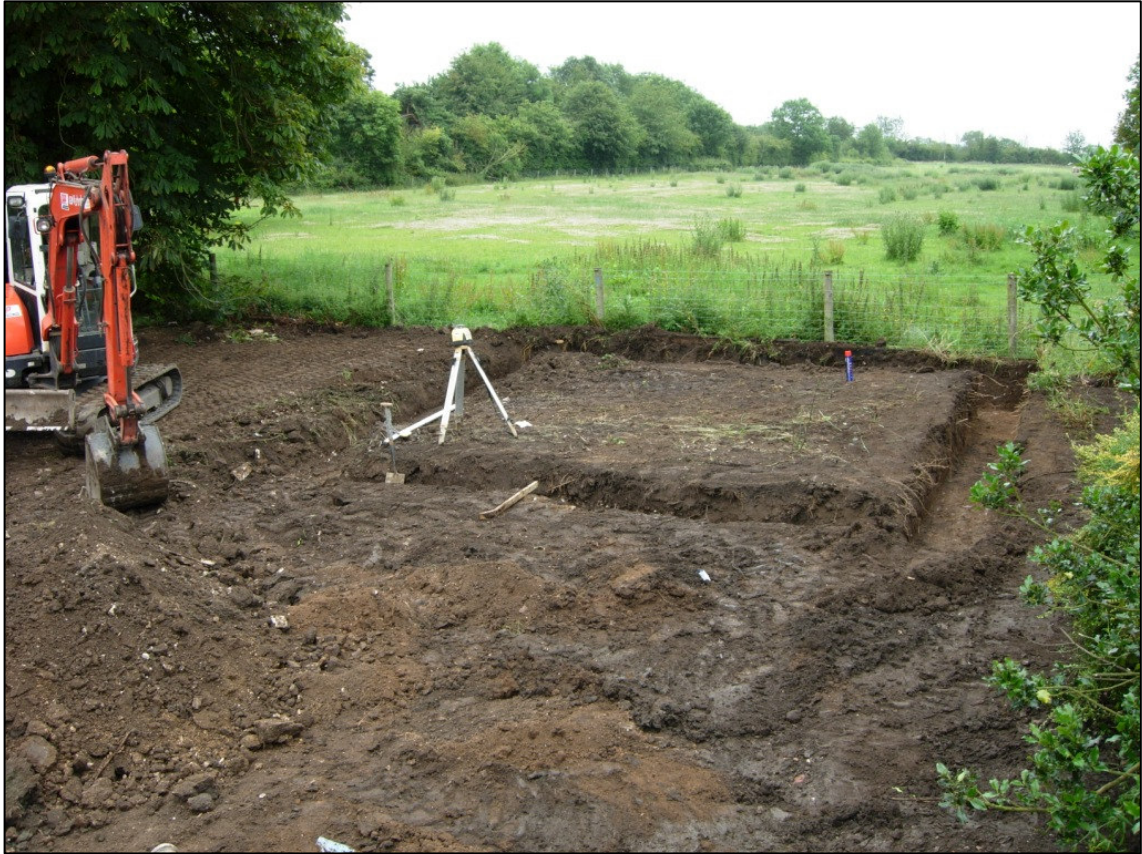
- 5.18 The foundations for the new garage covered an area measuring 6.50m north-south by 6.90m east-west, located in the south-east corner of the development site (see plate 6). The depth of excavation varied from 0.35m on the west side to 0.60m on the east side. No archaeological features were observed in these trenches - the 0.15m thick dark grey/brown topsoil (201) overlay a dark brown sandy silt subsoil (202) up to 0.35m thick, below which was a dark orange/brown silt clay with pea gravel inclusions (203) exposed in the base of all the trenches.

Plate 6: Phase 2 garage foundations, looking E.

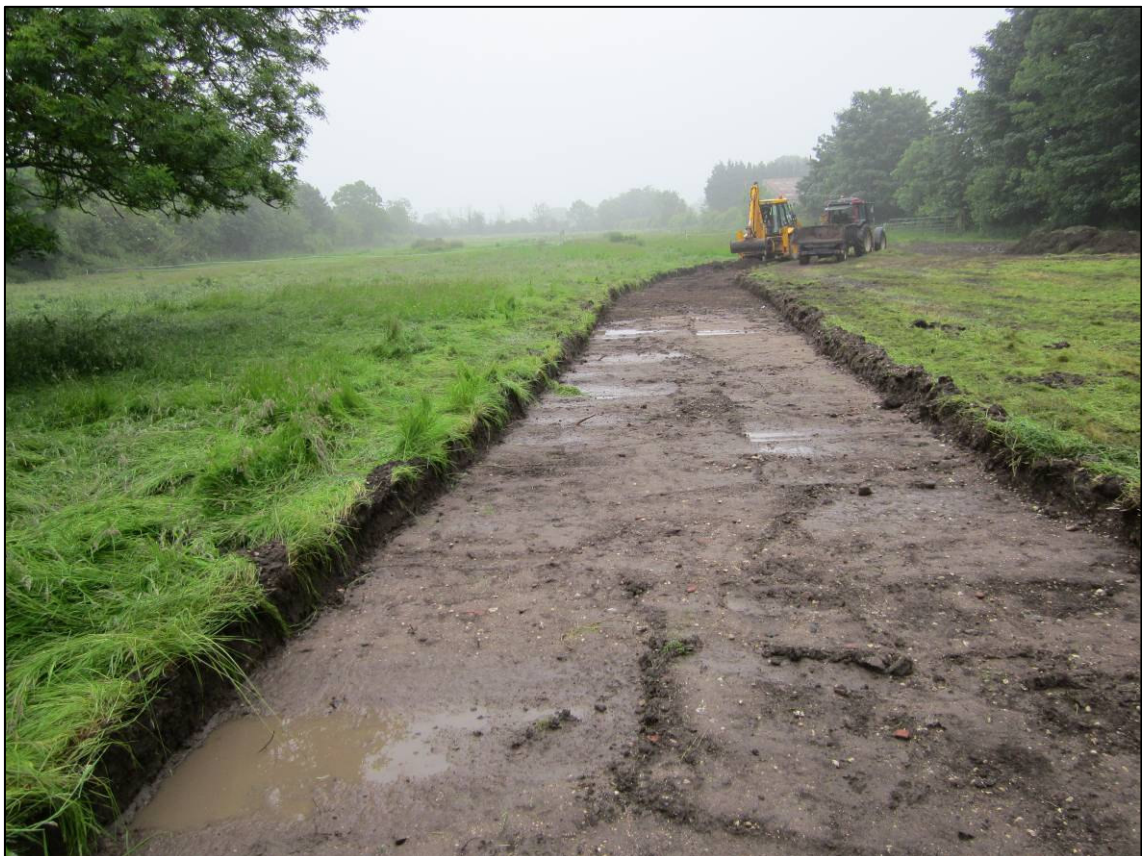
Plate 7: Phase 3 access road under excavation, looking E.
