ST LEONARD'S CHURCH, THRYBERGH,  
SOUTH YORKSHIRE

ARCHAEOLOGICAL OBSERVATIONS  
DURING GROUND INVESTIGATIONS

Report no: 2011/398.R01  
Version: Final  
Date: August 2011  
Authors: Shaun Richardson & Ed Dennison

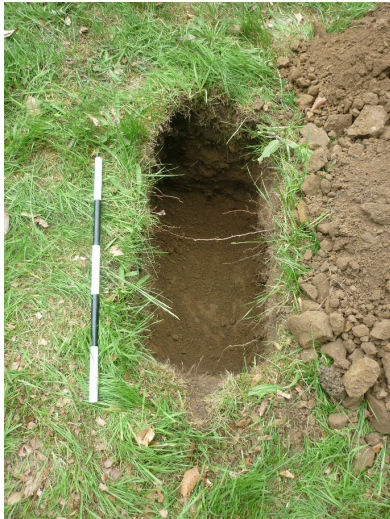
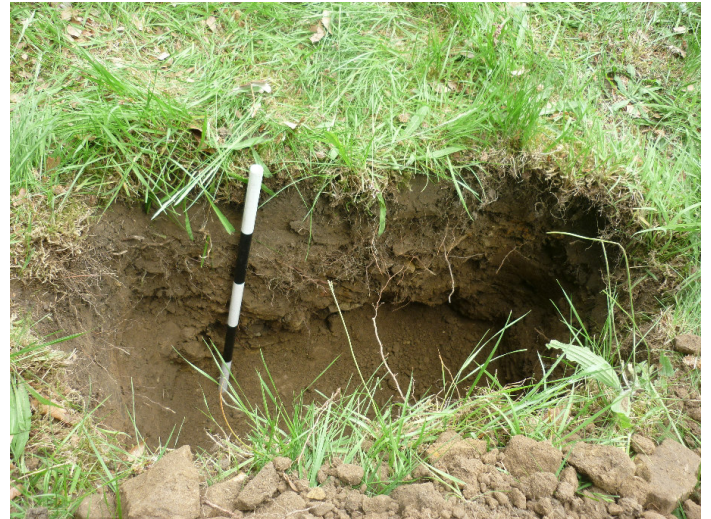
1-045.JPG

- 3.2 Percolation Pit 1 [1/045-046] was located off the south-east corner of the chancel, at an elevation of c.62.5m AOD. The pit measured 0.60m north-south by 0.35m east-west, and was excavated to a maximum depth of 0.50m below ground level (BGL) (c.62.0m AOD). From the ground surface to a depth of 0.18m BGL, turf and a mid to dark brown friable silt topsoil (001) were exposed. Beneath the topsoil, a mid to dark brown sandy silt (002) was seen, containing frequent inclusions (up to 0.10m across) of angular iron-stained sandstone fragments. This deposit continued below the base of the percolation pit, and the sandstone fragments became more frequent and compacted as the depth increased.

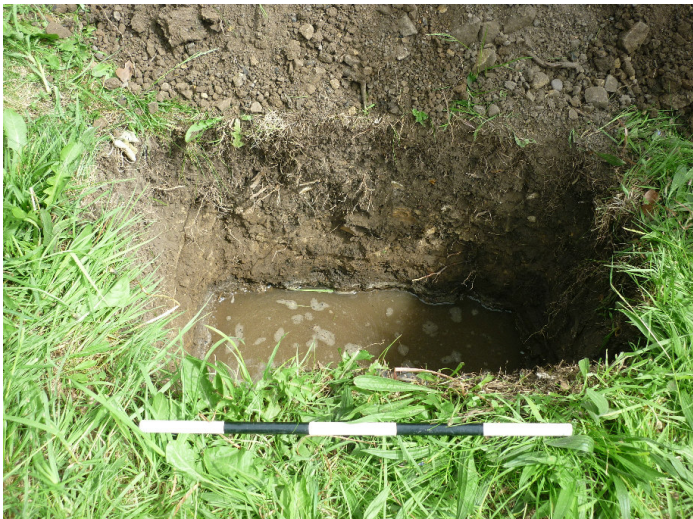
1-047.JPG

- 3.3 Percolation Pit 2 [1/047] was located to the north-east of the chancel, at an elevation of c.63.0m AOD. The pit measured 0.80m north-south by 0.50m east-west, and was excavated to a maximum depth of 0.60m BGL (c.62.40m AOD). From the ground surface to 0.20m BGL, turf and a mid to dark brown friable silt topsoil (001) were exposed. Beneath the topsoil, a mid to dark brown sandy silt (003) was seen, containing frequent inclusions (up to 0.10m across) of angular iron-stained sandstone fragments. This deposit continued below the base of the percolation pit, and the sandstone fragments became more frequent and compacted as the depth increased.

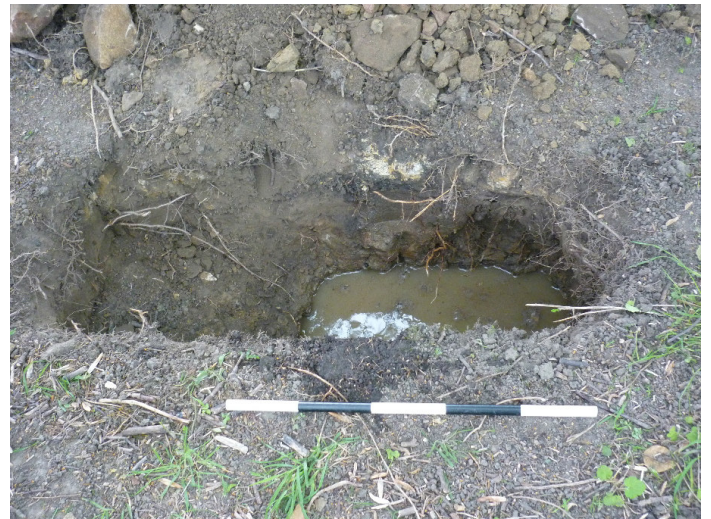
1-048.JPG

- 3.4 Percolation Pit 3 [1/048] was located to the west of George Gaze Pace's modern extension at the west end of the church, at an elevation of c.61.9m AOD. The pit measured 0.80m north-south by 0.50m east-west, and was excavated to a maximum depth of 0.50m below ground level (BGL) (c.61.4m AOD). From the

ground surface to 0.18m BGL, turf and a mid to dark brown friable silt topsoil (001) were exposed. Beneath the topsoil, a mid to dark brown sandy silt (004) was seen, containing frequent inclusions (up to 0.10m across) of angular iron-stained sandstone fragments; the fragments became more frequent and compacted as the depth increased. In the very base of the pit, the sandy silt was seen to overlie a hard greyish mid-brown clay (005).
