PROPOSED NEW DRAINAGE WORKS,  
HOWDEN MINSTER, HOWDEN, EAST YORKSHIRE

ARCHAEOLOGICAL DESK-BASED ASSESSMENT

Report no: 2009/353.R01  
Version: Final  
Date: November 2009  
Author: Ed Dennison

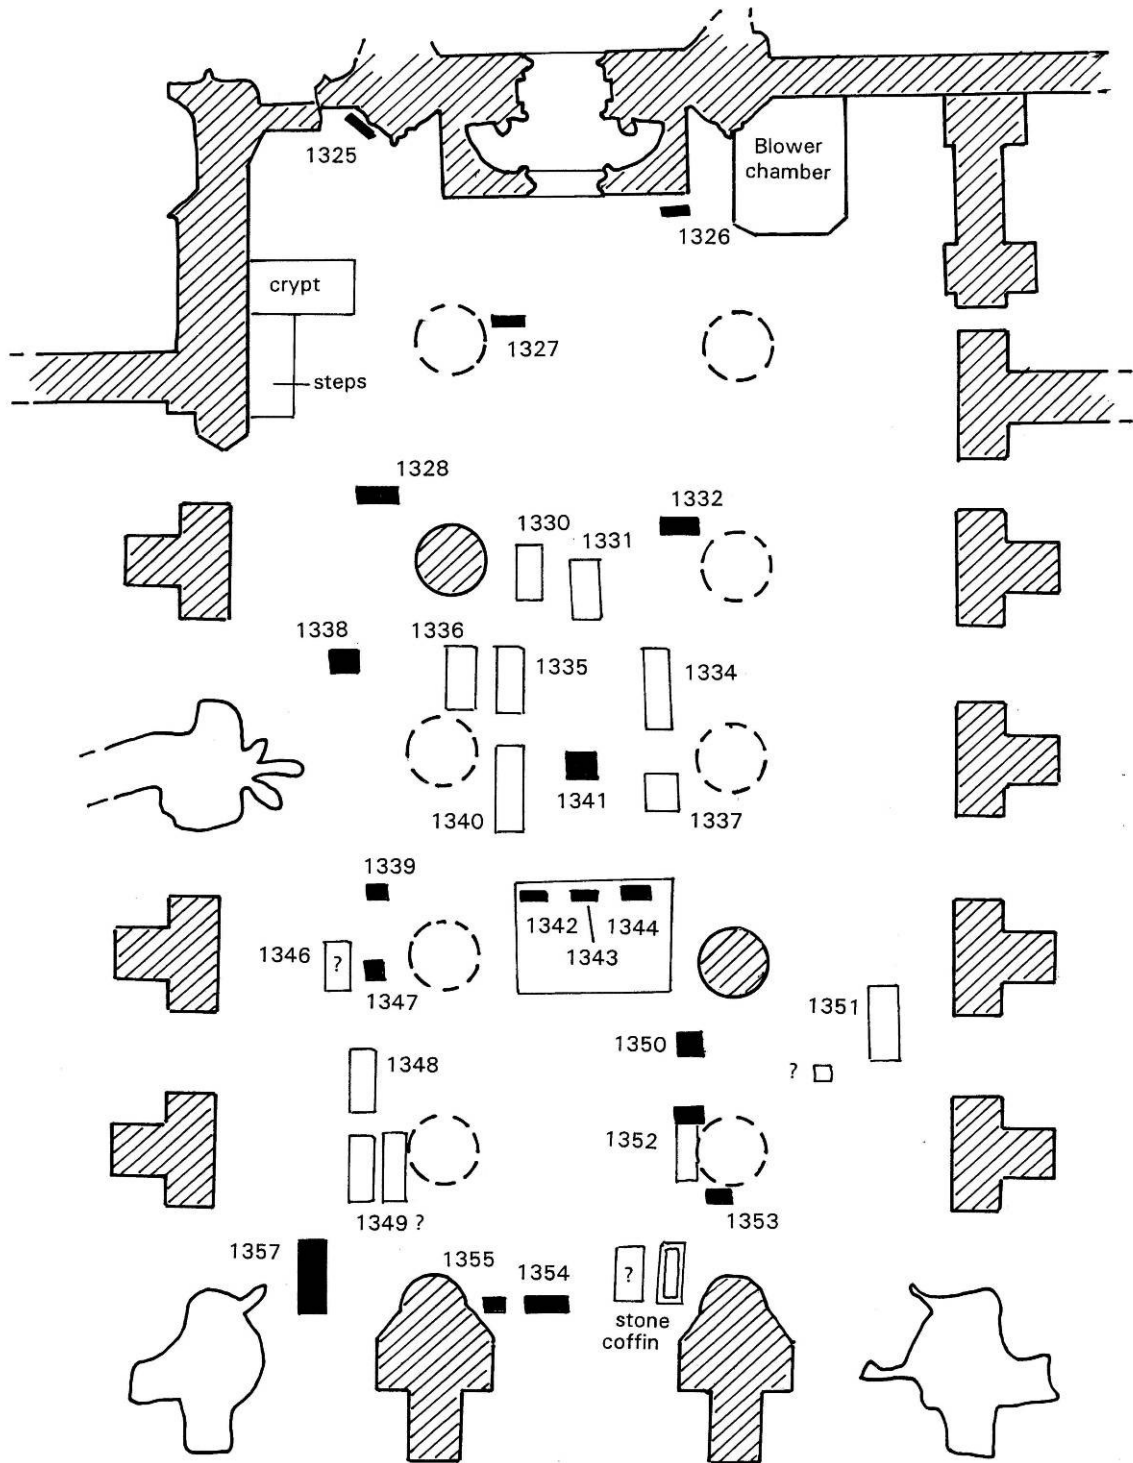
PROJECT HOWDEN MINSTER DRAINAGE WORKS	
TITLE SKETCH OF VISIBLE GRAVES	
SCALE NTS	DATE NOV 2009
EDAS	FIGURE 2

1329 identifiers

■ upstanding stones, crosses etc

- 4.11 The choir contains a number of marked graves of predominately 19th and 20th century dates, with the most recent being 2003, and also undoubtedly a much larger number of unmarked burials (see figure 2; plates 3 and 4). The monumental inscriptions were recorded by the East Yorkshire Family History Society in the 1990s (monuments 1325 to 1357), but there have been changes since and some are no longer visible (EYFHS 1999b, 162-166). The EYFHS plan of the graves is somewhat schematic and it is possible that some gravestones have been moved since the 1990s recording. As part of the July 2009 site visit, the inscriptions were re-recorded and a comparison with the EYFHS data is provided in Appendix 1.

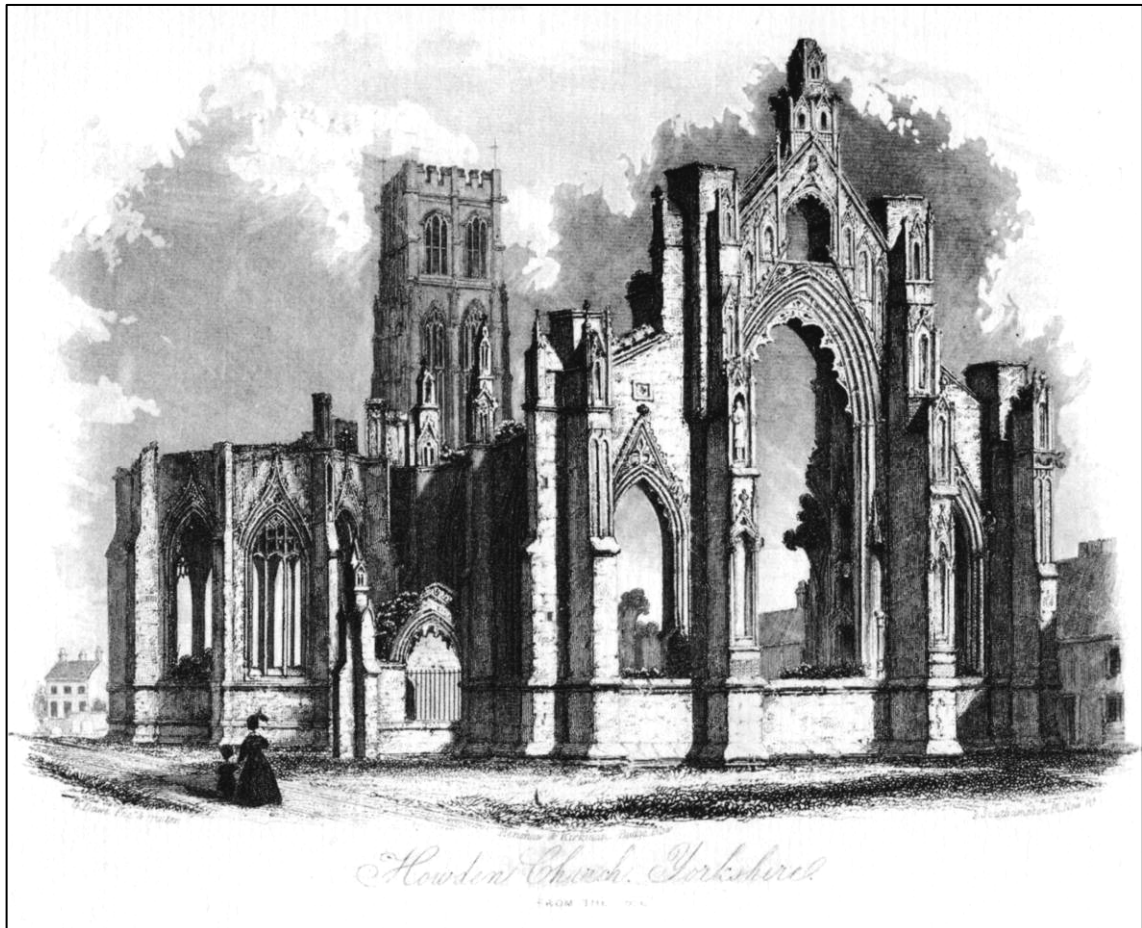
Plate 1: General view of ruined choir and chapter house, looking north-west (Clarke 1851, frontispiece).

- 2.5 The Minster features in a number of general antiquarian works on Howden, for example, that by Clarke (1850) (see plate 1). More useful from an architectural point of view are the very detailed architectural studies which began to appear from the mid 19th century onwards. For example, in 1843 Richardson reproduced a series of colour plates of the Minster as part of his study of monastic ruins in Yorkshire, including a section through the moulding of the central window of the west front (Richardson 1843).

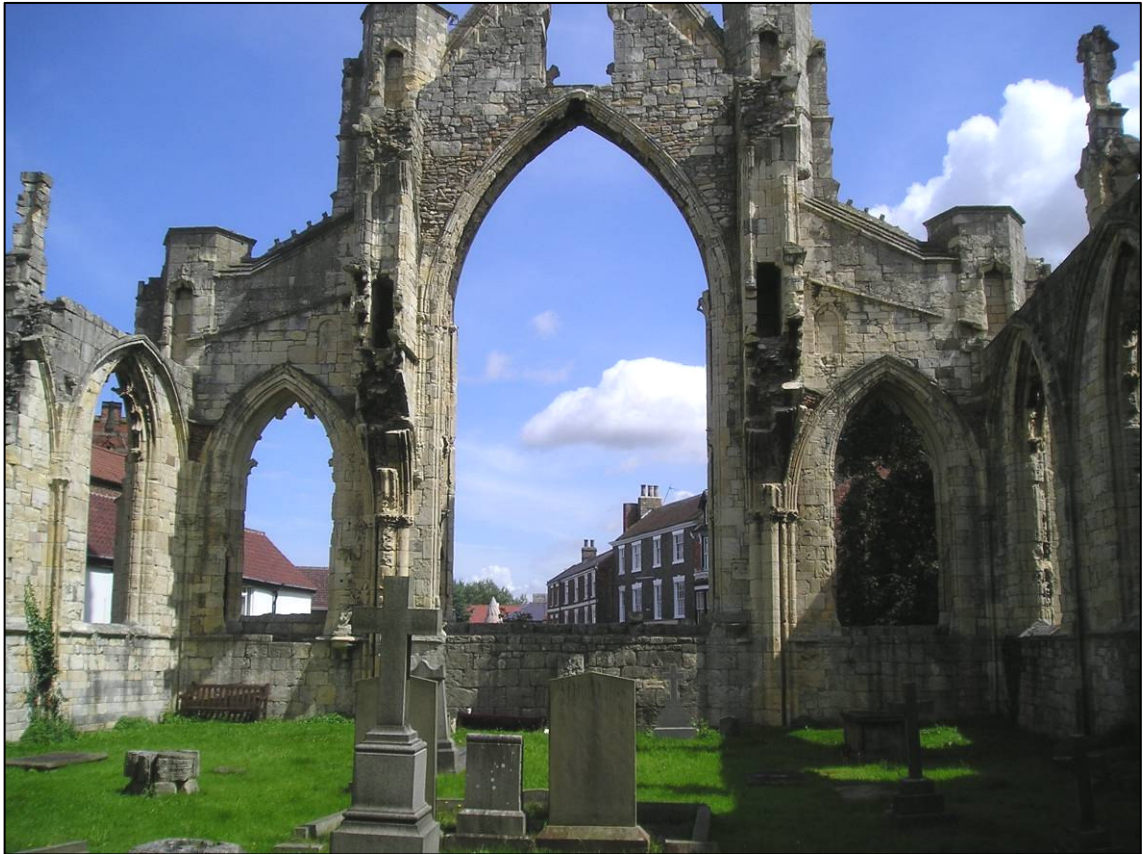
Plate 3: Interior of east end of ruined choir, looking east.

- 4.9 The interior east wall of the choir is of three bays and, as to the exterior, the central bay is taken up by the great east window (see plate 3). There are two tiers of niches to the window's jambs; the lower niches are very deep, and might once have connected with the aisle windows, forming short passages. The upper niches are shallower with canopies and empty pedestals. The remains of

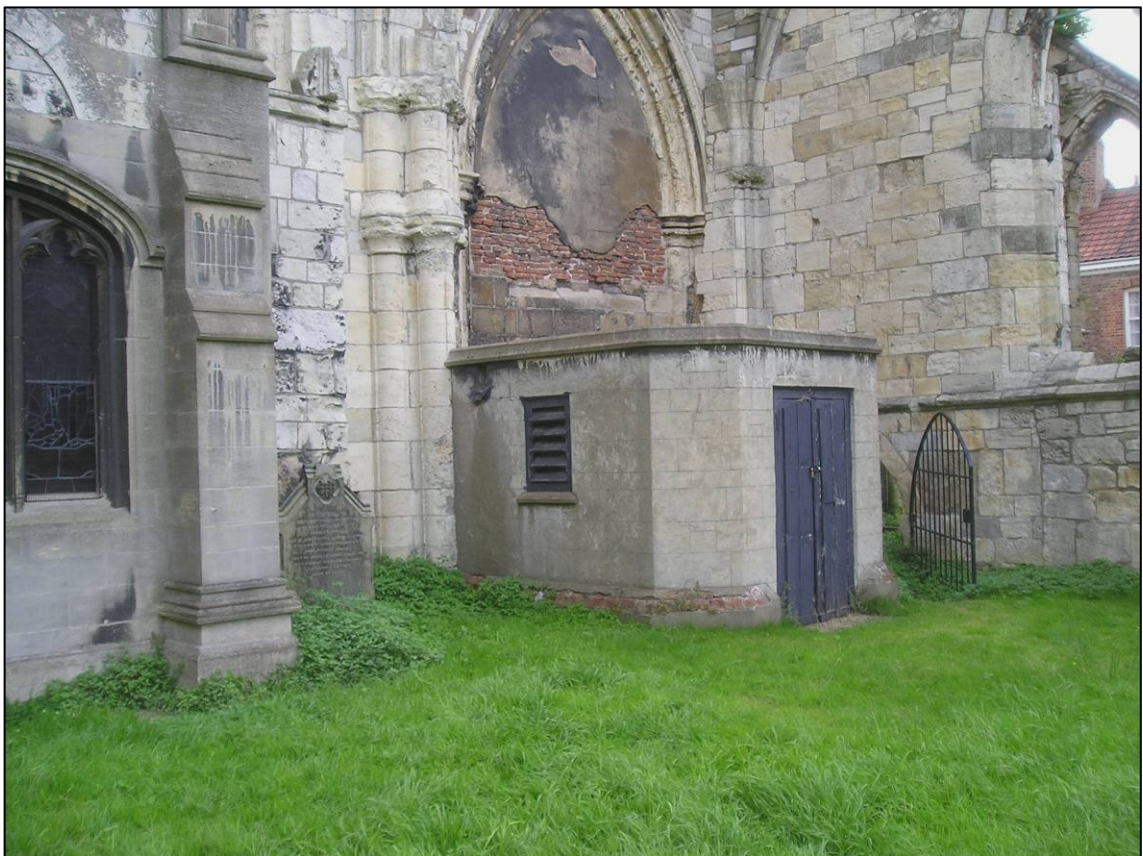
Plate 4: Interior of north-west corner of ruined choir, looking north-west.

- 4.5 The central space of the choir was of three storeys, with a triforium and clerestory; two roof scars can be seen on the east side of the tower, showing that the later choir was taller than the earlier structure, but with a slightly less but still steeply pitched roof. Apart from the present doorway to the south of the altar, at the base of the south transept opening, the former openings from the transepts into the choir are blocked, as is that from the crossing which contains a 19th century window. There is a small projection at the base of the blocked crossing opening of early 20th century appearance, although it incorporates a semi-circular inscription apparently commemorating one or more churchwardens and dated 1784 (see plate 2); this date presumably refers to the construction of a vestry in this location at that time (see Chapter 3 above). There is another low flat-roofed projecting structure, a Blower Chamber, of early 20th century date to the north (see plate 4).
