WEST MILL, ASKRIGG,  
NORTH YORKSHIRE

ARCHAEOLOGICAL AND  
ARCHITECTURAL SURVEY

VOLUME 3: APPENDICES

## CONDITION REPORT AND RECOMMENDED REPAIRS

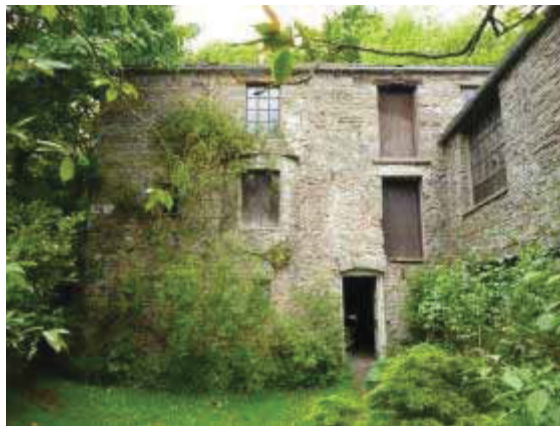
#### 3.1 THE MILL - Exterior elevations – reference drawing No. 2

- South Elevation – 1  
Numerous movement fractures – not excessive but requiring grouting and some bonding across in wall thickness, with in-situ concrete bonder and stainless steel reinforcing bars. Where cement repairs have been undertaken, these are unlikely to be properly grouted up and should be cut out and re-grouted with lime mortar. Many open joints to the south west corner require deep pointing using hydraulic lime NHL 3.5 and grit sand (1 : 2½). Repair stone slates to eaves of rounded half turret section of wall.  
£ 3,500 A
- West Elevation – 2  
Extensive open joints to gable and in lower middle to repoint. At wall base a bulge to the south of the doorway is in need of external skin rebuilding and tying into core.  
£ 4,000 A
- North Elevation – 3  
The lower areas around the Launder entry requires open joints repointing.

A large area to the first floor wall has numerous isolated open joints, and although of a lower urgency, ideally should be combined with work on the lower area.  
£ 3,000 A

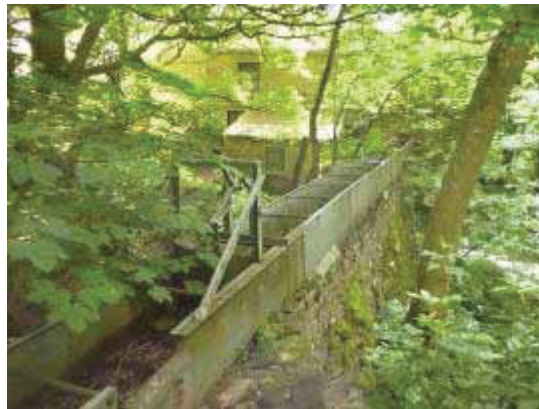
### 3.2 THE LAUNDER - Reference drawing No. 3.

- Minor erosion to concrete capping of stone piers/support wall – make good to reduce water entry/frost damage.
- The launder channel is in zinc. The base is concrete over zinc, inserted later to reduce leakage. Unfortunately it still leaks. Ideally re-line with fibreglass or rubberised compound or asphalt.
- Later ferrous metal trays were added to give support, these are rusting badly at the ends and may be becoming weak. Investigation is needed and possible reinforcing with galvanised plates.

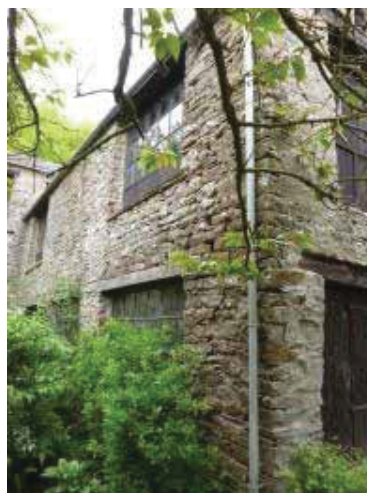
### 3.3 GARAGE - Reference drawing No. 4

- East elevation – 9  
Numerous vertical fractures only lightly repaired with just a surface application of cement mortar. Rake out and deep fill. Set up bonders to tie across the fractures. Work from both inside and external faces together. £ 3,500 A
- South Elevation – 10  
Open joints to the wall at east end and above wooden lintels, to repoint. £ 1,200 A

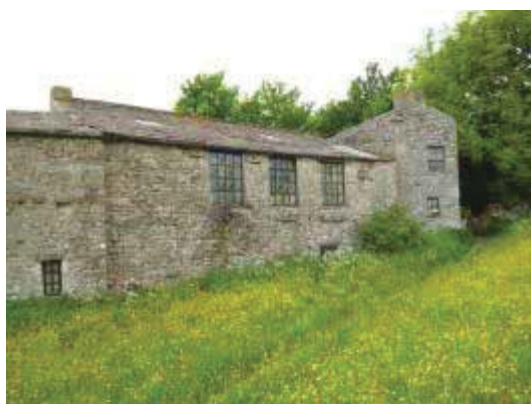
### 3.4 KILN RANGE - Reference drawing No. 4

- North Elevation – 5  
Area of wall in lower centre is bulging. This wall has been constructed in phases, but movement is more than differing standards of construction. Take down outer skin and rebuild tying back into core. £ 2,500 A
- Replace corrugated PVC skylight over the area with a metal framed conservation roof light. £ 1,500 C

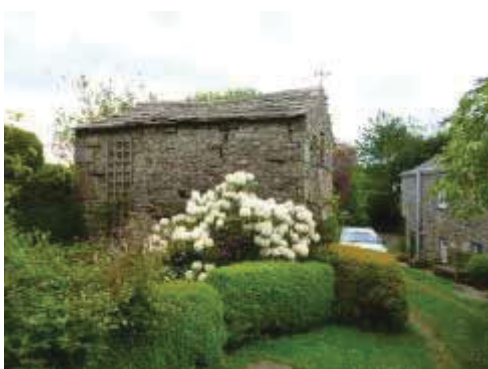
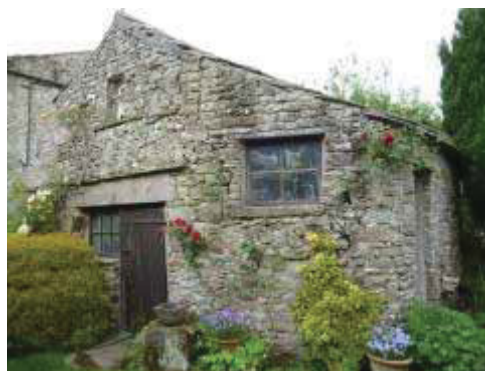
### 3.7 DOVE HOUSE (South of Barn) – Reference drawing No. 4.

- Roof  
The stone slate roof is much distorted. Need to strip/repair rotted roof timber and re-cover with existing slates. £ 5,000 A

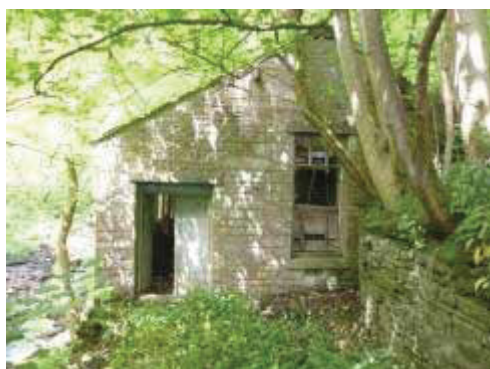
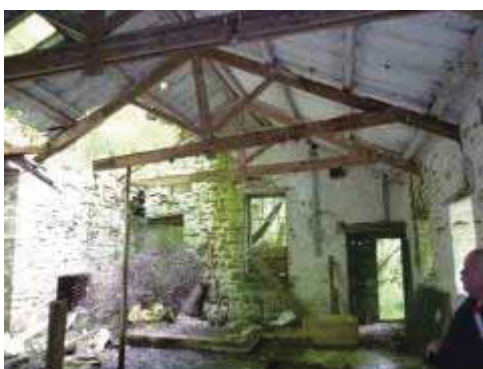
### 3.8 THE POWER HOUSE Built 1910 - Greatly extended 1930 (To be read in conjunction with Drawing No. 9)

- Roof

Composite timber trusses and asbestos cement sheeting (recently collapsed). Was the asbestos cement sheeting (1950's?) or is this 1930's original? Underside was painted presumably to reflect the light. Plain concrete tiles used at the end – as later repairs? All asbestos sheets are now broken following collapse of trusses.

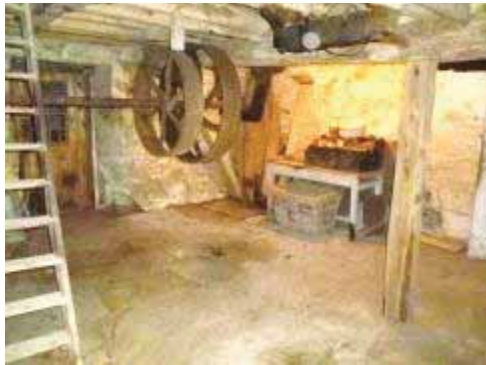
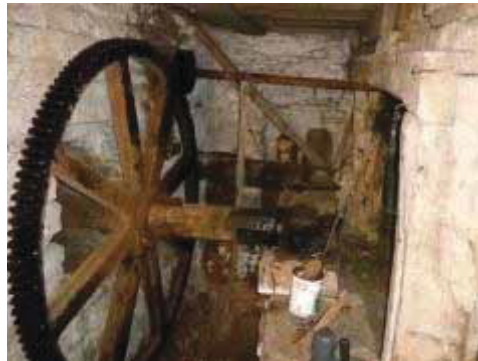
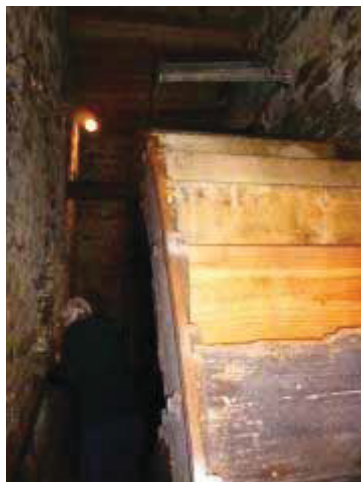
**3.9 THE MILL - Interior elevations – reference drawing No. 6**

- Elevation – 11  
Investigate movement to window opening arch bearings, possibly pin/tie the fractures and replaster. £ 1,500 B

- Elevation – 13  
Investigate fracture on top floor north wall, possibly fit ties or just grout. £ 550 B  
Investigate loose stones below window and possibly re-set. £ 500 B  
Overhaul main water wheel:  
Specialist advice £ 500 A  
Repairs to paddles, axle mounting, and spokes £ 1,500 B
