SARGILL LEAD SMELT MILL, HIGH ABBOTSDALE,
NORTH-EAST OF SEDBUSK,
NORTH YORKSHIRE

UPDATED ARCHAEOLOGICAL SURVEY WITH
PROPOSED PROTECTION AND MONITORING SCHEME

Report no: 2012/418.R01
Version: Final
Date: February 2013
Author: Shaun Richardson & Ed Dennison

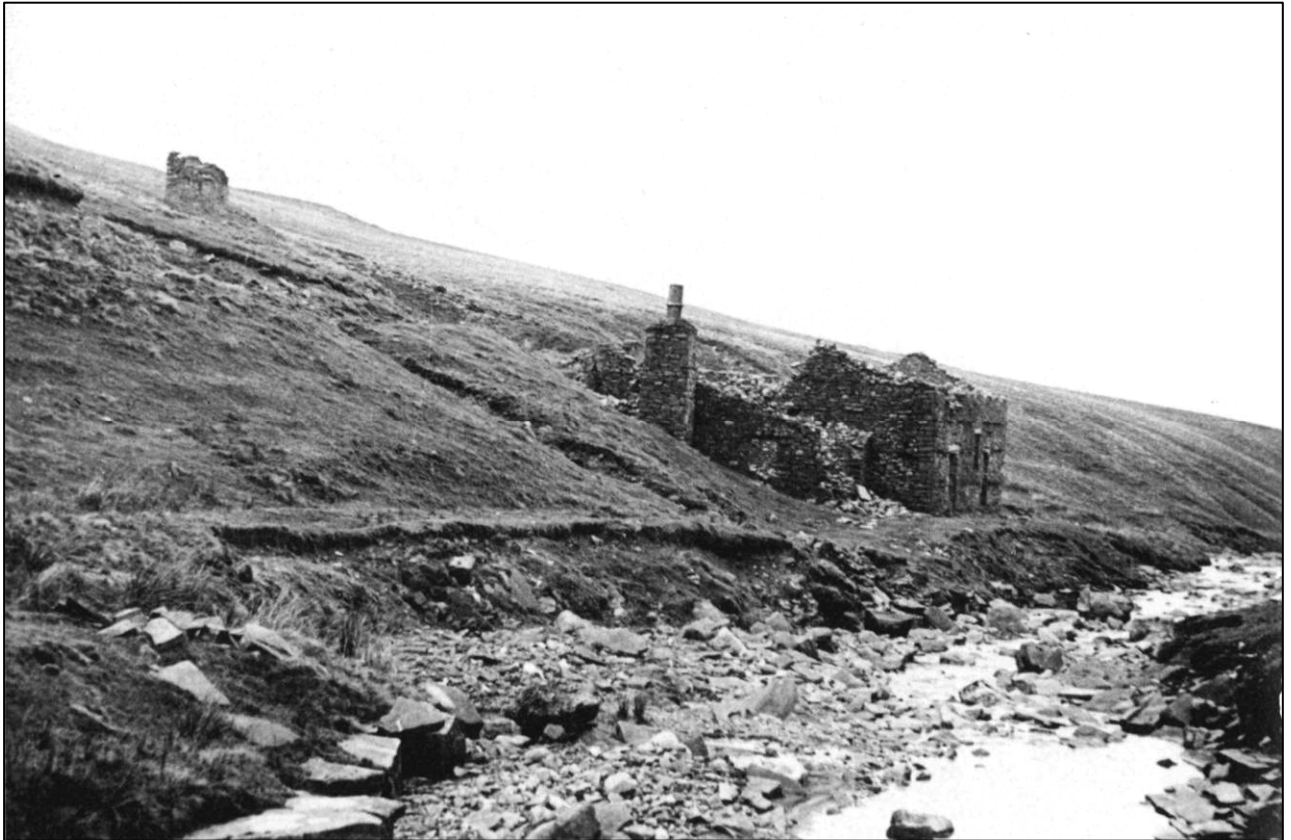
PROJECT		SARGILL SMELT MILL	
TITLE			
		EARLY PHOTOGRAPHS	
SCALE		DATE	
NTS		FEB 2013	
EDAS		FIGURE	
		4

Top: View of smelt mill and chimney, looking NE, taken in 1905-06 by Backhouse (Raistrick 1975, 96).

- 4.6 The area of the mill complex that has undergone the greatest decay between May 1997 and June/July 2012 is the south wall of the mill building (**SAR 31.1**). The 1905-06 photograph taken by Backhouse (Raistrick 1975, 96; see figure 4 top) shows the south elevation of the mill surviving to what was probably its approximate full height. The building was a tall single storey, and there were two doorways in the south elevation, flanking a raised window. Several courses of projecting throughstones are also visible. By June 1984 (Richard Lamb collection, 84029 & 84030; see figure 6), the upper parts of the south-east and north-east corners of the elevation had partially collapsed, almost certainly brought down by the collapse of the respective gables at either end. There had been some loss of walling to the top of the central part of the elevation as well, although both doorways and the central window remained intact, although by now partially blocked. The LUAU survey photographs and drawings (elevations 5 and 14) show that there was apparently little further collapse between 1984 and 1997. However, between 1997 and 2012, the timber lintel and the 0.6m height of masonry it supported over the eastern doorway has collapsed [1/366; 1/419] (see plate 22), and the internal lintel of the window to the west and the masonry above has also collapsed [1/367; 1/420], leaving the surviving external lintel in a precarious state (see plate 23); there is no external lintel and only a thin surviving central lintel which, when this collapses, will bring down the masonry above the west side of the window (see plate 24). The western doorway remains as recorded in 1997. There has also been some minor collapse at the very east end of the external elevation. Similarly, the upper northern end of the east wall of the mill (**SAR 31.2**; elevation 15) has collapsed since 1997 [1/432]. Finally, other walls to the rear of the smelt mill (**SAR 46** to **SAR 49**) are also now either much reduced in size or missing completely since 1997, possibly due to natural erosion and slumping caused by rabbit activity [1/470; 1/475].

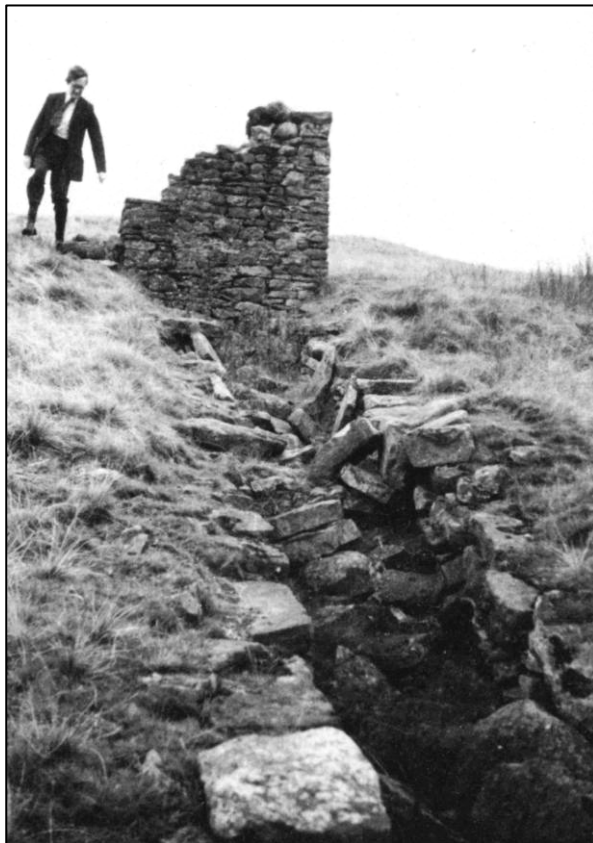
Bottom: View of chimney and flue, looking N, taken c.1950s-60s (Raistrick 1975, 97).

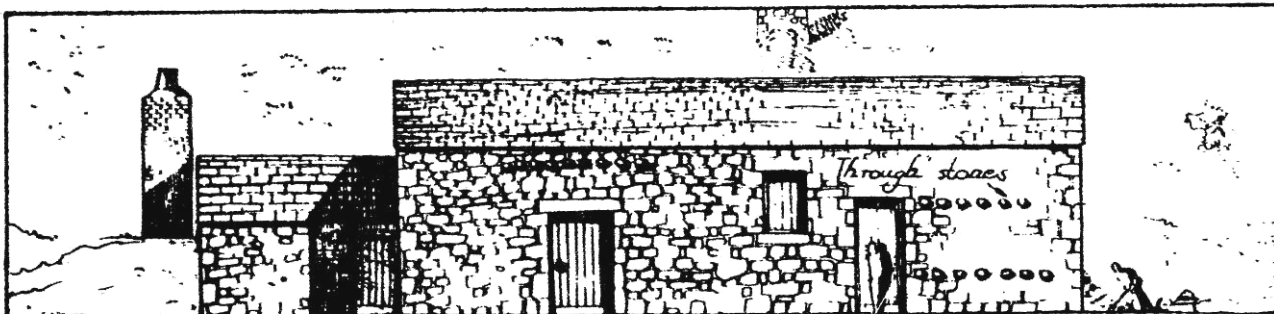
PROJECT		SARGILL SMELT MILL	
TITLE		CLOUGH & WELLS' 1948 SURVEY	
SCALE	NTS	DATE	FEB 2013
EDAS		FIGURE	5

FRONT ELEVATION

This mill is situated on the North bank of Sargill Beck 3 1/2 miles W.N.W of Askrigg being built early in the 19th century.

Closed about 1870.

GROUND PLAN

Surveyed by Robert T. Clough & C.B. Wells A.A.R.I.B.A. 1948

- 2.10 The first known detailed survey of the mill was made by Clough and Wells in 1948, but apparently not drawn up until 1955 (Clough 1980, 101) (see figure 5). Although an invaluable source of information, like many of Clough's other drawings, it is not certain to what extent he was depicting what survived or reconstructing elements from earlier sources, presumably including Backhouse's photograph. Clough also included two photographs of a cast-iron lead pig mould on wheels, marked 'SAR GILL'; each pig was stated to weigh 13 stones (Clough 1980, 102). In 1975, Raistrick noted of the same that 'a pig mould with SARGILL was in existence in Askrigg recently, but has not been seen for a few years' (Raistrick 1975, 98); it may be the same SARGILL mould which is on display at the Dales Countryside Museum in Hawes (Robert White, YDNPA, *pers. comm.*).

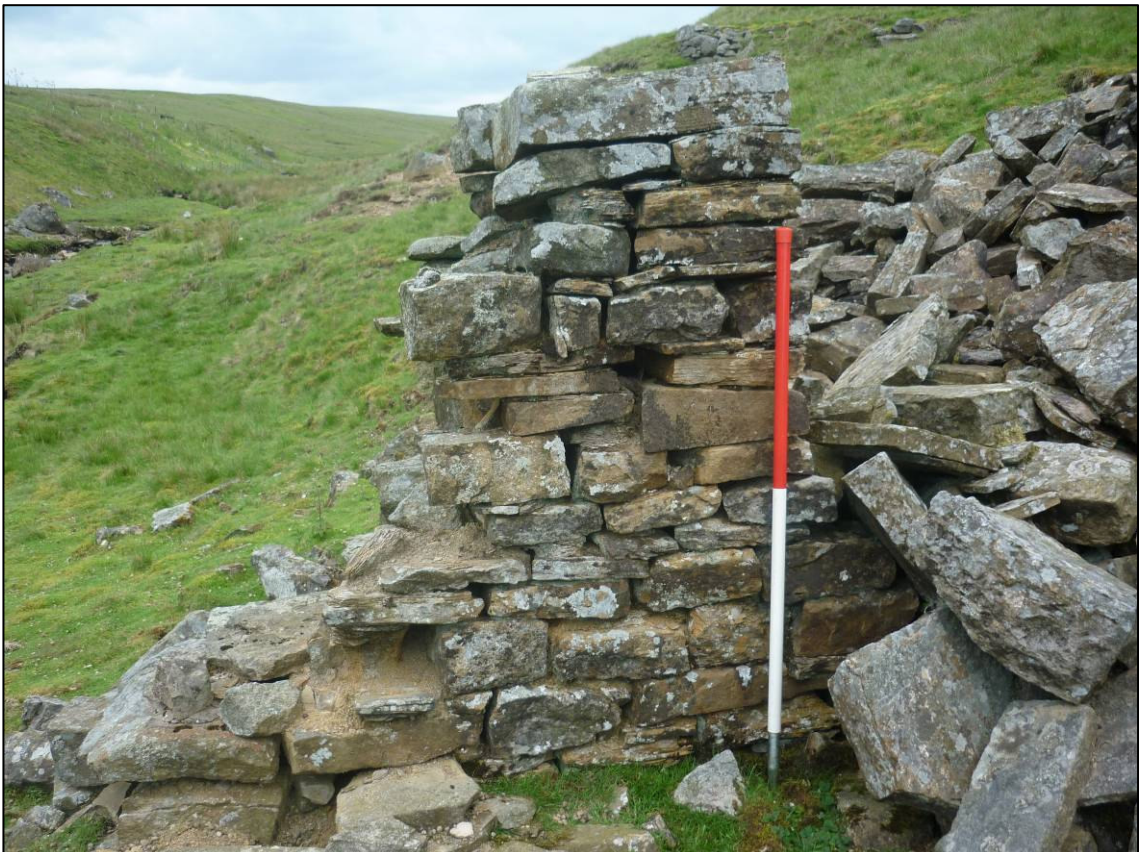
Plate 4: South end of west wall (internal face) of roasting house (SAR 43.2, elevation 8), looking W (photo 1/437).

- 3.12 The building measured 6.61m long by 5.24m wide, but only the north-west and south-west corners now survive to any degree (**SAR 43.1**) [1/436 to 1/438] (see plate 4). It was formerly entered by a 1.28m wide doorway in the south wall, positioned to the centre of the wall, although Clough erroneously shows it to be at the east end (Clough 1980, 101). Confusingly (and incorrectly), the LUAU 1997 report states that 'entrances were observed at the south-west and south-east corners' while their gazetteer states that there were doorways in the south and west walls (Wild & Cranstone 1997, 12 & 28). There appears to have been no direct internal connection between the building and the mill proper to the east. The building was lit by a window in the west wall (**SAR 43.2**), still extant when the early 20th century photograph was taken. Internally, the above-ground remains of the furnace itself are very slight, comprising only four iron bars (**SAR 45**) at the north-east corner. These bars are called 'beams' in the 1997 report (Wild & Cranstone

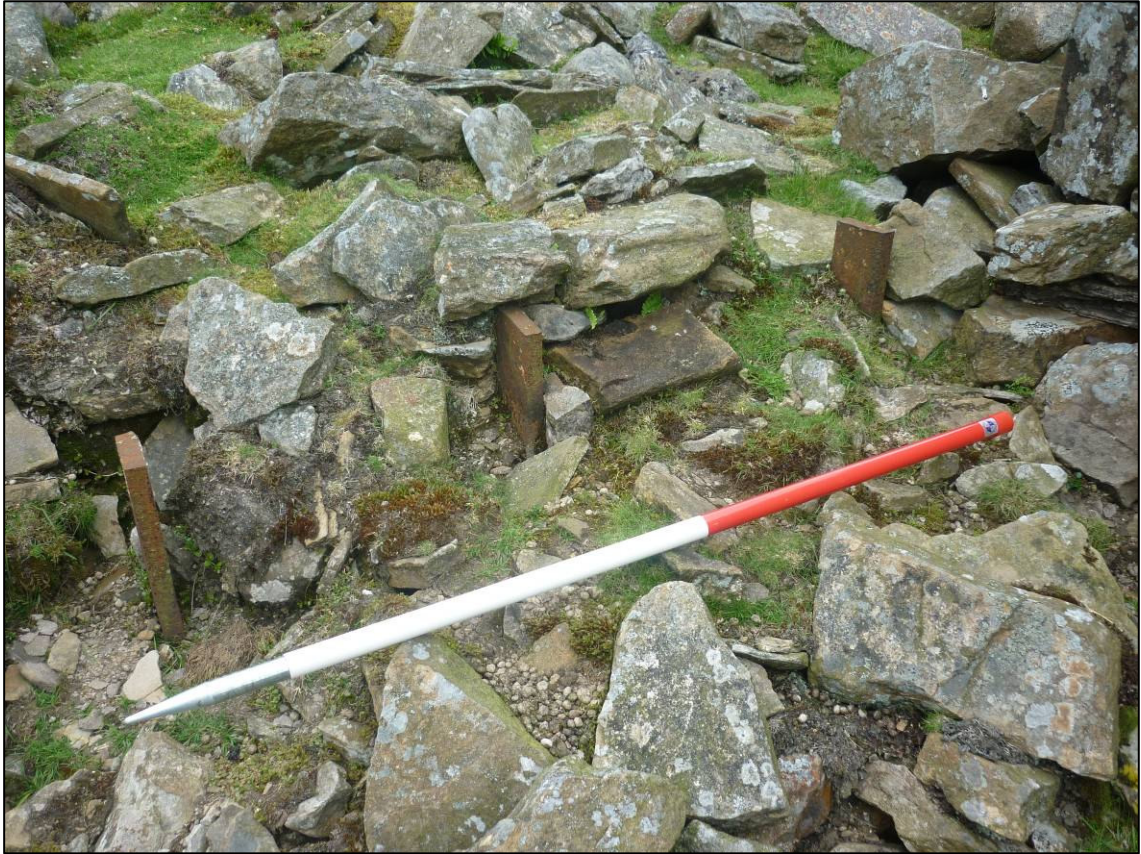
Plate 5: Upright iron standards (SAR 45) in north side of roasting house, looking NE (photo 1/439).

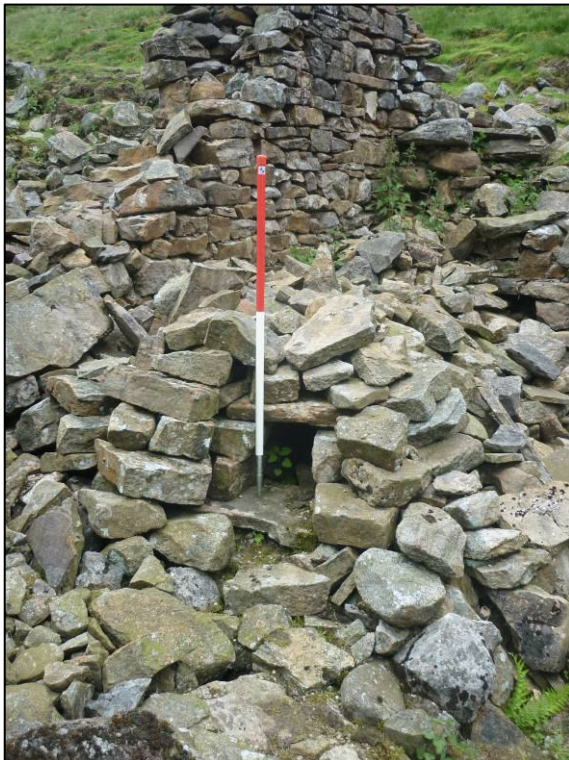
Plate 6: Possible animal trap or rabbit type over wheelpit (SAR 32) in blowing room, looking N (photo 1/443).

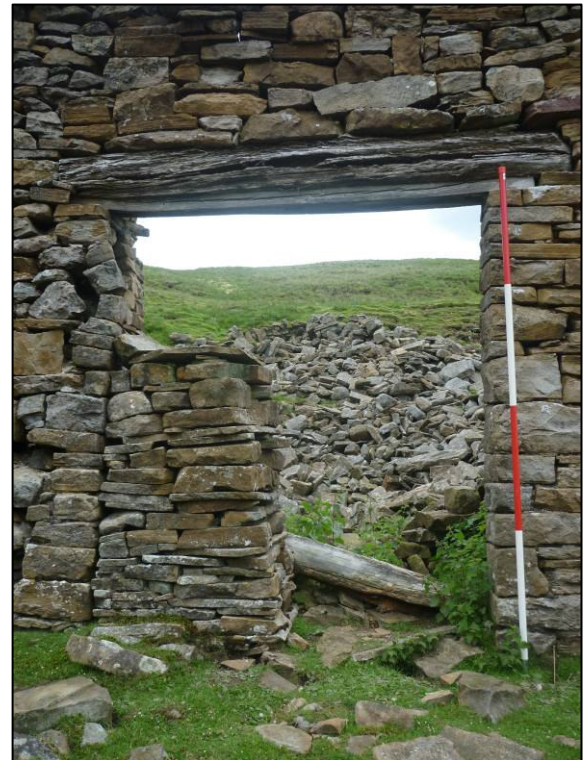
Plate 7: Opening in south wall of blowing room (SAR 31.1, elevation 5), looking S (photo 1/421).

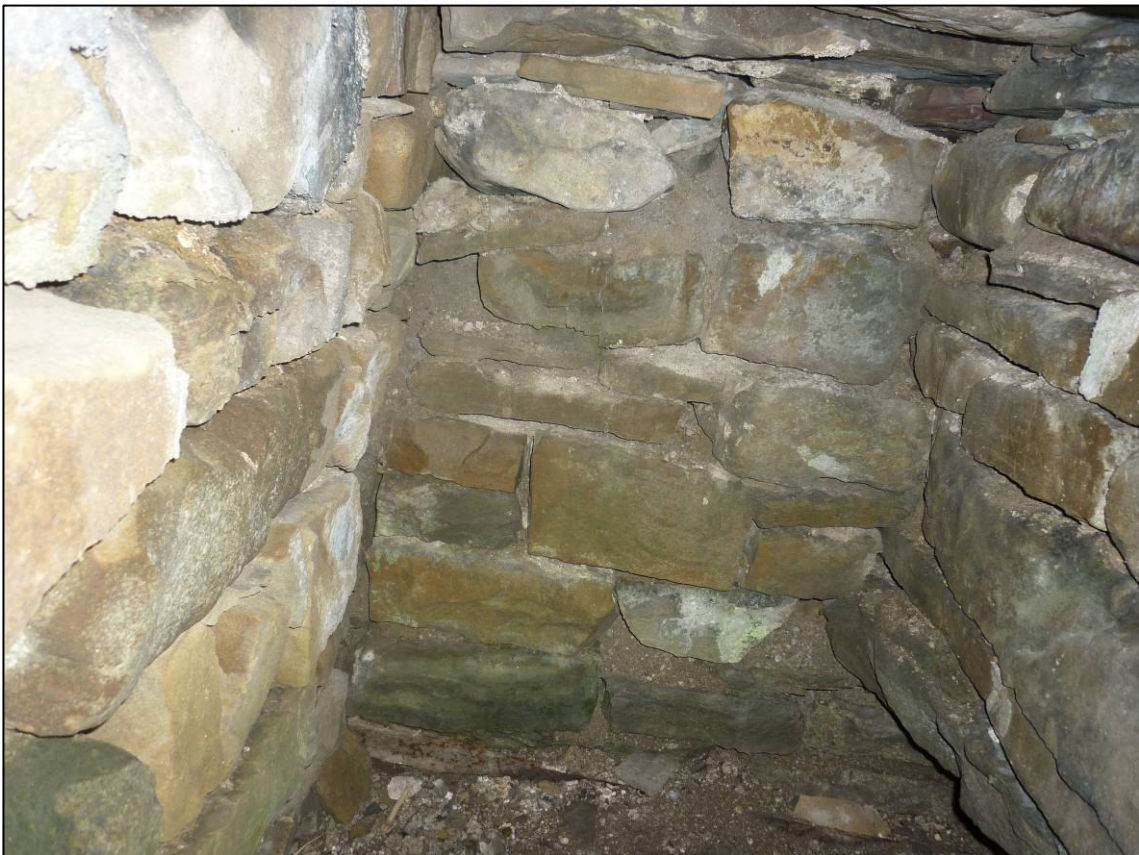
Plate 9: Interior of chamber at back of ore hearth (SAR 37), looking E (photo 1/426).

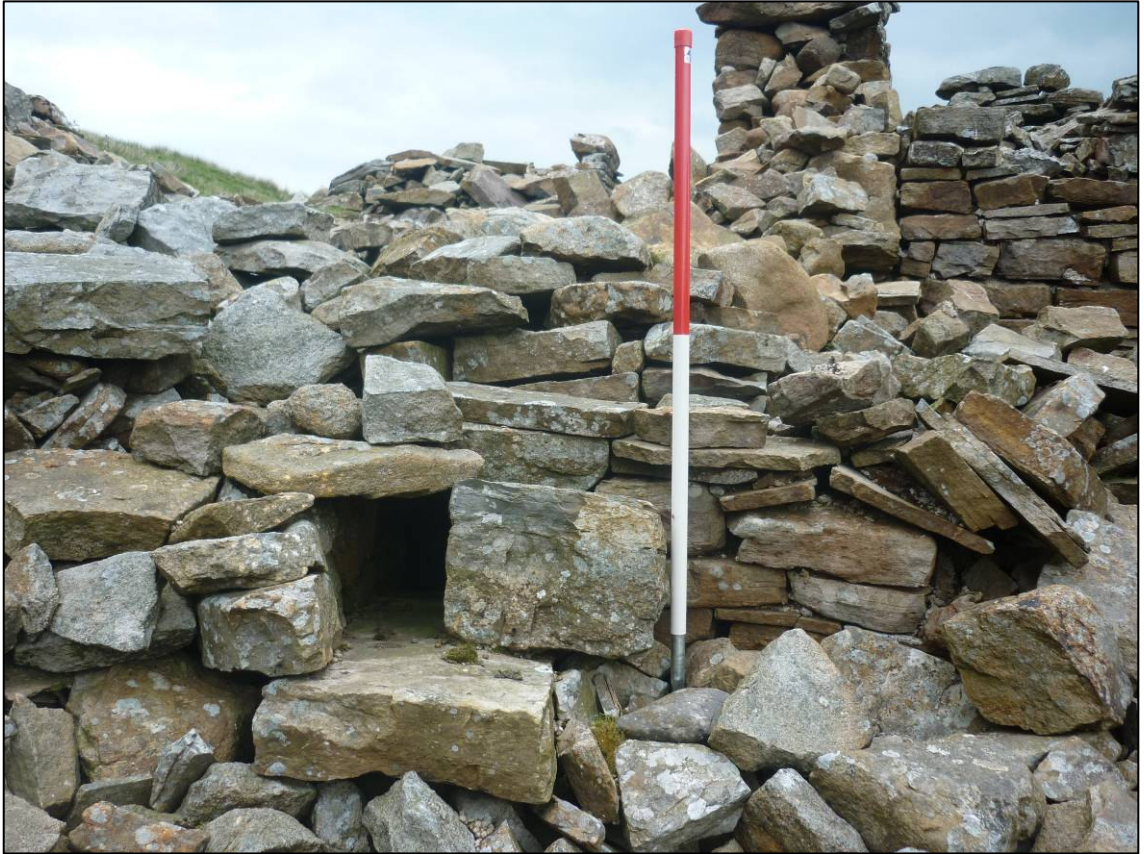
Plate 10: Opening (SAR 42) in west end of passage behind hearths (elevation 10), looking E (photo 1/449).

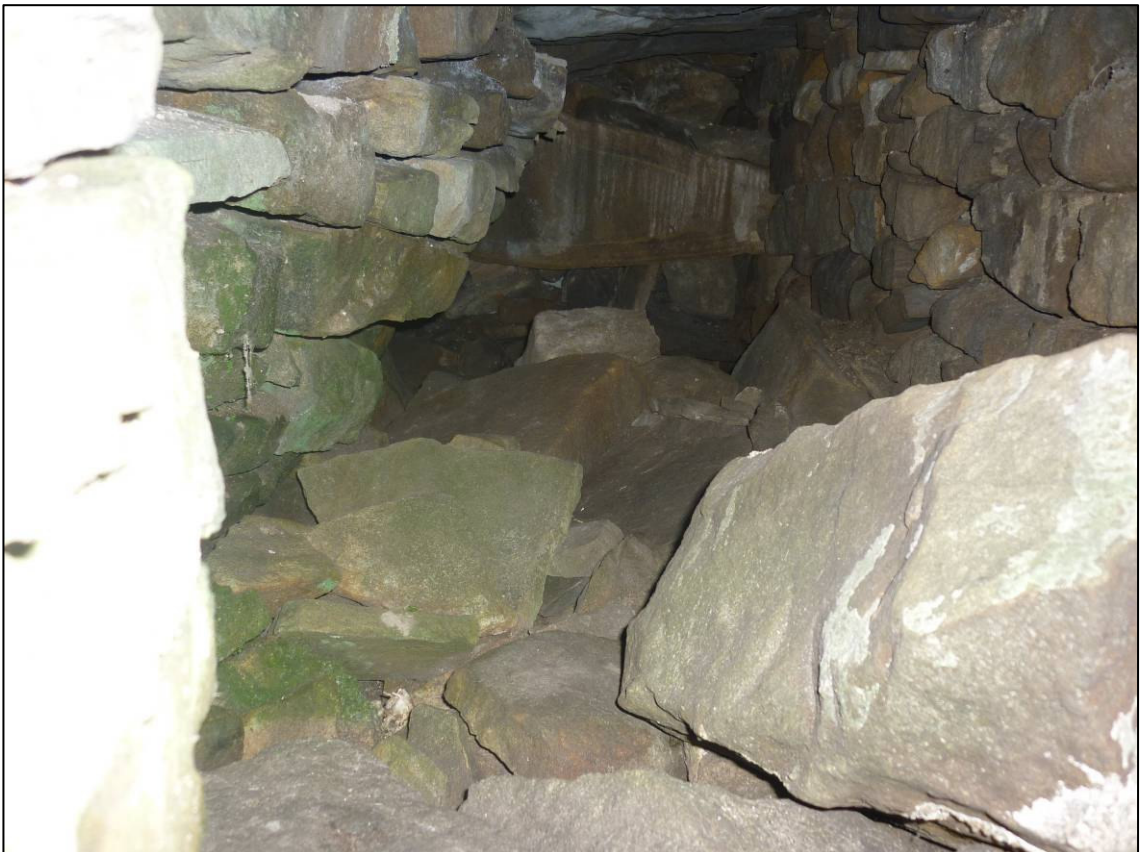
Plate 11: Interior of opening (SAR 42), looking E (photo 1/453).

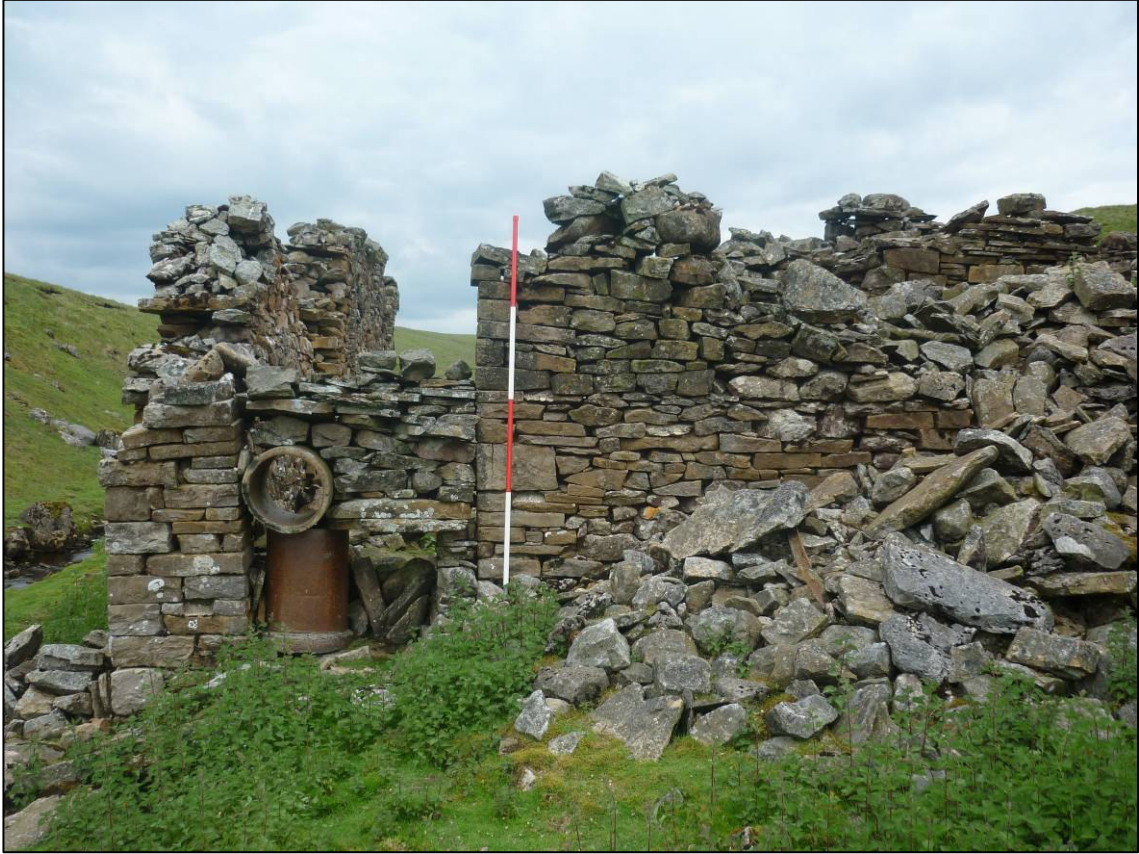
Plate 12: East external elevation of smelting mill (SAR 31.2, elevation 15), looking W (photo 1/430).

- 3.20 The east wall of the room (**SAR 31.2**) has a door at the south end, with one pintle and a latch surviving internally; as noted by LUAU, this doorway has been partly blocked with two large diameter ceramic pipes (probably the pot from the detached chimney to the north-west - SAR 44), and a gap left at the base of the blocking on the north side of the lower upright pipe, which itself has been crudely blocked, may form a sheep creep [1/430; 1/431] (see plate 12). The south wall of the room (part of **SAR 31.1**) contains a doorway in the centre and a window to the west, both blocked [1/427; 1/428] (see plate 13); the doorway has lost its timber lintel since 1997 while the internal lintel to the window in the process of collapse (see Chapter 4 below).

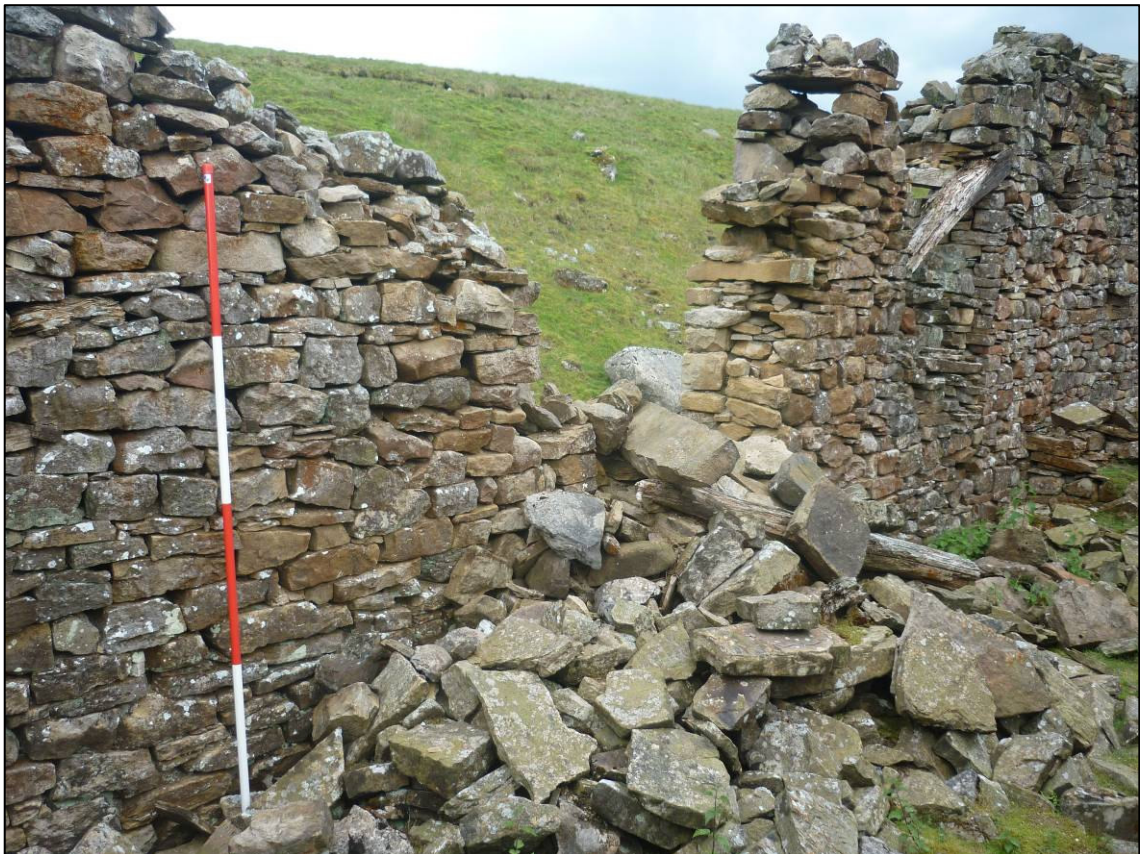
Plate 13: Internal elevation of south wall of smelting room (part of SAR 31.1, elevation 14), looking SW (photo 1/428).

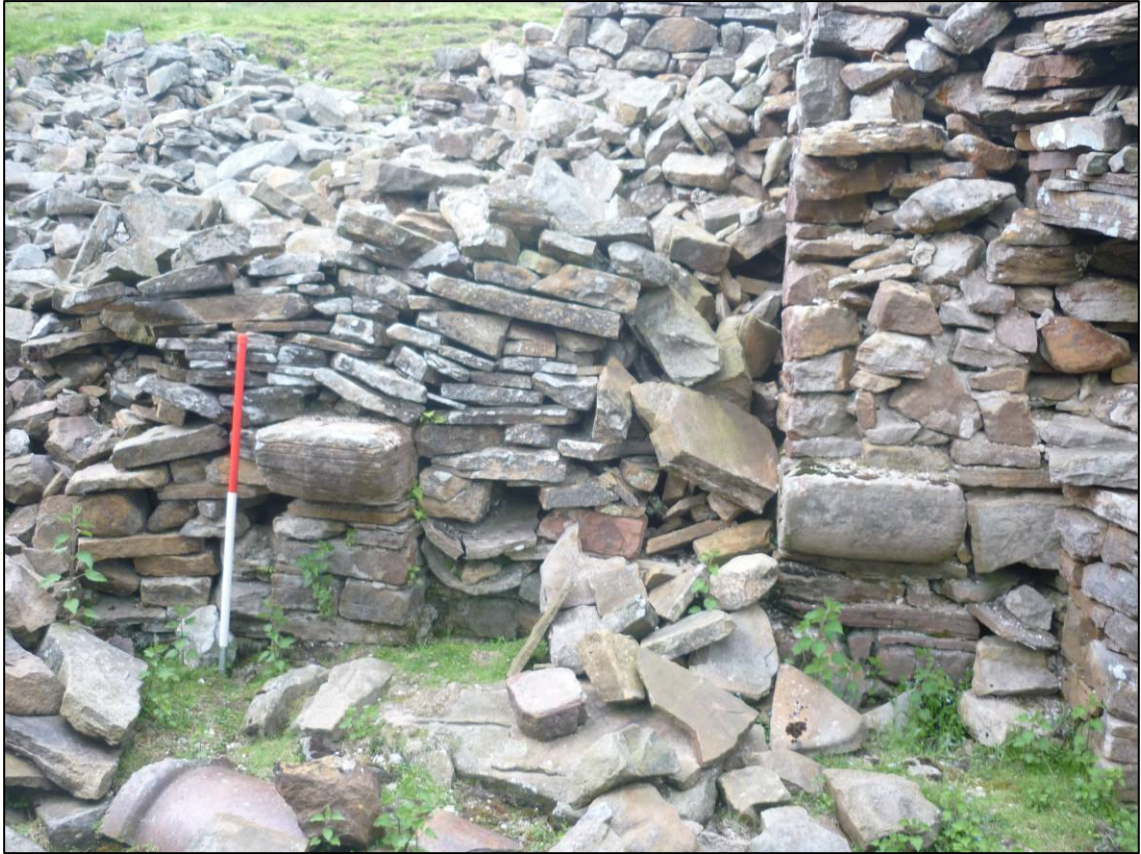
Plate 14: View of ore hearth (SAR 37) with drystone blocking on north side of smelting room (elevation 12), looking N (photo 1/457).

- 4.12 Despite the above, it might be considered appropriate to undertake a number of limited interventions to help stabilise the building in the short term and prevent imminent collapse. These interventions could include, for example:
- the renewal or replacement of the timber lintels over the window in the south wall (**SAR 31.1**) (see plates 23 and 24);
 - slight rebuilding of unsupported masonry around the east doorway in the south wall (**SAR 31.1**) (see plate 22);
 - the rebuilding or reforming of the walls and drystone interventions around the hearths (**SAR 38**, **SAR 39.1** and **SAR 39.2**) (see plates 14 and 15).

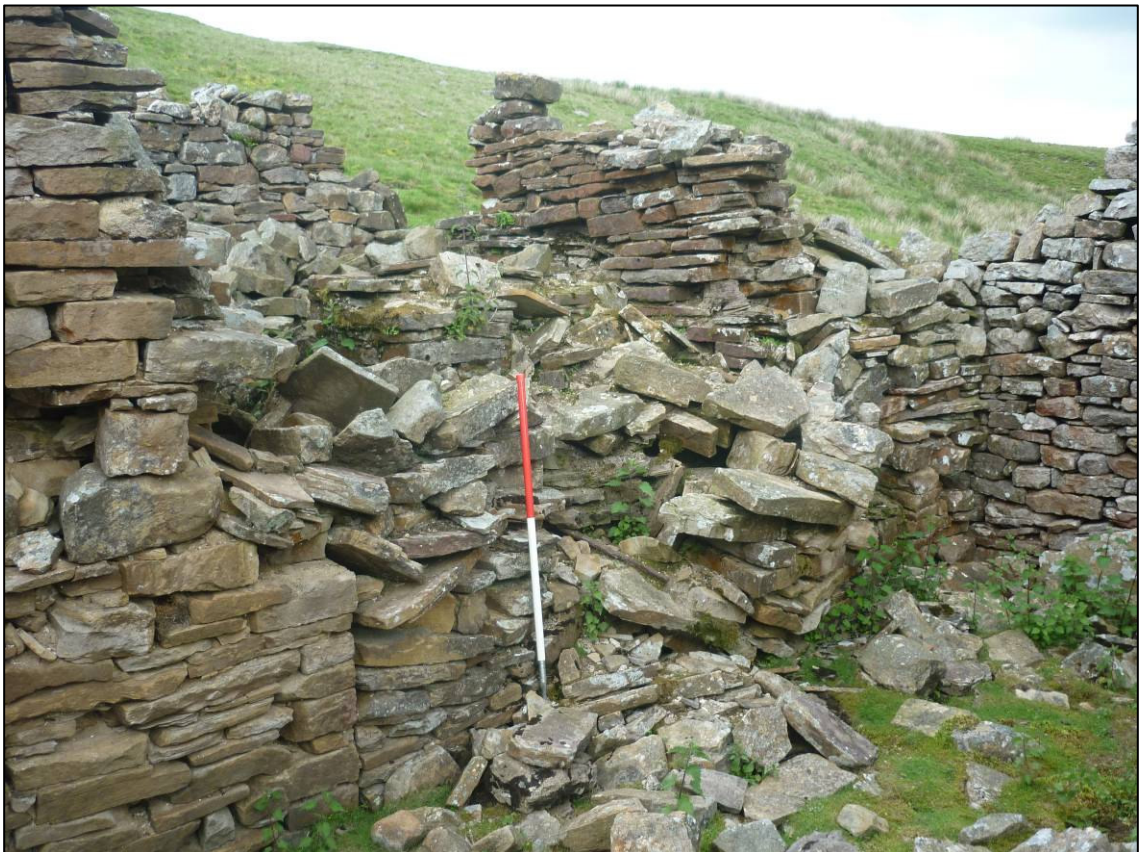
Plate 15: View of slag hearth (SAR 39) with drystone blocking on the side of smelting room (elevation 12), looking N (photo 1/461).

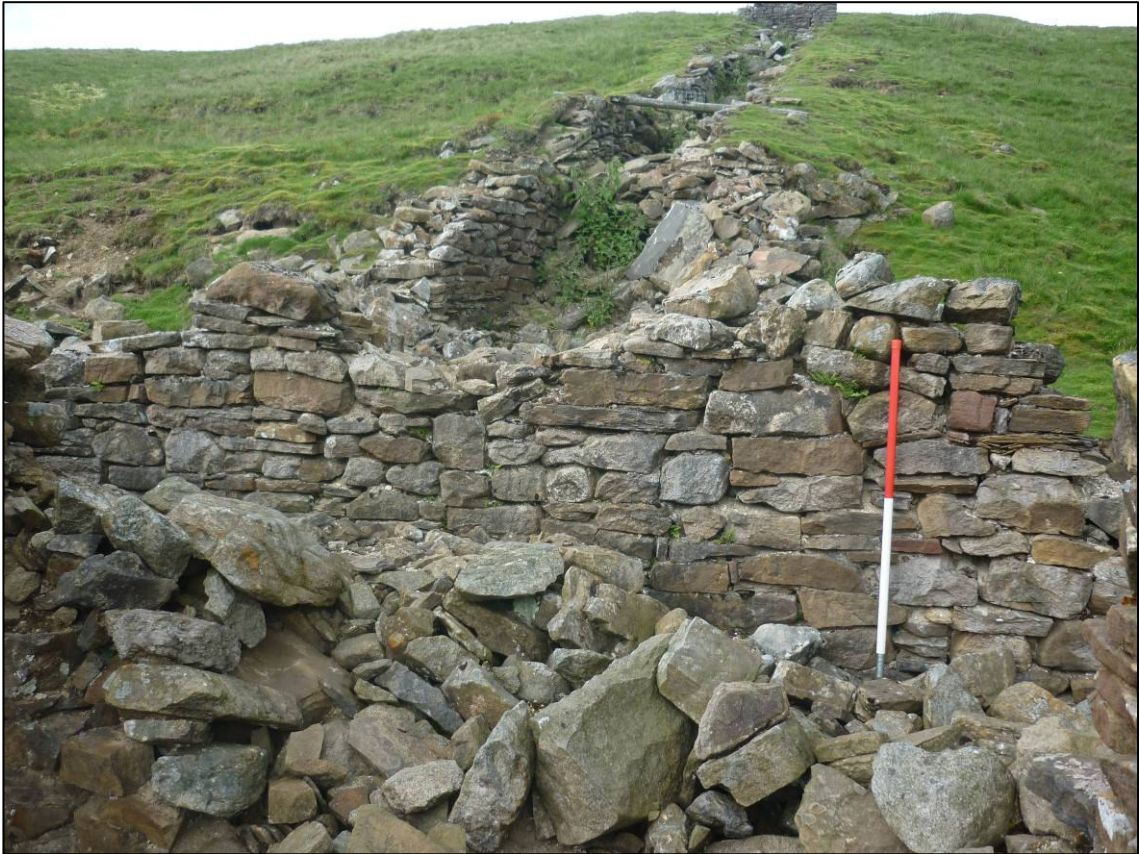
Plate 16: North wall of east-west passage (SAR 50.1, elevation 18), looking N (photo 1/465).

- 3.23 As has already been noted above, to the rear (north) of the furnaces there is a rubble-choked east-west aligned passage partly defined by wall **SAR 40** to the south and wall **SAR 50.1** to the north, that was mistakenly interpreted in 1997 as formerly housing the air-pipes from the bellows. In 1857, three conjoined sub-square structures are shown in this general location, outside the main body of the mill, and with the flue running north from the central structure. Clough shows the south wall here in 1948, pierced by two openings, each positioned behind one of the two ore hearths. The passage is divided into two parts of equal size, the east part labelled as a condenser, while the west part is shown as being flagged over (Clough 1980, 101). Interestingly, a small aperture with a flag roof may just be visible in this position on a slide taken in 1984 (Richard Lamb collection, 84031; see figure 7 top). Raistrick (1975, 98) stated that the structures shown by Clough were 'two small condenser chambers'. It is possible that the passage is a later addition to the mill, and it might have functioned as a dust chamber to help allow the settling out of particles of fume, replacing an earlier arrangement. Clearly, whatever arrangement existed latterly was thought to be inadequate in some way, as work was clearly started on a northern extension to the flue, although the structure was never built (see below; Richard Lamb, *pers. comm.*).

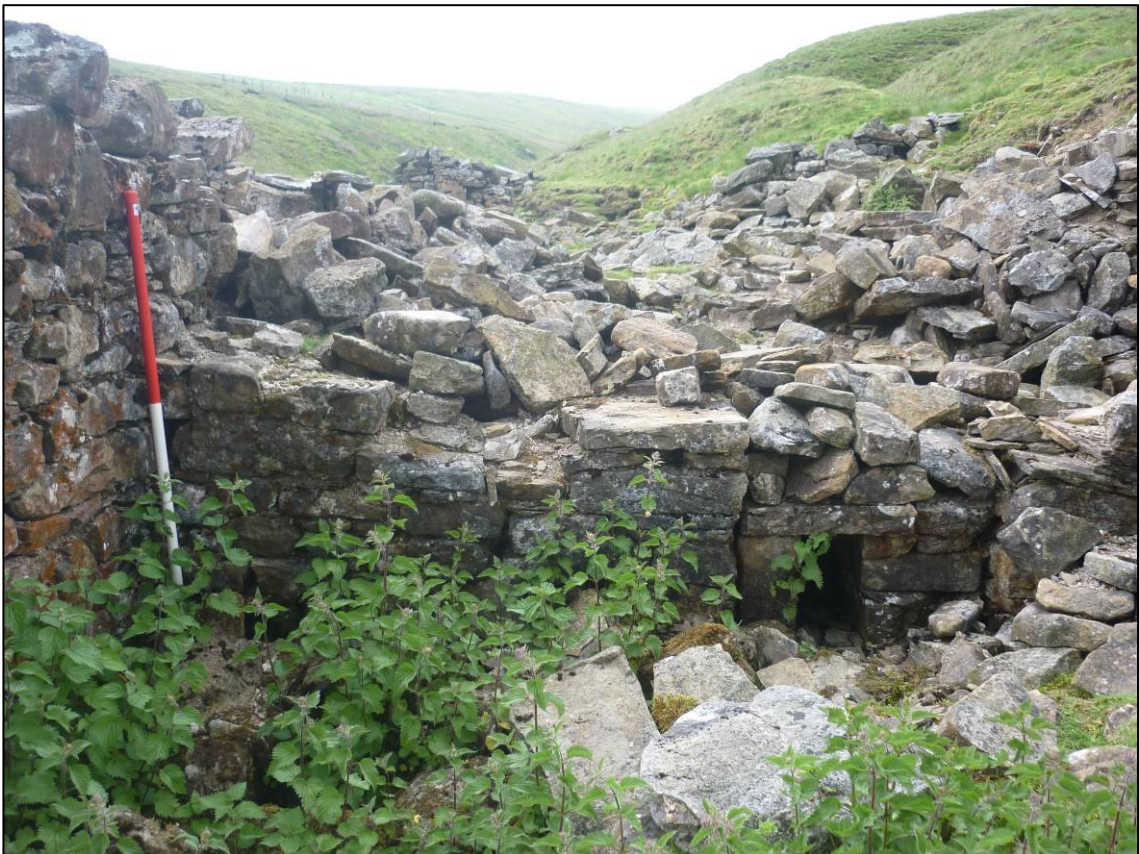
Plate 17: 'Cleaning door' opening in east side of possible settling chamber (SAR 50, elevation 17), looking W (photo 1/467).

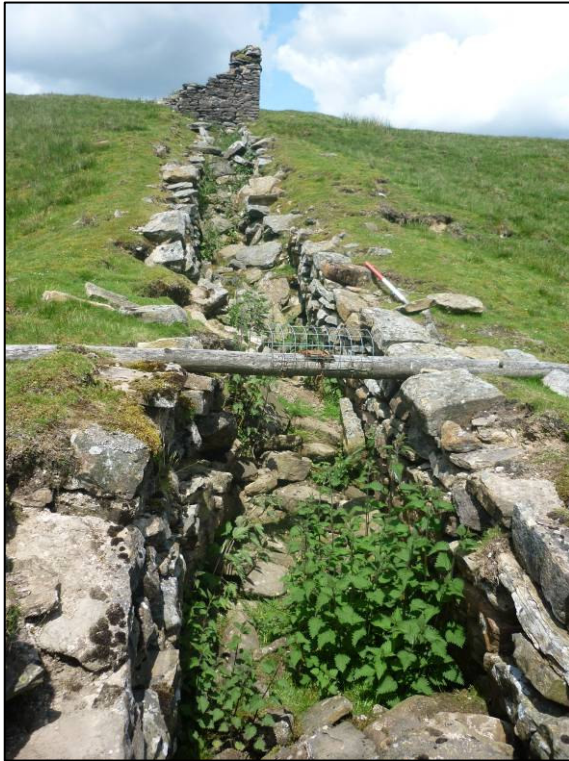
Plate 18: View up flue (SAR 9), looking N (photo 1/389).

Site Number SAR 09
NGR SD 89763 92603 - 89764 92622
Site type Flue
Period Nineteenth Century
Condition Good
Dimensions 18.80m long, 0.80m wide, 0.50m deep at north, 0.80m deep at south
Description A straight flue running north from possible condensing chamber SAR 50 to chimney SAR 04. The flue is a vertical straight-sided trench, lined on both sides with mortared stone walls 0.45m thick. The top is flush with the ground surface, suggesting that it survives to original height. There is no sign of vaulting; the top was probably stone flagged, although the apparent lack of slab-sized stone on the site suggests otherwise. Alternatively the top could have been wooden.
EDAS additions The feature is still as previously described. Comparison with the photograph published by Raistrick (1975, 97) and one taken by Lamb in 1984 (RL 84031) show that the fallen and *in situ* stonework of the flue have undergone little change in the past c.40 years. The sides of the flue survive up to 1m in height internally. Since 1997, a vermin trap has been created across the lower (southern) end of the flue. To secure the east end of the timber supporting the trap, a small number of stones around the top of the flue have been moved. Photos 1/386 to 1/392.

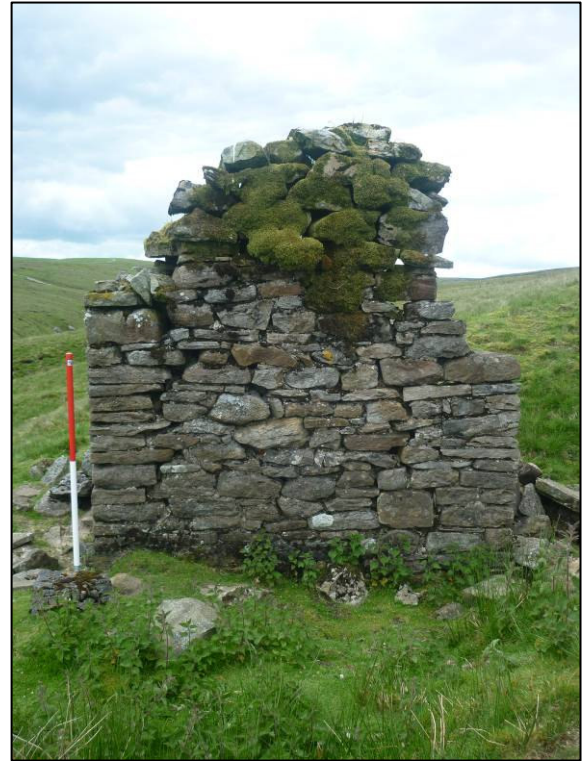
Plate 19: East side of chimney (SAR 04, elevation 2), looking W (photo 1/380).

Site Number SAR 04
NGR SD 89764 92623
Site type Chimney
Period Nineteenth Century
Condition Fair
Dimensions 2.16m long, 2.00m wide, 2.40m high on east side
Description The remains of an almost square-plan chimney stack situated at the north end of flue SAR 09. It is constructed of mortared stone; there is a course of through-stones at the top of the east wall, although these may be a ledge or baffle. The west wall does not survive.
EDAS additions In the photograph taken by Backhouse in 1905/06 (Raistrick 1975, 96), all four external elevations of the chimney survived to a considerably greater height than they do currently. The undated photograph published by Raistrick (1975, 97) but which must have been taken at least 30-40 years after Backhouse's shows that substantial collapse had taken place to the north and west sides in the intervening period.
The chimney has undergone some further minor collapse since 1997. To the east side of the south external elevation (Elevation 1) [1/379], stone facing survives to 1.38m above ground level (AGL), but above this (to 2.15m) is exposed corework; the corework is not shown in 1997, although overall the elevation is little different than in the photograph published by Raistrick (1975, 97). A short distance to the west of the east side of the same elevation, a ragged joint may rise vertically for a short distance, although this may be no more than a crack. On the east external elevation (Elevation 2) [1/380], there appears to have been some collapse at the upper north end; it is not easy to reconcile a line of through-stones marked in 1997 with the existing structure. The uppermost part of the elevation is unmortared, covered in moss and quite loose, and gives the impression of having been piled on top, rather than being a remnant of a mortared wall; it is arguably not present in the photograph published by Raistrick (1975, 97). On the north external elevation (Elevation 3) [1/381] only a small part of the original stone facing survives; the majority of the elevation is exposed corework, and a small section at the west end appears to comprise loose stones which have been piled there relatively recently, although they are differentiated in 1997. A step to the internal east elevation (Elevation 4) can be seen in profile in the external north elevation (Elevation 3). The west external elevation, as reported in 1997, barely survives AGL.

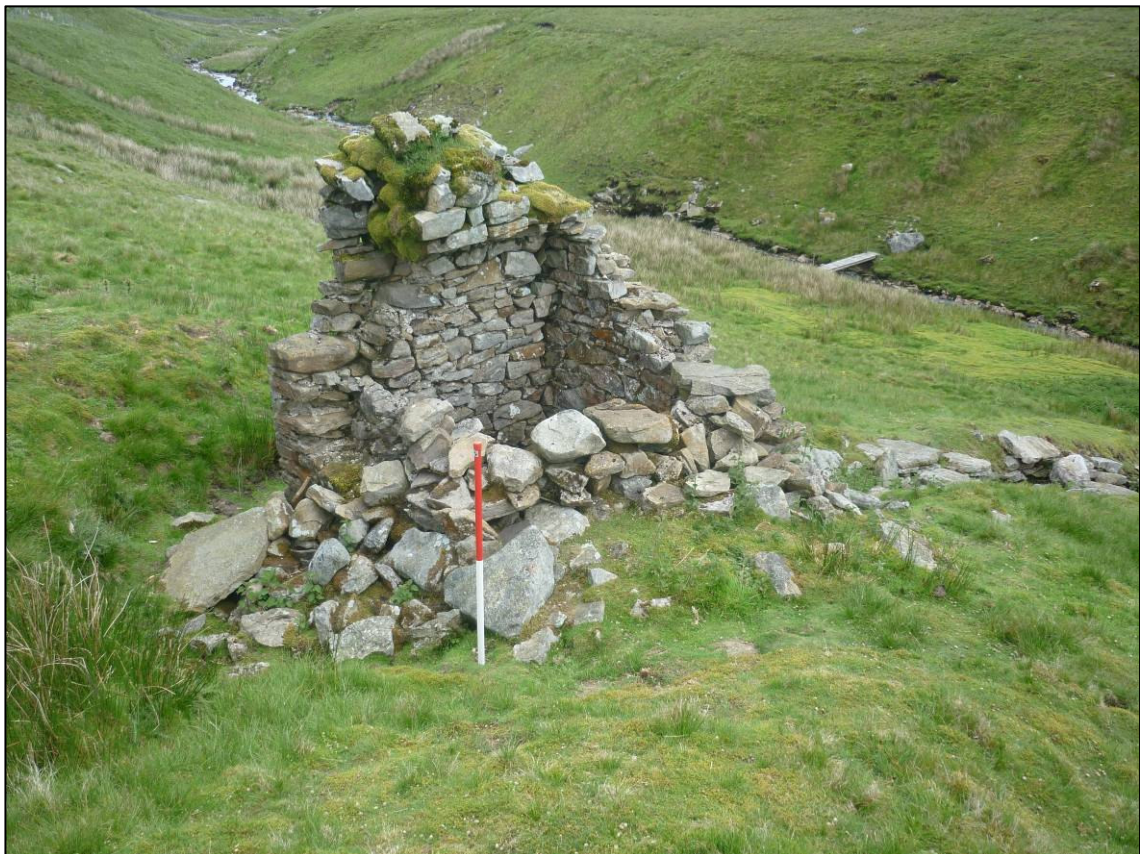
Plate 20: Chimney (SAR 04) at north end of flue (SAR 09), looking SE (photo 1/377).

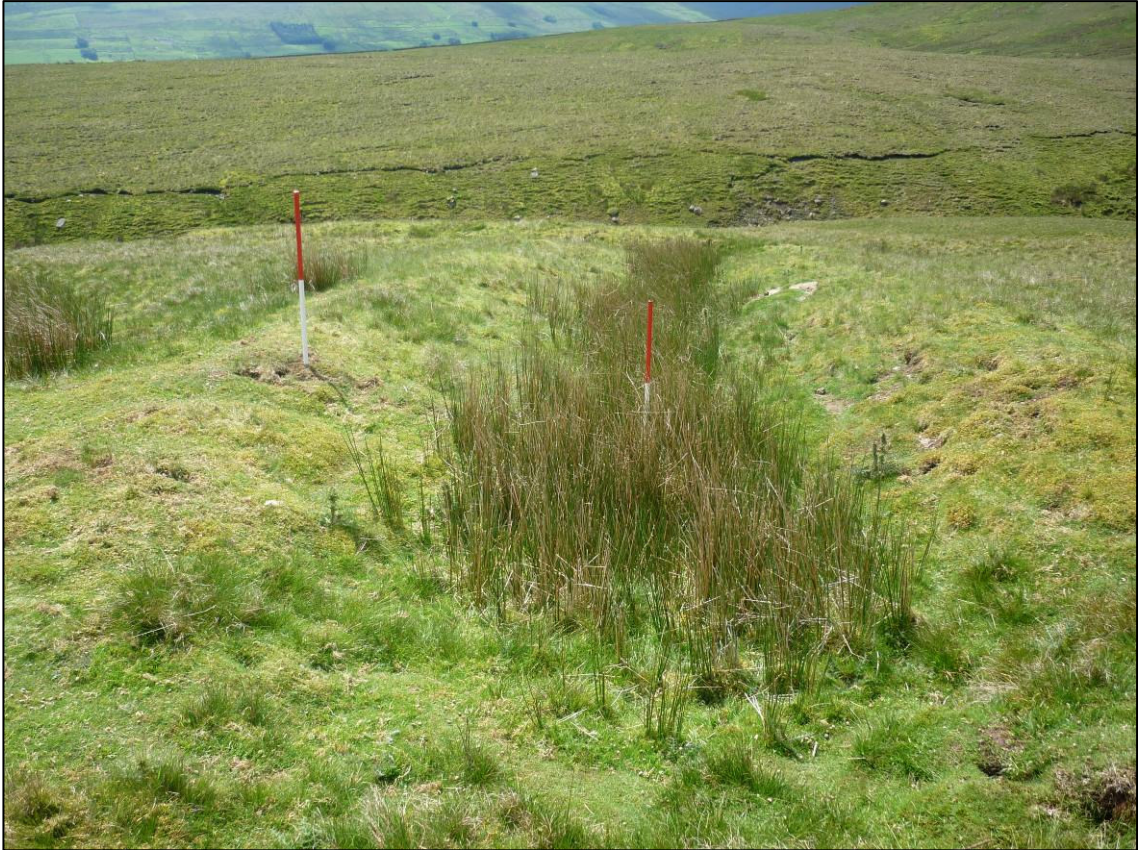
Plate 21: North end of zig-zag flue extension (SAR 01), looking S (photo 1/371).

Site Number	SAR 01
NGR	SD 89767 92683 - 89764 92625
Site type	Trench
Period	Nineteenth Century
Condition	Good
Dimensions	73.50m long, 5m wide at top, 0.85m wide at base, 0.80m deep
Description	'V'-section trench, zigzag in plan, running north up the hillside from chimney SAR 04. It has shallow banks of spoil to either side of the trench. It widens slightly at the northern end probably for a chimney base. It was the construction trench for an extension to the flue, which was never completed.
EDAS additions	The feature is still largely as previously described. The profile, rather than being 'V-section', is more a relatively level base with a short vertical section to either side, which then angle backwards towards the banks running parallel to the sides. There is no evidence for stone lining or any other construction within the trench. There is a very slight bank running parallel to the top eastern edge of the northernmost north-west/south-east aligned section of the trench, which is not shown on the 1997 survey. This is the reverse of the section to the north, where the narrower bank is to the western side and the wider bank to the eastern. The feature does not appear on the 1857 Ordnance Survey map, suggesting that it may have been added after this date. However, neither is it shown on the 1914 edition, and so its omission in 1857 may not be significant. It is not mentioned by either Clough or Raistrick. This form of 'zig-zag' flue is not common in Yorkshire, and is more usually associated with smelt mills in Derbyshire, for example (Richard Lamb, <i>pers. comm.</i>). Photos 1/371; 1/372.

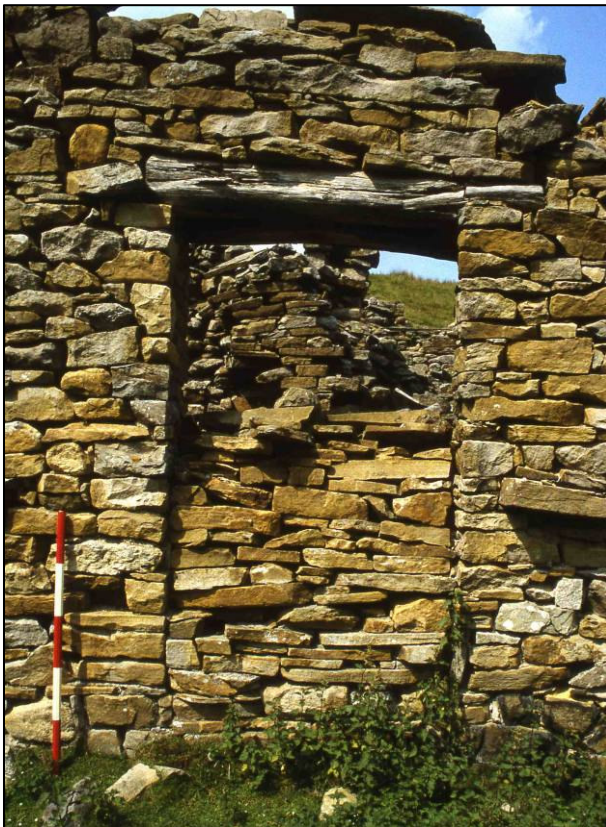
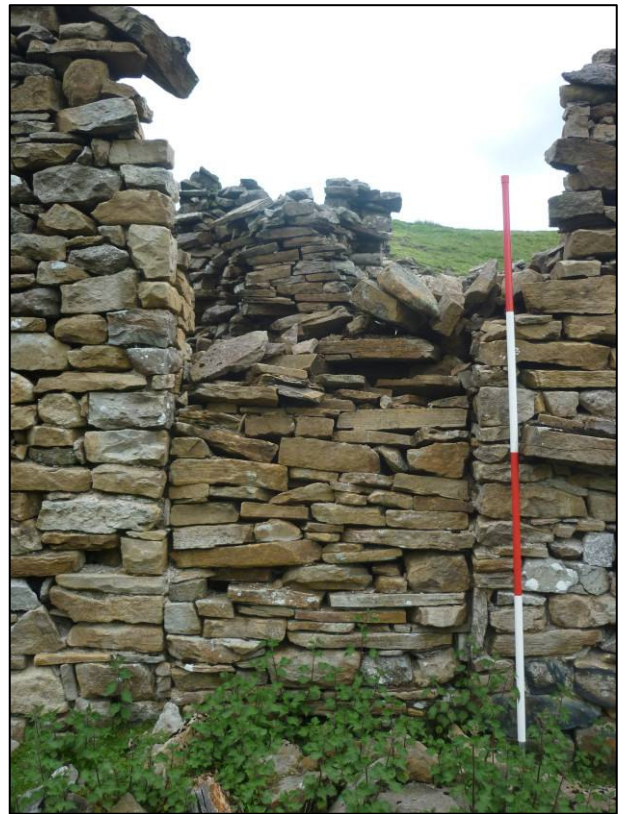
Plate 22: Door at east end of south external wall of smelt mill (SAR 31.1, elevation 5), looking N - in May 1997 (left) and June 2012 (right).

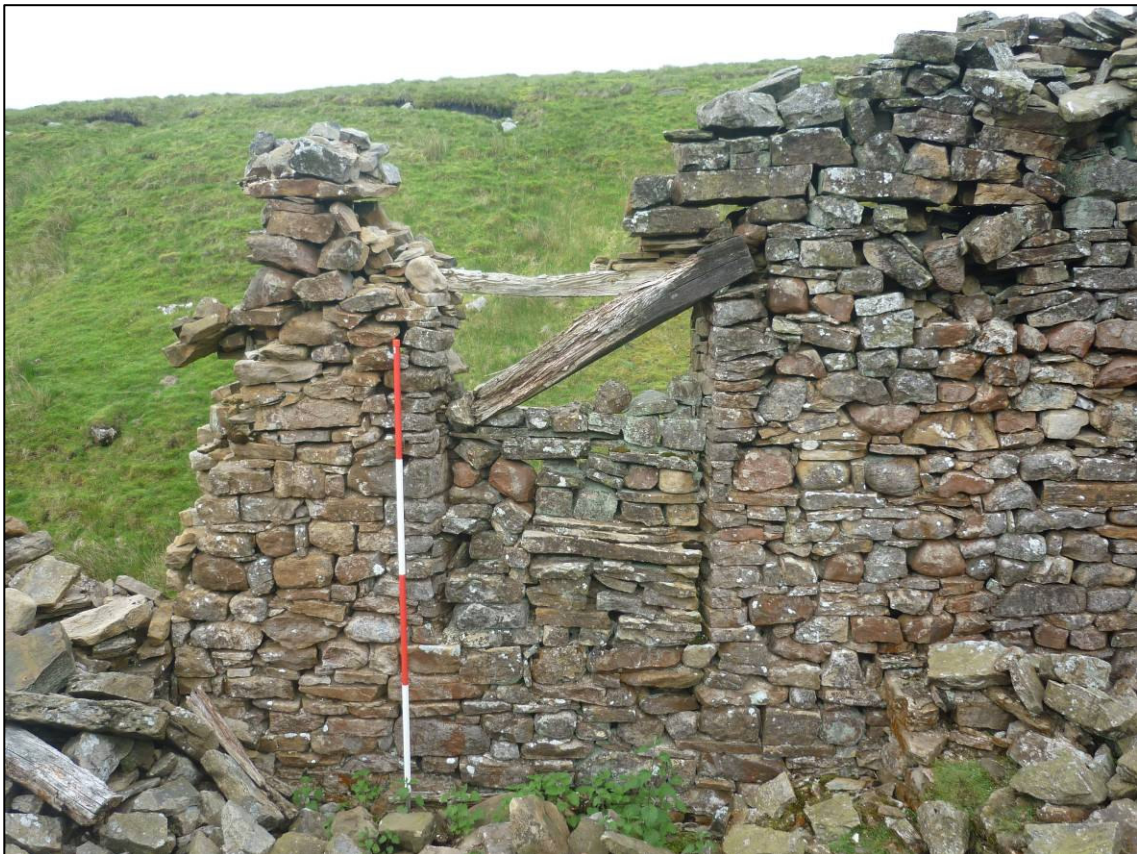
Plate 24: Window in centre of south internal wall of smelt mill (SAR 31.1, elevation 14), looking S (photo 1/427).
