EXTERNAL DRAINAGE WORKS,
ST LEONARD'S CHURCH,
THRYBERGH, SOUTH YORKSHIRE

ARCHAEOLOGICAL OBSERVATION,
INVESTIGATION AND RECORDING

Report no: 2011/398.R02
Version: Final
Date: July 2013
Author: Ed Dennison

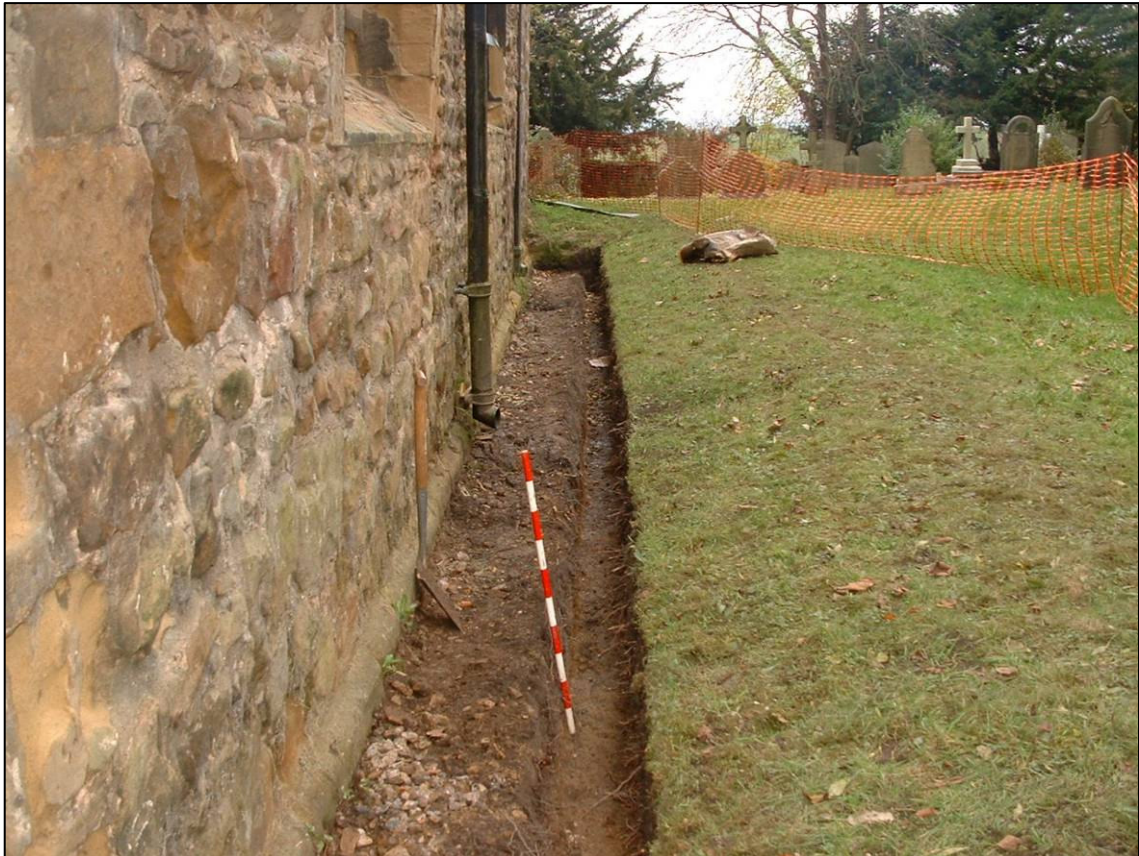
- 4.1 This trench was dug along, and parallel to, the north side of the church, with an extension to the north-east from the east end running to a new soakway (Trench 2). Trench 1 measured c.37.0m long by 0.30m wide, and was excavated to a maximum depth of 0.60m (see plates 1 and 3). A natural deposit [105] composed of fragmented sandstone bedrock was encountered in the base of the trench at c.0.60m BGL (below ground level). Overlying this was either a levelling or demolition layer [104] up to 0.30m thick that was composed of loose sandstone rubble.

Plate 1: General view of excavated Trench 1 within cleared area on north side of nave, looking W.

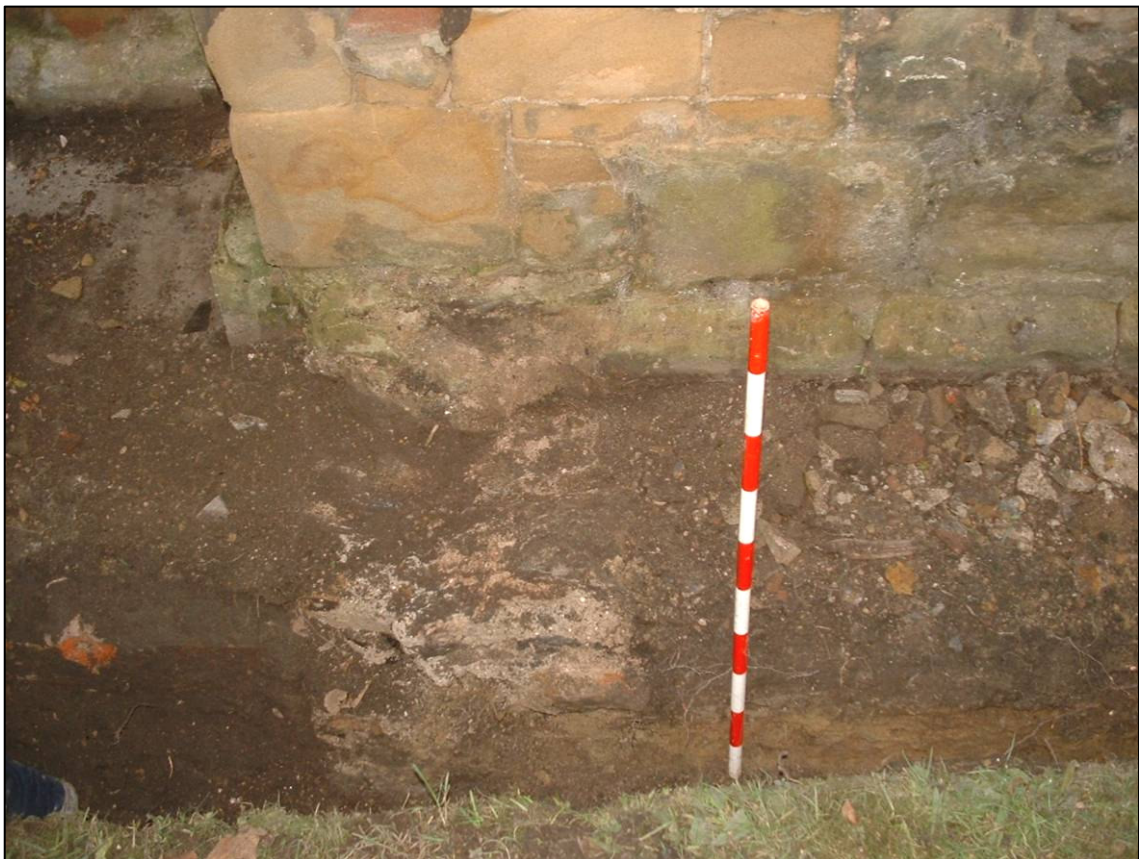
- 4.2 Dug into this layer [104], in the eastern half of the trench, were two mortared sandstone rubble foundations [101] and [102]. Both foundations measured 0.50m wide and were aligned north-south across the width of the trench, c.2.90m apart from each other. The western foundation [101] was partly visible on the surface and appeared to be contemporary with the existing nave wall; it was aligned on the north-east corner of the nave (see plate 2). The function of these two foundations, or indeed any relationship between the two, could not be established. Located to the east of foundation [102] was a north-east/south-west aligned red brick and sandstone capped culvert [103], 0.30m wide, which was associated with the former roof drainage system. Sealing the two foundations [101] and [102], and culvert [103], was a 0.10m depth of dark brown sandy silt topsoil and turf [100].

Plate 2: Foundation [101] exposed in Trench 1, at junction of nave and chancel, looking S.

- 5.2 The two parallel 0.50m wide sandstone foundations [101 and 102] exposed on the north side of the church at the west end of the chancel are of interest, and they may represent the remains of an earlier and/or attached structure here. However, the location and orientation of the western foundation [101] implies that it might be a former buttress. Unfortunately, the limited scale of the excavations meant that the dates and functions of the foundations could not be ascertained, or even if the two foundations were related.

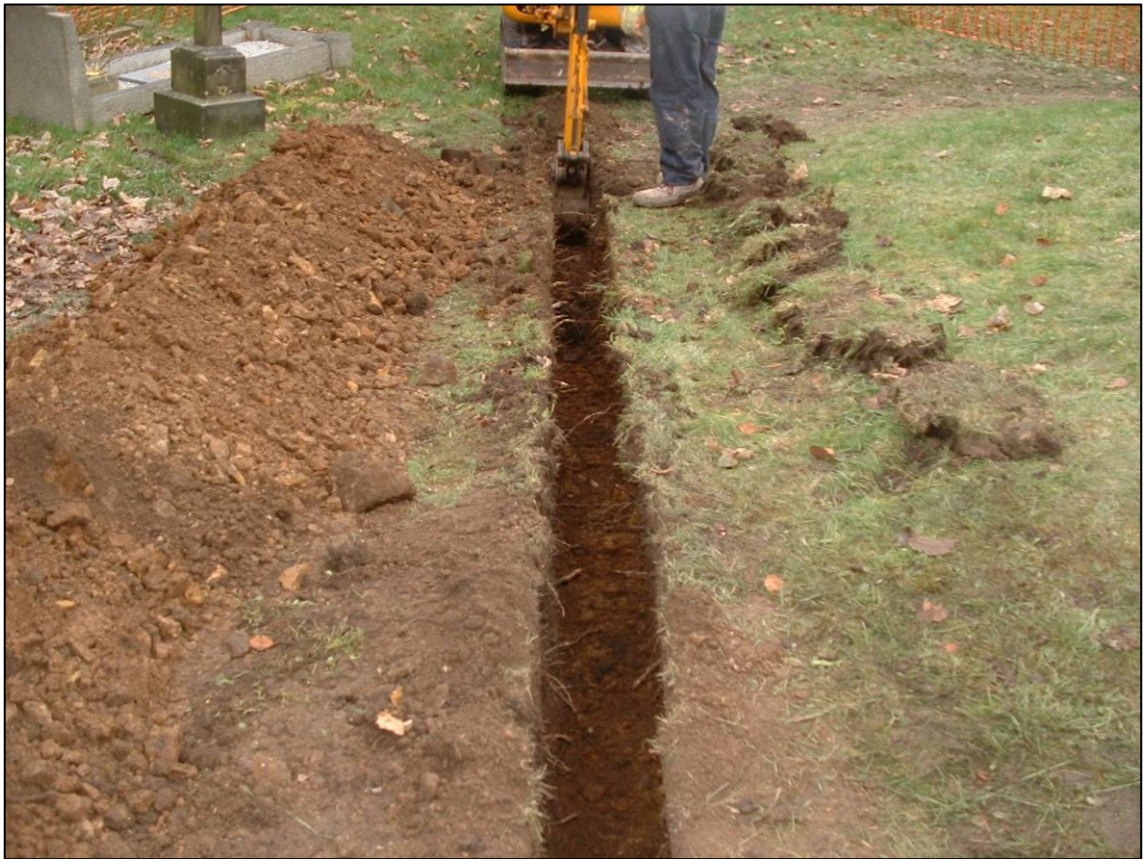
Plate 3: General view of east end of Trench 1, looking NE towards Trench 2.

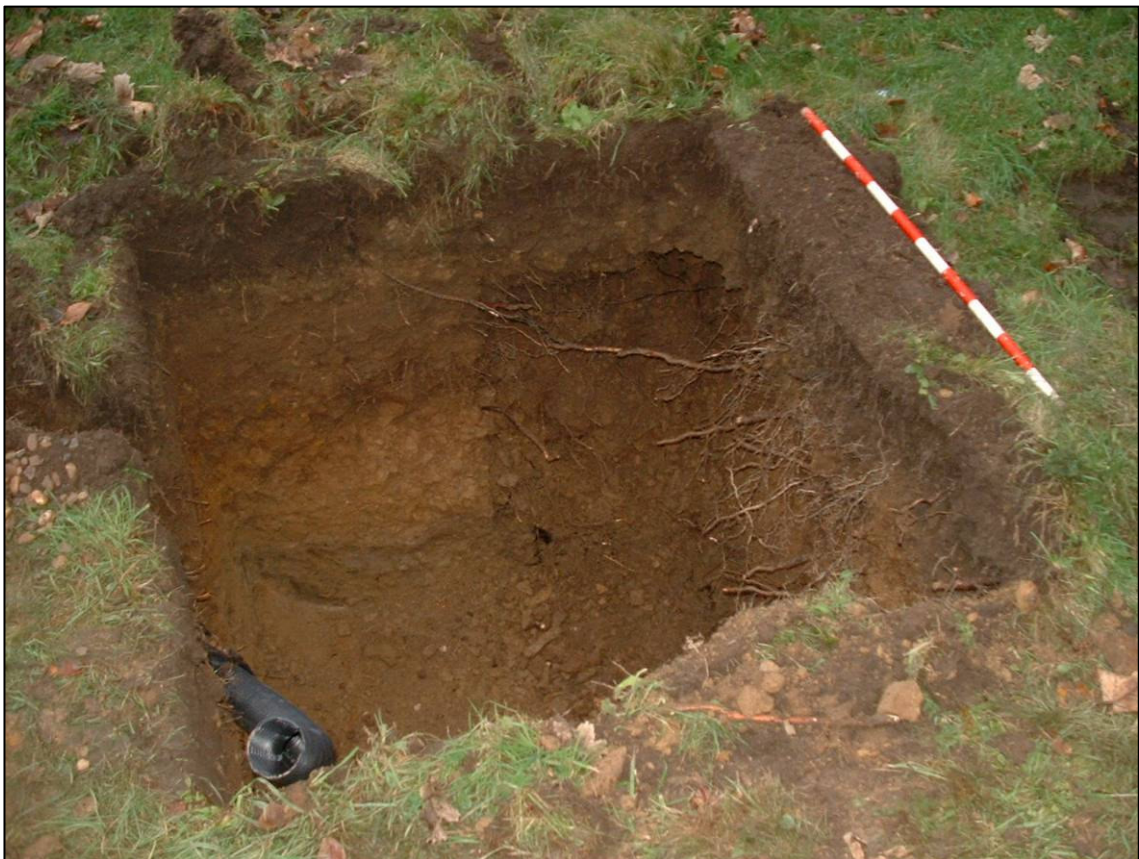
- 4.5 The underlying natural deposit [204] was composed of the same fragmented sandstone bedrock seen in Trench 1, here encountered at c.0.70m BGL. The natural was sealed by a 0.50m depth of a greyish-brown sandy silt graveyard soil [203]. Cut into this graveyard soil along the north side of the trench was a probable east-west grave cut [202] that was exposed for a depth of 0.80m and a width of 0.50m (see plate 4). The grave cut contained a mixed dark brown sandy-silt fill [201], 0.80m deep, as well as fragmented inclusions of re-deposited natural sandstone. Sealing the grave fill was a dark brown sandy silt topsoil and turf [200] that was 0.20m deep. On the south side of the trench, the greyish-brown sandy silt graveyard soil [203] lay directly under the dark brown sandy silt topsoil [200] which was 0.20m thick.

Plate 4: West side of Trench 2 (soakaway) showing grave cut [202] on right, looking NW.

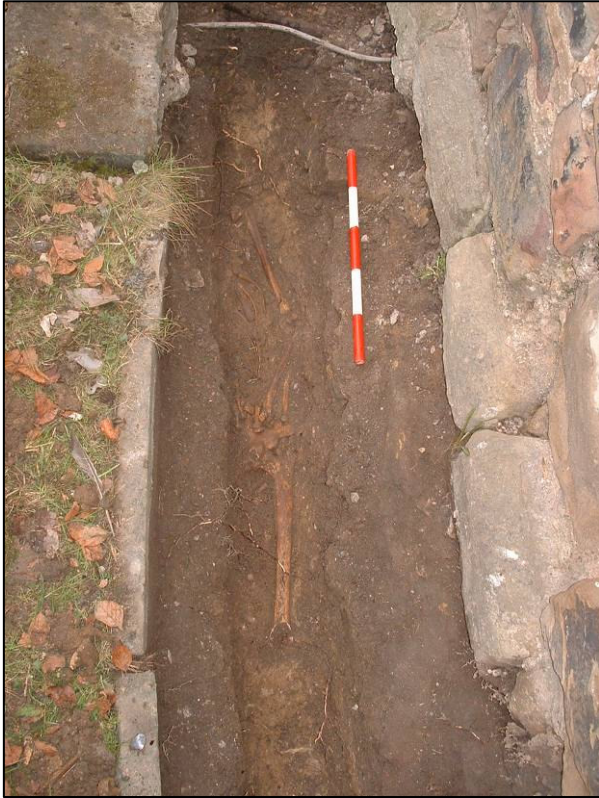
- 4.7 Towards the centre of the trench, adjacent to the junction of the nave and chancel, a grave cut [305] was partly exposed cut into the natural [309]. The cut [305] measured 1.60m long and was exposed for a width of 0.25m and a depth of 0.20m. Excavation of the cut revealed the left side of an inhumation [304] in an extended supine position and orientated east-west with the skull (not exposed by excavation) at the west end of the grave; the top of the skeleton lay at a depth of 0.35m BGL while the base of the grave was at 0.44m BGL (see figure 4). The left arm was slightly flexed with the hand rested on the pelvic area and the left leg was extended - the lower leg had been initially disturbed by the excavation work (see plate 5). The grave contained a single fill consisting of a dark brownish-grey clayey-sandy-silt [303], with occasional sandstone and charcoal fleck inclusions. A number of small copper alloy studs were recovered from the fill just above the pelvic area along with a larger ferrous metal stud/nail, which implies the presence of a coffin although no remains were visible within the excavated trench. A single sherd of residual medieval pottery was also recovered from the grave fill [303]. The excavated remains were reburied within the base of the excavated trench.

Plate 5: In situ burial [304] exposed in Trench 3 at east end of south side of nave, looking E.

- 5.1 Given the origins and age of the church, and the longevity of the associated churchyard, it was not unsurprising that the below-ground excavations, although relatively limited in extent, identified one confirmed *in situ* human burial [304] and the probable sites of two other graves [307 and 202]. The *in situ* burial [304] lay on the south side of the church, close to the junction of the nave and chancel, at a depth of 0.35m-0.44m BGL - it comprised the left side of an extended east-west aligned inhumation. Not all remains of this burial were excavated, as it extended beyond the limits of the trench, and the bones were reinterred in the same position in the base of the excavation. The burial could not be dated with any certainty, although the metal studs recovered from the fill of the grave [303] would indicate an 18th-19th century date. The remains of another undated east-west aligned burial [307] were identified just to the east in the same trench, although this had been disturbed by previous drainage work. A further grave cut [202] was noted in the north-eastern soakaway, and hints of another were noted in the south-east soakaway; in these latter two cases, no human remains were identified.

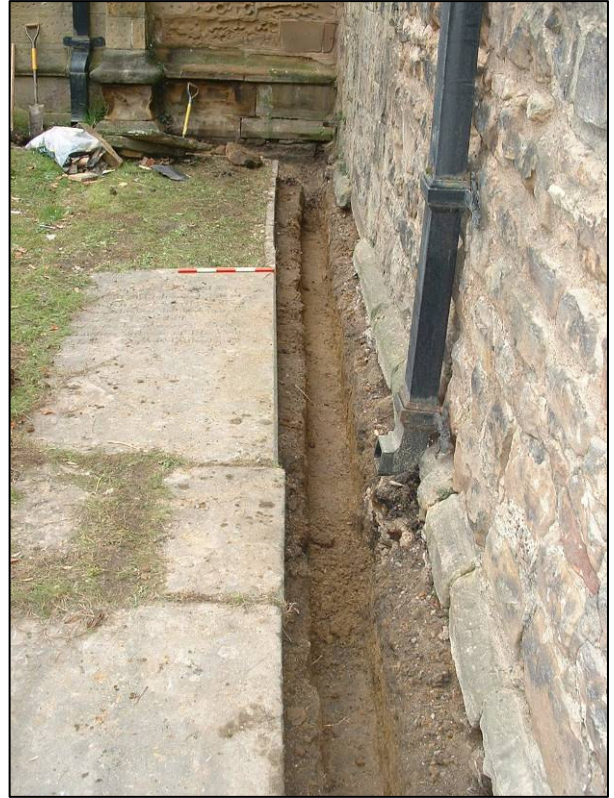
- 4.6 This trench was dug along, and parallel to, the south side of the church, with a dog-leg extension from the east end running to a soakaway (Trench 4); the trench measured c.40.0m long by 0.25m-0.30m wide and 0.60m deep (see plates 6 and 8). The natural fragmented sandstone bedrock [309] was encountered at c.0.35m BGL along the majority of the trench closest to the church walls.

Plate 6: General view of Trench 3 along south side of nave, looking E.

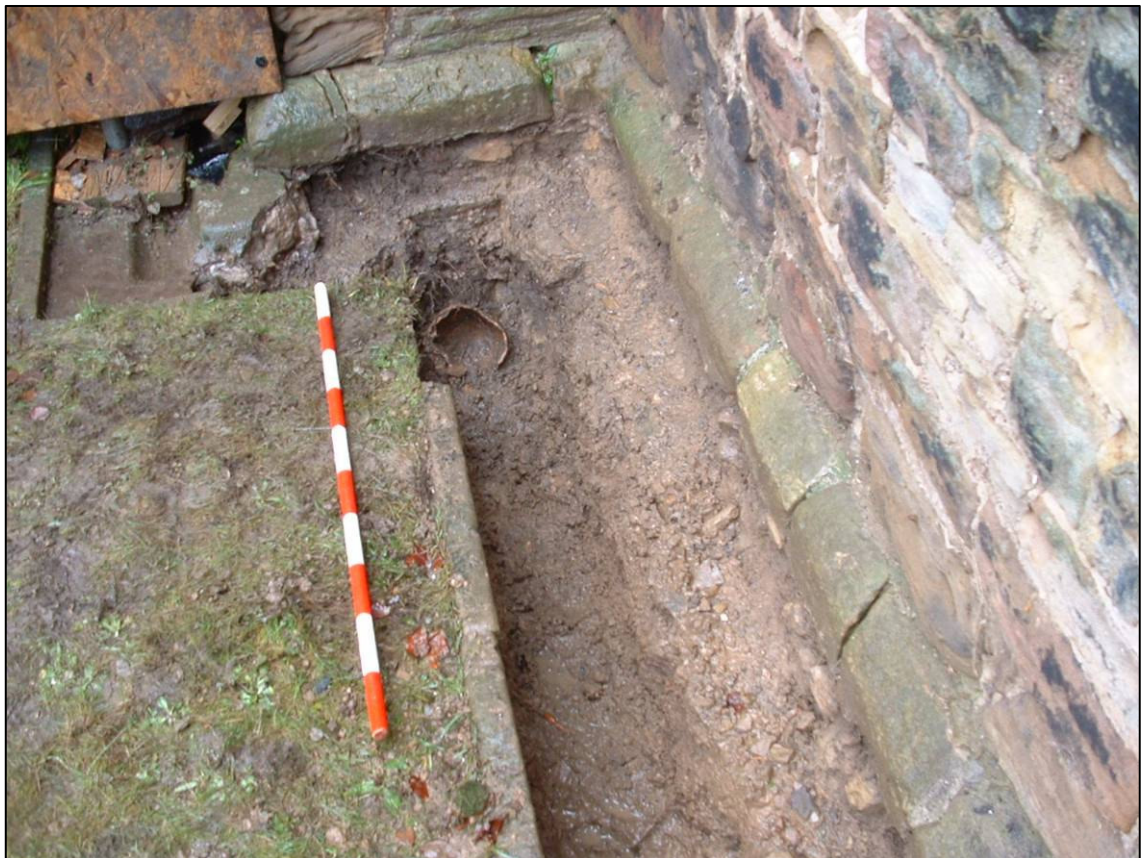
- 4.8 Just to the east of grave 305 was another grave cut [307] that was exposed for a length of 1.00m and width of 0.30m. It contained a fill that consisted of a dark brown-grey clayey-sandy-silt [306], with occasional sandstone and charcoal fleck inclusions. This grave cut was revealed during the removal of a concrete drain and disarticulated human bone was recovered during this process, including the damaged skull (see plate 7). It is likely that the burial had been disturbed by the previous installation of the concrete drain. Once again, the bones were replaced in the excavated trench.

Plate 7: Disturbed in situ burial [307] exposed in Trench 3 at west end of south side of chancel, looking E.

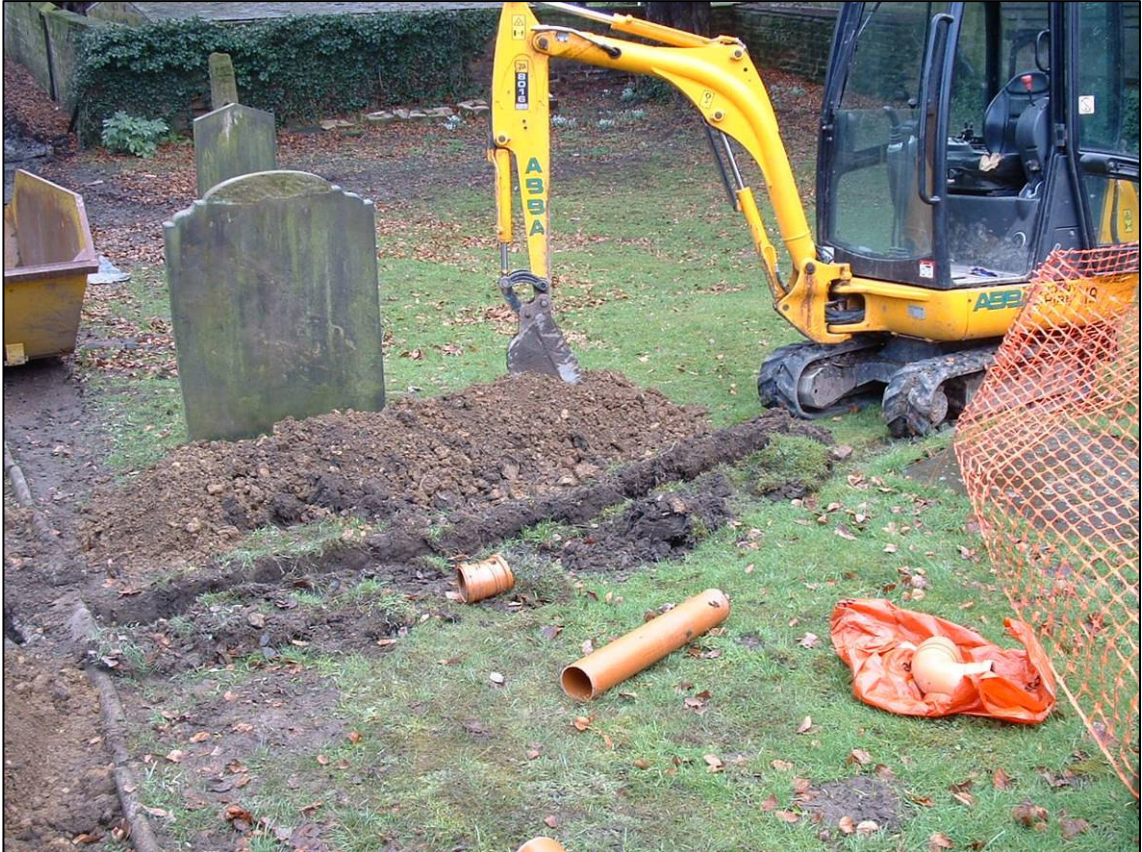
- 4.10 Towards the south-east corner of the chancel, Trench 3 was diverted to the south-east towards Trench 4. It was at this point that layer 308 became prevalent and sealed the natural deposits [309]. Layer 308 consisted of loose brownish-orange sandstone and sandy silt with a maximum depth of 0.40m, and they appeared to represent either a landscaping deposit or a graveyard soil sealed by a dark brown sandy silt topsoil and turf 0.20m deep [310].

Plate 8: Excavation of Trench 3 on south side of path towards Trench 4, looking E.

- 5.3 The presence of a loose brownish-orange sandstone and sandy silt [308 and 401], seen in the eastern extent of Trench 3 and in the adjacent soakaway (Trench 4), and which extended to a depth of 1.10m below the topsoil, suggests that the area off the south-east corner of the church is made-up ground, possibly associated with former landscaping.

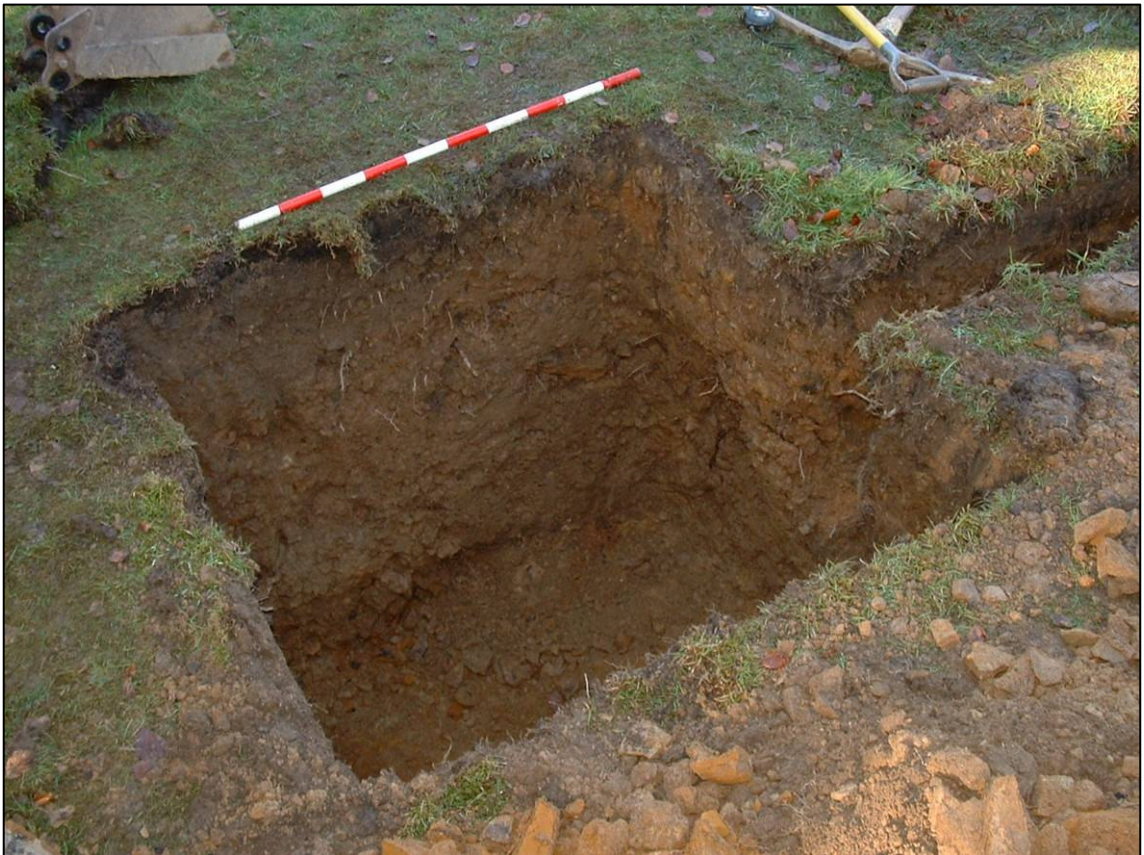
- 4.11 Trench 4 was another soakaway (no. 1) located in the south-east corner of the churchyard, and the area of excavation measured 1.20m by 1.20m. Although the trench was excavated to a maximum depth of 1.30m, natural deposits were not exposed. The soakaway lay c.4m to the north-west of one of the percolation pits (PP1) dug in 2011.
- 4.12 A loose brownish-orange sandstone and sandy silt [401] with an exposed depth of 1.10m was seen, which represents a continuation of layer 308 recorded in Trench 3 (see plate 9). Within the southern edge of the trench, layer 401 appeared disturbed possibly indicating the presence of an adjacent grave, although no such feature was noted in the excavation. Sealing layer 401 was a dark brown sandy-silt topsoil and turf [400], 0.20m thick. No finds were recovered from Trench 4.

Plate 9: General view of Trench 4 (soakaway) after excavation, looking W.
