PLATELAYERS' HUT, NORTH OF RIBBLEHEAD VIADUCT,
RIBBLEHEAD, NORTH YORKSHIRE

ARCHAEOLOGICAL SURVEY

Report no: 2013/462.R01
Version: Final
Date: August 2013
Author: Shaun Richardson & Ed Dennison

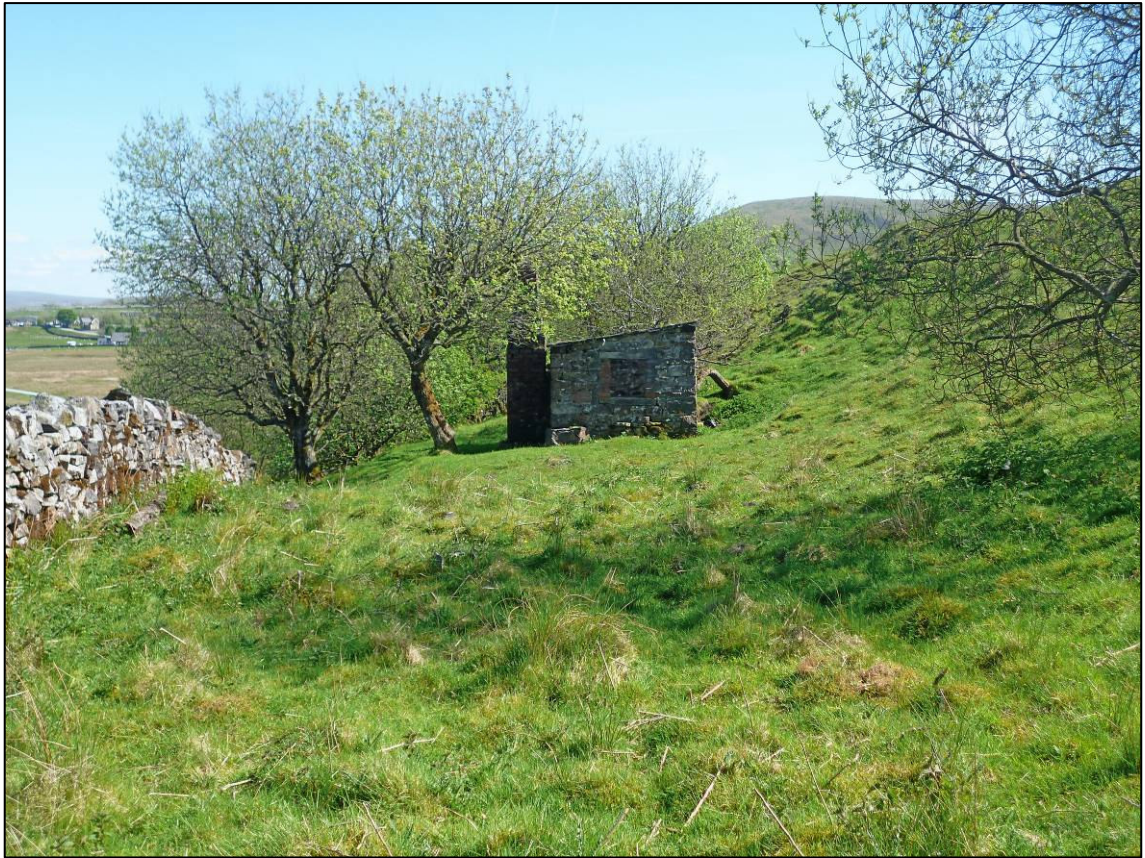
Plate 1: General view of Platelayer's hut, looking S (photo 1/761).

- 4.3 As already noted above, the hut is positioned on the 'Up' side of the Settle to Carlisle Railway line, to the immediate east of the southern end of the Ribblehead viaduct's north embankment. A slight terrace has been created near the bottom of the embankment's eastern slope [1/760, 1/761], so that the hut stands on a level platform [1/729, 1/730] (see plates 1 and 2). There is a scarp to the east, sloping down towards the adjacent drystone wall, and a smaller scarp around the north-west corner of the hut, sloping towards the building. The ground level falls away steeply to the south of the hut, following the natural topography, and it appears that the hut was originally approached from the north-west, inside the line of the existing drystone wall, along a flattened strip of ground resembling a trackway.

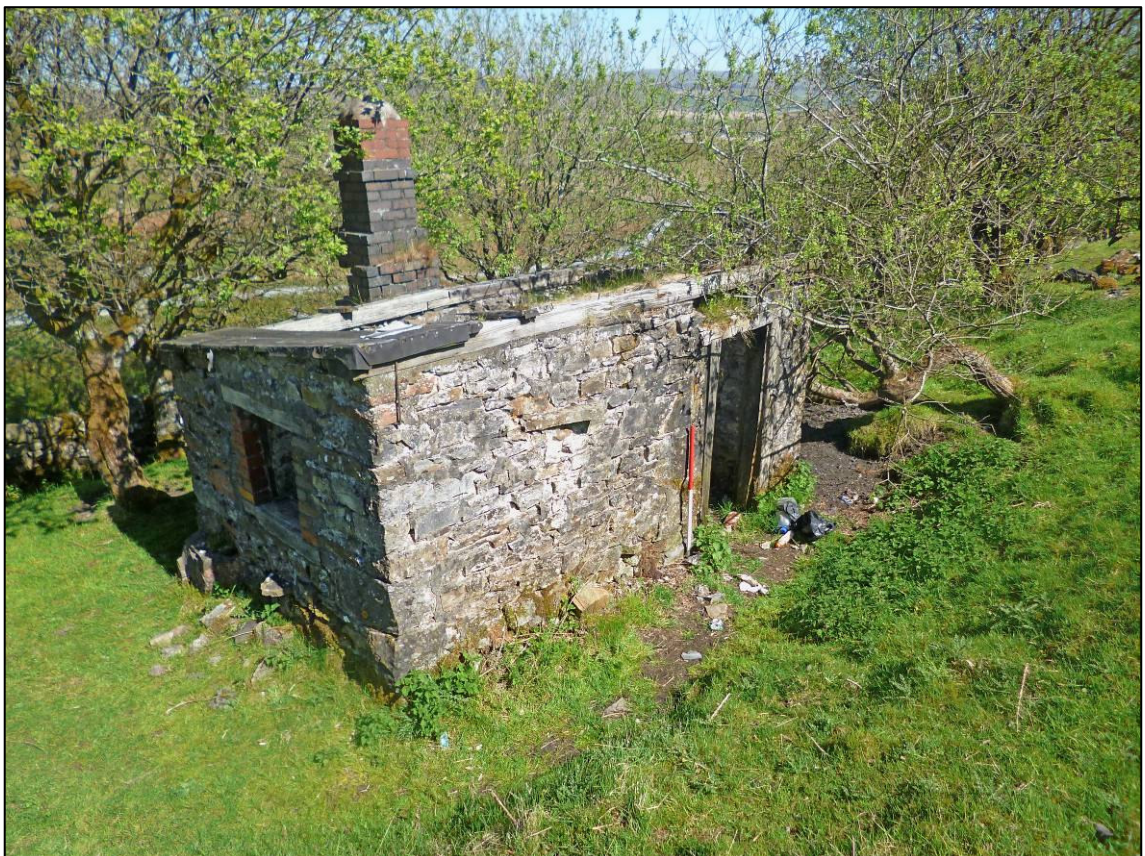
Plate 2: Platelayer's hut, looking SE (photo 1/738).

- 4.4 The hut has a slightly sub-rectangular plan, with maximum external dimensions of 4.24m north-south by 2.68m east-west; the external walls vary in width between 0.40m to 0.46m. It is of a single storey, with a former maximum internal floor to ceiling height of c.2.05m (see plate 2).

- 4.9 The south gable is largely obscured by a tree [1/736, 1/737] but appears featureless. The west elevation [1/738, 1/739, 1/740] has a doorway opening at the south end, forming the only access to the interior of the hut (see plate 2). The jambs and lintel of the door frame are made from cut-down railway sleepers, lined with boards [1/741, 1/742] (see plate 8). The door itself has gone, but it was originally mounted externally on a pair of pintles to the north jamb, with a latch to the south jamb. There is some localised collapse over the doorway. As on the east elevation, the two ends of the wall-plate are secured to the stonework below using round-section wrought-iron clamps (see plate 5).

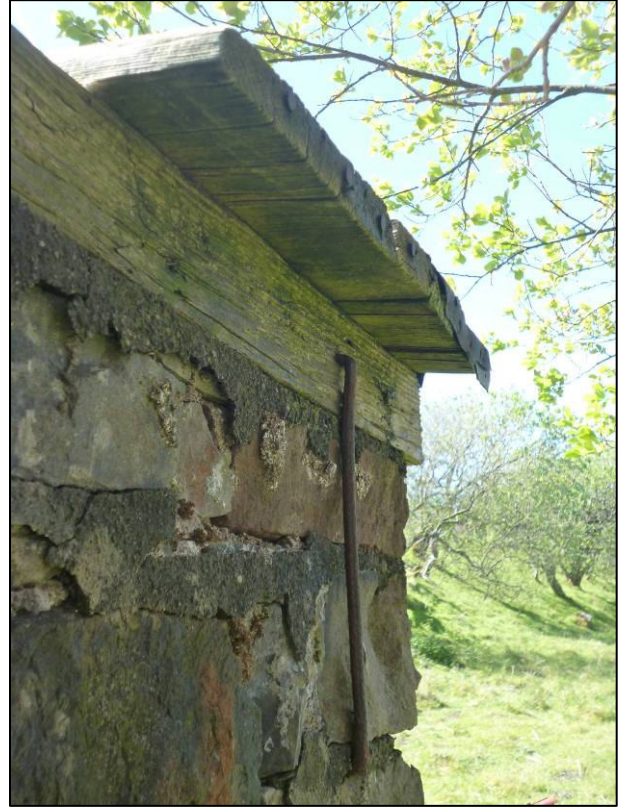
Plate 4: Roofing boards and clamp in north-east corner, looking NW (photo 1/746).

- 4.8 The east elevation [1/732, 1/734, 1/735] is dominated by the external chimney stack (see plate 7). This stack is free-standing, but is linked to the hut by a horizontal flue, c.1.30m in height. Both the flue and the stack are of brick, but rise from a limestone footing, just visible at the base [1/733]. The stack rises to a total height of 3.60m and is initially 0.70m square, but it steps inwards in several stages before reaching the cement capping which presumably once secured a chimney pot [1/731]; small areas of the corner brickwork have collapsed. At either end of the elevation, the wall-plate is secured to the stonework below using round-section wrought-iron clamps [1/745, 1/746] (see plate 4).

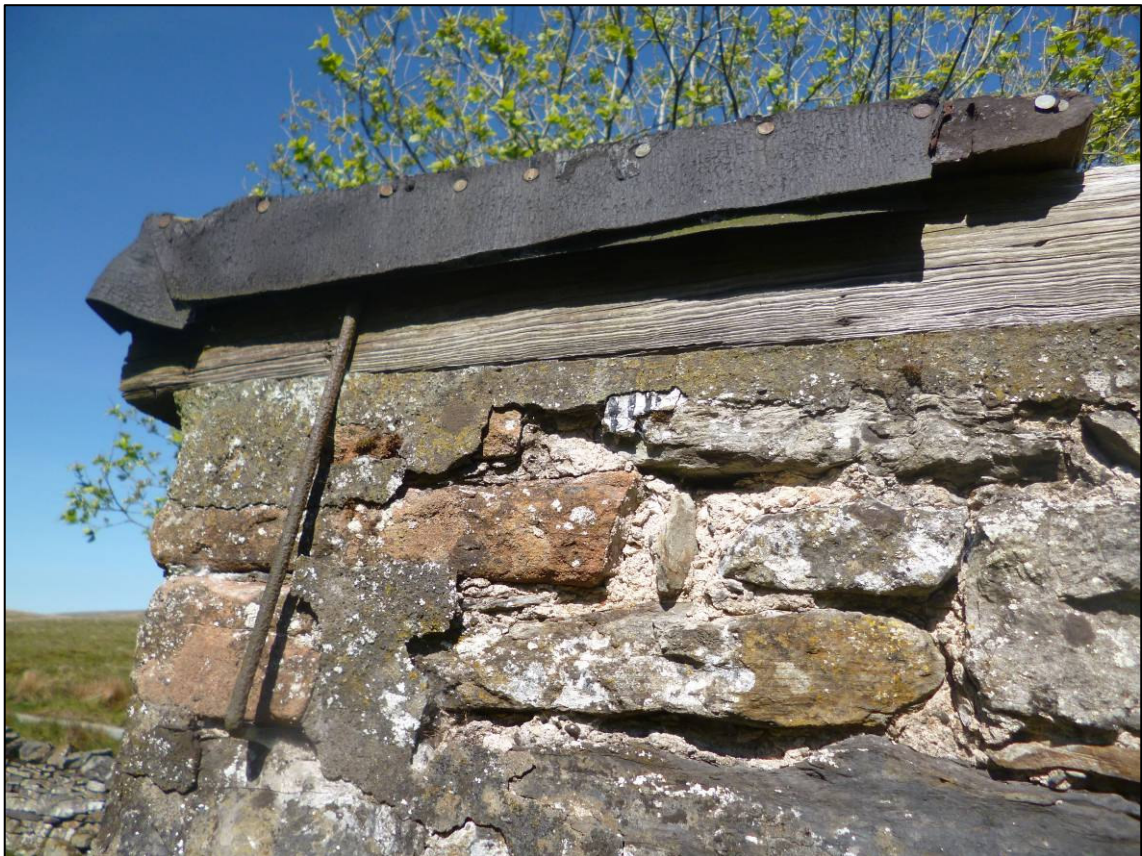
Plate 5: Roof structure in north-west corner, looking E (photo 1/743).

- 4.6 The hut was originally provided with a single-pitch roof, sloping gently down from west to east. The roof structure was simple but interesting, in that the wall-plates running along the top of the east and west walls each comprise a pair of softwood railway sleepers, laid end to end. The sleepers measure 0.25m by 0.12m in section, and are joined at the centre using a simple side-halved scarf with vertical butts [1/750] (see plate 3). Softwood boards, up to 0.24m wide, were positioned across and between the wall-plates, and secured to them using square-section handmade nails [1/757, 1/758, 1/759] (see plate 4). It would appear that a canvas-like material was then laid over the boards, and then the whole covered with felt; the only scraps of such material to survive are at the north-west corner and along the north gable [1/743, 1/744] (see plate 5). The felt had been fixed into place using round-headed galvanised nails.

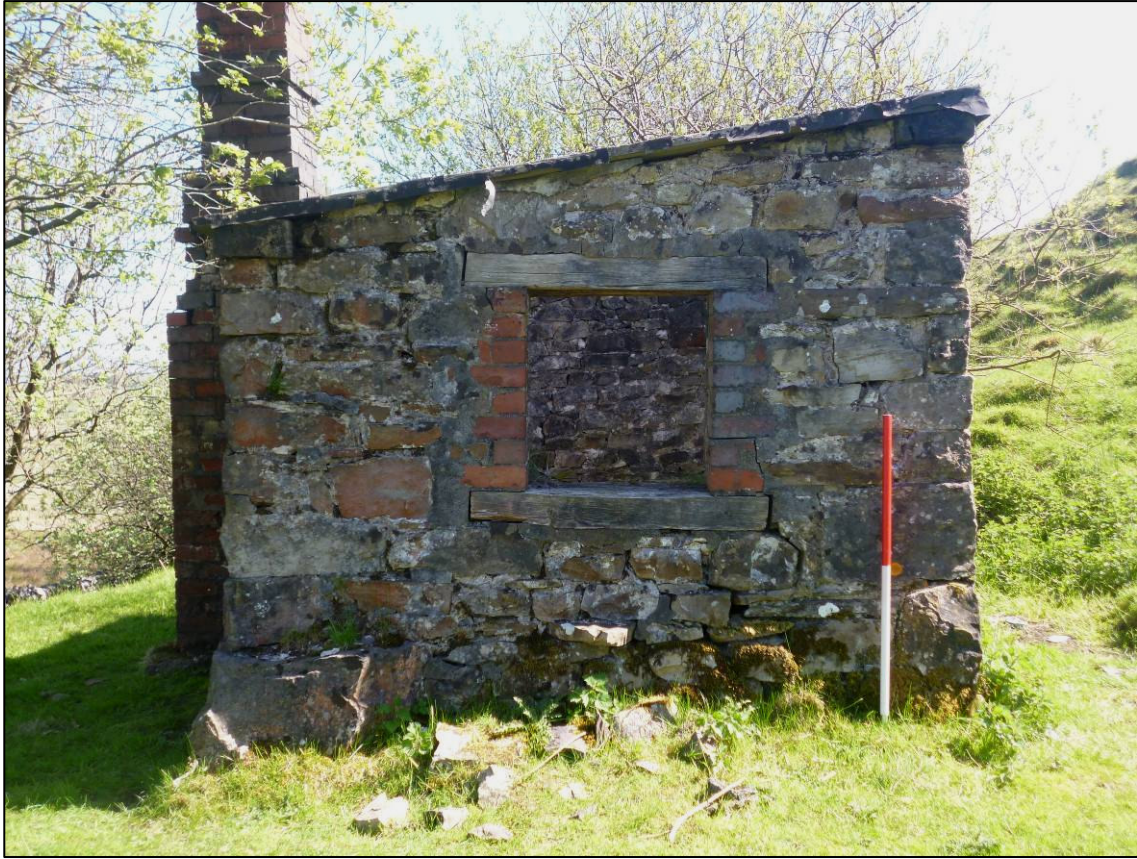
Plate 6: North gable, looking S (photo 1/727).

- 4.7 The north gable [1/727, 1/728] is pierced by a central flat-headed window opening, with brick jambs and a softwood lintel and sill, again perhaps cut down railway sleepers (see plate 6). The opening was once fitted with a frame [1/751], but this had been removed by the time of the survey. The window is either wholly inserted or an enlargement of an earlier feature, as evidenced by the cement mortar used around it both externally and internally.

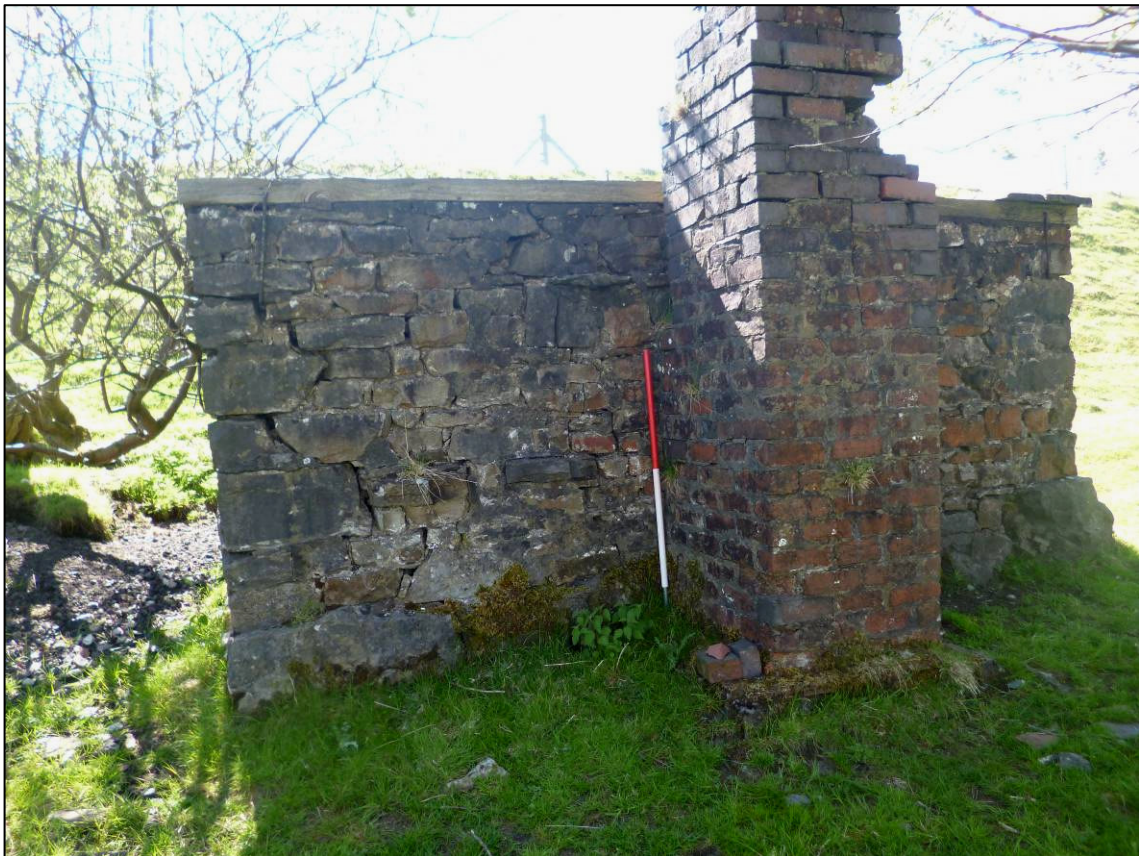
Plate 7: East elevation, looking W (photo 1/735).

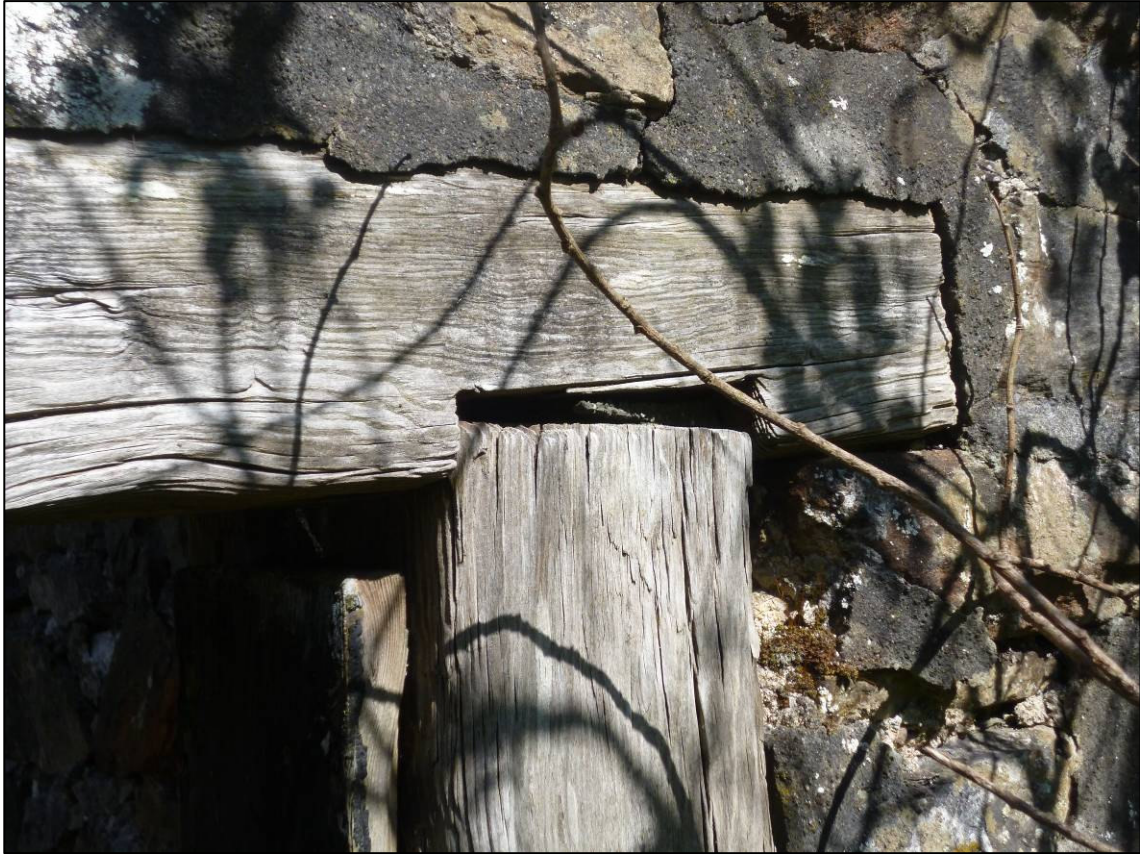
Plate 8: Detail to head of doorway in west elevation, looking E (photo 1/742).

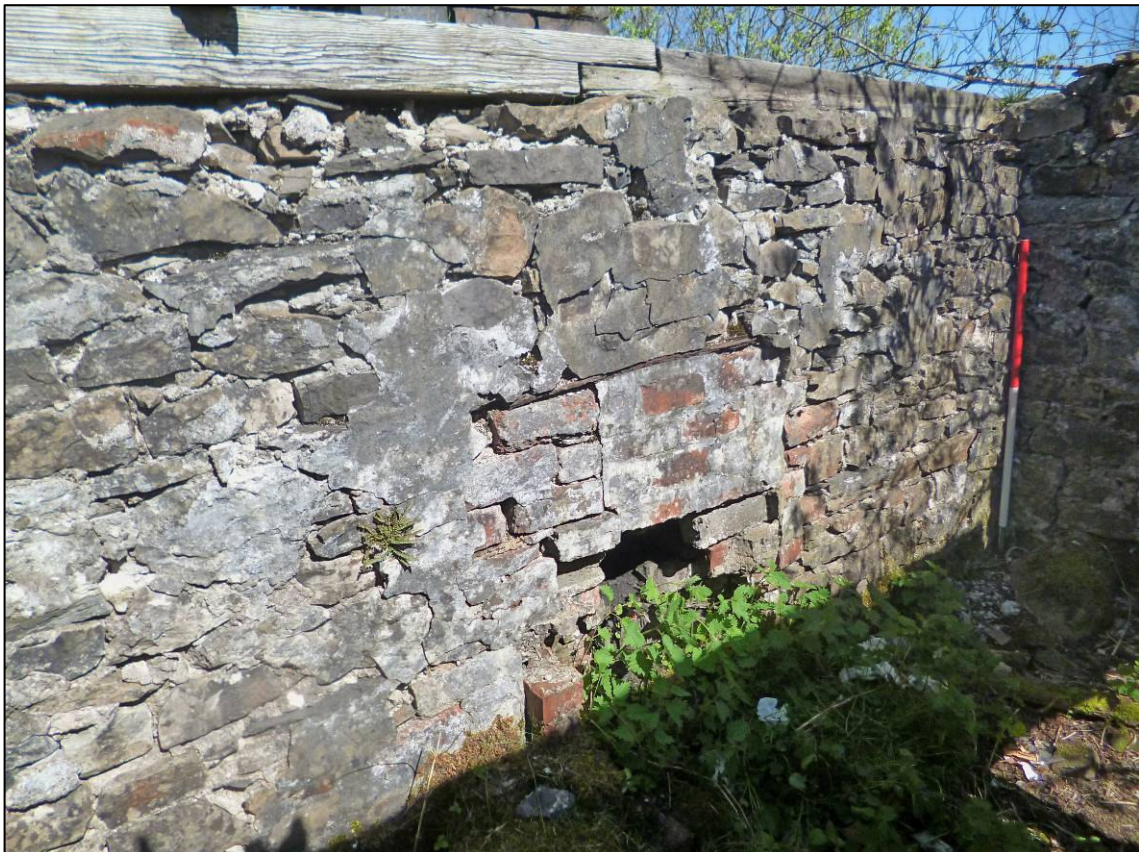
Plate 9: Internal east wall, looking SE (photo 1/753).

- 4.10 As has already been noted, the only access to the interior of the hut was through the doorway in the west elevation. At the time of the survey, the interior of the hut was filled with soil, vegetation, excrement and refuse, and so it was not possible to observe the original floor covering or indeed to see if it survived.
- 4.11 The north wall [1/749], with the exception of the aforementioned window, is blank. The east wall [1/752, 1/753] has a low stone step or pier at the very north end, and

to the centre, the remains of either a fireplace or stove position (see plate 9). This had been largely destroyed at the time of the survey, and the lower part was buried in the soil fill of the interior, but it appeared to comprise two low brick piers flanking the flue, with an area of blocking/alteration above rising to a thin iron plate set into the wall. The south wall [1/747, 1/748] is blank. The west wall [1/754, 1/755] appears to have two sockets or recesses to the upper part, one positioned at the north end and the other adjacent to the doorway at the south end. Between the two, a round-headed nail projects from the wall, set above an unusually long stone [1/756]. The internal walls preserve some fragmentary traces of lime-wash plaster.
