SECTION OF WALL AT DOCTOR WOOD,
SOUTH-WEST OF KISDON, MUKER,
NORTH YORKSHIRE

ARCHAEOLOGICAL SURVEY

Report no: 2013/464.R01
Version: Final
Date: November 2013
Author: Ed Dennison & Shaun Richardson

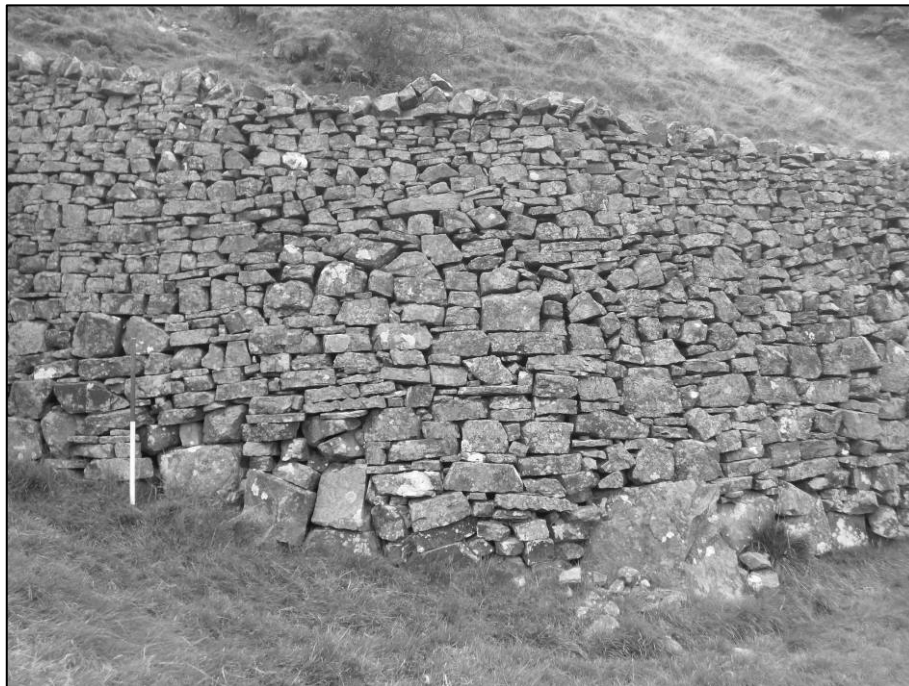
- 4.5 The wall then began to curve to the south-east [1/919, 1/920], gaining height as it did so, so that on reaching the point where it regained a more easterly direction [1/896], it stood up to 2.8m high, with vertical coping (see front cover). The point where the wall changed direction was marked by a large orthostat in the base, measuring 1.0m long by 0.75m high [1/921, 1/922]. By this point, the rubble used in the construction of the wall was less evenly sized and graduated than it was to the west of the barn, with patches of larger squared rubble amongst more thinly coursed material; it might be suggested that the lower 1.5m height of the wall here was an earlier phase which had subsequently been heightened or rebuilt. There were generally more orthostats to the base of the wall in this section, but they were intermittent, and none so large as that present at the change of direction.

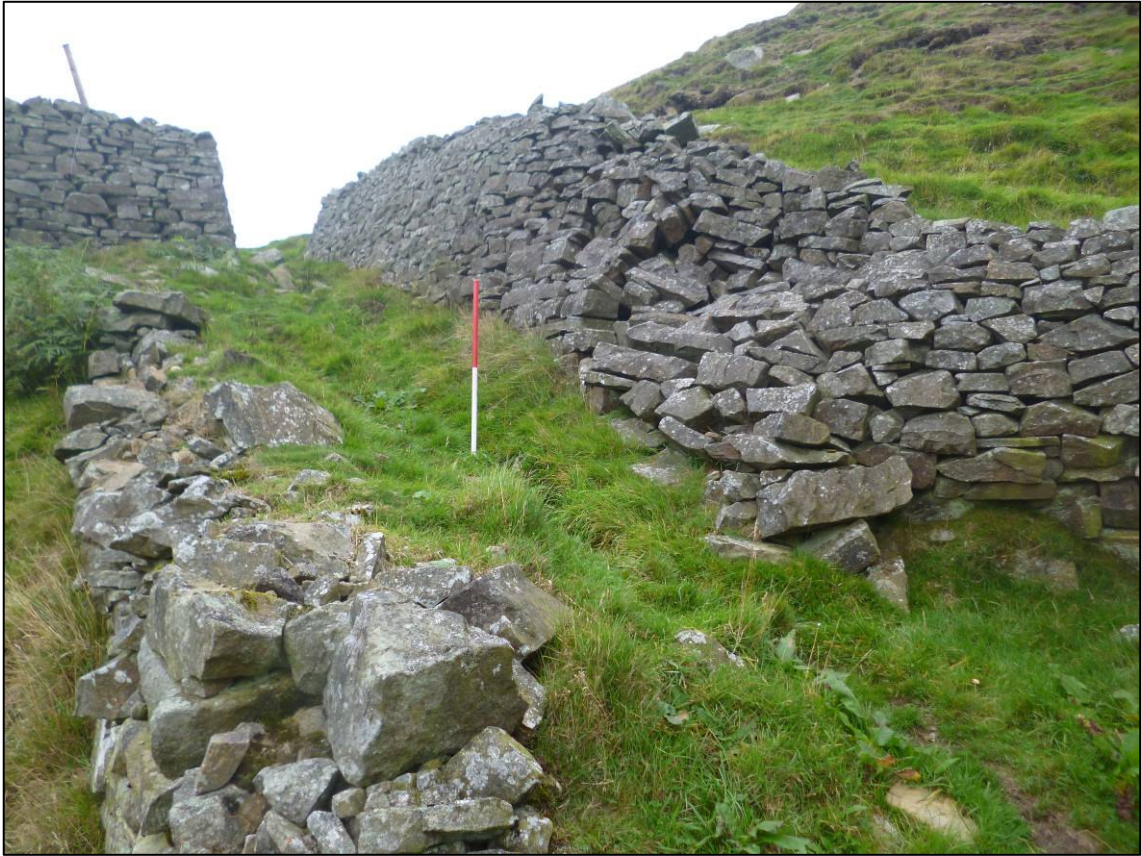
- 4.2 The west end of the wall started adjacent to a gateway, beyond which was the eroded route of the Pennine Way [1/972]. At the point where it met the gateway [1/900], the wall had a slightly tapered profile, measuring 0.8m wide at the base and decreasing to 0.5m wide at the top. The south face stood up to 2.1m high. Here, the wall was built of roughly coursed and squared stone rubble, the rubble decreasing slightly in size from bottom to top (see plate 1). This part of the wall retained a small amount of slanted coping, but had no throughstones. A steep trackway, c.3.0m wide, descended from the gateway along the south side of the wall, itself carried on a retaining wall to the south side standing up to 1.0m in height; this retaining wall was 0.8m wide at the base and 0.4m wide at the top, and the 1857 Ordnance Survey 6" map shows that it originally continued as far as the south-west corner of the barn (see figure 3).

Plate 1: Revetted track at west end of wall, looking NW (photo 1/900).

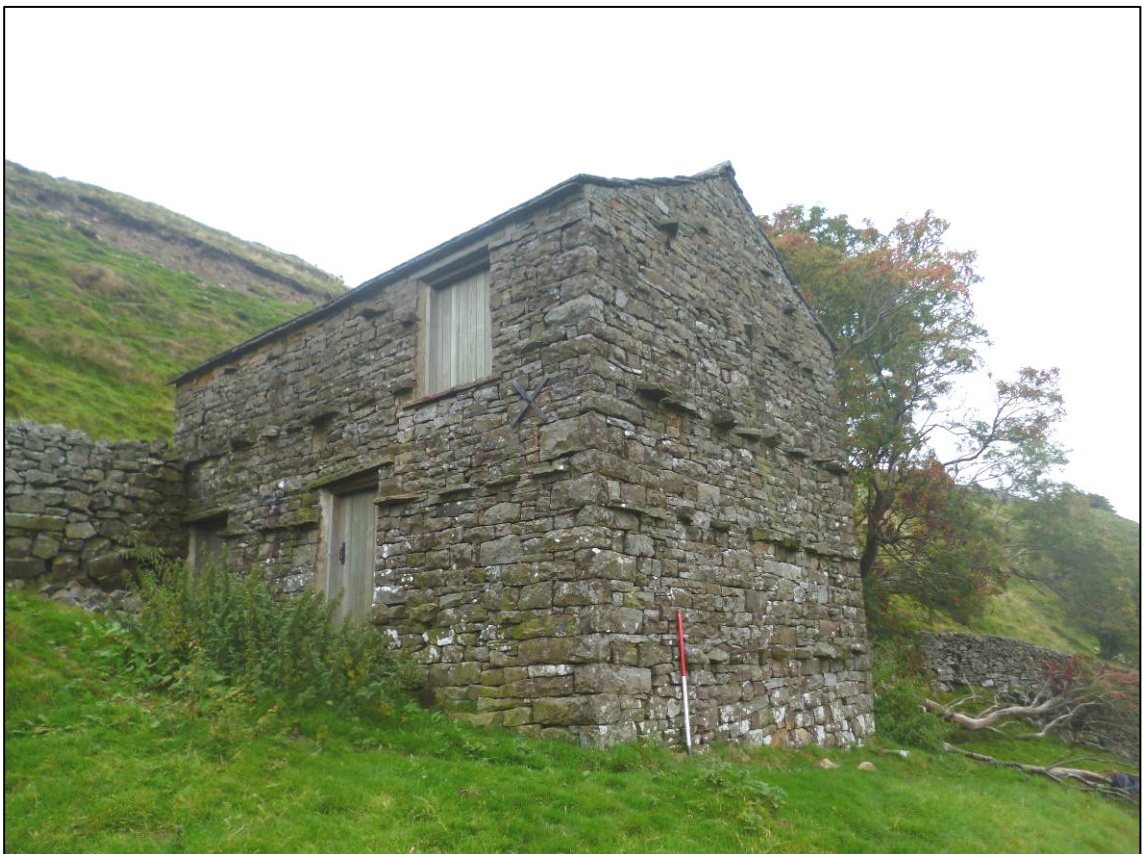
- 4.3 The main wall line continued as far as a well-preserved field barn [1/905, 1/906, 1/908, 1/971], which it butted (see plate 2). Just before the wall butted the barn, it contained a small recess near the base, measuring 0.4m wide by 0.5m high by 0.4m deep [1/903]; both lintel and sill were formed by single pieces of stone (see plate 3). The position of the recess, adjacent to the barn's only ground floor doorway, suggests that it may have been used to house a lamp or other pieces of equipment.

Plate 2: Field barn, looking NE (photo 1/906).

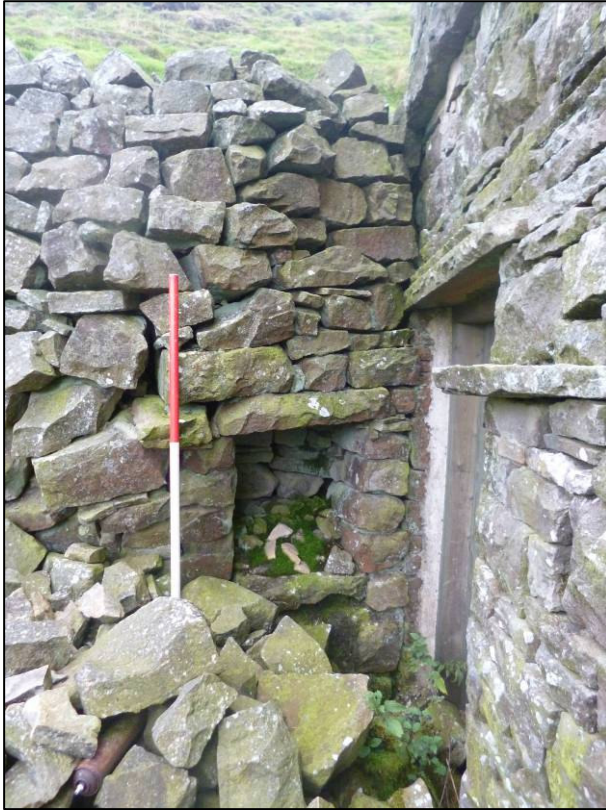
Plate 3: Recess in south face of wall west of barn, looking N (photo 1/903).

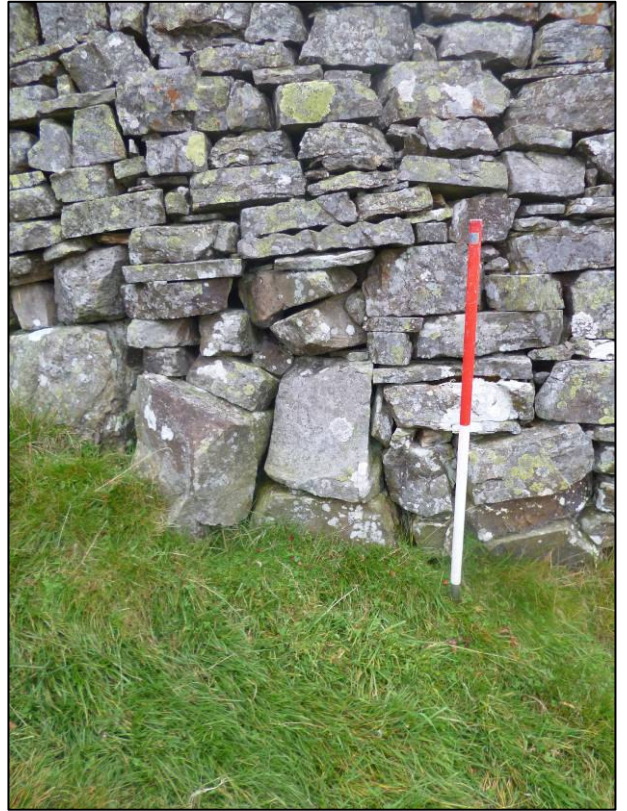
- 4.6 A number of other features were visible to the east and west of this large orthostat. To the west, two stones placed on top of each other at the base of the wall [1/923] may have blocked a former opening, perhaps a rabbit hole, measuring 0.6m high and 0.3m wide (see plate 4). To the east of the orthostat, there may have been a similar, but slightly taller, blocked feature [1/924]. It is possible that, taken together, the two blocked openings might represent part of a helm-like structure, as has been recorded elsewhere within the Yorkshire Dales - helms are open-sided lean-tos with a solid back wall and later field walls sometimes reveal the positions of the front supporting posts as tall narrow blocked gaps in the wall (Moorhouse 2003, 350-351; Moorhouse 2006, 58-60). However, the fact that the wall had a slightly curving alignment between the two blocked openings might preclude this, and there were no suggestive earthworks in the immediate vicinity.

Plate 4: Possible blocked feature in south face of wall west of corner orthostat, looking NE (photo 1/923).

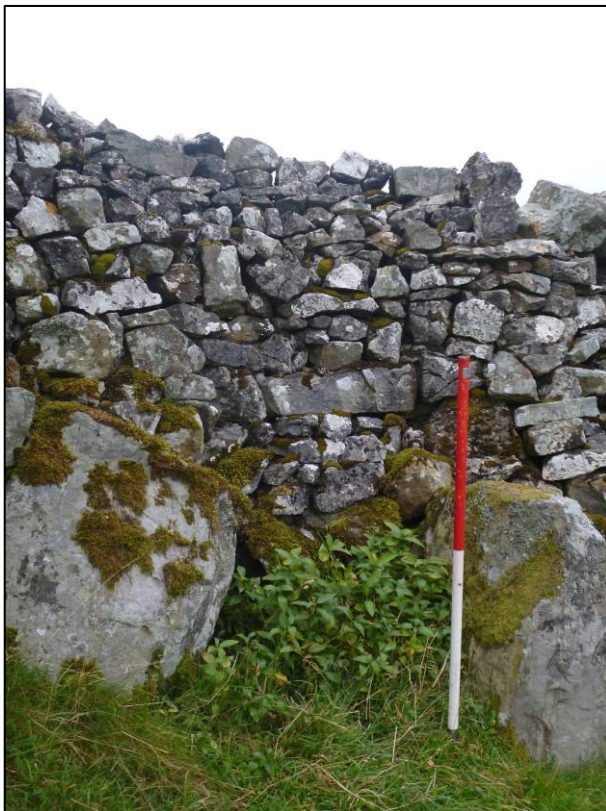
Plate 5: Blocked opening in west face of wall, south of east gateway, looking E (photo 1/953).

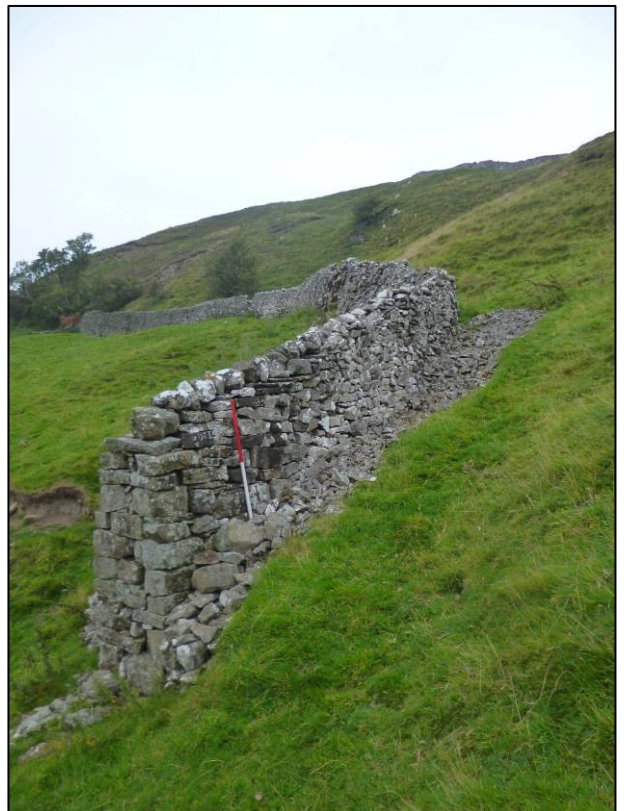
has since been rebuilt [1/936, 1/937]. Beyond this, the wall angled towards the south-east for c.15m, before again resuming a southern alignment [1/939, 1/941], running down the steep south-facing slope here [1/940] (see plate 9). There was another well-built angled projection at the base of the west face of the wall [1/942], before an inserted 3.14m wide gateway; to the north of the gateway, the wall measured 0.85m wide at the base, 0.70m wide at the top and stood a maximum of 2.0m in height, with vertical coping (see plate 6). On the east side of the wall, to the north of the gateway, there was a spread of small angular limestone rubble, covering an area 10.0m long by 1.2m wide, perhaps left over from a previous repair [1/960]. To the north of this, a shallow linear depression ran parallel to the east side of the wall [1/961].

Plate 6: East face of wall to north of east gateway, looking NW (photo 1/960).

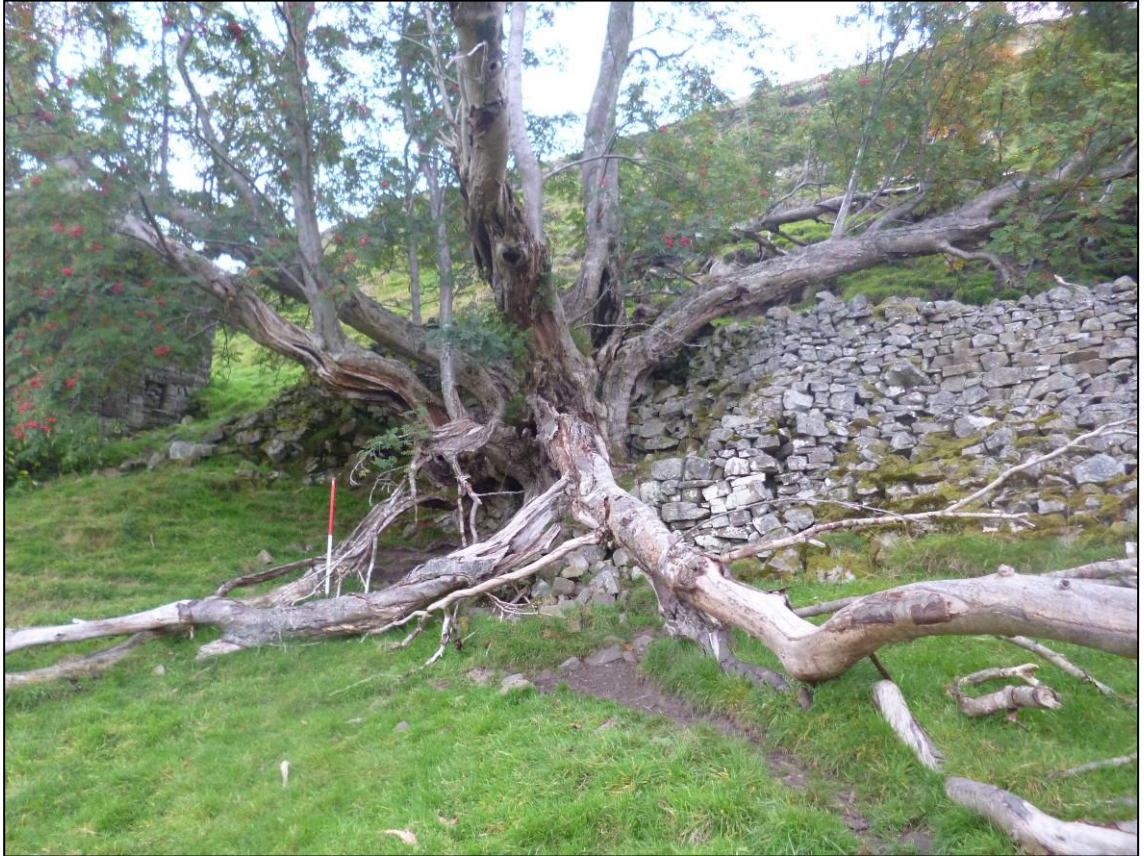
- 4.4 To the east of the barn, there was a gap some 3.5m wide where the wall had completely collapsed, its alignment marked by a steep south-facing slope containing a high proportion of rubble. Where the structure of the wall recommenced, it was of similar construction to before, but slightly less high, standing up to 2.0m high to the south face. Approximately 4.0m east of where it recommenced, the wall ran behind a very large ancient rowan tree [1/911-1/914], measuring a maximum of 2.0m in diameter (approximately east-west) (see plate 7). To the immediate north of the tree, the north face of the wall stood only 0.5m high, and had largely collapsed [1/968, 1/970]. To the east of the tree, where the wall resumed its full height, a low curving offshoot had been built off the south face to run around the front of the tree

Plate 7: Rowan tree to south face of wall, east of barn, looking NW (photo 1/914).

- 5.3 The survey has shown that a number of sections of the wall have either collapsed, or are in danger of collapse, particularly around the large rowan tree to the east of the field barn. The wall is in need of some limited repair and maintenance, which would simply be a continuation of a long history of such action. Wherever possible, any future repairs should ensure that the general character and appearance of the wall is maintained, and that any identified wall furniture, such as blocked or extant openings, the recess next to the barn, joints etc, is not altered or removed by this work.

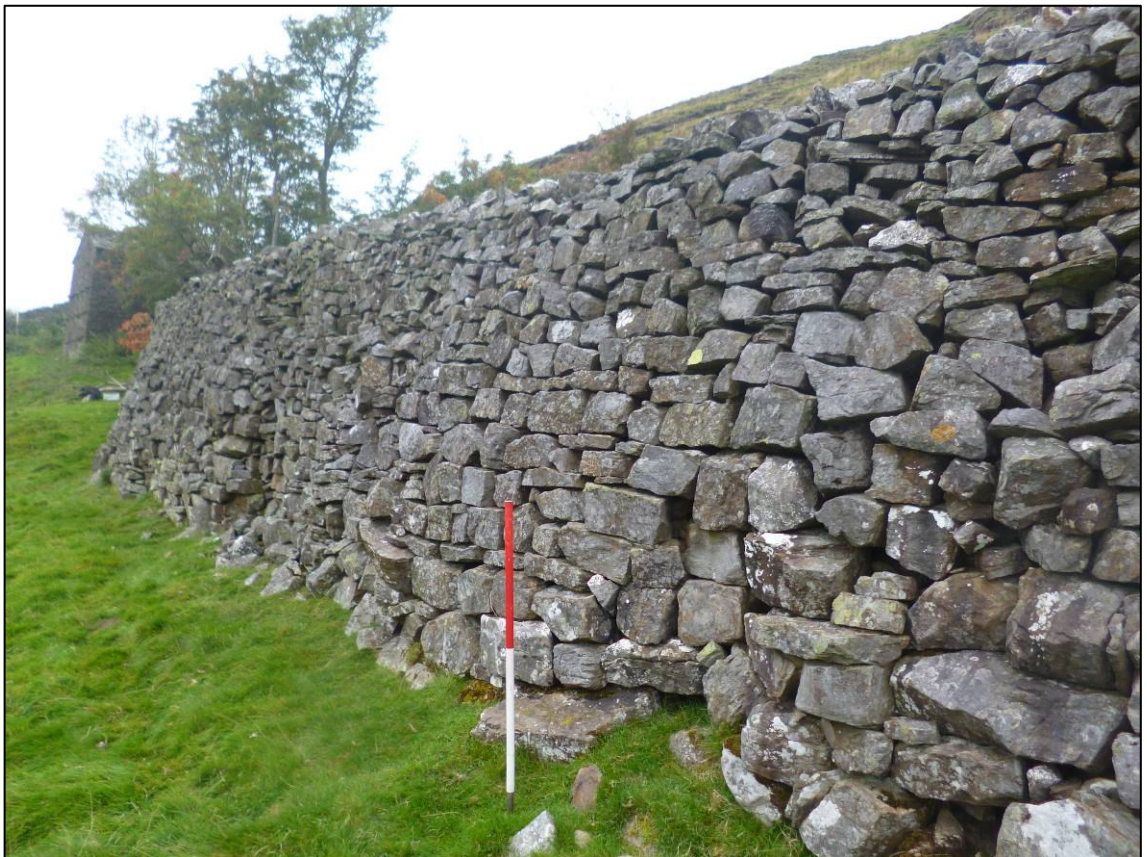
- 4.7 The wall continued on an east-west alignment with a similar height and method of construction [1/925, 1/926, 1/929] (see plate 8). There were what appear to be several low, angled joints to the lower part of the south face, but it was difficult to tell if these were the result of older features or joints incorporated into the wall line, or simply repairs resulting from collapse. A shallow linear depression ran parallel to the north face [1/963, 1/966], most probably the remains of a ditch or drain. Further east, the wall began to drop in height, averaging 1.50m high [1/930-1/932].

Plate 8: South face of east-west section of wall, looking W (photo 1/926).

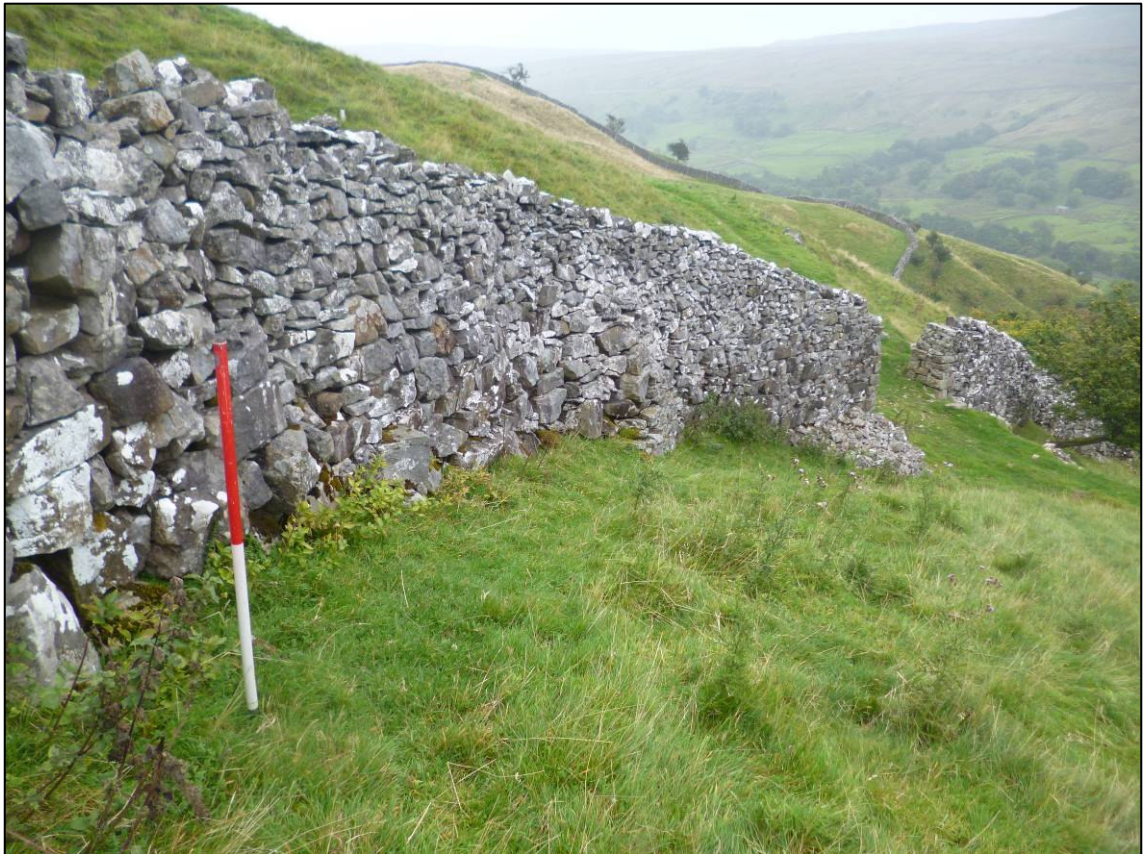
Plate 9: West face of wall towards east gateway, looking SE (photo 1/940).

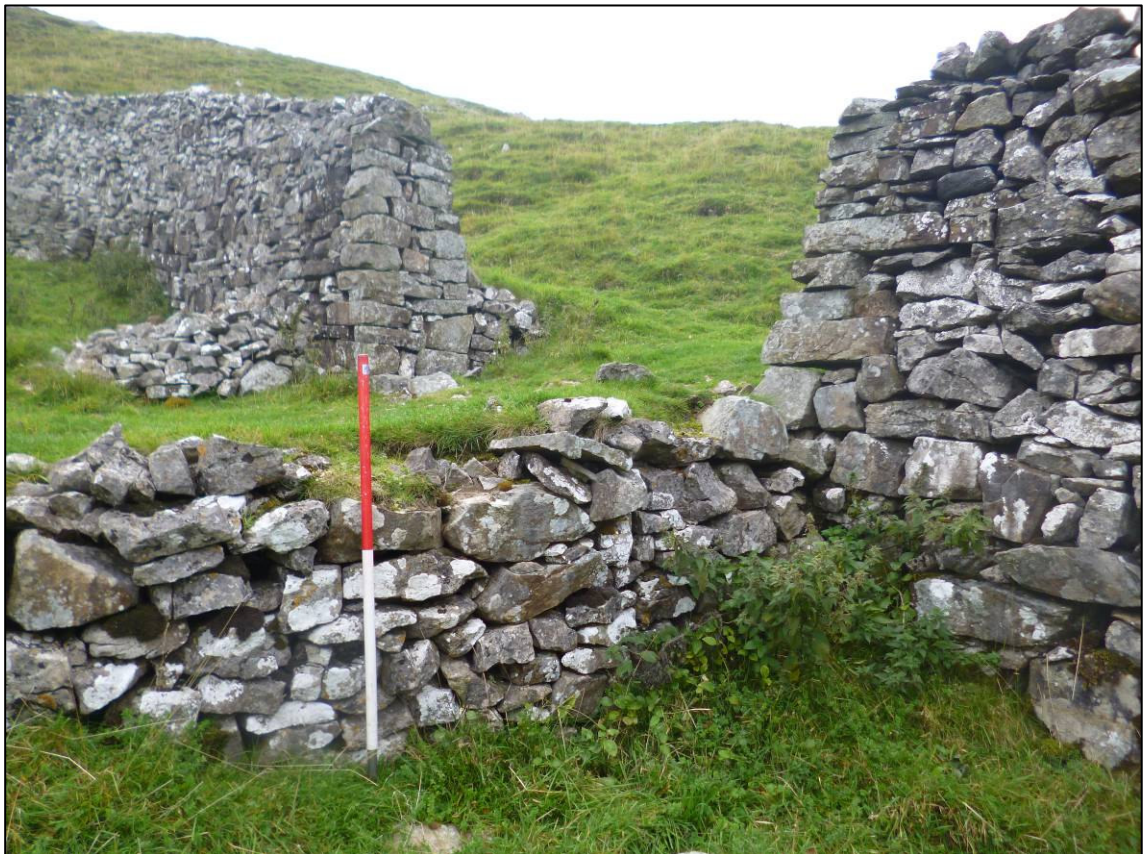
- 4.10 The ends of the wall created by the inserted gateway had been squared off with well constructed and coursed stonework, in total contrast to the wall to either side [1/943, 1/944] (see plate 10); no evidence for any gate fittings was evident. A small dump of rubble lay on the west side of the opening, presumably taken from the wall to create the opening. The c.2m wide track passing through the gateway was carried on a low retaining wall on its south side [1/945], which crossed a number of earlier north-west/south-east aligned linear depressions which appeared to be of natural origin.

Plate 10: Revetted trackway through east gateway, looking N (photo 1/945).

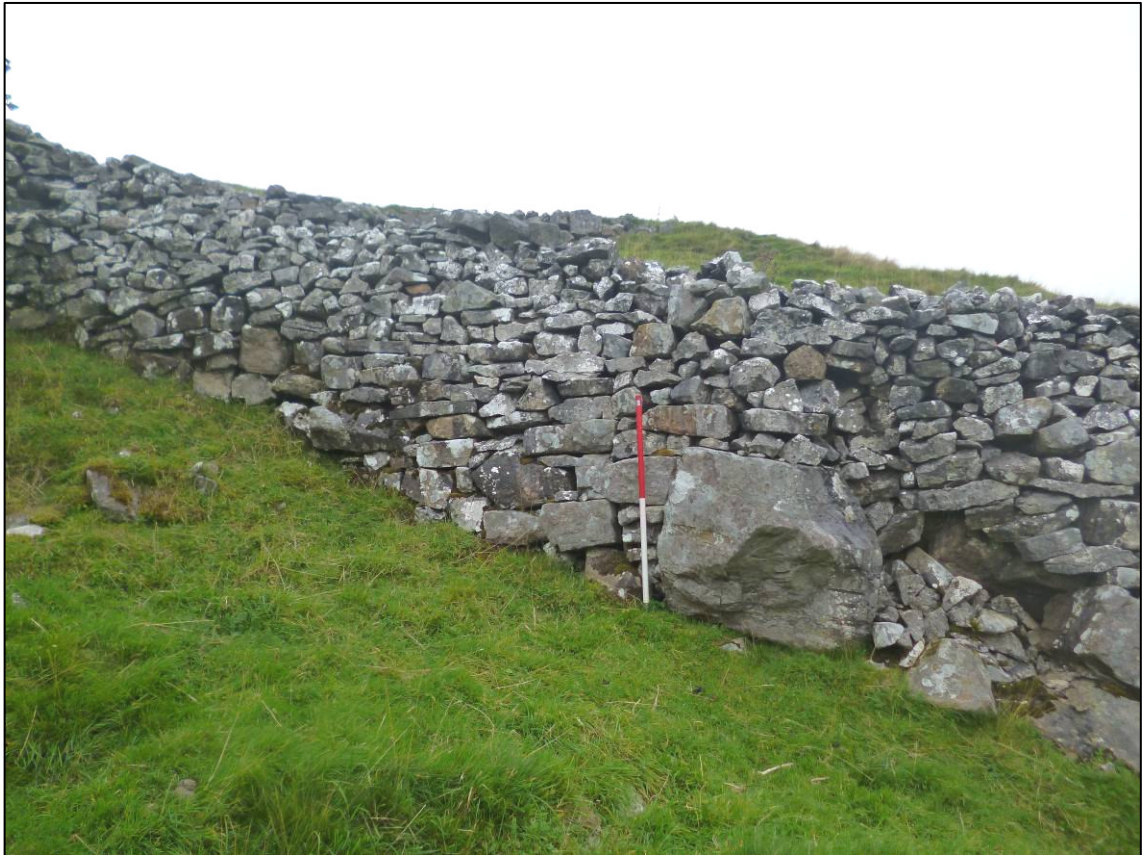
Plate 11: Orthostat in west face of wall, south of east gateway, looking E (photo 1/947).

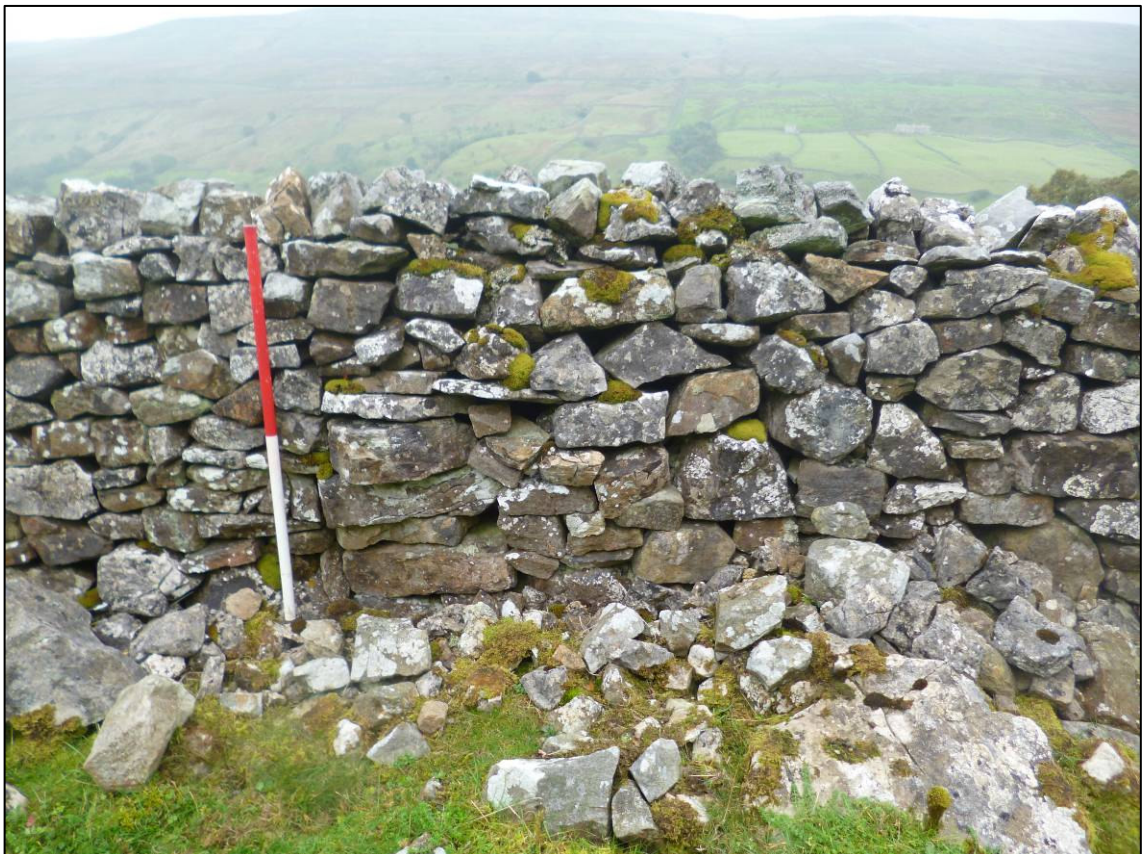
Plate 12: Blocked opening in north face of wall at change of angle, looking S (photo 1/964).
