ERECTION OF DWELLING, DETACHED GARAGE AND  
ASSOCIATED WORKS FOLLOWING DEMOLITION OF  
EXISTING, WOODLANDS, MAIN ROAD,  
BEWHOLME, EAST YORKSHIRE

ARCHAEOLOGICAL OBSERVATION,  
INVESTIGATION AND RECORDING

Report no: 2012/437.R01  
Version: Final  
Date: November 2013  
Author: Ed Dennison & Richard Coates

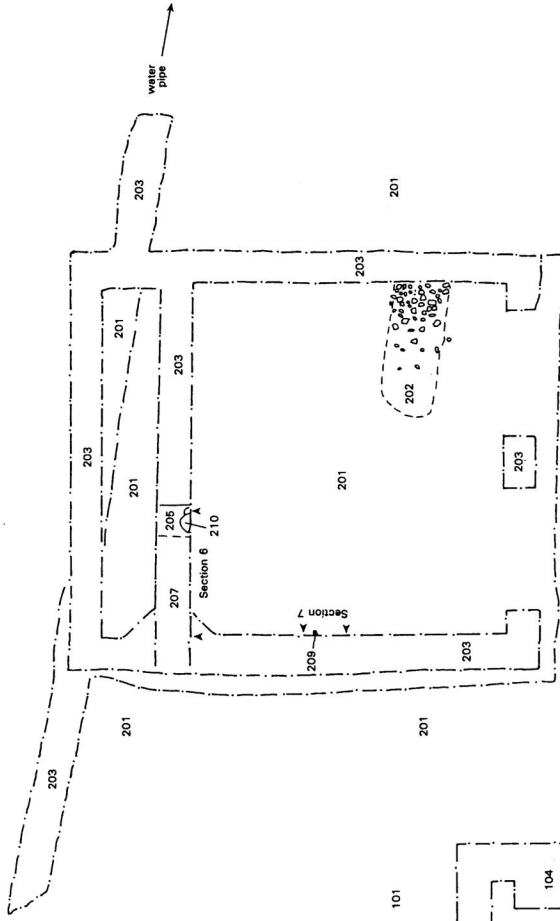
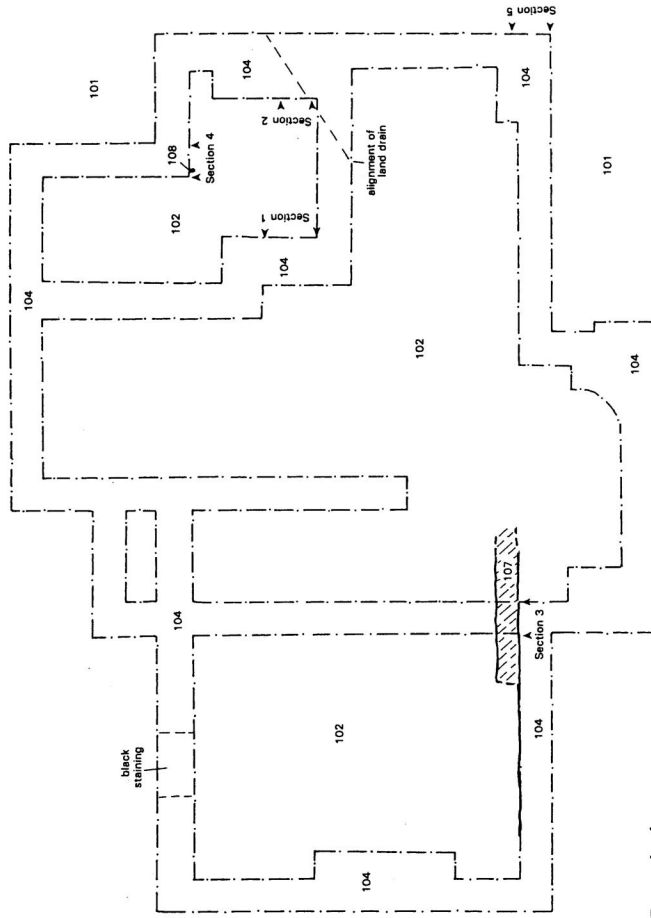
PROJECT	WOODLANDS, BEWHOLME		
TITLE	WATCHING BRIEF RESULTS - PLAN		
SCALE	AS SHOWN	DATE	NOV 2013
	EDAS	FIGURE	4

Trench 2

Trench 1

- 5.1 As noted above, the excavations for the house foundations comprised five north-south and six east-west trenches, covering an overall area of 11.95m north-south by 16.20m east-west; the trenches were c.0.60m wide and between 0.95m-1.25m deep BGL.

- 5.7 As noted above, the trenches dug for the garage foundations comprised two north-south and two east-west aligned connecting trenches, c.0.60m wide and c.0.75m-0.96m deep (BGL), covering a general area of 8.70m north-south by 7.90m east-west within a slightly larger area of topsoil strip. The underlying natural clay (104) seen in Trench 1 was not encountered within Trench 2. A recently installed east-west water service pipe also had to be re-excavated and moved to allow the excavation of the northern-most east-west garage wall foundation trench.

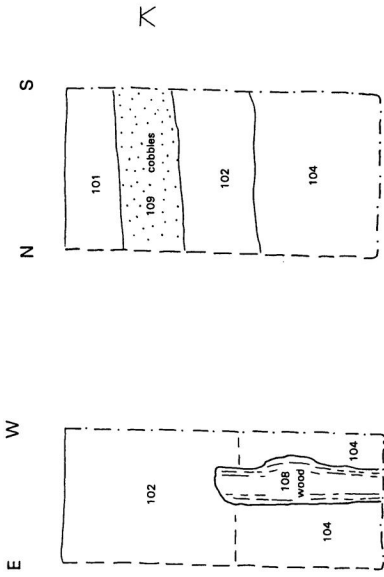
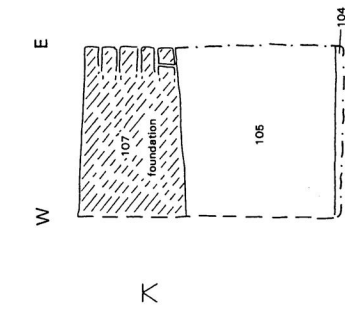
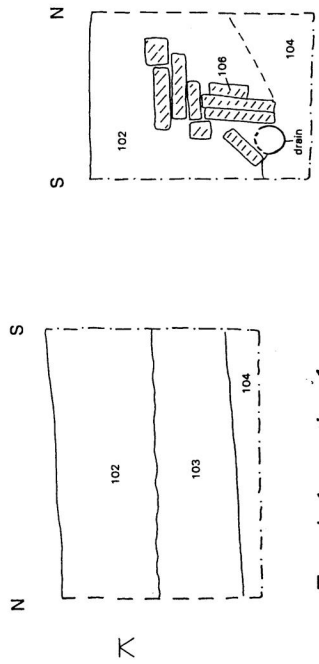
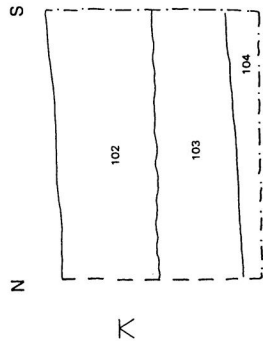
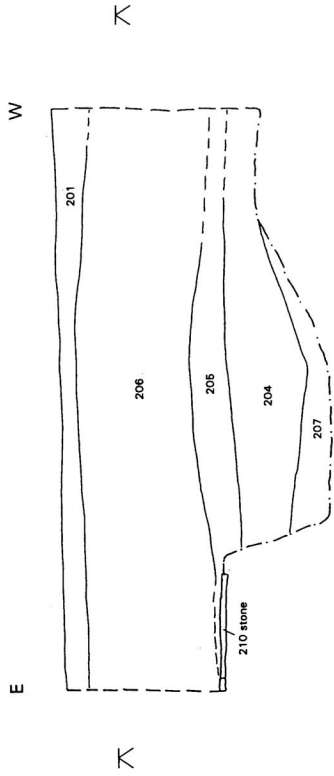
PROJECT	WOODLANDS, BEWHOLME		
TITLE	WATCHING BRIEF RESULTS - SECTIONS		
SCALE	AS SHOWN	DATE	NOV 2013
	EDAS		FIGURE 5

Trench 1, section 4

Trench 1, section 3

Trench 1, section 2

Trench 1, section 1

Trench 2, section 6

- 5.3 A number of east-west and south-west/north-east aligned ceramic land drains, encountered at between 0.50m to 0.60m BGL, had also been cut into the natural clay (104). In the eastern foundation trench, the loose grey silt backfill of a cut for one land drain (106) contained a number of un-bonded complete bricks laid vertically and horizontally over the drain (see Section 2 and plate 5).

- 5.8 At the west end of the internal east-west aligned foundation trench, a deposit of soft grey 'plastic' clay silt (207) over 0.15m thick was encountered 0.85m BGL (see Section 6). This was overlain by a 0.30m thick layer of a firm mid grey-brown silt clay (204), encountered 0.60m BGL, from which six sherds of late 19th century brown glazed red earthenware pottery and shards of 20th century glass were recovered. Overlying the grey-brown silt clay (204), and encountered 0.45m BGL, was a 0.15m thick layer of very loose and soft mid-grey clayey silt (205) containing late 17th-18th century CBM inclusions. This deposit also contained a 0.38m long, more than 0.15m wide and c.0.02m thick limestone block with a piece of medium-sized chalk (210) next to it; neither piece contained any visible signs of tooling and both were left in situ in the bottom of the trench. The loose mid-grey clay silt (205) was overlain by a 0.40m-0.50m thick layer of firm mid grey-brown clay silt (206) containing occasional small stones and CBM. One sherd of post-medieval pottery was recovered from this latter deposit.

- 5.9 In the western north-south aligned foundation trench, a modern treated wooden post (209) 0.15m in diameter and over 0.45m long, had been driven into the firm mid grey-brown clay silt (206) (see Section 7); another similar post was noted c.4.00m to the north within the centre of the northern east-west trench. An area of hardstanding or the remains of a localised cobbled surface (202), measuring 0.90m wide (north-south) by 3.10m long (east-west), overlay the mid grey-brown clay silt (206) in the south-east corner of the garage footprint (see plate 8).

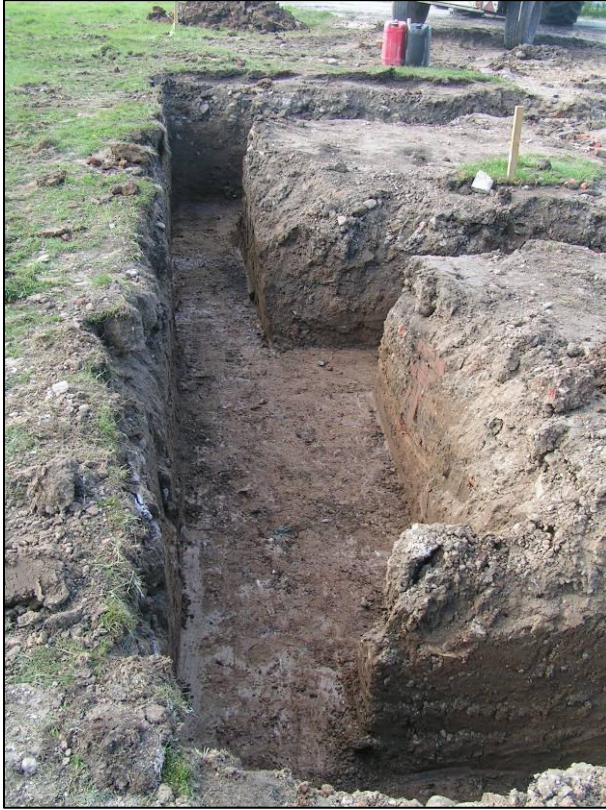
Plate 1: View along eastern north-south aligned house trench (Trench 1), looking S.

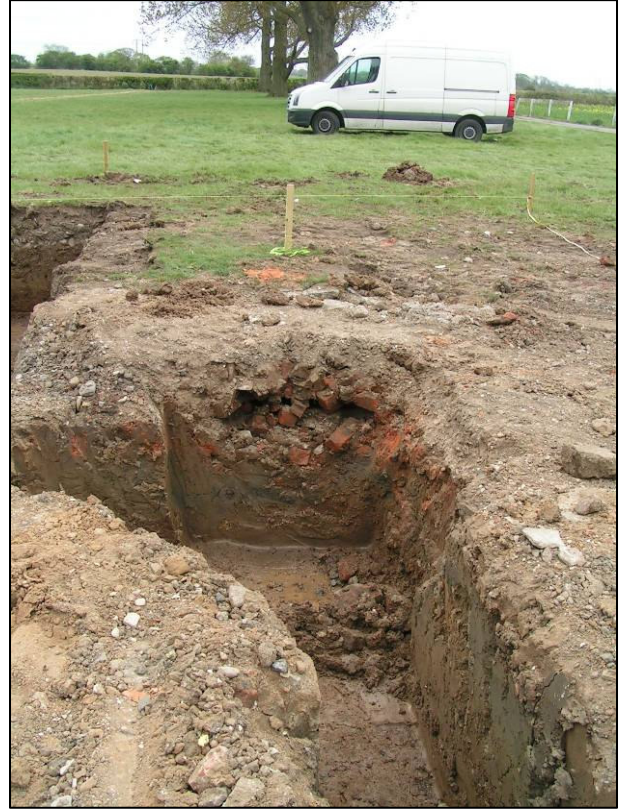
Plate 2: South central side of house foundation (Trench 1), looking E

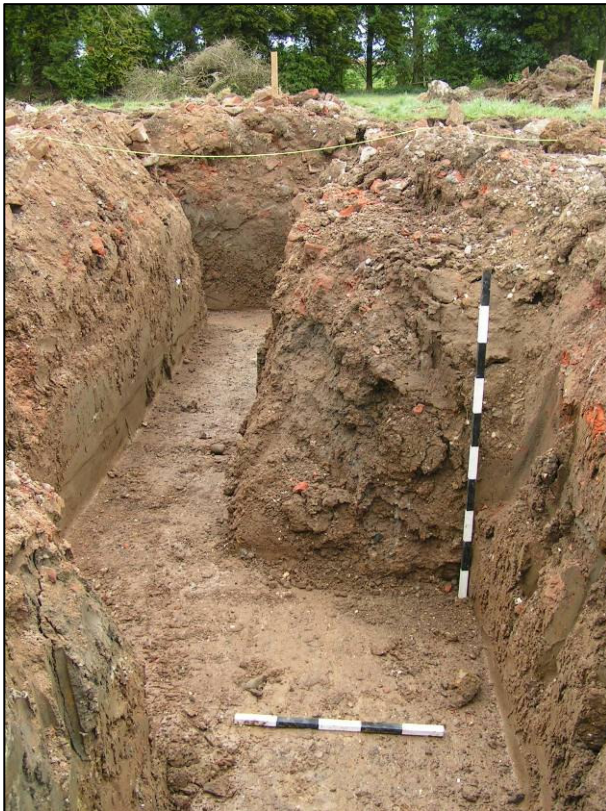
Plate 3: View along north-south aligned internal house trench (Trench 1), looking N.

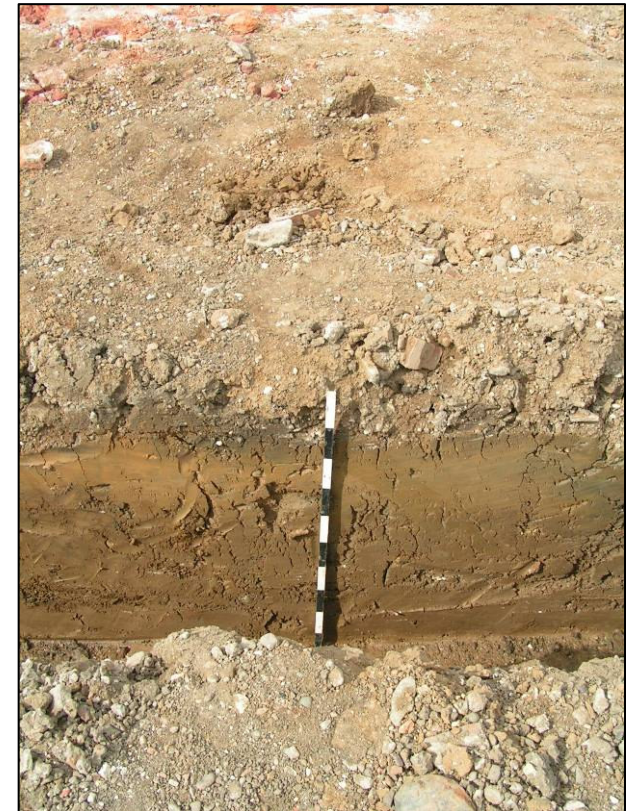
- 5.4 In the central area of the building footprint, the natural clay (104) was overlain by a stiff mid grey-blue 'plastic' clay (103) up to 0.30m thick, which contained occasional ceramic building material (CBM) inclusions; the top of this deposit was encountered 0.39m BGL (see Section 1). This 'plastic' clay (103) was in turn overlain by a 0.39m thick loose dark-mid grey clayey silt (102), which contained large quantities of bricks and brick fragments, primarily resulting from the demolition of the former house on the site, as well as occasional small stones (see plates 2 and 3). This dark-mid grey silt (102) was of variable thickness throughout the site (between 0.39m and 0.65m thick), appearing shallower to the west and north, and thicker to the east and south, and it formed the current ground level within the building footprint (see plate 4).

Plate 4: Typical stratigraphy in internal house trench (Trench 1), looking W.

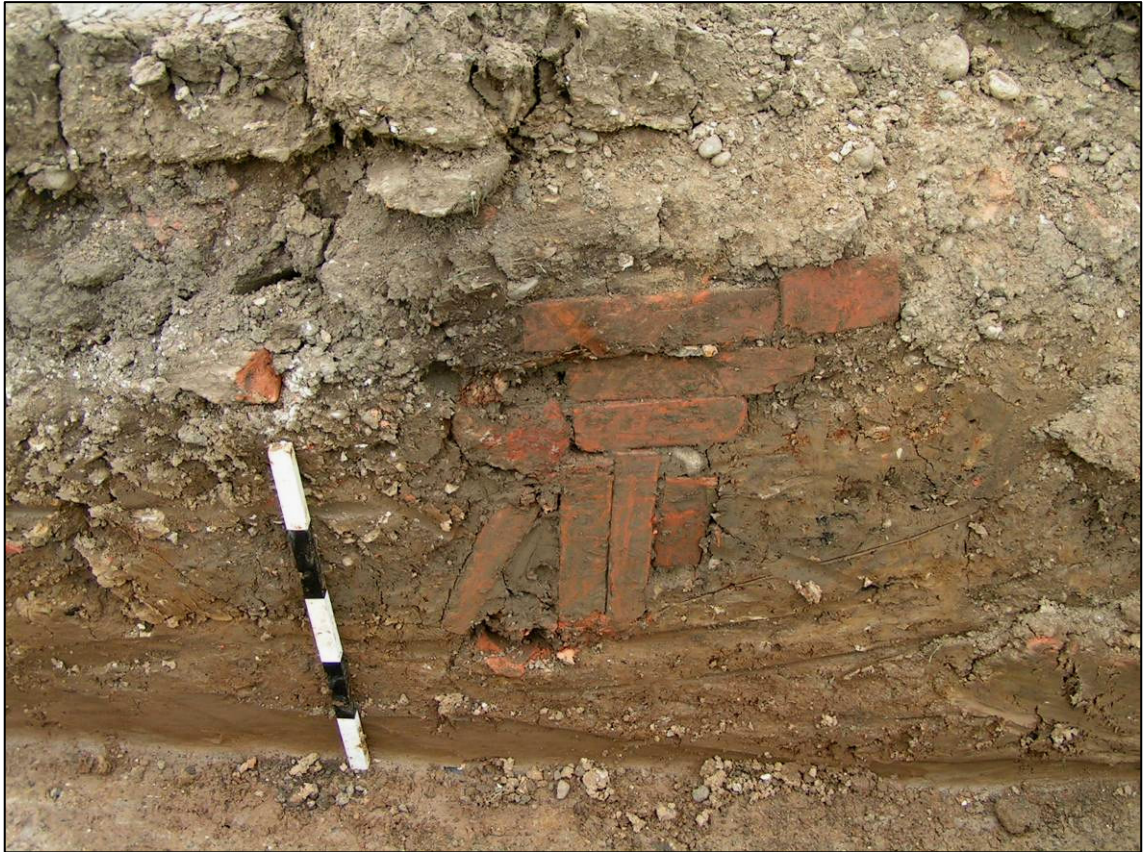
Plate 5: Drain (106) with bricks above, west side of eastern-most north-south house trench (Trench 1, section 2), looking W.

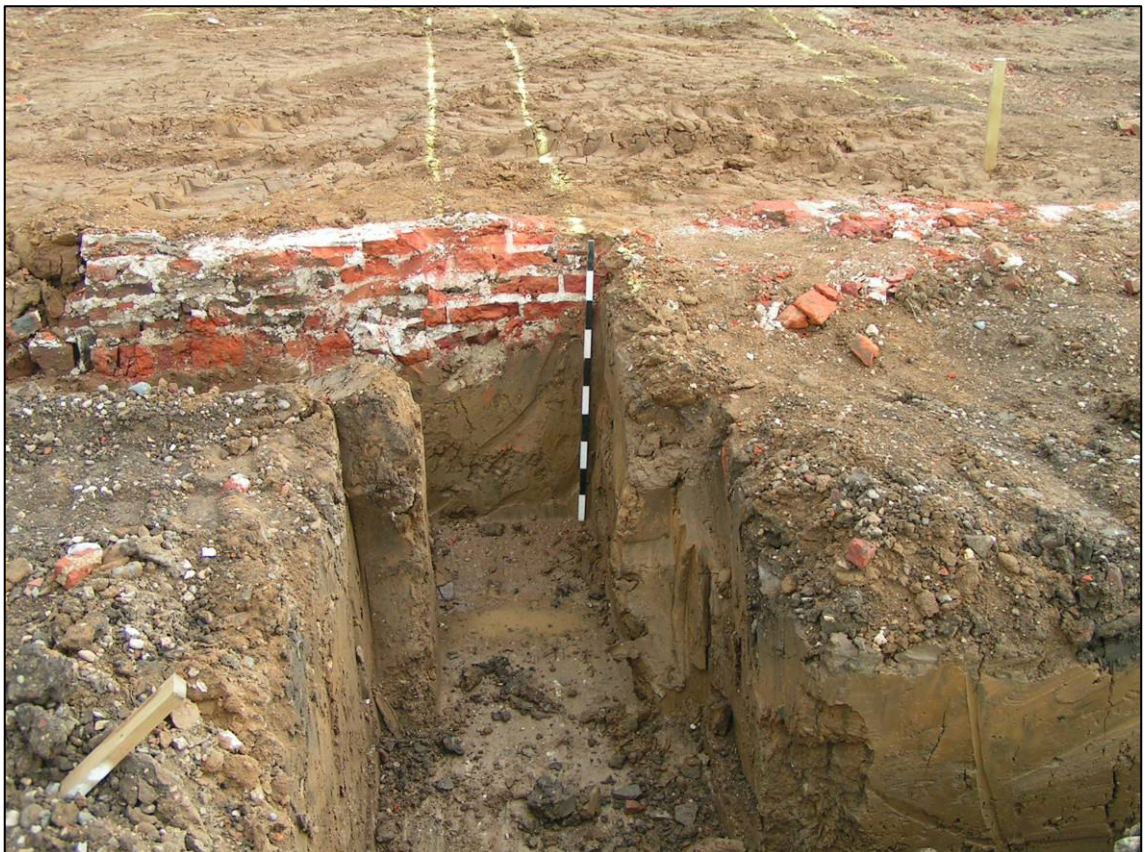
- 5.5 Towards the south-west corner of the southern foundation trench, a very loose brown-yellow 'plastic' sandy clay (105), up to 0.62m thick and with few inclusions, was encountered at 0.40m BGL. This deposit, which may have been a variation of the natural clay (104), was overlain by an east-west aligned brick foundation (107) representing the south wall of the former house (see Section 3). The foundation was 0.27m high and 0.40m wide, and a total length of c.2.50m was exposed in plan and section; although it was visible periodically in section further to the west, it was not noted in the western-most north-south aligned trench. A total of five heavily mortar-bonded courses remained, the lowest course formed by headers while the four courses above were laid as stretchers (see plate 6).

Plate 6: Brick wall foundation (107), on south-west side of house foundations (Trench 1), looking N.

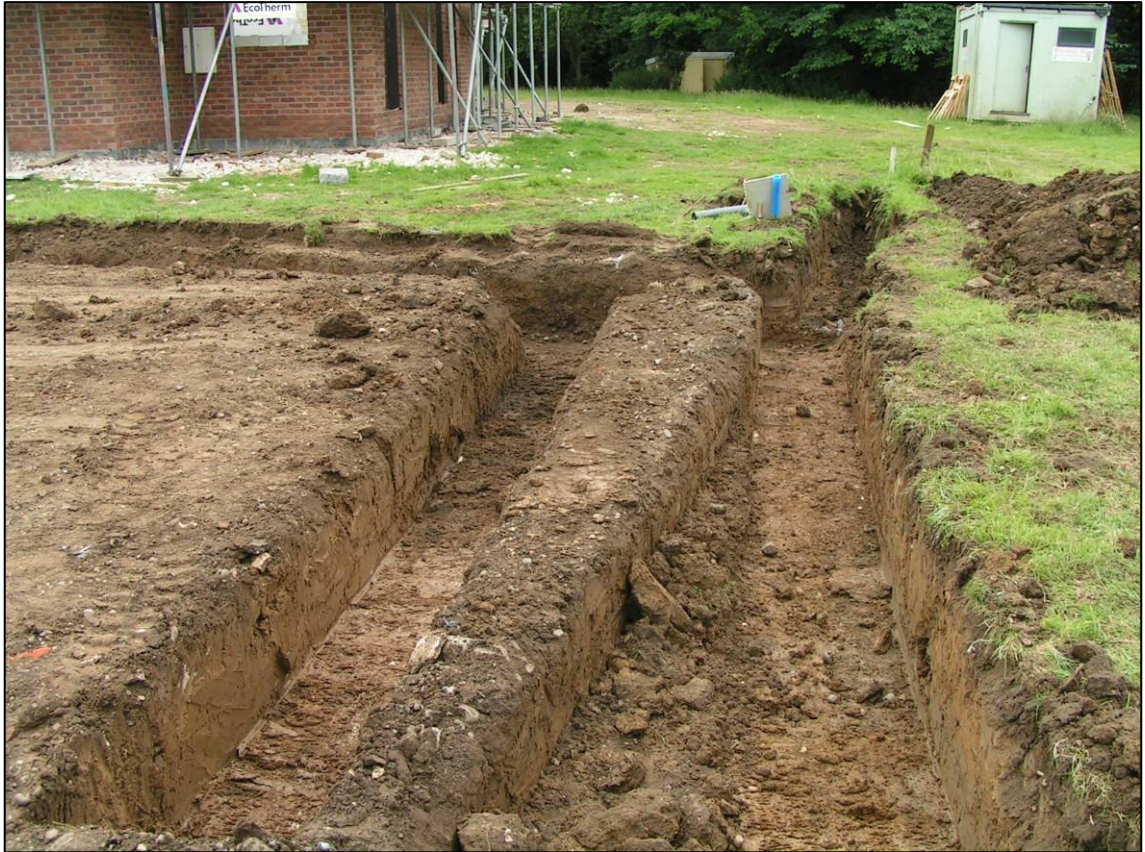
- 3.3 The excavations for the house foundations comprised several interconnecting trenches, five orientated north-south and six orientated east-west, covering an area measuring 11.95m north-south by 16.20m east-west in total. These trenches were nominally 0.60m wide and of variable depth, ranging between 0.95m to 1.25m deep below existing ground level (BGL); for archaeological recording purposes, these trenches were collectively designated as Trench 1 (see plates 1 to 4). The foundation trenches for the garage comprised two north-south and two east-west aligned connecting trenches, covering a general area of 8.70m north-south by 7.90m east-west, located within a slightly larger area of topsoil strip; these trenches were 0.60m wide and 0.75m-0.96m deep and were collectively designated as Trench 2 (see plate 7).

Plate 7: General view of north end of garage foundations (Trench 2), looking W.

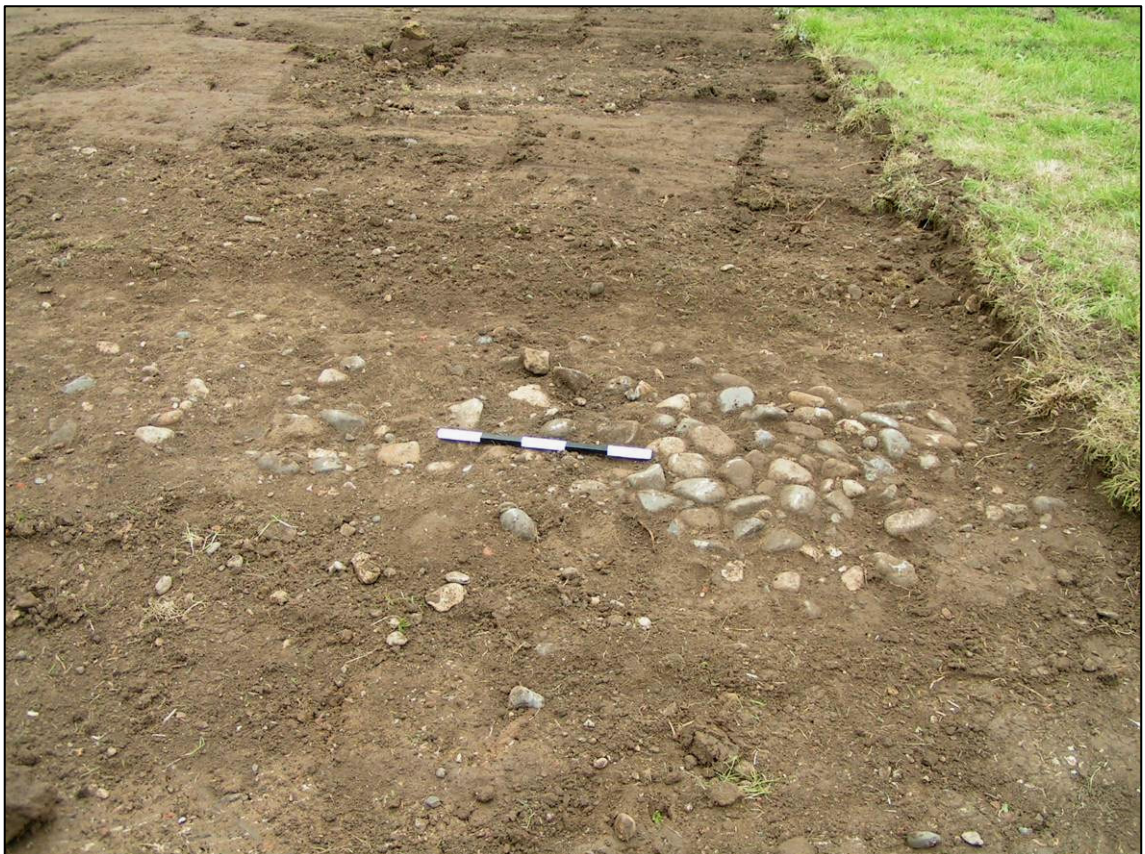
Plate 8: Area of cobbled surface (202) within Trench 2, looking N.
