BROCKMA GILL EAST, MORLEY GATE,
KEARTON, NORTH YORKSHIRE

ARCHITECTURAL AND
ARCHAEOLOGICAL RECORDING

Report no: 2012/439.R01
Version: Final
Date: October 2013
Author: Shaun Richardson & Ed Dennison

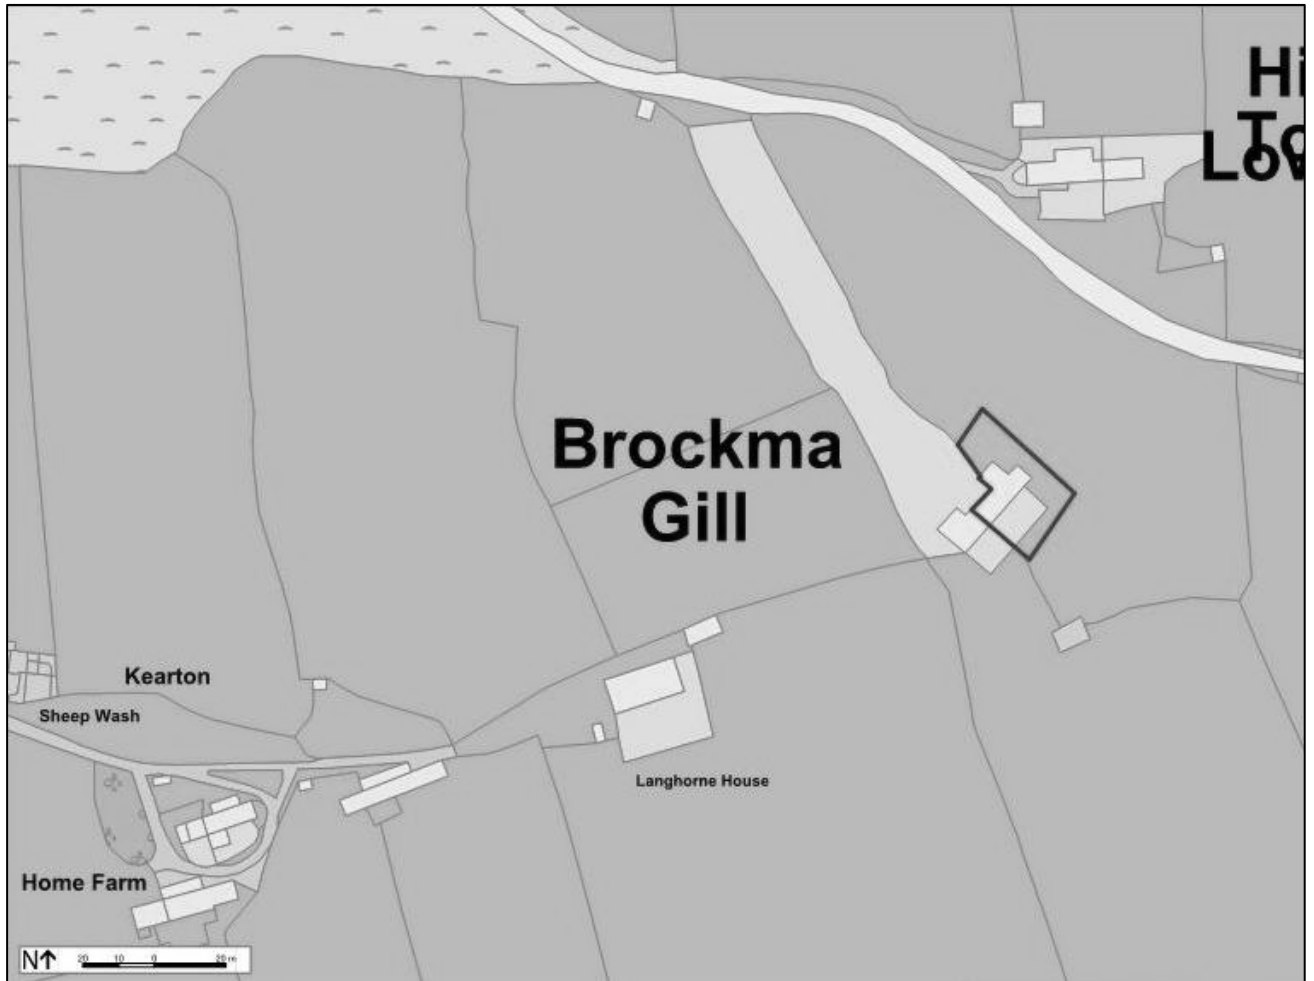
PROJECT		BROCKMA GILL EAST, KEARTON	
TITLE		DETAILED LOCATION	
SCALE	AS SHOWN	DATE	OCT 2013
	EDAS	FIGURE	2

Plan provided by Niche Design Architects Ltd.

- 3.3 Brockma Gill is located at the east end of the hamlet of Kearton (see figures 2 and 3). It is set some 50m south-west of the unclassified Healaugh to Surrender road, but at a much lower level, being c.13m lower than the road surface. A gateway in the drystone wall lining the south side of the road opens onto the principal approach to the complex, a grassed track, terraced into the south-facing slope here and with an average width of 3.0m. The track follows a sinuous route (the same as shown in 1857), falling steeply from north to south. At first, it is slightly embanked on the south side only, but as it moves south-west, it is steeply scarped both above and below (see figure 7).

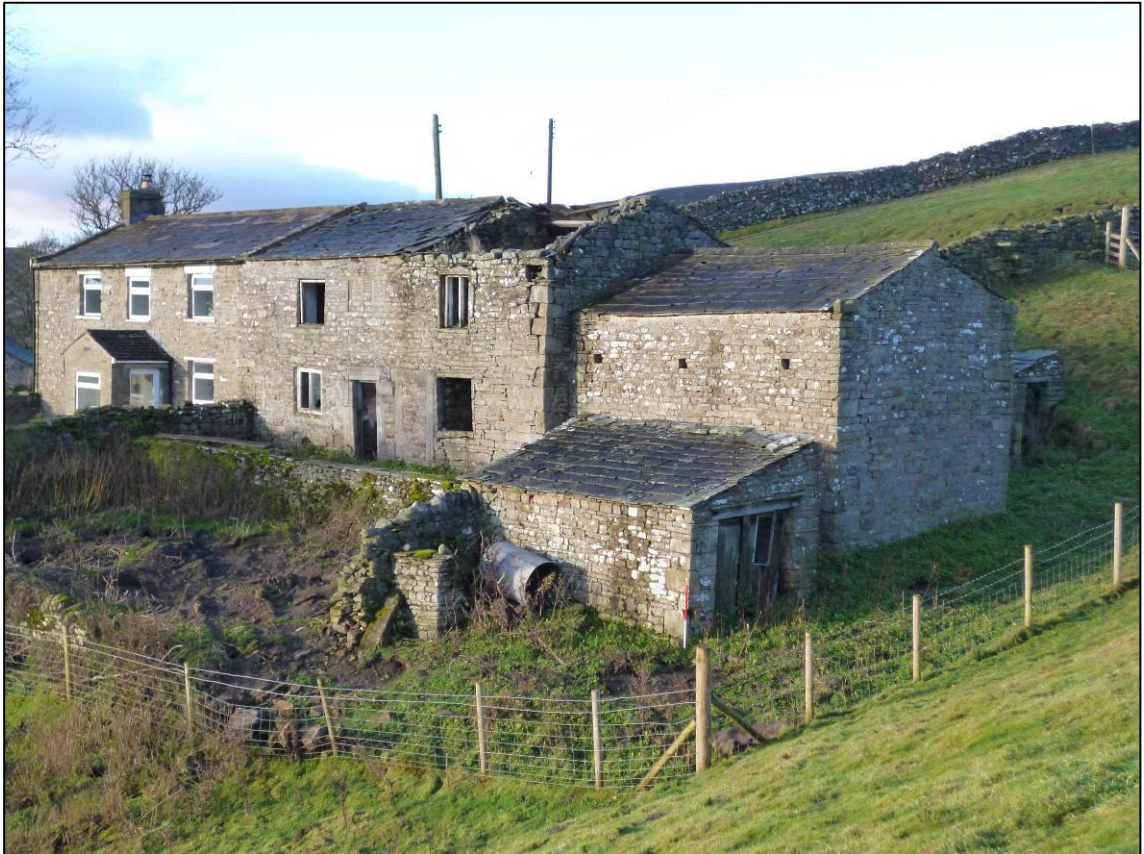
Plate 1: Brockma Gill, looking W (photo 3/237).

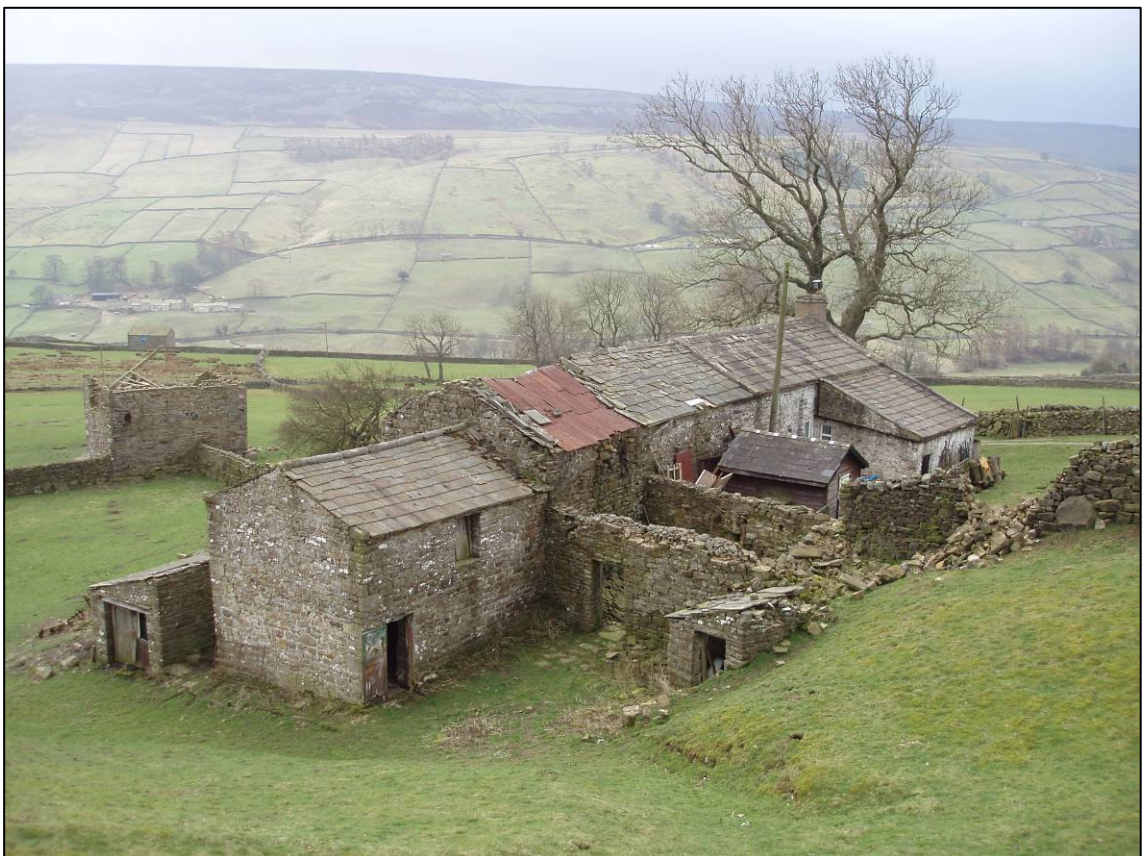
Plate 2: Brockma Gill, looking S (Crosby photo 1/033).

- 3.31 The north structure is slightly sub-rectangular in plan and was formed by a single cell, with maximum external dimensions of 6.25m north-south by 4.70m east-west (see plate 2). It was of a single storey, although the pitched roof structure had entirely collapsed and been removed; a mortar 'shadow' remains on the north elevation of the house, indicating that the roof originally had a shallow pitch [2/028, 2/030, 2/031, 2/034] (see plate 15). The load-bearing external walls have an average width of 0.60m; the north and west walls in particular bulge very markedly at lower levels, giving face to face measurements of well over 1.0m. All walls are built of relatively thinly coursed and squared gritstone rubble, set with a lime mortar, although there is much local variation. The north wall effectively forms a revetment to the slope behind.

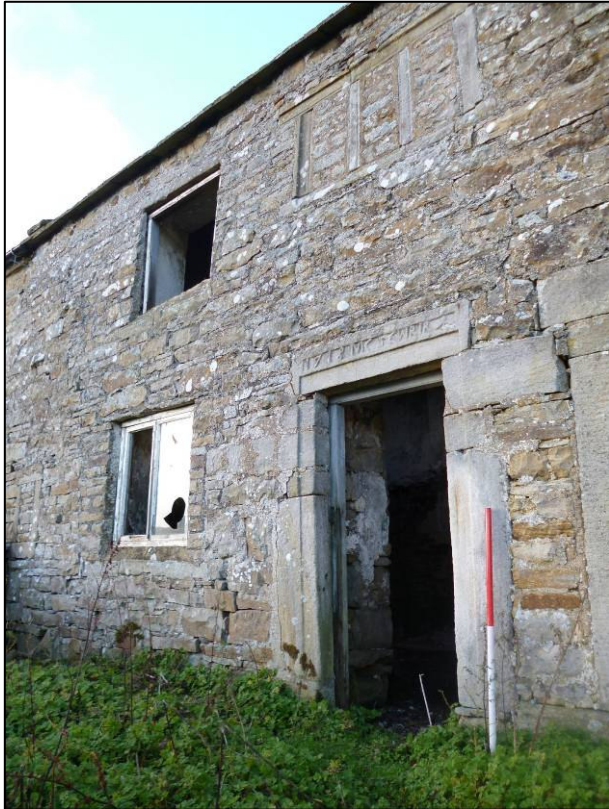
Plate 5: South elevation of west cell of house, looking W (photo 3/289).

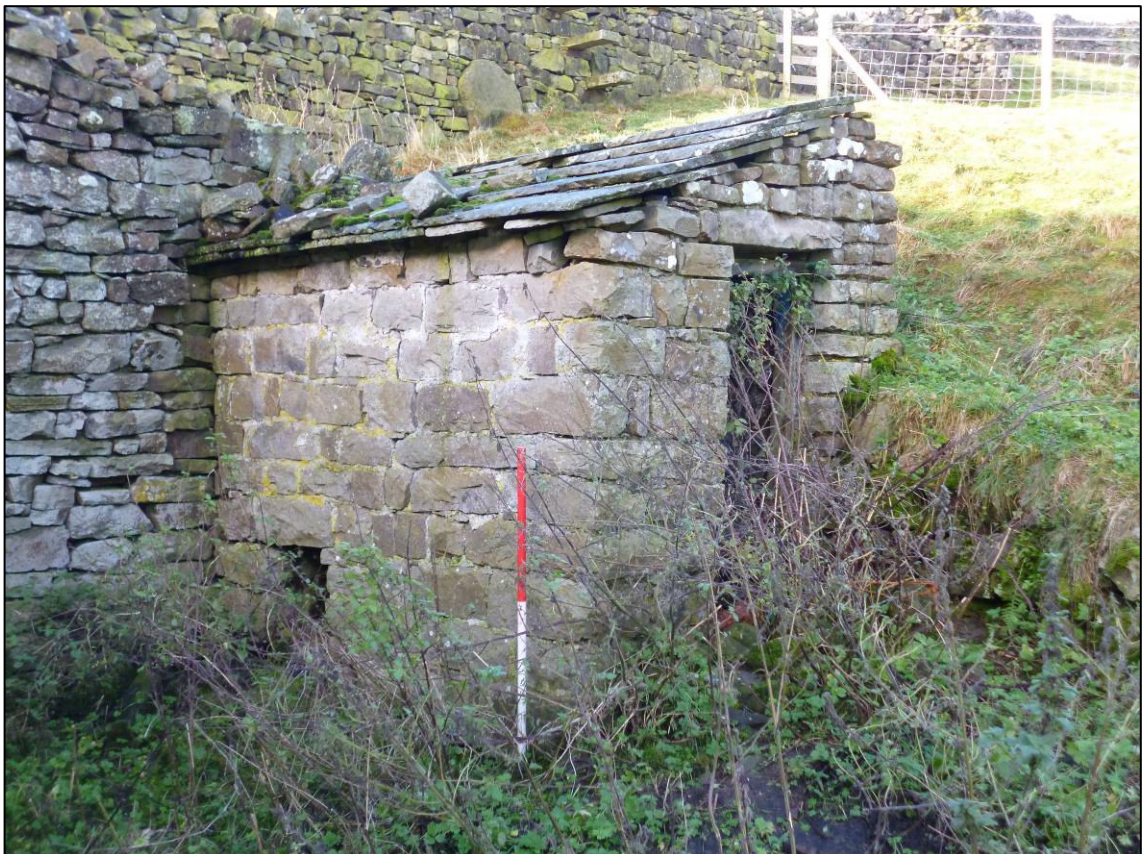
- 3.34 The privy is first depicted in 1912, attached to the north-east corner of the north structure (see figure 4). It is of a single storey, measuring 2.30m east-west by 1.90m north-south, and is built from coursed squared gritstone set with a lime mortar, with a single pitch stone slated roof sloping downwards from north to south [3/252] (see plate 17). There is a low opening to the base of the west end of the south wall [1/043], and a doorway in the east gable retaining a frame but no door [2/041; 3/266]. A low stone revetment wall curves around to the east from the privy for a short distance. The interior of the privy was not inspected in detail as it was filled with debris at the time of the survey.

Plate 17: Privy, looking W (photo 3/252).

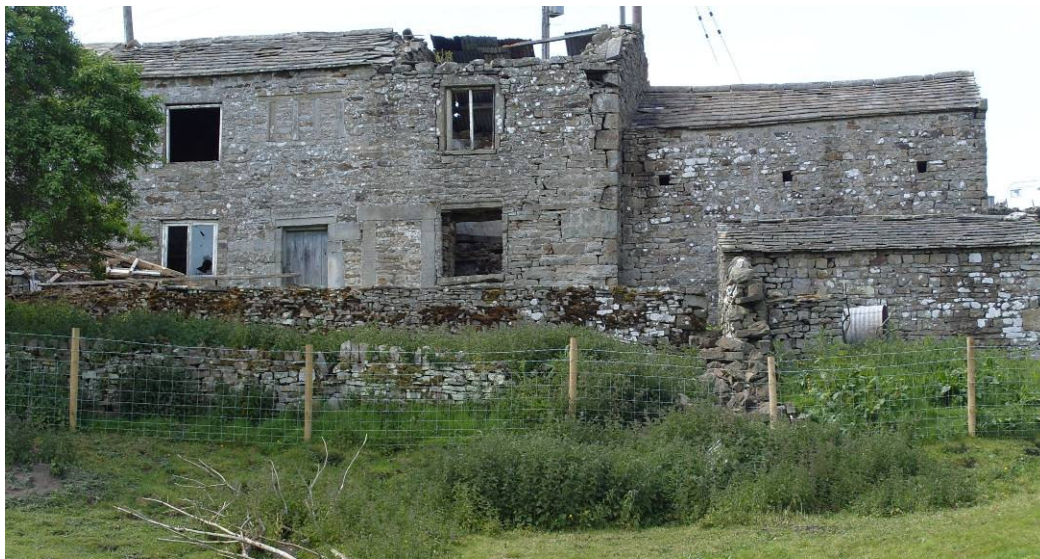
Brockma Gill East. 2011

- 1.1 A programme of work at Brockma Gill East, a derelict former farmhouse and associated out buildings is required to fulfil a planning condition for their development and re-occupation. The work is to provide a detailed record of the building prior to conversion and a watching brief on intrusive ground works. Brockma Gill East is located in the hamlet of Kearton about 4.5km to the west of Reeth, Swaledale in the Yorkshire Dales National Park.
- 1.2 A written scheme of investigation is required, detailing how the work will be carried out.

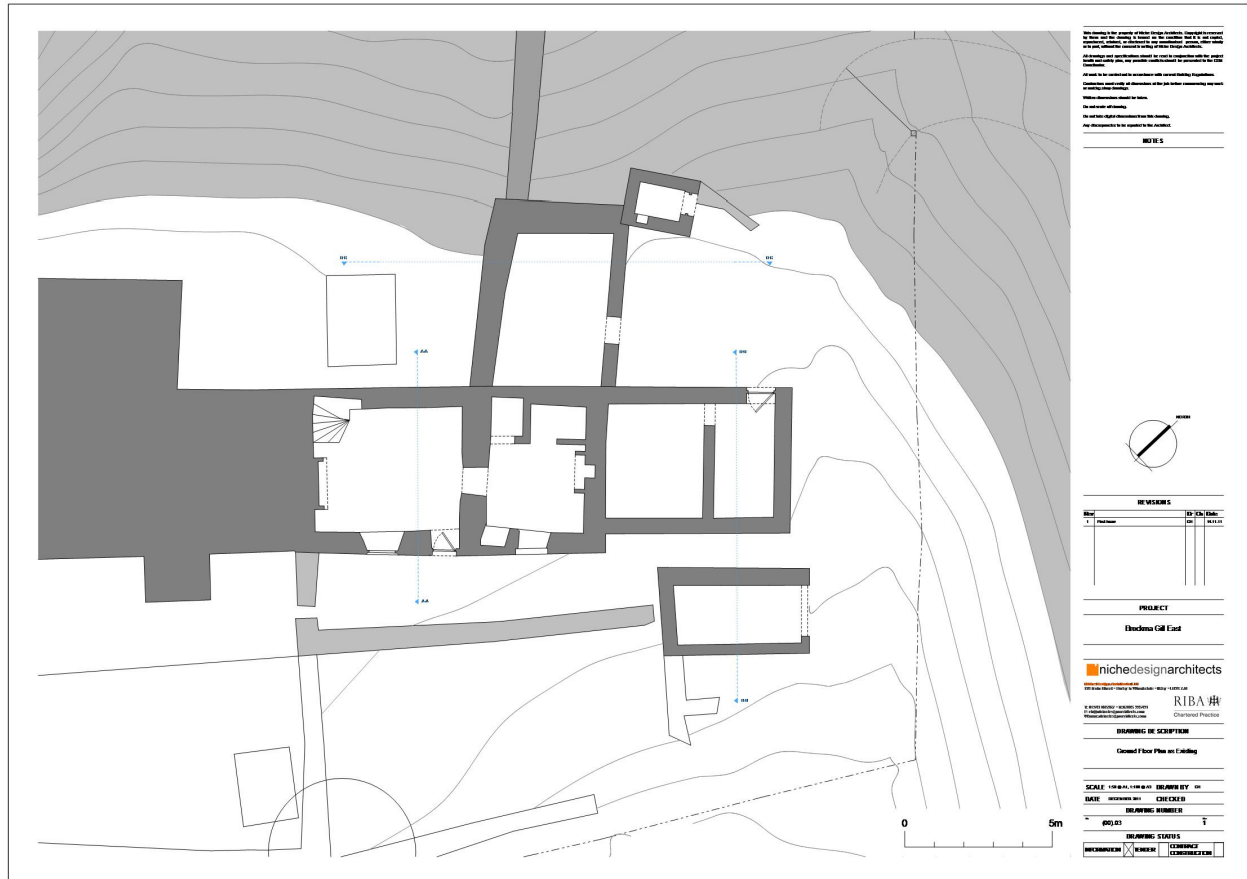
FIGURE 5: FLOOR PLANS AS EXISTING
 Top - ground floor plan, bottom - first floor plan
 (not to scale - drawings supplied by Niche Design Architects)

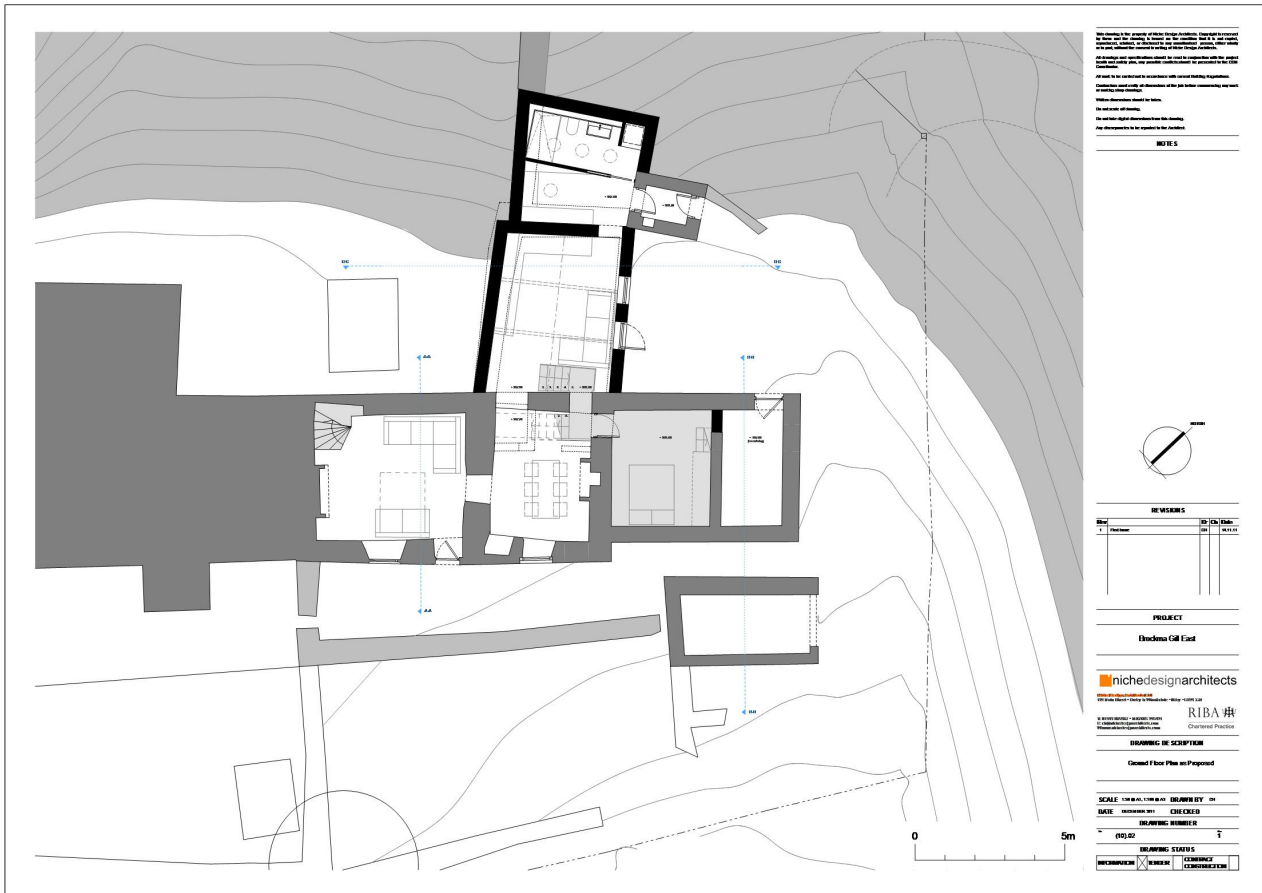
FIGURE 6: FLOOR PLANS AS PROPOSED
 Top - ground floor plan, bottom - first floor plan
 (not to scale - drawings supplied by Niche Design Architects)

- 5.1 The Niche Design Architects report details the proposed works at the site. These works can be summarised under two headings, those required to stabilise the building, and those required to refurbish the building to create habitable accommodation (see figure 6).
