ARCHAEOLOGICAL EVALUATION STRATEGY  
FOR SHEFFIELD CASTLE,  
SHEFFIELD, SOUTH YORKSHIRE

VOLUME 1: DATA GATHERING,  
SYNTHESIS AND ASSESSMENT OF POTENTIAL

VOLUME 1A: TEXT AND APPENDICES

Report no: 2013/460.R01  
Version: Final  
Date: May 2014  
Author: Shaun Richardson & Ed Dennison

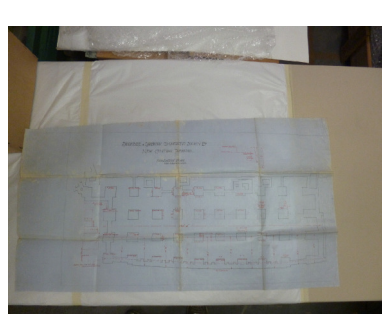
1-567.JPG

1	567	Black and white photograph dated September 1927, not taken by Armstrong, shows curving ashlar masonry with a rubble wall apparently built across the top of it (MSA: A L Armstrong archive 1995.85)
1	569 to 574	<i>Brightside &amp; Carbrook Co-operative Society Ltd , New Central Premises: Foundation Plan, Scale 8 feet to an Inch</i> (MSA: Box File - Drawings Plans Maps)
1	576 to 580	Undated plan of Castle Hill area (MSA: Box File - Drawings Plans Maps)
1	581 to 584	<i>City of Sheffield: New Retail Market, Castle Hill. Markets Committee (Drawing no. 7269 G)</i> , ground plan by W G Davies, City Architect (MSA: Box File - Drawings Plans Maps)
2	613	Photograph, in envelope in front of Himsworth's site diary (MSA)
2	614	Photograph, in envelope in front of Himsworth's site diary (MSA)
2	615-617, 619-621, 623-669	Various photographs from Himsworth's site diary (MSA)
2	670	Photograph, in envelope in front of Himsworth's site diary (MSA)
