KILBURN MOOR PLANTATION, SUTTON BANK,  
NORTH YORKSHIRE

ARCHAEOLOGICAL SURVEY OF  
20TH CENTURY MILITARY REMAINS

Report no: 2011/409.R01  
Version: Final  
Date: January 2014  
Author: Ed Dennison & Shaun Richardson

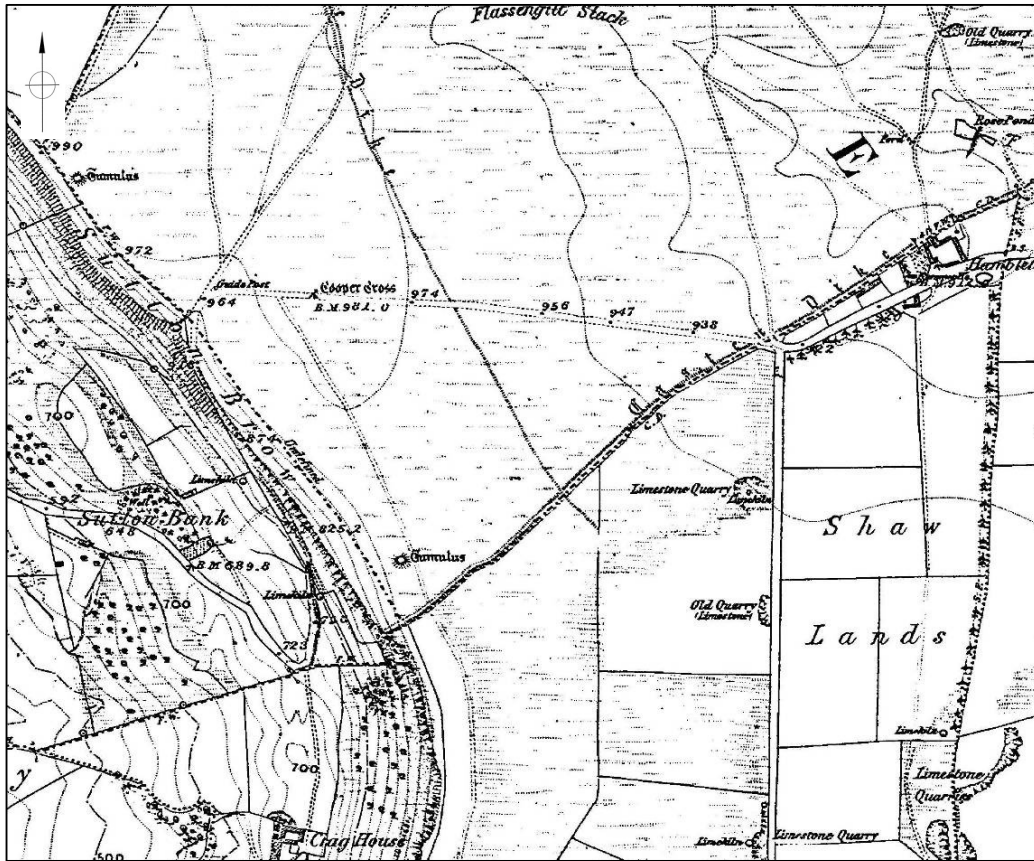
PROJECT		KILBURN MOOR PLANTATION	
TITLE		HISTORIC ORDNANCE SURVEY MAPS	
SCALE	AS SHOWN	DATE	JAN 2014
EDAS		FIGURE	2

Top: Ordnance Survey 1856 6" map, sheet 88 (surveyed 1853).

Bottom: Ordnance Survey 1913 6" map, sheet 88SE (surveyed in 1853, revised 1910).

- 3.6 It is not known precisely when Kilburn Moor Plantation was first established. It is not shown on the Ordnance Survey 1856 6" map (sheet 88, surveyed 1853), but is

depicted on the 1895 6" edition (sheet 88SE, re-surveyed in 1891); at this time, the Casten Dike formed the south-eastern edge of the plantation (see figure 2). However, it is likely that the plantation has been felled and re-planted at least once, as the area is shown as being heather moorland on an aerial photograph dating to May 1940 (see figure 6).

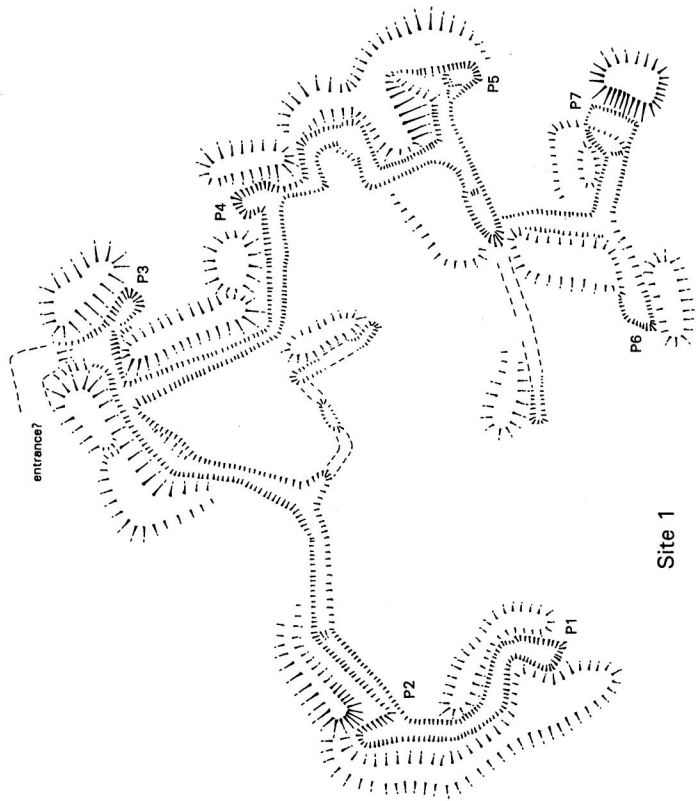
- 3.8 Site 1 lay within the westernmost of the nine divorced survey areas, located in the north-west corner of the plantation, c.70m to the south of the A170. It was the most complex of all of the earthworks recorded, and covered an area measuring a maximum of 30m east-west by 25m north-south.

- 3.9 The remains formed a single main trench with an average width of 0.8m, and an average depth of 0.5m; the sides of the trench were near vertical, although there was no indication for any former timber or other revetments. In plan, the main trench incorporated numerous right-angled or angled returns, so that it formed a many-sided defensive position, open only to the south side. Smaller spurs ran off the main trench leading to individual firing positions or pits, shielded by low flat-topped banks. These banks stood to a maximum height of 0.8m externally; the combined average surviving height from the visible base of the main trench to the top of any surrounding bank was c.1.0m.

- 3.10 The earthworks are described in a clockwise direction, starting at the south-west end of the trench. Here, there is a sub-rectangular pit (P1), measuring 2.0m long (north-south) by 1.2m wide (east-west). The main trench leaves the north end of this pit and runs west and then north-west, flanked by spread banks on either side; that to the south has a maximum width of 2.5m, but the average width is 1.5m. After several metres, the trench runs into another pit-like depression, of similar dimensions to the first (P2). It then leaves the south-east corner of the pit to follow a north-east alignment for 4.0m, before angling slightly to the east for another 4.0m; the western section has a spread bank only on the north side, which is more prominent than the bank to the immediate south-west and may indeed overlie it. At the east end of this angled section, there is another sharply defined change of angle. At this point, a short spur off the south side of the main trench appears to have lead into a narrower trench, which passes through several angled returns into a short almost north-west/south-east aligned section 4.0m long section which has a spread bank parallel to the north-east side.

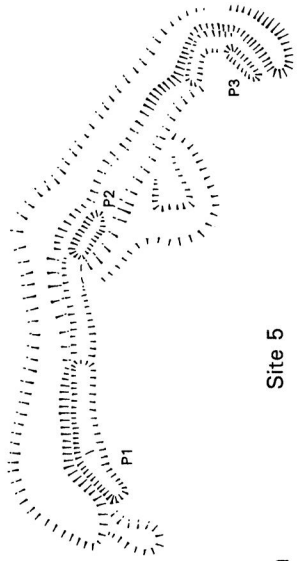
- 3.23 Site 5 was located c.150m south of the A170, between the central ride/drive and the Cleave Dike. The earthworks represent a single predominantly east-west aligned trench probably once linking three pits, the whole has a shallow V-shape, projecting outwards slightly to the north; the site covers an area measuring 21.0m north-west/south-east by 8.0m north-east/south-west.

- 3.24 Commencing at the west end, the western pit is aligned north-east/south-west and measures 1.8m long (P1) [2/439, 2/440]. It is not clearly separate from the main body of the trench, and although this does run east on a slightly different angle; indeed, a section of the trench appears to have been deepened after the original excavation to make it the same depth as the pit, thus creating a longer angled pit 5.2m long. Both the pit and the trench have a maximum depth of 0.8m. The trench runs east to meet a central pit (P2) [2/441], which is aligned north-west/south-east and measures 2.0m long by 0.8m wide and deep. The trench then angles more to the south-east when leaving the pit, and is both wider and more poorly defined here. It may be cut through an earlier and perhaps unconnected feature to the immediate south-west, formed by a small sub-triangular depression surrounded by a low bank. The trench continues and curves south towards the eastern pit, and again, as at the west end, it may have been deepened subsequent to its original excavation [1/708]. The pit itself (P3) is aligned north-east/south-west, measuring 1.7m long by 0.8m wide overall, and has a maximum depth of 0.6m.

- 3.25 There is a spread curvilinear flat-topped bank running along the whole of the north side of the pits/trench, standing up to 0.6m high externally. Initially it is over 2.50m wide, but it narrows to 1.80m in places; it widens again slightly in front of the central pit (P2) at the point of the shallow V. At the east end of the trench, the bank curves around to the south-west and is most prominent, 0.8m high, on the south-east side of the easternmost pit (P3).

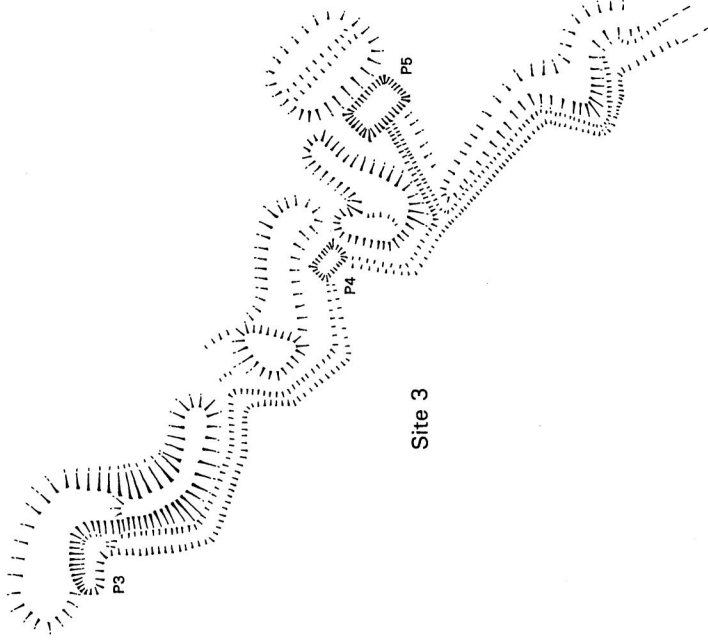
- 3.16 Site 3 was located c.170m south of the A170, immediately to the west of the central ride/drive. It almost certainly once formed a single position with Site 4 just to the east. The earthworks take the form of two outlying pits beyond the north-west end of a zig-zag plan trench, aligned generally north-west/south-east, covering an area measuring a maximum of 44.0m north-west/south-east by 11.0m north-east/south-west.
- 3.17 Of the pair of outlying pits, the western one (P1) is slightly the larger, measuring 1.8m long (north-east/south-west) by a maximum of 1.0m wide, and up to 0.8m deep [2/436]. It has a broad crescentic flat-topped bank around its west side. The

- 3.18 The main trench alignment has a total visible length of c.32.0m [2/437, 2/438], although it almost certainly once extended further to the south-east and may well have been infilled during the creation of the adjacent plantation drive/ride. The main trench has an average width of 1.0m and a maximum depth of 0.9m, including the height of the external bank. At the north-west end, there is a rectangular pit (P3), measuring 1.8m long (east-west) by 1.0m wide (north-south). It has a spread flat-topped bank, up to 2.5m wide and 0.9m high externally, on its north side, which projects beyond the west end of the pit. The main trench leaves the southern corner of the pit and follows a rather irregular zig-zag course on a general south-east alignment for 15m. The bank on the north-east side also continues, following a broadly parallel but more sinuous course and maintaining a width of c.2.0m. However, there is at least one section of the flattened top of the bank which is slightly raised above that on either side, while there is a complete break opposite where the main trench comes to a sharp V-point; a very low earthwork might arguably once have crossed this break, but it is much lower than the bank on either side. To the south-east of the break, a raised section of the bank has a slightly raised triangular plan, but it then continues as before.

- 3.19 At the south-east end of its zig-zag section, the main trench enters a well-preserved and well defined rectangular pit (P4), measuring 1.5m long (north-west/south-east) by 0.9m wide and 0.9m deep, with near vertical sides [1/704, 1/705] (see plate 6). The flat-topped bank to the north curves around in front of the pit, but there is again a narrow break opposite the north-east corner. The main trench leaves the southern corner of the pit and runs directly south for 2.5m before angling sharply to the south-east. Shortly after this point, a very straight spur runs 4.0m to the north-east, where it enters another well-preserved rectangular pit (P5), 2.4m long (north-west/south-east), 1.4m wide and 0.9m deep. The pit has a spread sub-rectangular bank on its north-east side, measuring c.4.0m long (north-west/south-east) by 3.5m wide, and with the flat top divided longitudinally by a shallow depression.

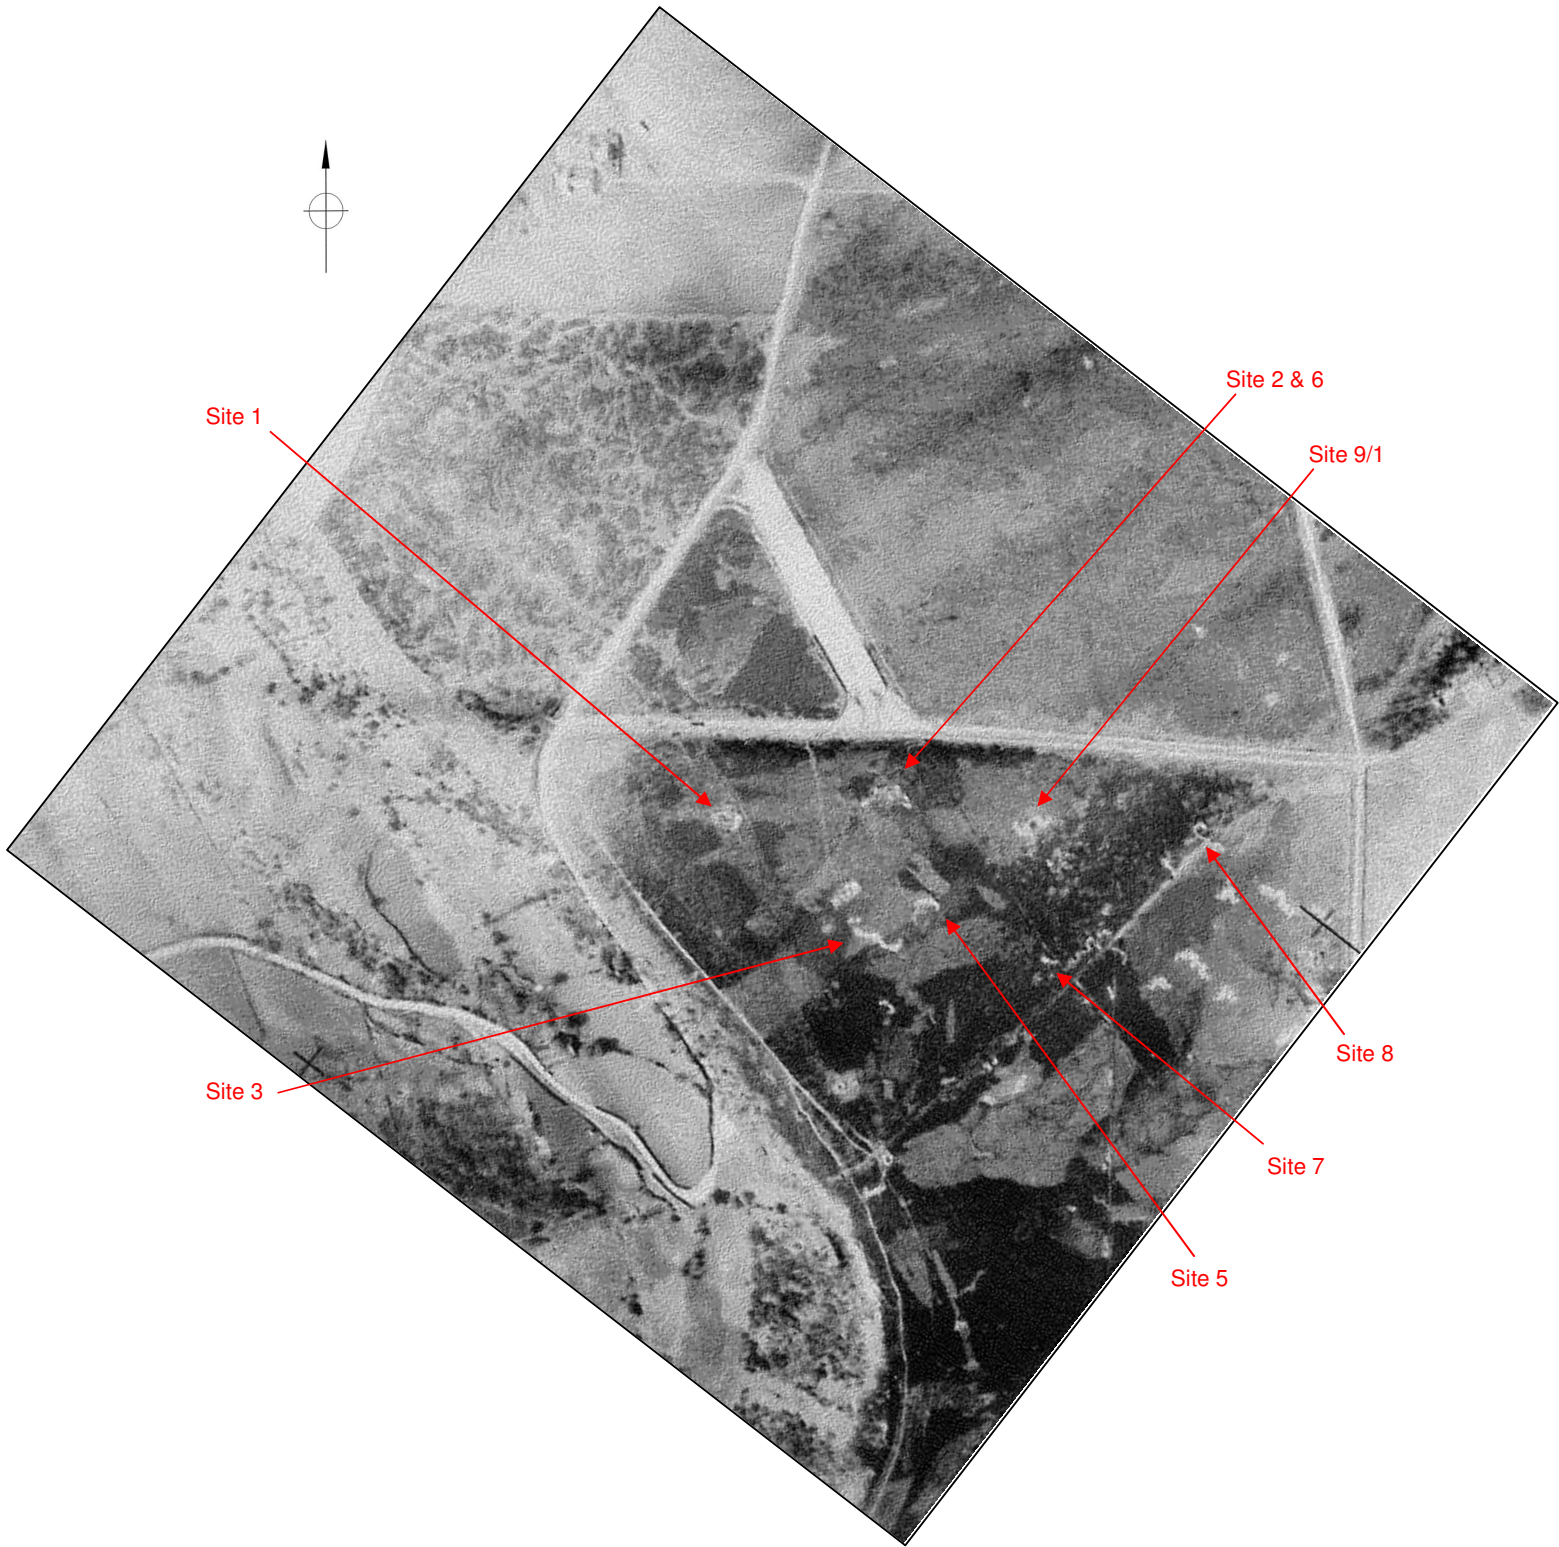
PROJECT		KILBURN MOOR PLANTATION	
TITLE		1940 AERIAL PHOTOGRAPH	
SCALE	DATE	NTS	JAN 2014
EDAS		FIGURE	6

Source: Aerial photograph 10/UK/1524, frame D3 dated 03/05/1940 (provided by NYMNP).

photograph of the area taken in May 1940 (English Heritage Archive 10/UK/1524, supplied courtesy of the NYMNP) (see figure 6). Although not especially clear, the photograph shows that the plantation was heather moorland at this time, and areas of differential burning for the management of grouse are evident. However, also visible are a number of localised areas of disturbance showing up as white or lighter coloured material, presumably representing freshly-dug spoil. These areas bear a close correlation to the recorded earthworks, for example Sites 1, 2/6, 3, 5, 7, 8 and 9; the V-shaped trench alignment of Site 5 is particularly well shown. A small number of other areas of disturbance can also be seen, for example to the south of Site 3, and along the north side of the Casten Dike to the north-east of its junction with the Cleave Dike; Site 7 is visible here, but there is a longer linear crenellated or indented trench stretching for at least c.20m to the north-east, along the north side of the Casten Dike. This site is no longer visible on the ground, the area having been taken into a perimeter drive or ride. There are several other areas of disturbance on the south side of the Casten Dike, again to the east of the continuation of the Cleave Dike, and there is also a possible earthwork dug into the top of the tumulus in the south-west part of the survey area. On the assumption that the lighter coloured material does represent recently excavated spoil, it would suggest that the recorded earthworks in Kilburn Moor Plantation all date to the spring of 1940, and it is clear that the excavations extend further to the south, beyond the Casten Dike.

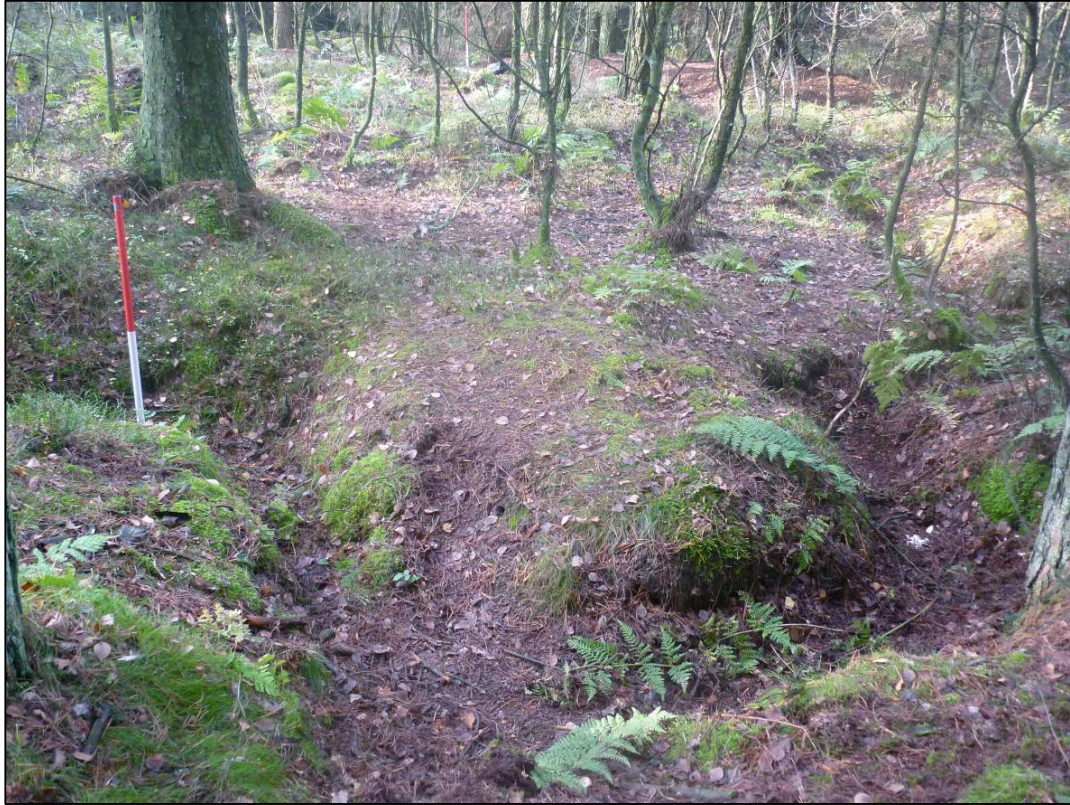
Plate 1: Site 1, crenellated trench on E side, looking W (photo 1/697).

- 3.11 From this sharply defined change of angle, the main trench runs east for a further 4.0m before turning more to the north-east for another 4.0m; there is a spread but prominent shallow bank on its north-west side. The main trench then takes a sharp right-angle to continue further to the south-east [2/434] (see plate 3), but the original alignment is continued to the north-east as a short spur which incorporates another pit on its east side (P3) which has a bank to the north-east. A gap between this bank and the shallow bank mentioned above might define an entrance into the trench complex.

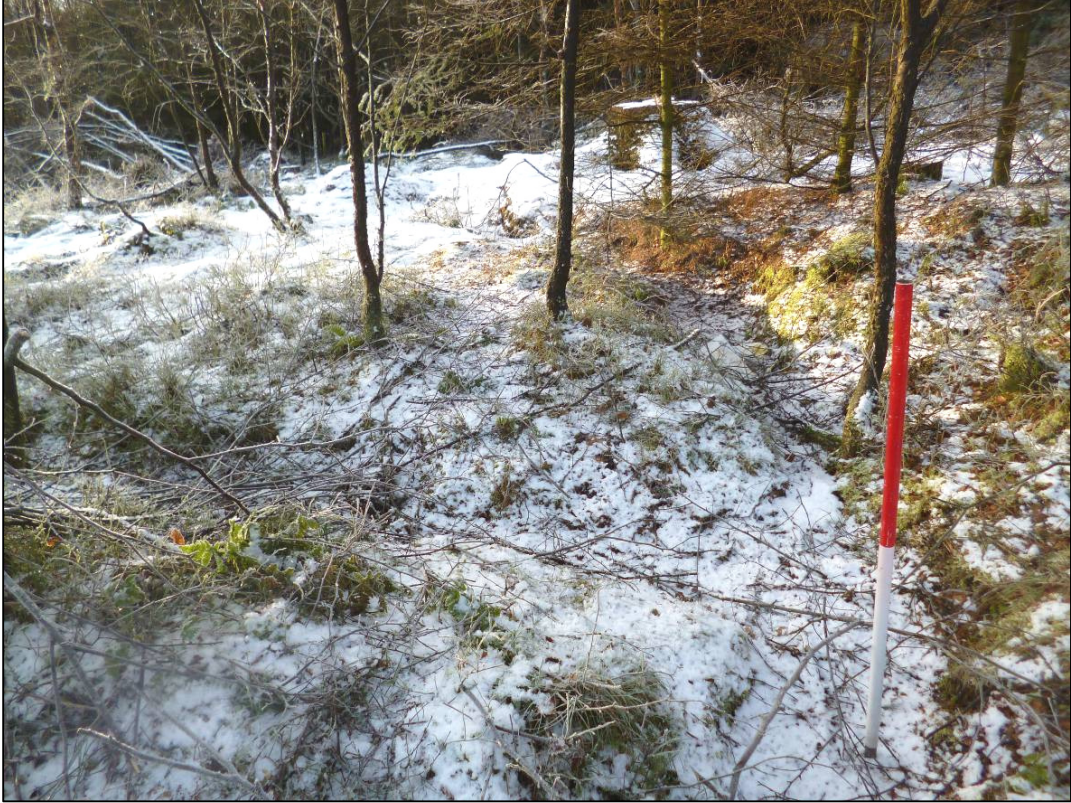
Plate 3: Site 1, north trenches from pit 3, looking W (photo 2/434).

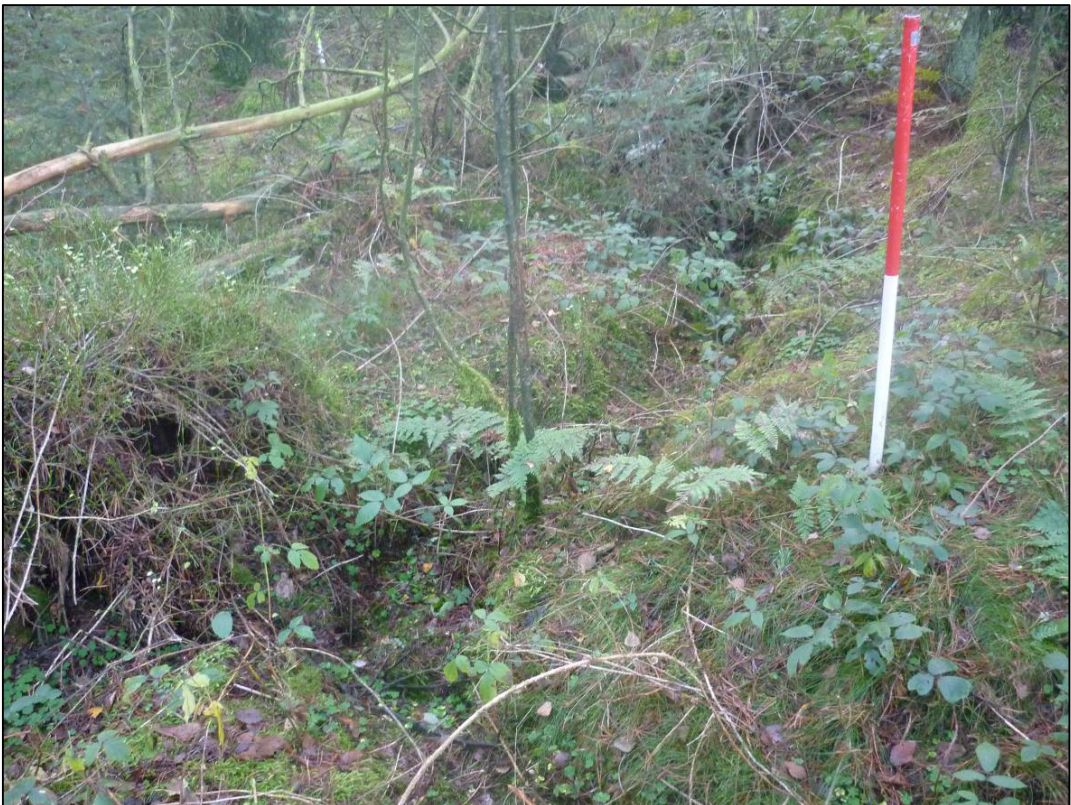
Plate 4: Site 2, pits 1 & 2 linked by trench, looking S (photo 1/701).

- 3.15 The two westernmost pits (P1 and P2) formed a pair, linked by a narrow 5.0m long angled trench [1/700, 1/701, 1/703; 2/433] (see plate 4). Each pit is c.2.0m long by 0.8m wide, and they survive to a maximum depth of 0.9m. Both have wide spread flat-topped banks, up to 2.5m wide and 0.5m high, to their north-west sides. The single pit (P3), located 4.5m to the east, is somewhat larger, is well defined and measures 2.4m long by 1.4m wide, and up to 0.9m deep [2/429, 2/430, 2/431] (see plate 5). Short spurs leave the south and east corners, perhaps suggesting that there were once linking trenches to the east and west, as is the case with the main trench in Site 3 (see below). The pit is protected by spread banks to the north and south; that to the north is more substantial, and has a shallow V-shaped projection to its northern edge.

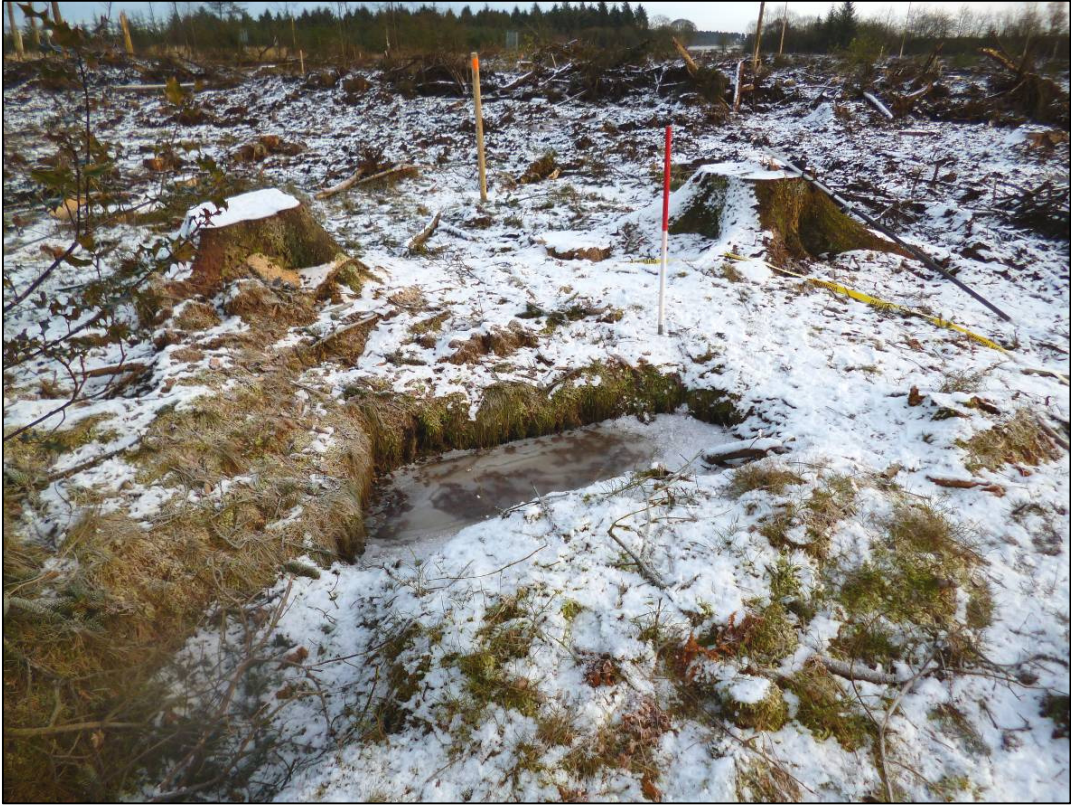
Plate 5: Site 2, pit 3, looking SE (photo 2/429).

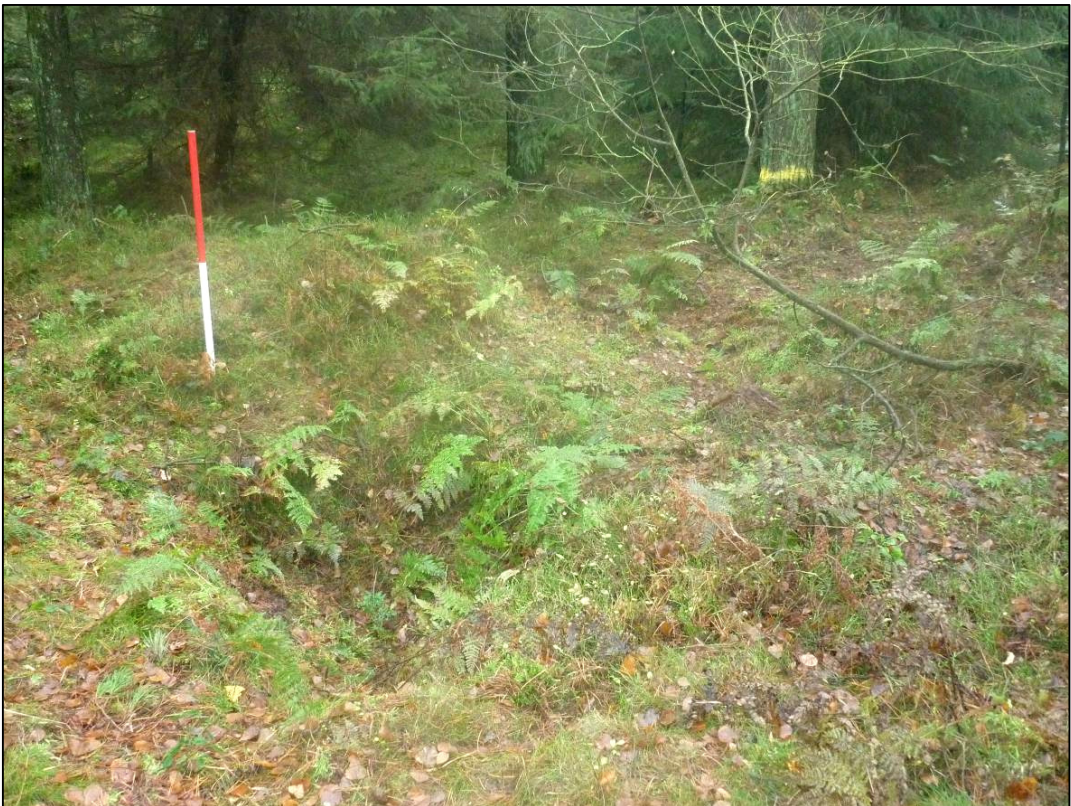
Plate 6: Site 3, pit 4, looking N (photo 1/704).

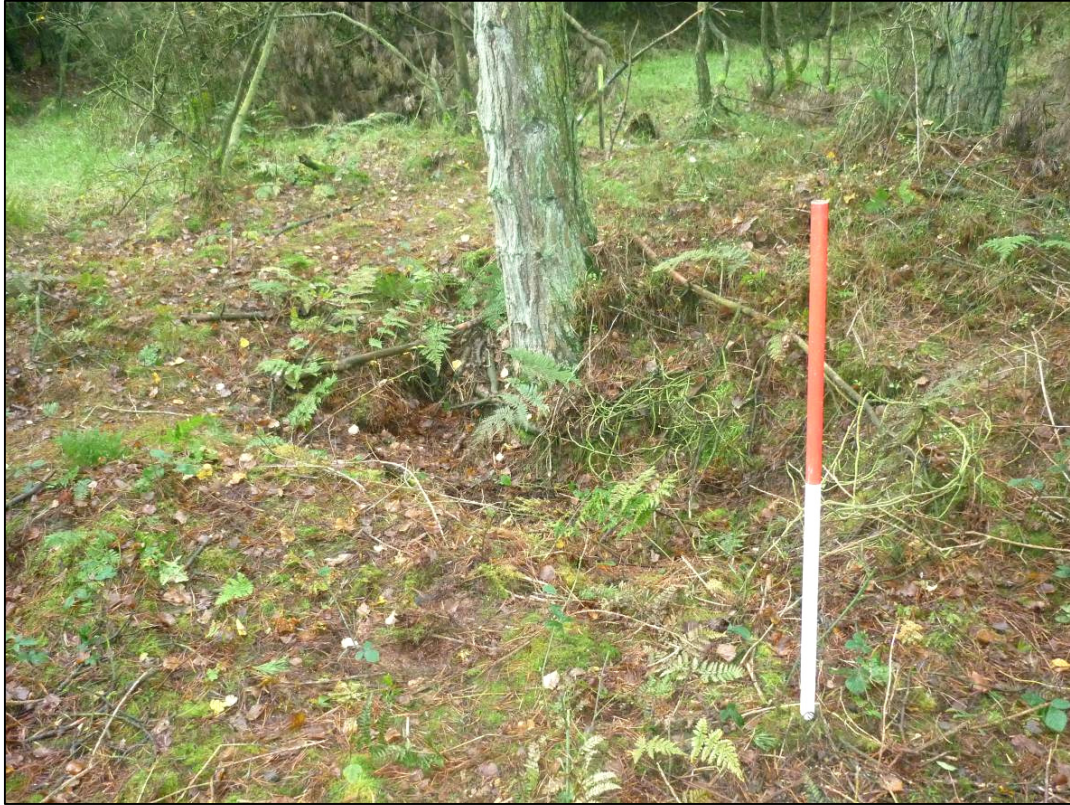
Plate 7: Site 4, pit 1, looking S (photo 1/707).

- 3.21 This site was located c.190m south of the A170, very close to the east side of the central ride/drive. It almost certainly once formed a single position with Site 3 to the west of the same drive. The earthworks define two separate pits, on a general north-south alignment and individually aligned north-east/south-west, covering an area of 8.0m north-south by 2.5m east-west.
- 3.22 Both pits have steep, near vertical sides, and a maximum depth of 1.0m, including the height of the external banks. Both are broadly rectangular in plan, varying between 1.5m-2.2m long and 0.8m wide [1/707] (see plate 7). The northern pit (P1) has very faint traces of a short trench leaving the southern corner and running south towards the second pit. There is a spread curvilinear flat-topped bank on the north side, which appears to have a short arm running north from the main mound.

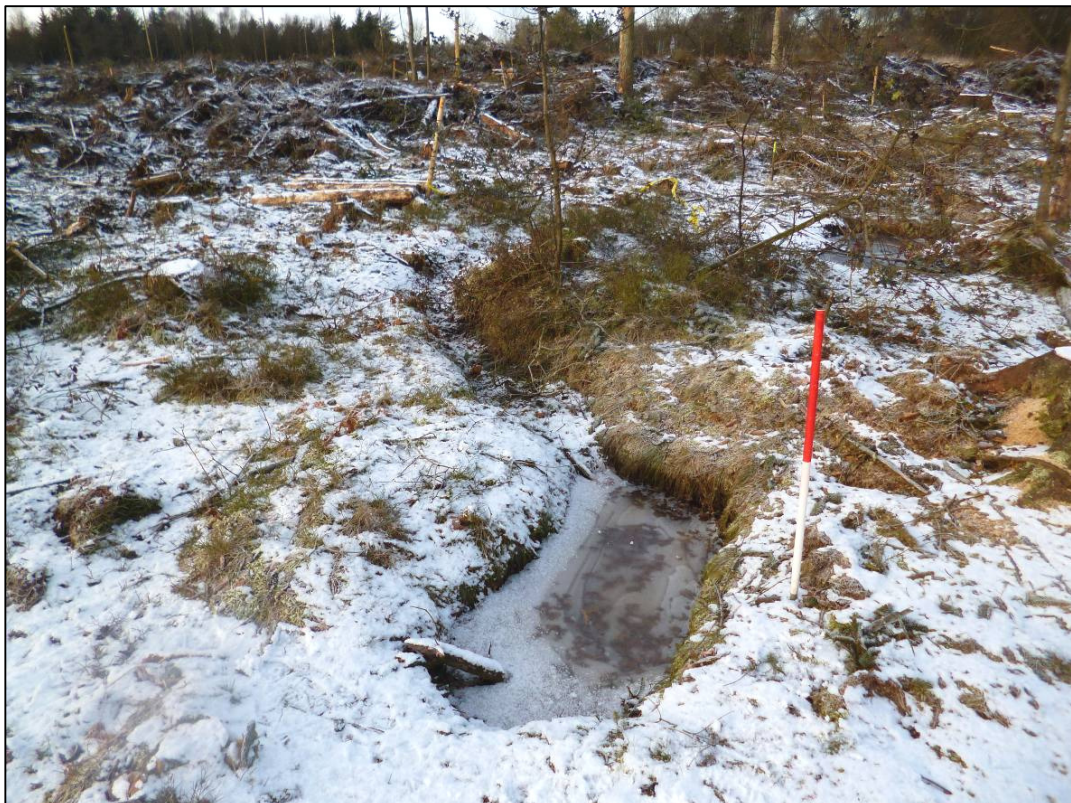
Plate 8: Site 6, pit 4, looking NW (photo 2/426).

- 3.27 All the pits at this site have steep, near vertical sides, and a maximum depth of 1.0m, including the height of external banks. All are broadly rectangular in plan, varying between 1.5m-2.0m long by 0.8m-1.0m wide. The north-western pit (P1) is aligned east-west, and has a spread bulbous flat-topped bank on its north side. The second pit (P2) is also aligned east-west, and has a short trench leaving its west end, which may once have continued further to the west; there is again a curving flat-topped bank on the north side, 0.5m high, perhaps overlying a lower bank at the east end. The third pit (P3) is aligned north-west/south-east, and has a spread flat-topped bank on the north-east side and a small sub-circular mound to the north-west. The fourth pit (P4), at the south-east end of the complex, is also aligned north-west/south-east and is well preserved, measuring 1.8m long by 0.8m wide [1/709; 2/426, 2/427] (see plate 8). Like Pit 2, this also has a shallow trench

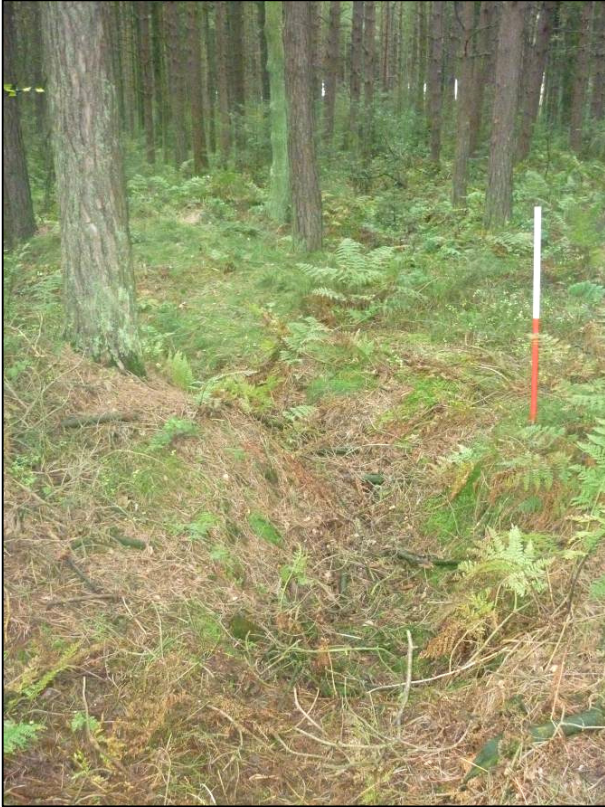
Plate 9: Site 7, pit 1, looking S (photo 1/710).

- 3.30 A north-west/south-east aligned pit (P1) at the north-west end of the angled trench measures 1.8m long by 1.0m wide, and has a maximum depth of 0.8m [1/710] (see plate 9). A north-south aligned straight section of trench then leaves the pit and runs south for 5.0m; it has an average width of 0.8m and an average depth of 0.5m. This section of the trench is flanked by spread flat-topped banks on both the east and west sides. At its south end, the trench returns to the east through a very sharp right-angle, to run for a further 5.0m into a second north-west/south-east aligned pit (P2), which measures 1.5m long by 0.8m wide. The trench then continues beyond this pit and runs east for a further 6.0m to enter the third north-west/south-east aligned pit; the earthworks suggest that this section of the trench may have been re-cut at some point. The third pit (P3) is placed in what would originally have been the ditch of the Cleave Dike, and it measures 1.9m long by 1.0m wide and is 0.8m deep [1/711] (see plate 10). To the immediate north of the pit, a c.4.0m section of the dike's ditch has been largely infilled; either side of this infill, the ditch is a prominent earthwork 3.4m wide and over 1.0m deep. This infilling is clearly deliberate and must be associated with the 20th century earthworks, as it required far more material than would be created by the upcast from the trench and pit alone.

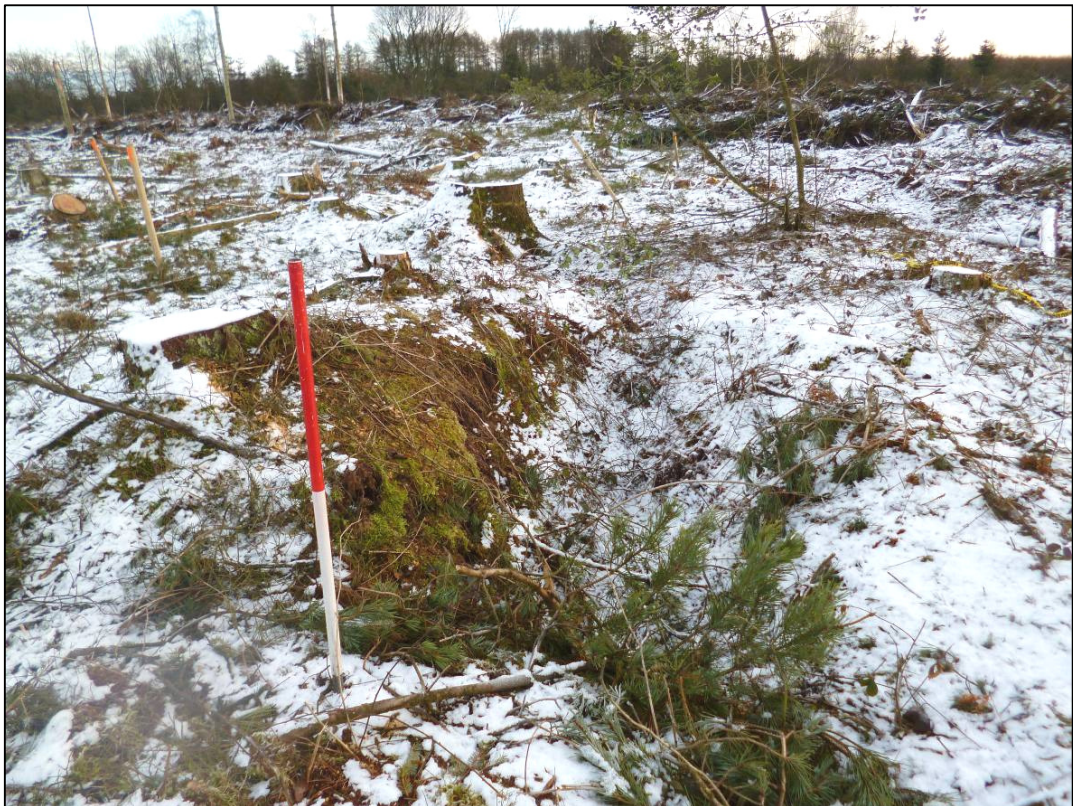
Plate 11: Site 9/3, pit 7 on N edge of depression, looking E (photo 2/446).

- 3.40 This pit is set on the southern edge of a shallow sub-oval depression or hollow, measuring 13.0m north-south, possibly a natural feature or the result of shallow quarrying which appears to have been modified by the military earthworks which have been set out around the edge of this depression. A well defined trench, 0.8m wide by 0.5m deep [2/447], runs south-east on a slight V-shaped alignment for 5.0m from Pit 3 before entering a further pit (P4), which is aligned north-east/south-west and is of similar dimensions to Pit 3. The trench then leaves the north end of this pit and follows a slightly curvilinear route north towards another pit (P5), which is slightly L-shaped in plan and 0.6m deep. A spread flat-topped bank 1.0m wide runs along the north side of the aforementioned trench and three pits. There is a similar but shorter bank to the east side of Pit 5, and it is probable that this once partly shielded a trench running north from this pit to another pit (P6), some 3.0m to the north; this section of trench is not well defined, and there may be some infilling to create a 1.0m wide entrance into the sub-oval depression. Pit 6 has a slightly different shape to the others, being almost square (1.0m across all four sides) and 0.4m deep, and is protected by a spread flat-topped bank which wraps around its north and east sides. Finally, an additional well-defined east-west pit (P7), 1.5m long by 1.0m wide and isolated from all of the others, can be seen dug into the north side of the depression [2/446] (see plate 11).
