EXTERNAL DRAINAGE WORKS,  
ST MARTIN'S CHURCH, MAIN STREET,  
SEAMER, NORTH YORKSHIRE

ARCHAEOLOGICAL WATCHING BRIEF

Report no: 2011/393.R01  
Version: Final  
Date: January 2014  
Author: Ed Dennison & Kate Dennett

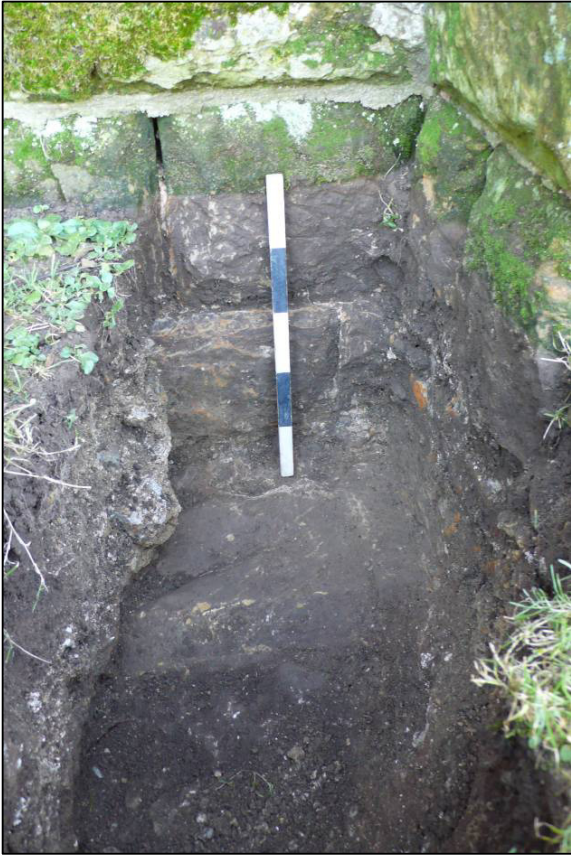
Plate 1: South end of Trench 1, showing foundations (006) of north side of tower, looking S.

- 5.2 In the base of the south end of Trench 1, a single sherd of pottery was found embedded in what appeared to be a fairly compacted deposit of cobbles and fragmented sandstone rubble, all bound with a very firm brown loam (005), extending c.1.5m north from the north side of the tower, and butting up to the foundations (006); the top of the rubble/cobbles lay at 0.60m BGL. The plain unglazed sherd was Staxton ware of late 12th to early 15th century date (Peter Didsbury, *pers. comm.*), and was from the body of a thin-walled, wheel thrown vessel. The foundations of the tower (006) were overlain by the compacted lime mortar deposit (007) noted above (see plate 1), and there was also a thin layer of sticky white chalky marl (003) adjacent to this side of the tower. A possible cut with a bowl-shaped section (015), excavated through the loose dark brown loam (002) and the underlying subsoil (010), was only partially visible here, filled with a friable dark brown loam (004). This cut, and the underlying rubble deposit (005), may both be related to the building or rebuilding of the tower, but it was not possible to determine any precise relationship from such a limited view presented by the excavation. The friable/loose brown loam subsoil (010) was also exposed in the bottom of the rest of Trenches 1 and 2.

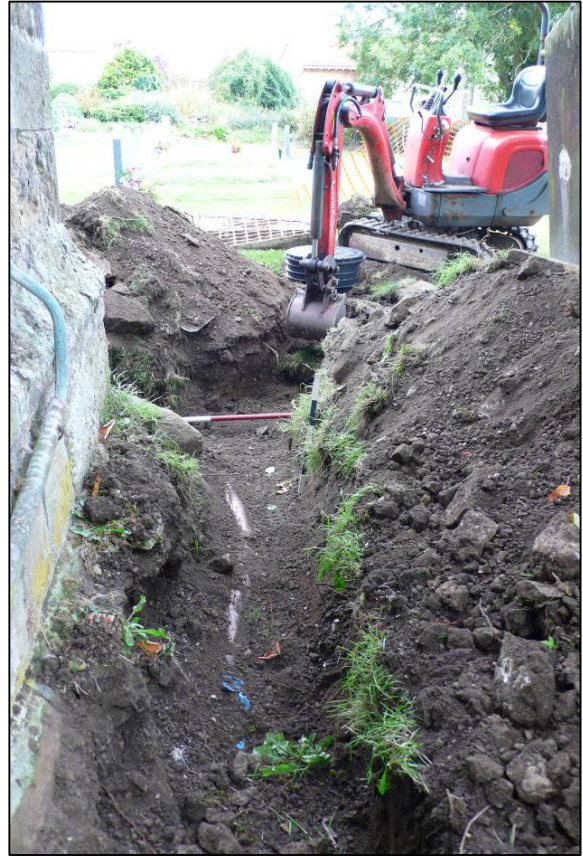
Plate 2: Excavation of Trench 4 showing drainage pipe (019), looking N.

- 5.6 Trench 4, dug along the east side of the vestry, exposed a friable dark brown loam containing occasional fragments of brick, glass, stone, slate and bone, up to 0.40m deep (016), immediately below the soil and turf. This deposit, which extended into Trench 5, appeared to be a relatively modern soil, deposited after recently completed drainage works in the vicinity. At the south end of Trench 4 was a small spread of limestone rubble and stone/tile fragments of an unknown depth, in a loose dark brown loam (017). Again, this is likely to relate to earlier drainage works in the vicinity. Within the trench was a glazed ceramic drain (019), 0.13m wide (see plate 2), the north end of which appeared to connect another similar drain (018) in Trench 5 (see plate 6); the latter ran east from a gully (028). The limestone foundation of the east wall of the vestry (031) was occasionally exposed in Trench 4, but no other features of archaeological interest were exposed by these groundworks.

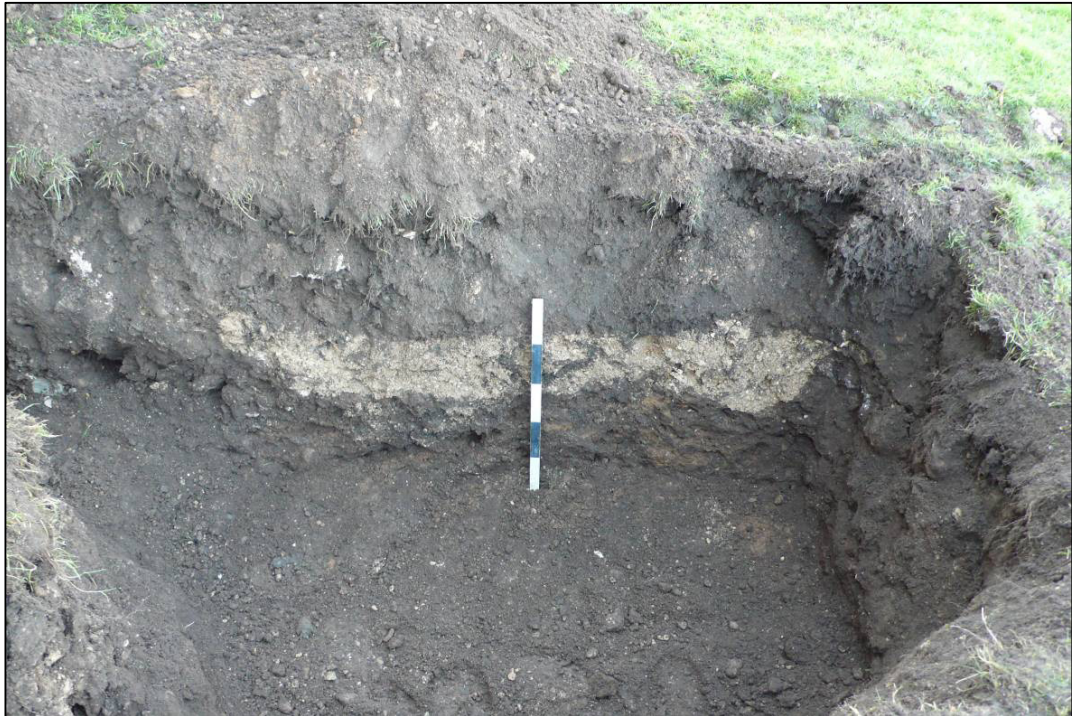
Plate 3: Grave cut (014) and backfill (008, 009 & 012) exposed in west side of inspection chamber pit at north end of Trench 1, looking W.

- 5.3 The excavation of the west side of the inspection pit at the junction of Trenches 1 and 2 cut through what appeared to be an unmarked grave, exposing the upper layers of the backfill (008, 009, 012) and possibly the remains of a brick base for a

previously demolished table or chest tomb monument (see plate 3). The grave was formed by vertical-sided cut c.1.20m wide (014), and a single, very small, sherd of blue and white glazed pottery, of 19th or early 20th century date was noted in the upper backfill (012).

- 5.4 No human bone was present in Trenches 1 or 2, and only one residual fragmented bone (a tibia) was noted in the inspection pit, within the primary grave backfill deposit (009). This was reburied in Trench 1.

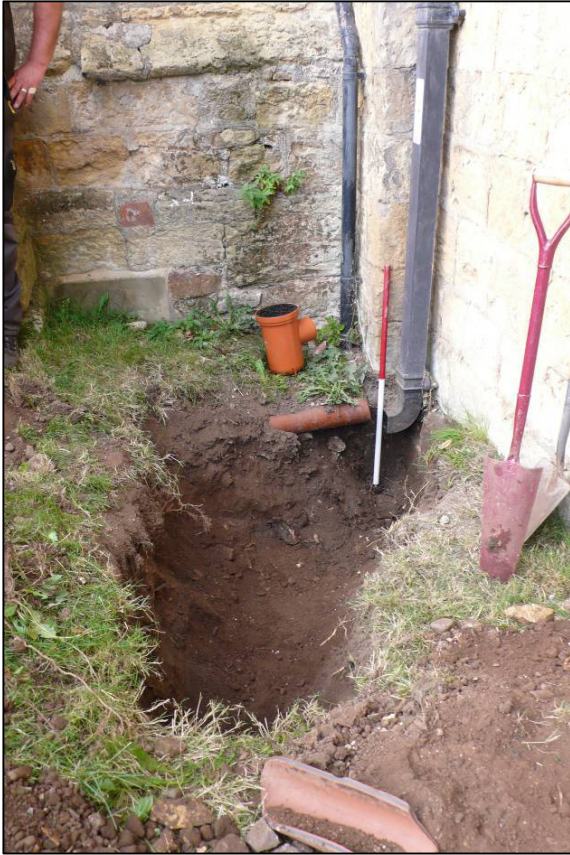
Plate 4: Excavation of Trench 3, looking W.

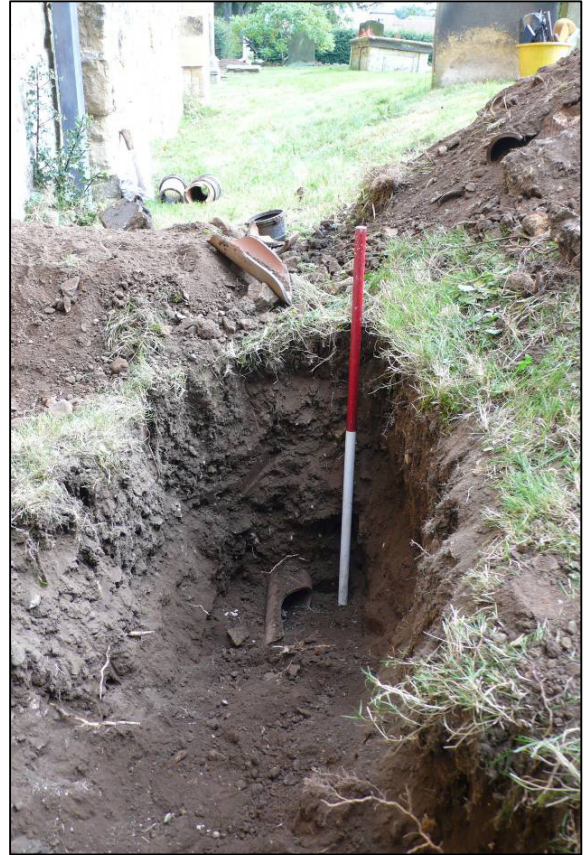
Plate 5: Excavation of Trench 3, showing drain pipe (021), looking E.

- 5.5 The excavation of Trench 3 partially exposed the ashlar foundation of the south wall of the nave (023/029), but no other archaeological features of interest were noted. A glazed ceramic drainage pipe, 0.13m wide (021), ran south-east from a gully (026) in the angle of the nave and south porch; two other plastic pipes (022 and 025) fed into this gully. The ceramic drain was probably contained within a cut (027), although this was not really visible in the surrounding red-brown loam which also contained fragments of brick, stone, bone, tile and drain pipe (024) (see plates 4 and 5). A number of residual fragments of human bone were exposed in the trench, and these were collected together and re-buried in the base of the excavation.

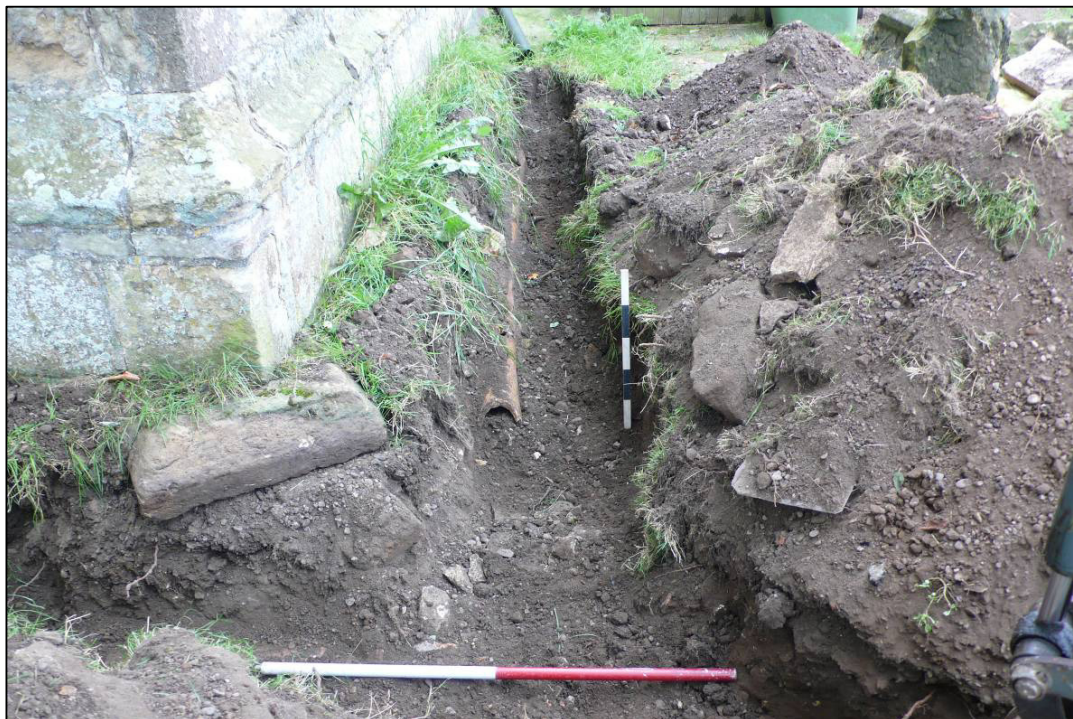
Plate 6: Old drain pipe (018) exposed in trench 5, looking W.
