RESTORATION OF 3 NO. STOCK PONDS  
TO AGRICULTURAL LAND,  
PARK FARM, DUNFLAT ROAD,  
RISBY, EAST YORKSHIRE

ARCHAEOLOGICAL OBSERVATION,  
INVESTIGATION AND RECORDING

Report no: 2013/471.R01  
Version: Final  
Date: January 2014  
Author: Ed Dennison

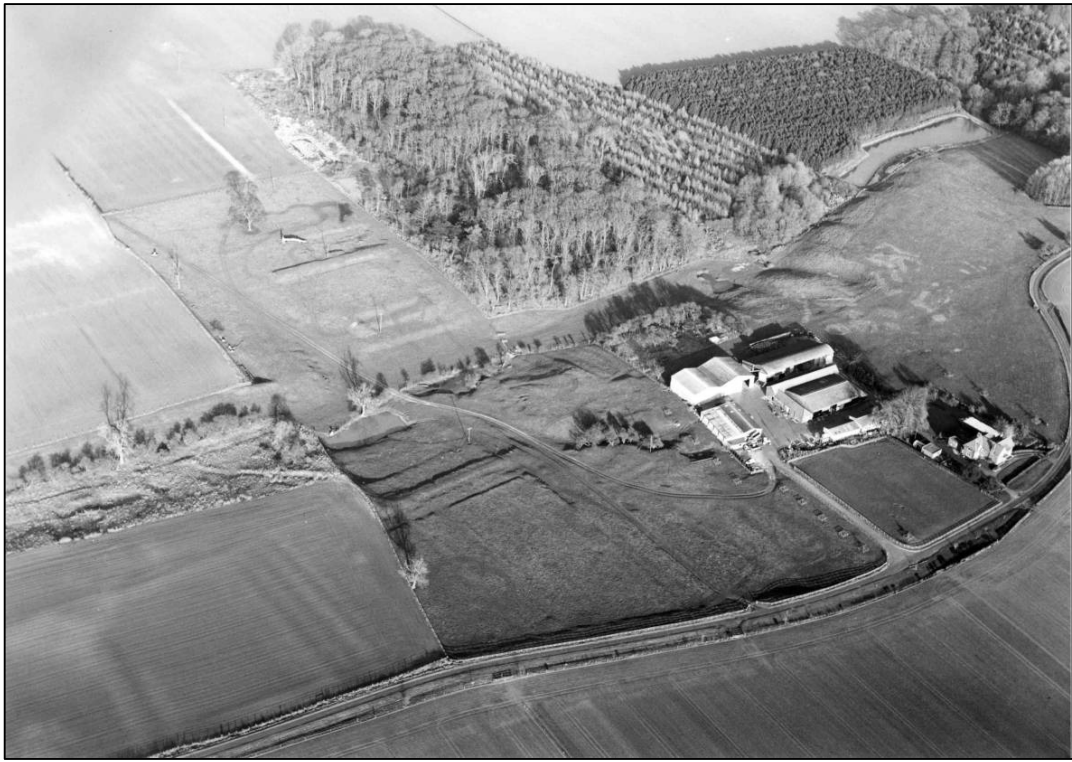
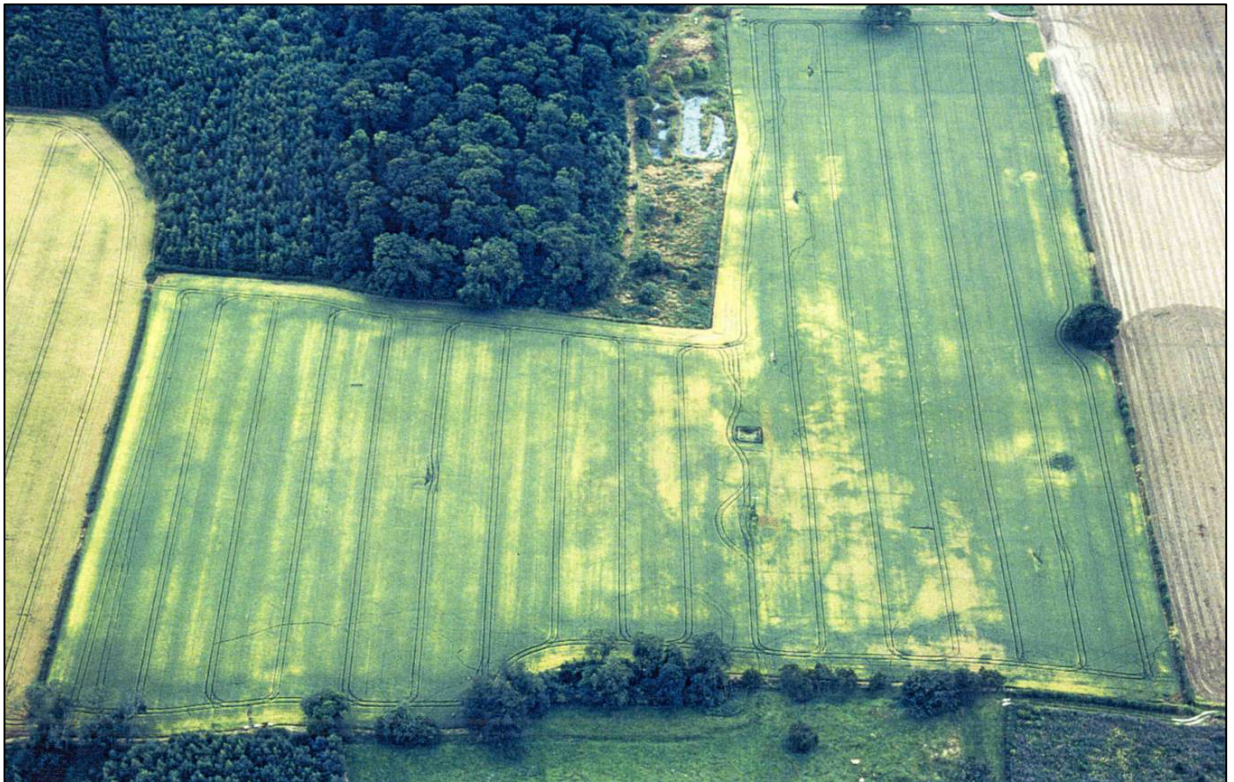
PROJECT		RISBY STOCK PONDS	
TITLE		1990s AERIAL PHOTOGRAPHS	
SCALE	DATE	NTS	JAN 2014
EDAS		FIGURE	6

Sources:  
 Top: Aerial photograph taken 14th January 1992 (HAP 91/28/4), looking north-east.  
 Bottom: Aerial photograph taken 22nd July 1999 (NMR 17314/07 - TA 0035/8), looking south.

- 5.7 By the time of the later 1890 Ordnance Survey map (sheet 225/3), only the larger rectangular pond south-east of Gillan Spring is clearly shown. Its depiction suggests that it may have become silted since 1855, but it was still water-filled and shown as an earthwork rather than just a body of water. Of the discrete group of three ponds shown in 1855, only the angular bank or former leat marking their southern limit is shown. All features are depicted in the same manner on the 1910 Ordnance Survey map. On an aerial photograph taken in December 1945 (RAF/3G/TUD/UK/1 frame 5014), the larger rectangular pond can still be seen as an earthwork, as can the sub-square feature to its south, which is very regular in appearance and resembles a former structure. Field notes made by the Ordnance Survey in 1961 appear to indicate a pair of sub-square structures to the west of the former position of the three ponds shown in 1855, but there is no indication of the ponds themselves. In December 1975, the larger rectangular pond can again be seen on an aerial photograph, as can the possible structure to the south-east; two of the group of three ponds shown in 1855 appear to have been cleared out, joined at either end, and were possibly water-filled (MAL/75066 frame 60). The shape of the latter may still be visible in 1988 but, apart from the two smallest ponds nearest the central part of the Blackdike canal, the other features had been ploughed out by this date (AP OS/88264 frame 143); this situation was also shown on aerial photographs taken in January 1992 (HAP 91/28/4) and July 1999 (NMR 17314/07 - TA 0035/8 and NMR 17321/52 - TA 0035/4) (see figure 6).

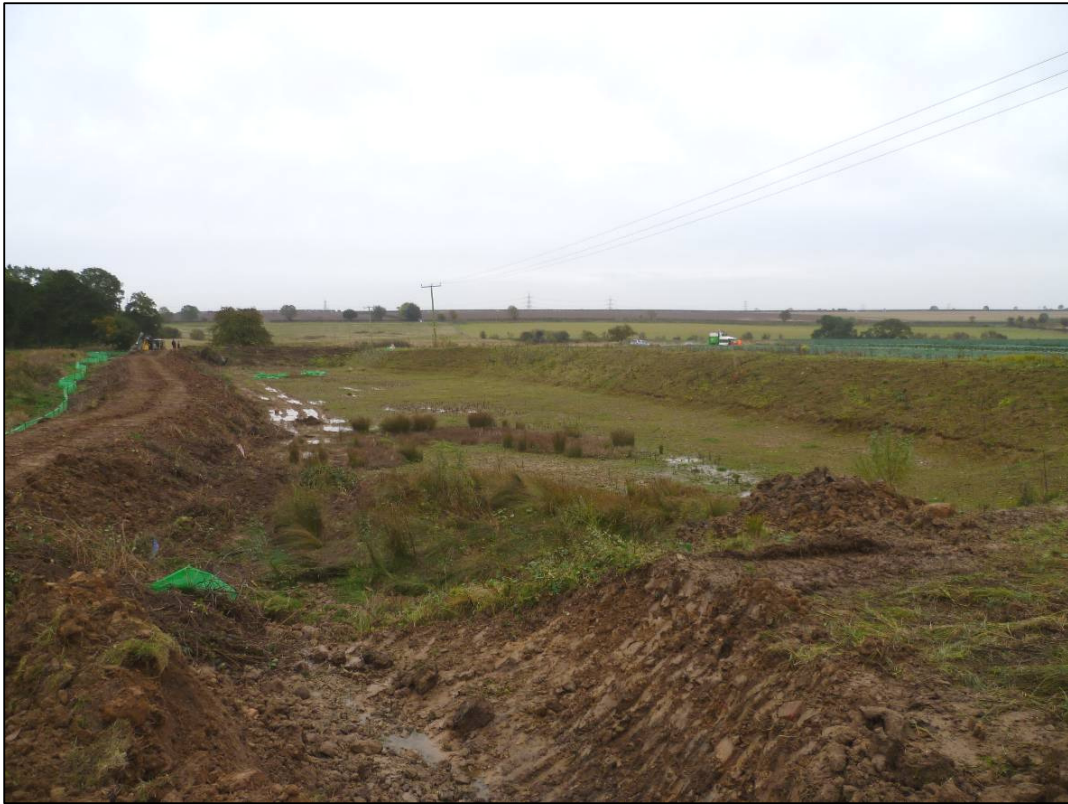
Plate 1: Central pond prior to start of work, showing cut through northern dam, looking SW.

- 6.1 No significant archaeological features or deposits were observed during the periodic watching brief. As no disturbance to pre-pond ground levels, or other existing ground levels around the ponds, was envisaged as part of the restoration project, this was not surprising.
- 6.2 The first phase of work comprised the infilling and levelling of the southern triangular pond, and the excavation of a gap in the eastern end of the dam

between the northern and central ponds (see plates 1 and 2). As part of the former work, an undefined scatter of brick, cobbles and stone was revealed in scrub on and just below the surface in the south-east corner of the site, just beyond the area of the pond, from where other similar material had been gathered in the past. The bricks that were whole typically measured 240mm x 120mm x 65mm, and one piece of worked ashlar masonry measured 270mm square by 85mm thick; this had moulding along one side (see plate 3). It was assumed that it originated from the site of the demolished mid 17th century hall immediately to the south of the pond. Some of the bricks and the piece of ashlar were added to a pile of other similar *ex-situ* material already placed around a tree stump in the very south-east corner of the site, which was to remain on site. The excavation through the dam to the north did not reveal any stratigraphy to the structure.

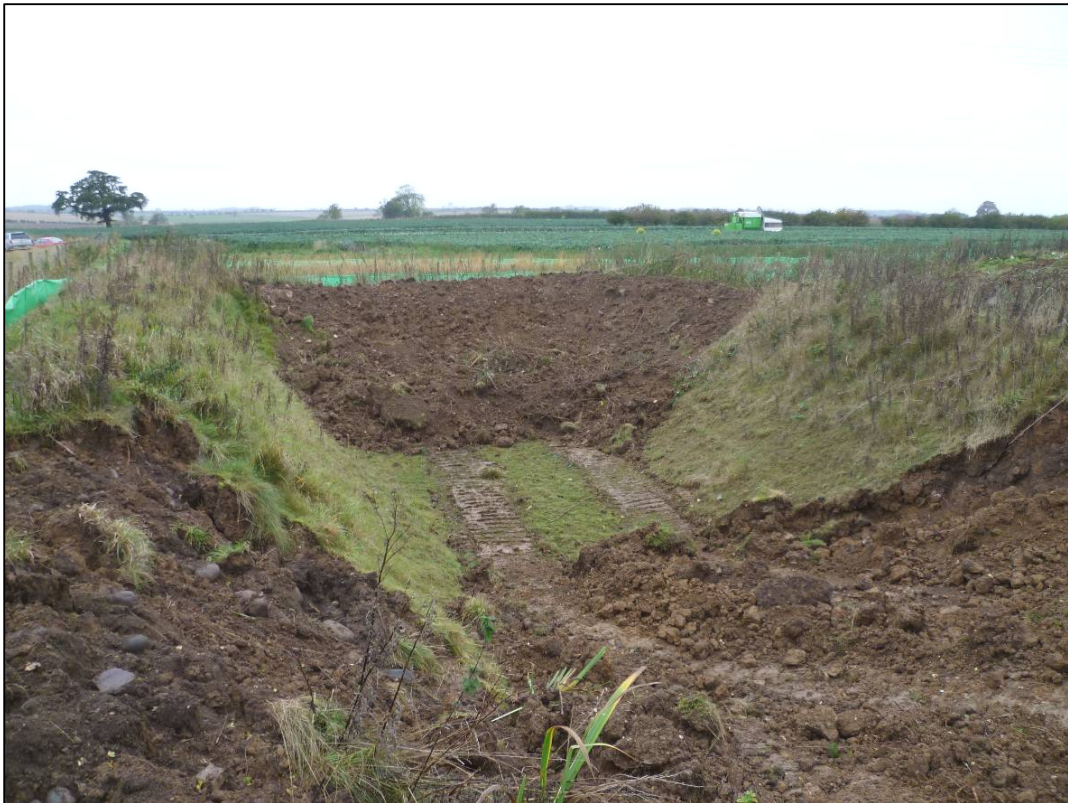
Plate 2: Infilling of smaller southern pond, looking W. looking S.

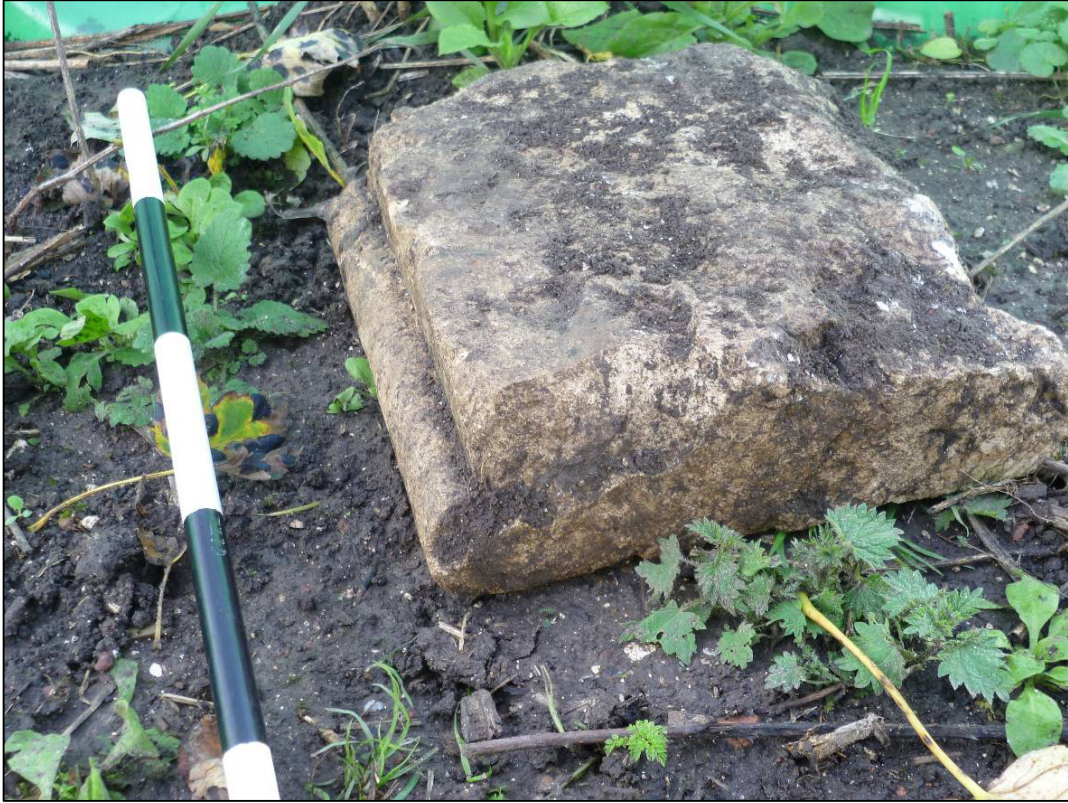
Plate 3: Piece of ex situ worked masonry with moulding, found near southern pond.

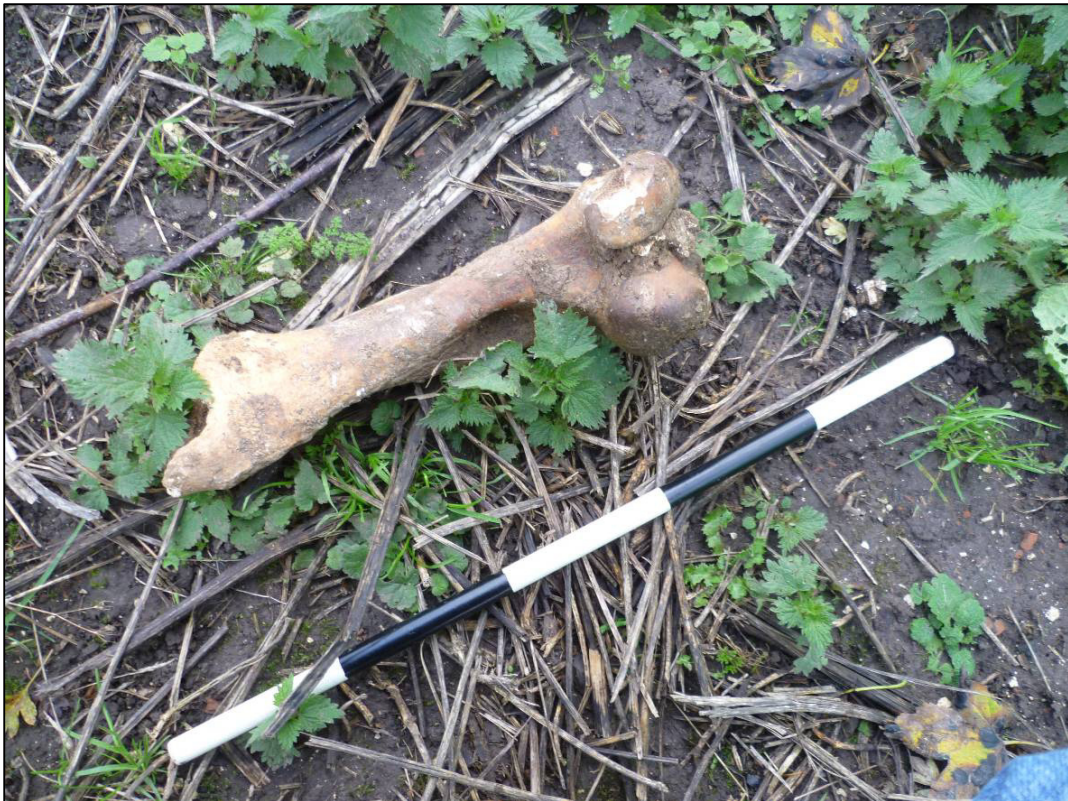
Plate 4: Section of ex situ adult cow femur, found in gap between central and northern ponds.

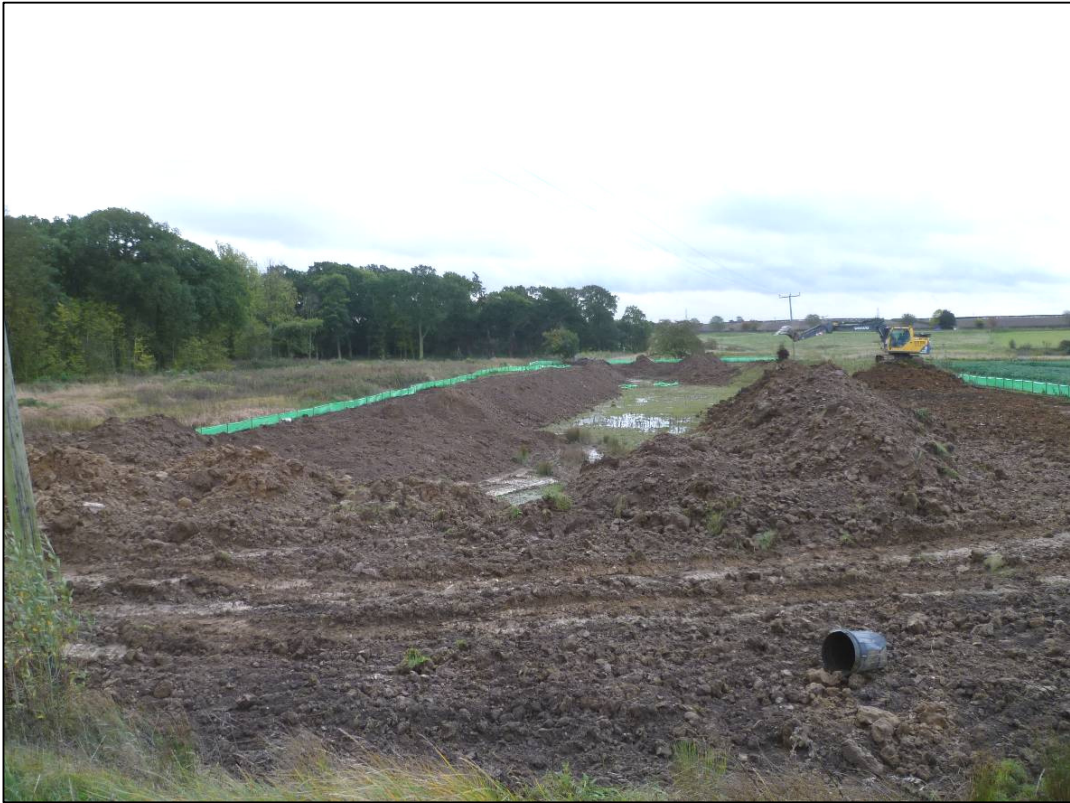
Plate 5: Infilling of central pond, looking S.

- 6.3 Earthmoving continued to the central pond, with spoil from the demolished bunds being used to infill the interior (see plate 5). There was a small scatter of brick (mostly broken) with an occasional larger natural stone in the stripped area at the centre of the east side of the former bund, but no significant concentrations or any evidence for structures were noted; it is assumed that this material was imported to the site within the spoil used to construct the bund here.

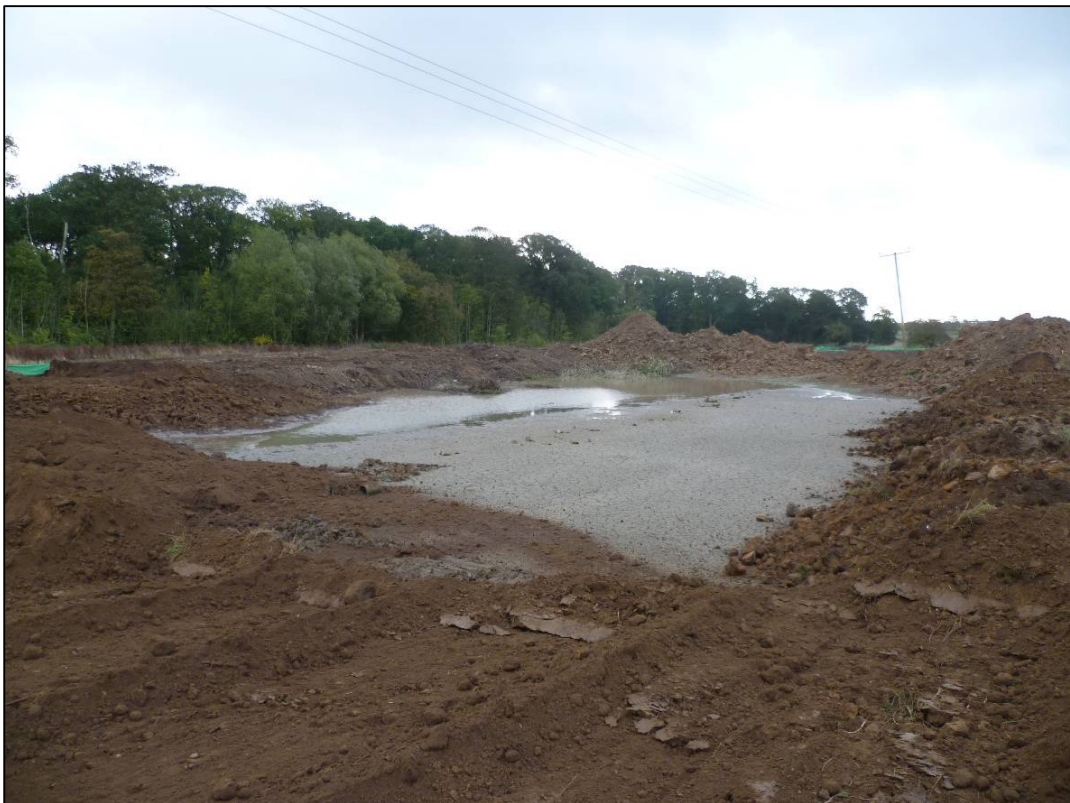
Plate 6: Infilling of northern pond, looking SE.

- 6.4 The northern and largest pond was the last one to be infilled and re-graded (see plate 6); here the spoil from the demolished bunds was generally much wetter and stickier, and a small sub-circular pond had to be left in the approximate centre of the interior so surface water could collect. Once again, no definite archaeological features were revealed by the earthworking operations. Generally, there was a higher proportion of brick and chalk rubble in the southern half of this pond, although this was *ex situ* material within the spoil forming the bunds; no structural detail was exposed anywhere on the site. The northern half of the pond contained virtually no brick or chalk, and the topsoil was of a good quality, although two or three pieces of broken ceramic land drain were revealed. The excavator driver reported finding a large bone, 330mm long, from the area around a telegraph pole in the gap between the central and northern pond; this represented three-quarters of an adult cow (*Bos*) femur, which had the proximal end broken off (see plate 4). The site of the find was inspected but no further bones were visible or exposed. The bone itself was placed on the aforementioned pile of bricks and stones in the very south-east corner of the site.

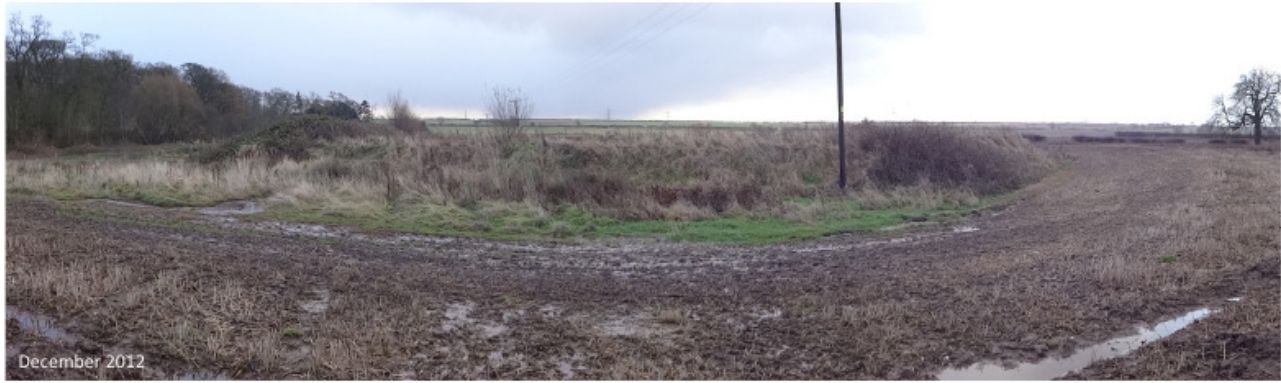
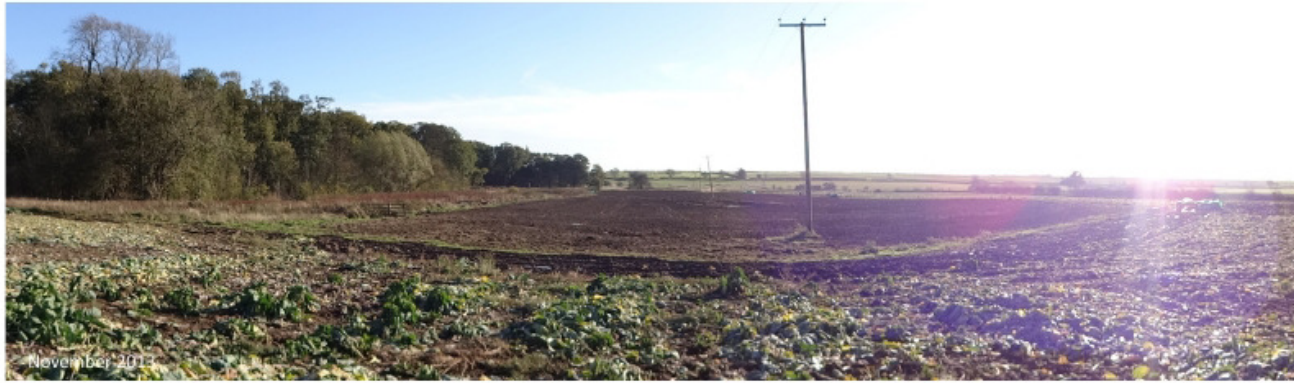
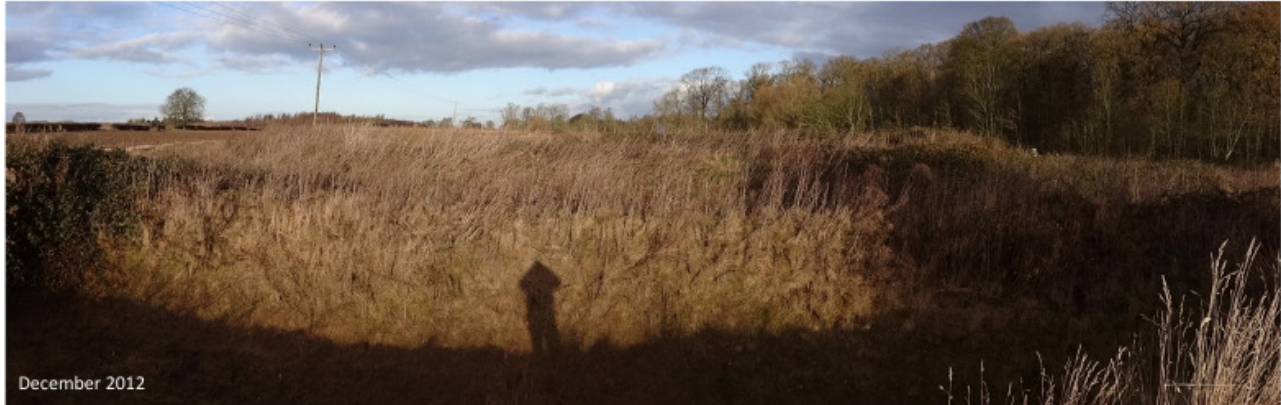
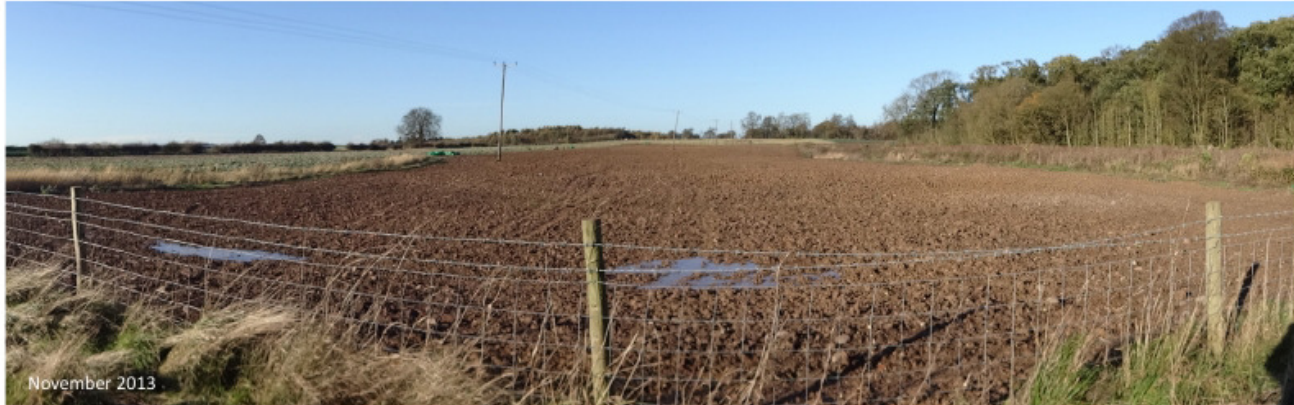
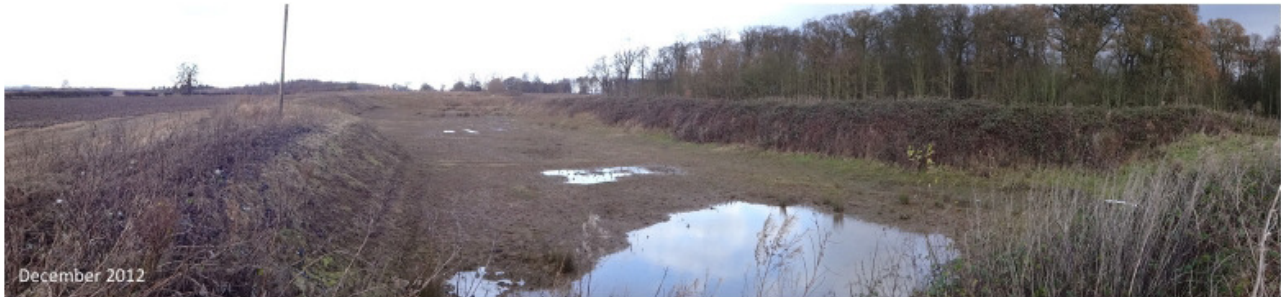
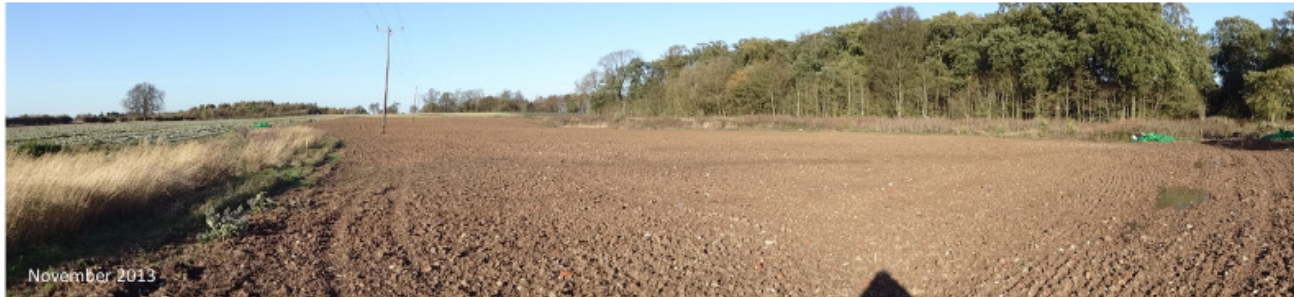
Plate 7: 'Before and after' photographs of restoration works (courtesy The Landscape Agency).

- 6.5 A series of 'before and after' photographs of the works was produced by The Landscape Agency, and these are reproduced as plate 7, with permission.
