SMITHY BUILDING, ABOVE HUNGRY HUSHES,
MOULDS SIDE, ARKENGARTHDALE,
NORTH YORKSHIRE

ARCHAEOLOGICAL SURVEY

Report no: 2012/432.R01
Version: Final
Date: October 2014
Author: Shaun Richardson & Ed Dennison

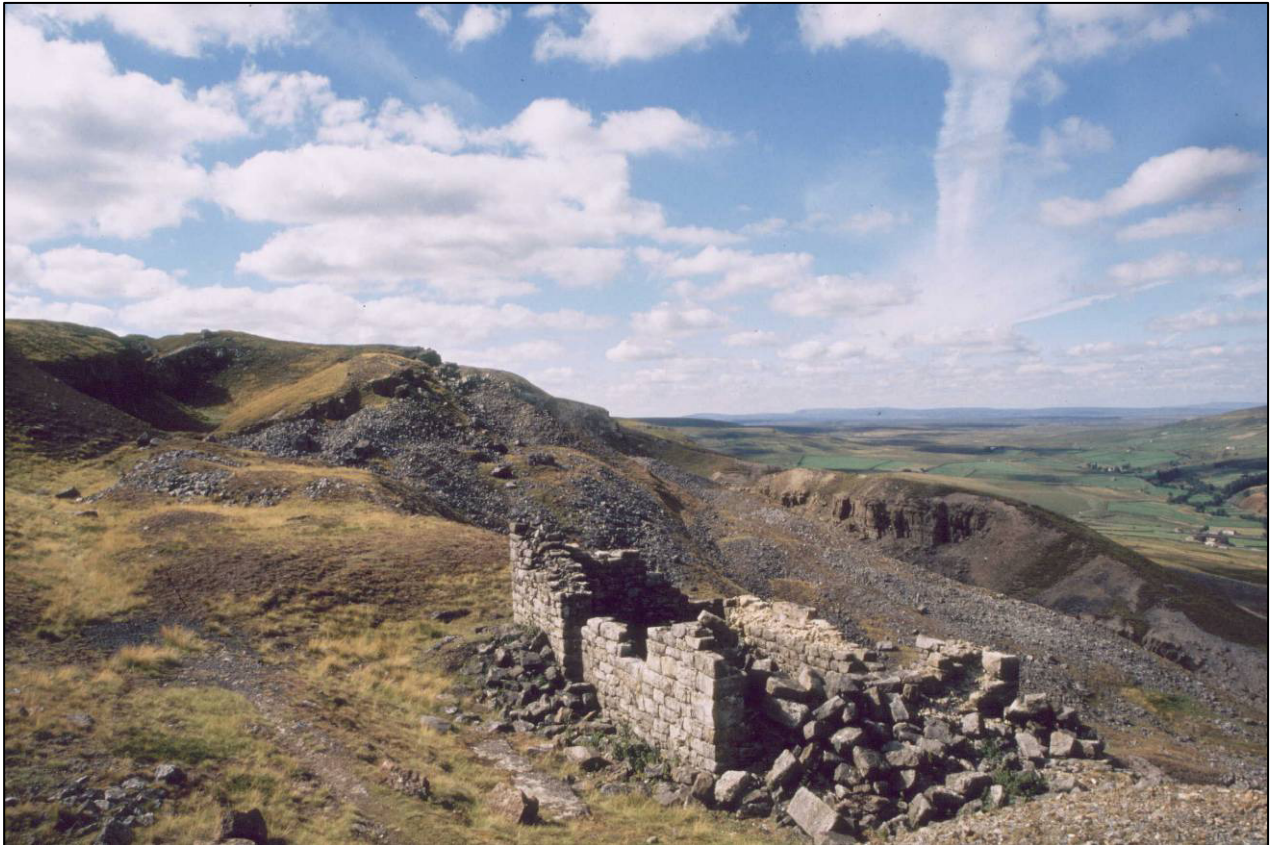
PROJECT	HUNGRY HUSHES SMITHY	
TITLE	1990 PHOTOGRAPH	
SCALE	NTS	DATE OCT 2014
EDAS	FIGURE 4

35mm colour slide taken by Richard Lamb, looking NW, 18th August 1990 (reproduced with permission).

- 4.6 In 1990, the facing of the east gable had largely collapsed externally, apart from at the very north and south ends, with a large spread of fallen stone to the east (see figure 4). Since then, it has been almost completely rebuilt to a height of 1.60m [1/001, 1/002] (see plate 3). The surviving pre-1990 elements are probably represented by the lowest visible one or two courses at the base of the gable, the lowest five stones to the north-east corner, and the lowest four stones to the south-east corner; in 1990, a large sub-square stone used as a quoin is visible above this height.

- 4.8 In 1990, the west gable stood to something close to 2.00m high at the south-west corner, but it then stepped downwards towards the north-west corner (see figure 4). The latter was rebuilt to about the same height as the rest after 1990, but it has subsequently collapsed outwards, as has part of the original central part [1/006, 1/007] (see plate 4). The surviving pre-1990 elements are represented by the south-west corner, the lowest c.0.50m of the central part (now hidden by collapse), and the lowest visible three or four stones of the north-west corner.

- 4.9 In 1990, the south elevation stood to a height of c.1.30m at the south-east corner, but then stepped upwards to over 1.50m as it moved west (see figure 4). There then appears to have been a window opening, and an off-centre doorway; the east jamb of the doorway stood to c.1.10m in height. The west jamb was somewhat higher, and the south-west corner close to 2.00m high [1/998] (see plate 5). Since 1990, the parts of the elevation described above appear to have been left relatively undisturbed. However, that part of the elevation to the east of the doorway has been raised to an average height of between 1.50m-1.60m, and the 1.15m wide window opening visible in 1990 has been quite expertly blocked [1/995]. To the west of the doorway, it is possible that the higher south-west corner shown in 1990 was dismantled and used to heighten the doorway's west jamb. There is a heap of smithing waste adjacent to the base of the west end of the elevation [1/997].

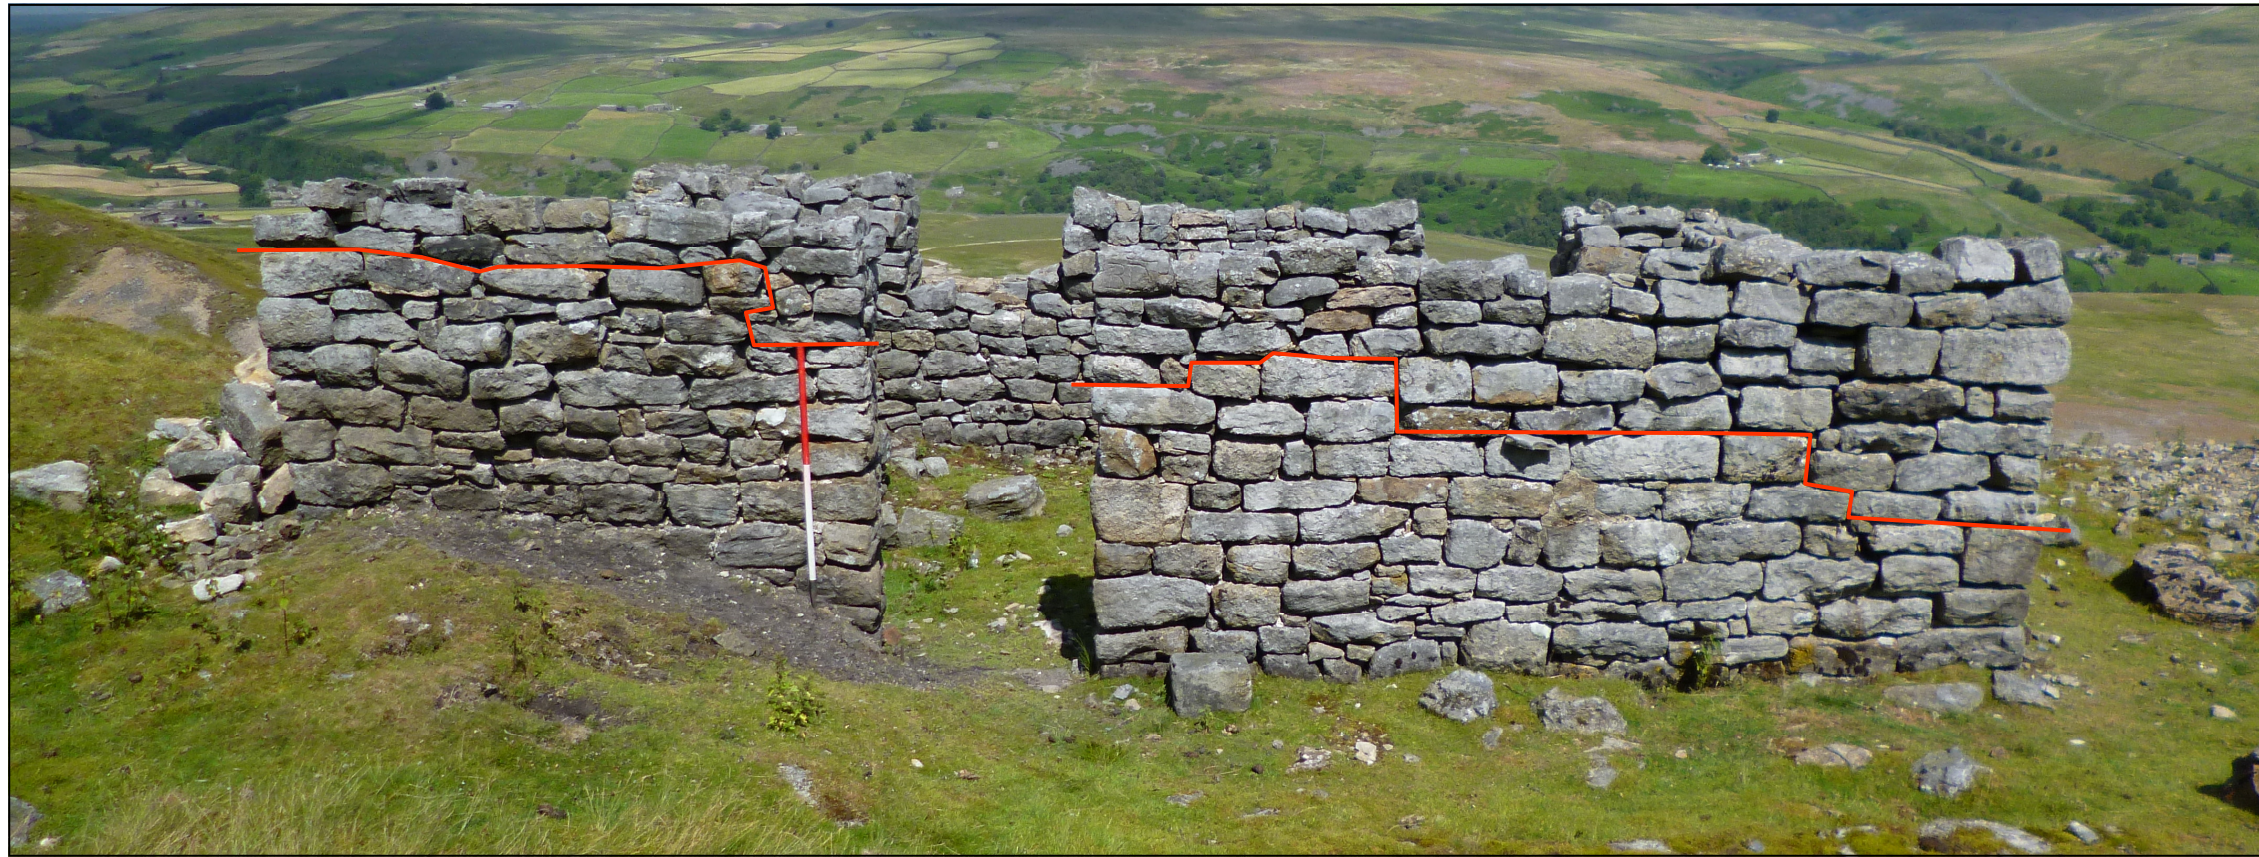
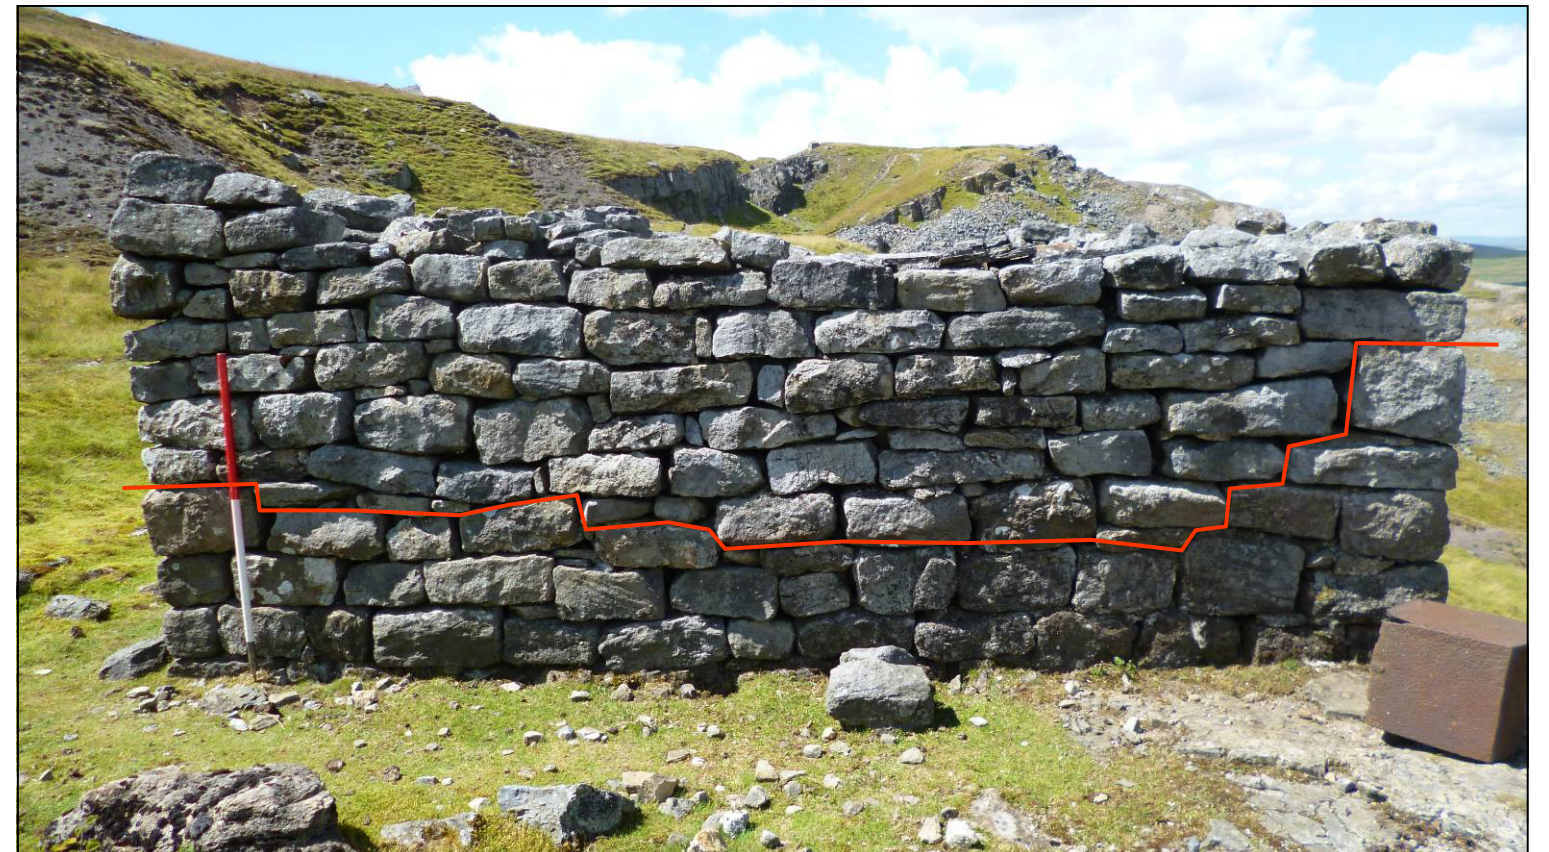
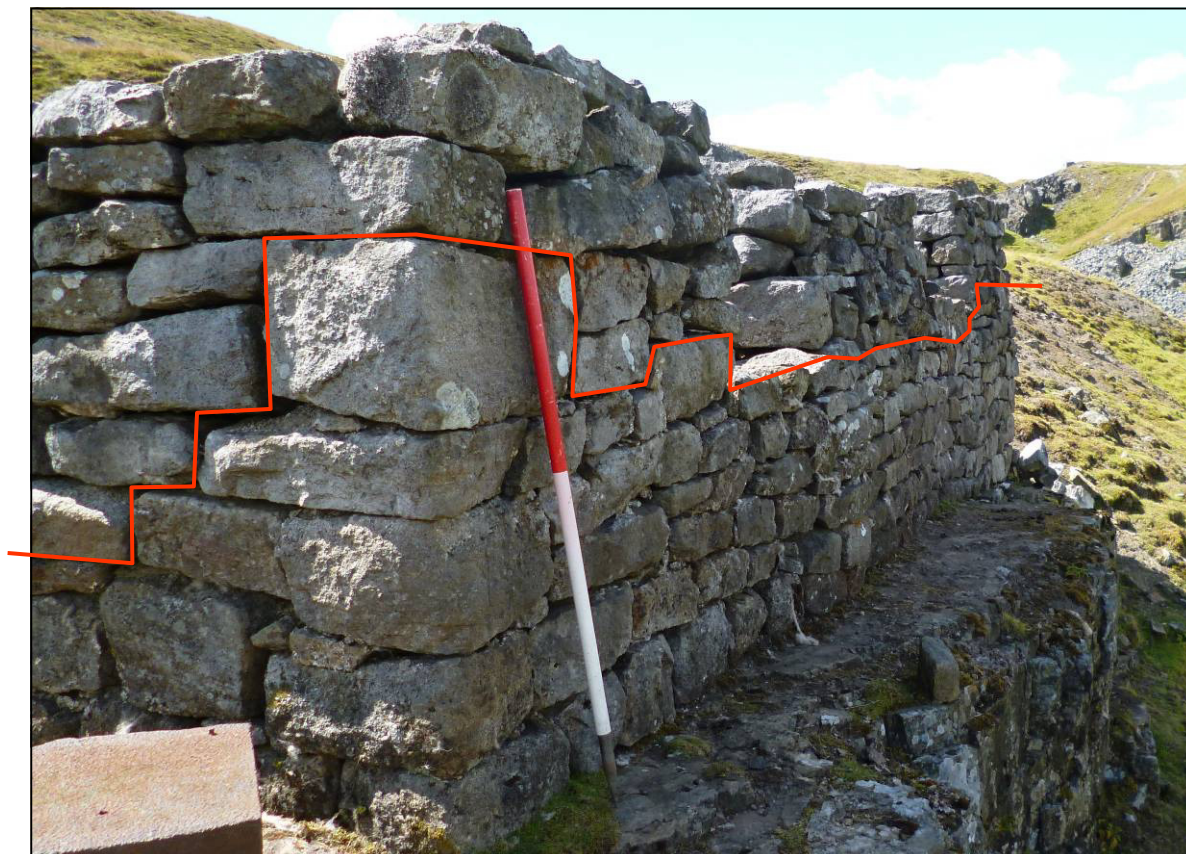
PROJECT		HUNGRY HUSHES SMITHY	
TITLE			
EXTENT OF POST 1990 REBUILDING?			
SCALE	NTS	DATE	OCT 2014
EDAS		FIGURE	6

South elevation

East elevation

North elevation

- 4.1 A detailed description of the smithy building is given below, based on the records made in the field. It is described in a logical sequence. The setting, plan form, structure and architectural detailing are described first, followed by an account of the external elevations and a circulation description of the interior. Reference should also be made to the surveyed ground plan, and the photographic record which appears as Appendix 1; photographs are referenced in the following text in italics with square brackets, the numbers before the stroke representing the film number and the number after indicating the shot e.g. [1/32]. Throughout the text, reference is made to Richard Lamb’s 1990 photograph (see figure 4), which has been used where possible to gauge the extent of modern rebuilding (see figure 6).

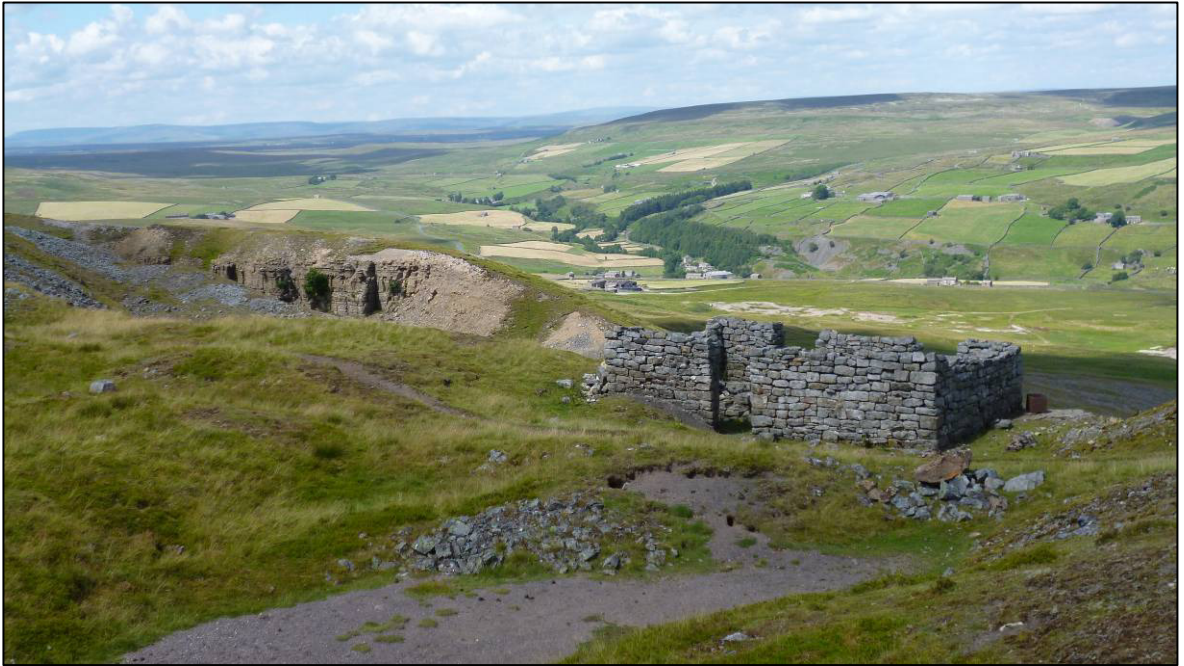
Plate 1: General view of smithy building within landscape context, looking NW (photo 1/033).

- 4.3 As already noted above, the smithy is located in an isolated and elevated position on Moulds Side, on the southern slope of Arkengarthdale, within an extensive area of former mining remains. It lies above Lily Jock’s Hush, on the edge of a very steep north-facing scarp [1/030-1/033] (see plate 1). The upper break of slope,

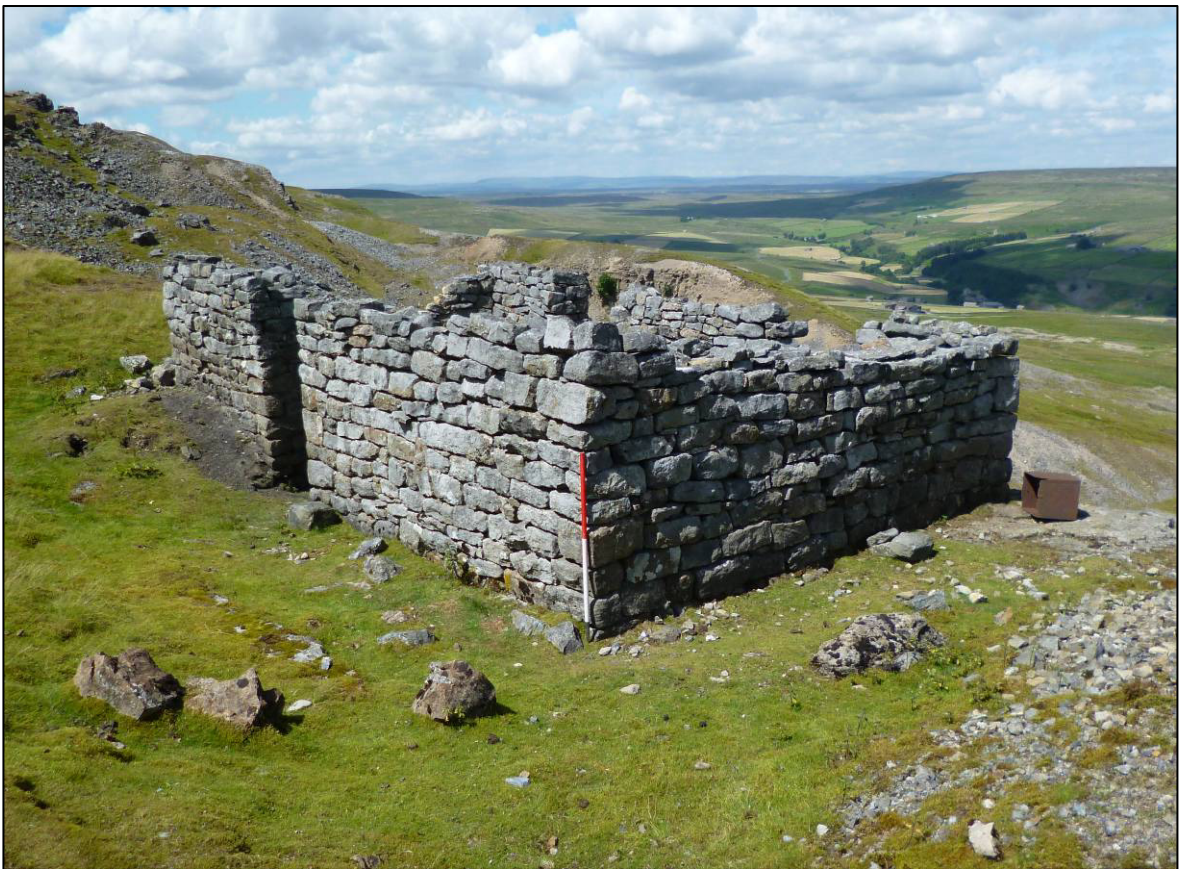
Plate 2: Smithy building, looking NE (photo 1/029).

- 4.4 The smithy has a slightly sub-rectangular plan, with maximum external dimensions of 7.30m east-west by 4.32m north-south; the external walls vary in width between 0.45m to 0.60m. It is of a single storey, and was originally provided with either a pitched or single-pitch roof, but subsequent collapse has removed almost all evidence for the roof form. It was formerly covered with corrugated iron sheeting (Tyson 1995, 93-94), and small fragments of such survive within rubble at the base of the very steep slope above which the smithy stands, together with several decayed softwood timbers up to 2.70m in length, which are also assumed to have formed part of the roof structure. The external walls now survive to a maximum height of 2.15m to the south side, and this probably represents something close to the original eaves level, although much results from post-1990 rebuilding [1/029, 1/999] (see plate 2).

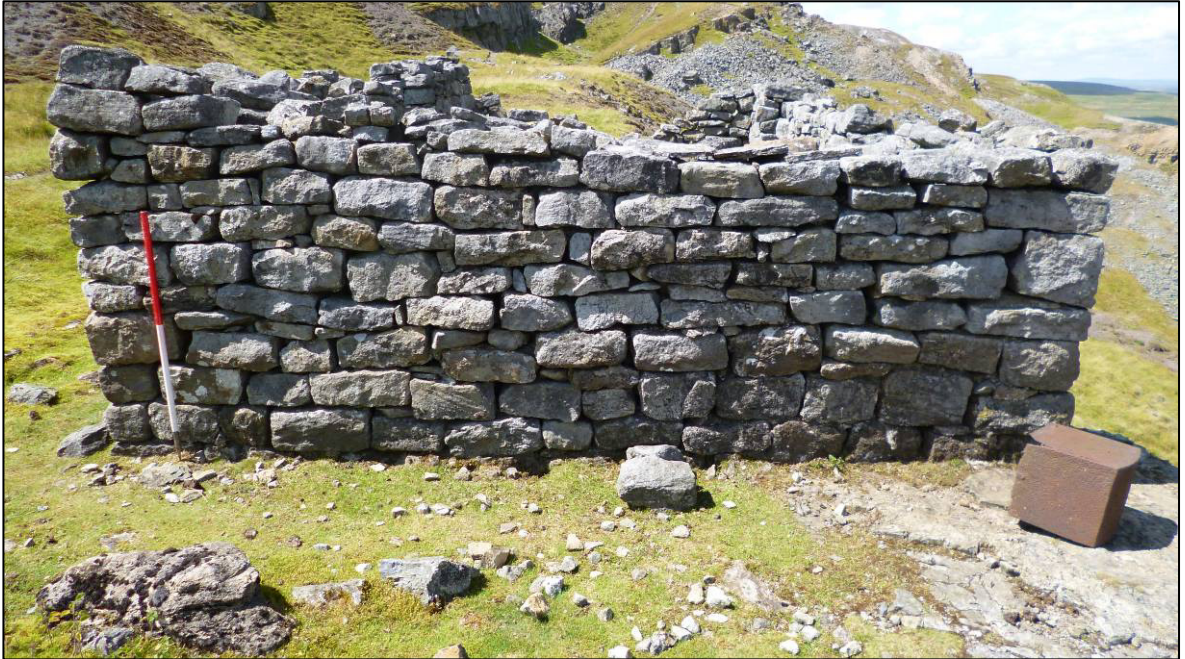
Plate 3: East elevation, looking W (photo 1/001).

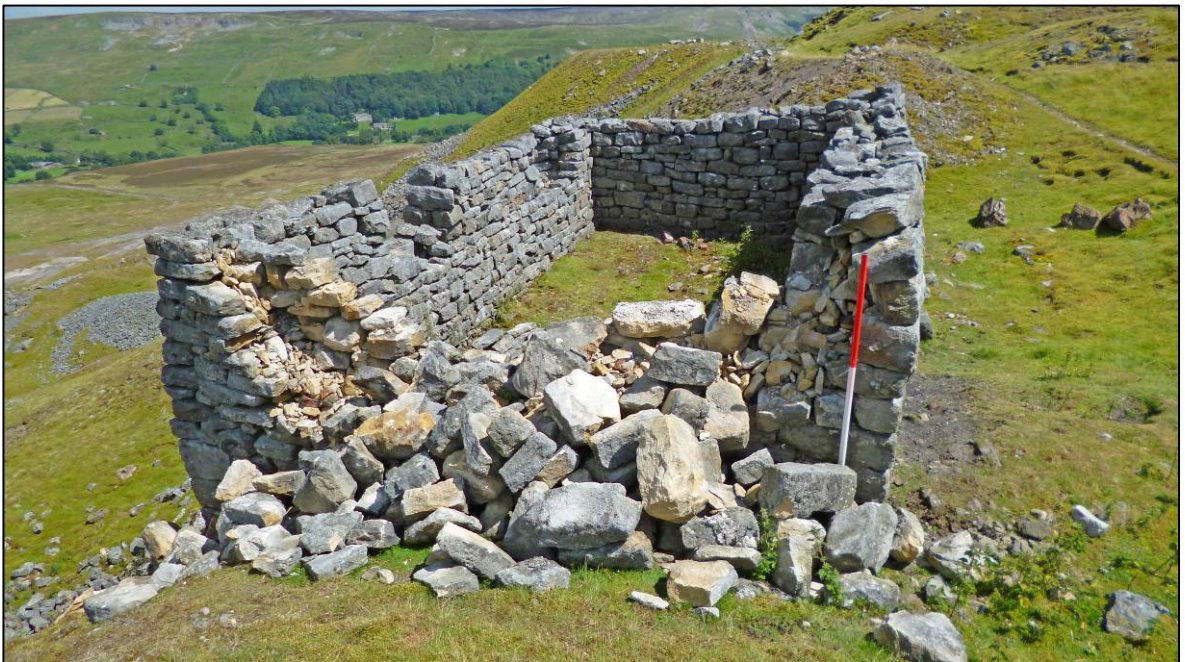
Plate 4: West elevation, looking E (photo 1/006).

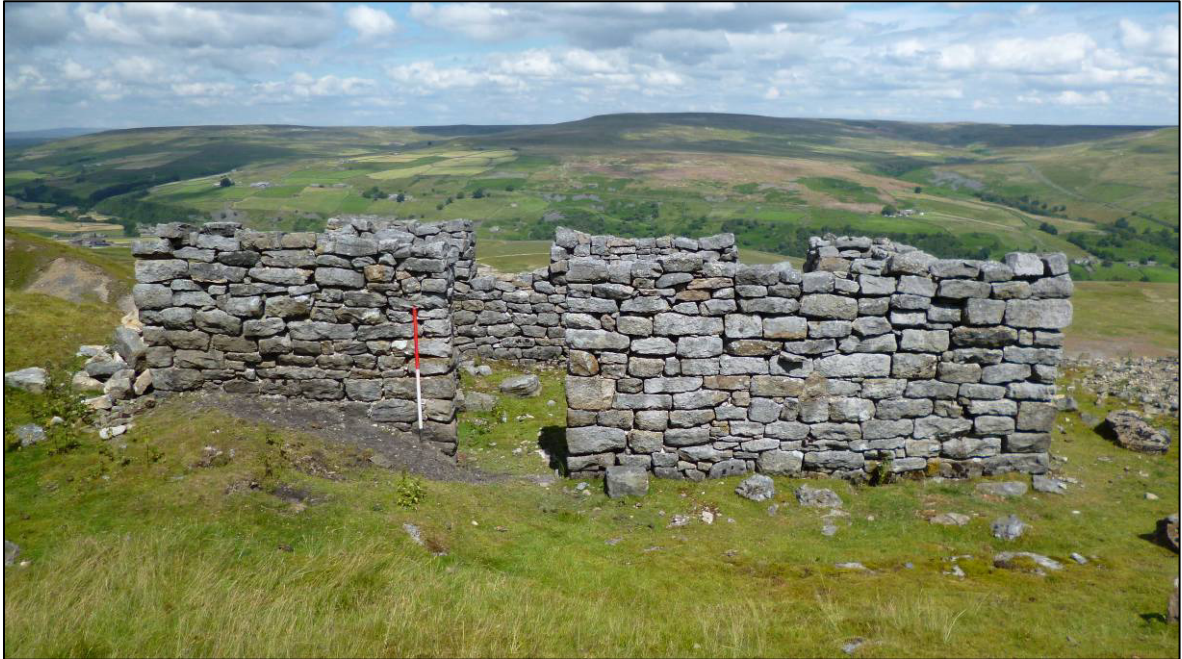
Plate 5: South elevation, looking N (photo 1/998).

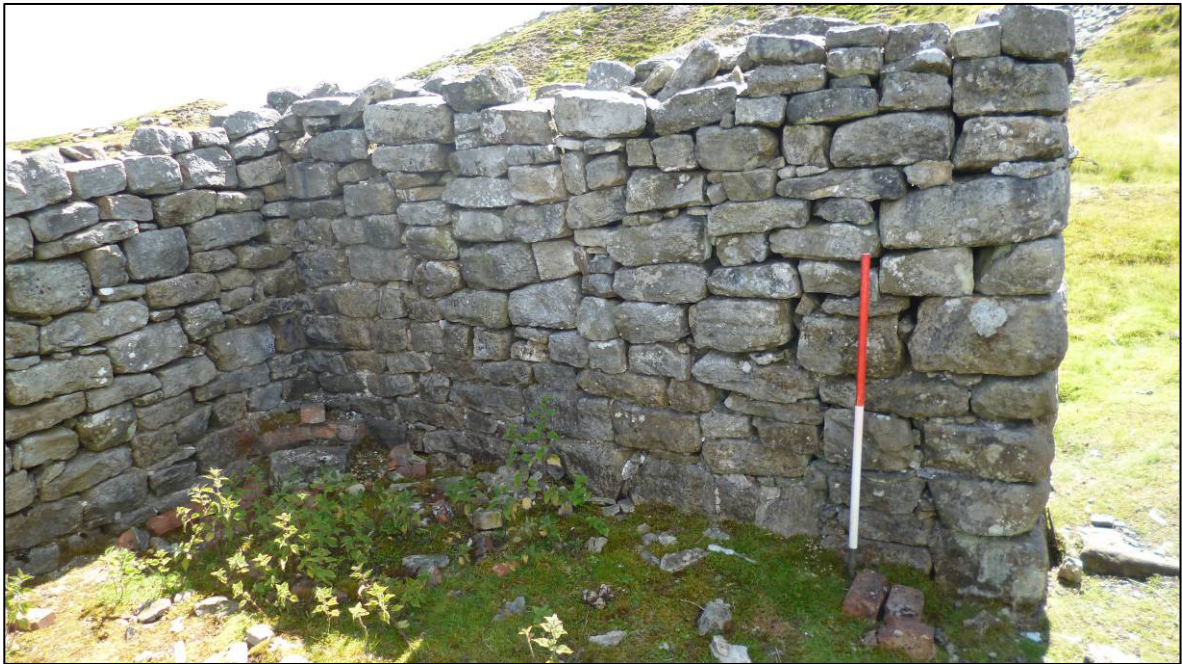
Plate 6: East end of south internal wall, looking SE (photo 1/011).

- 4.14 The blocked window noted externally to the south wall is also visible internally [1/011] (see plate 6); the 1990 photograph suggests that the same proportion of the internal face of this wall has been rebuilt as that described externally above. To the west of the off-centre doorway, there is a feature set 1.20m above the internal ground level that may once have been a socket, although it is perhaps more likely to represent no more than a fallen stone [1/012, 1/013].

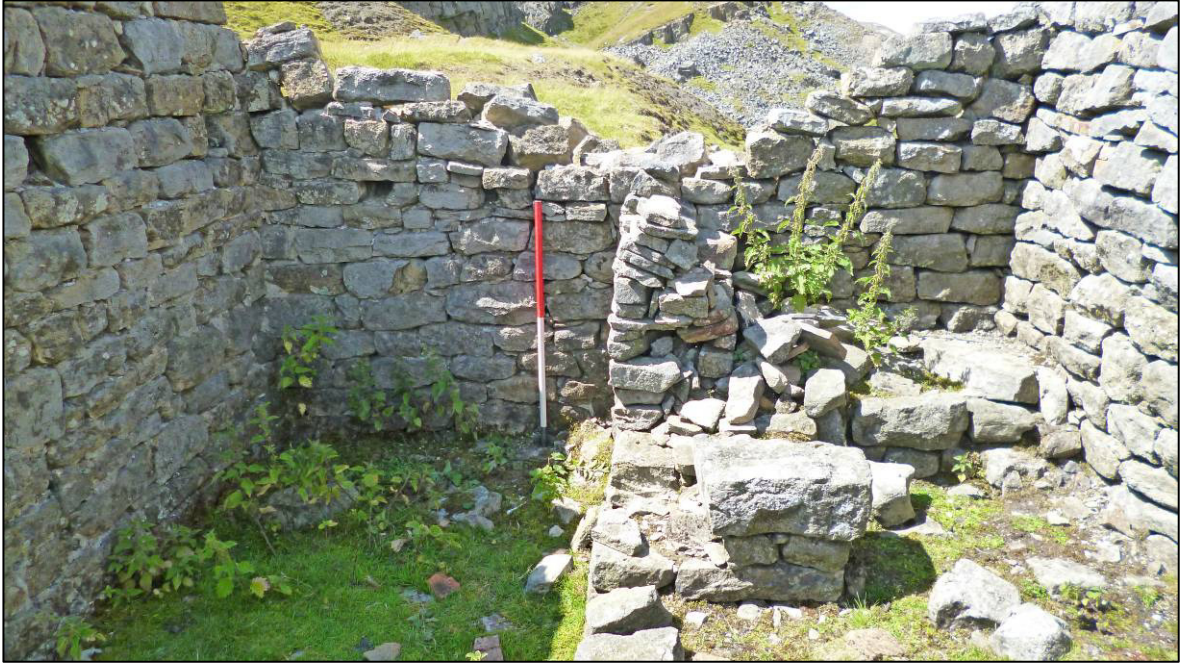
Plate 7: West internal wall, showing remains of forge to right, looking W (photo 1/023).

- 4.15 At the south end of the west wall, a more convincing socket, 0.28m deep, is placed 1.07m above the internal ground level. The remains of the forge stand at the north end of the west wall [1/023]. There are two stone walls to the front (east) of the forge which would have flanked the breeze hole; the wider south wall survives to c.0.50m in height, but the north wall is visible in plan only. The main body of the hearth comprises a low stone platform, with a wall rising from its south end. This wall butts the main west wall of the smithy, but does not appear to have been rebuilt since 1990 and probably represents an original feature [1/024] (see plate 7). It would have supported one side of the canopy or hood over the hearth, with the flue rising above. There is now no visible sign of the tuyere, but it seems likely that the bellows were housed in the space to the south of the forge. Their form is unknown, but they may have been circular, or perhaps a hand-cranked blower was used. The original bellows remained *in situ* in the smithy building until at least 1965, but were subsequently removed (Rowena Hutchinson, *pers. comm.*). The smithy would also have housed all the other necessary equipment of the smith, including an anvil, a bench and vice and other tools. There are some metal fittings, including a 0.35m square cast-iron plate, in the rubble at the base of the slope beneath the smithy building.

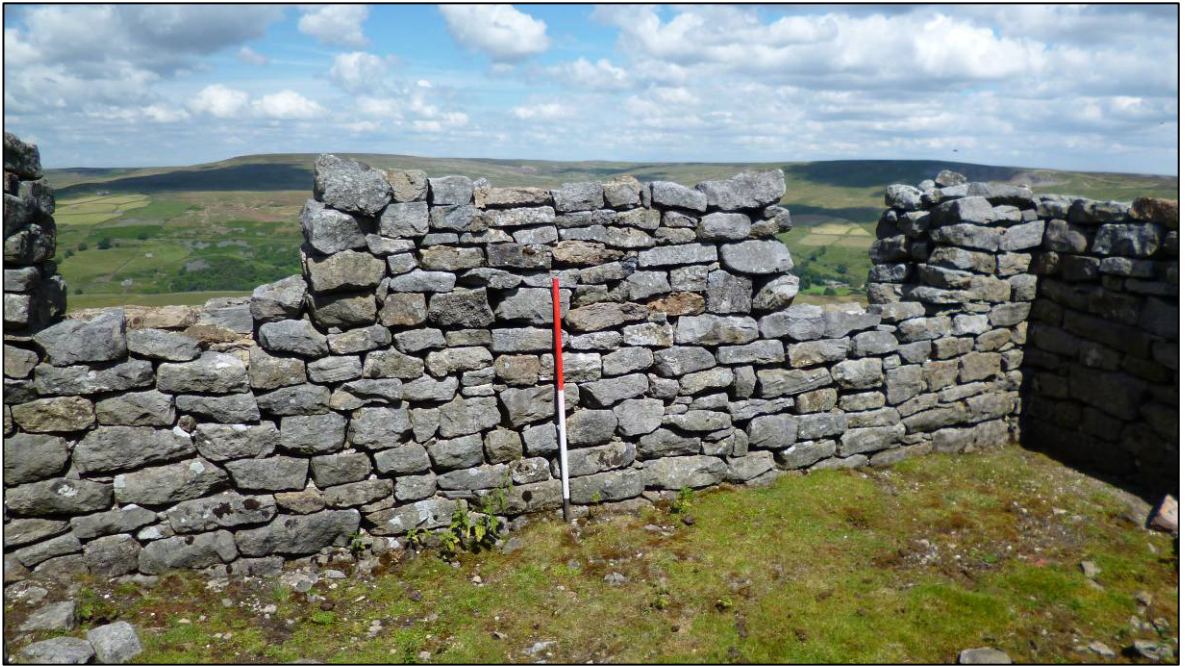
Plate 8: North internal wall, looking NE (photo 1/026).

- 4.16 The 1990 photograph suggests that the same proportion of the internal face of the north wall has been rebuilt as that described externally above [1/026] (see plate 8). Towards the centre of the north wall, a straight joint is visible at a lower level, between the two windows and apparently set within stonework dating to before 1990 [1/025].

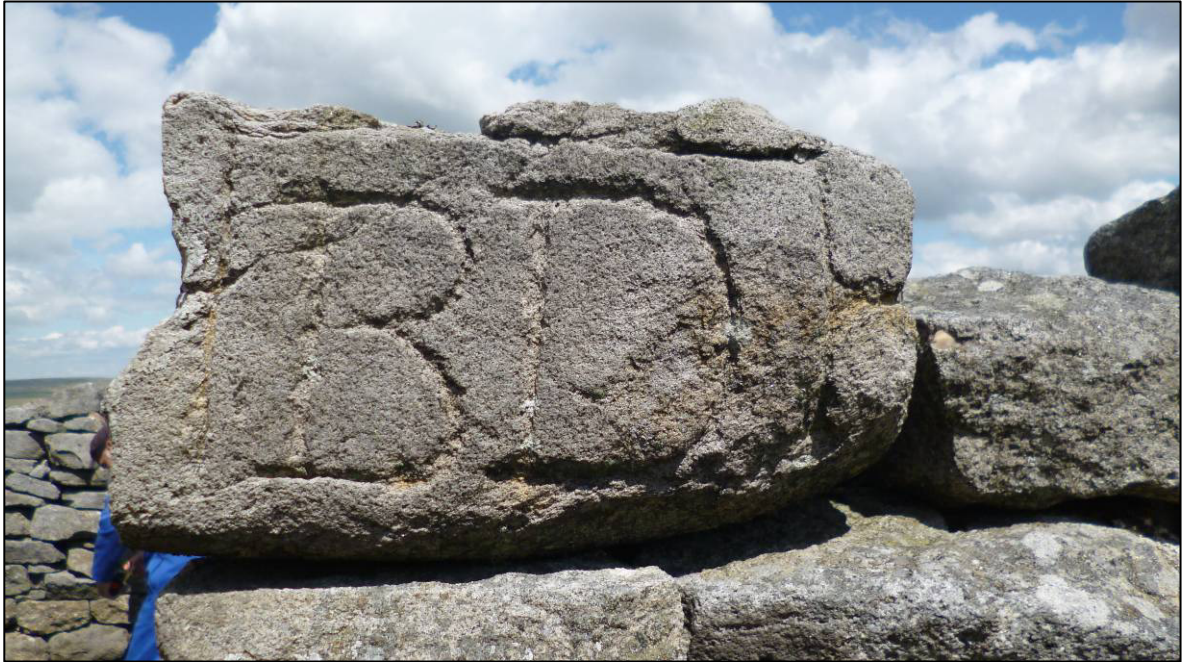
Plate 9: Graffiti ('BD') at top of east jamb of south doorway, looking N (photo 1/996).

- 4.18 Starting with the external elevations, at the top of the east jamb of the doorway in the south elevation, there is a re-set stone bearing the large capital initials 'BD' set within a rectangular frame [1/996] (see plate 9); these initials do not correspond with anyone on the list of those working at the site in 1940 or 1950 by Tyson (1995, 95) nor are any local people with these initials known (Kay Jackson, Rowena Hutchinson, *pers. comm.*). To the north of centre of the east gable, there is a re-set stone bearing graffiti, but it is now too worn to read clearly [1/005].

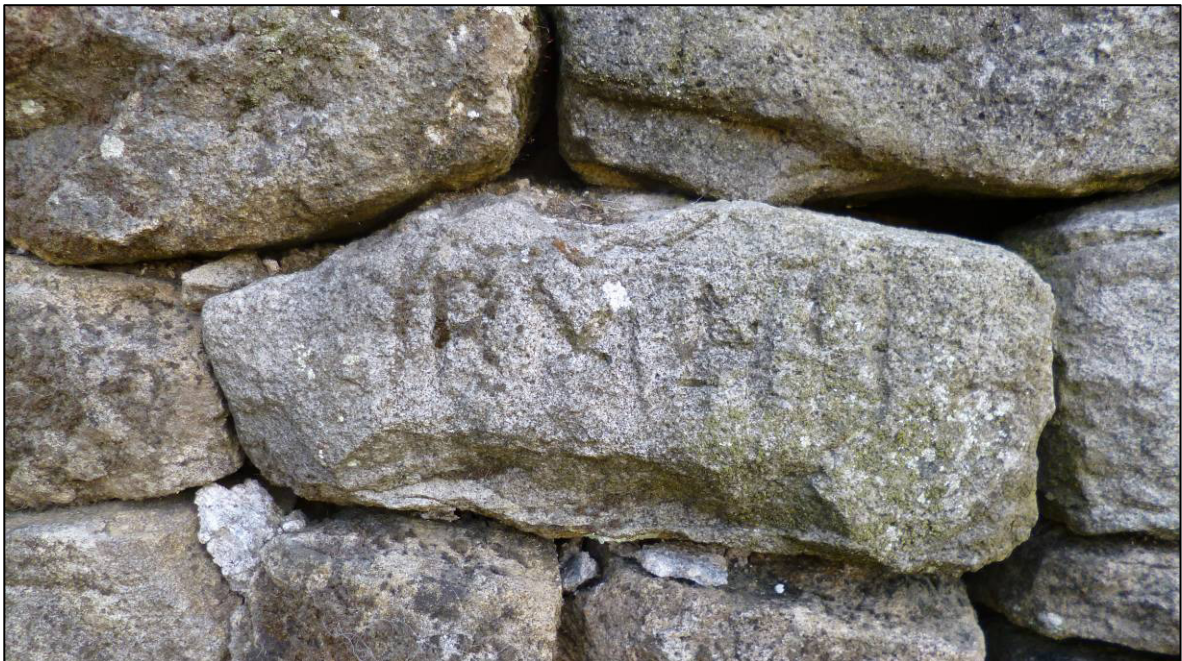
Plate 10: Graffiti ('RMH') within internal blocking of south window, looking S (photo 1/015).

- 4.19 Within the interior, to the east of the doorway in the south wall, there are two stones bearing graffiti, both apparently re-set within the blocking of the window opening here. The upper stone is worn, and may bear the capital initials 'FB', or possibly the combination 'F 8' [1/014]; again, it is not possible to relate these to the names given by Tyson or of local people. Below, the lower stone may bear the capital initials 'RMH' set within a roughly rectangular frame [1/015] (see plate 10). Although a Ralph Hird worked at the chert quarries for a very significant time (Wright 1950, 89), the initials must surely relate to Ramsay Moralee Hutchinson, who was employed at the smithy between 1940 and 1950 (Les Tyson and Rowena Hutchinson, *pers. comm.*). At the upper part of the west end of the south wall, there are a group of five separate stones, three of which bear graffiti which is consecutive [1/016]. These are important, as this part of the structure does not appear to have been rebuilt after 1990 and so they may be the only graffiti which remains *in situ*. The uppermost stone bears the capital initials 'SD' set within a rectangular frame [1/019] (see plate 11); these are carved in a similar manner to the aforementioned 'BD', but again cannot be identified. Below this, a second stone may bear the same capital initials set within a rectangular frame, possibly inverted, but it is rather worn [1/020]. The three consecutive stones appear to bear the date 'SEP 27 1934 (or alternatively 1937)' [1/021, 1/022] (see plate 12). Finally, in the west jamb of the west window in the north wall, there is a re-set stone that is worn and difficult to read. However, it may have been inverted, and bear illegible capital initials over the date '1940' [1/027]. As has already been noted, this was the date that Ramsay Hutchinson arrived at the smithy.

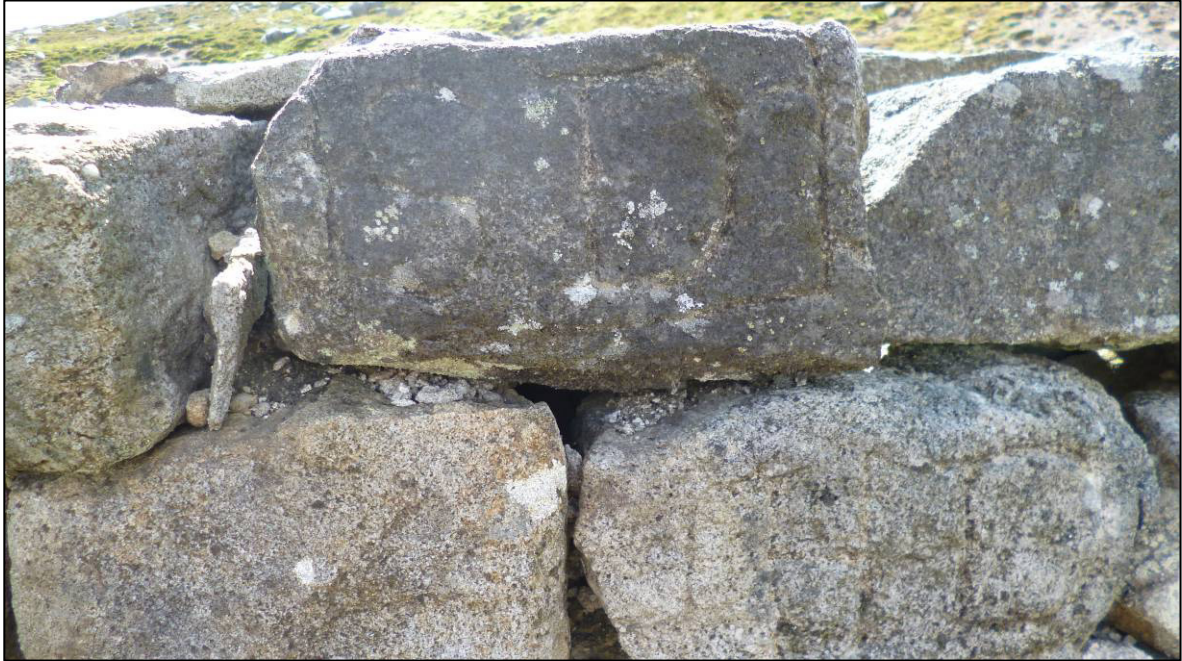
Plate 11: Graffiti ('SD'), west end of south internal wall, looking S (photo 1/019).

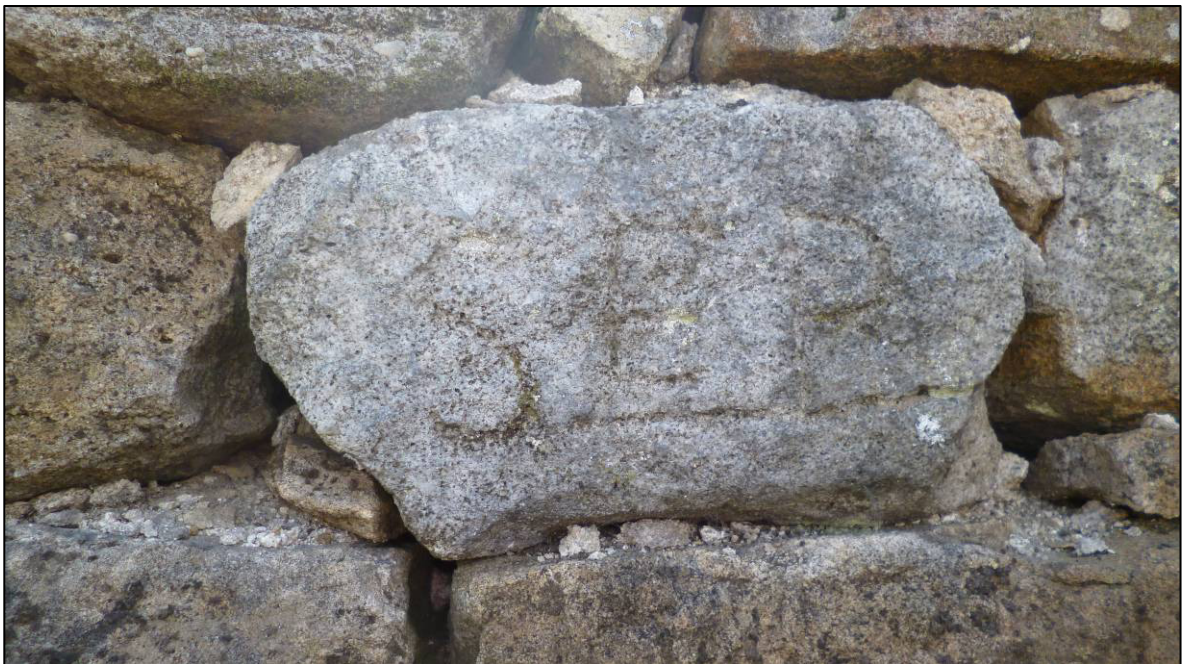
Plate 12: Graffiti ('SEP'), west end of south internal wall, looking S (photo 1/021).
