CONSTRUCTION OF NINE SHOOTING BUTTS, NORTH-EAST OF BOGG HOUSE, RUDLAND RIGG, FARNDALE, NORTH YORKSHIRE

ARCHAEOLOGICAL OBSERVATION, INVESTIGATION AND RECORDING

Report no: 2014/481.R01

Author: Ed Dennison & John Tibbles

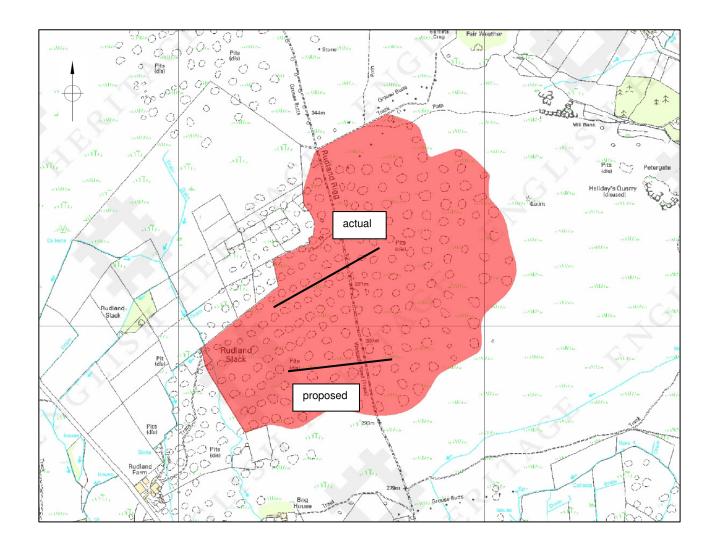
RUDLAND RIGG SHOOTING BUTTS		
ALIGNMENTS OF BUTTS		
NTS	AUG 2014	
EDAS	^{FIGURE}

Alignments of grouse butts shown as black line. Area of Scheduled Monument shown in red.

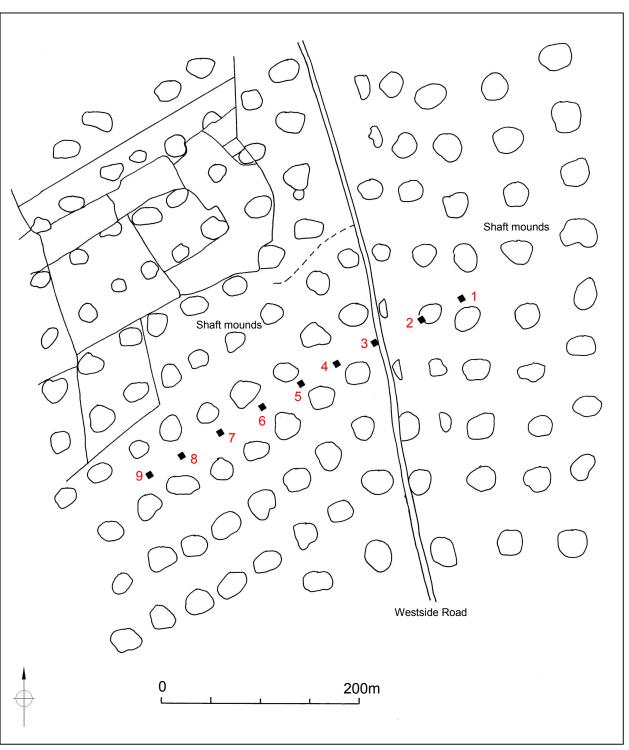
RUDLAND RIGG SHOOTING BUTTS		
DETAILED LOCATION		
AS SHOWN	AUG 2014	
EDAS	FIGURE 3

Plan based on modern Ordnance Survey map.

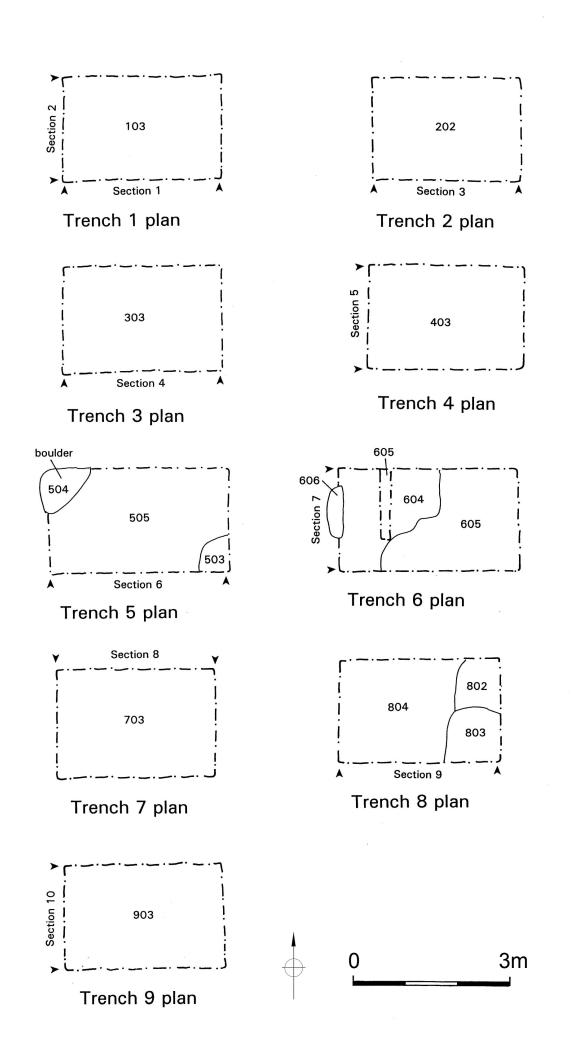
RUDLAND RIGG SHOOTING BUTTS		
TRENCH PLANS AND SECTIONS		
AS SHOWN	AUG 2014	
EDAS	FIGURE 4

Trench 1, Section 1

Trench 2, Section 3

Trench 4, Section 5

Trench 3, Section 4

Trench 5, Section 6

Trench 6, Section 7

5.1 The trenches were machine-stripped down to the underlying natural orange/white/silver and brown sands, which were present at c.0.30m-0.50m below the existing ground surface (BGL), into which the trenches had been excavated. As noted above, trenches were numbered from east to west - Trenches 1 and 2 lay on the east side of Westside Road while Trenches 3 to 9 lay to the west, and all were aligned east-west. Apart from Trench 2, all the trenches were excavated equidistant between two lines of colliery shaft mounds, on a general west facing slope. Figure 4 depicts the recorded trench plans and sections.

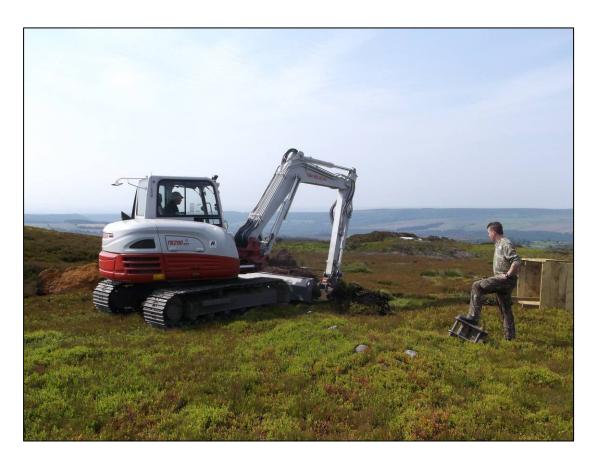
Plate 1: General view of excavation in progress, looking SW.

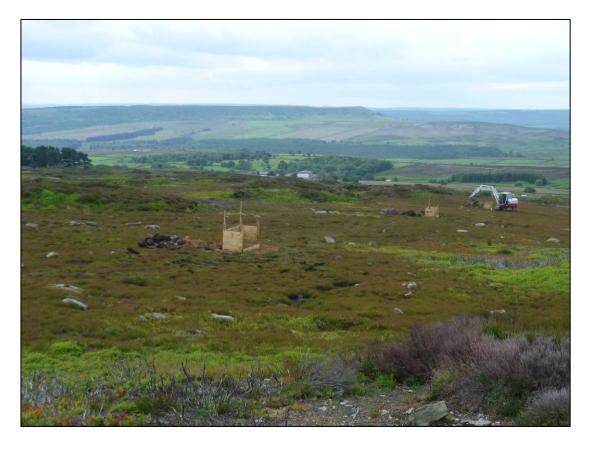
Plate 2: General view of construction work, looking SW.

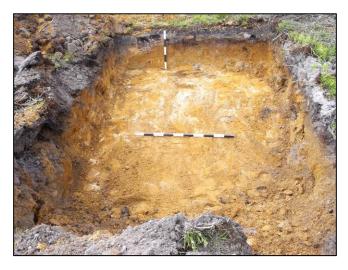
Plate 3: Trench 1 after excavation, looking W.

This trench measured 3.00m long by 2.00m wide, and 0.80m deep on the east side and 0.60m on the west. The coarse white/orange mottled sand (103), a natural deposit, lay at c.0.20m BGL directly below a soft mottled black/dark grey sand (102) with an average thickness of 0.20m (see plate 3). A dark brown loamy peat topsoil (101), c.0.05m-0.10m thick, sealed the trench into which heather was growing.

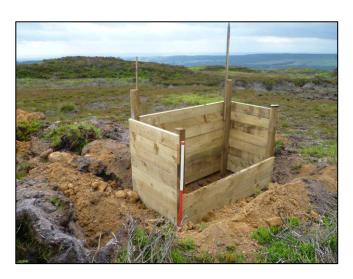
Plate 4: Trench 1 with butt inserted, looking SE.

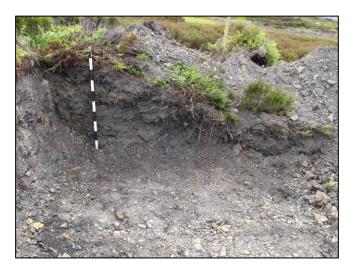
Plate 5: Section through spoil revealed by Trench 2, looking S.

5.3 Trench 2 lay 49.70m to the west of Trench 1, and measured 2.80m long by 2.00m wide, with depths ranging between 0.40m in the west and 1.00m in the east. The trench had been cut into the south-west side of a shaft mound associated with the coal mining industry (see plate 6). The underlying natural deposit was not encountered within the depth of excavation. A dark grey loose shaley material (202) composed of firm shale pieces less than 0.20m in diameter with other fragments of stone, represented 100% of the excavated material (see plate 5). A soft dark brown loamy peat topsoil (201), c.0.10m thick, sealed the trench into which heather was growing. This trench lay 40.00m to the east of the edge of Westside Road.

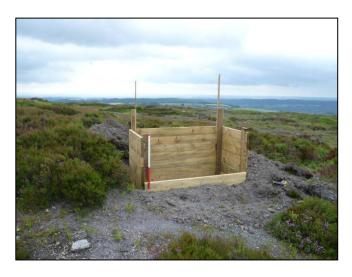
Plate 6: Trench 2 with butt inserted on SW side of shaft mound, looking SE.

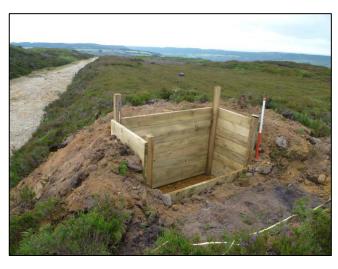
Plate 7: Trench 3 with butt inserted on W side of Westside Road, looking S.

5.4 This trench was 3.00m long by 2.00m wide by 0.90m deep. It was located on the immediate west side of the sunken Westside Road (see plate 7). The natural firm coarse orange sand (303) lay at c.0.50m BGL directly below a firm silver-grey sand (302) with an average thickness of 0.20m. A soft dark brown loamy peat topsoil (301), c.0.30m thick, sealed the trench into which heather was growing.

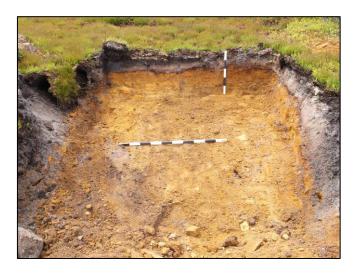
Plate 8: Trench 4 after excavation, looking W.

5.5 Trench 4 measured c.3.00m long by 2.00m wide by 0.50m deep, and was located 45.10m to the west of Trench 3. The firm natural coarse orange sand (403) lay at c.0.20m BGL, directly below a firm silver-grey sand (402) averaging 0.10m thick (see plate 8). A soft dark brown loamy peat topsoil (401), c.0.10m-0.15m thickand containing frequent small stones, sealed the trench into which heather was growing. At the interface of deposits 402 and 403, and within the upper exposed elements of the natural (403), several large natural boulders less than 1.00m long were removed by the machine, damaging the east, north and south sides of the trench.

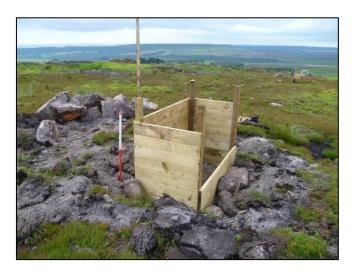
Plate 9: Trench 5 with butt inserted, showing removed boulders, looking SW.

5.6 This trench lay 42.65m to the west of Trench 4, and measured c.3.50m long by 2.00m wide by 0.50m-0.60m deep. The firm natural coarse orange-grey sand (503) was only partially visible within the north-facing section and the south-east corner of the bottom of the trench at c.0.25m BGL. This was overlain by a firm silver-grey sand (502) with an average thickness of 0.35m. As seen in Trench 4, the interface between deposits 502 and 503, and within the exposed elements of the natural (503), was marked by the presence of several large natural boulders less than 1.00m long (504); these were removed by the machine, causing damage to the sides and base of the trench, and placed to one side (see plate 9). The holes resulting from the removed boulders were backfilled with a combination of deposits 502 and 503 (=505) to create a level base to the trench. A single large boulder, measuring c.0.90m long by 0.70m high, was left in situ within the northwest corner of the trench. A soft dark brown, loamy peat topsoil (501), c.0.10m-0.20m thick, sealed the trench into which heather was growing.

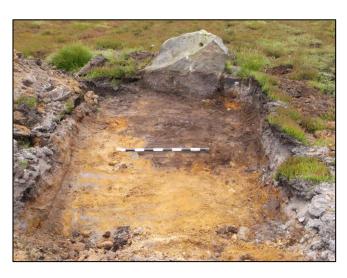
Plate 10: Trench 6 after excavation showing boulder (606) and dark deposit (604), looking W.

5.7 Trench 6 measured c.3.40m long by 2.00m wide by 0.30m-0.40m deep, and it was positioned 45.50m to the west of Trench 5. The firm natural coarse orange sand (605) lay directly below the topsoil (601) in the southern side of the trench and

below a 0.20m thick layer of a firm grey natural sand (603) with frequent cobbles less than 0.15m in size in the northern section. A soft dark brown/black peat (602) was recorded in the south-west corner of the trench, c.0.30m thick.

5.8 A large upright boulder (606), 0.90m high by 1.00m wide, was recorded in the western side of the trench, against which the dark brown/black peat (602) appeared to butt. Extending east from the boulder was an irregular natural depression within the natural orange sand (605) (see plate 10). A small hand-excavated sondage 0.20m wide showed it to be less than 0.10m deep and filled with a dark grey-brown sand (604), and confirmed it was of natural origin. A dark brown loamy peat topsoil (601), c.0.10m-0.15m thick, sealed the trench with the exception of boulder 606. The large upright boulder was retained as part of the construction (see plate 11).

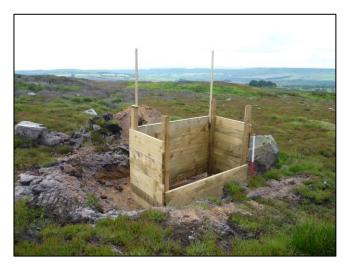
Plate 11: Trench 6 with butt inserted, looking SW.

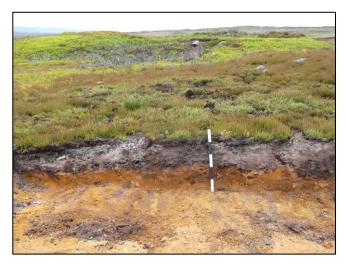
Plate 12: South-facing section of Trench 7 after excavation, looking N.

5.9 This trench measured 3.00m long by 2.00m wide by 0.30m-0.50m deep, and was excavated 46.50m to the west of Trench 6. The firm natural coarse orange sand (703) lay at c.0.20m-0.30m BGL, directly below a firm silver-grey sand (702) with an average thickness of 0.15m (see plate 12). A thin soft dark brown loamy peat topsoil (701), c.0.05m thick, sealed the trench into which heather was growing.

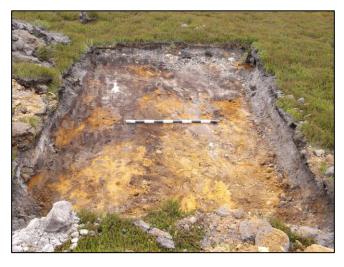
Plate 13: Trench 9 after excavation, looking W.

5.11 This trench was the westernmost trench in the alignment, located 40.50m to the west of Trench 8. It measured 3.00m long by 2.00m wide by only 0.20m deep. The natural coarse orange/white mottled sand (903) lay at c.0.20m BGL, directly below a 0.10m thick layer of firm silver-grey sand (902) (see plate 13). A soft dark brown loamy peat topsoil (901), c.0.10m thick sealed the trench into which heather was growing.

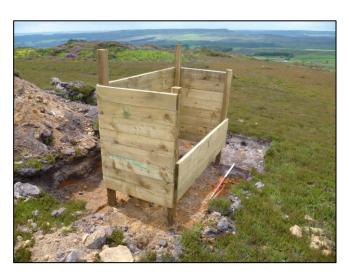
Plate 14: Trench 9 with butt ready for insertion, looking SW.

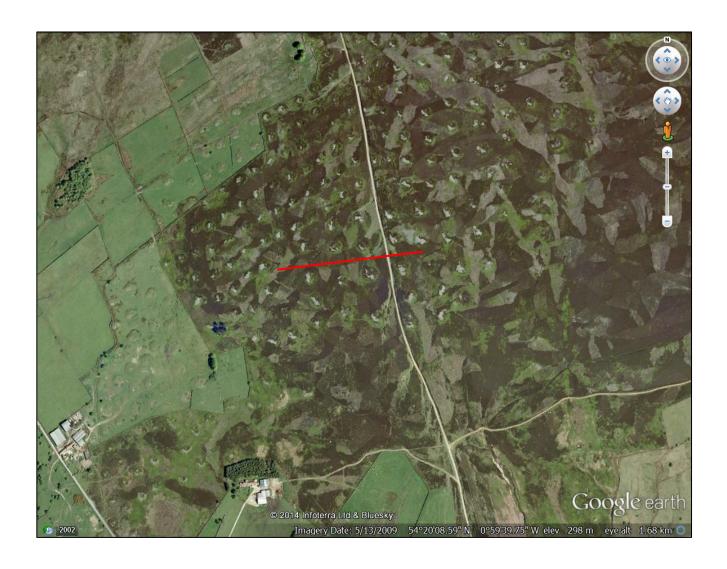
FIGURE 3: SITE OF DEVELOPMENT Source: Google Earth

New alignment of grouse butts shown as red line.

2.1 The proposed line of nine new shooting butts runs on an almost east-west alignment across a track known Westside Road, c.600m north-east of Bogg House on Rudland Rigg, Bransdale Moor, Fadmoor, North Yorkshire (NGRs SE 65355 93858 to SE 65721 93893). This part of Rudland Rigg lies c.5km to the north-west of Gillamoor village (see figure 1). The alignment extends over a distance of c.300m, and comprises two new butts on the east side of the track and seven to the west; the butts will be spaced c.45m apart (see figures 2 and 3).
