BENT RIGG RADAR STATION,  
SOUTH-EAST OF RAVENSCAR, STAINTON DALE,  
NORTH YORKSHIRE

ARCHAEOLOGICAL SURVEY

Report no: 2011/410.R01  
Version: Final  
Date: September 2014  
Author: Ed Dennison & Shaun Richardson

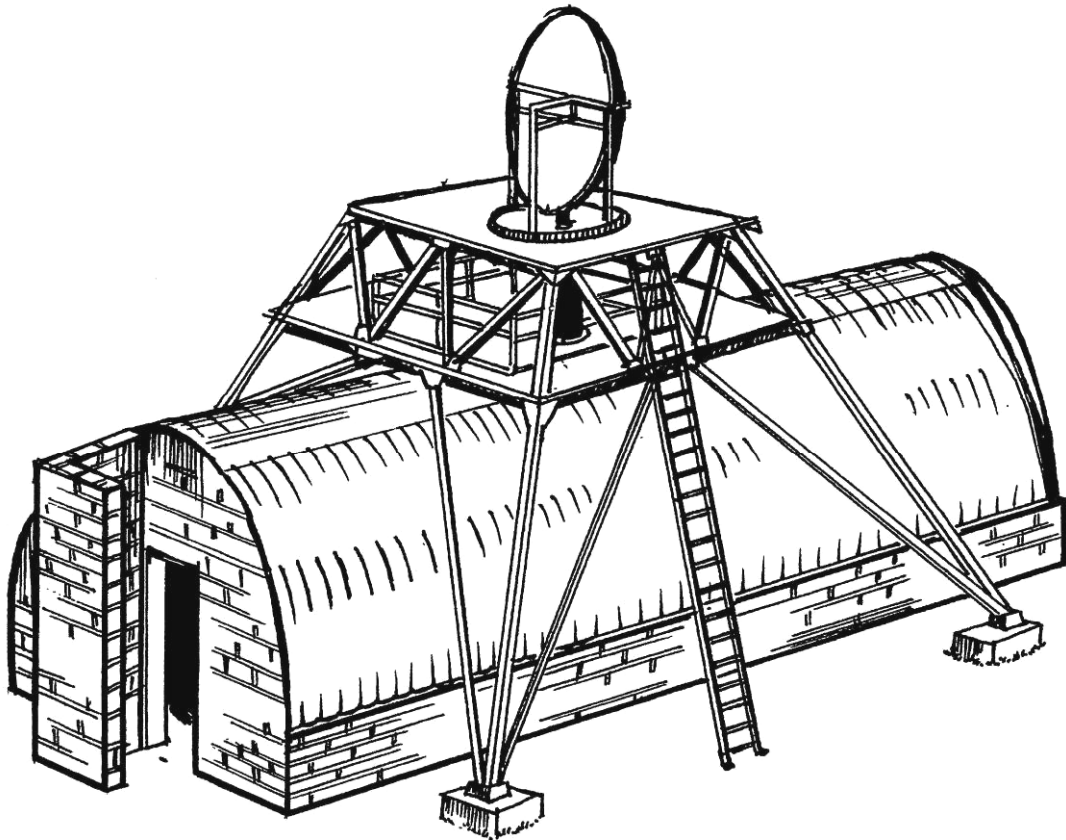
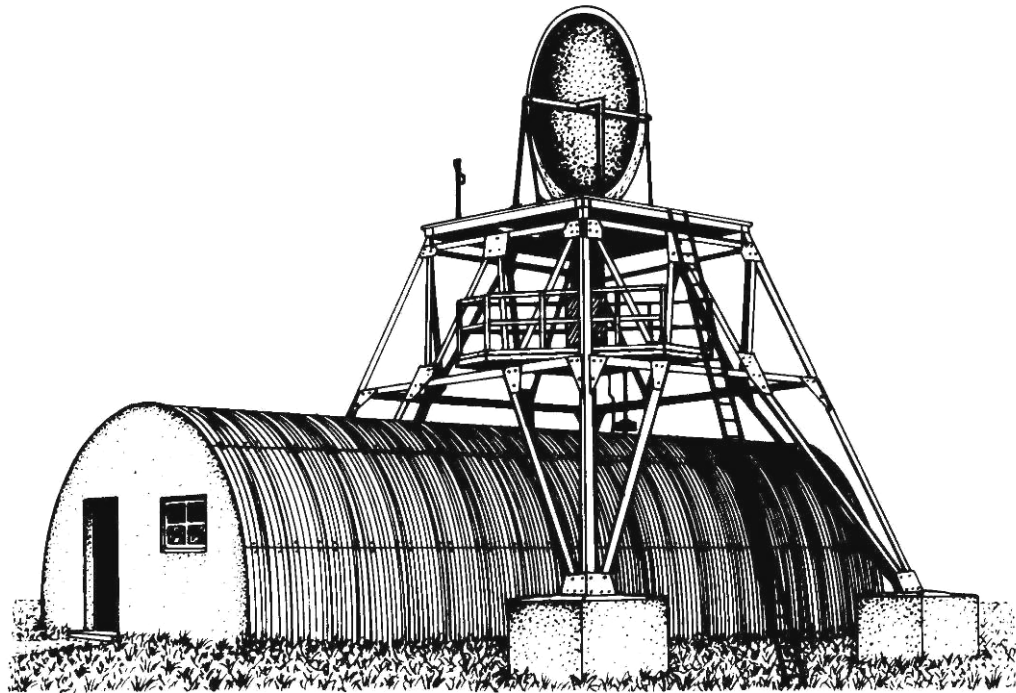
PROJECT		BENT RIGG RADAR STATION	
TITLE		TYPE 52 NISSEN RECONSTRUCTION	
SCALE	NTS	DATE	SEPT 2014
EDAS		FIGURE	3

Top: Type 52 Nissen and gantry arrangement at Bent Rigg (Source: Harwood & McMillan 2008, 187).

Bottom: Generic Type 52 Nissen and gantry arrangement (Source: Lowry 1995, 44).

- 2.20 This confusion with the above dates suggests that the precise date of installation and the construction of the concrete Tx/Rx block lies between 1942 and 1944. For example, it might be that the earlier Type 52 array on top of the curved asbestos hut was relatively short-lived, probably being erected in early 1942 but then replaced by the concrete Tx/Rx building and array by the summer of 1942. Alternatively, the curved asbestos hut array could have continued in use until 1944 before being replaced. By comparison, the very similar concrete Tx/Rx block at Craster in Northumberland is thought most likely to date to towards the end of 1941, and to have initially have been provided with a 1.5m radar which was replaced by a centimetric set after December 1942 (Hunt & Ainsworth 2006, 34-35). Whichever option is chosen, the Type 52 configuration was a standard station for both air and sea watching by the end of the war (Lowry 1995, 47).

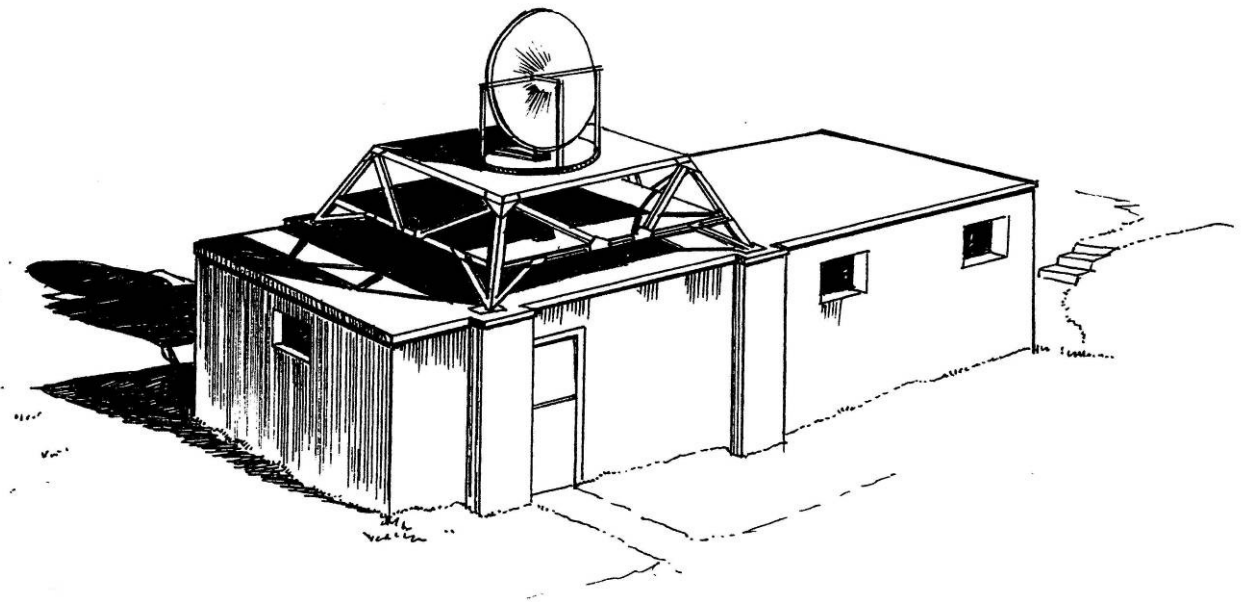
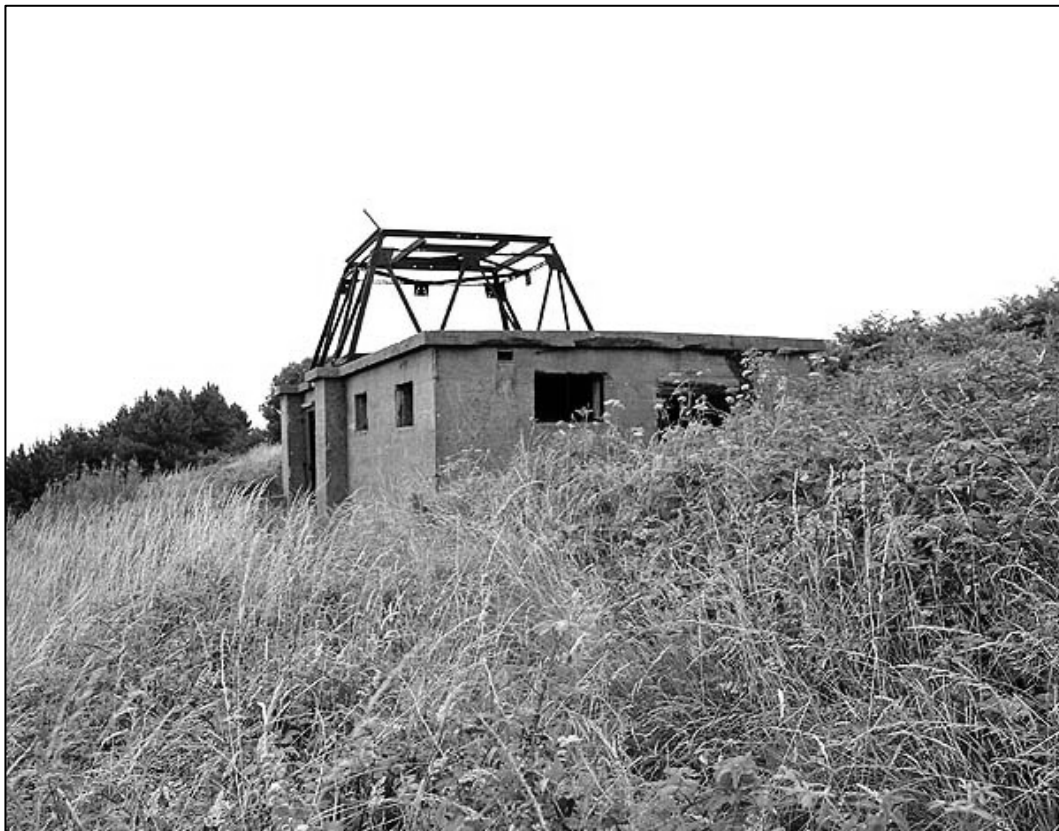
Top: Tx/Rx block at Bent Rigg (Source: Harwood & McMillan 2008, 188).

Bottom: Remains of Tx/Rx block with array framework, Swansea Bay CHL station (Source: [www.subbrit.org.uk/sb-sites/sites/m/margam/index.shtml](http://www.subbrit.org.uk/sb-sites/sites/m/margam/index.shtml)).

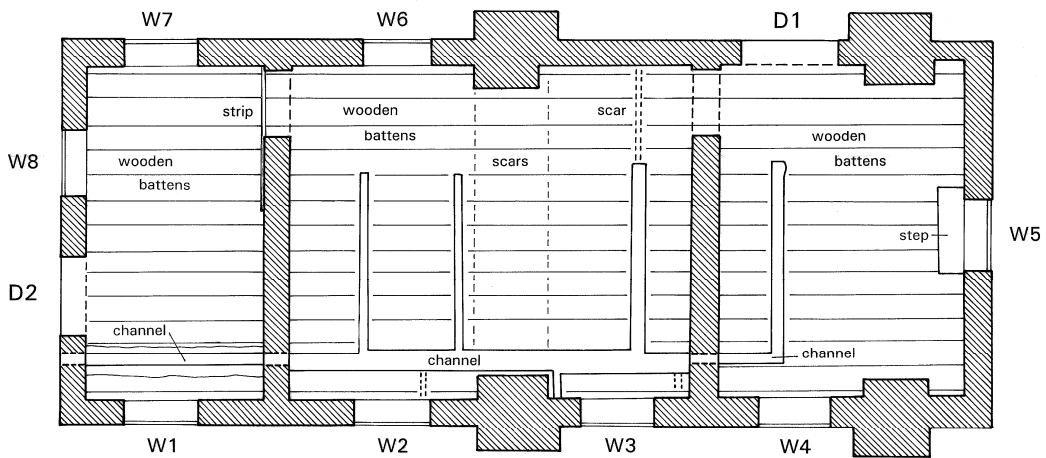
PROJECT		BENT RIGG RADAR STATION	
TITLE		BUILDING R4 PLANS	
SCALE	AS SHOWN	DATE	SEPT 2014
EDAS		FIGURE	10

Roof plan

Floor plan showing channels and wooden battens

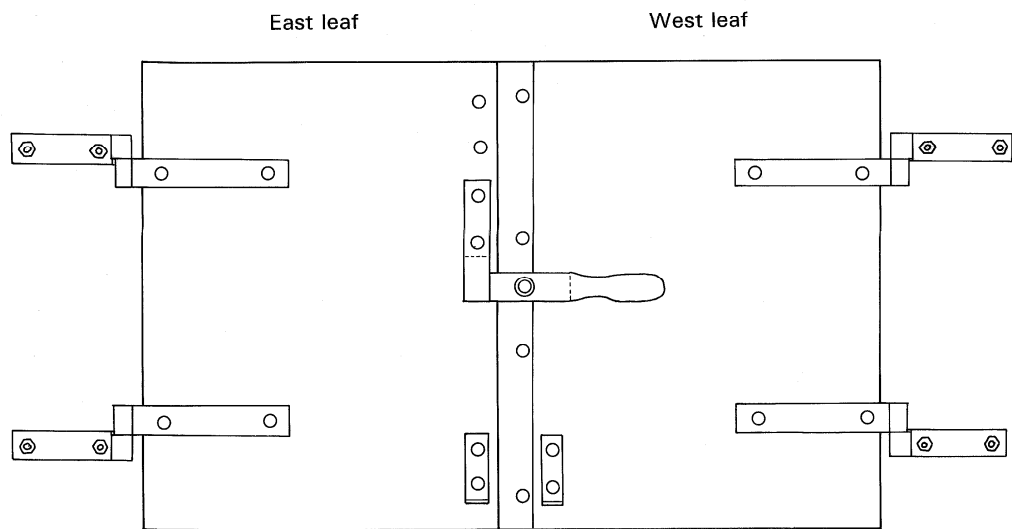
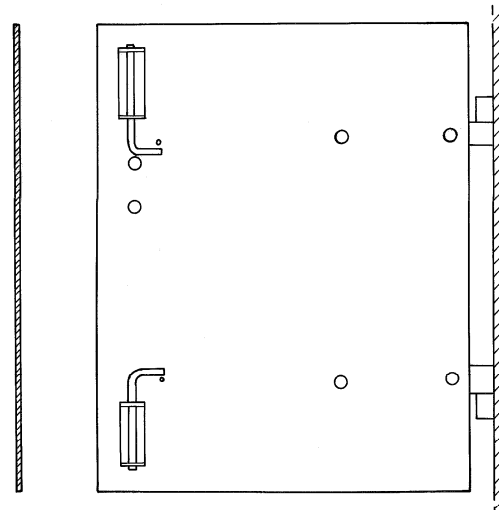
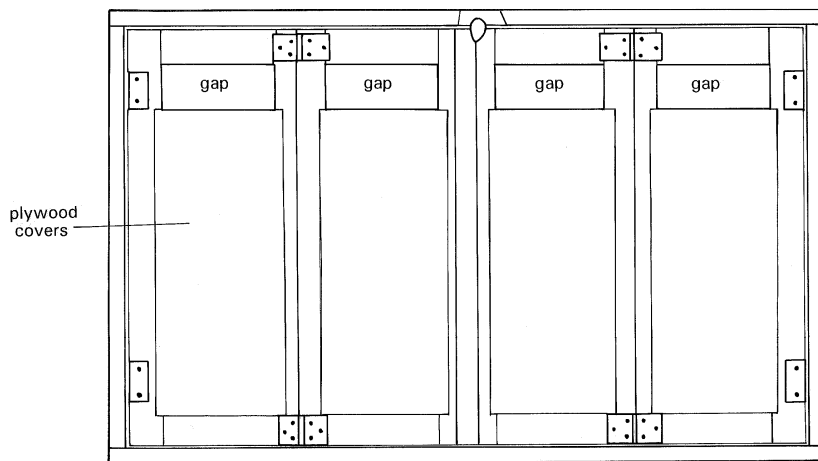
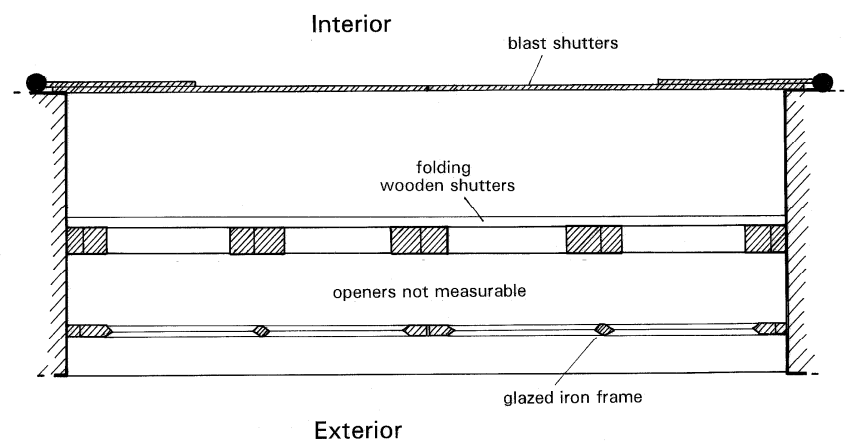
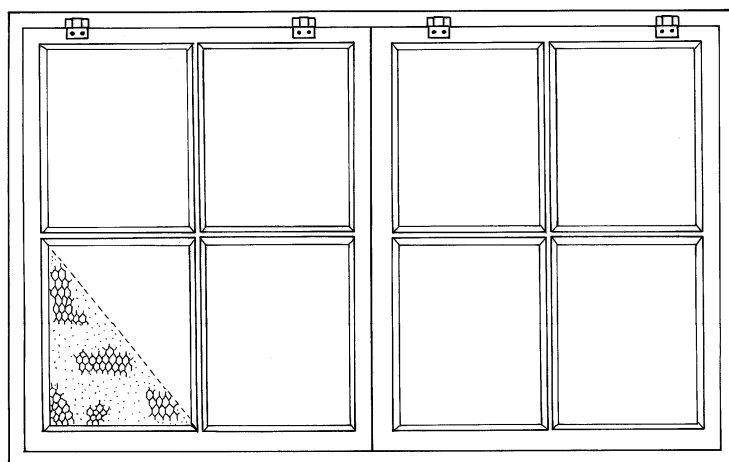
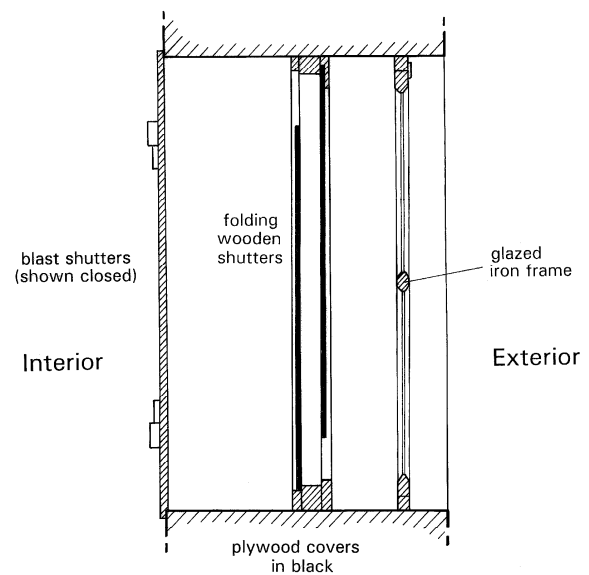
PROJECT		BENT RIGG RADAR STATION	
TITLE		BUILDING R4 WINDOW DETAIL	
SCALE	AS SHOWN	DATE	SEPT 2014
EDAS		FIGURE	11

**Internal blast shutters (W4)**  
Shown fully closed, viewed from interior

**Internal blast shutters (W4)**  
Rear of east leaf when open

**Internal wooden shutters (W7)**  
Shown fully closed, viewed from interior

**Simplified composite plan**

wire pattern of original glazing partly shown

**External iron frame (W4)**  
viewed from exterior

**Typical composite cross section**

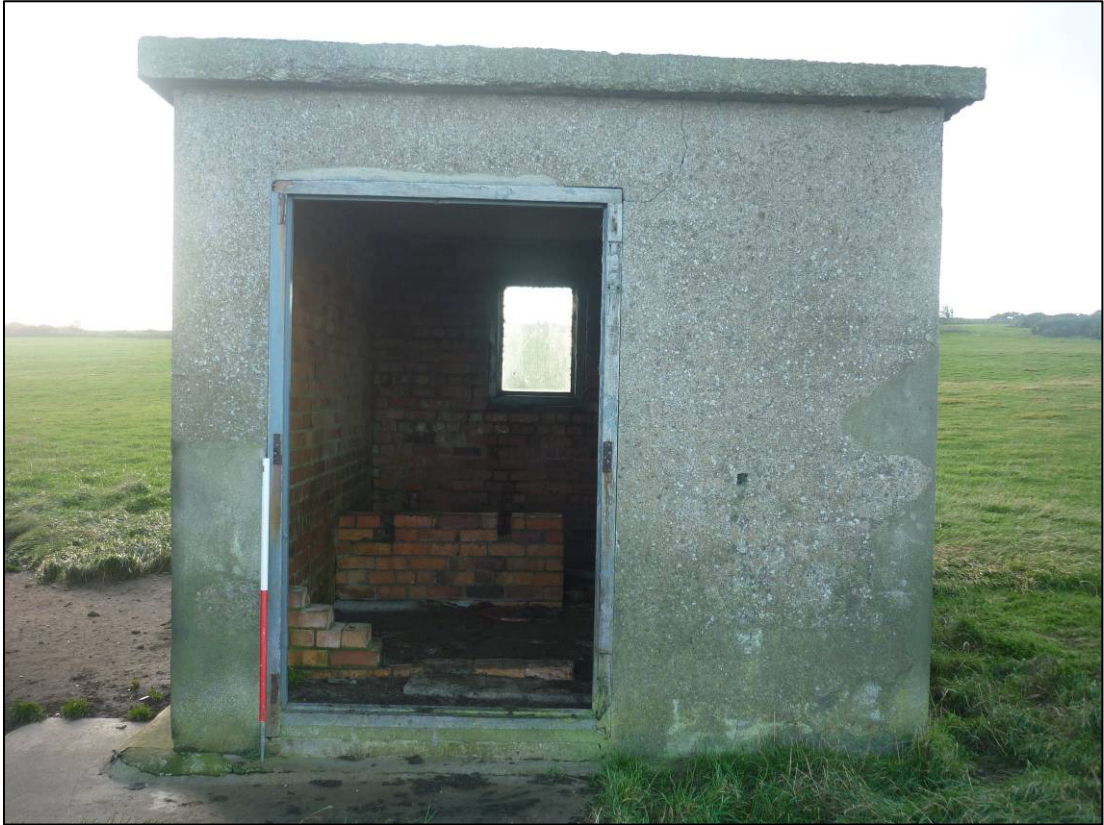
Plate 3: Building R1, east external elevation, looking SW (photo 2/954, December 2011).

- 3.17 This building has maximum external dimensions of 4.95m east-west by 3.00m north-south. The bricks used in its construction are machine-moulded and light red/orange in colour (average dimensions 220mm x 110mm x 70mm) and set with a cement mortar. The external east wall [1/845; 2/954] is largely as recorded by Kenyon in August/September 1997, the frame to the left (south) jamb having been replaced during the late 2000 conservation works; the door which it is assumed was fitted here at the same time has been broken off and thrown into the interior (see plate 3). The patches of repaired render and a crack above the top right corner of the door still remain. The external north wall [1/846] is as recorded in August/September 1997, as is the west wall [1/847], with the exception of the window, which had an inner frame fitted with safety glass inserted into the earlier frame during the late 2000 conservation works - the outer frame has lost its paint and the bottom is now rotted; the whole is now painted a greyish-blue, rather than the dark brown noted in June 2000. Patches of repaired render are visible (as in 1997) as well as a small area of fallen render. The external south wall is as recorded in 1997 [1/848, 1/849], although only five of the eight square holes referred to in 2000 were visible at the time of the EDAS survey; Kenyon shows five such features on her 1997 survey drawing. A narrow strip of concrete runs along the base of the east external elevation, returning along the south wall for a short

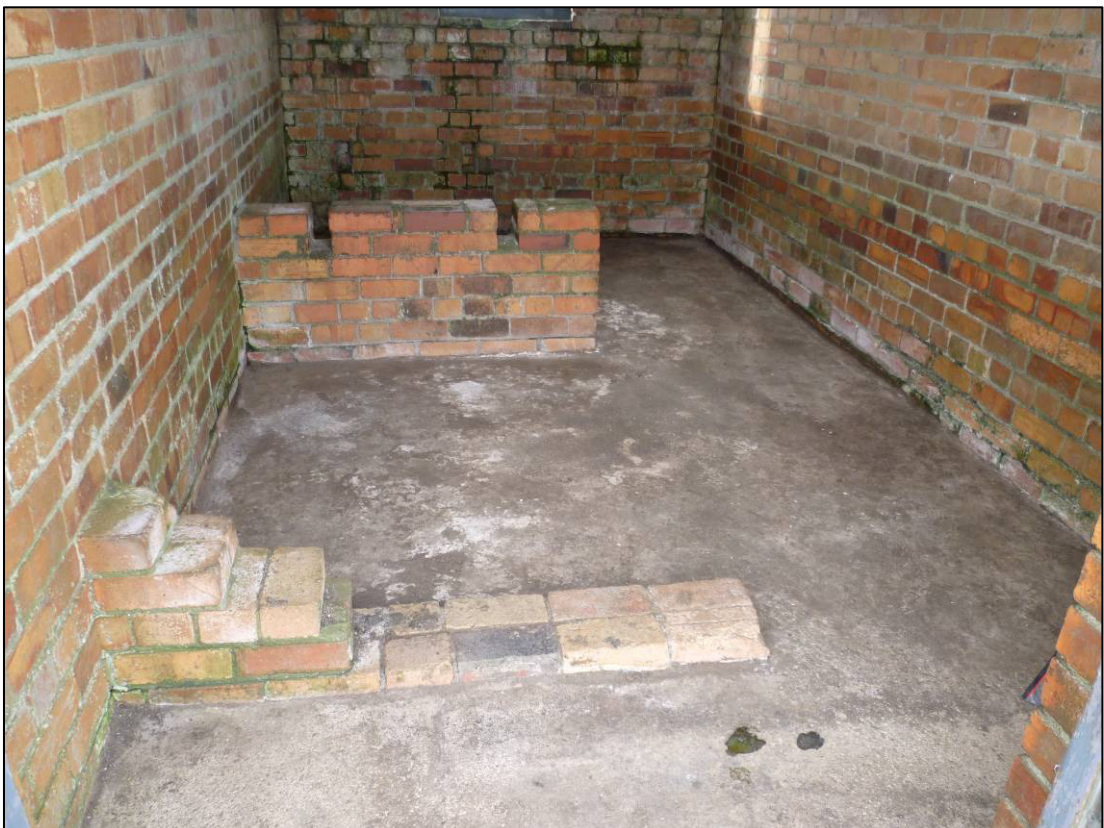
Plate 4: Interior of Building R1 after clearance, showing brick supports for fuel tank, looking SW (photo 4/566, February 2012).

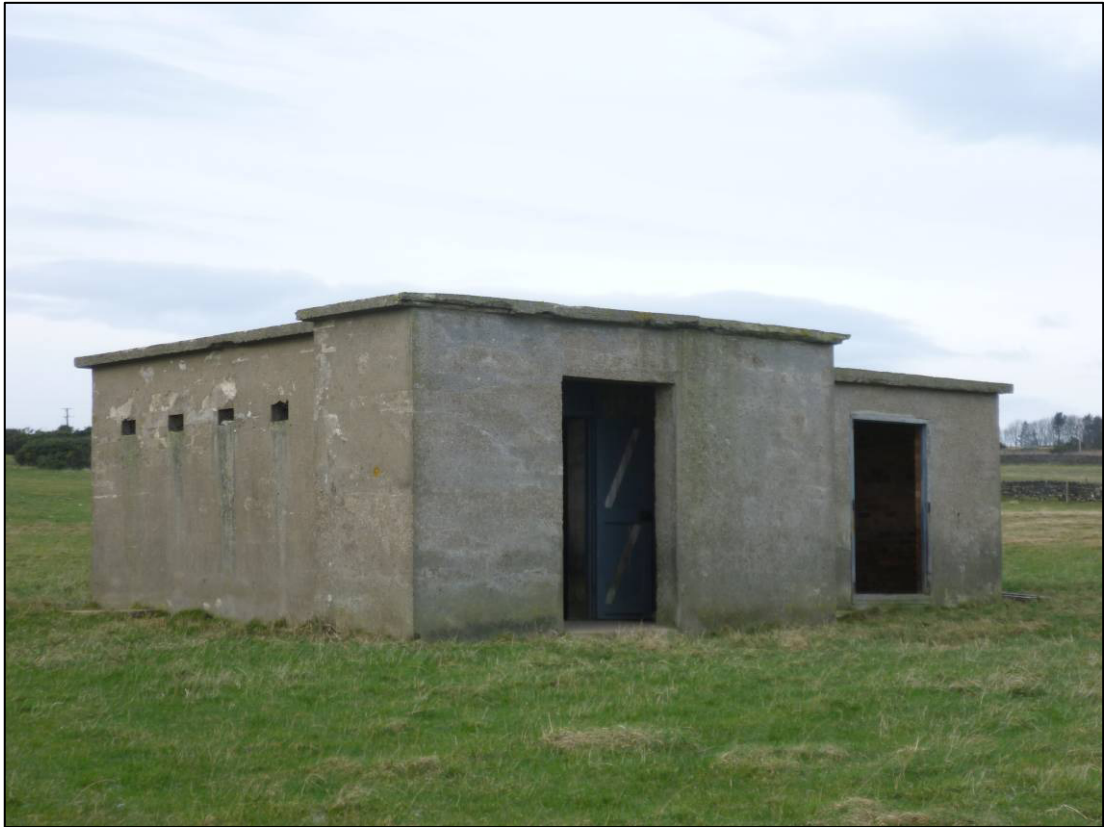
Plate 5: Building R2, south and east external elevations, looking NW  
(photo 4/575, February 2012).

- 3.20 This building has maximum external dimensions of 6.95m east-west by 5.10m north-south. The external east wall [1/856, 1/857; 2/952; 4/569, 4/574, 4/575] of the screen/porch is as recorded by Kenyon in October 1997 (see plate 5), although the edges of the concrete roof are worn. The doorway to the 'external' east wall of the main part of the building retains the frame noted in June 2000 but it has since been overpainted a greyish-blue and the etched 'ENGINE HOUSE' lettering on the lintel is no longer visible; a painted wooden panel has been added above the lintel, presumably as part of the late 2000 conservation works (see plate 8). The opening was fitted with new double doors during the conservation works but only one (north) leaf now remains *in situ*, the other having been thrown into the interior. There are two more small square recesses or holes in the north external wall [1/850] than were recorded in 1997, placed at the very west end of the wall (see plate 6). The external west wall [1/852] is as recorded in 1997, with the northern of the two vent openings [1/851] retaining probably the most complete set of fittings described in 2000 (see plate 7). The external south wall [1/853] is as recorded in 1997. Each of the vents has a streak of discoloration below it, running down to the ground surface, but it is not clear what the source is, perhaps staining from the former metal grills; similar, but fainter, streaks can be seen below vents in the external north wall. The concrete drain cover [1/855], with its central ring, at the base of the south wall is still present, while a narrow strip of concrete runs parallel to the base of the east external wall.

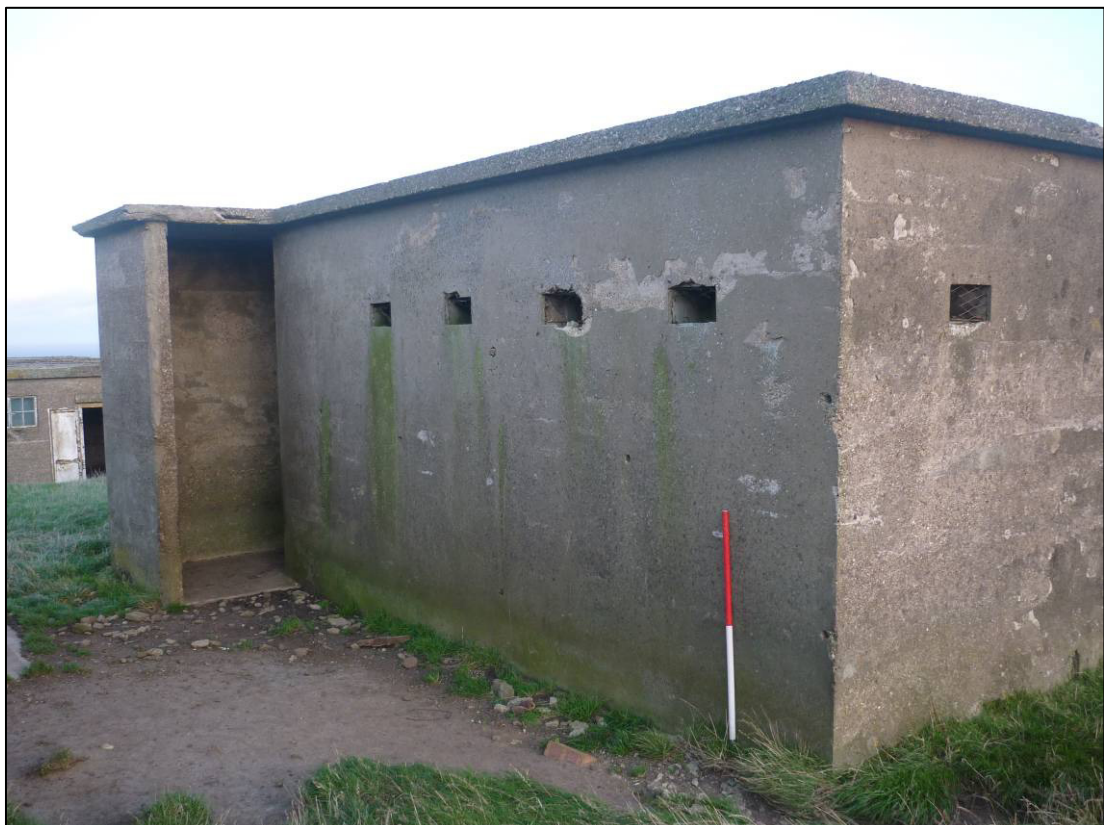
Plate 6: Building R2, north external elevation and porch, looking SE  
(photo 1/850, December 2011).

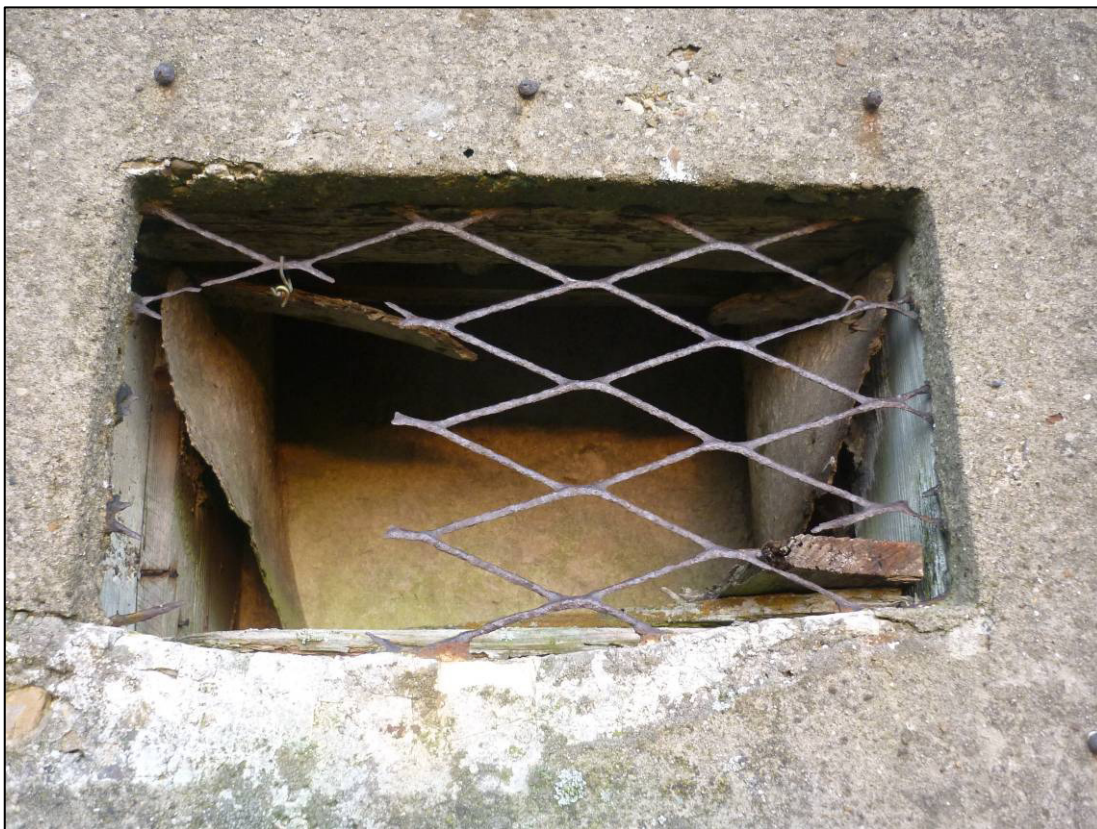
Plate 7: Building R2, detail of north vent in west elevation, looking NE (photo 1/851, December 2011).

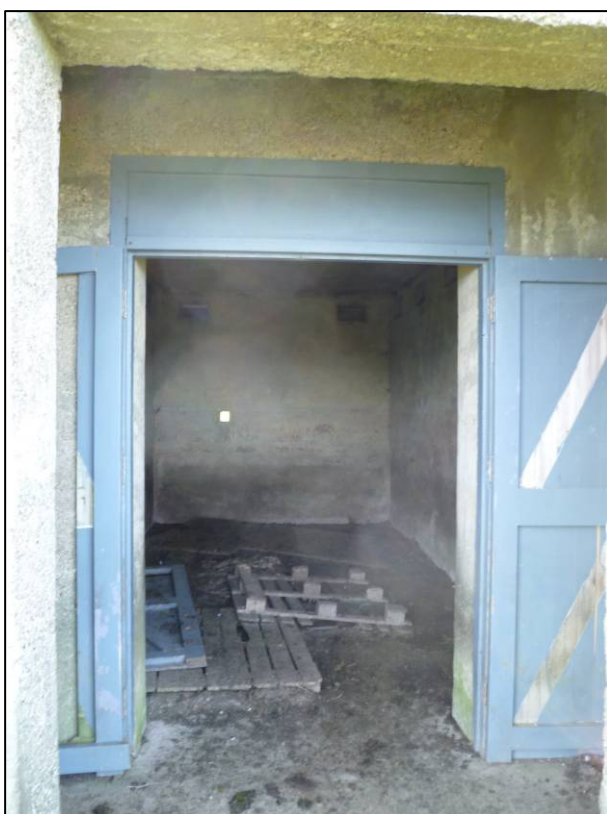
Plate 8: Building R2, 'internal' door in east elevation, looking SW (December 2011).

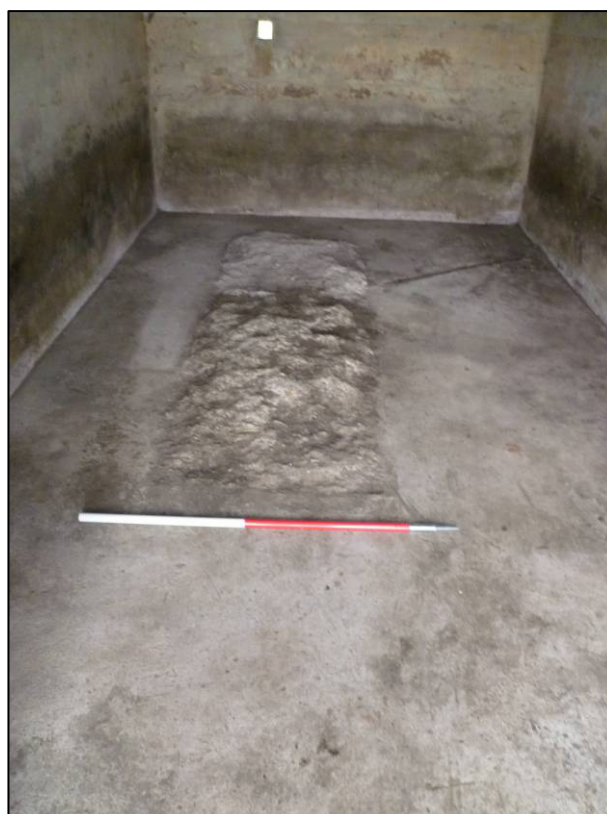
Plate 9: Building R2, remains of engine bed after clearance, looking SW (photo 4/573, February 2012).

- 3.23 The clearance of the floor of this building in late January 2012 revealed a concrete floor together with the outline of the former machine bed which would have supported the generator (see plate 9). This outline measured 2.87m by 0.83m and it was aligned with the south wall although 0.64m to the north of it, and 0.57m from the west wall; a corroded metal strip ran north-west from near its north-west corner towards the west end of the north wall [4/571-4/573]. The bed had clearly been dismantled as far as possible, leaving a pock-marked surface, and no markings or bolts to secure the generator remain. The position of the former machine bed corresponds exactly with that seen in the Standby Set House at Craster (Hunt & Ainsworth 2006, 23-24). The south leaf of the wooden door had also been refixed but other material found during clearance, including a telephone cable mount, remained outside [4/570].

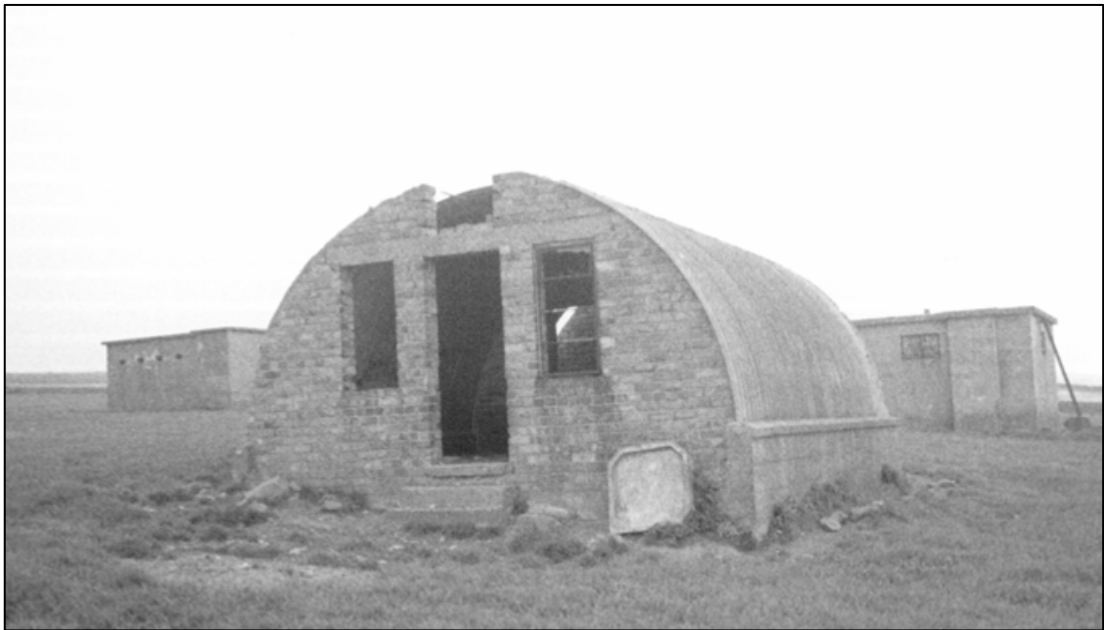
Plate 10: Building R3, looking NW (NT photo 100/9, February 1998).

- 3.27 The adjacent concrete slab noted in June 2000 remains [2/005], but it has been moved from its former position propped against the south external elevation (see plate 10), and is now laid flat at the north end of the west external elevation (see plate 13). In addition, it was noted by the current survey that there is a very slightly raised bank, 0.80m wide, running parallel to the west external wall of the building, in line with the slab. The firmness of the bank suggests that it may comprise turf-covered brickwork. The bank curves around the south-west corner of the building and then stops. However, a similar bank is visible curving around the south-east corner of the building, and then continues along the base of the east external elevation as a 0.30m high north-east facing scarp. There may also be a very slight platform to the immediate north-east of the building, again aligned roughly parallel to the building, measuring 1.1m in length by 5m in width.

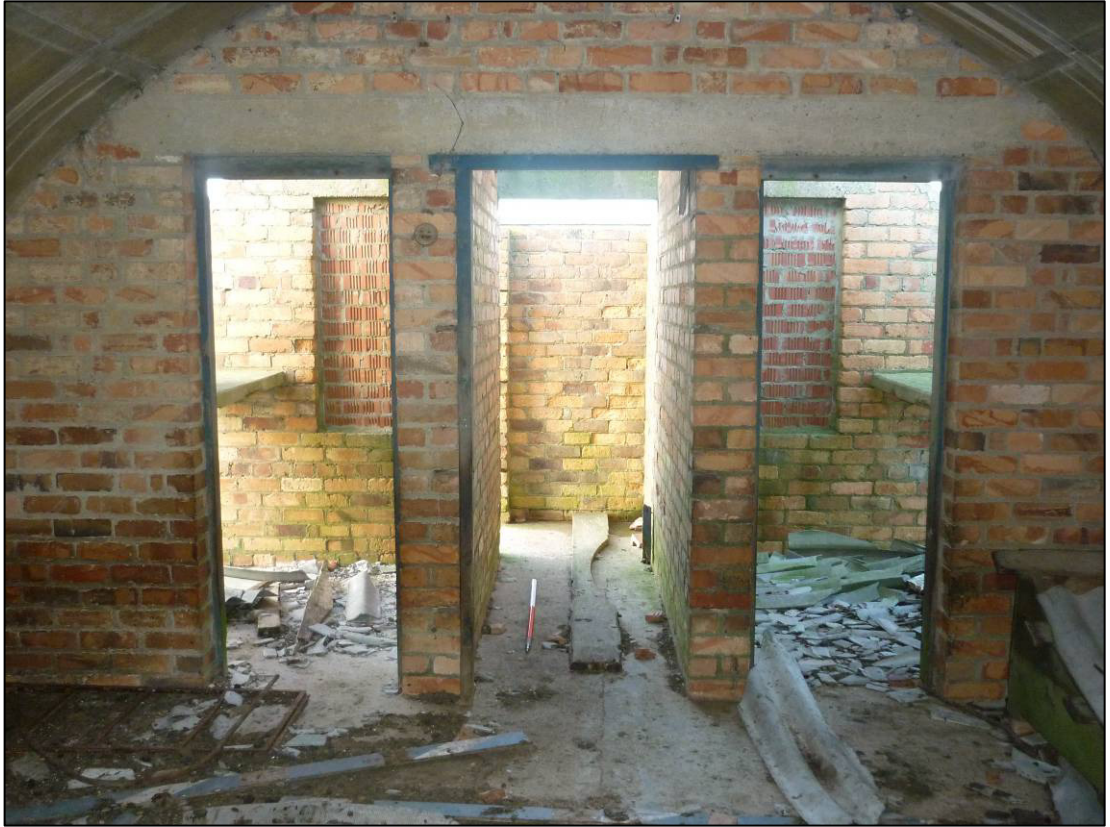
Plate 14: Building R3, interior looking NW (photo 2/012, December 2011).

- 3.28 At the time of the current survey, the interior of the building was in poor condition, with missing asbestos to the north and south ends of the roof. There were significant quantities of broken asbestos sheeting on the floor, a wooden former with asbestos sheeting laid on it and a plastic bin in one corner, together with a broken wooden door frame [2/011, 2/012, 2/022, 2/023, 2/025; 4/581]; it is assumed that these were left over from the late 2000 conservation works.

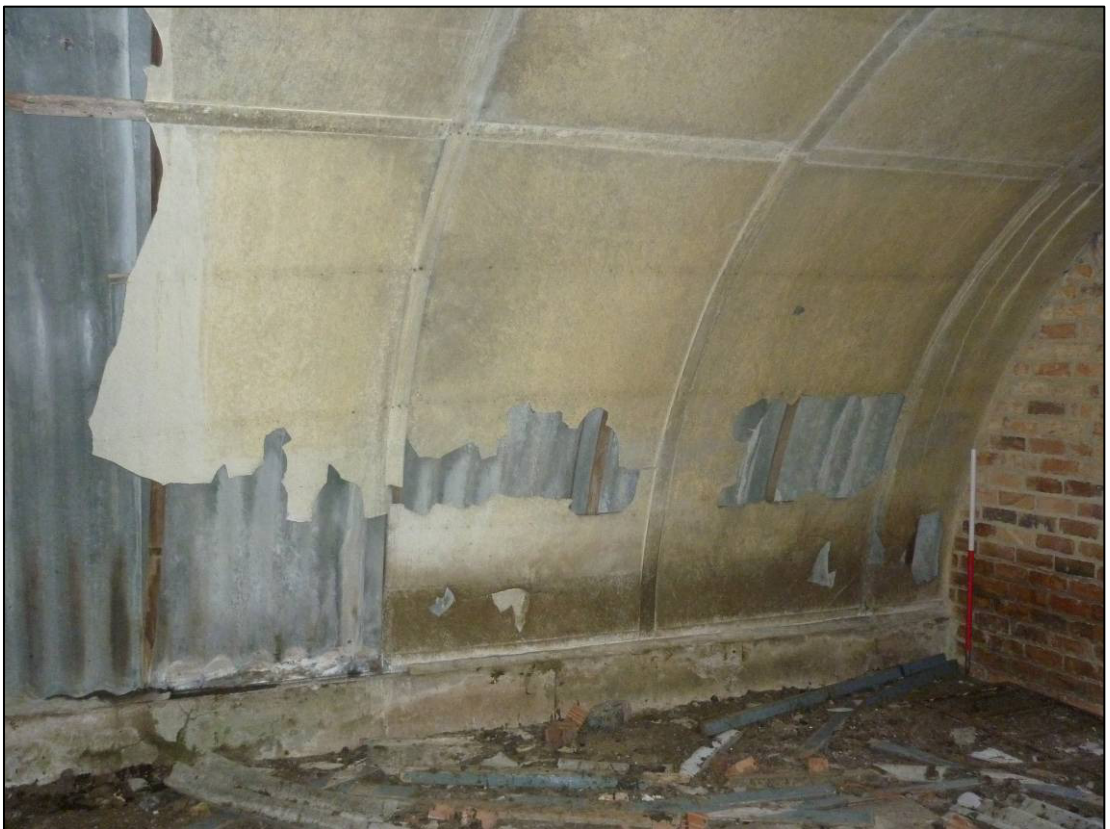
Plate 15: Building R3, interior showing construction, looking SW (photo 2/023, December 2011).

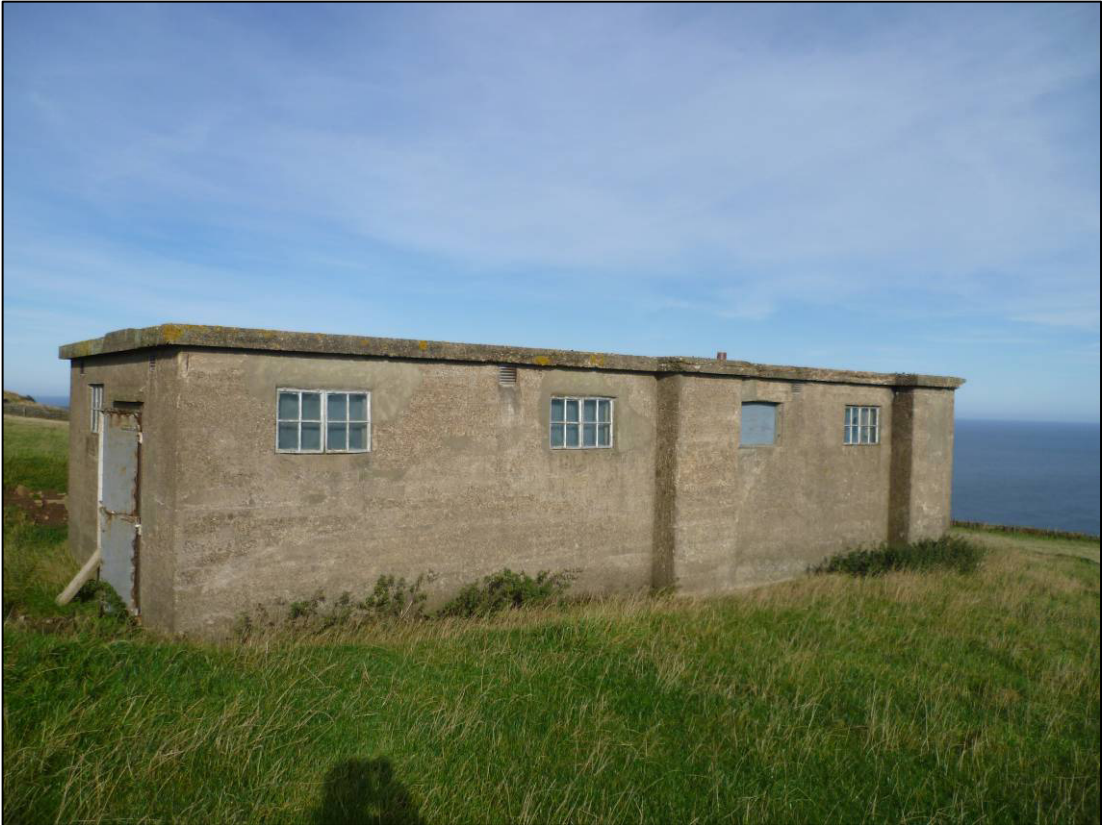
Plate 16: Building R4, south elevation, looking N (December 2011).

- 3.34 The external elevations of the building are largely as recorded by Kenyon in January 1998, the main changes having resulted from the conservation works undertaken in late 2000. Commencing with the south external elevation [2/960-2/963] (see plate 16), all of the four windows were reglazed during the conservation works and painted with silver 'Hammerite' paint, and none of the glass with hexagonal wire reinforcement survives, although fragments can still be found lying on the ground around the building. The external frame of window W3 on the south elevation has been removed and replaced with a wooden ply panel. The timber shutters have also been removed, but the internal blast doors are as described in June 2000; four pots of paint were placed behind them within the window at the time of the EDAS survey. The timber shutter remains have been removed from window W4 and the top right-hand pane of the west leaf, replaced during the conservation works, is now broken. There are areas of more recent concrete render over windows W1 and W2 in this elevation.

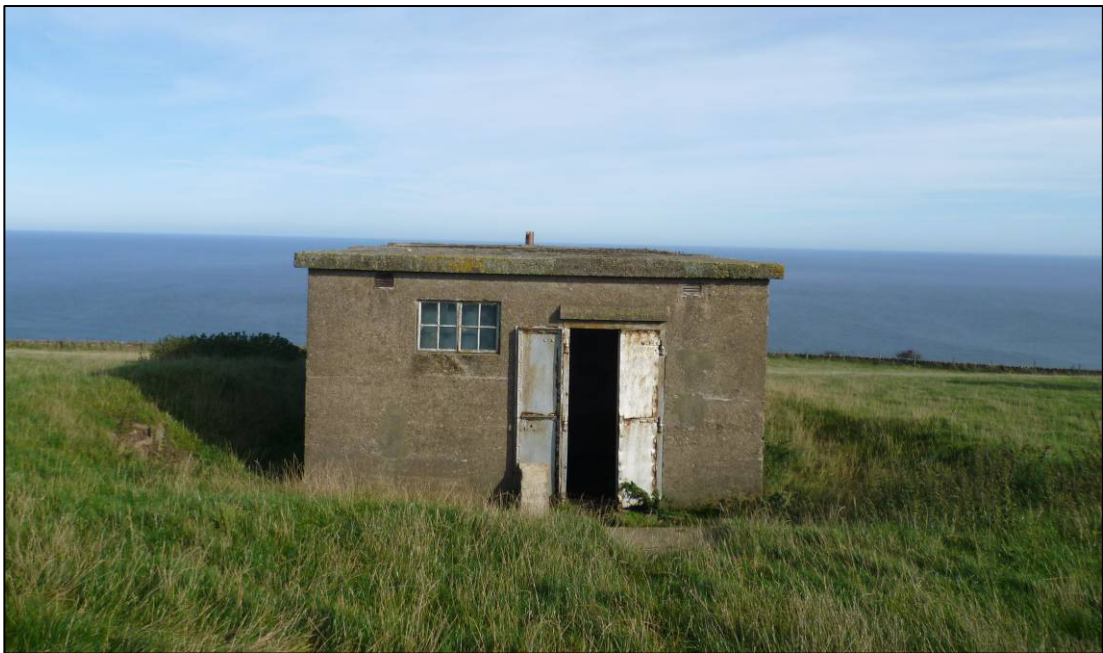
Plate 17: Building R4, west elevation, looking NE showing earthworks (December 2011).

replaced with wooden ply panels, while the door (D1), reconditioned in late 2000, is now rusting and the right hand leaf is detached and lying inside the building (see plate 18). On the west external elevation [2/955, 2/958] (see plate 17), the window (W8) was reglazed during the late 2000 conservation works and painted with silver metal paint; the bottom left-hand pane of both leaves of the external metal frame are now broken. The door (D2) was also made operational, primed and painted silver but it is now rusting [2/959].

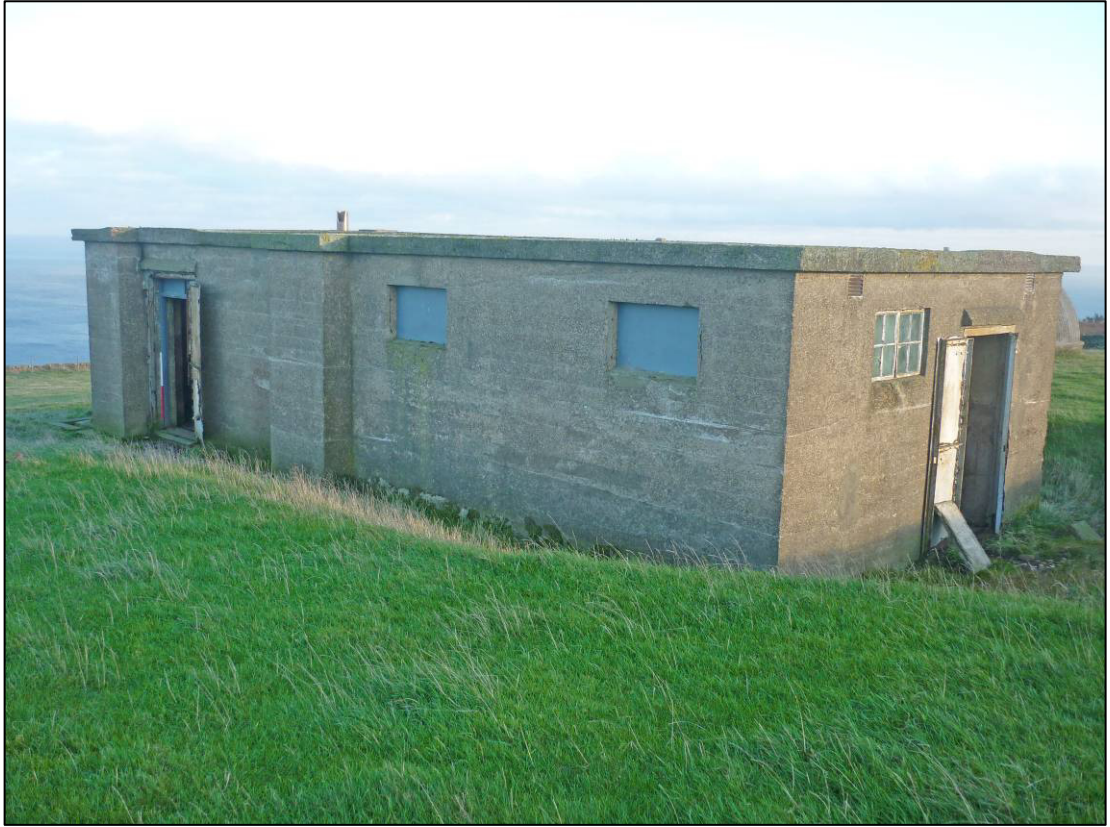
Plate 18: Building R4, north elevation, looking SE (photo 2/971, December 2011).

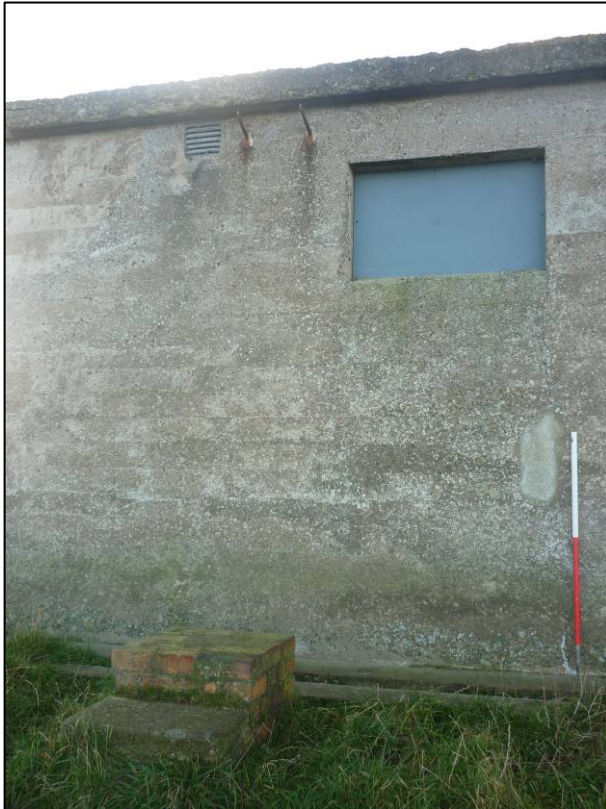
Plate 19: Building R4, east elevation showing former ladder position, looking SE (photo 2/967, December 2011).

- 3.35 On the east external elevation [2/966-2/968], the external metal frame of window W5 was removed during the late 2000 conservation works and replaced with a wooden ply panel. The metal ladder, giving access to the roof, is missing, but the rusting metal brackets for the top of the ladder and brick base still survive (see plate 19); the 2000 conservation works required it to be taken down, painted and stored in the building. On the north external elevation [2/970-2/972], the remains of the external metal frame to windows W6 and W7 have been removed and

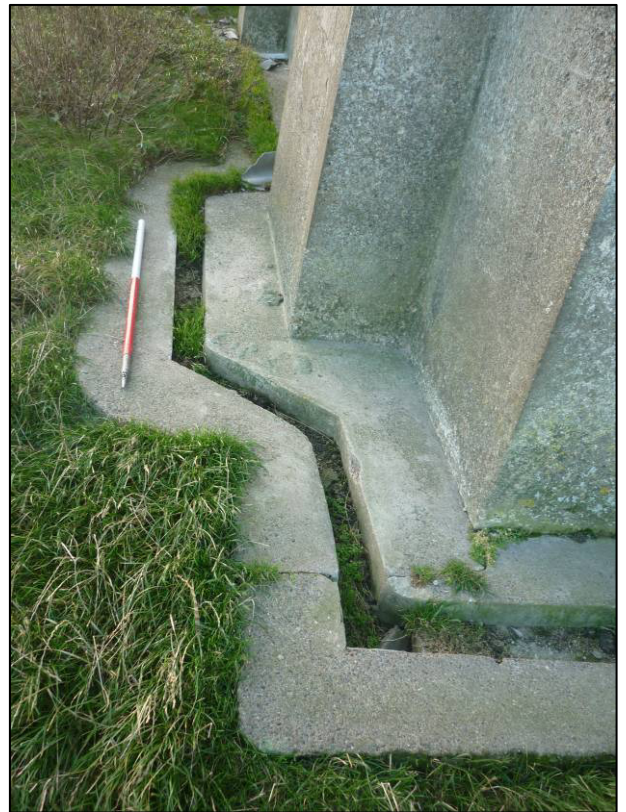
Plate 20: Building R4, external drain around NE corner, looking SW (photo 2/964, December 2011).

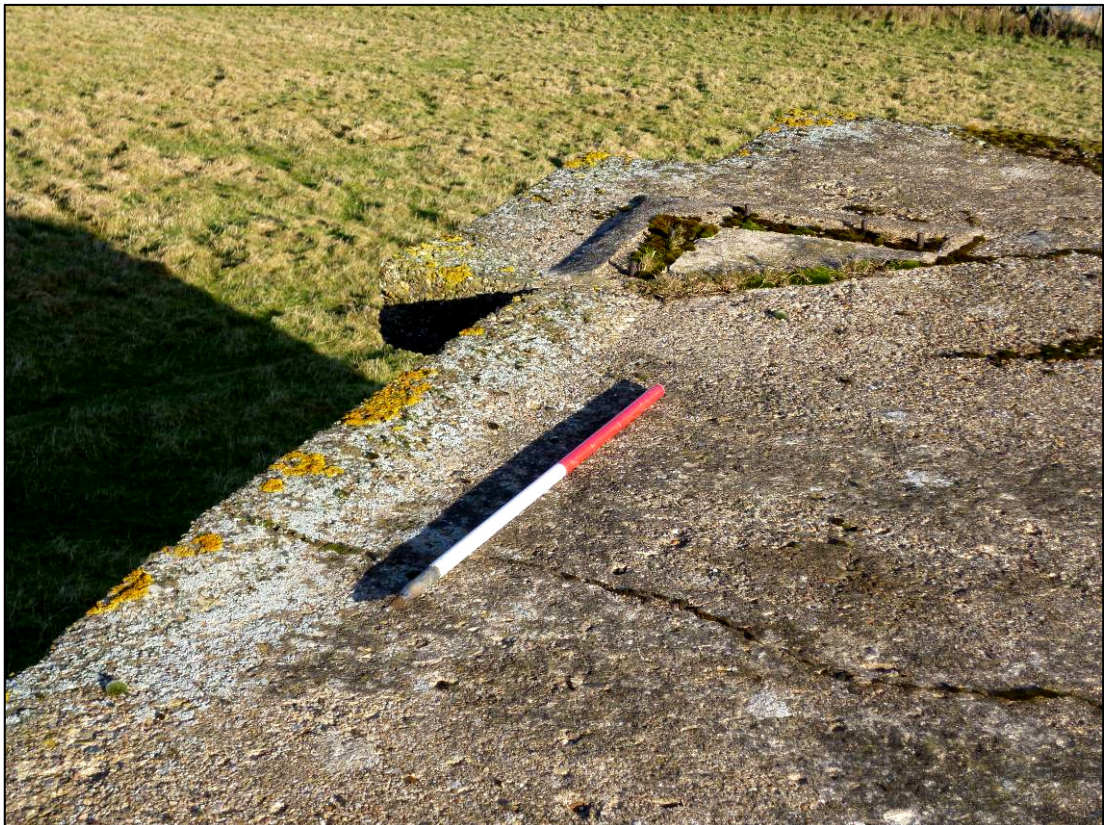
Plate 22: Roof of Building R4, showing base of radar array and lip over doorway D1, looking NE (photo 5/385, December 2012).

- 3.38 The main surviving features on the roof are the bases which secured the four legs or piers of a metal Type 52 aerial array to the roof. Each array base is placed in line with (although not always exactly central to) one of the external concrete piers of the building; the area covered by the bases measures 5.80m square. Each base comprises a sub-pentagonal concrete pad (essentially formed by a 0.79m square with the internal corner replaced by an angle), slightly raised above the surface of the slab by up to 0.06m [5/386]. The pads were apparently created by cutting out a shallow surface recess of the same shape into the surface of the slab and then adding additional concrete into this recess, so that resulting pad was raised above the slab. Within each pad, there is the shallow impression left by a pair of rectangular metal plates to which the legs or piers of the aerial array were fixed. Metal bolts (6mm in diameter) project up to 11mm from within the impressions left by the plates. The bolts do not appear to have been threaded, although this may be the result of weathering and decay. The arrangement of the bolts is not the same for all of the bases; the western two bases have four bolts to each plate [5/384], whereas the eastern bases have only three [5/387-5/389] (see plate 23). In the internal angle of the plate impressions to each base, there is a slight right-angled depression with a shallow internal groove to each side. The only exception to the description given above is the south-west pad; here, the plate footprints are slightly raised rather than recessed, and there is also a 0.06m diameter circular hole filled with lead to the internal angle [5/390, 5/391].
