BENT RIGG RADAR STATION,  
SOUTH-EAST OF RAVENSCAR, STAINTON DALE,  
NORTH YORKSHIRE

ARCHAEOLOGICAL SURVEY

Report no: 2011/410.R01  
Version: Final  
Date: September 2014  
Author: Ed Dennison & Shaun Richardson

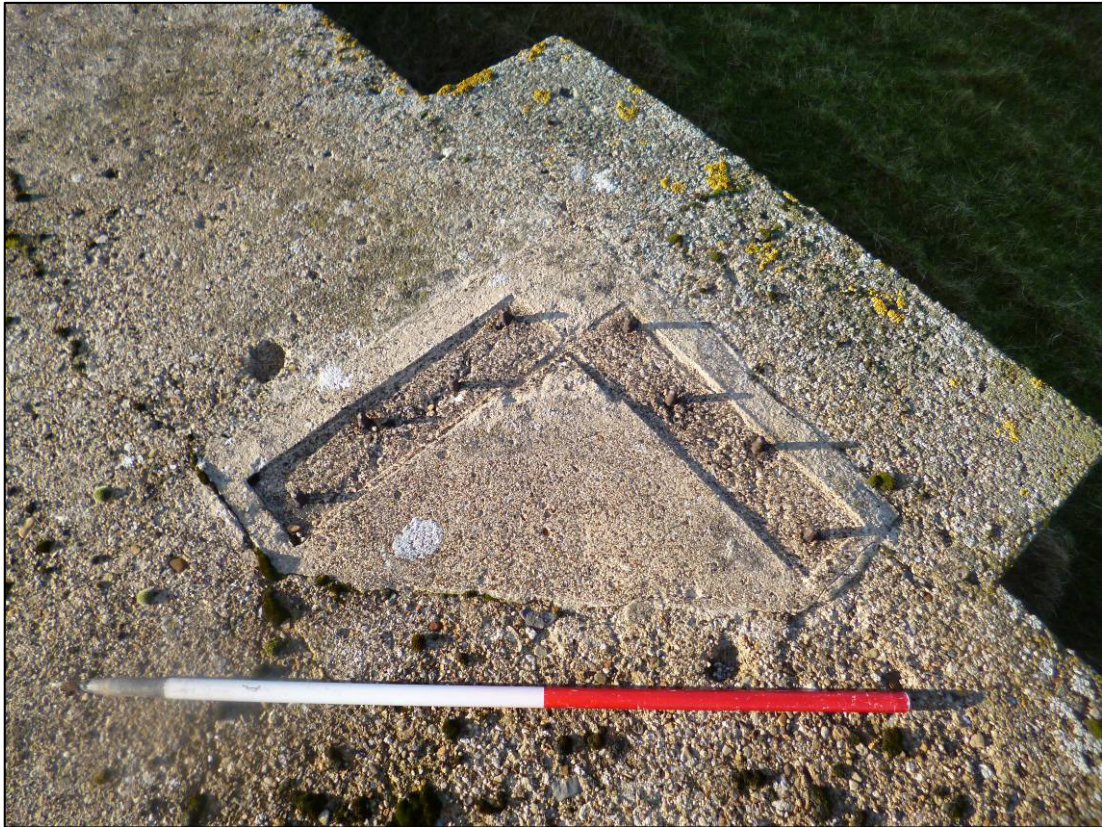
Plate 23: Roof of Building R4, north-west base of radar array, looking NW (photo 5/384, December 2012).

- 3.38 The main surviving features on the roof are the bases which secured the four legs or piers of a metal Type 52 aerial array to the roof. Each array base is placed in line with (although not always exactly central to) one of the external concrete piers of the building; the area covered by the bases measures 5.80m square. Each base comprises a sub-pentagonal concrete pad (essentially formed by a 0.79m square with the internal corner replaced by an angle), slightly raised above the surface of the slab by up to 0.06m [5/386]. The pads were apparently created by cutting out a shallow surface recess of the same shape into the surface of the slab and then adding additional concrete into this recess, so that resulting pad was raised above the slab. Within each pad, there is the shallow impression left by a pair of rectangular metal plates to which the legs or piers of the aerial array were fixed. Metal bolts (6mm in diameter) project up to 11mm from within the impressions left by the plates. The bolts do not appear to have been threaded, although this may be the result of weathering and decay. The arrangement of the bolts is not the same for all of the bases; the western two bases have four bolts to each plate [5/384], whereas the eastern bases have only three [5/387-5/389] (see plate 23). In the internal angle of the plate impressions to each base, there is a slight right-angled depression with a shallow internal groove to each side. The only exception to the description given above is the south-west pad; here, the plate footprints are slightly raised rather than recessed, and there is also a 0.06m diameter circular hole filled with lead to the internal angle [5/390, 5/391].

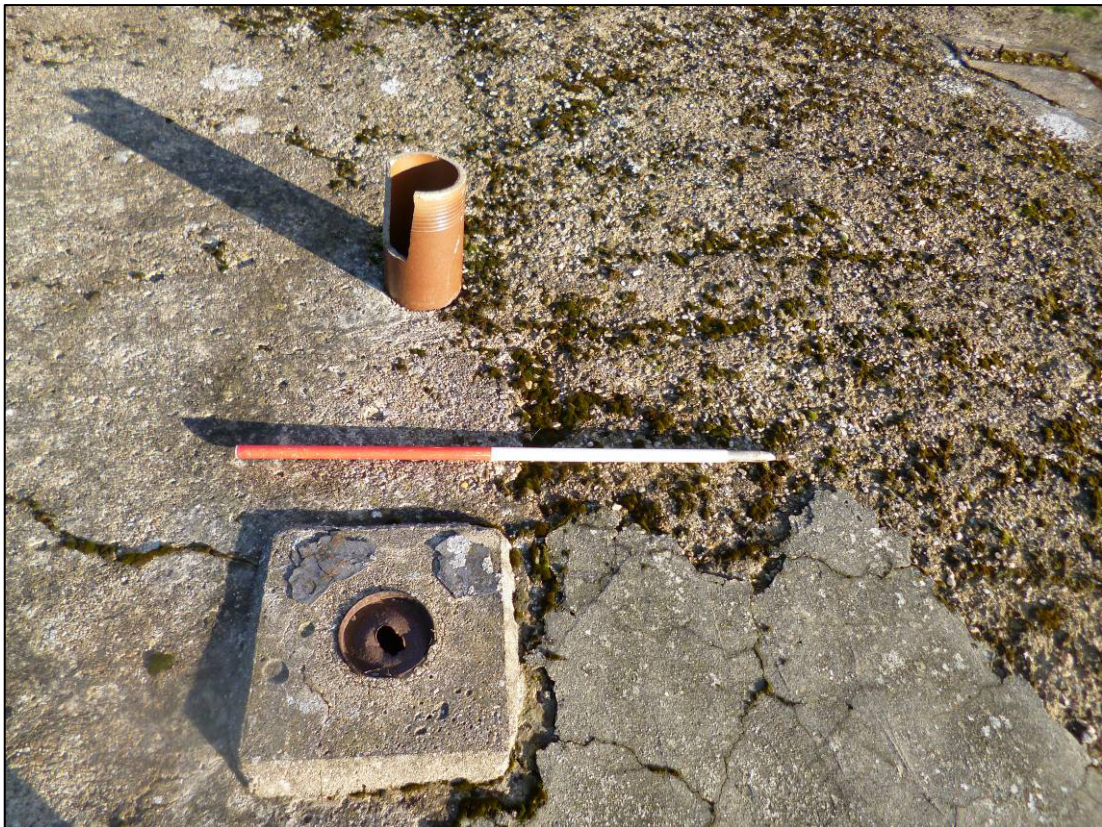
Plate 24: Roof of Building R4, pad of radar turning mechanism and pipe, looking E (photo 5/379, December 2012).

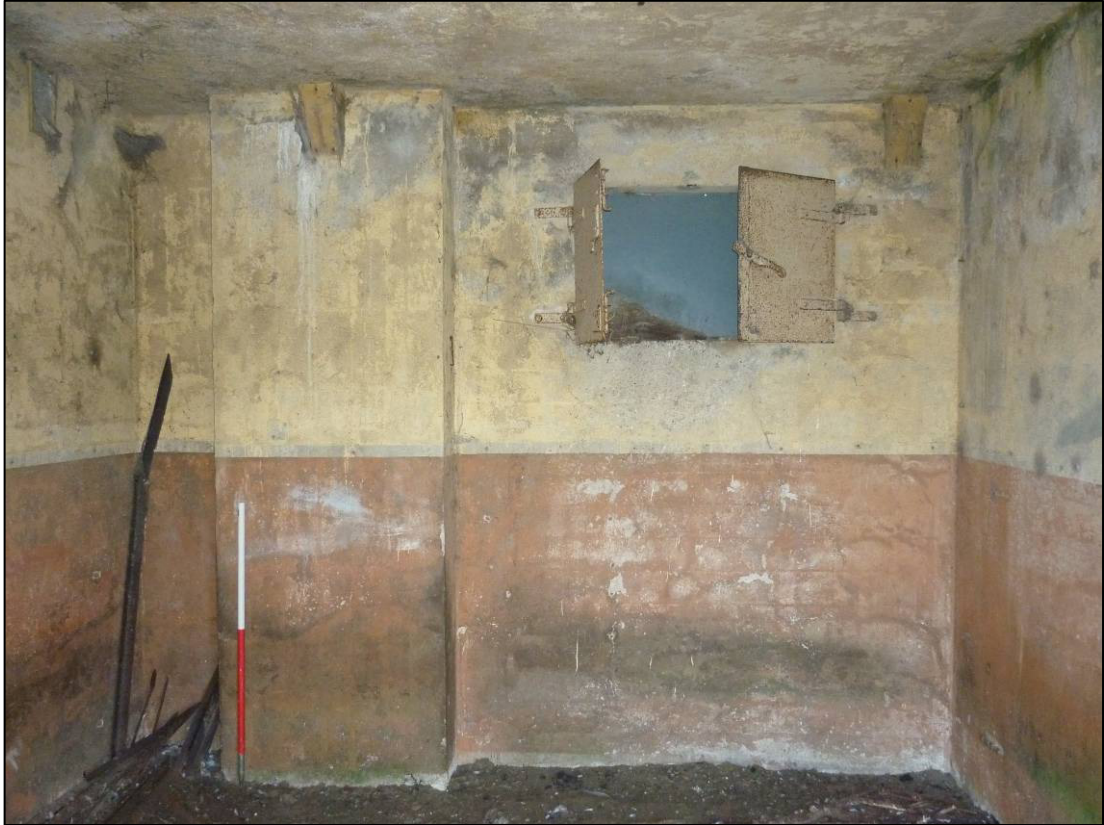
Plate 25: Building R4, internal south elevation of east room showing decoration, blast doors to window and triangular wooden blocks, looking S (photo 2/978, December 2011).

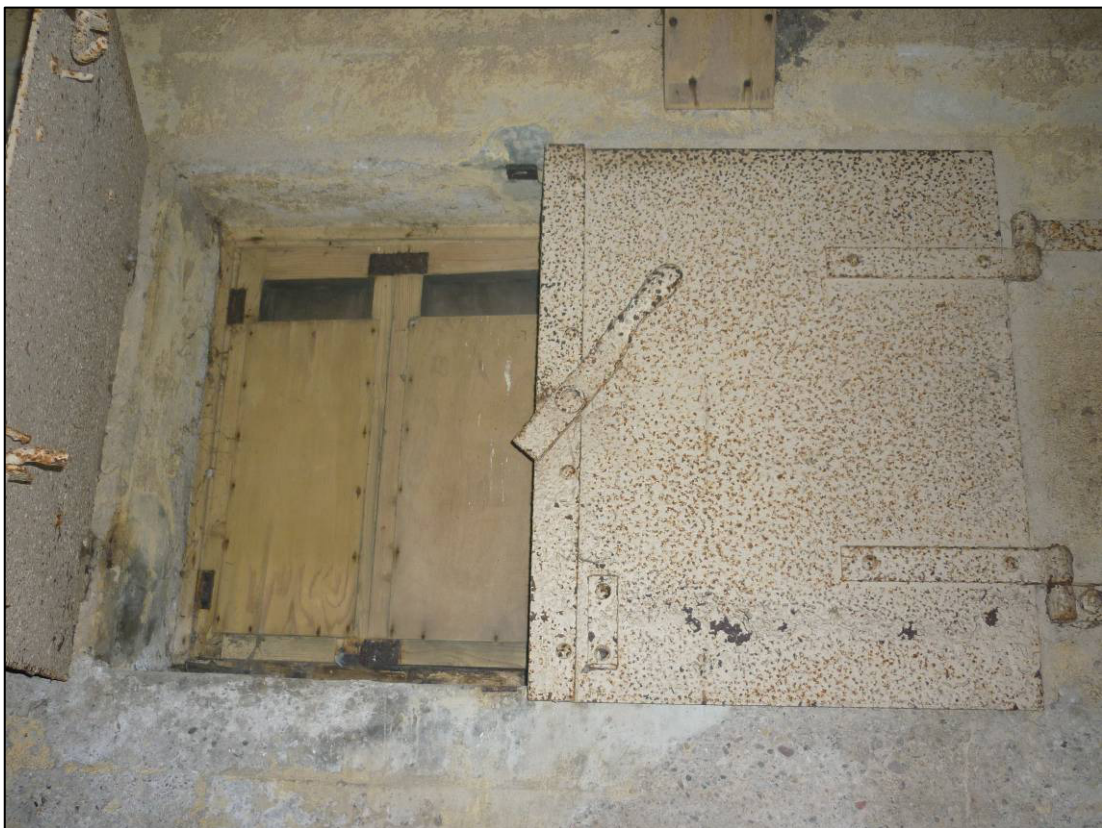
Plate 26: Building R4, internal north elevation of west room, showing blast shutters and folding wooden shutters, looking N (photo 3/282, January 2012).

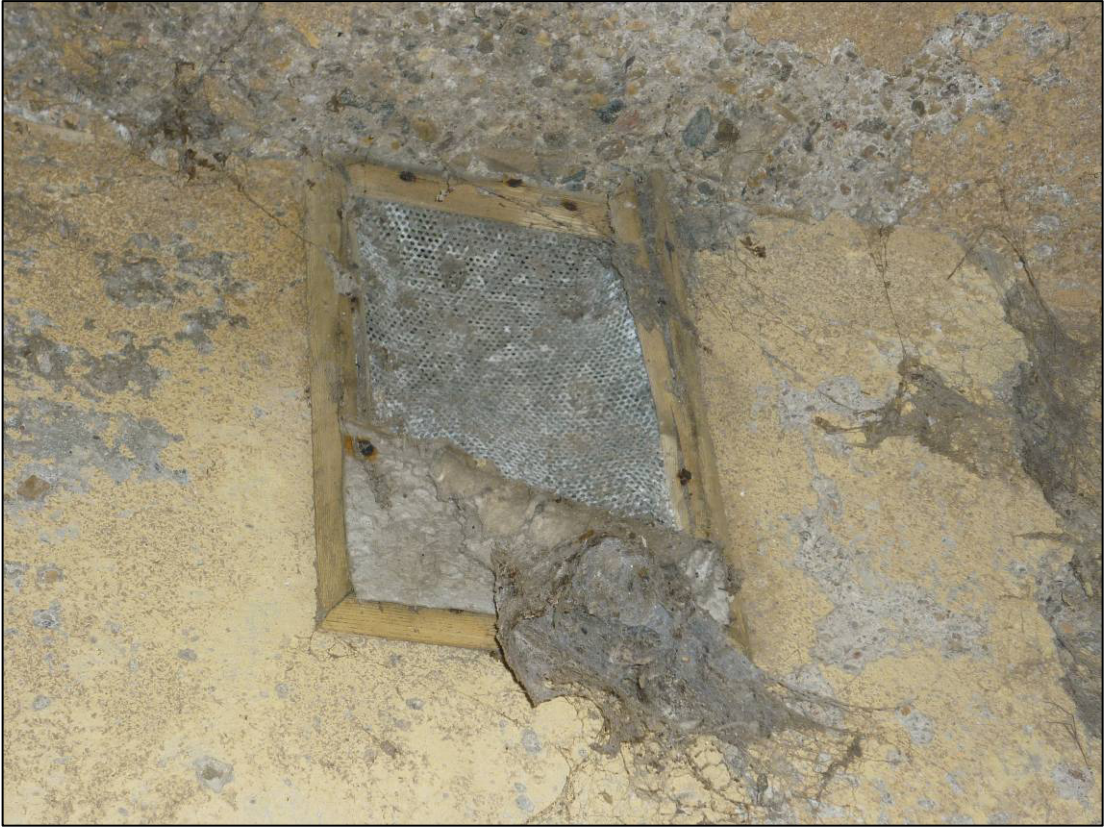
Plate 27: Building R4, east internal elevation of east room, detail of covered vent, looking NE (photo 2/981, December 2011).

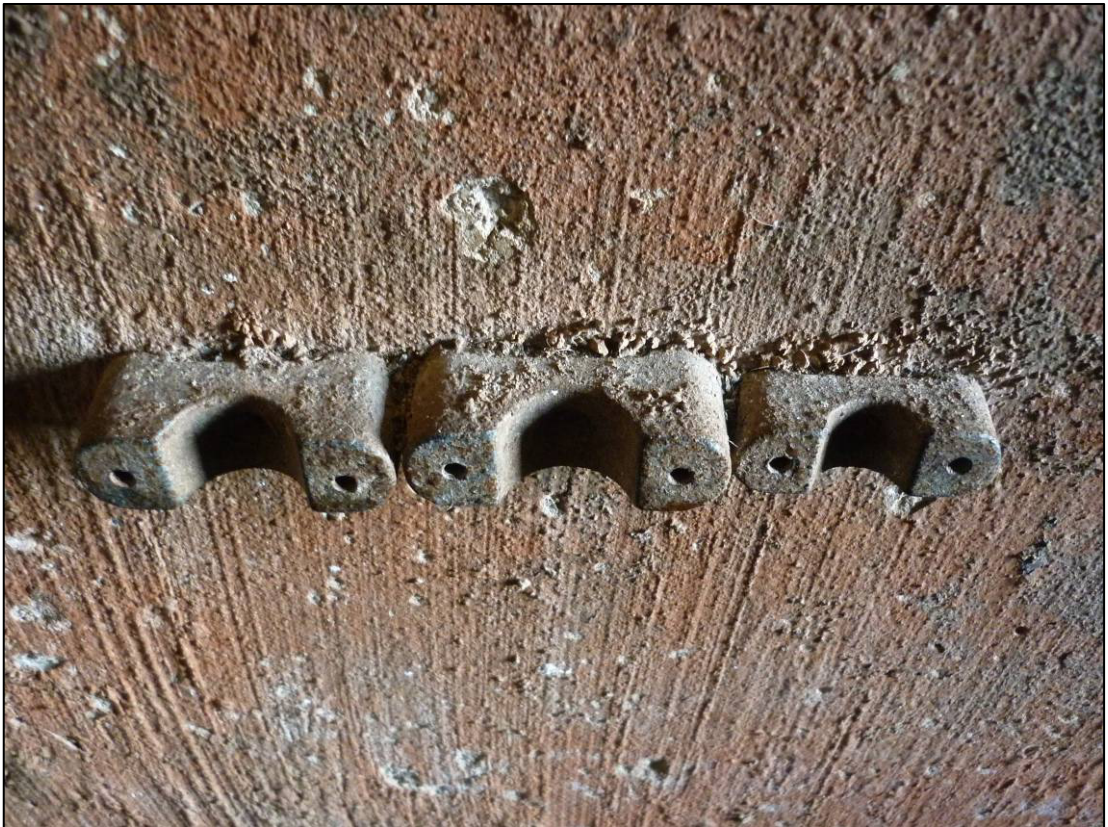
Plate 28: Building R4, west internal elevation of east room, showing bakelite clips, looking SW (photo 3/292, January 2012).

- 3.21 The internal east [1/861], north [1/864, 1/865], south [1/862, 1/863] and west [1/858] walls are generally as recorded by Kenyon in October 1997. Although it was noted in June 2000 that the bakelite clamps recorded in 1997 were no longer present, a single clamp or cable holder does still survive on the east internal wall, with the faint impressions left by other, removed, examples still just visible in oblique torchlight. In addition to the features noted by Kenyon, in the east internal wall to the north of the doorway, 1.19m above the internal floor level, two threaded bolts project from the wall face, flanking a circular recess 0.06m in diameter and 0.04m in depth. Directly above them, close to the ceiling, two screws may mark the former position of a bakelite clamp. To the south of the doorway, just above the neutral strip, there may be further evidence for removed fittings.

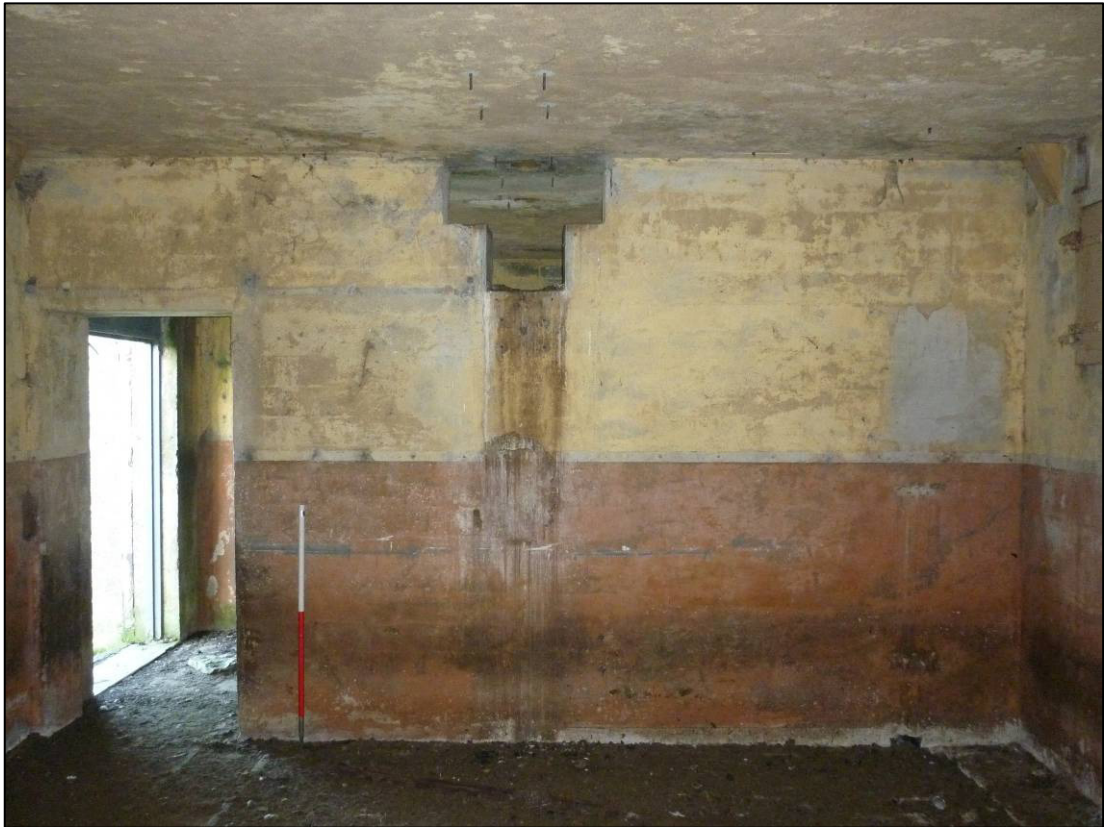
Plate 29: Building R4, east internal elevation of central room, showing decoration, fittings for sliding door, T-shaped opening and roof bolts, looking NE (photo 2/982, December 2011).

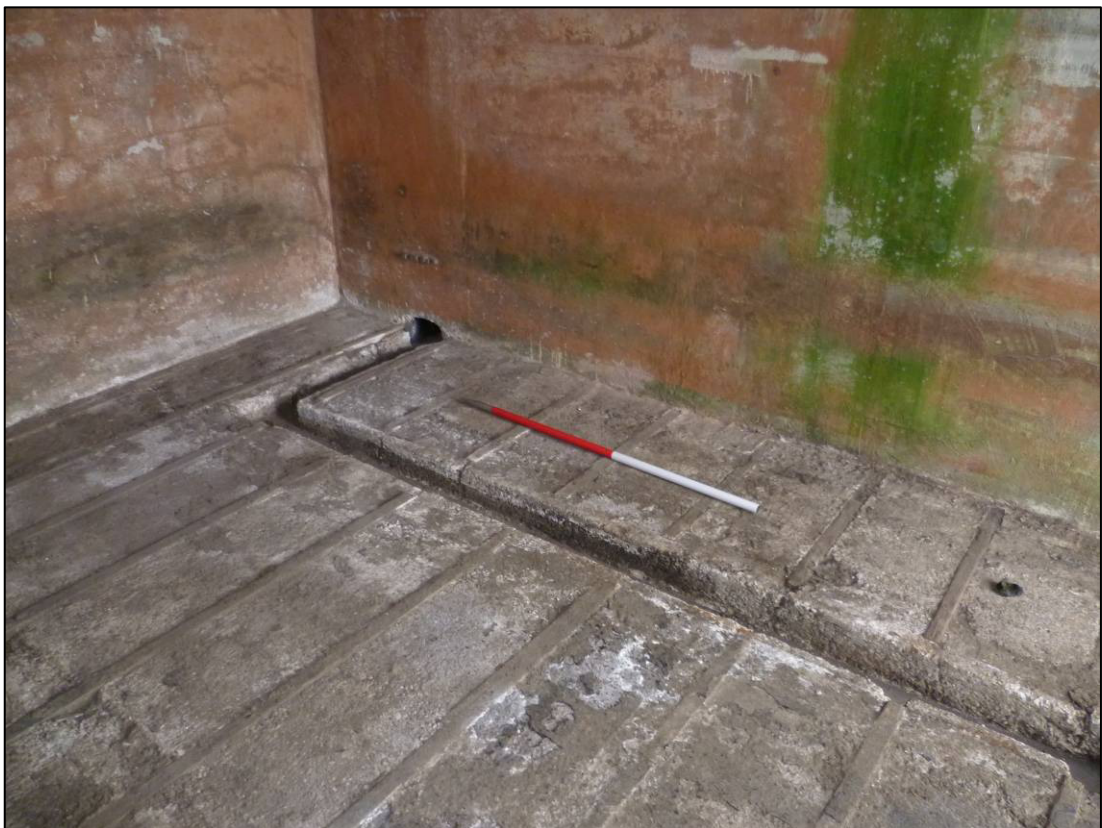
Plate 30: Building R4, floor of east room after clearance showing cable ducts and battens in concrete floor, looking E (photo 4/587, February 2012).

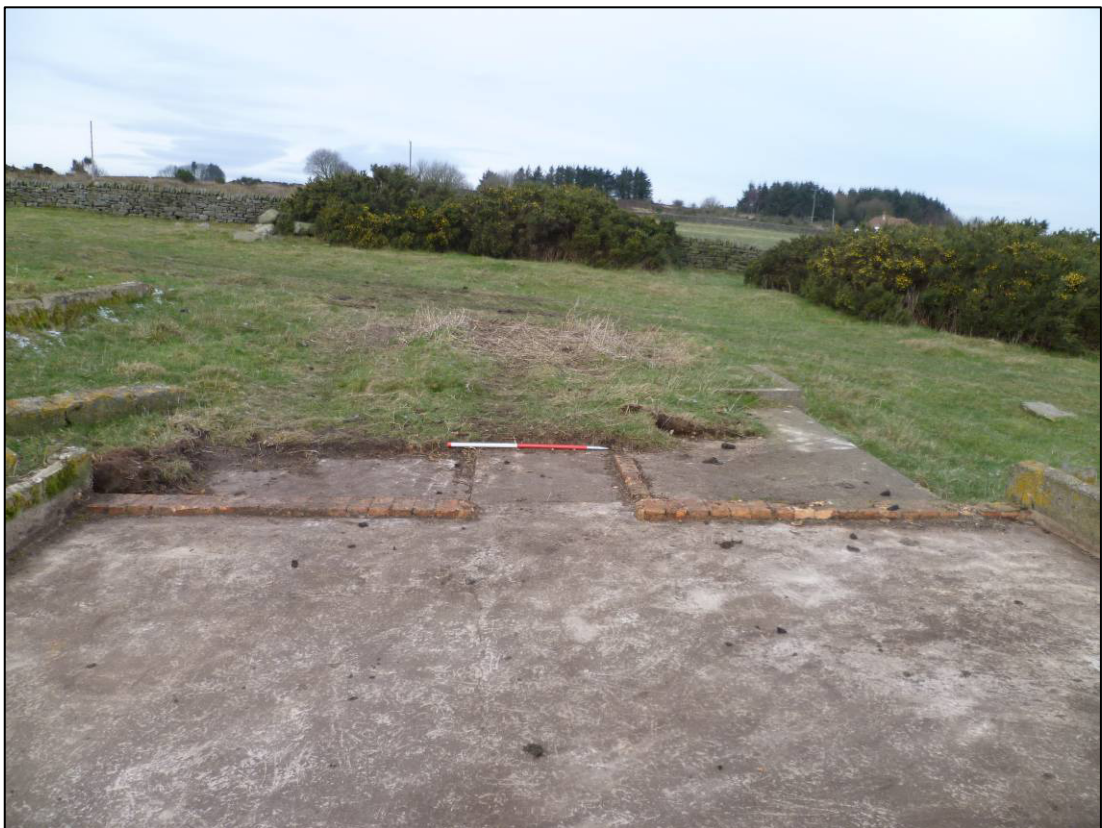
Plate 38: North end of southern part of Building A11 after clearance (photo 4/561, February 2012).

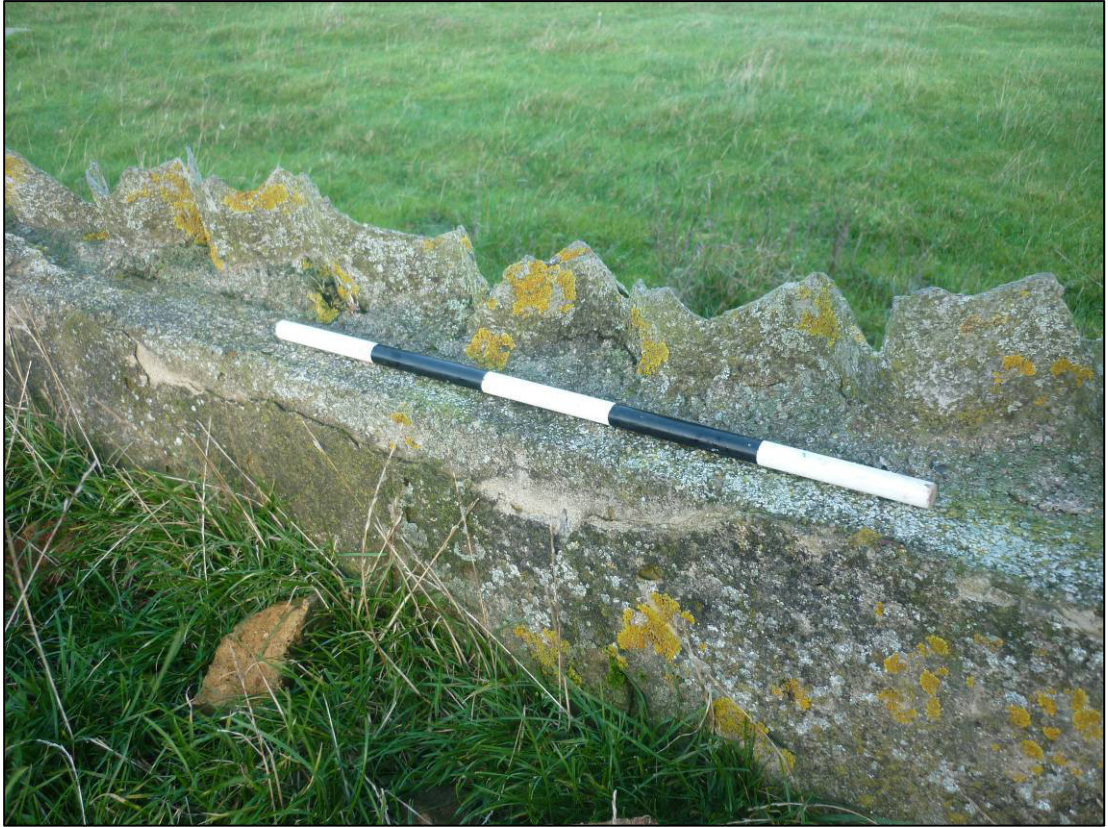
Plate 39: Building A11, remains of asbestos wall on east side, looking N (photo 2/941, December 2011).

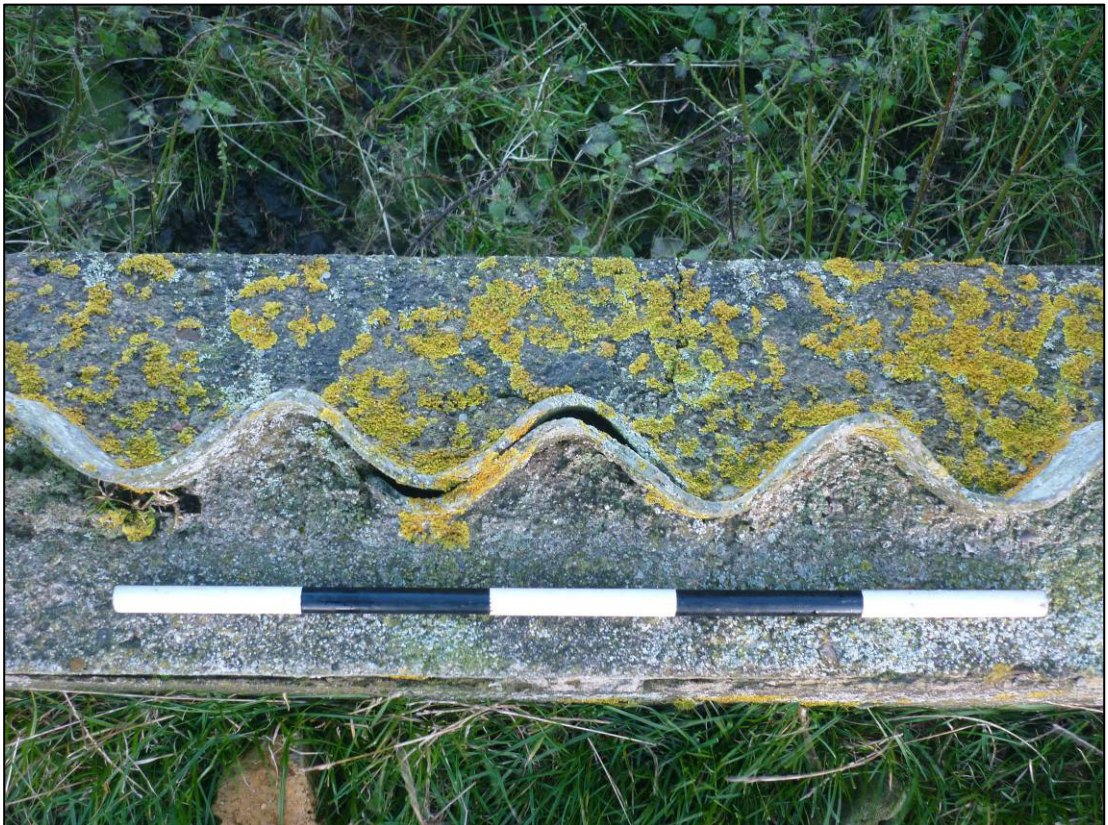
Plate 40: Building A11, detail of asbestos wall on east side (photo 2/940, December 2011).

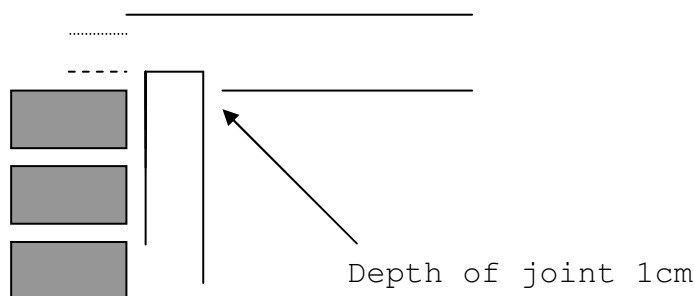
The east window has construction details similar to those seen in the west but with timber surviving in the east jamb and lintel. In the west jamb there is a 5 x 6cm hole towards the south edge of the wall at sill level. There are 9 x 1.5cm slots for timbers at 44 and 88 cm above the sill. The east jamb timber is 7cm wide and 3.5cm deep, held in place by framing to the cill and lintel components and by nailing (using two round-headed nails) to the timber inserts in the jamb. In place the timber is recessed 2.5cm from the external face of the wall. Metal staining from an iron window structure marks the outer 2.5cm of the remaining timber. There are screw-holes from mounting the metal structure at 67 and 102cm above sill level. There is a simple joint between the timber jamb and lintel as shown -

The lintel timber is 7cm wide and 3.5cm thick, also mounted 2.5cm inside the exterior face of the opening. The tenon fitted into the jamb brickwork is slightly reduced from the main width of the timber. The uprights are mainly held in place by a single main vertical nail.

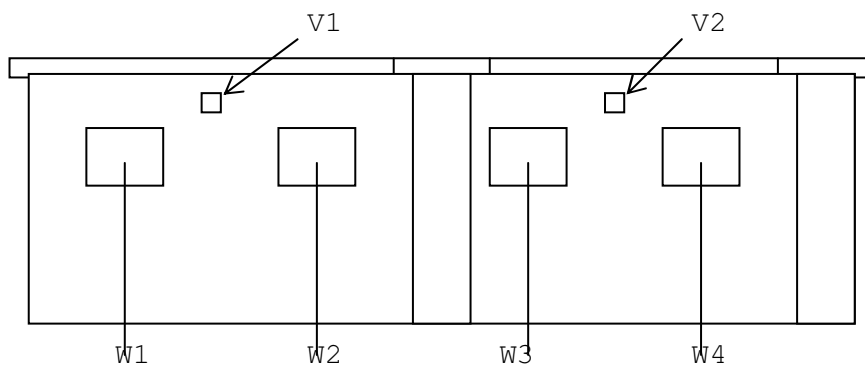
W1: Window at the western end of the southern side of the building. Double leaf metal framed window, with each half opening on top hung hinges. Each half is divided into four lights. Overall external dimensions are 1.00m x 63cm. Each opening half is 48 x 60cm; each light 20 x 26cm. Main frame and hinges are in iron. The hinge and latch for the opener is in bronze.

W4: Eastern window of the south wall, much as those described above. The frame is rusted shut but otherwise in good condition. Both leaves are present; all glass is broken but c.40% remains in situ. Only the outer segments of the shutter remain in both the east and west leaves. Both blast doors are present.

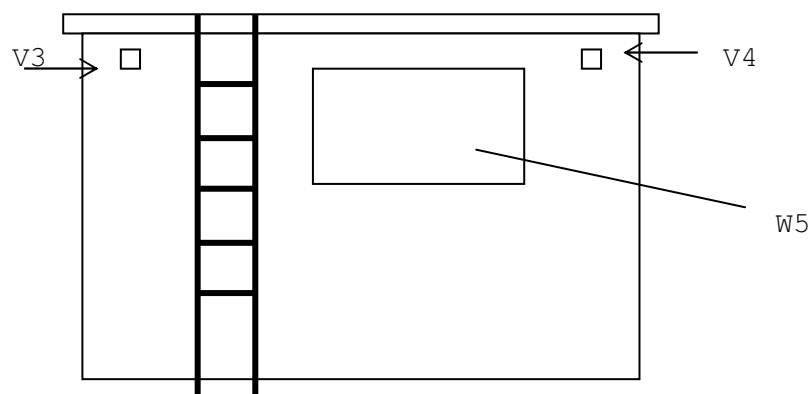
V3 & V4: Vents, as described above.

W5: Single window in the east wall of the building, much as described above. The window frame is in poor condition; the outer frame is generally present, though only 40% the left (south) moveable leaf is present and that without glass. The right (north) leaf is damaged, much of the bottom missing, with no glass.

The handle lock is actually broken off in W5, with the fragments on the floor nearby.

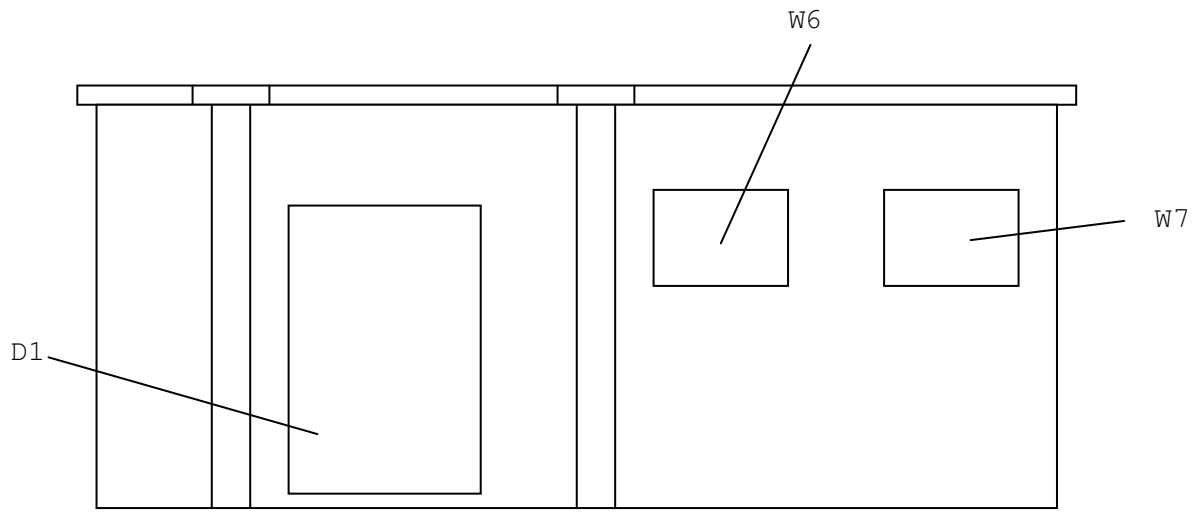
D1: Door opening measuring 1.38m wide by 2.2.6m high. Originally closed by a pair of interlocking steel doors – but only the west leaf now remains. The doors were mounted in a steel frame set into the concrete walls, hung on three hinge pintles. The doors opened outwards, in contrast to the blast shutters. The surviving hinges have brass pintles and turning washers. The handle and locking mechanisms have been stripped off.

W6: Window, originally as those described above. However it is now in very poor condition. The blast shutters are missing; so are the timber shutters with the exception of the external frame. In the window frame, most of the west leaf and half of the east is missing. Little glass remains. The west, base and centre of the of the fixed iron frame is also missing along with half of the east side.

The window frame is not so well preserved. Much of the east side of the outer frame is missing. The bottom parts of both leaves are missing or poorly preserved. However, the west leaf is still articulated and moves on its hinges.

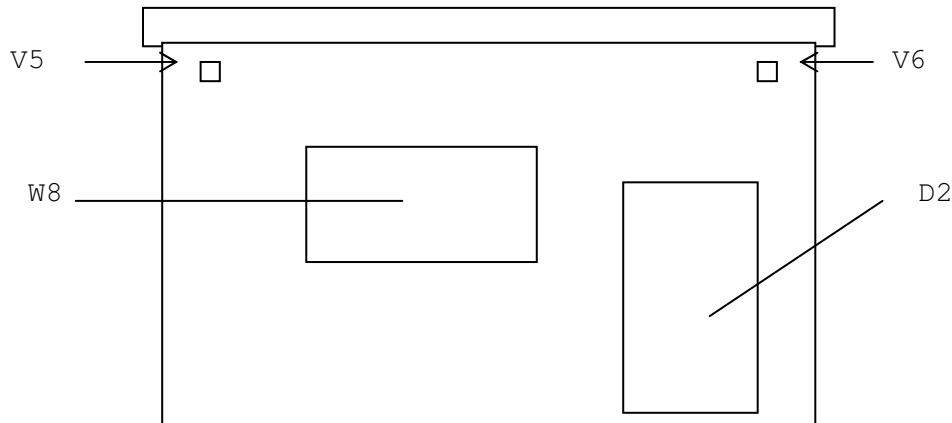
W8: Window in the west wall of the building. Blast doors both present. Only the side and top of the outer frame of the wooden shutters remain. The window frame itself is not in bad condition, but with very little glass in place.

D2 is a second double-leafed door, built as is described above for D1. It fills an opening measuring 1.23m wide by 2.23m high. The handle and locking mechanisms have been removed, and the doors have rusted shut. There is some dark coloured paint still adhering to the door surfaces.
