CHURCH OF ALL SAINTS,
WATH UPON DEARNE, ROTHERHAM,
SOUTH YORKSHIRE

ARCHAEOLOGICAL OBSERVATION,
INVESTIGATION AND RECORDING

Report no: 2013/452.R02
Version: Final
Date: February 2015
Authors: Shaun Richardson & Ed Dennison

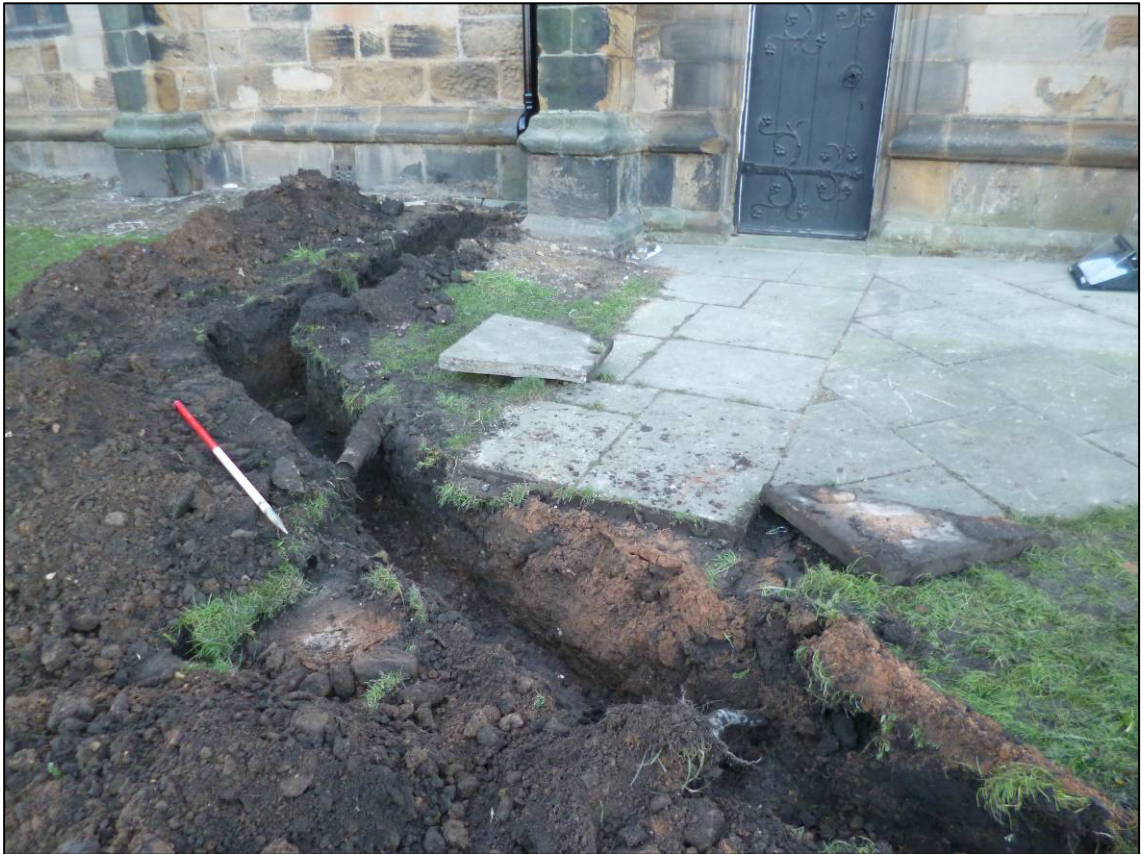
- 4.1 Trench 1 was excavated from a point just to the east of the second buttress from the west end of the north aisle, below an existing downpipe (see plate 1). The trench was aligned virtually north-south for 3.40m, before diverting to the north-west, at the point where an inspection chamber was installed. From here, the trench was aligned north-west/south-east for a distance of 5.30m, crossing a modern north-south orientated flagstone path, before reaching the soakaway pit. The trench averaged 0.40m wide throughout, and was 0.30m below ground level (BGL) at the south end (35.61m AOD), increasing to 0.70m BGL (34.91m AOD) at the north-west end. The soakaway pit was aligned north-west/south-east, and measured 2.30m long by 1.60m wide (see plate 2); it was to contain plastic crates wrapped in a permeable membrane and was excavated to a maximum depth of 1.75m BGL (33.86m AOD).

Plate 1: Excavation of Trench 1 in progress, looking S.

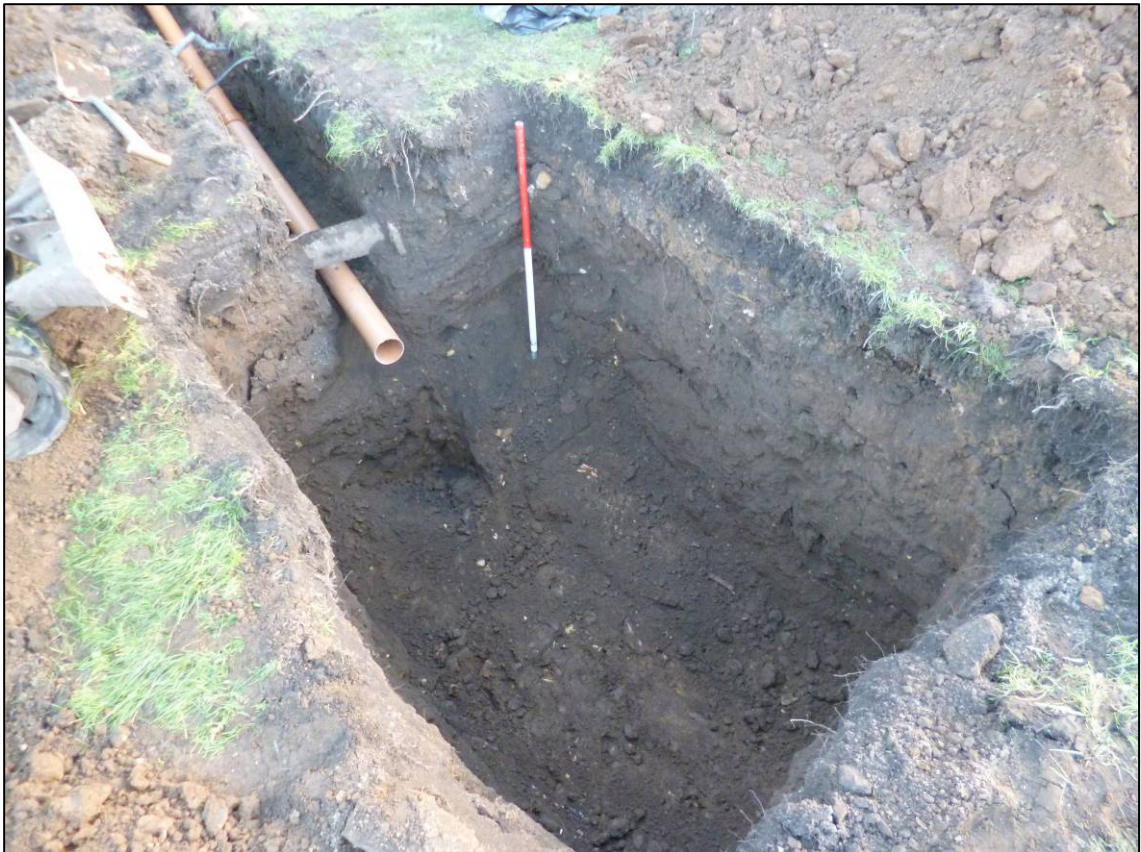
- 4.4 All the articulated burials and disarticulated human remains observed during the watching brief came from this context, and only from within the soakaway pit. Within the pit, only relatively small amounts of disarticulated human remains were recovered above a depth of 1.50m BGL (34.11m AOD). Three articulated burials were observed in the base of the soakaway pit, all within context 003, although none had clearly visible grave cuts. The uppermost burial (004) extended into the south-east side of the pit, at a depth of 1.55m BGL (34.06m AOD). The extended, supine and articulated skeleton was in a poor condition, and aligned north-west/south-east. A decayed, fragmentary skull was recovered from the north-west end, but this appeared to result from later disturbance, as decayed extended left and right legs were excavated below, with the feet towards the north-west. The individual, an adult, had been placed within a coffin; the decayed vertical pine board forming the north side remained visible, and a number of rusted iron nails

- 4.6 Once these three burials had been removed, it was noted that, as the excavation of the soakaway pit continued below c.1.60m BGL (34.01m AOD), the proportion of disarticulated human remains within the pit increased significantly. It was possible that some of these may have represented further articulated burials which were disturbed by the mechanical excavator. Due to the increasing amount of human remains, levels were again taken by the main contractor on the drainage run, and it was found that an adequate fall had been achieved to allow the soakaway to function correctly. Excavation of the pit therefore ceased at a maximum of 1.75m BGL (33.86m AOD), without further disturbance to human remains.

Plate 2: Soakaway pit after excavation, looking S.

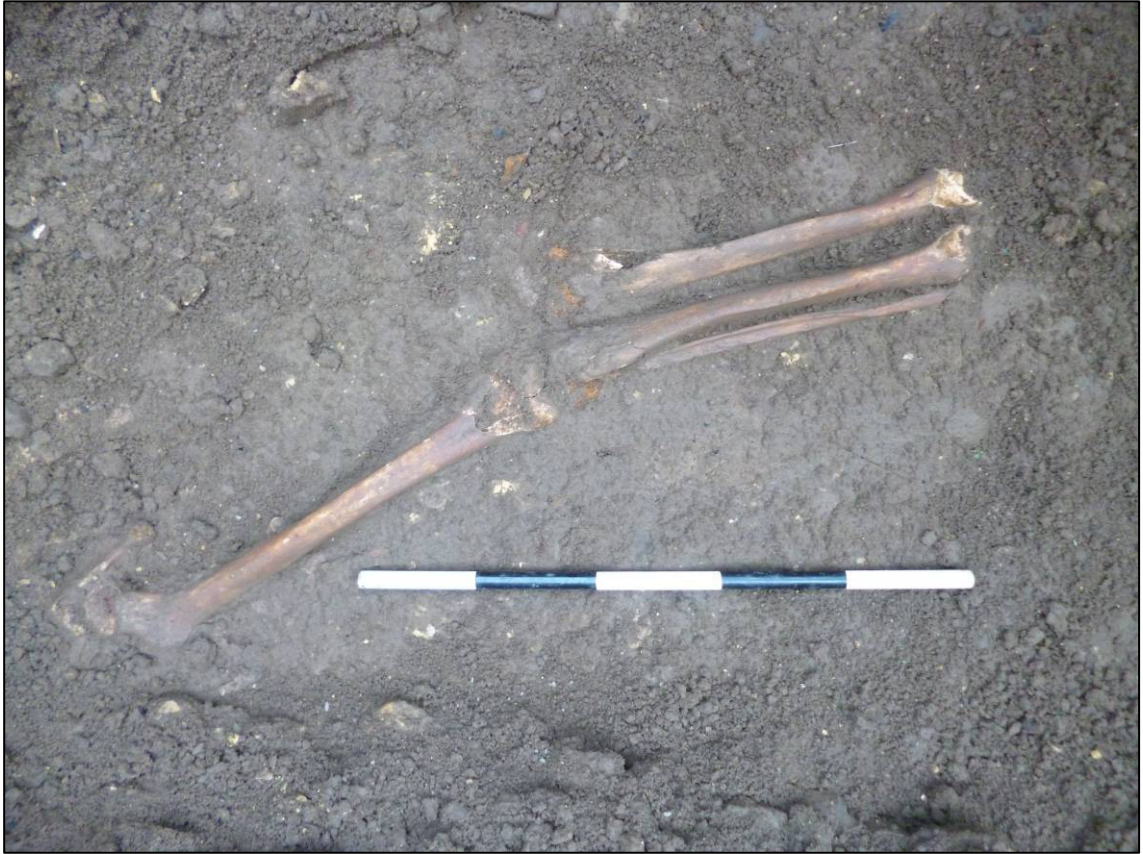
- 4.5 The uppermost burial (004) may have partly truncated a second burial (006) located to the north-west. This extended, articulated, adult skeleton was in relatively good condition, and lay at a depth of 1.50m BGL (34.11m AOD). The skeleton was aligned approximately east-west, with the feet to the east; the pelvis, and both legs were turned to the north, so that the left leg was resting on the ground (see plate 3). Both feet were missing, apparently truncated by burial 004 to the south-east. The latter appeared also to have partly disturbed a second burial (005), placed immediately to the south, at a depth of 1.60m BGL (34.01m AOD), causing damage to the head and chest area. The extended, articulated, supine adult skeleton was aligned north-west/south-east, with the head to the north-west; it continued beneath the south-eastern edge of the soakaway pit.

Plate 3: Burial 006 in west side of soakaway pit, looking N.

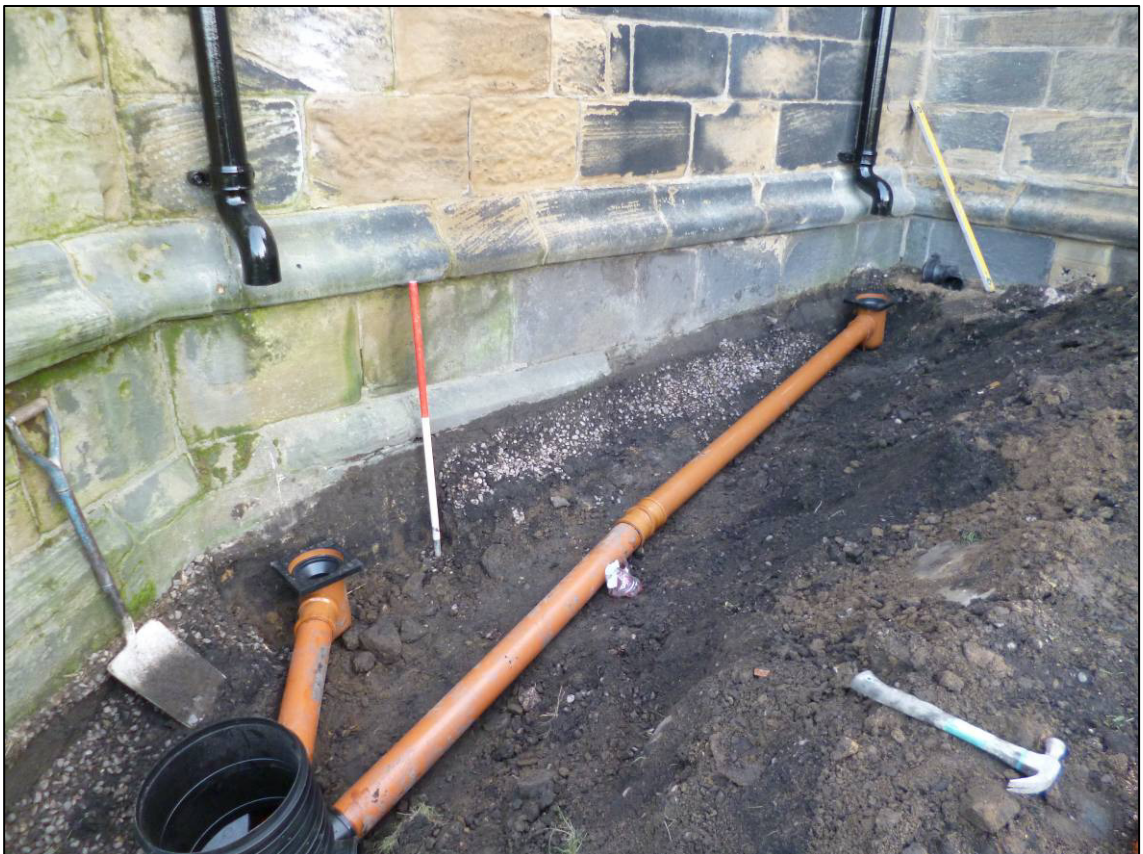
- 4.7 Trench 2 was excavated from the corner of the church where the north aisle and Lady Chapel meet, below an existing downpipe. The trench was aligned virtually north-south for 6.00m, as far as the projecting end of the angle buttress at the north-west corner of the Lady Chapel (see plate 4). At the south end of the trench, adjacent to the north aisle, the ground level was 35.93m AOD; the trench was excavated to a depth of 0.30m BGL here (35.63m AOD). At its northern end, the ground level was set at 35.53m AOD and the excavation reached a maximum depth of 0.40m BGL (35.13m AOD). The trench averaged between 0.40m-0.50m wide.

- 4.8 For the whole of its length, the trench followed an existing drainage run. The same two uppermost contexts, (001 and 002), as described in Trench 1 above were encountered, mixed with gravel from a French drain. No disarticulated human remains were recovered from the trench. Where the church walls were revealed, they were seen to extend vertically beneath the lowest visible plinth, although no other architectural features were exposed.

Plate 4: Trench 2 after excavation, looking SE.
